**A PHASE 1 ARCHAEOLOGICAL IMPACT ASSESMENT (AIA) FOR THE AIRPORTS COMPANY OF SOUTH AFRICA (ACSA) PROPOSED PORT ELIZABETH AIRPORT STORMWATER UPGRADE, WALMER, NELSON MANDELA BAY MUNICIPALITY, EASTERN CAPE PROVINCE**

April 2013

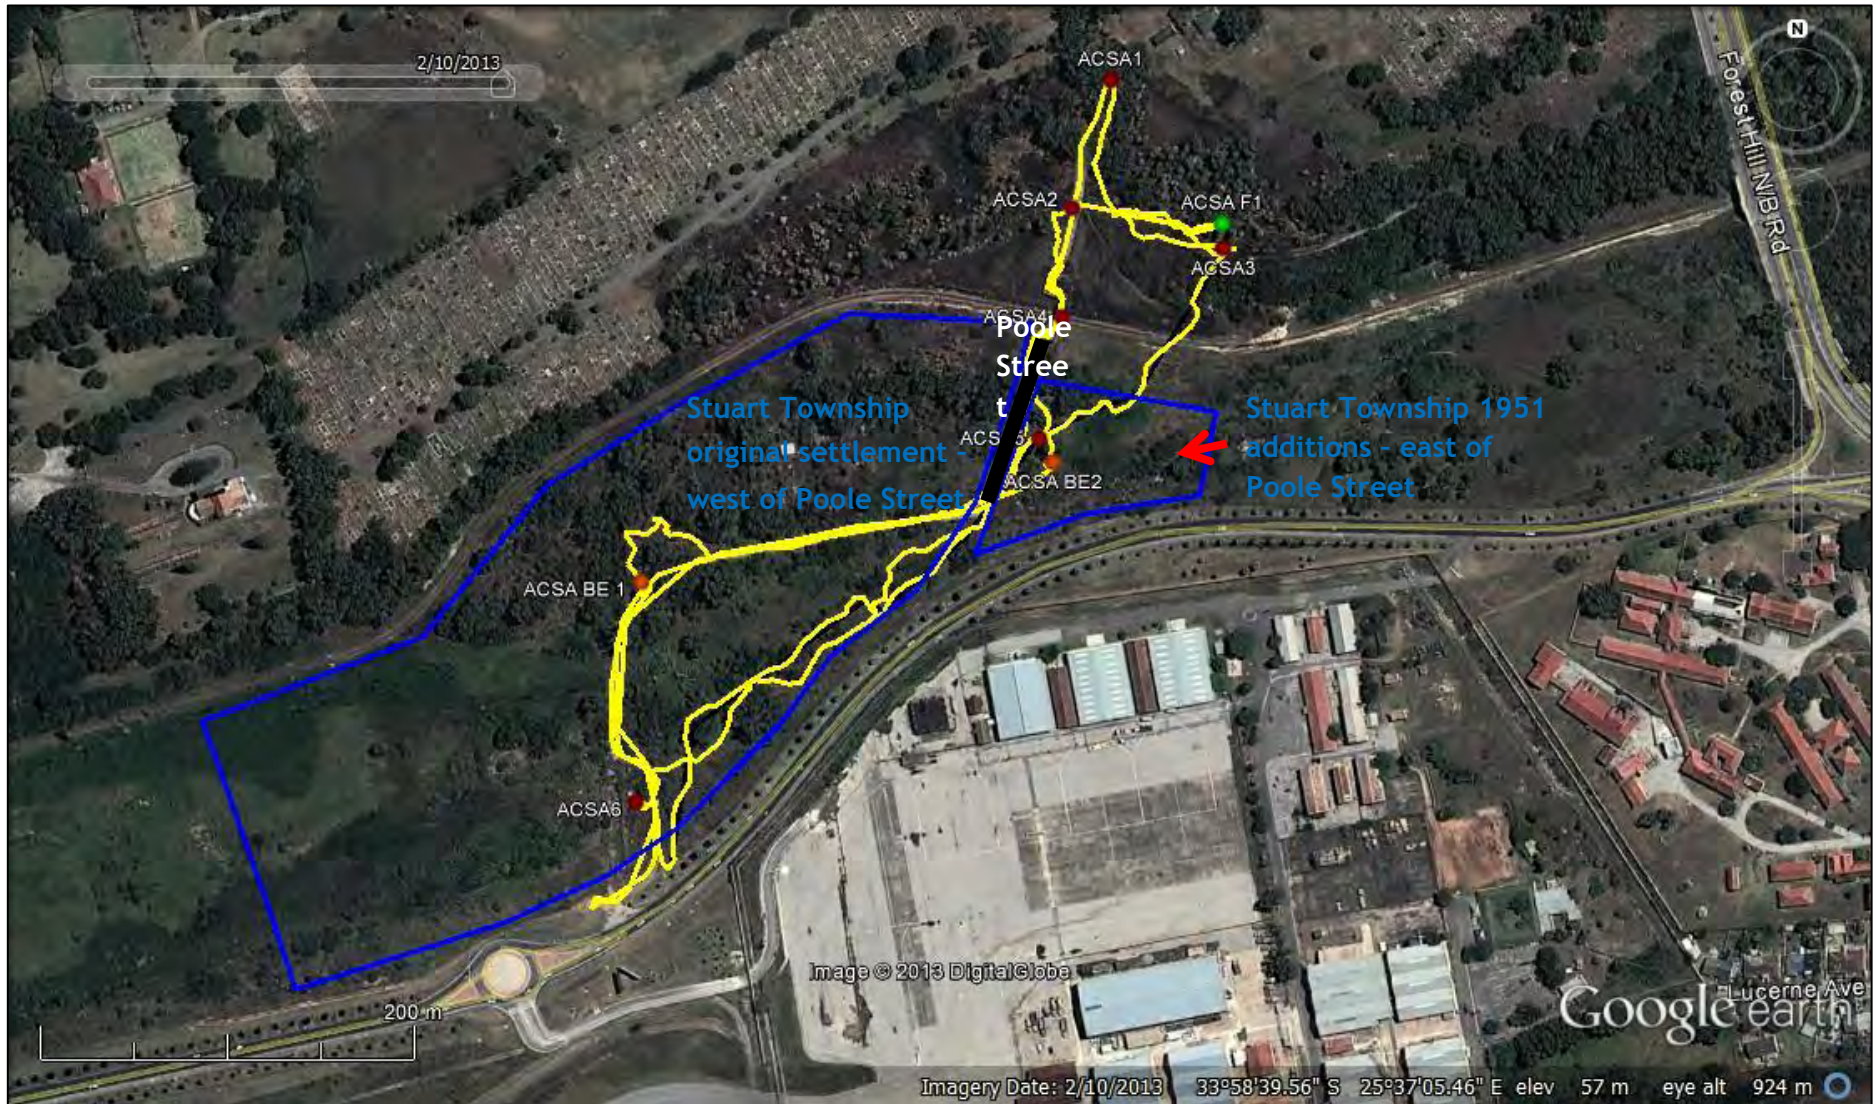
Figure 9. View of tracks and recorded areas in relation to the extent of the layout of Stuart Township (demolished in 1979) (blue outlines, not to scale).

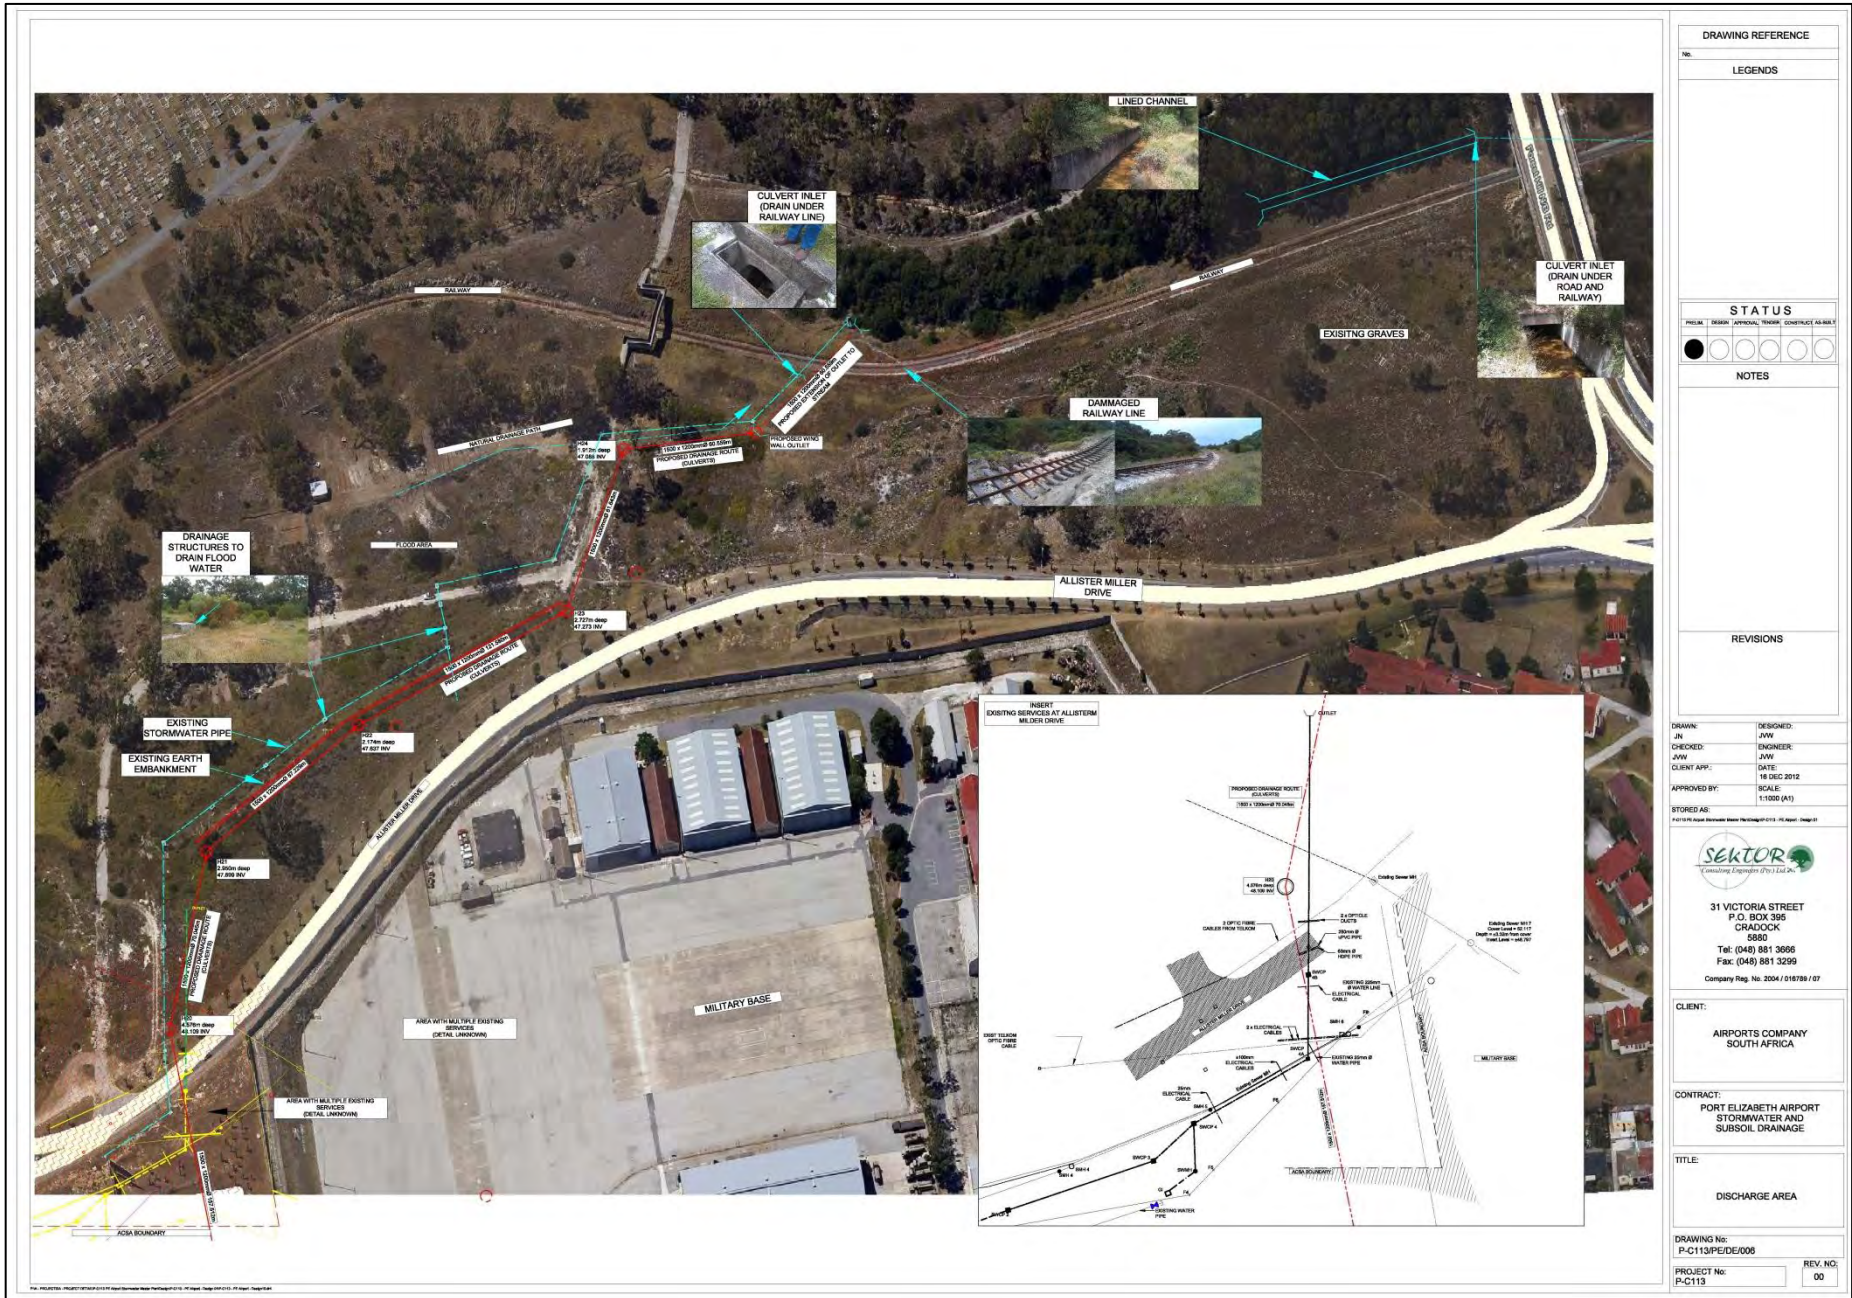
DRAWING No:  
P-C113/PE/DE/006  
PROJECT No:  
P-C113  
REV. NO:  
00

Figure 10. GIS generated map of the layout of the area proposed for the ACSA stormwater outfall system upgrade (image courtesy of SRK Consulting).

TITLE:  
DISCHARGE AREA

Figure 11. GIS generated map of the layout of the area proposed for the ACSA stormwater outfall system upgrade including the route of the existing pipeline (image courtesy of SRK Consulting).

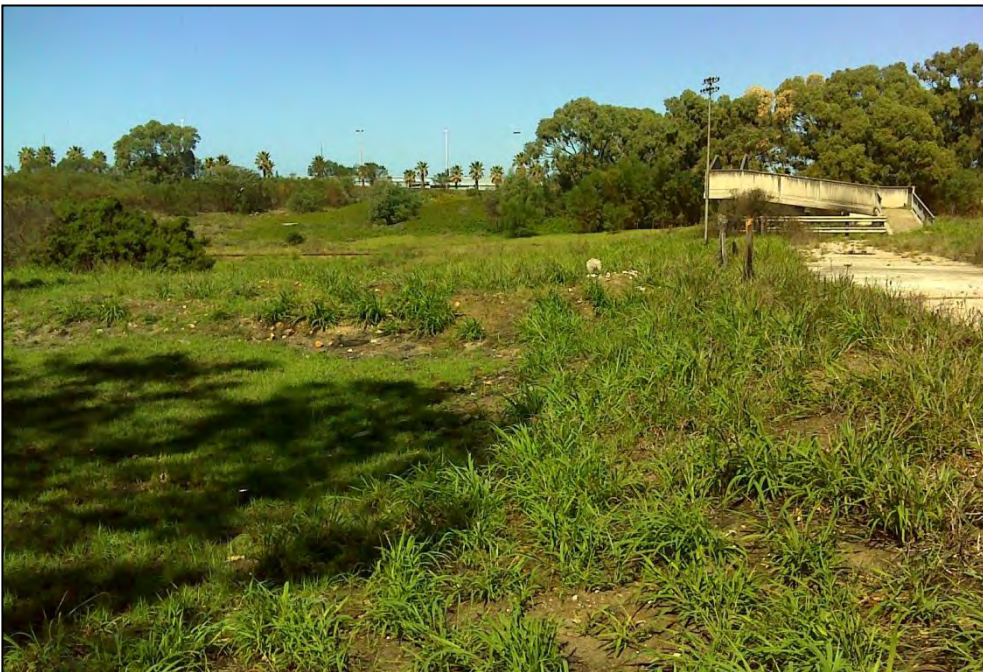
**Figure 15.** Example of one of the exposed areas within the immediate vicinity of the proposed pipeline route.

Most of the area proposed for development is covered in dense grass and other vegetation with very few exposed surface areas, which made archaeological visibility difficult (Figures 11-14). The proposed area for development has been heavily disturbed by the construction of the built environment such as fences, roads (gravelled and tarred), a railway line and a railway bridge crossing (Figures 15-16). Building remains from the now defunct Stuart Township are visible over the wider area and can be identified by the uneven surface cover where it is possible that further remains occur below the current dense vegetation cover and growth (Figure 17). In addition, the surface would have been heavily disturbed during the construction of this pipeline and associated manholes and the construction of the houses and structures associated with Stuart Township (Figures 18-21).

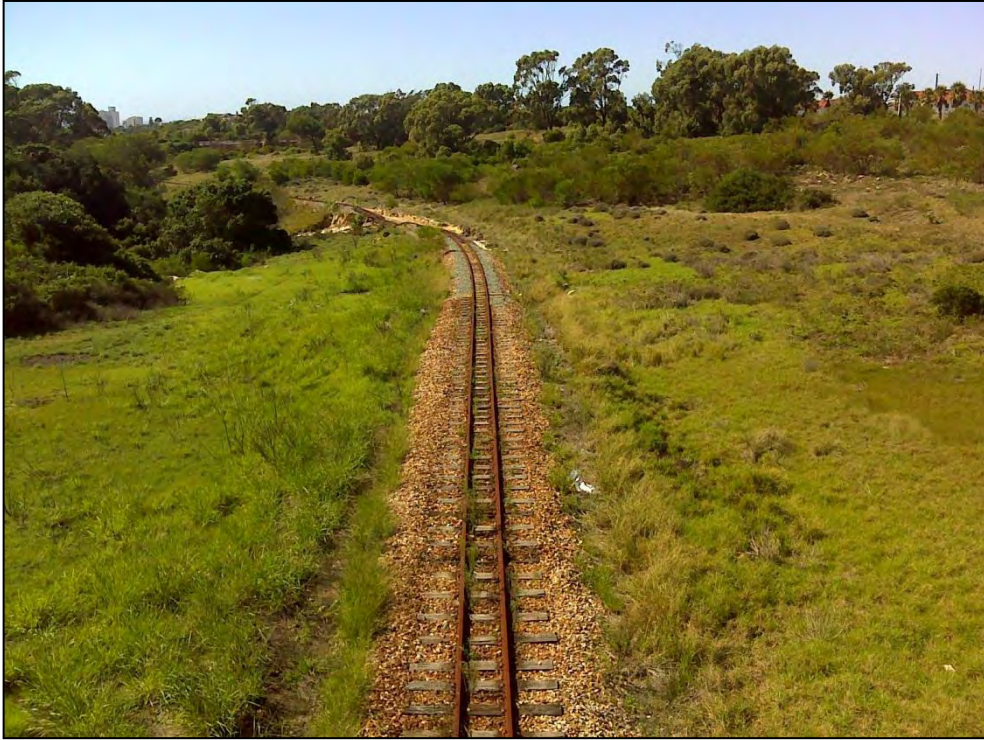
**Figure 17. View of the disused railway line running through the proposed route for the pipeline.**

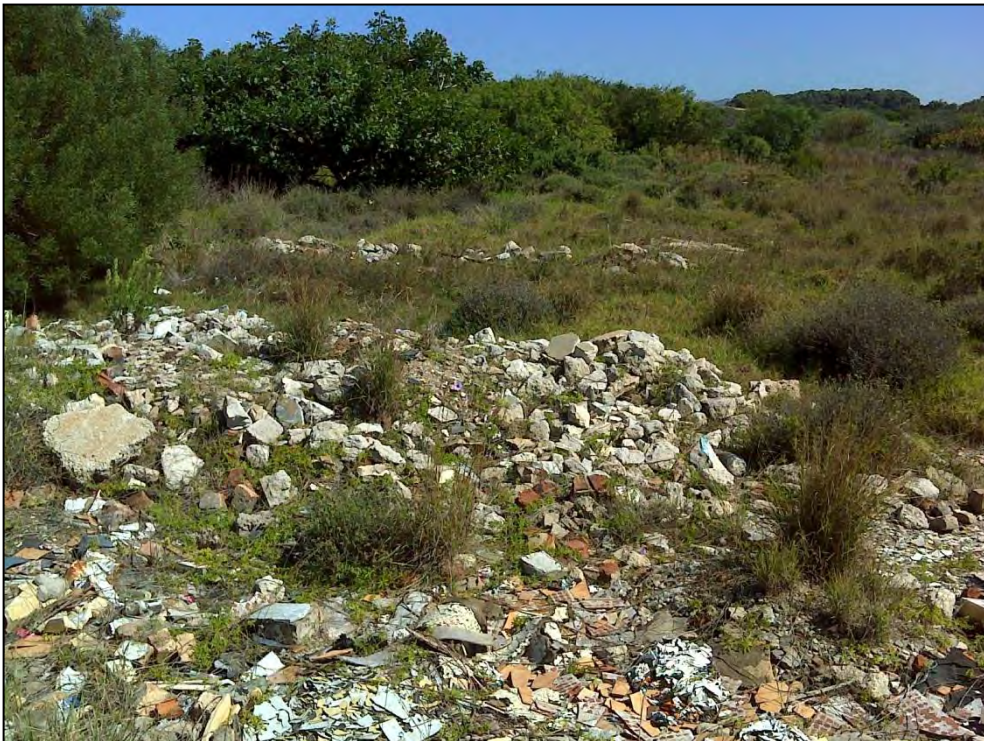
**Figure 18. View of remains of the building structures associate with Stuart Township within the immediate vicinity of the proposed route for the pipeline.**

Two built environment features, the remains of building foundations (ACSA BE1) and the possible drinking trough (ACSA BE2) were identified within the immediate area of the proposed route for the pipeline. It is unlikely that these features would be affected during construction activities. However, it is possible that the remains of additional building structures associated with Stuart Township would be uncovered underneath the dense vegetation. As Stuart Township was established in 1938 and the eastern side of Poole Street extended by 1951, the remains of the settlement are generally protected under the National Heritage Resources Act (NHRA 25 of 1999).

1. A demolition permit should be applied for as the remains and ruins of Stuart Township and its later extension in 1951 is older than 60 years and may be covered by the dense vegetation within the proposed route for the stormwater outfall system.

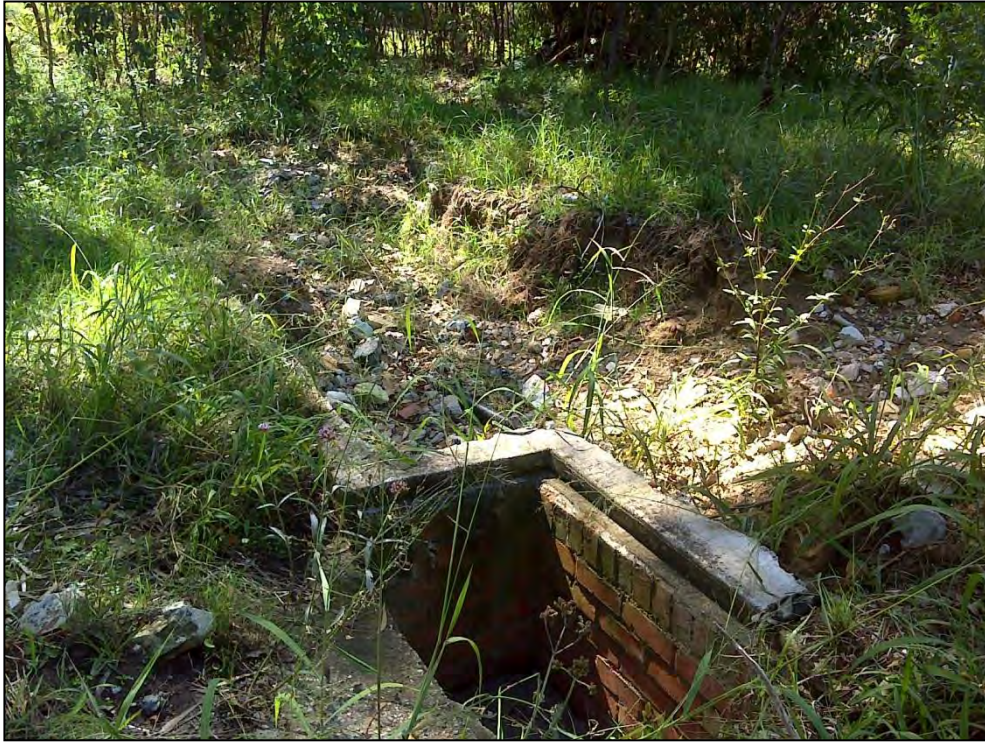
**Figure 19.** View of the existing underground stormwater pipeline proposed for upgrade.

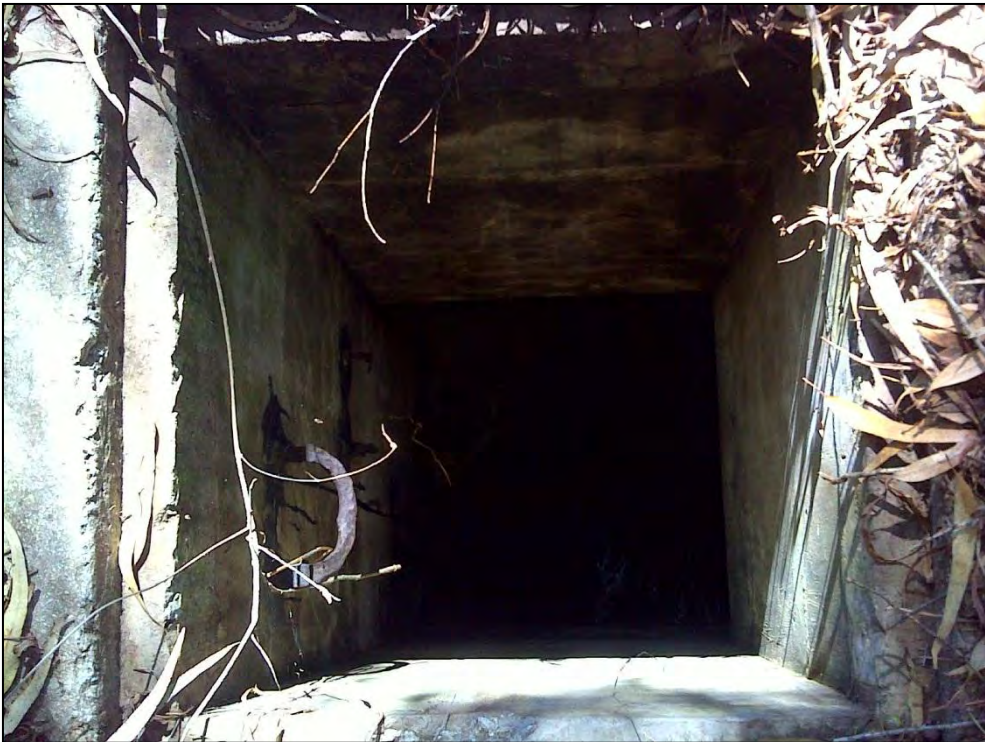
**Figure 20.** Looking into one of the underground open manholes.

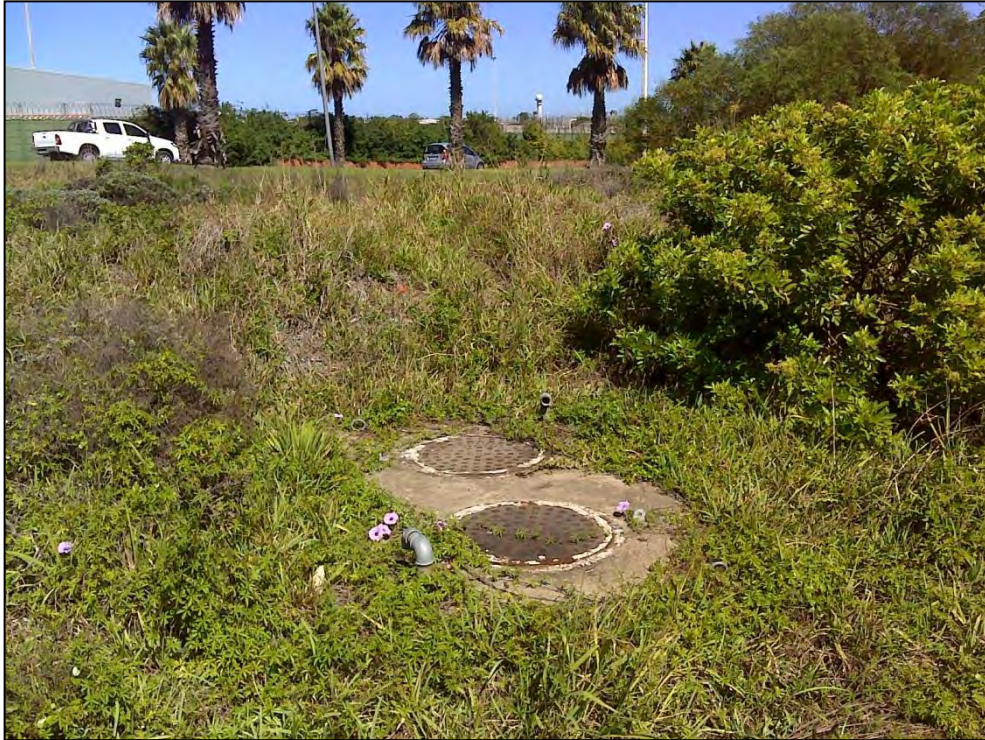
**Figure 21. View of manhole covers near to Allister Miller Drive.**

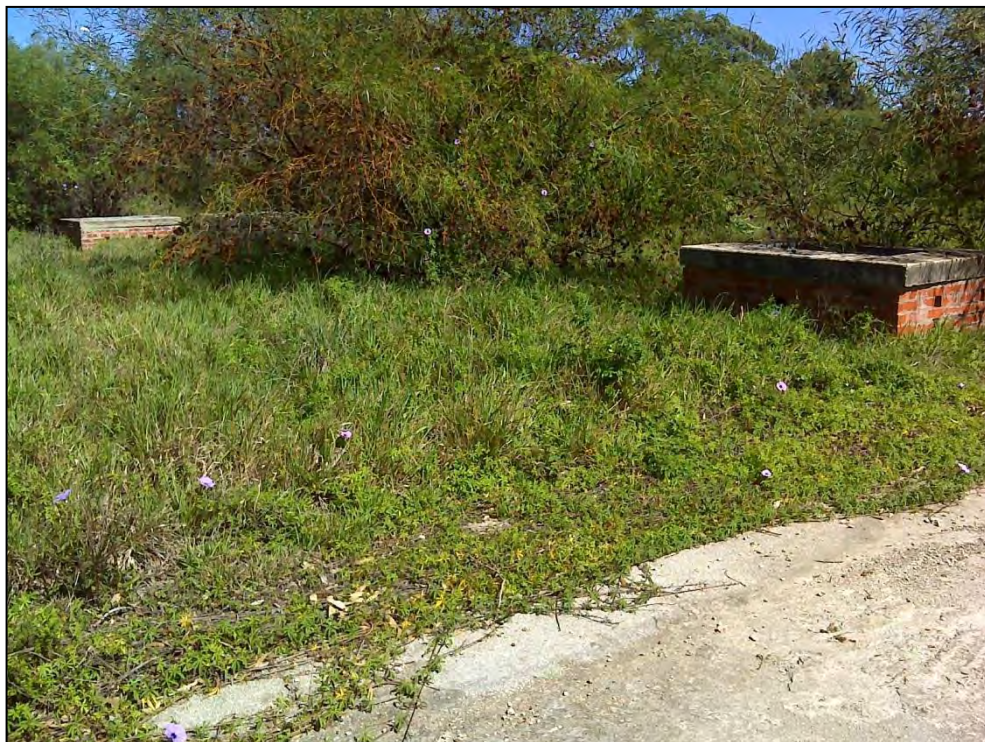
**Figure 22. View the manholes for the existing stormwater pipeline.**

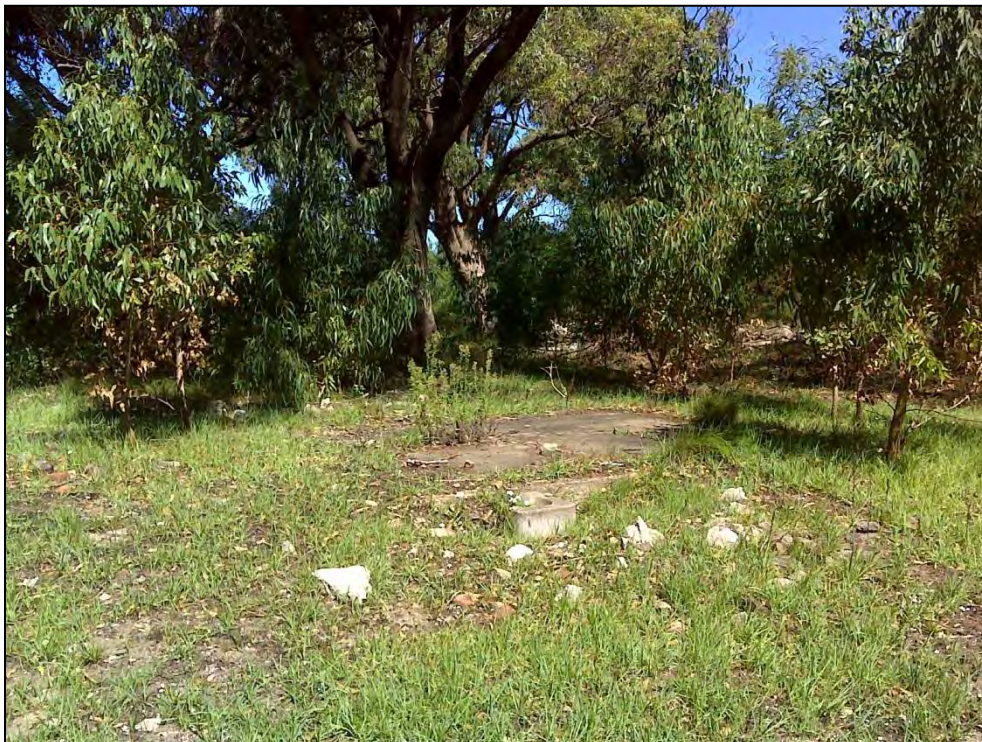
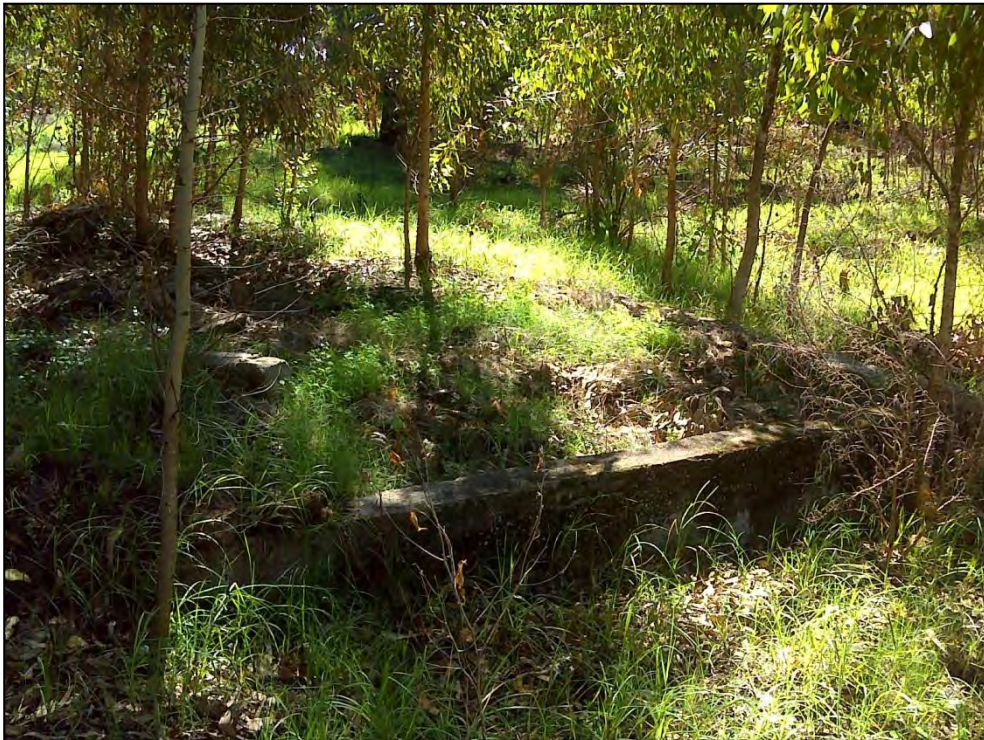
Building foundations (ACSA BE1) (Figures 24-25) and possibly a livestock drinking trough (ACSA BE2) (Figure 24) were encountered during the survey and suggest that the building foundations were a part of Stuart Township that was demolished during the late 1950's and early 1960's owing to forced removals during that period. The remains of a road that may have been one of the internal roads and now leads to Forest Hill Drive can be observed at the most northern point of the proposed route for the pipeline, near the GPS point marked ACSA3.

The remains of the building foundations can be identified by stairs that are situated along the tarred road that runs through the wider area, about 165 m from the entrance along Allister Miller Drive. No historical heritage remains were identified in association the foundations, most of the materials identified seem to have been manufactured within the last 20 years and possibly littered or dumped within the area. The trough is not situated in the area proposed for development, and therefore is unlikely to be negatively affected by the construction activities.

Figure 23. View of the remains of the foundations at ACSA BE1.

**Figure 24.** View of the remains of the foundations at ACSA BE1.

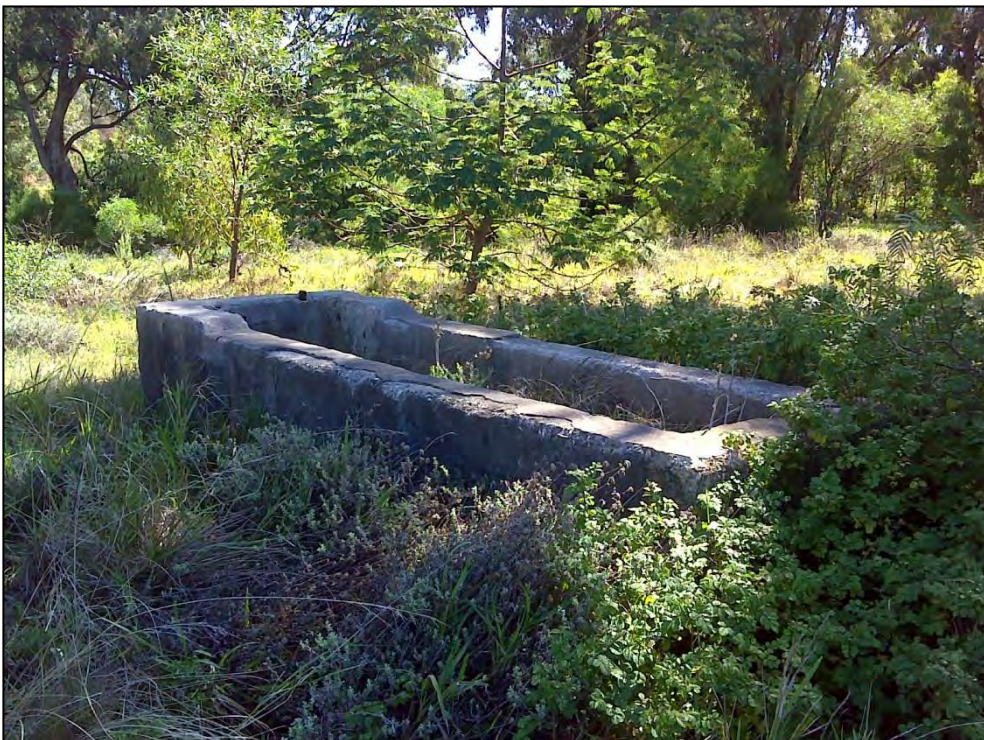
**Figure 25.** View of the possible drinking trough observed during the survey of the surrounding area of the proposed route for the pipeline.

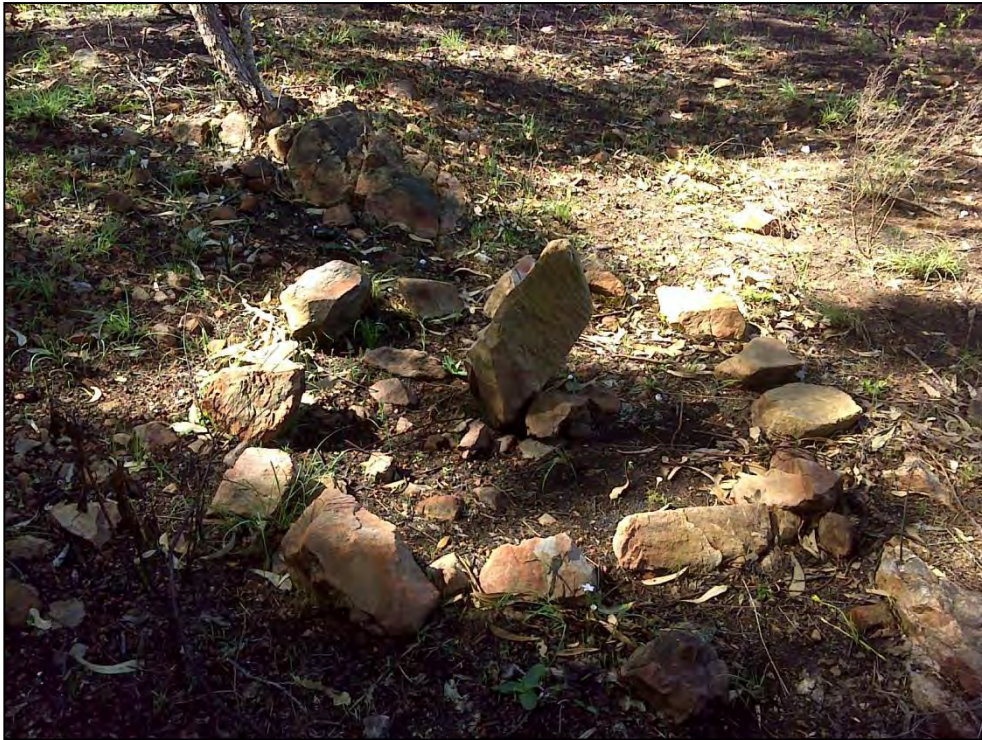
In addition, a stone packed circular feature (ACSA F1) (Figure 19), approximately 1 m x 1 m in extent with an upright rock placed in the middle of the circle was identified on a small hill directly above the remains of the old roadway. It is possible that the structure may have recently been packed for cultural, religious, or arbitrary purposes and does not occur within the proposed route for the pipeline.

Figure 26. View of the stone packed feature located at ACSA F1.

One stone packed circular (ACSA F1) (probably recently packed) was identified outside of the proposed route for the pipeline. This feature should not be negatively affected by the construction of the pipeline.
