## Archaeological Impact Assessment

**Title:** Melkbos Private School Expansion.

Proposal to expand the existing school on Farm 88 Melkbos to provide additional classrooms, sports fields and spectator facilities and parking.

6 January 2009

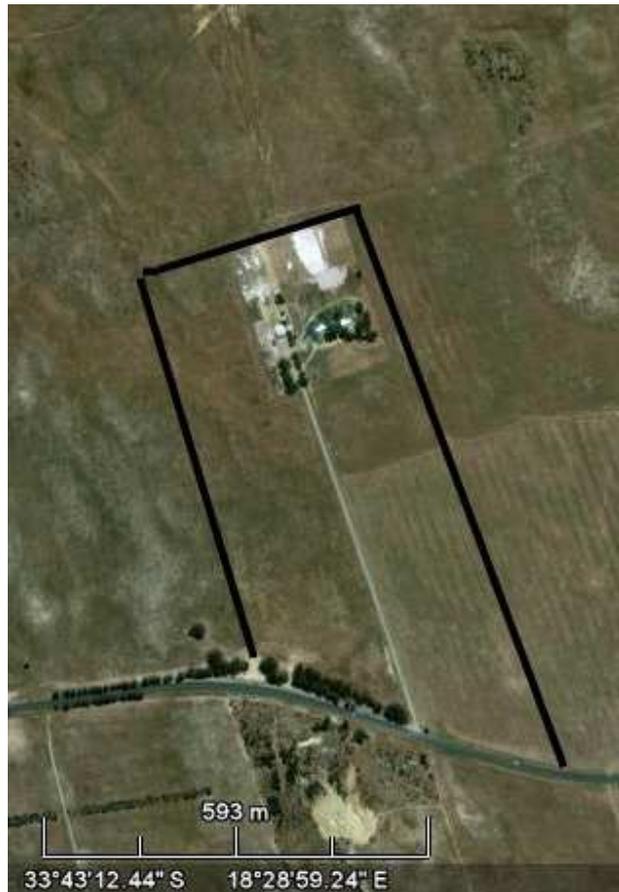
Figure 2. The property lies north of the R304, the school buildings are on the northern side and the setting cultivated farmland.

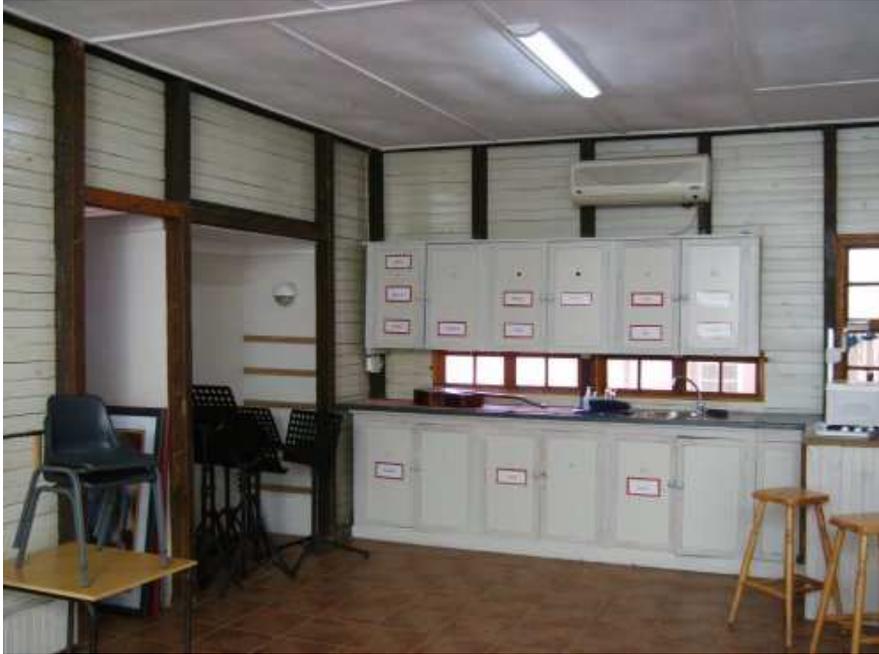
**Figure 4. The science laboratory in part of the original wooden structure**

The wooden structure as part of the main building should be retained without alteration as it is the footprint of building history on the property.

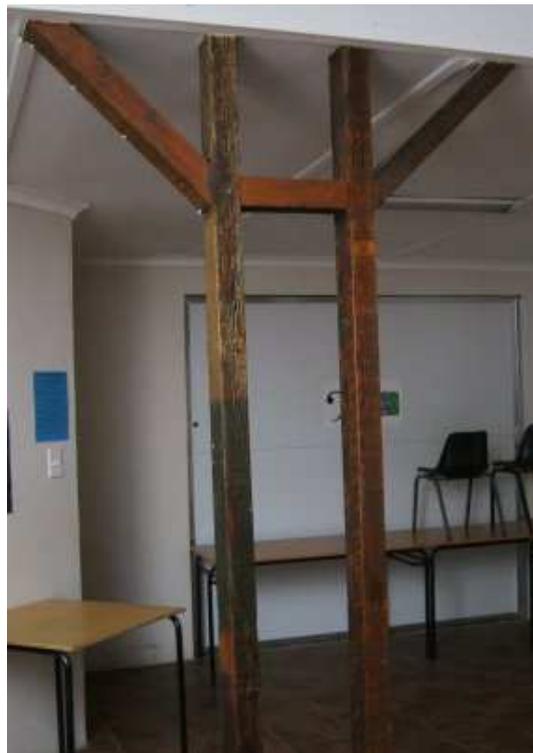
**Figure 5. Detail of the joinery where part of the cladding has been removed**

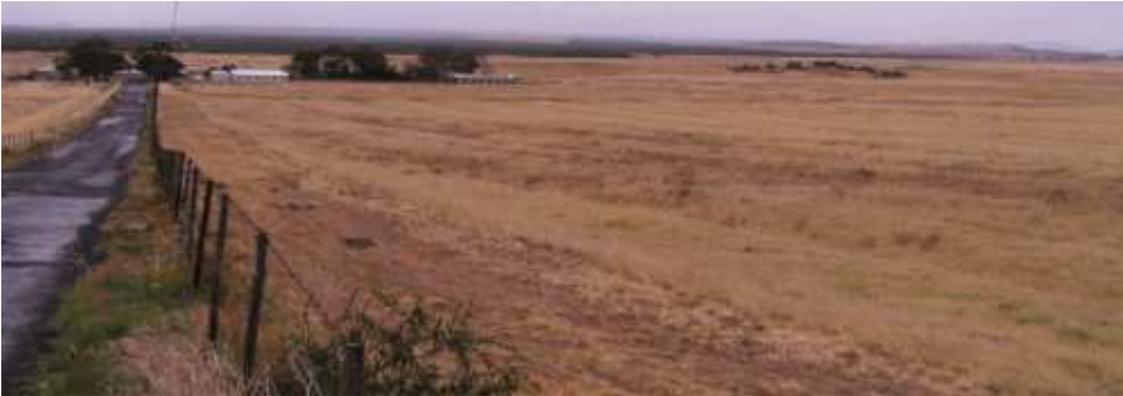
The area is cultivated farmland. The ground surface is pale coloured cover sands (Fig. 6). Subsurface exposures in drainage ditches show a duplex profile (Fig. 7) of less than 2 m

**Figure 6. The pale cover sands exposed in the plough zone, school buildings in the distance**

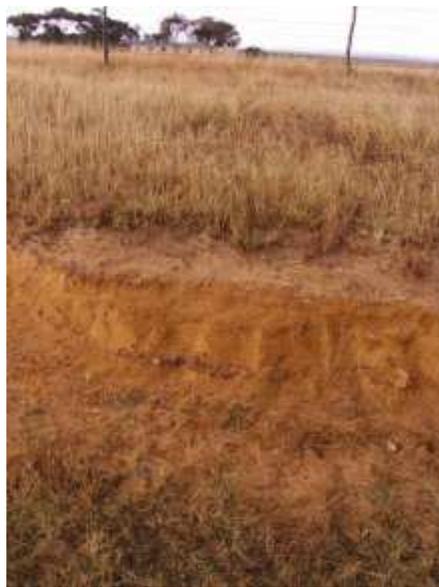
with sands over ferruginised clayey material with iron concretions over weathered Malmesbury metasediments.

**Figure 7. Duplex soil profile, sands over clayey material, on weathered bedrock. No archaeological or palaeontological were observed in such profiles during the survey.**

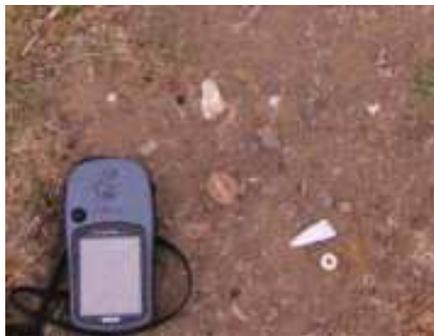
No *in situ* archaeological or palaeontological materials were observed. The rugby sports field has been dressed with imported shelly material. Some of this material came from a shell midden because an ostrich eggshell bead (Fig. 8) was located on the edge of the field (Fig. 8). Silcrete artefacts were noted in south western corner of the property among other materials introduced as substrate for portion of the old course of the R304. The drainage ditch exposures failed to reveal any buried cultural materials.

**Figure 8. Ostrich eggshell bead imported along with shelly material to dress the rugby field**

It is recommended that should any excavations by chance uncover buried palaeontological or archaeological materials including human remains that Heritage Western Cape is notified (Mr N Wiltshire, Heritage Resource Management Services, HWC, Private Bag X9067, Cape Town 8000, Tel:021 483 9743, Fax:021 483 9842, nwiltshire@pgwc.gov.za). In this context the indicators would be *in situ* shell from middens and fossil bovid bones from hyena dens. Features like human burials can occur in unpredictable locations.
