# ARCHAEOLOGICAL IMPACT ASSESSMENT: EXPLORATORY EXCAVATION OF THE AREA OUTSIDE THE RUSTENBERG WALLED CEMETERY AT THE UNIVERSITY OF CAPE TOWN, CITY OF CAPE TOWN, WESTERN CAPE

Prepared in terms of the National Heritage Resources Act No 25 of 1999 and as a requirement for Permit No: 80/08/04/022/51

November 2008

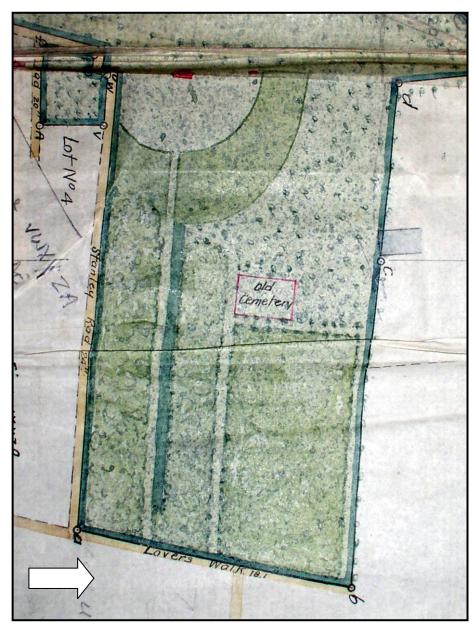
Figure 2: The Surveyor General's Diagram of 1917, showing the location of the cemetery (SG 8123/1917).

The only **concrete** evidence for the location of the "old cemetery" is the Surveyor General's Diagram (Figure 2) that accompanied the University of Cape Town Deed of Grant and this survey was conducted in 1917 (SG 8123/1917).

Fieldwork was successful as a remnant of a stone wall, which appears to date to the early 20<sup>th</sup> century, was uncovered along the exact line indicated on the Surveyor General's diagram of 1917. It may be assumed that this would represent the outer (northern) wall of the cemetery as indicated in Figure 2. A number of recommendations result from this exploratory excavation:

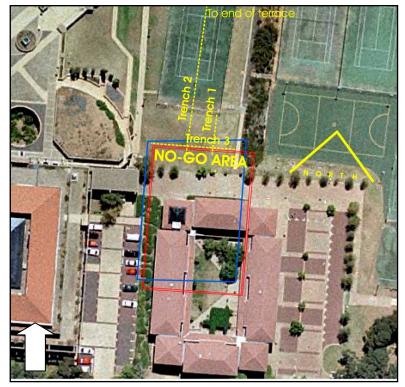
Figure 3: The overlay of the 1917 Survey Diagram and the location of the three trenches discussed in the text.

Prior to the commencement of archaeological work, the ACO was presented with a diagram indicating the position of the "old cemetery" (established through the original Survey Diagram) and the three (3) trenches which had agreed upon during the public participation process (Figure 3). A mechanical excavator was used to excavate the trenches. Excavations commenced on 5 November and ceased on the 10 November 2008. Inclement weather and mechanical problems with the excavator hampered excavations.

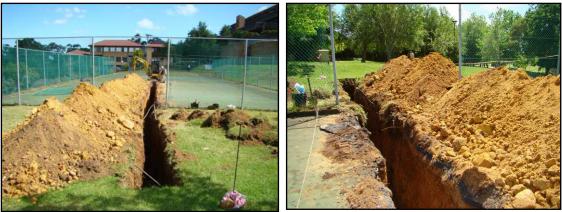
Trench 1, looking north-south (left) and south-north (right).

Trench 1, 1m wide and 58m long was excavated through the length of the present staff tennis court in a north-south direction (Figure 4). The trench was excavated to a depth of approximately 2m, to decomposing large sandstone boulders signifying bedrock. The archaeologists were advised to dig to a depth of 0.3m below the level of undisturbed soil or clay and this was achieved in Trench 1.

**Trench 1:** The stratigraphy (soil profile) was fairly consistent throughout Trench 1. The top 200mm comprises the asphalt of the tennis court and a humic brown soil. Below this is a yellow gravel layer which varies between 300mm and 500mm. According to the site engineer, this top unit represents disturbed material and does not relate to the original soil horizon. Below this layer is a yellow clayey matrix with large sandstone boulders (Figure 5). These boulders appear to lie on bedrock. The soil profile of the last 25m of the Trench, approaching the edge of the anticipated cemetery wall, was observed to be very unstable, with large areas caving in. This prevented detailed stratigraphic observations from being made. No artefactual remains were found in this Trench, with the exception of some recent plastic and rusted metal sheets to the north of the tennis court.

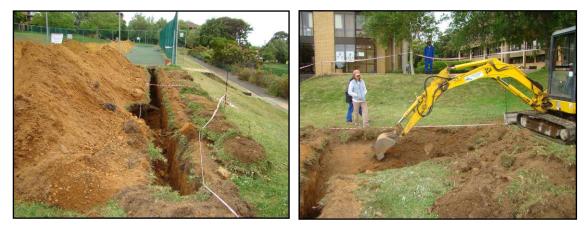
Trench 2 on the edge of the terrace (left) and the start of Trench 3 (right).

**Trench 2**: The soil profile of the trench located at the end of the terrace was substantially different from Trench 1. The Yellow Gravel Layer was very uneven and collapsed in large sections. Beneath this layer was a red/brown loamy soil which extended down to 1.6m, when we stopped further excavations due to the unstable nature of the soil. There was a single thin black soil parting running through the red/brown soil at the depth of 1m from the surface (Figure 6). This trench appears to represent disturbed soils and there is no evidence of the yellow clay and sandstone boulders found at the base of Trench 1.

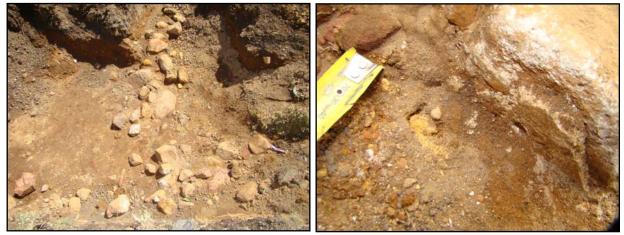
found at the end of this rubble layer, suggesting the corner of a possible wall or structure which had collapsed outward. Some of the boulders were coated in limestone plaster, suggesting they may have formed the outside of a wall (Figure 7). The structure of this plaster indicates that it dates to the period 1900 (Hart, pers comm.) which places it within the time frame for the construction of the cemetery wall.

Trench 3: Section of the collapsed stone walling (left) viewed from the southern section of Trench 3, looking northward. A sandstone rock with lime plaster (right).

We have no information on the structure of the wall. Archaeological excavations have revealed a combination of red brick, sandstone boulders and lime plaster lying in an east-west direction. There is no indication of a formal wall or even the footing or foundations of a wall. The stones and bricks are lying in a haphazard fashion, suggesting a structure which had been demolished at some time in the past. There are several large boulders at the easterly end of this rubble layer, suggesting the corner of a possible wall or structure which had collapsed outward. Some of these boulders were coated in limestone plaster, suggesting they may have formed the outside of a wall. Trench 3 therefore appears to have cut into a section of the cemetery wall.

- It was recommended that a proper geo-referencing of the wall remnant be undertaken before it is covered up. This will allow the position of the "walling" to be retained into the future and will prevent possible destruction during building operations;

- That a set-back or buffer of 2m outside of the "stone walling" should be established beyond which the contractor may not go. This would be to protect the walling from possible destruction during building operations;

- That the "stone walling" should be covered be white sand or geotextile before it is covered in soil, in order that it may be uncovered at a later date for possible display;

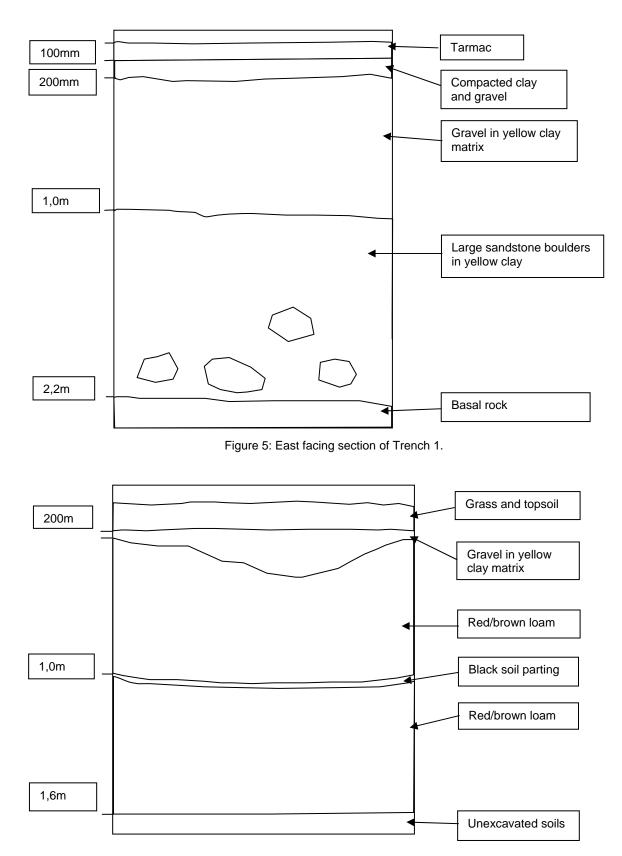
Figure 6: West facing section of Trench 2.

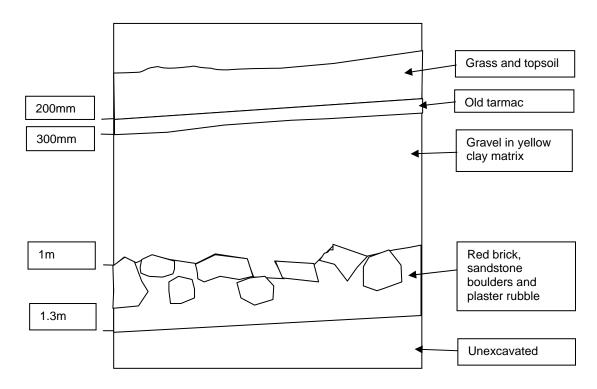
Figure 7: South facing section of Trench 3.
