Phase 1 Archaeological Impact Assessment of Portions of Lilyvale 2313 and Bayswater 2865, Bloemfontein

L. Rossouw
National Museum
PO Box 266
Bloemfontein

Report prepared for:
Terraworks Environmental Consultants
PO Box 13578
Noordstad, 9302

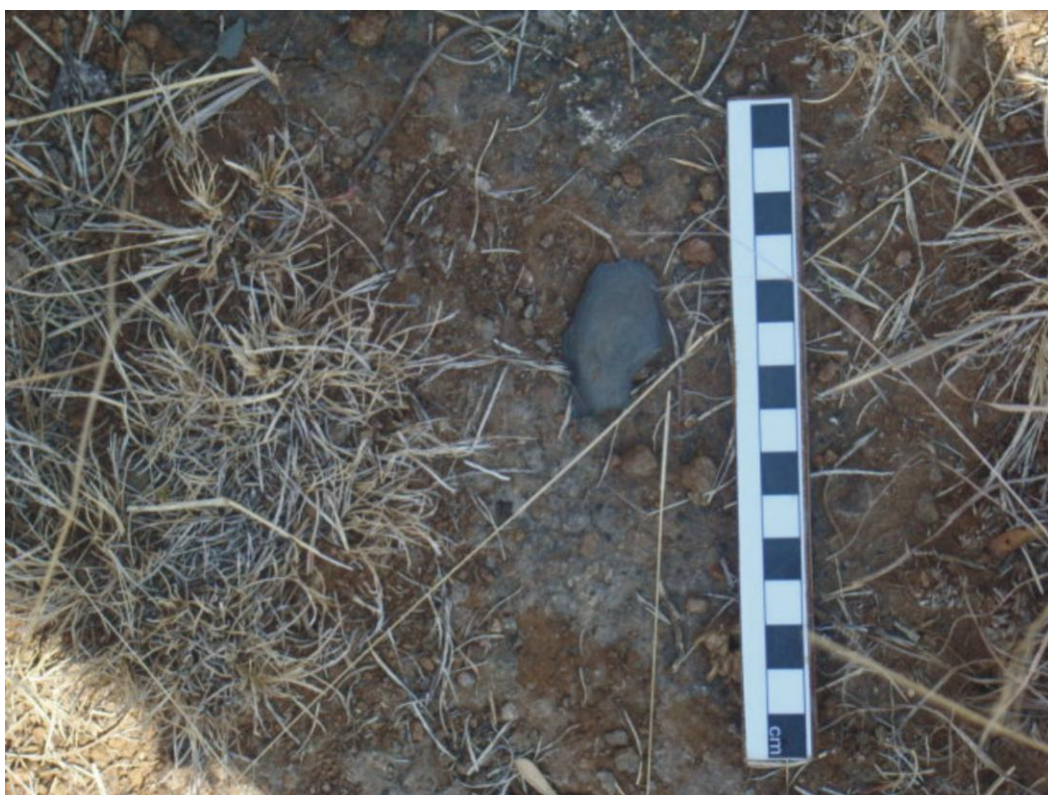
Figure 3. The distribution of the artefacts range from isolated flakes to small loose scatters of various pieces of debitage. All the stone tools observed during the pedestrian survey were located as individual finds.

The few artefacts recorded are all made of hornfels, a raw material commonly found in outcrops near dolerite intrusions as it is formed when underlying mudstones are baked by intrusive lava. The distribution of the artefacts ranged from isolated flakes to small loose scatters of various pieces of debitage. All the stone tools observed during the pedestrian survey were located as individual finds. The artefact scatters were mainly observed on the dolerite ridge around Area D (**Fig. 3**). The artefacts are uncapped and exposed and most likely out of context as a result of lateral as well as vertical (lag deposits) displacement over time. This is also indicated by the co-occurrence of MSA and LSA and material on the landscape. There is no evidence for the accumulation and preservation of intact fossil material within the overlying Quaternary sediments at the site. No rock engravings were observed, although engravings are known from the Botanical Gardens nearby.

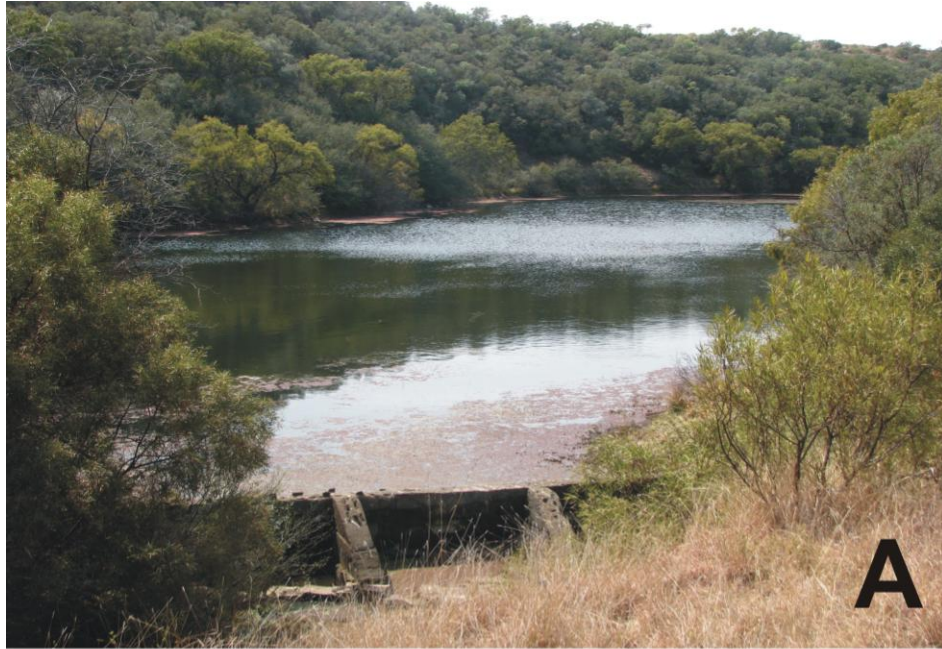
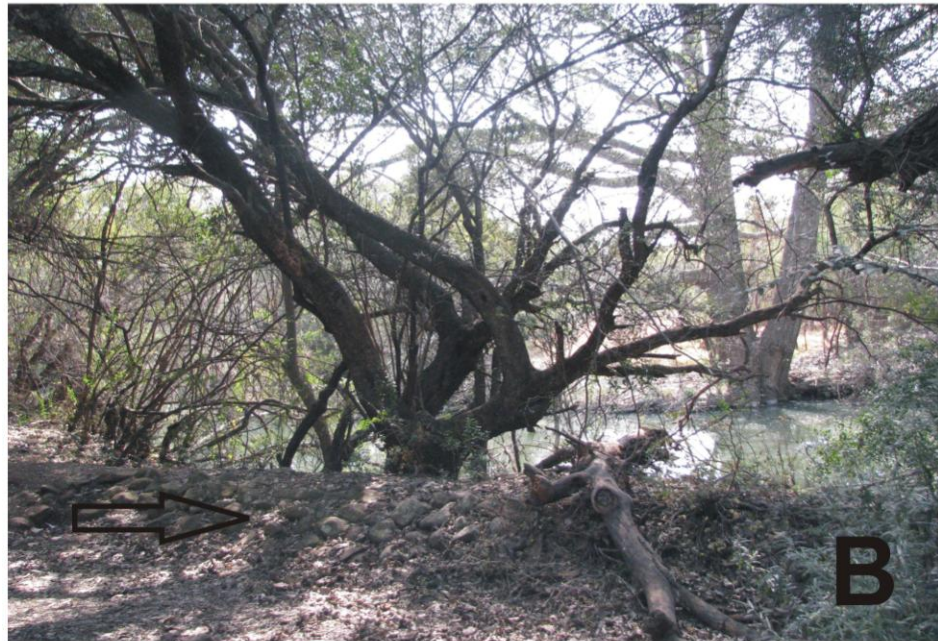
Figure 4. Area A. A large dam is located at the southern border of the site (A). A low dam wall consisting of dolerite cobbles runs along its western bank (B).

A large dam, contained by a concrete weir, is located at the southern end of the site. A low dam wall consisting of dolerite cobbles runs along its western bank (**Fig. 4**). The dam is not indicated on the 1913 British military map (**Fig. 5**). All watering points are indicated on the map, either as a dam, tank or a pump, etc. The fact that no dams are indicated in the affected area would seem to indicate that no dams existed there before 1913. The earliest aerial photographs of Bloemfontein dating to 1941 show a series of

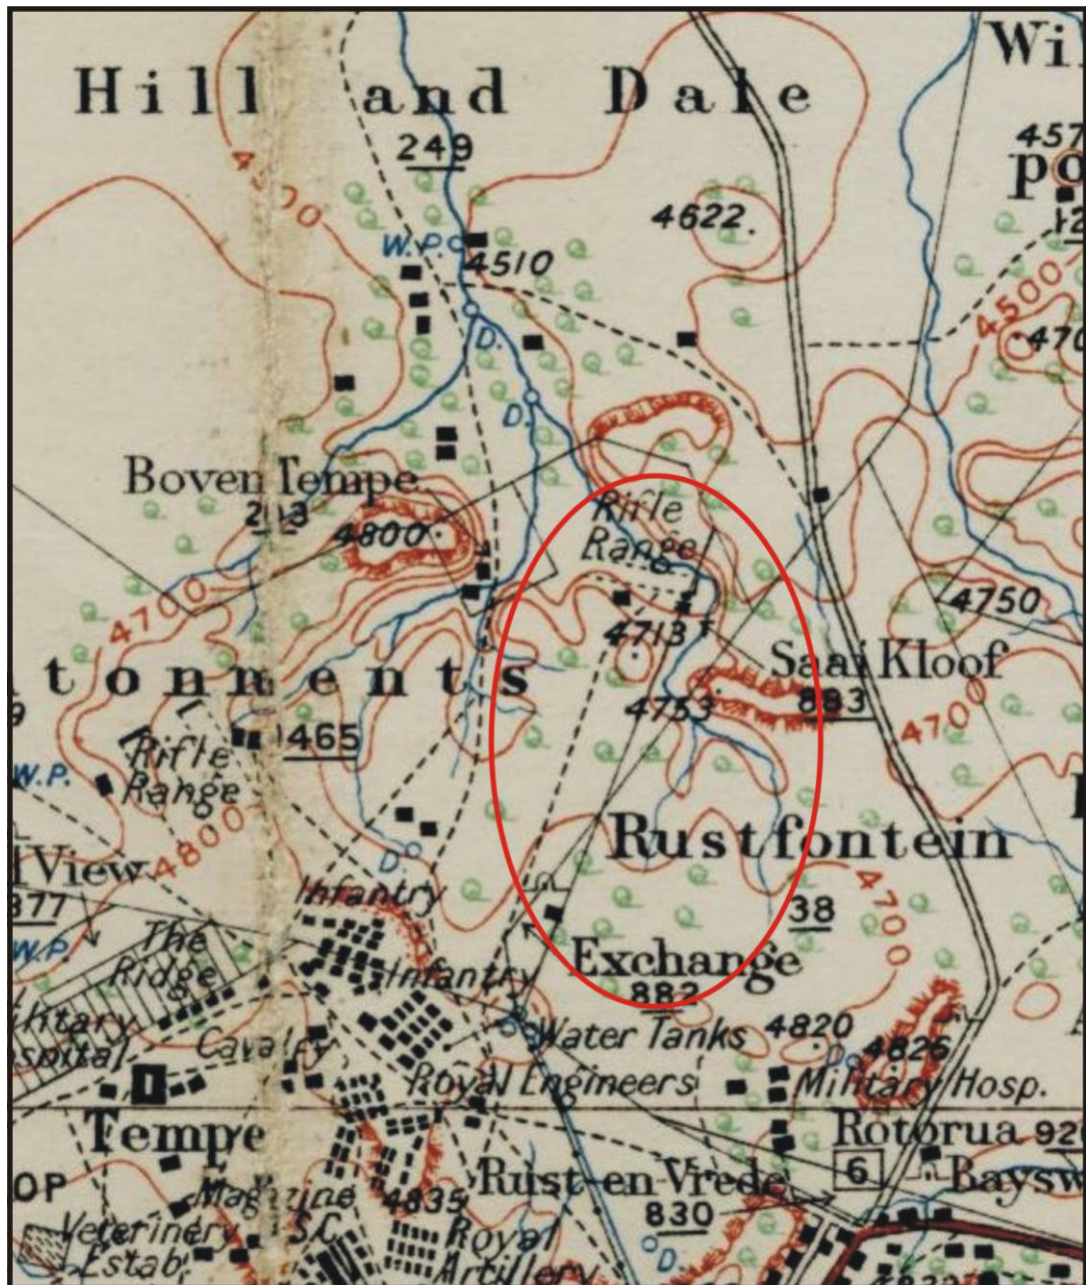
Figure 5. Portion of a British military map dated circa 1913, showing the general location of the survey area. No dams are indicated in the affected area.

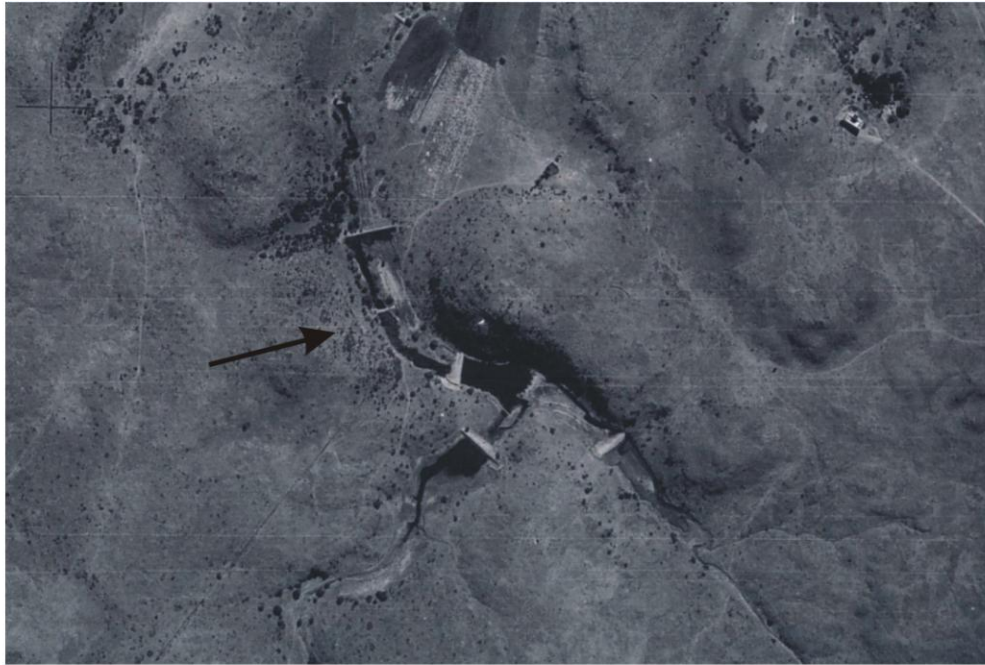
Figure 6. Dams and weirs are shown on an aerial photograph of the affected area, dated 1941.

weirs where the dam is located (**Fig. 6**), while the 1951 1:50 000 topographic map of Bloemfontein indicates it clearly (**Fig. 7**).

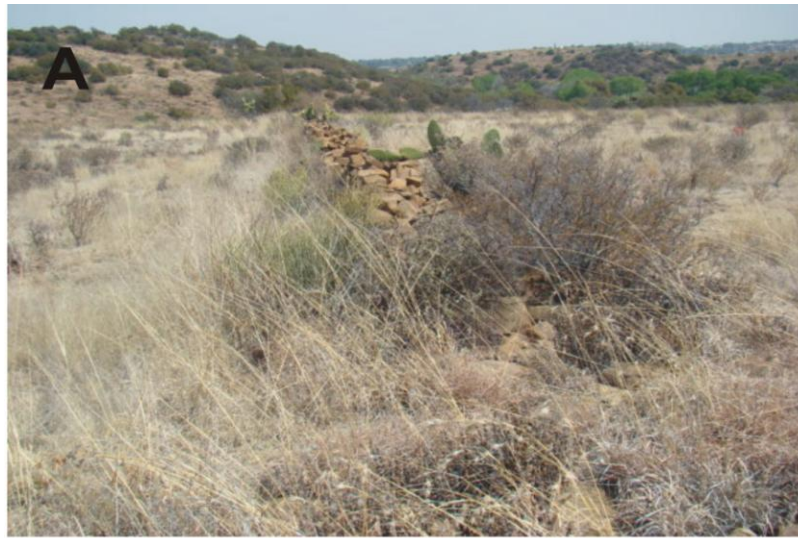
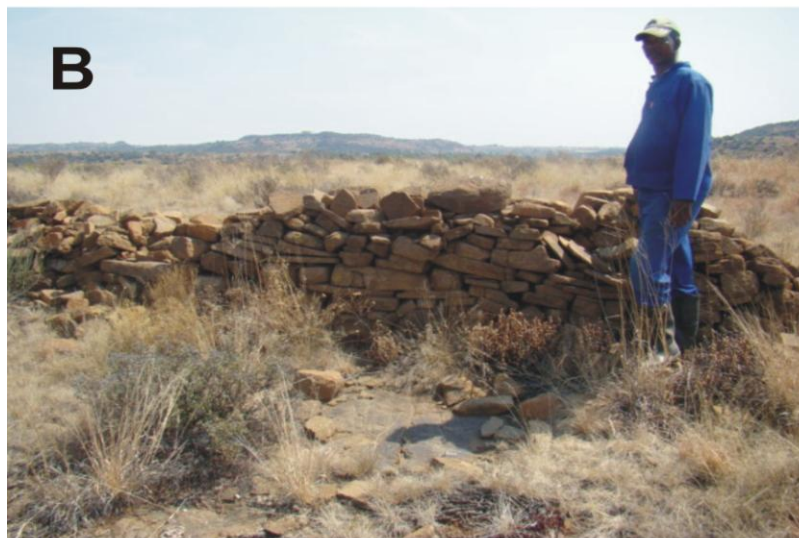
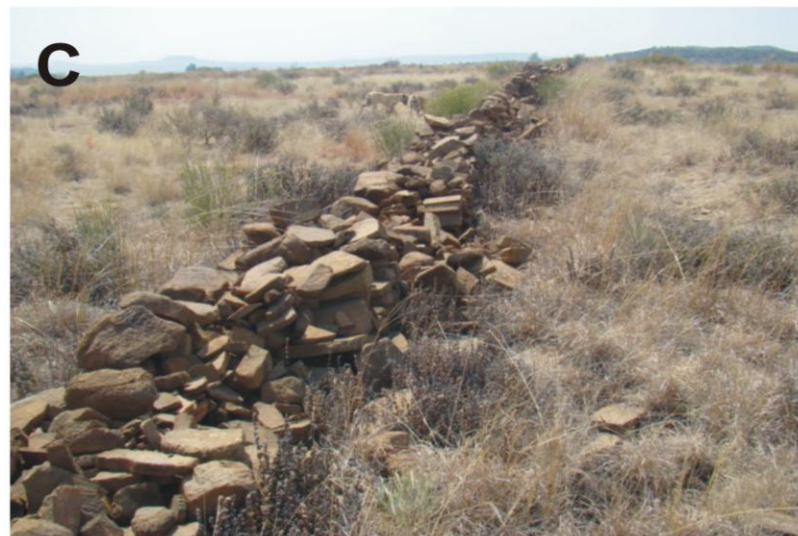
Figure 8. Area E. A 900 m long section of stone walling runs in a north-easterly direction from the dam and exits the site about halfway along on the eastern boundary (A). The height of the wall averages less than a metre and consists of large dolerite boulders on the outside faces, with smaller rocks packed in the middle (B & C).

A 900 m long section of stone walling runs in a north-easterly direction from the dam and exits the site about halfway along on the eastern boundary (**Fig. 6, 7 & 8 A**). This wall is one of the last remaining traces of the British military occupation of the northern part of Bloemfontein. The walls were built by the British Engineers, which had their camp stationed at Tempe. The stone wall in the affected area is part of a wall which originally ran from the water towers east of Tempe (marked on the British Military map of 1913), to the edge of Hillandale farm. Some sections of these walls can still be seen in the Botanical Gardens, behind the Bloemfontein Spa, and in the Lilyvale area, between Hillsboro and the Lettie Fouche Nasorgsentrum. The portion of the wall recorded in the survey area is mostly intact, with only a small section which has been demolished where a farm road cuts across it (see **Fig. 2**). The height of the wall averages less than a metre and consists of large dolerite boulders on the outside faces, with smaller rocks packed in the middle (**Fig. 8, B & C**).

The area investigated in this assessment is located within an old military zone relating to the military occupation of Bloemfontein by the British after 1900. The section of stone wall located in Area E is older than 60 years. It is part of a larger structure and can be related directly to the presence of the British troops in Bloemfontein from 1900. It therefore falls under the protection of the National Heritage Resources Act no. 25 of 1999, and as such would require a permit to be issued for its destruction.

- The stone wall and stone-build ruins are some of the most robust cultural heritage resources on the property. The stone wall section and stone-build ruins in Area C and E can be included into the development plan of the site with positive effect. This will require a management plan to include buffer zones for their preservation both during and after development.

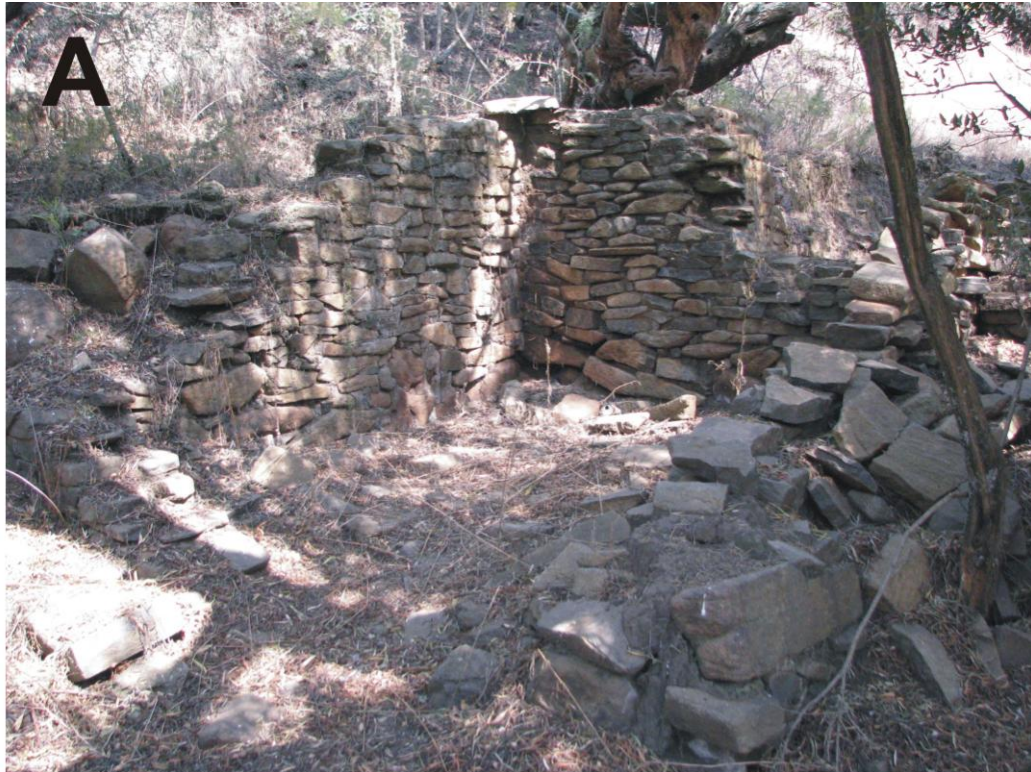
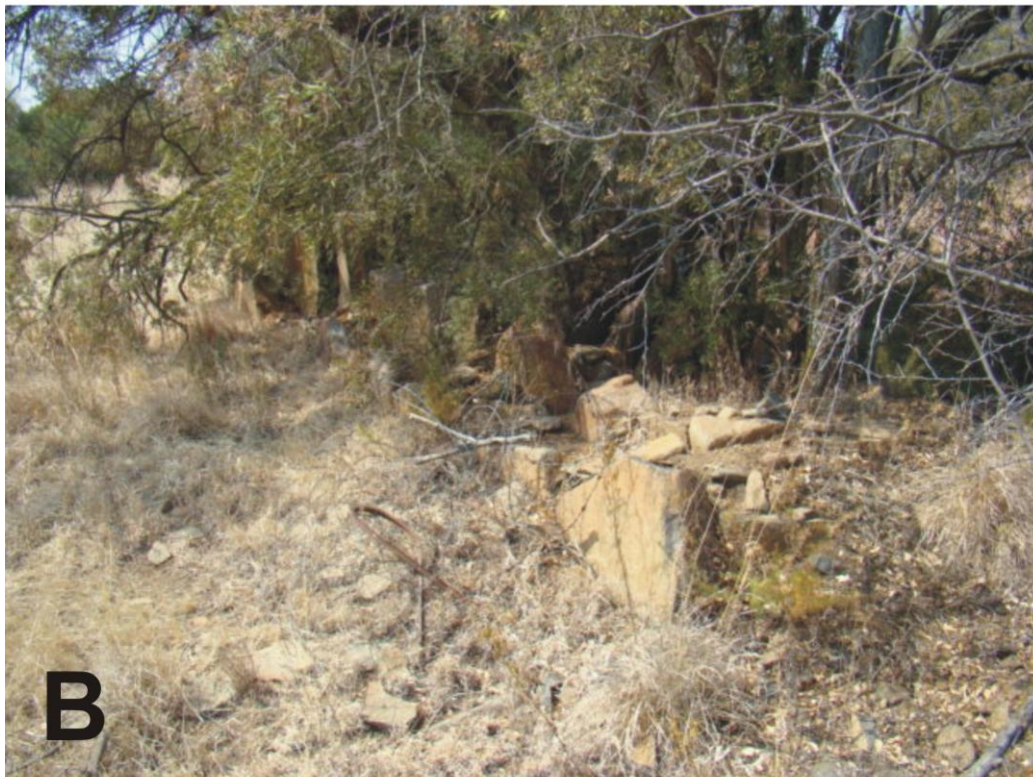
Figure 9. Partial walls (A) and foundations (B) of at least six small, rectangular dwellings are located along the hill slopes in Area A and C.

Several other stone structures that were observed during the survey include the foundations and / or partial walls of at least six small, rectangular dwellings, mostly concentrated around the koppies in Area A and C (**Fig. 9**). The foundations of late 20th century farm labourers' dwellings and an accompanying rubbish dump were observed in Area H (**Fig. 10**).

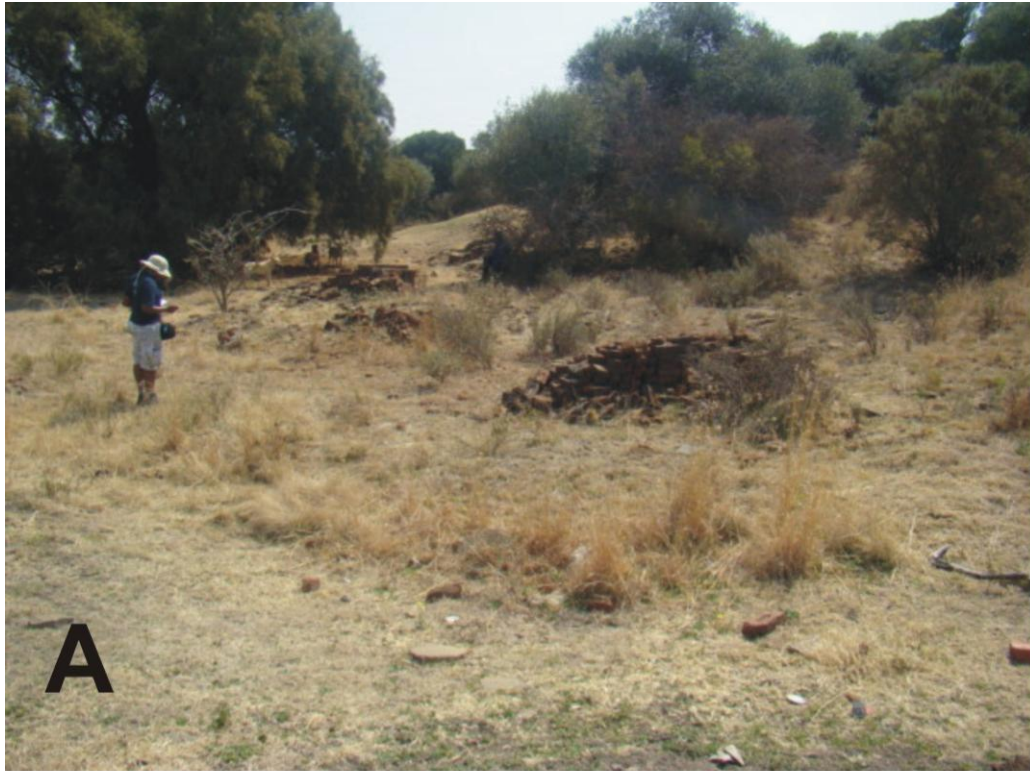
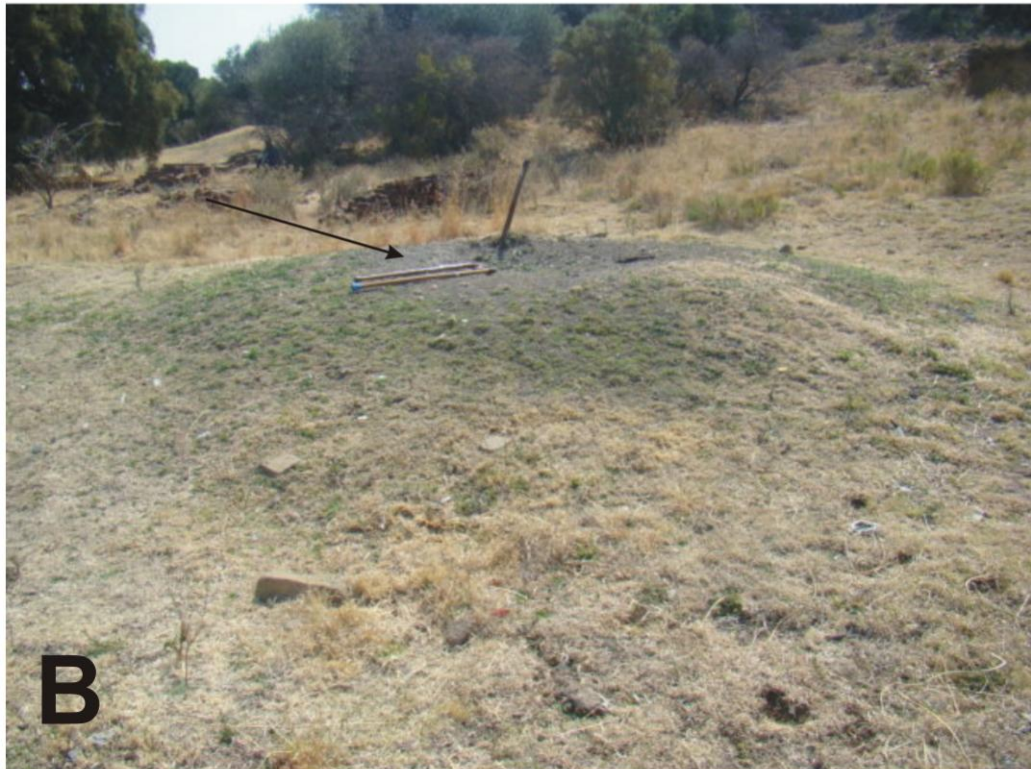
Figure 10. Foundations of late 20th century farm labourers' dwellings and an accompanying rubbish dump in Area H.

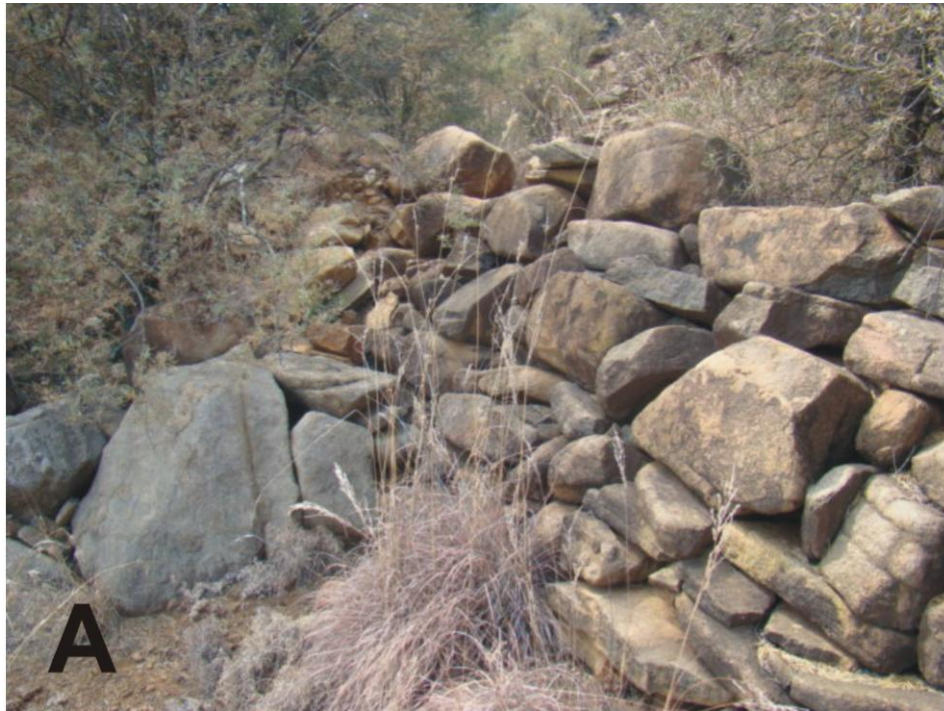
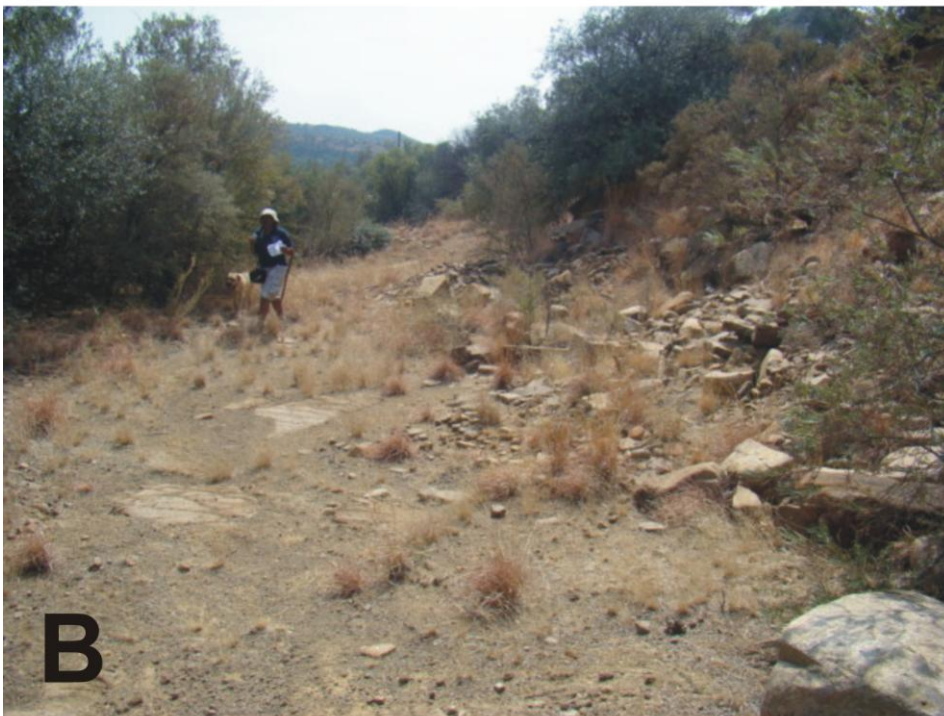
Figure 11. Remains of sections of dolerite cobble foundation and support (A) for an old road construction (B).

The remains of sections of dolerite cobble foundation and walling support, were recorded of what appears to be part of an old road construction that runs along the foot of the koppie in Area B and C and connects with an existing track at the south-eastern margin of the site (**Fig. 11**). The road is marked on the 1993, 1:50 000 topographic map, but not the 1951, 1:50 000 topographic map of Bloemfontein.

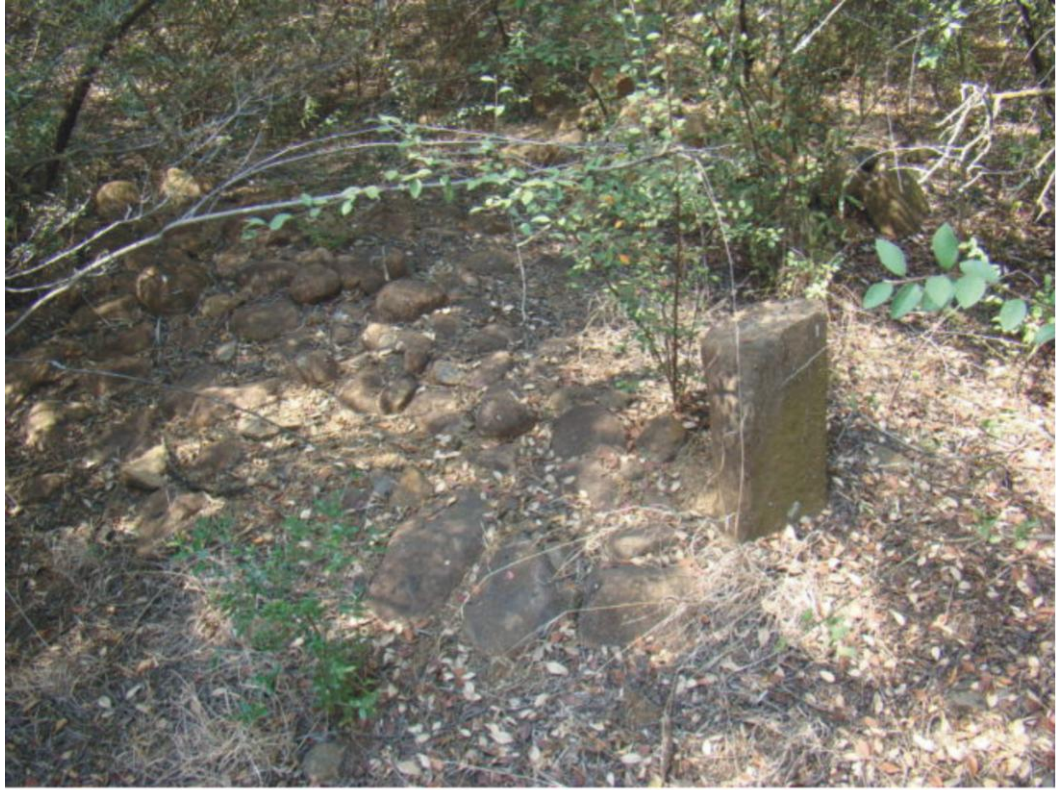
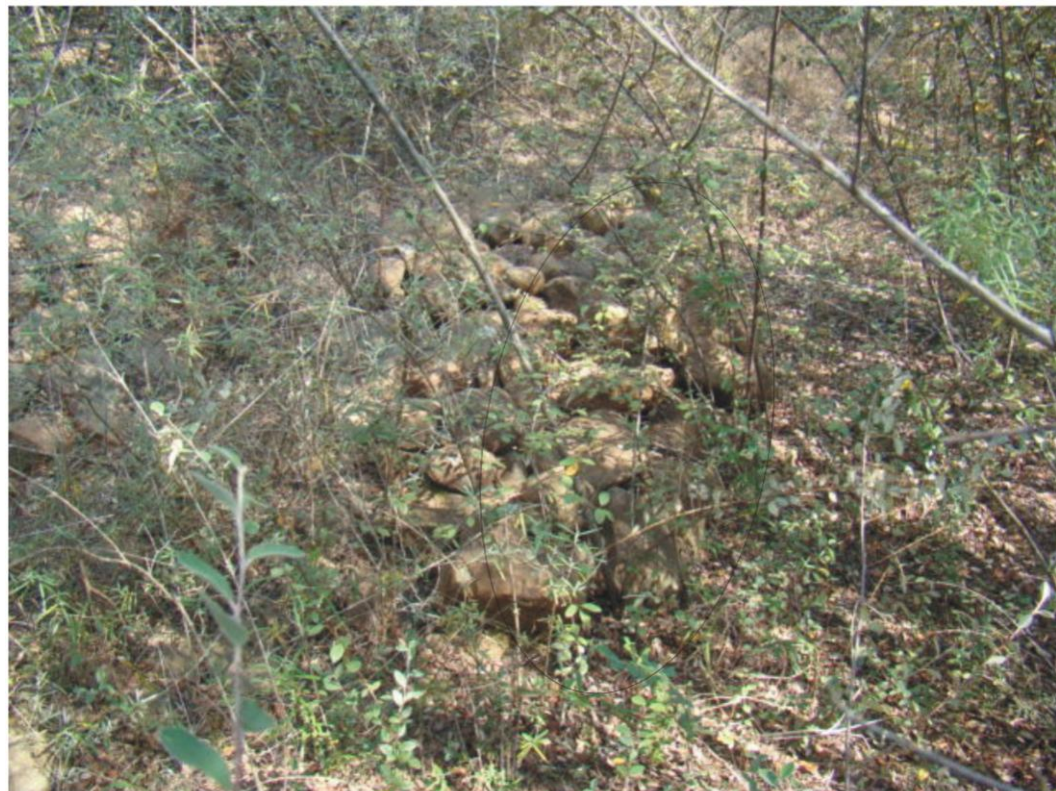
Figure 12. Area A. Graves located in a densely vegetated area about 300 m south of the current homestead.

Fifteen graves were recorded in a densely vegetated area in Area A, about 300 m south of the current homestead (**Fig. 12**). No dates can be ascribed to the graves, although they appear similar to other farm workers graves in the vicinity, such as those recorded at Lilyvale 2313/25 (33).

- A management plan needs to be submitted for the graves in Area A and G. The owners of the property are responsible for the protection and maintenance of the graves unless there is an agreement reached with regard to the exhumation and re-interment of the contents of the graves in accordance with any regulations made by the responsible heritage resources authority. Graves older than 60 years would fall under regulations such as subsection 1 of Section 36 (see particularly 36 (3) (a) (b)) of the National Heritage Resources Act and the Human Tissues Act. Exhumation of graves less than 60 years old would fall under the Exhumations Ordinance, Ordinance No.12 of 1980 (see Appendix 1).

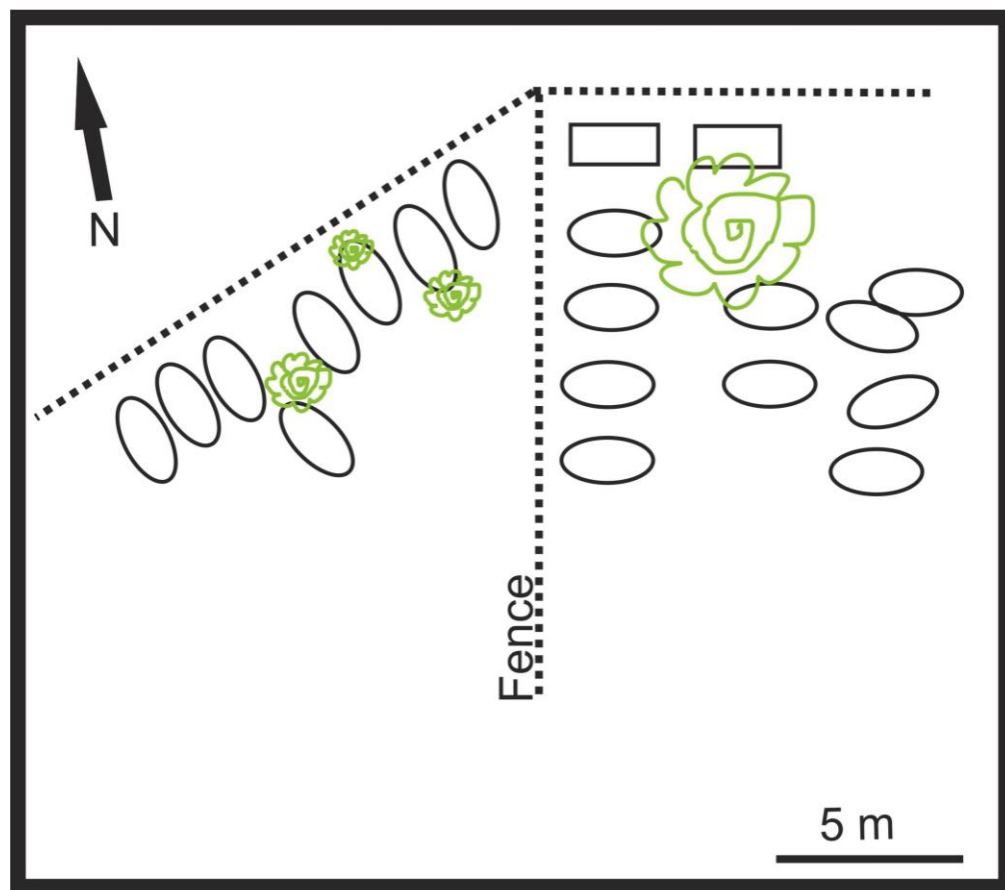
Figure 13. Layout of the graveyard in Area G.

Another graveyard containing twenty graves is located on the site's north-eastern boundary in Area G (**Fig. 13**). The layout of the graveyard appears to be aligned with interconnecting farm fences bordering on a neighboring farm to the east. It consists of a loose arrangement of heavily overgrown graves, with occasional head markers and dolerite cobble domes (**Fig. 14, Table 3**). Only five of the graves observed have headstones in place and only one is still legible. The earliest, dateable grave is from 1964, but it is very likely that it may not be the oldest grave within the graveyard.

As with all graves, the graveyard in Area G is protected by either the Human Tissues Act or the National Heritage Resources Act. Graves older than 60 years may not be moved without a permit from the South African Heritage Resources Agency.

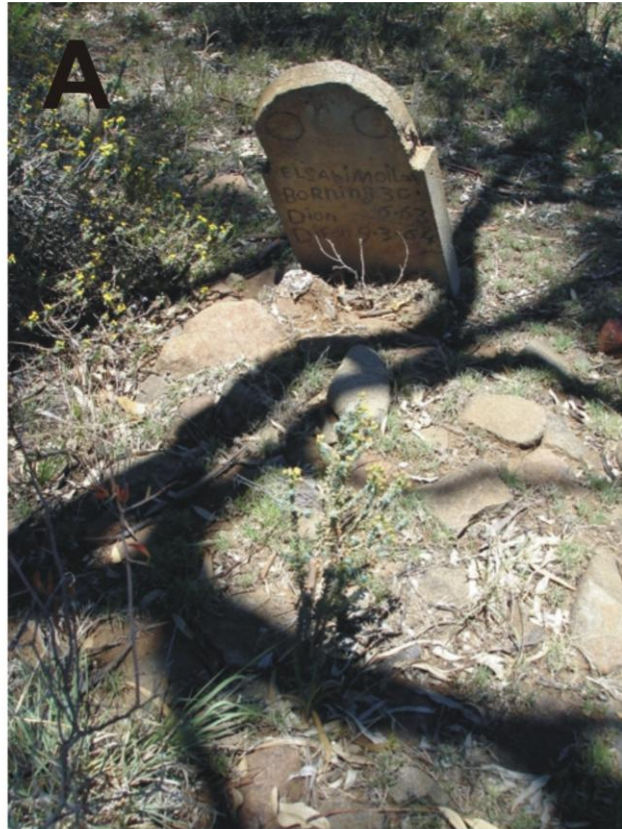
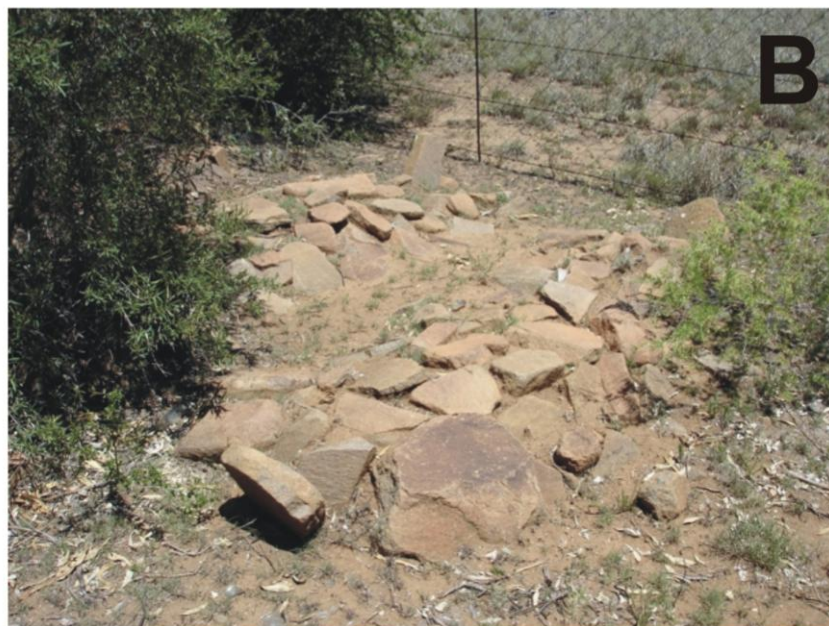
Figure 14. The graveyard in Area G consists of a loose arrangement of heavily overgrown graves, with occasional head markers (A) and dolerite cobble domes (B).
