### PHASE 1 ARCHAEOLOGICAL IMPACT ASSESSMENT

# BULK RISING MAIN EAST, NGCOBO CLUSTER 6, EASTERN CAPE, SOUTH AFRICA

**DATE:** 2011-04-22

# PHASE 1 ARCHAEOLOGICAL IMPACT ASSESSMENT BULK RISING MAIN EAST, NGCOBO CLUSTER 6, EASTERN CAPE, SOUTH AFRICA

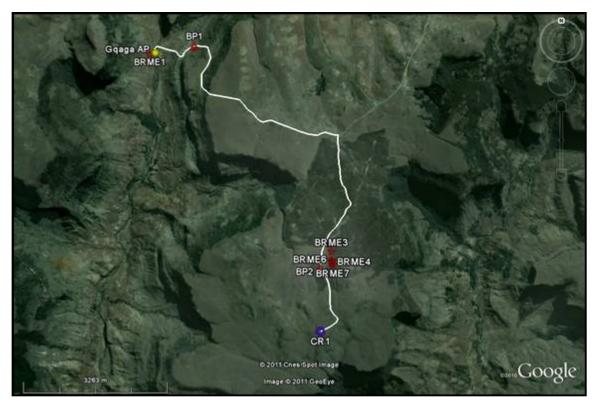
**Figure 3:** Archaeological and cultural heritage sites along the proposed *Bulk Rising Main East, Ngcobo Cluster 6* study site

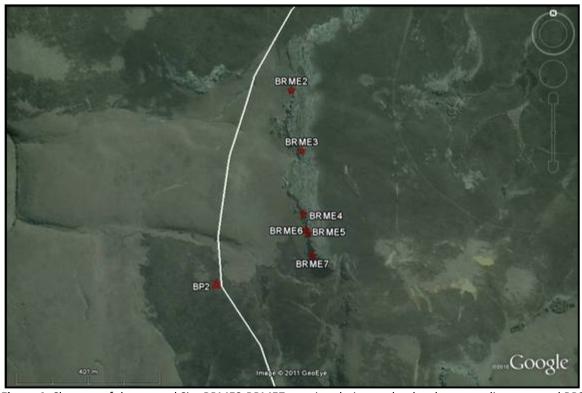
Figure 4: Close-up of the general Site BRME2-BRME7 area in relation to the development alignment and BP2

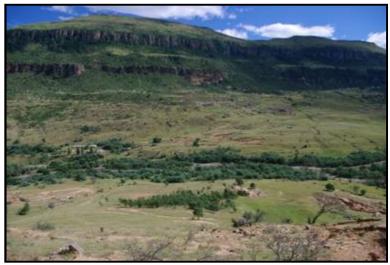
Figure 6: View from approximate co-ordinate 5 down to the Nqancule River (with Site BRME1 to the left)

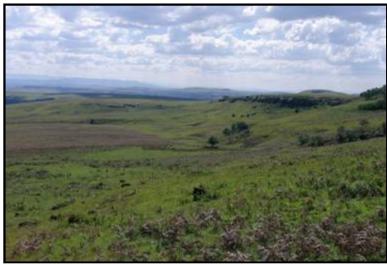
**Figure 12:** View from approximate co-ordinate 59 back towards the north of the study site with the Sites BRME2-BRME7 situated in the rocky outcrops towards the right middle-ground of the image

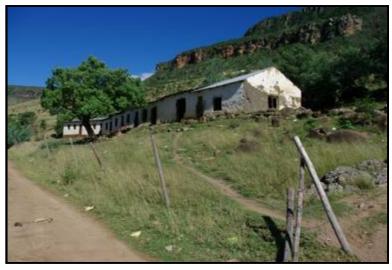
Site BRME1 is situated approximately 130m west of the Gqaga Abstraction Point (Gqaga AP / GAP). Landscape topography distinguishes the site locale from the abstraction point, being situated partly up the steep slope from the abstraction points' riverbed locale. The site may well pre-date 60 years of age, but the exact date thereof is unknown, implying that the site may well be formally protected under the NHRA 1999. The site comprises of an old school building, but seemingly at present in disuse – school tables are stacked inside classrooms, but the structure is dilapidated and doors and windows have been removed. The school yard is fenced, incorporating also a few newer structures, but the fence is not well kept.

Figure 14: General view of Site BRME1

**RECOMMENDATIONS:** Site BRME1 may well pre-date 60 years of age, implying that the site may be formally protected under the NHRA 1999. The site is at present fenced (though the fence is not well kept). The site is situated approximately 130m upslope from the proposed line route development. The *Bulk Rising Main East, Ngcobo Cluster 6* project will not impact on the site. *In situ* conservation (conservation as is, without the developer having to comply with additional conservation measures) is recommended.

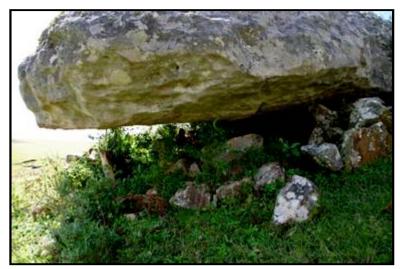
Site BRME2 is situated more or less 100m east of the proposed line route. The site is characterized by a fairly flattish, approximate 2.5m in diameter circular shaped stone overhang. The bottom of the overhang is filled in with a stacked stone wall to create the enclosure. Enclosure remains comprised of typical white ashy dung deposits and more recent dung remains signaling use of the site as a stock enclosure most probably used by young boy herders to keep sheep / goat lambs. The site can fairly confidently be dated as younger than 100 years, implying that the site is not formally protected under the NHRA 1999, but does constitute a contemporary cultural heritage site and supporting the general observation of fairly recent occupation of the plateau terrain.

Figure 15: View of Site BRME2

**RECOMMENDATIONS:** Site BRME2 post-dates 100 years of age, implying that the site is not formally protected under the NHRA 1999. The site however comprises of a contemporary cultural heritage site, most probably still periodically in use. The site is situated approximately 100m east of the proposed development line route and, supported by fairly steep topography, will not be impacted on by the development. *In situ* conservation (conservation as is, without the developer having to comply with additional conservation measures) is recommended.

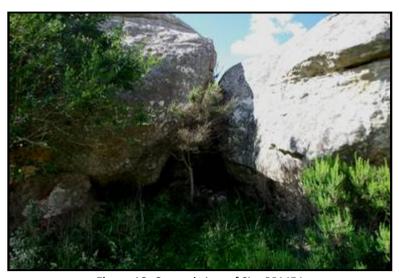
Site BRME4 is characterized by a small wall of no more than 0.8m in width covering a crevice in the natural stone outcrops to create a cave-like enclosure of approximately 3x5m. The floor of the cave-like enclosure is covered with silty washed-in material, ashy white dung deposits and more recent dung, indicating fairly recent use of the site. No residential or artefact remains were found in association with the site; inferred to have been solely used for stock keeping purposes. The site is situated approximately 220m east of the proposed line route. The site can reasonably be inferred to post-date 100 years of age, thus not formally protected under the NHRA 1999. The site does constitute a contemporary cultural heritage site.

Figure 18: General view of Site BRME4

**RECOMMENDATIONS:** Site BRME4 post-dates 100 years of age; the site is not formally protected under the NHRA 1999. The site constitutes a contemporary cultural heritage site, most probably still periodically in use. The site is situated more or less 220m east of the proposed development alignment and will not be impacted on. *In situ* conservation (conservation as is, without the developer having to comply with additional conservation measures) is recommended.
