PHASE 1 ARCHAEOLOGICAL IMPACT ASSESSMENT

**CAGADU DISTRICT AND INACCESSIBLE ROADS PROJECT,
EASTERN CAPE, SOUTH AFRICA**

DATE: 2011-12-12

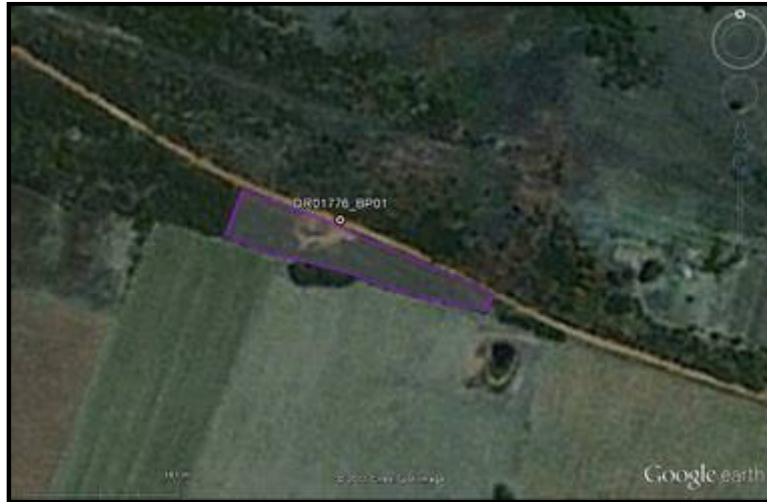
Figure 3: Borrow pit DR01776_BP01

No archaeological or cultural heritage resources, as defined and protected under the NHRA 1999, were identified on the surface or within exposed sub-surface sections during the Phase 1 AIA assessment of borrow pit DR01776_BP01.

RECOMMENDATIONS: It is recommended that use of borrow pit DR01776_BP01 proceeds as applied for without the developer having to comply with additional heritage compliance requirements.

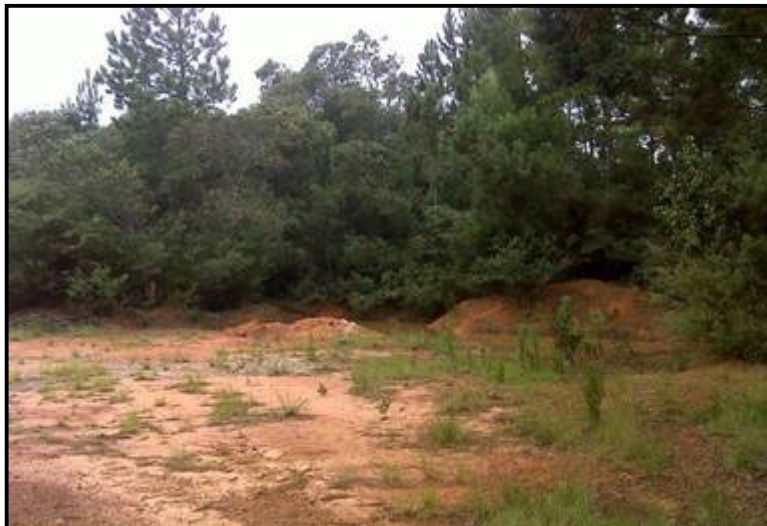
Figure 4: Current impact at borrow pit DR01776_BP01

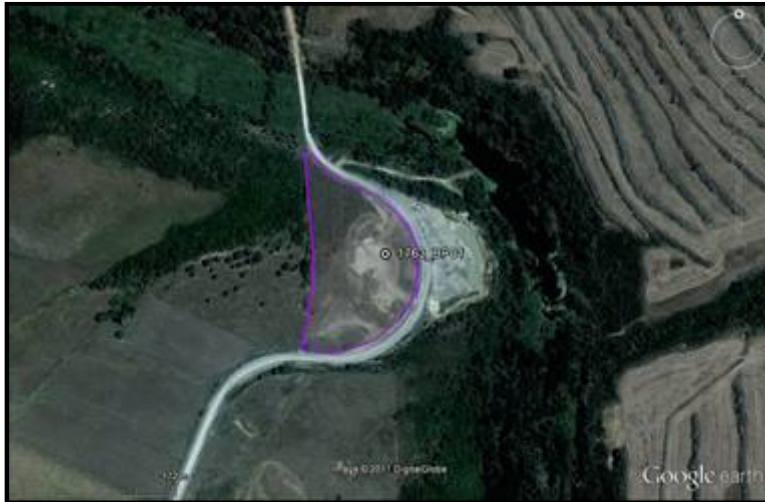
Figure 5: Borrow pit 1763_BP01

No archaeological or cultural heritage resources, as defined and protected under the NHRA 1999, were identified on the surface or within exposed sub-surface sections during the Phase 1 AIA assessment of borrow pit 1763_BP01.

RECOMMENDATIONS: It is recommended that use of borrow pit 1763_BP01 proceeds as applied for without the developer having to comply with additional heritage compliance requirements.

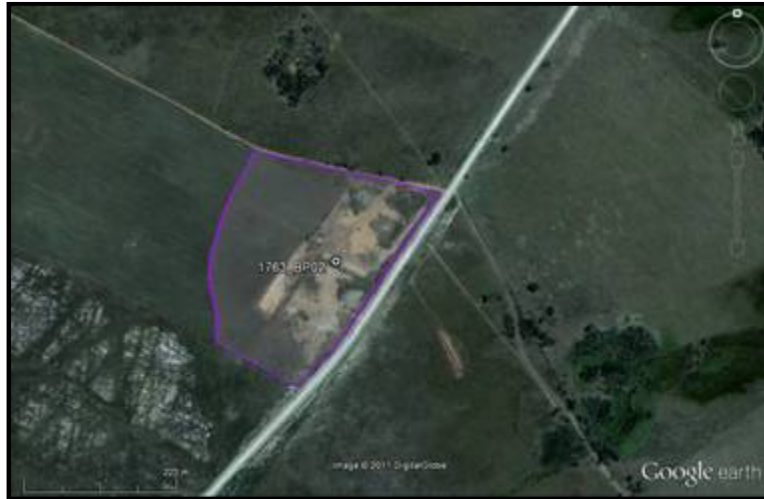
Figure 7: Borrow pit 1763_BP01

No archaeological or cultural heritage resources, as defined and protected under the NHRA 1999, were identified on the surface or within exposed sub-surface sections during the Phase 1 AIA assessment of borrow pit 1763_BP02.

RECOMMENDATIONS: It is recommended that use of borrow pit 1763_BP02 proceeds as applied for without the developer having to comply with additional heritage compliance requirements.

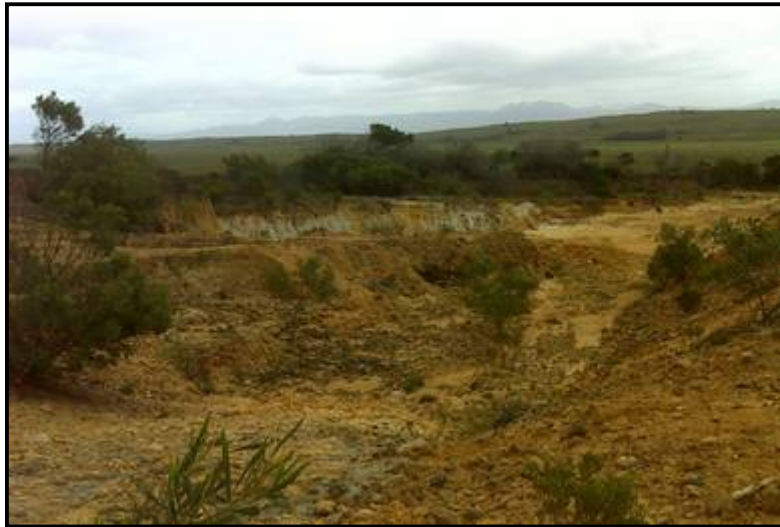
Figure 8: Current large scale impact at borrow pit 1763_BP02

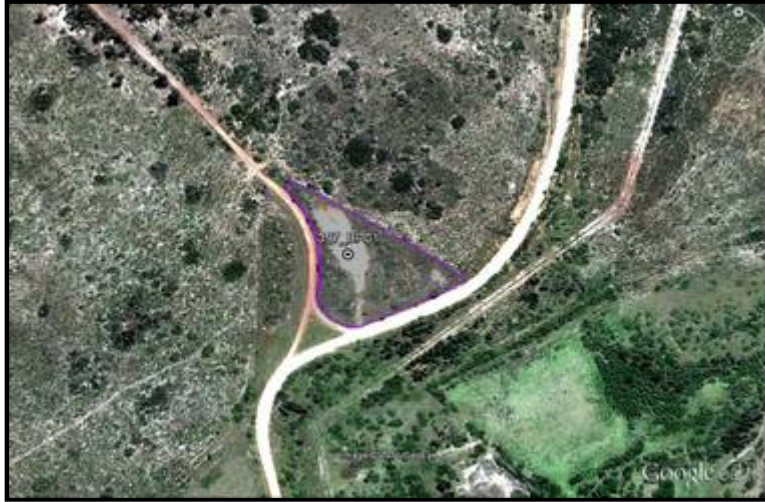
Figure 9: Borrow pit 397_BP01

No archaeological or cultural heritage resources, as defined and protected under the NHRA 1999, were identified on the surface or within exposed sub-surface sections during the Phase 1 AIA assessment of borrow pit 397_BP01.

RECOMMENDATIONS: It is recommended that use of borrow pit 397_BP01 proceeds as applied for without the developer having to comply with additional heritage compliance requirements.

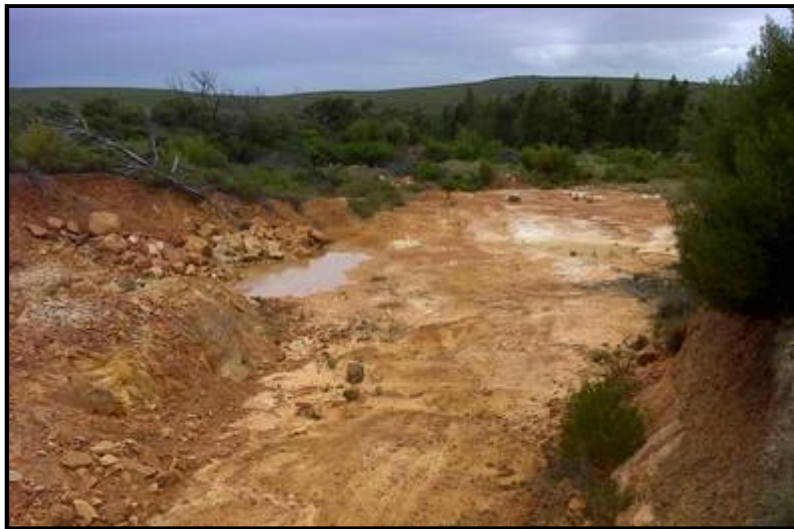
Figure 10: Current large scale impact at borrow pit 397_BP01

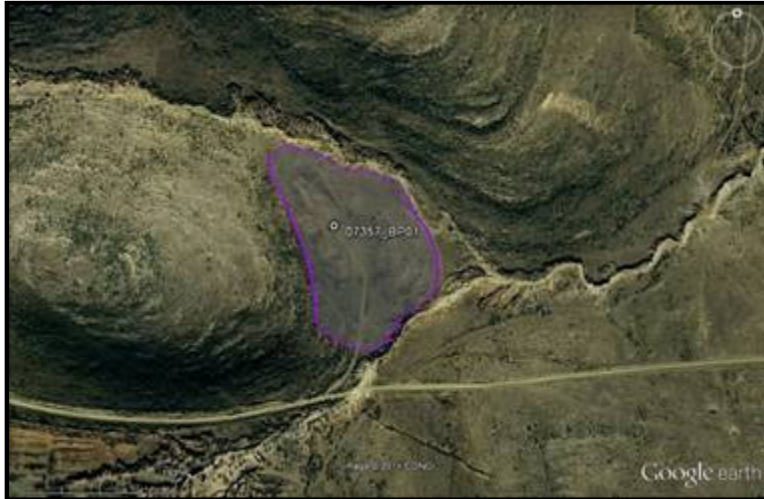
Figure 12: Borrow pit 07357_BP01

No archaeological or cultural heritage resources, as defined and protected under the NHRA 1999, were identified on the surface or within exposed sub-surface sections during the Phase 1 AIA assessment of borrow pit 07357_BP01.

RECOMMENDATIONS: It is recommended that use of borrow pit 07357_BP01 proceeds as applied for without the developer having to comply with additional heritage compliance requirements.

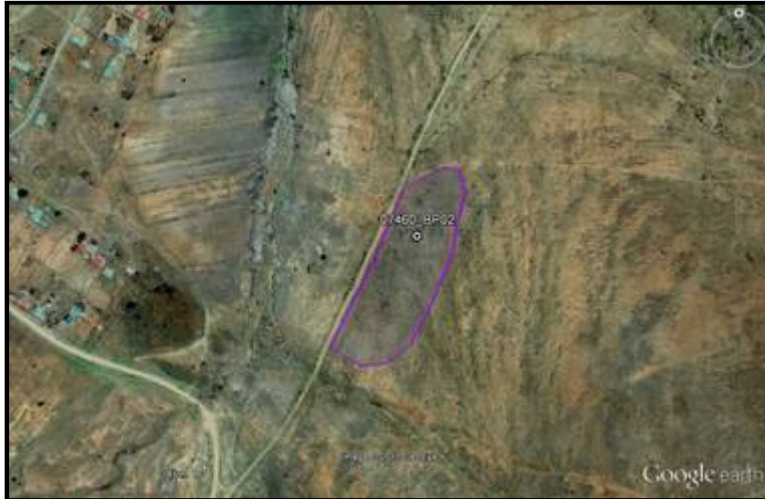
Figure 14: Borrow pit 07460_BP02

No archaeological or cultural heritage resources, as defined and protected under the NHRA 1999, were identified on the surface or within exposed sub-surface sections during the Phase 1 AIA assessment of borrow pit 07460_BP02.

RECOMMENDATIONS: It is recommended that use of borrow pit 07460_BP02 proceeds as applied for without the developer having to comply with additional heritage compliance requirements.

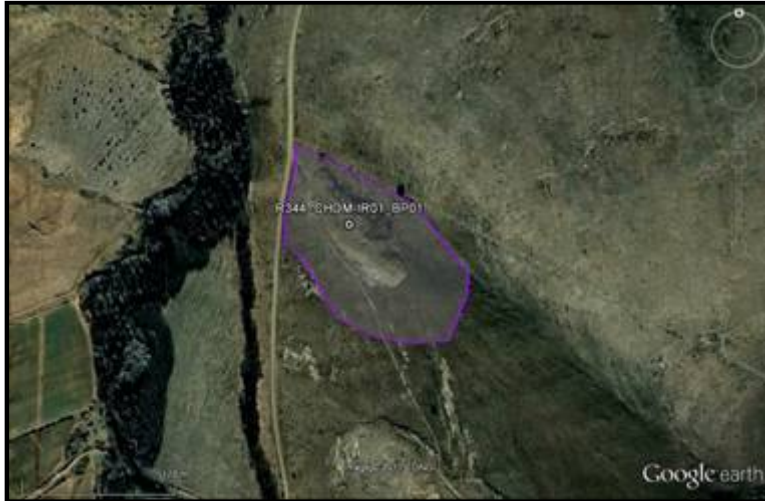
Figure 16: Borrow pit R344-CHDM-IR01_BP01

No archaeological or cultural heritage resources, as defined and protected under the NHRA 1999, were identified on the surface or within exposed sub-surface sections during the Phase 1 AIA assessment of borrow pit R344-CHDM-IR01_BP01.

RECOMMENDATIONS: It is recommended that use of borrow pit R344-CHDM-IR01_BP01 proceeds as applied for without the developer having to comply with additional heritage compliance requirements.

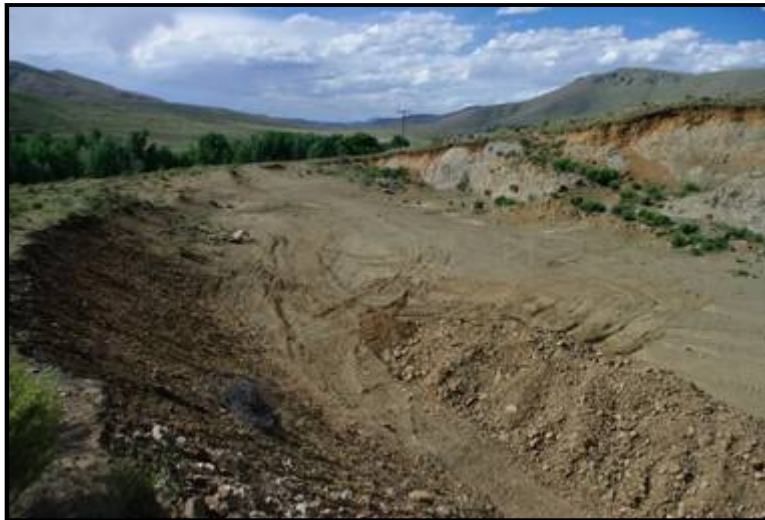
Figure 17: Current impact at the large existing R344-CHDM-IR01_BP01 study site

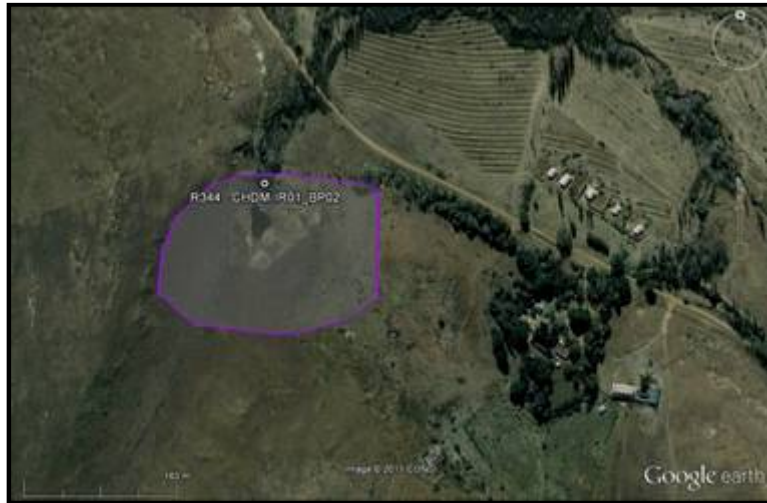
Figure 18: Borrow pit R344-CHDM-IR01_BP02

No archaeological or cultural heritage resources, as defined and protected under the NHRA 1999, were identified on the surface or within exposed sub-surface sections during the Phase 1 AIA assessment of borrow pit R344-CHDM-IR01_BP02.

RECOMMENDATIONS: It is recommended that use of borrow pit R344-CHDM-IR01_BP02 proceeds as applied for without the developer having to comply with additional heritage compliance requirements.

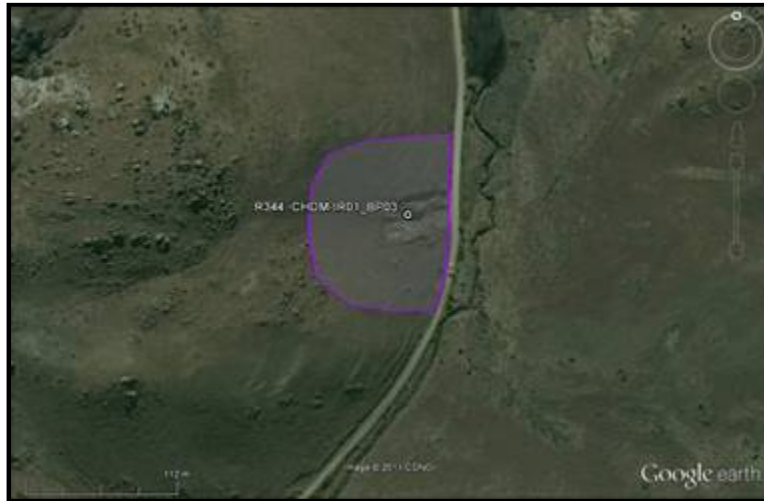
Figure 20: Borrow pit R344-CHDM-IR01_BP03

No archaeological or cultural heritage resources, as defined and protected under the NHRA 1999, were identified on the surface or within exposed sub-surface sections during the Phase 1 AIA assessment of borrow pit R344-CHDM-IR01_BP03.

RECOMMENDATIONS: It is recommended that use of borrow pit R344-CHDM-IR01_BP03 proceeds as applied for without the developer having to comply with additional heritage compliance requirements.

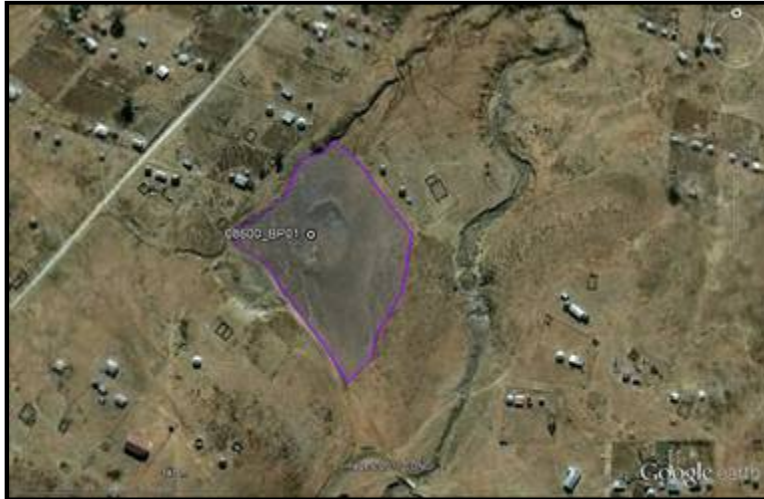
Figure 22: Borrow pit 08600_BP01

No archaeological or cultural heritage resources, as defined and protected under the NHRA 1999, were identified on the surface or within exposed sub-surface sections during the Phase 1 AIA assessment of borrow pit 08600_BP01.

RECOMMENDATIONS: It is recommended that use of borrow pit 08600_BP01 proceeds as applied for without the developer having to comply with additional heritage compliance requirements.

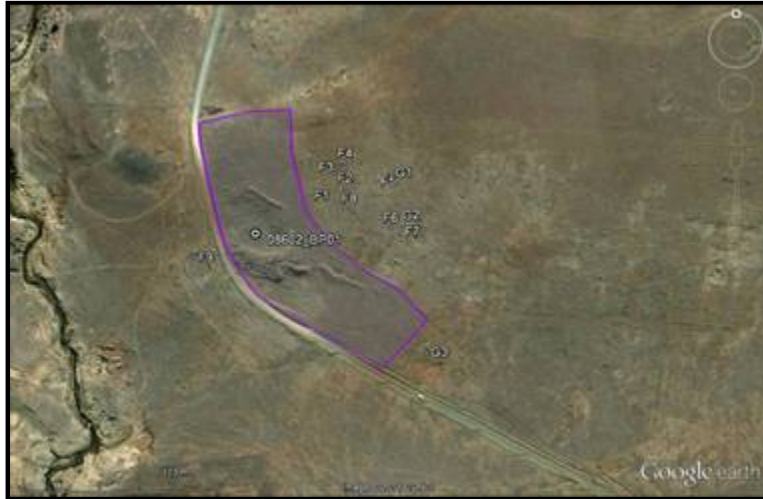
Figure 24: Borrow pit 08602_BP01

The borrow pit 08602_BP01 area is characterized by the remains of a former Iron Age village to the east (and extending fairly far beyond the area of recording) with a single stock enclosure situated to the west of the study site, west of the access road. The general area is also underlain by a Stone Age member, with only the odd artefact visible on the surface but with disturbed areas displaying fairly high densities of material, most probably confined to the top approximate 15cm layer. Development to date have not impacted on any Iron Age remains and formalization of the borrow pit is possible without impacting thereon. However quarrying has impacted on Stone Age remains and continued use of the area by definition will further impact directly on Stone Age resources.

Underlying the Iron Age remains at the site is a Stone Age member, overlain by topsoil with very few artefacts visible in undisturbed surface areas. Stone Age lithic artefacts were found eroded in disturbed erosion dongas at the borrow pit area and also in disturbance caused by Iron Age occupation. Based on the members sub-surface context it is impossible to determine basic site extend or attempt an artefact ratio (artefacts: m²) recording in order to describe basic densities of artefacts. Typologically and technologically the member is ascribed to the Middle Stone Age (MSA) typified by its flake and blade technology with artefacts being fairly large, implying an early to middle MSA industry.

RECOMMENDATIONS: Iron Age remains, including both recorded features and graves are ascribed a SAHRA *Medium Significance* and a *Generally Protected B Field Rating*. Development has already impacted on the general site area, but not on individual features, the majority of which are situated to the east of the existing borrow pit. In the case of borrow pit 08602_BP01 formalization of the borrow pit, implying a fence and controlled access, will aid in ensuring the conservation of features, rather than continued informal use thereof.

Stone Age material at the site is ascribed a SAHRA *Medium Significance* and *Generally Protected B Field Rating*. Current impact has already affected the Stone Age resources at the site and continued use imply further direct impact thereon. It is recommended that test pit excavations be done before development proceeds to collect a sample of the material and determine depth of deposit. Excavations should be done under a SAHRA Excavation permit.

1. The site should be permanently sign posted (It is recommended that the sign be placed to the east of the borrow pit);
2. Test excavations to collect a sample of the Stone Age material that will be impacted on should be done before development commences. Test excavations should be done under a SAHRA Excavation Permit after which destruction of the remainder of the Stone Age material can proceed under a SAHRA Site Destruction Permit.

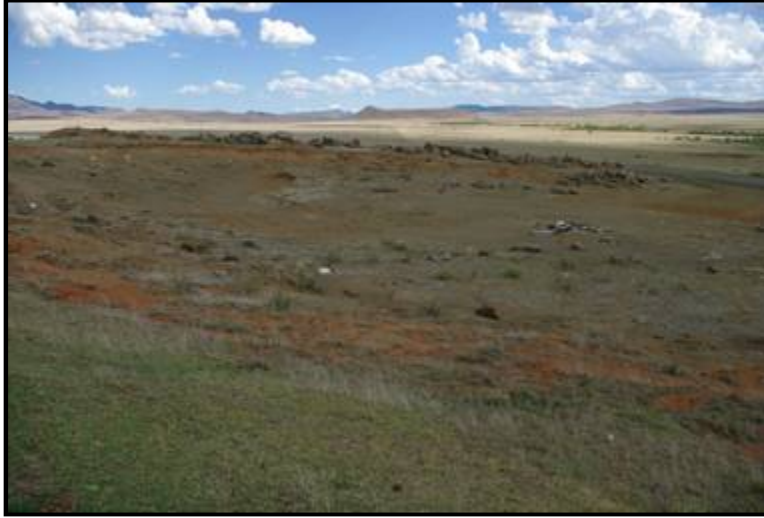
Figure 25: General view of the 08602_BP01 borrow pit

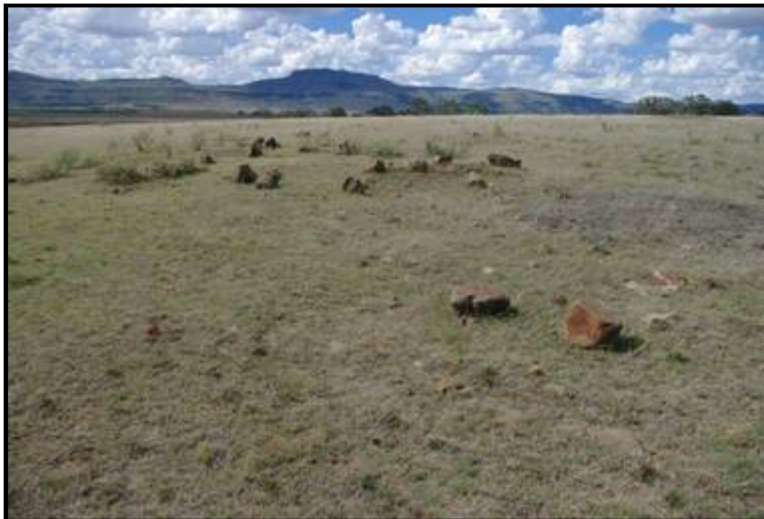
Figure 26: Remains of a circular stock enclosure with evidence of a grain pit towards the east

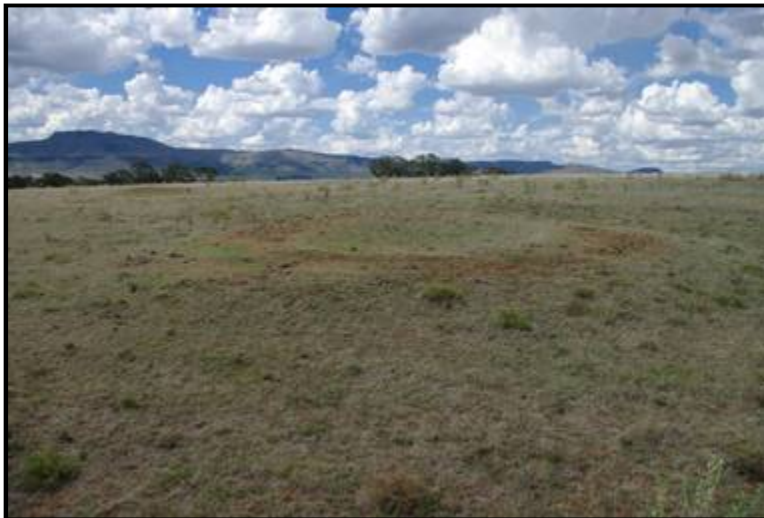
Figure 27: Remains of a hut – Stone Age artefacts were often identified in disturbed Iron Age areas

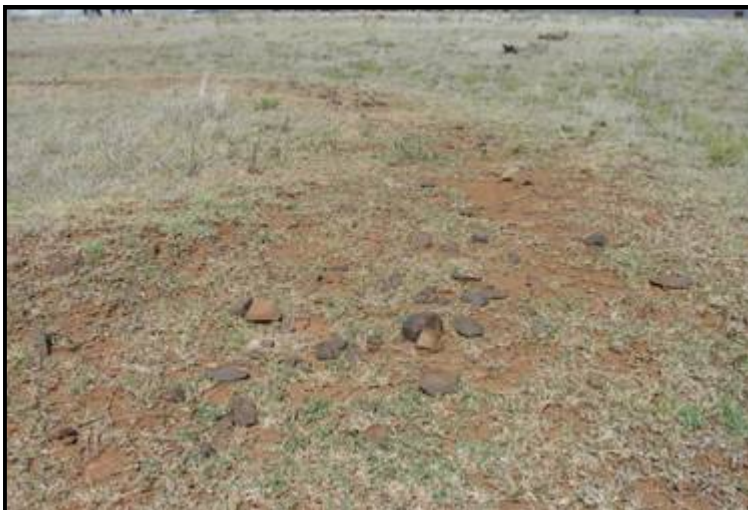
Figure 28: Lithic artefacts visible in hut wall mound remains

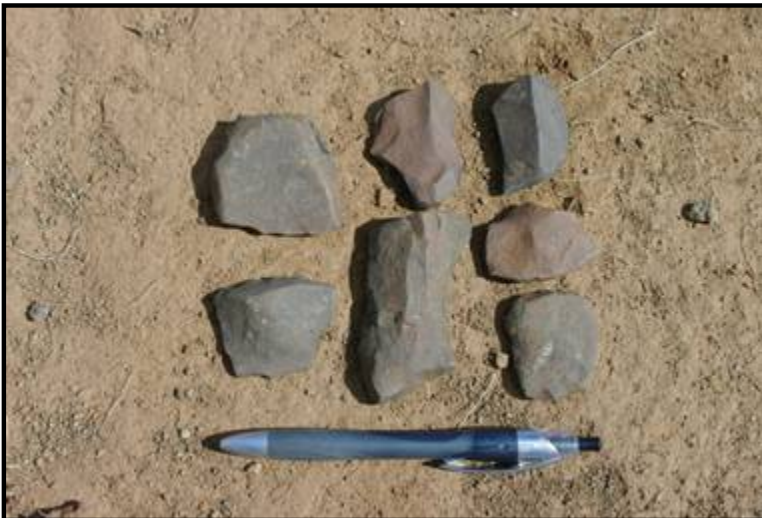
Figure 32: A selection of Stone Age artefacts from the general borrow pit area

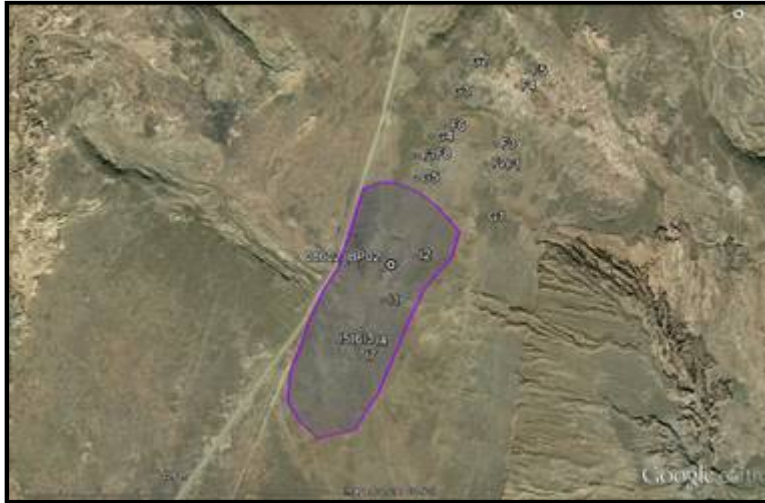
Figure 33: Borrow pit 08602_BP02

Current quarrying impact at the borrow pit 08602_BP02 study site has impacted on and in cases largely destroyed a number of Iron Age features. Related features were recorded to the north-east of the study site. Associated site features however continue further south, south-west (to as far as the 08602_BP04 study site) and west, across the access road to the banks of the Ndonga River. The rich Iron Age cultural landscape at the study site is directly associated with the Ndonga Ethiopian Mission Church site (dated roughly to the mid 1800's), known to be situated in the area between the 08602_BP02 and the 08602_BP04 borrow pit sites, across the road and closer to the banks of the Ndonga River. Attempts to locate the actual Mission Church site was abandoned; the assessment was done at the time of the Umkwetha Initiation Ceremony and bands of young boys/men were active across the landscape with a number of Umkwetha huts situated more specifically in the area west of the access road and intersecting archaeological Iron Age features; emphasizing the contemporary cultural significance of the Iron Age cultural landscape. In addition borrowing activities at the study site has already impacted on the Stone Age member underlying the Iron Age site. Continued use of the site will result in further impact on Stone Age resources.

RECOMMENDATIONS: It is not recommended that development at the site continues as applied for.

Iron Age remains, including both recorded features and graves are ascribed a SAHRA *High Significance* and a *Generally Protected A Field Rating*. Iron Age features recorded in the vicinity of the 08602_BP02 study site form an integrated part of the Ndonga Ethiopian Mission Church Iron Age cultural landscape and further impact on this prominent component of the cultural landscape is not recommended. Should development however have to proceed, then it should be preceded by extensive recording of the Ndonga Ethiopian Mission Church cultural landscape and excavation of all features already impacted on as well as signatory features that will not be impacted to further our understanding of the complexities of the site. All excavations should be done under a SAHRA Excavation Permit.

Stone Age material at the site is ascribed a SAHRA *Medium Significance* and *Generally Protected B Field Rating*. Current impact has already affected the Stone Age resources at the site and continued use imply further direct impact thereon. It is recommended that test pit excavations be done before development proceeds to collect a sample of the material and determine depth of deposit. Excavations should be done under a SAHRA Excavation Permit.

1. The site should be permanently sign posted (It is recommended that the sign be placed to the F3 stock enclosure feature);

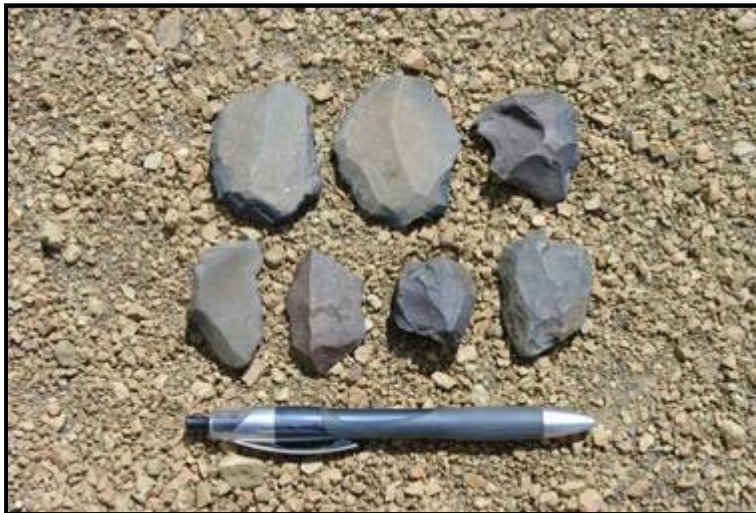
Figure 35: A selection of lithic artefacts from the borrow pit study site

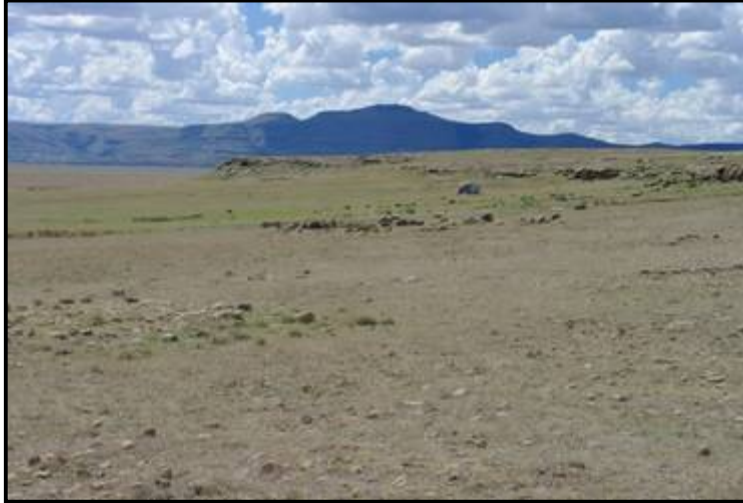
Figure 36: General view of the area surrounding the 08602_BP02 study site, with its many Iron Age stone features and an Umkwtha hut situated amidst features

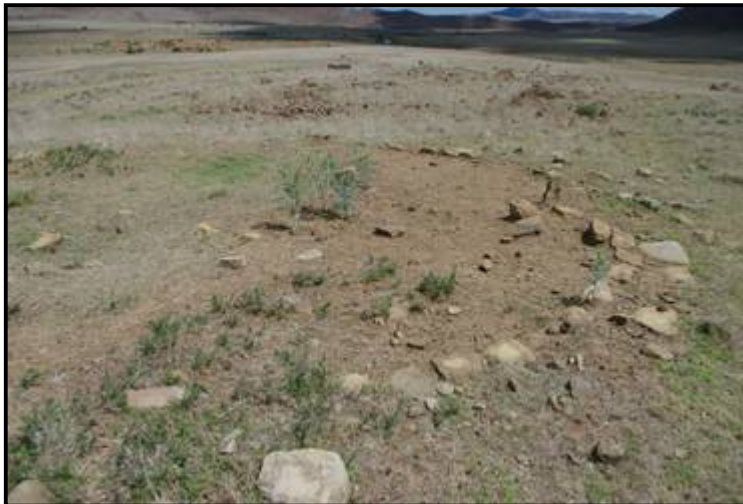
Figure 37: View of the I2 feature situated within the already impacted area

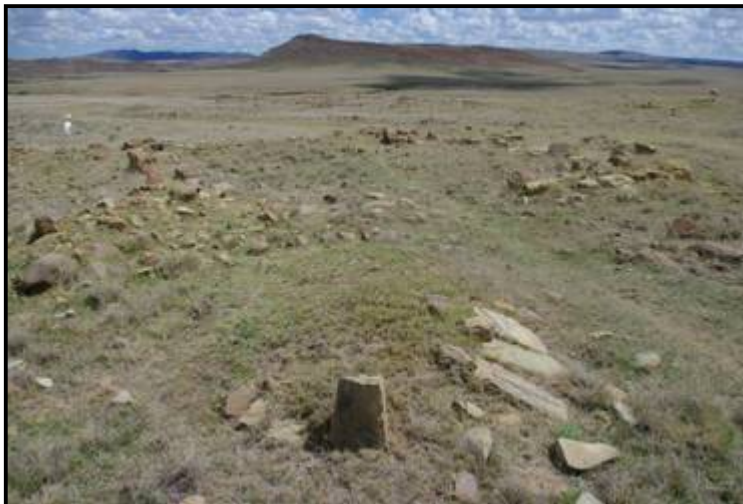
Figure 38: The grave of the I3 feature situated within the already impacted area

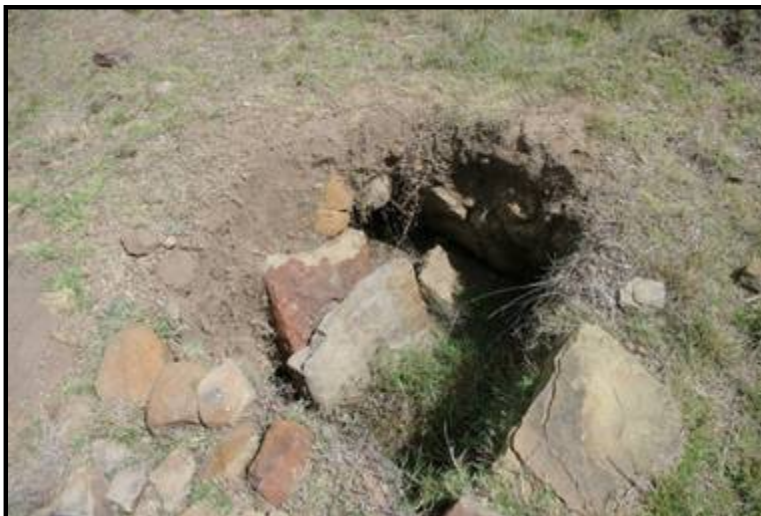
Figure 39: Stone outlines of a grain storage pit

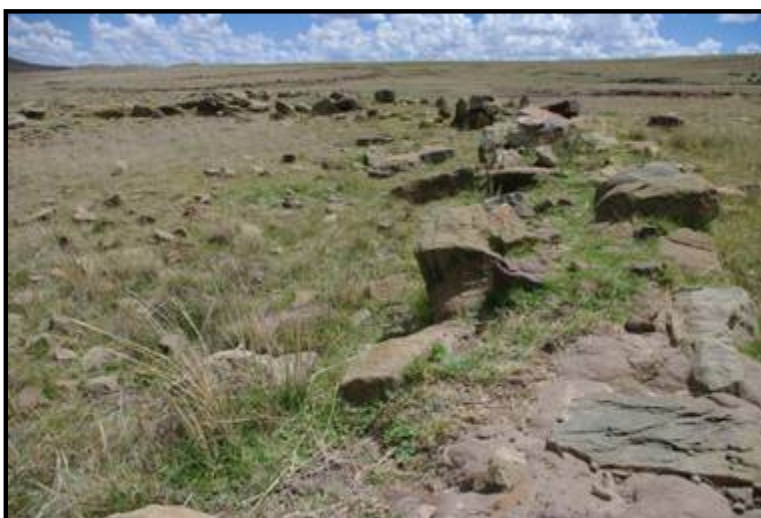
Figure 40: Stone wall remains of the large rectangular F3 feature

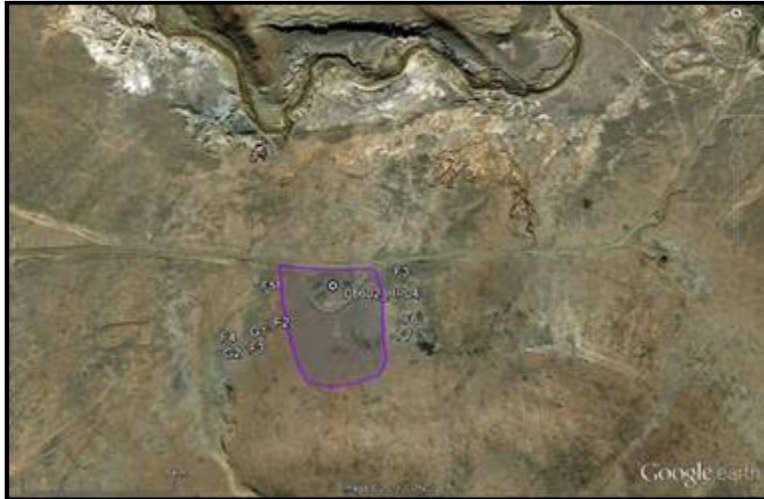
Figure 45: Borrow pit 08602_BP04

A number of Iron Age features are situated specifically west of the proposed borrow pit study site with a single identified resource located to the east thereof. More Iron Age remains are present, but not recorded for purposes of this report, situated west of the borrow pit study site, at distances of 250+m thereof, but all together, still comprising part of the greater Ndonga Ethiopian Mission Church Iron Age cultural landscape, with a number of prominent features also situated north of the access road towards the Ndonga River Valley. Current impact at the borrow pit study site and continued further use of the site can be managed with reference to the conservation of Iron Age features. Stone Age resources recorded at Site 08602_BP02.1 tapered out noticeably towards the borrow pit 08602_BP04 site. With only a handful encountered at the site and immediate surrounds.

RECOMMENDATIONS: Iron Age remains, including both recorded features and graves are ascribed a SAHRA *High Significance* and a *Generally Protected A Field Rating*. Again the Iron Age features recorded form part of the Ndonga Ethiopian Mission Church Iron Age cultural landscape. None of the features have been impacted on to date and none will be impacted by continued use of the site, provided that the current approximate 20m conservation buffer between the borrow pit and the site features be maintained. Feature G3 being situated at the entrance area of the borrow pit and by implication more exposed to increasing impact should be formally conserved. The feature should be permanently fenced with an access gate. The site should be permanently sign posted.

Stone Age material at the site is of such a low density that a SAHRA site significance assignation is not relevant. It is recommended that destruction of Stone Age resources proceed without the developer having to apply for a SAHRA Site Destruction Permit.

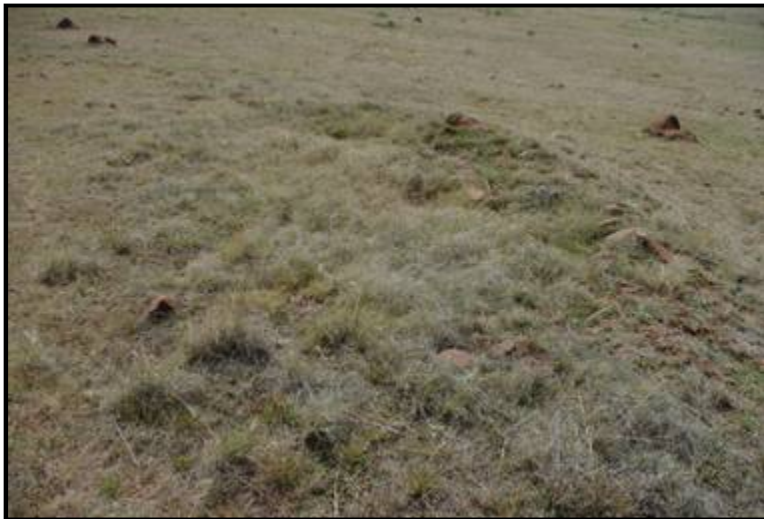
Figure 48: View of the F2 hut mound remains

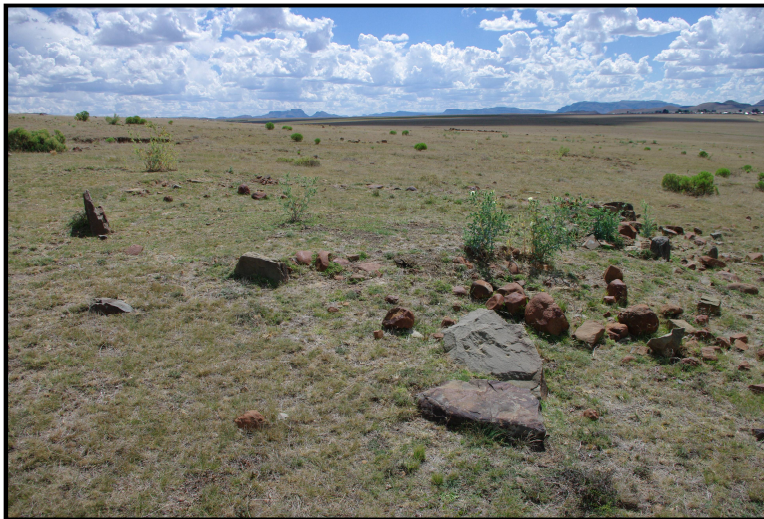
Figure 50: Selected graves from the G1 feature

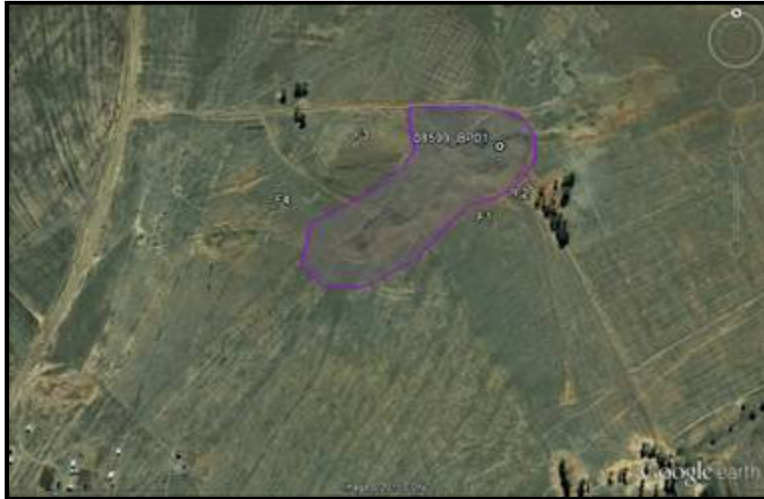
Figure 53: Borrow pit 08599_BP01

The general borrow pit 08599_BP01 area is typified by the widely dispersed stock enclosure features constituting the Iron Age Site 08599_BP01.1. The site is further described below. No Iron Age features are situated within the development footprint: Phase 1 AIA assessment yielded no archaeological or cultural heritage resources either on the surface or within exposed sub-surface sections of the immediate borrow pit 08599_BP01 study site.

Site 08599_BP01.1 is typified by the characteristic widely spread site features of many Later Iron Age sites across the Eastern Cape. Features in direct proximity to the borrow pit study site are briefly described: Features 1 and 2 (F1 – S31°38'26.1"; E27°24'30.5"; F2 – S31°38'24.5"; E27°24'33.3") comprises, in each case, of the stone foundation remains of a circular stock enclosure with an approximate diameter of 5m and a smaller rectangular adjoining calf camp to the one side. Feature 3 (F3 - S31°38'20.8"; E27°24'21.1": Site co-ordinate) constitutes a 'complex' of stock enclosure remains situated along the slope of the hill down to the road and extending slightly east, west and south-westwards thereof. Stock enclosures are all rectangular in shape with an adjoining smaller calf camp. The stock enclosure highest up on the slope of the hill comprises of 2 stock camps (in the region of approximately 7x5m) with an adjoining calf camp, while all the other remains, the enclosure just down-slope, and the one slightly to the east thereof both comprise of only one stock enclosure with an adjoining calf camp. Slightly towards the west of F3 is a small enclosure, again demarcated only by rough foundation remains, more or less 2x2m in size. A number of circular stone outlines (fire pits / storage stands) all with diameters of approximately 80cm to 1m are present in the general area. Feature 4 (F4 – S31°38'25.0"; E27°24'15.1") demarcates the locality of the enclosure situated furthest south west; remains of an approximate 5x4m rectangular stock enclosure with walls still standing to approximately 30-40cm high. Further to the west of the recorded site features associated stone feature remains taper out towards the road and south towards the village where the distinction between abandoned or old and new stone enclosures becomes muddled.

The rectangular shape of stock enclosure features are the best indication of a site date, implying a date at least coinciding with Colonial settlement. A mixture of circular and rectangular enclosure remains are often found, in cases implying extended temporal use of a site. No residential remains were identified with the stock enclosure

None of the Iron Age features recorded as forming part of Site 08599_BP01.1 are directly threatened or will be impacted on by the proposed development; Features 1 and 2 (F1 & F2) being the most sensitive, and situated between 10-30m from the recorded site assessment area. This approximate 10-30m 'conservation barrier' between the site features and the borrow pit fence should be maintained. Alternatively the features, both stock enclosures, should be destroyed under a SAHRA Site Destruction Permit (Phase 2 mitigation of the stock enclosures are not recommended, based on the limited potential research data that such excavations can possibly yield). In addition the site should be permanently sign posted.

RECOMMENDATIONS: Site 08599_BP01.1 is ascribed a SAHRA *Low Significance* and a *Generally Protected C Field Rating*. The features comprising the site will primarily be conserved, aside from possible impact on Feature 2 (F2, stone foundation remains of a stock enclosure). It is recommended that use of borrow pit 08599_BP01 proceeds as applied for provided the developer complies with the following requirements:

3. The site should be permanently sign posted (It is recommended that the sign be placed in the vicinity of the most prominent site feature being the F2 'complex' of remains);
4. Should Features 1 and 2 (F1 & F2) fall within the final borrow pit fence the features should be destroyed under a SAHRA Site Destruction Permit.

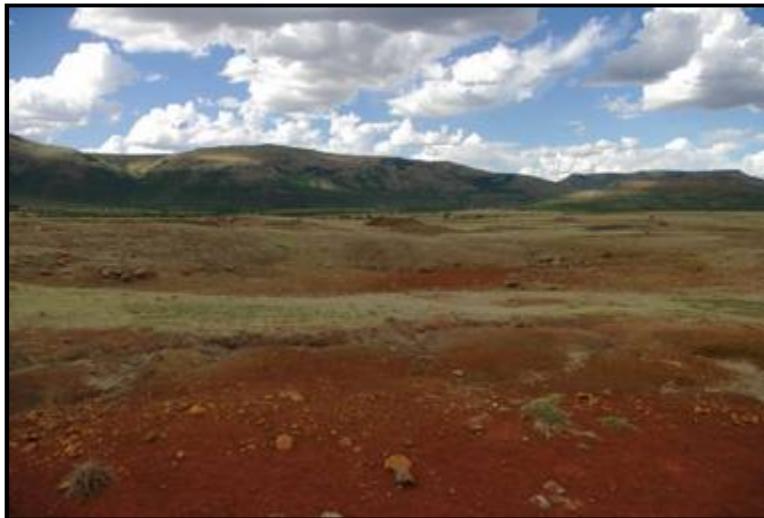
Figure 54: View of a portion of the 08599_BP01 borrow pit study site

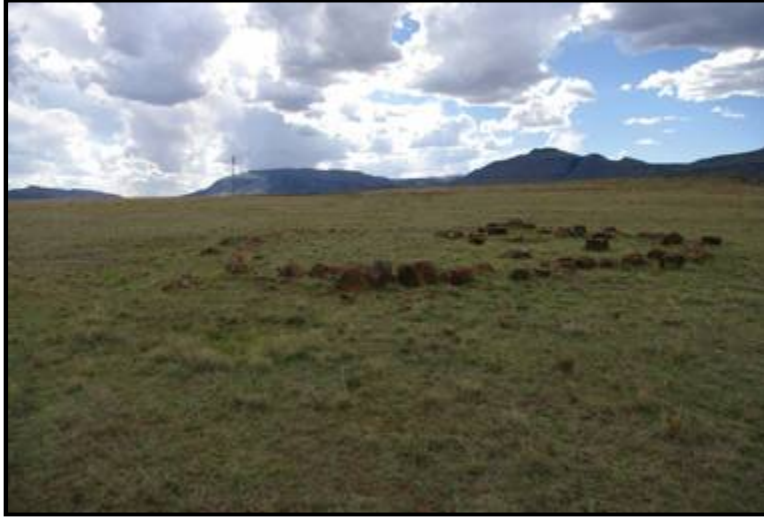
Figure 55: View of the F1 feature

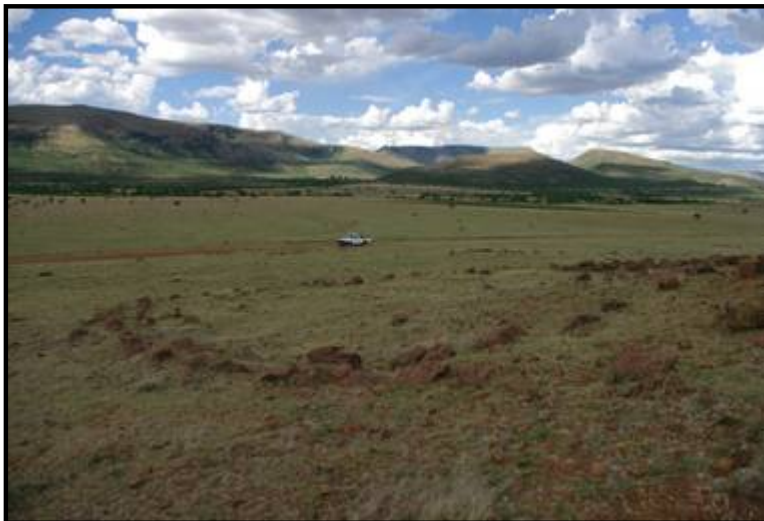
Figure 56: The main 'kraal' complex at the F3 feature

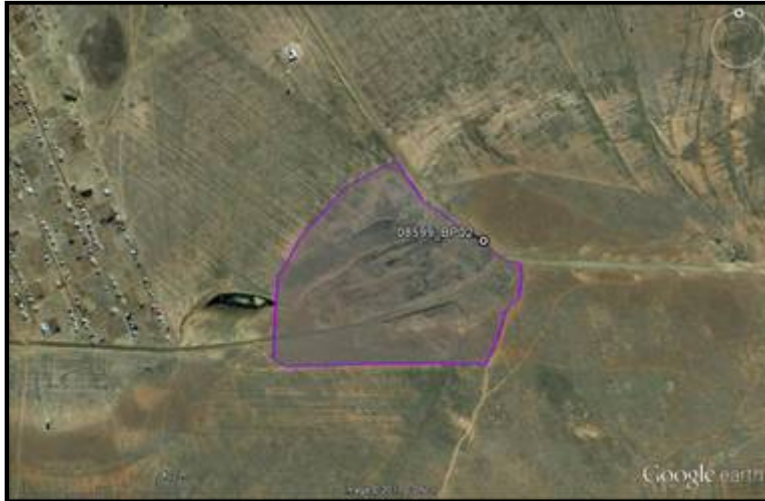
Figure 61: Borrow pit 08599_BP02

The borrow pit 08599_BP01 study site is characterized by low densities of Middle Stone Age (MSA) material, with particular low densities identified on the surface, but with more artefact present in slightly scraped areas. This Stone Age feature is further described as Site 08599_BP02.1.

The general surface area around borrow pit 08599_BP02 yielded a few Stone Age artefacts, but in general with densities too low to ascribed an artefact ratio (artefacts: m²) thereto. However, closer to current quarrying impact and identified in slightly scraped surfaces of the gravel access road and at intervals across the existing area of impact lense-like features or 'collections' of artefacts were present. These surface 'collections' were usually found in fairly small areas, approximating 3x3m areas, where varying artefact ratios of 8-15:1 was recorded. All 'collections' comprised of Middle Stone Age (MSA) artefacts, typified by the flake and blade technology used. Based on the size of the artefacts it is inferred that the collection may rather date to earlier or middle MSA times. Very low densities of artefacts were still present between these clustered 'collections' – giving the impression of clear activity (perhaps knapping) areas, whilst general use of the site, basic post depositional processes and the site's prolonged exposure to the elements have resulted in a fair degree of surface disturbance. No anthropic member was identified in the large exposed sub-surface sections of the borrow pit; lense-like features with stratigraphic depth are not expected.

RECOMMENDATIONS: Site 08599_BP02.1 is ascribed a SAHRA *Low Significance* and a *Generally Protected C Field Rating*. It is recommended that a systematic surface sample be taken before development continues at the site (alternatively the site will have to be conserved in its entirety).

5. At 08599_BP02 lensed Stone Age 'collections' would need to be sampled before development proceeds.
- ❖ **Sign Posting:** Sign posting is not at present defined by SAHRA and the following can be used as guideline: Signs should indicate that the sites are formally protected under the NHRA 1999 and that any damage thereto or impact thereon is prohibited by law. In addition the sites should indicate a reference for purposes of future identification. Sign boards can be in the region of approximately 60-70cm x 40cm in size which will provide for a reasonable size sign with clear legible lettering. Sign boards are usually done by professional sign writers (durability) on a metal board and fixed to a treated wooden or metal pole. Sign boards can be in a basic color (black / white/ green / blue) with any font type (lettering in black / white). It is recommended that sign posts be done in English / Xhosa.

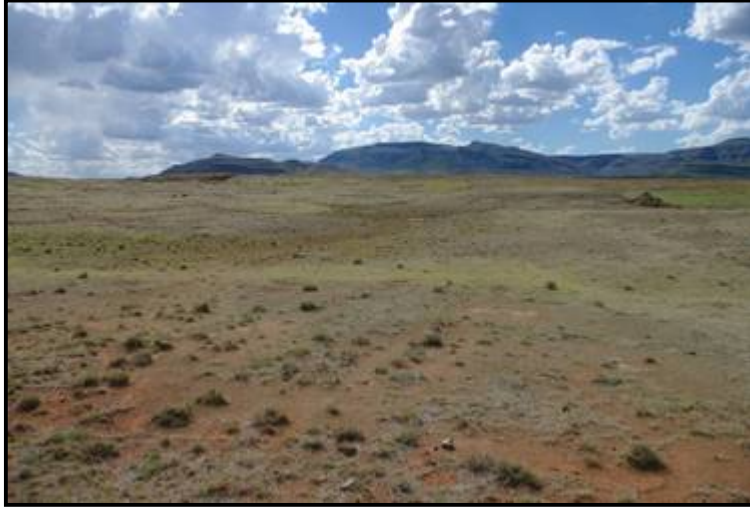
Figure 62: General view of the large08599_BP02 study site

1. Systematic surface sample of the MSA lithic features to be taken before development continues. The sample has to be taken under a SAHRA Collections Permit.

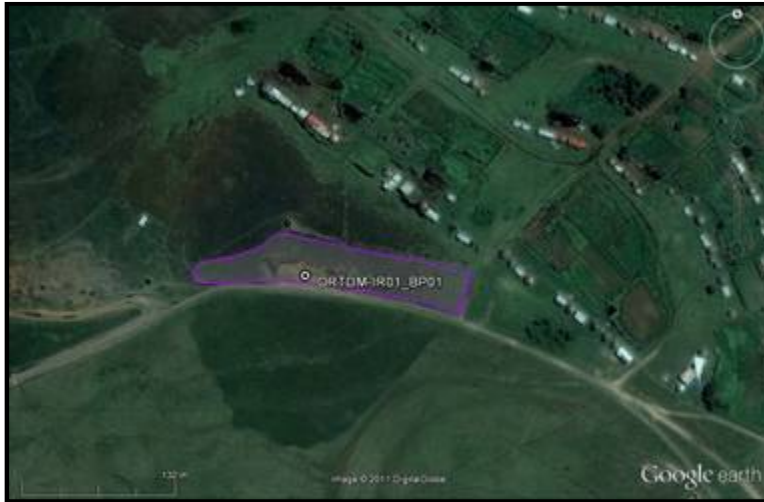
Figure 66: Borrow pit ORTDM-IR01_BP01

No archaeological or cultural heritage resources, as defined and protected under the NHRA 1999, were identified on the surface or within exposed sub-surface sections during the Phase 1 AIA assessment of borrow pit ORTDM-IR01_BP01.

RECOMMENDATIONS: It is recommended that use of borrow pit ORTDM-IR01_BP01 proceeds as applied for without the developer having to comply with additional heritage compliance requirements.

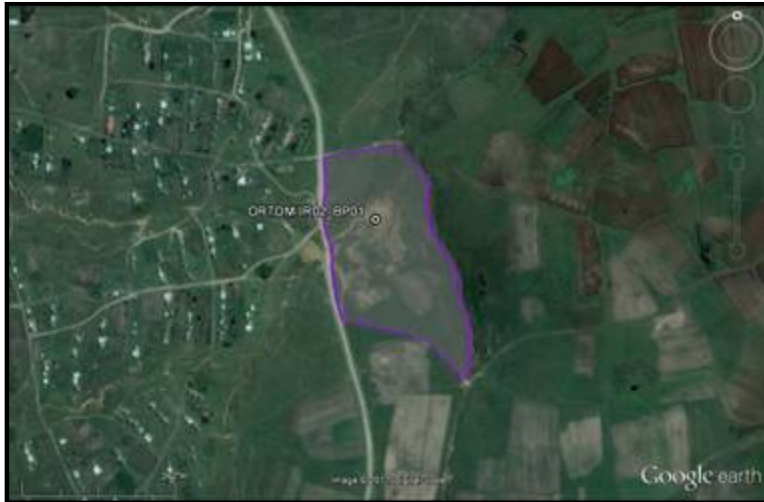
Figure 68: Borrow pit ORTDM-IR02_BP01

No archaeological or cultural heritage resources, as defined and protected under the NHRA 1999, were identified on the surface or within exposed sub-surface sections during the Phase 1 AIA assessment of borrow pit ORTDM-IR02_BP01.

RECOMMENDATIONS: It is recommended that use of borrow pit ORTDM-IR02_BP01 proceeds as applied for without the developer having to comply with additional heritage compliance requirements.

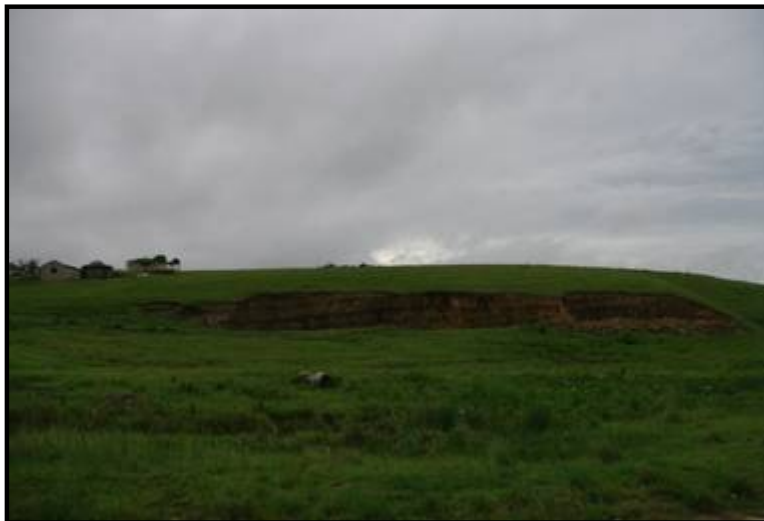
No archaeological or cultural heritage resources, as defined and protected under the NHRA 1999, were identified on the surface or within exposed sub-surface sections during the Phase 1 AIA assessment of borrow pit ORTDM-IR02_BP02.

Figure 71: Current impact at the ORTDM-IR02_BP02 locale

RECOMMENDATIONS: It is recommended that use of borrow pit ORTDM-IR02_BP02 proceeds as applied for without the developer having to comply with additional heritage compliance requirements.

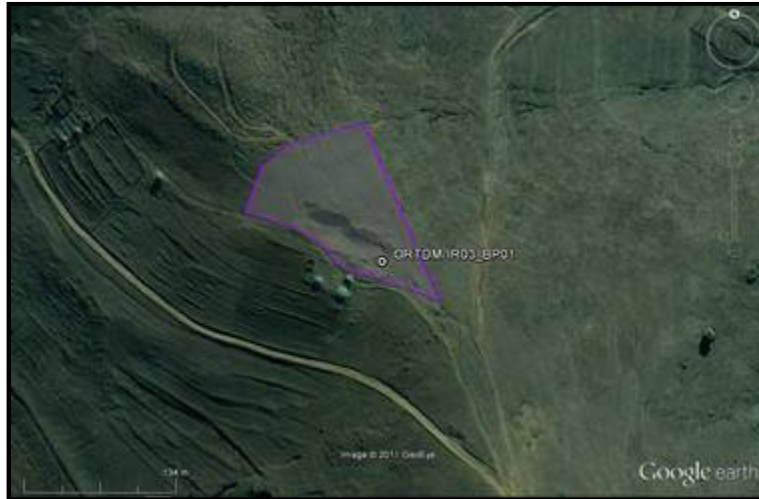
Figure 72: Borrow pit ORTDM-IR03_BP01

No archaeological or cultural heritage resources, as defined and protected under the NHRA 1999, were identified on the surface or within exposed sub-surface sections during the Phase 1 AIA assessment of borrow pit ORTDM-IR03_BP01.

RECOMMENDATIONS: It is recommended that use of borrow pit ORTDM-IR03_BP01 proceeds as applied for without the developer having to comply with additional heritage compliance requirements.

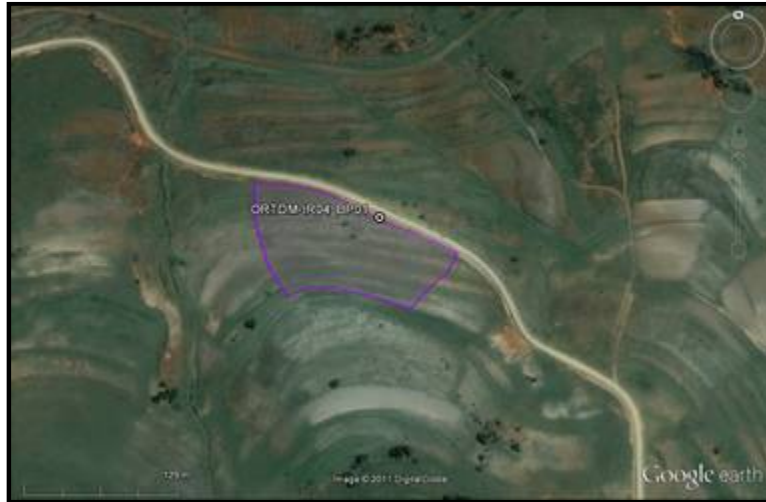
Figure 73: Borrow pit ORTDM-IR04_BP01

No archaeological or cultural heritage resources, as defined and protected under the NHRA 1999, were identified on the surface or within exposed sub-surface sections during the Phase 1 AIA assessment of borrow pit ORTDM-IR04_BP01.

RECOMMENDATIONS: It is recommended that use of borrow pit ORTDM-IR04_BP01 proceeds as applied for without the developer having to comply with additional heritage compliance requirements.
