PHASE 1 ARCHAEOLOGICAL IMPACT ASSESSMENT

**CAGADU DISTRICT AND INACCESSIBLE ROADS PROJECT,
EASTERN CAPE, SOUTH AFRICA**

DATE: 2011-12-12

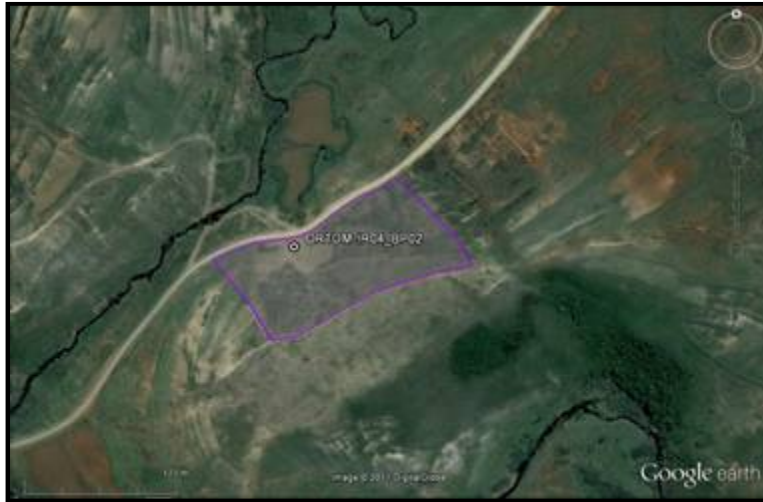
Figure 75: Borrow pit ORTDM-IR04_BP02

No archaeological or cultural heritage resources, as defined and protected under the NHRA 1999, were identified on the surface or within exposed sub-surface sections during the Phase 1 AIA assessment of borrow pit ORTDM-IR04_BP02.

RECOMMENDATIONS: It is recommended that use of borrow pit ORTDM-IR04_BP02 proceeds as applied for without the developer having to comply with additional heritage compliance requirements.

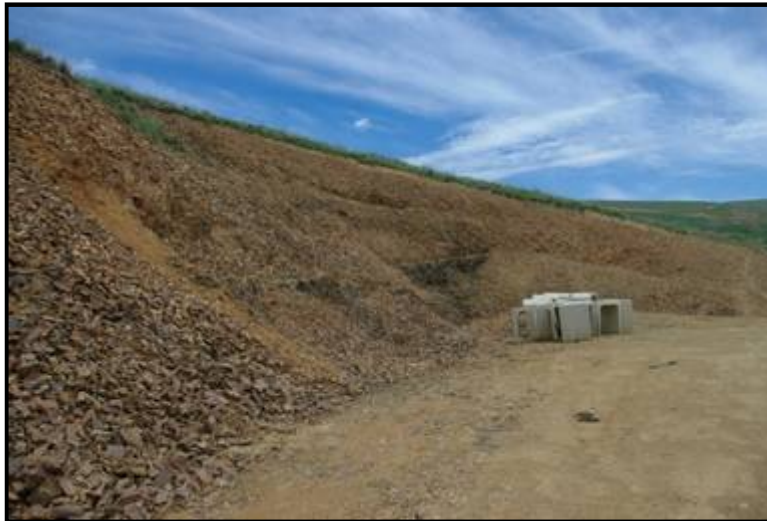
Figure 76: Exposed anthropic sterile sections at ORTDM-IR04_BP02

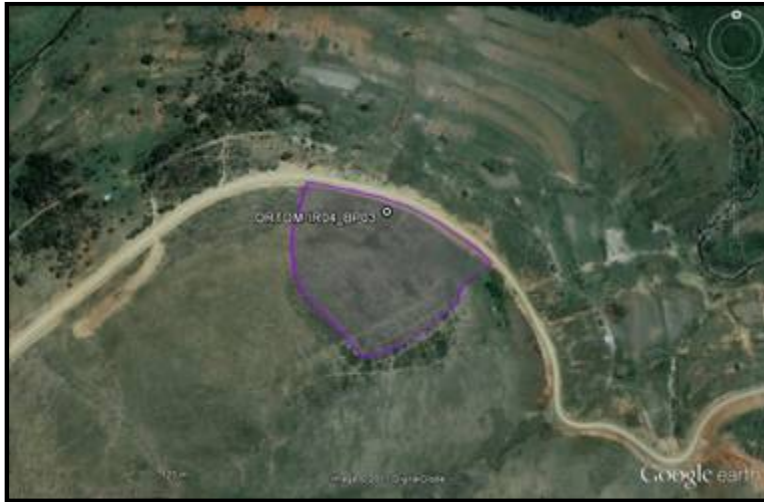
Figure 77: Borrow pit ORTDM-IR04_BP03

No archaeological or cultural heritage resources, as defined and protected under the NHRA 1999, were identified on the surface or within exposed sub-surface sections during the Phase 1 AIA assessment of borrow pit ORTDM-IR04_BP03.

RECOMMENDATIONS: It is recommended that use of borrow pit ORTDM-IR04_BP02 proceeds as applied for without the developer having to comply with additional heritage compliance requirements.

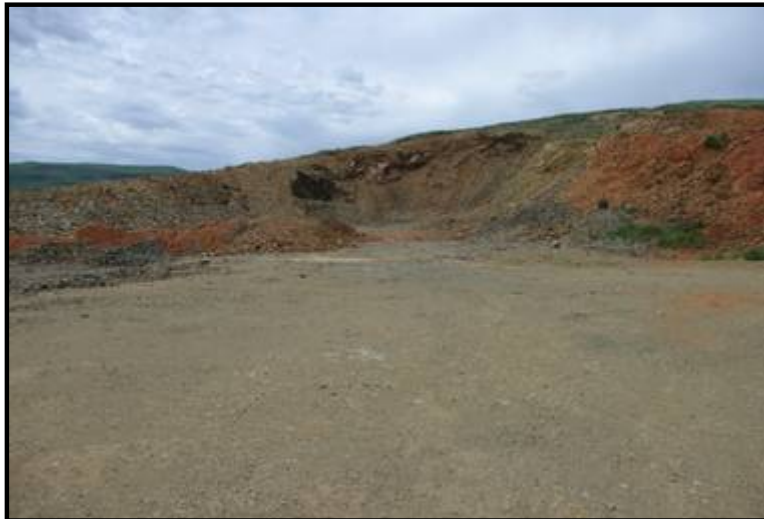
No archaeological or cultural heritage resources, as defined and protected under the NHRA 1999, were identified on the surface or within exposed sub-surface sections during the Phase 1 AIA assessment of borrow pit ORTDM-IR04_BP04.

Figure 80: Existing large scale impact at the ORTDM-IR04_BP04 study site

RECOMMENDATIONS: It is recommended that use of borrow pit ORTDM-IR04_BP04 proceeds as applied for without the developer having to comply with additional heritage compliance requirements.

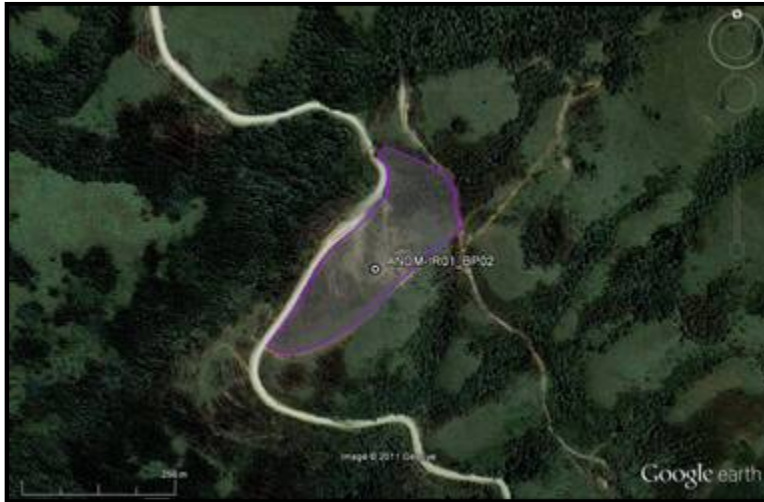
Figure 84: Borrow pit ANDM-IR01_BP02

No archaeological or cultural heritage resources, as defined and protected under the NHRA 1999, were identified on the surface or within exposed sub-surface sections during the Phase 1 AIA assessment of borrow pit ANDM-IR01_BP02.

RECOMMENDATIONS: It is recommended that use of borrow pit ANDM-IR01_BP02 proceeds as applied for without the developer having to comply with additional heritage compliance requirements.

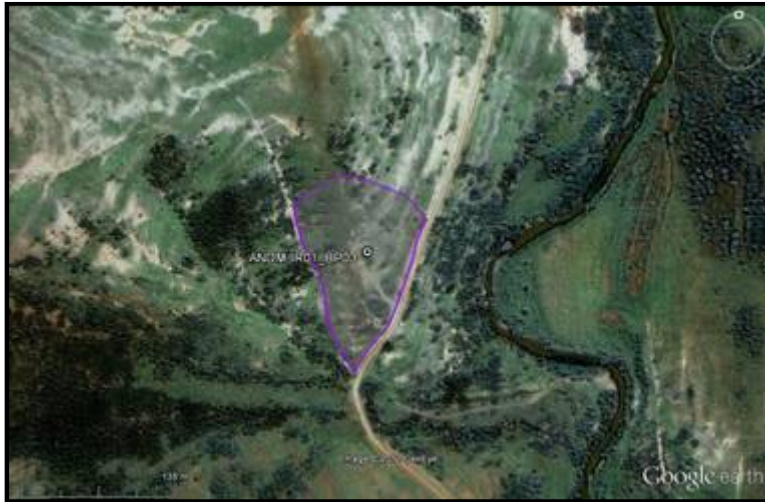
Figure 86: Borrow pit ANDM-IR01_BP03

No archaeological or cultural heritage resources, as defined and protected under the NHRA 1999, were identified on the surface or within exposed sub-surface sections during the Phase 1 AIA assessment of borrow pit ANDM-IR01_BP03.

RECOMMENDATIONS: It is recommended that use of borrow pit ANDM-IR01_BP03 proceeds as applied for without the developer having to comply with additional heritage compliance requirements.

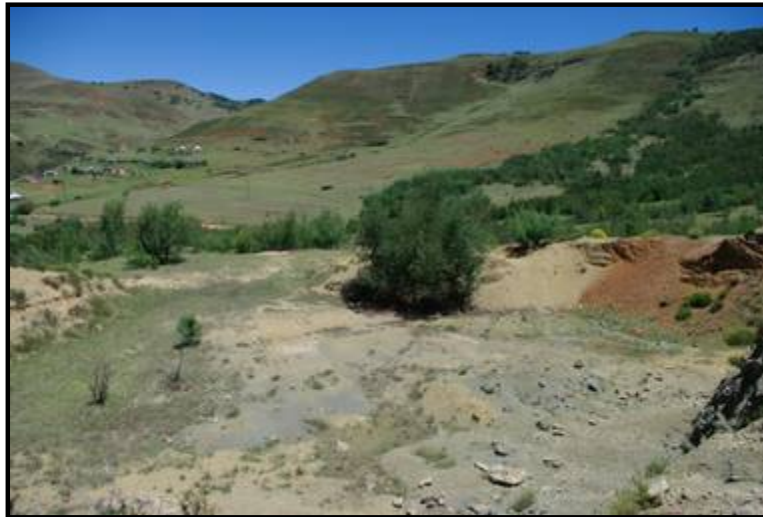
Figure 87: Some current disturbance at the ANDM-IR01_BP03 study site

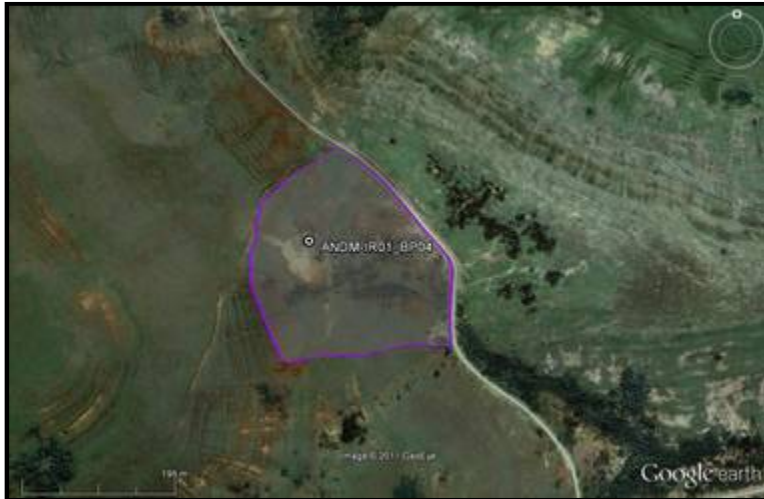
Figure 88: Borrow pit ANDM-IR01_BP04

No archaeological or cultural heritage resources, as defined and protected under the NHRA 1999, were identified on the surface or within exposed sub-surface sections during the Phase 1 AIA assessment of borrow pit ANDM-IR01_BP04.

RECOMMENDATIONS: It is recommended that use of borrow pit ANDM-IR01_BP04 proceeds as applied for without the developer having to comply with additional heritage compliance requirements.

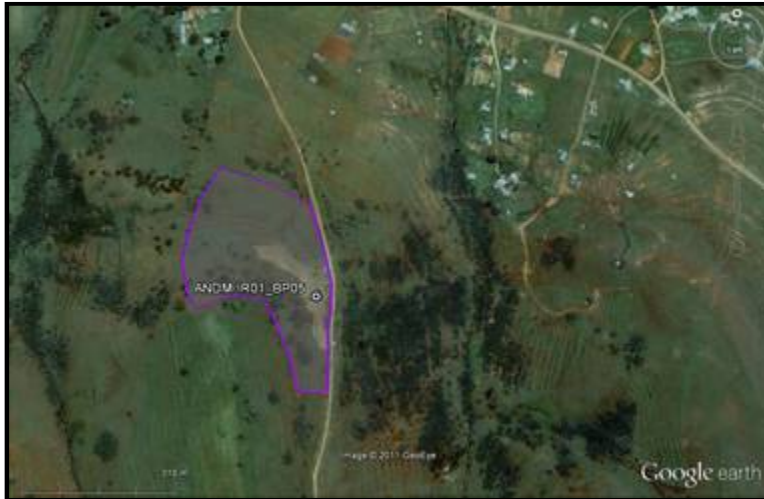
Figure 90: Borrow pit ANDM-IR01_BP05

No archaeological or cultural heritage resources, as defined and protected under the NHRA 1999, were identified on the surface or within exposed sub-surface sections during the Phase 1 AIA assessment of borrow pit ANDM-IR01_BP05.

RECOMMENDATIONS: It is recommended that use of borrow pit ANDM-IR01_BP05 proceeds as applied for without the developer having to comply with additional heritage compliance requirements.
