Babylonstoren Farm 1268
Archaeological Impact Assessment
Koornhuis

Executive Summary

An Archaeological Impact Assessment for the Babylonstoren Koornhuis was requested in a SAHRA ROD dated 8 September 2009. The Babylonstoren werf is in the process of being altered/renovated; the main dwelling and the fowl house has already been renovated; work on the wine cellar and animal shed associated with the kraal is in progress and the proposed plans for the Koornhuis are being submitted. A very tight time schedule was allowed for the archaeological testing, and seven test pits were excavated in strategically placed areas to try and extract as much information about the use and re-use of the building over time.

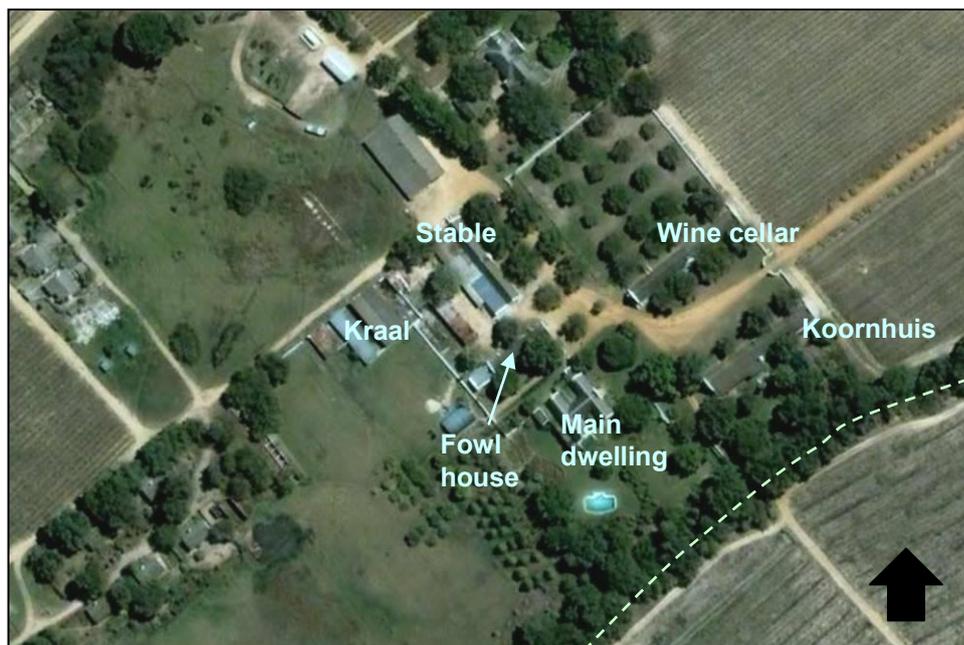
Figure 2: Detail of the werf (Google Earth 2009). The approximate alignment of the furrow/stream is shown by the green dashed line.

The Koornhuis is the counterpart of wine cellar, together forming the forecourt to the main dwelling. According to Walton (1989:41) these buildings were deliberately designed at an angle, so creating a false perspective, focusing the viewer's attention on the main dwelling. The current proposal is to recreate the early 19th century aspect of the forecourt; replacing the current loft window with a replica of the front gable of the wine cellar. The Koornhuis is to be reused as a photographic studio, with a residential component.

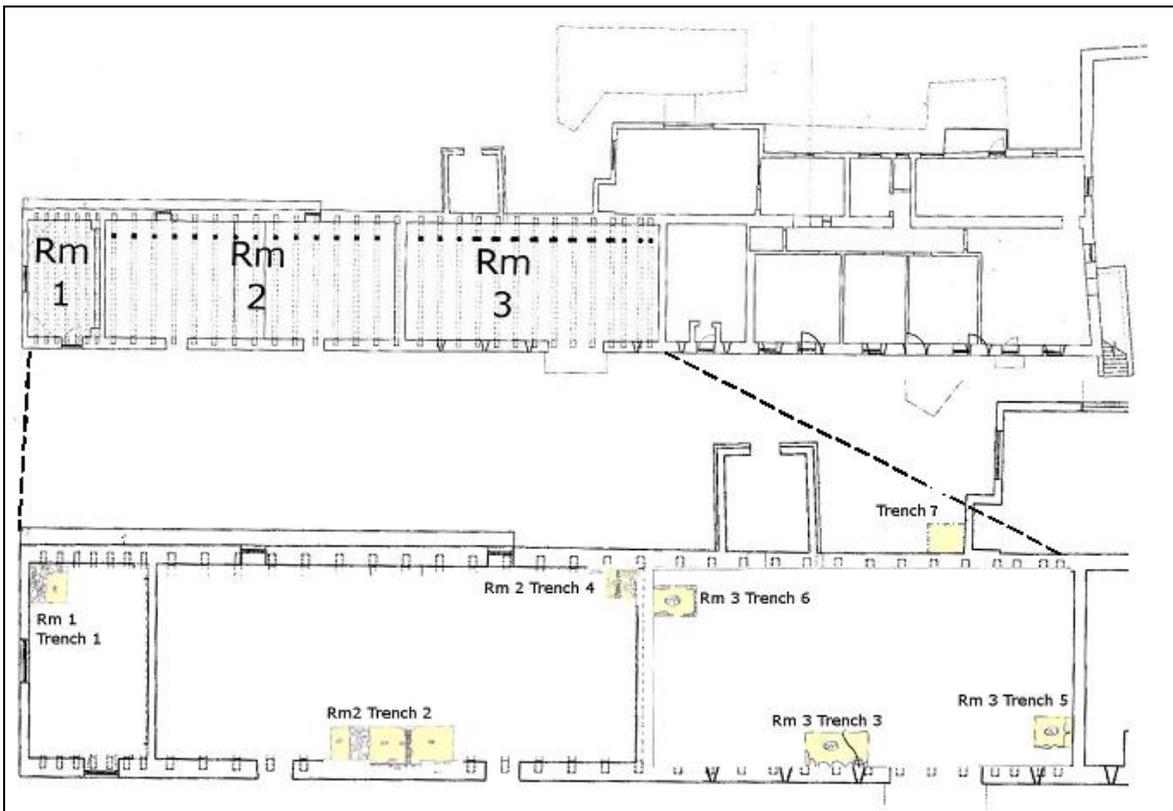
Figure 3: Location of rooms and trenches within the building

Seven test trenches were made at the Koornhuis: six tests in the interior of the building and one on the exterior (see Fig. 3). The tests were made to check for pre-existing features, internal dividing walls, changes in floor levels and evidence of change of use of the building. Six labourers were employed, working in teams of two, under the supervision of Katie Smuts. Excavations were conducted using picks, spades, and trowels. As far as possible, layers were excavated stratigraphically. Trenches were excavated to the natural ground surface, and where possible, the foundation trenches of the walls exposed.

Archaeological testing was only possible in the three rooms to the northern end of the building, as the rest of the building was not accessible. A temporary benchmark was selected (the lowest string course of the northeastern gate post of the werf) and assigned an arbitrary value of 10m. All levels were taken from this datum point using a dumpy level and are given on the sections relative to this point. For simplicity, the building was taken as aligned north/south, although its layout is NNE/SSW.

Owing to time constraints, it was not possible to lay out a grid, but the test trenches are plotted on the measured drawing of the building, provided by Chris Fick of MRArchitects. A selection of sections was drawn, chosen for their relevance in terms of better understanding the sequence of construction.

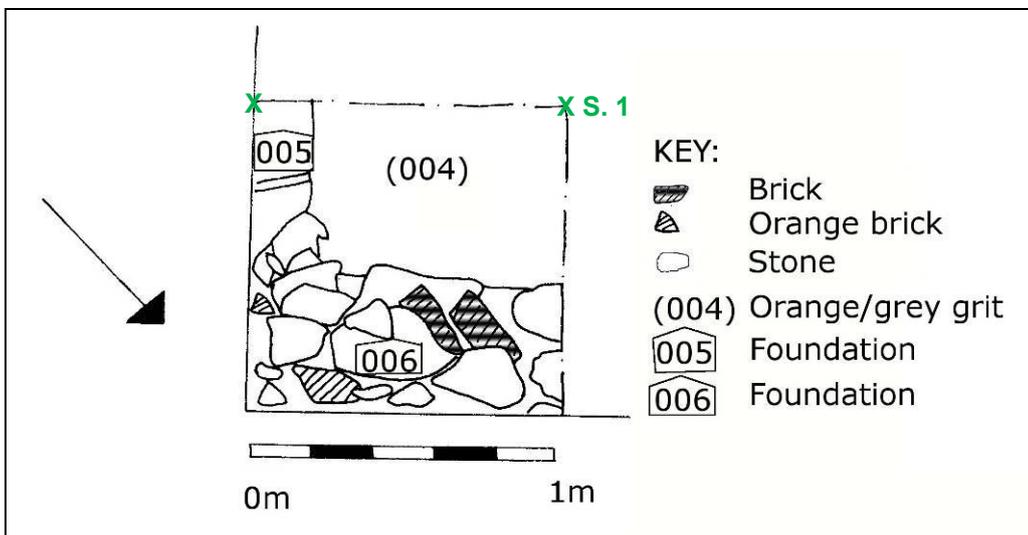
Figure 4: Plan 1 showing Trench 1 Room 1. Location of Section 1 indicated in green

A 1m x 1m square was excavated in the north-eastern corner of Room 1. The uppermost layer in this room is a floor surface consisting of crushed brick (01). This floor level represents the most recent floor level of the room and was still in use at the time of excavation. The floor was laid on a levelling layer of mottled light brown gritty sand with several broken brick fragments (02). This makeup layer in turn overlay a dark sandy silt layer (03) that probably constitutes a terracing event that occurred prior to the construction of the building. This deposit was cut by the foundation trench (67) and was used to backfill the trench (68). The foundations (05) for the north/south external wall of the building were overlain to the north by the modern east/west foundations (06) of the repaired north gable wall. This wall had collapsed at some point, destroying part of the north/south wall, and was rebuilt in modern brick. The foundations for this new wall are quite substantial and include

some modern brick in their fabric. Trench 1 was excavated down to the level of the upper natural (04), a layer of orange-grey, gritty sand.

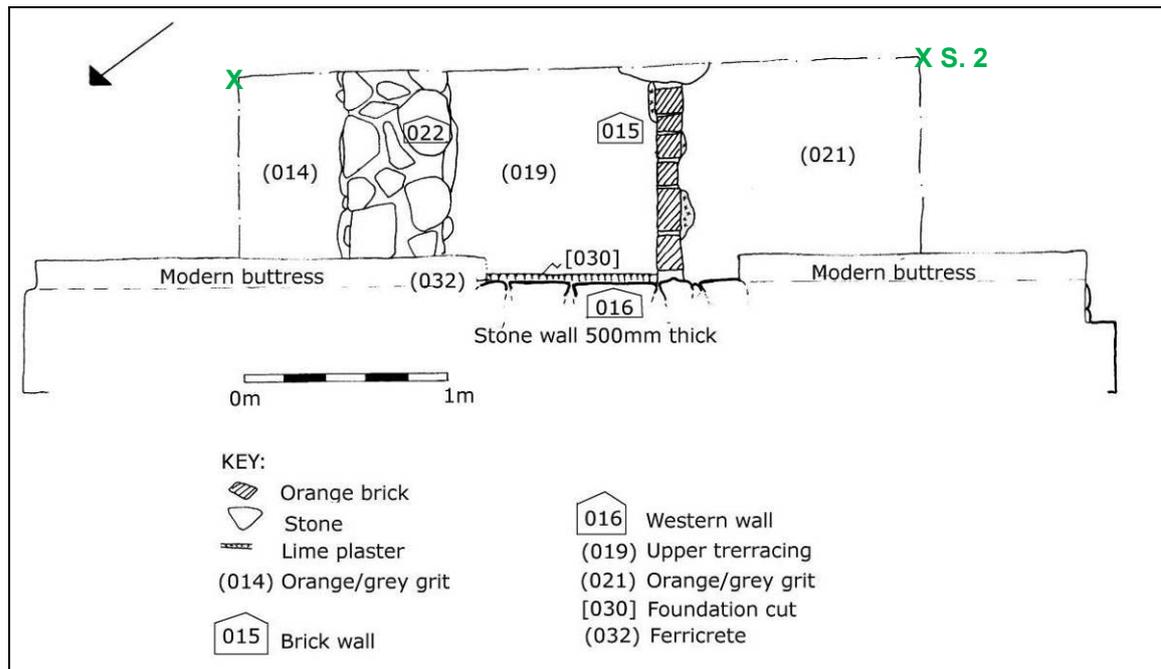
Figure 6: Plan 2 showing Trench 2 Room 2. Location of section 2 indicated in green

This trench measured 3.34m x 1m and tested for changing floor surfaces and for internal dividing walls. Two internal walls were uncovered: (22) was a substantial stone wall and (15) was a shallow brick wall with no foundation. Wall 22 is 500mm wide, and appears to have had a foundation of a single course of stone overlaid with four courses of smaller cobbles. As the wall was subsequently demolished, it is uncertain whether its superstructure had been brick, or whether, as with the outer walls, it was stone to sill height.

Deposits from Trench 2 were assigned individual context numbers north of wall 22, between 22 and 15 and south of 15, although it became clear that, with a few exceptions, the layers were consistent across the trench. Each part of the trench is, nevertheless, described as they were excavated and recorded.

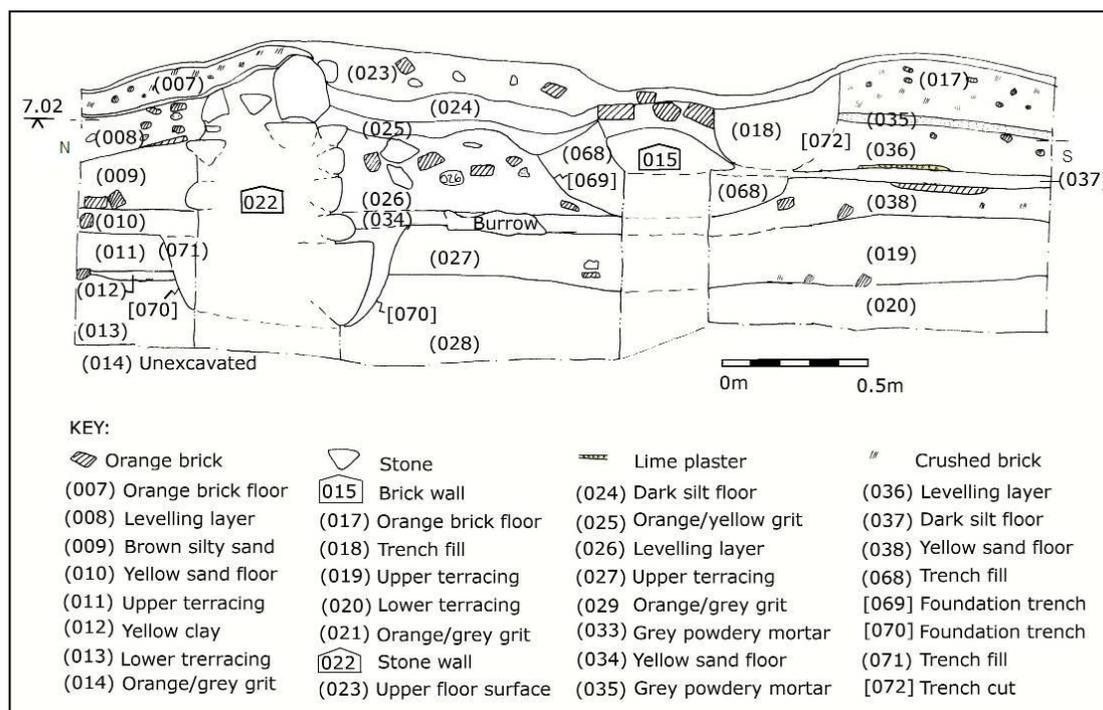
Figure 7: Section 2 Trench 2 west facing

The uppermost floor surface in the room (23) comprised compacted, mid-grey gritty sand. This floor surface directly overlay the remnants of a crushed orange brick floor (07 and 17) which survived towards the northern and southern ends of the trench, but had failed in the middle. Where the crushed brick floor had failed, its level had been raised by the upper surface 23. The crushed brick surface is equivalent to floor level 01 in Room 1. Both floor 07 and 17 are underlain by a thin layer of powdered grey mortar (33 and 35, respectively). Floor 07 to the north and its sub-layer of grey mortar (33), overlay wall 22, but to the south, floor 17 has been truncated by a trench (72) dug alongside wall 15.

Below floor 07 is layer 08, a mottled sandy silt levelling layer, and this in turn overlies 09, a mid brown layer of silty sand. Below this layer are the remnants of a badly degraded yellow silty sand floor (10). Although it is largely failed close to wall 22, this floor level would appear to be laid over the uppermost foundation level of the wall. This deposit represents the floor level of the building after the construction of wall 22. The northern face of the wall seemed disturbed and several stones were missing. The foundation cut for wall 22 (30) is cut from below floor level 10, through deposits 11, 12 and 13 and backfilled with a mid-brown, silty sand deposit (31). Layer 11 comprises dark sandy silt and represents the terracing of the ground prior to construction. Layers 11 and 13 appear to be two phases of terracing, divided by deposit 12, a thin, ephemeral layer of yellow clay with a fragment of unbaked brick. This layer could relate to the preparation of building materials in the vicinity prior to the commencement of construction. Both 11 and 13 are mid grey brown sandy silt. This northernmost part of Trench 2 was excavated down to the coarse orange-grey gritty sand of the upper layer of natural substrate (14).

The portion of Trench 2 between walls 22 and 15 has no surviving remnant of floor surface 7/17. The uppermost deposit here is the compacted mid-grey silty sand layer 23. This overlies wall 15. Below 23 is a well compacted layer of dark silt (24) that, while uneven for a floor surface, is very similar to the upper rammed earth floor in the Cellar building (Smuts pers comm.). Below 24 is a layer of firm orange-yellow gritty sand (25). These two surfaces combined make for a water-tight, damp-proof floor surface, indicating that this narrow space – just under a metre wide – could have been used for storing agricultural products such as grain or damp sensitive farm equipment such as tack and harnesses.

The cut for the foundation trench (69) for wall 15 is cut from below these floor layers and filled with a mottled, mid-brown deposit flecked with small fragments of brick and some plaster (68). The trench cuts a robust make up layer of mottled gritty sand (26) with some medium sized stone inclusions up to 100mm and several brick fragments. This, in turn, is laid over a yellow silty sand floor (34) that corresponds to the level of floor surface 10 to the north of wall 22. Again, this floor surface is poorly preserved and damaged by at least one rodent burrow. The foundation trench (70) for 22 is dug from below this floor surface, through terracing levels 27 and 28 and backfilled with a mottled mid greyish-brown silty sand (71) that represents a mixing of these two deposits. As shown on Plan 2 (see Fig. 6), the foundation trench (30) for the north/south external wall was located and the lowest course of the foundations exposed. The trench was dug through the upper natural (29), a coarse, gritty orange-grey sand, into the underlying ferricrete gravels (32) and backfilled with a mix of these materials (31).

Wall 15 survives as a single course of brick with fragments of plaster attached to the southern face. The most intact brick measures 200mm by 120mm by 80mm. A large boulder is evident in section, and this has several bricks overlying it, which would appear to be part of the structure of the wall. The compacted, mid-grey gritty sand layer 23 continues over wall 15 to the south. This layer overlies the orange, crushed brick floor (17) that corresponds with the continuing surface to the northern end of the trench (07). This crushed brick floor to the south of wall 15 is laid over a thin layer of powdered grey mortar (35) that could have been laid, like layer 25 as a means of further waterproofing the floor, or could simply be related to building activities taking place before the floor was laid.

These upper layers overlie a mottled mid-brown silty sand makeup layer (36). Although the deposit adjacent to wall 15 towards the south is very disturbed, it would appear that deposits 17, 35 and 36 are all cut by a trench (72) that is filled with a loose, dark silty material (18). It is very clear that floor 17 is truncated, and it is possible that the activity related to trench 72 was responsible for the failure of the orange brick floor in the centre of the room.

Below 36 and partially disturbed by 72 is a compacted dark, silty floor level (37), overlain in places by an ephemeral layer of white lime plaster. This could be the remnants of an upper mortar surface to the rammed silt floor in this area and could be a continuation of the plaster found on wall 15 itself. The layer below 37 is a yellow silty sand floor level (38) that corresponds with floor 34, north of wall 15 and is a continuation of the same floor level. This floor, unlike 34, is slightly disturbed by the foundation trench (69) for wall 15. The foundation trench fill (68) is of the same material as that north of 15, namely, a mottled, mid-brown deposit flecked with small fragments of brick and some plaster.

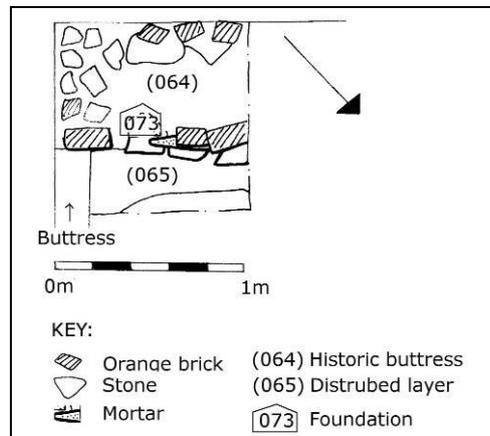
Figure 8: Plan 3 showing Trench 4 Room 3

Trench 4 was excavated in order to reveal the foundations of the internal east/west wall that divides Rooms 2 and 3. This wall was buttressed on the northern side by loosely packed stones and bricks in a light brown silty sand matrix (64). This material sloped down away from the wall and extended 700mm into the trench, across what would appear to be the foundations for the wall (73). A mottled, highly disturbed deposit (65) was removed from beyond the wall footings, but this cleaned off onto a large stone in the northern part of the trench. It was decided not to enlarge the trench, nor to disturb the footings of the wall. Given the shallow nature of the trench, it was planned, but no section drawings were made. A modern butress like that in Trench 2 runs along the eastern wall and stops at the point where the buttressing material 64 begins. This could indicate that, rather than simply being buttressing material, 64 is the remnant of some east/west structure that had abutted the wall and was removed after the concrete butress was built. This might have been a feeding trough, or some similar feature.

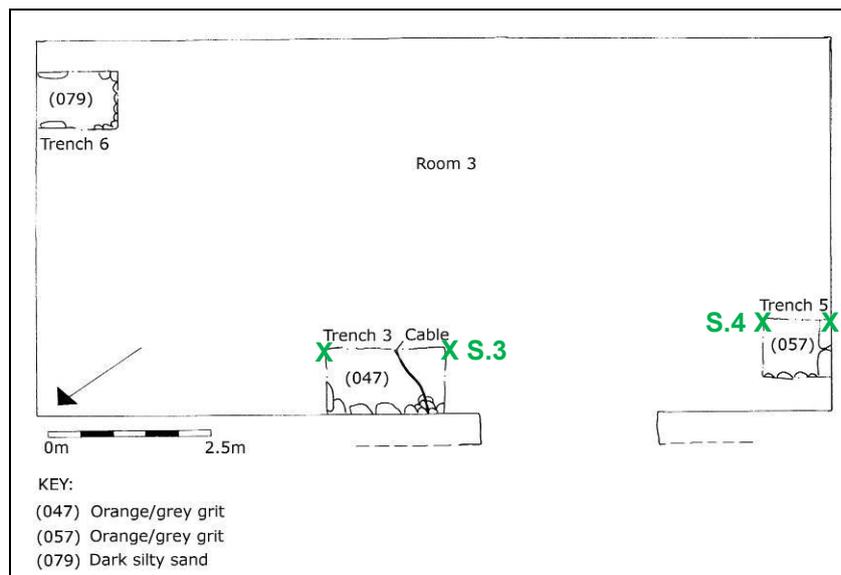
Figure 9: Plan 4 showing Trenches 3, 5 and 6 Room 3. Location of sections 3 and 4 indicated in green

Three trenches were opened in Room 3. Trench 3 was dug against the western external wall, and measured 1.75m north/south by 1m east/west. The trench was positioned at the corresponding

location of the trench in the Cellar that revealed the original north end wall of the earlier building, i.e. at approximately 29m from the southern end of the two buildings. Trench 5 was located in the south-western corner of the building to investigate the higher floor levels there. This trench measured 1.10m north/south by 0.90m east/west. Trench 6 was located in the opposite corner of the room, in the north-eastern corner and measured 1.25m north/south by 0.80m east/west. The dimensions of these last two trenches were limited by the large numbers of cobbles and boulders present that hindered excavation. In Trench 6 at least, some of these cobbles seem to be the remnants of a cobbled floor that might exist in patches throughout the whole room.

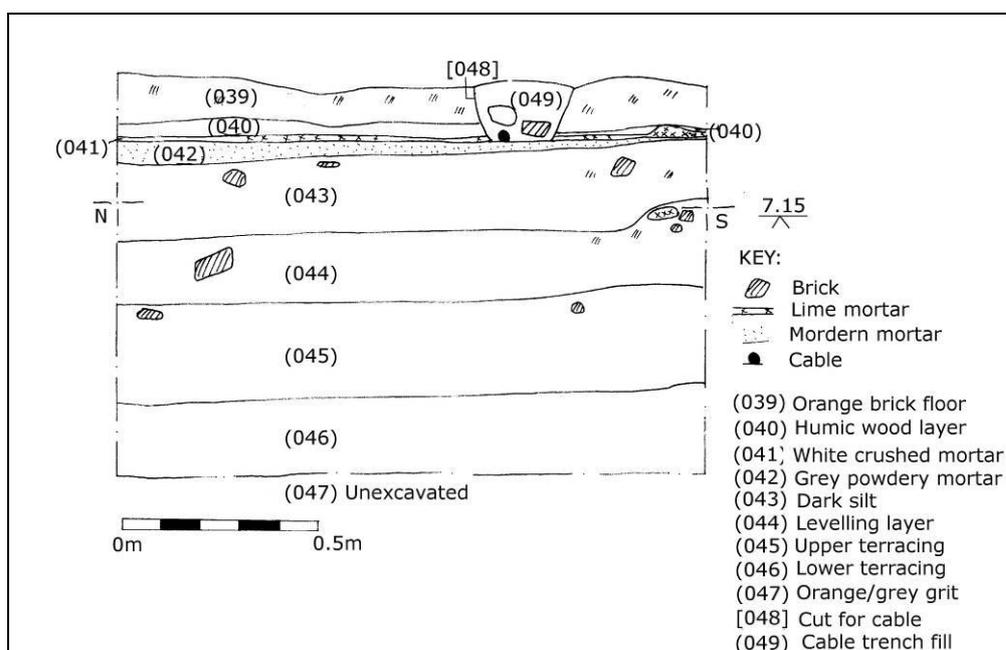
Figure 10: Section 3 Trench 3 west facing

The uppermost layer in Trench 3 was the orange gritty, crushed brick floor surface that is found throughout the building, assigned its own context number again (39). This overlay a band of dark humic silt with a large quantity of degraded wood (40). This layer, in turn, overlay a thin layer of white crushed mortar with some lime component (41). All of these layers were cut by a trench (48) for an electric cable that ran SW/NE through the trench. This trench was filled with loose dark silty sand (49) with stone and brick inclusions visible. Where the cable turns in from the western wall and runs across the trench, there is a pile of cobbles evident in Plan 4 of Room 2. Although this corresponds to the location of the wall in the cellar building, it could not be proved from excavations that these cobbles represent an earlier end wall of the Koornhuis. Rather, this would seem unlikely as no cobbles are apparent in the opposite trench section and the cable trench is not cut deep enough to have entirely truncated the wall. It is possible that these cobbles represent the upper foundation layers of the western wall that were disturbed or even a portion of a collapsed cobble floor.

Below the cable trench was a layer of grey mortar (42), this was darker and more fine and powdery than 41 above it. Below this layer was a thick, compacted layer of dark silt (43) similar to that of the Cellar, and layers 24 and 37 in Trench 2. Under this floor surface is a mottled mid-brown gritty sand make up layer with variable brick fragments up to 100mm, crushed brick and chunks of lime plaster up to 80mm (44). Below these layers again we see two layers of terracing. The upper layer (45) consists of dark brown sandy silt with some small brick fragments up to 60mm, while the lower deposit (46) is paler brown with a grittier sand component and no inclusions. The trench was excavated down to the upper natural (47) which, as elsewhere throughout the Koornhuis, is a gritty orange-grey sand (47).

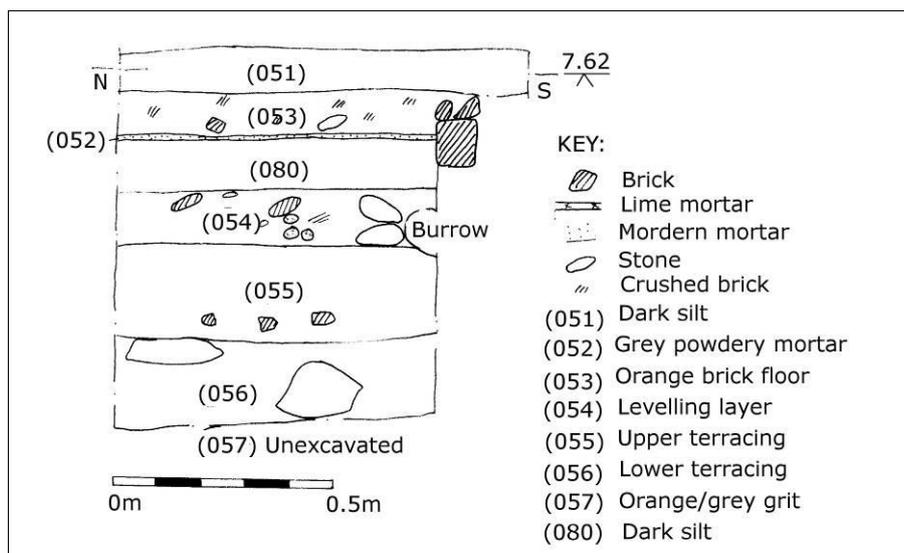
Figure 11: Section 4 Trench 5 west facing

The uppermost layer of Trench 5 is a floor surface of compacted, dark silty sand (51). This deposit overlies a crushed orange brick layer (53) that corresponds to the orange floor surface found throughout the building. As in Trench 2, this layer lies over a deposit of pale grey powdery mortar (52). Overlain by this grey deposit is another floor surface of compact dark silt (80). Below this floor is a mottled, dark brown gritty silty sand makeup layer (54). Below this layer are the two levels of terracing: the upper (55) consisting of loose, dark sandy silt with some clay or unfired brick fragments in it, the lower (56) a pale mid-brown gritty sand with two large boulders up to 0.20m within the deposit. The trench was excavated down to the gritty orange-grey sand of the upper natural substrate (57).

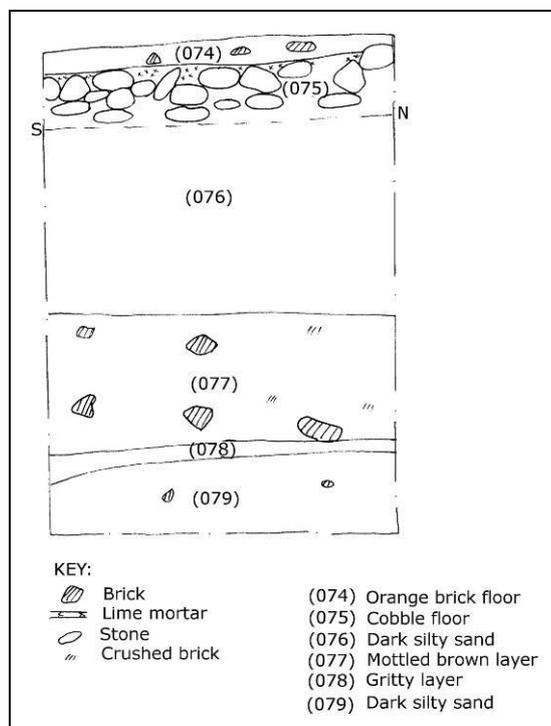
Figure 12: Sketch profile 1 Trench 6 east facing (not to scale)

Trench 6 was opened in order to test the foundations of the east/west internal dividing wall between Rooms 2 and 3. Excavations were hindered by the large number of substantial boulders and a thick band of cobbles encountered. Once through the cobble layer, there was no floor surface apparent in the deposit. The trench soon became too deep to continue safely and the natural substrate was never reached. Due to the depth of the trench, it was not feasible to draw a section of it, although a detailed sketch was made. In Trench 6, again, the uppermost level is the crushed brick floor surface (74). This overlies the cobbles which are embedded in gritty light brown sand (75) and show a white residue that could be the remnants of a lime capping. The cobbles overlie a thick, dark silty sand layer (76) that in turn overlies a mottled yellow brown layer with a high frequency of brick fragments and crushed brick (77). Between 77 and the lowest level excavated lies a layer of pale gritty sand (78) that could represent redeposited natural or a horizon between two terracing levels. The lowest level, only partly excavated, is a dark silty sand with small grit inclusions as well as some brick fragments (79).

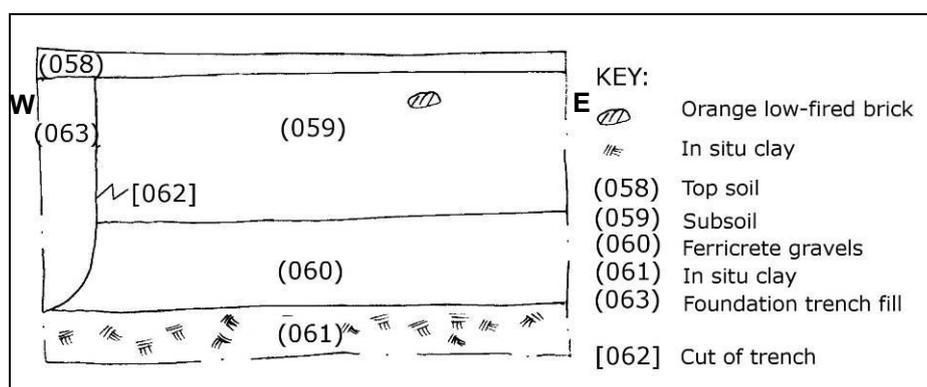
Figure 13: Sketch profile 2 Trench 7 south facing (not to scale)

Trench 7 was located to the east of the building beyond the external wall (see Fig. 3) in a corner created by a chimney abutting the Koornhuis and extending to the east, at a point roughly opposite the central doorway in the western facade. This area has been disturbed by more recent building work in the form of lean-tos, such as the chimney and a nearby silo built against the eastern wall of the Koornhuis. The trench measured 1m east/west and 0.97m north/south. As with Trench 6, a detailed sketch was made of the deposits, but no section drawing was made.

The upper deposit was formed by the topsoil (58), a dark, humic silty sand. Below this level was the subsoil, (59), a mid-brown silty sand with occasional small brick fragments. This deposit was cut by the foundation trench for the east wall of the Koornhuis (62) which was filled with a light brown silty sand backfill (63). This trench was cut through the two layers underlying the subsoil too. The upper of these (60) was a mid-grey-brown sand with a large grit component up to 2mm and a high frequency of small ferricrete nodules up to 4mm. This layer corresponds with the ferricrete layer 32 from Trench 2. Below this was a red-flecked yellow-orange clay (61) that was clearly undisturbed and constitutes the lowest level of natural bedding layers encountered during excavation.

The natural substrate of the area, revealed in Trench 7 is red-flecked yellow clay overlain by a mid-grey-brown sand with a large grit component (>2mm) and a high frequency of small ferricrete nodules (>4mm). The overlying silty sands of the area have a high quantity of sharp sand, arising from wind erosion of the surrounding mountains. This sand makes for excellent building material and is widely used in the bricks and mortar for the farm's buildings.

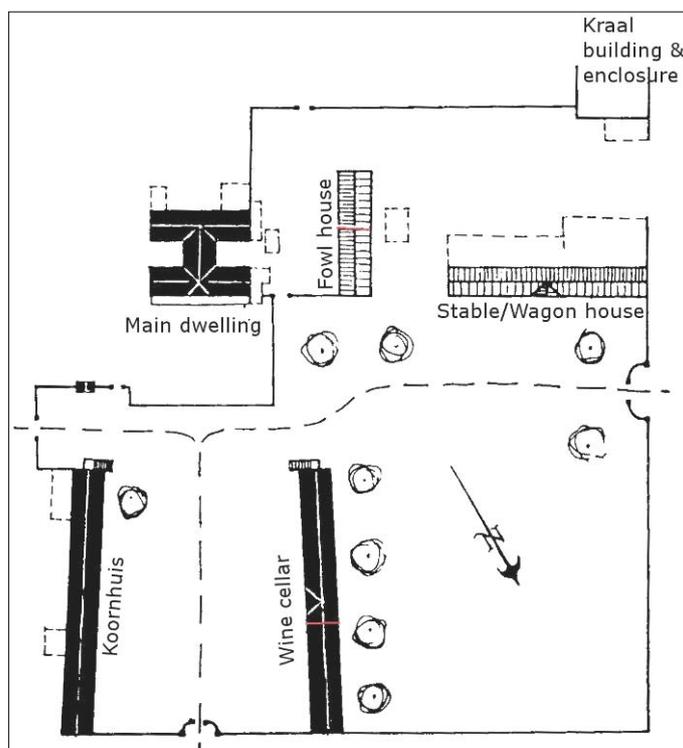
Figure 2: Werf layout as presented in Walton (1989:41) attributed to Hans Fransen. Red lines indicate approximate location of original end walls of buildings.

According to Smuts (pers comm. 2009), there is clear evidence that the cellar was built in two phases. The original building ended just to the north of the existing front gable (Refer to red line on wine cellar in Figure 2 above). The northern extension of the wine cellar abuts what would have been the end wall of the building. Like the original portion, the extension is constructed in stone to ceiling height, and may have been added soon after the earlier building was completed.

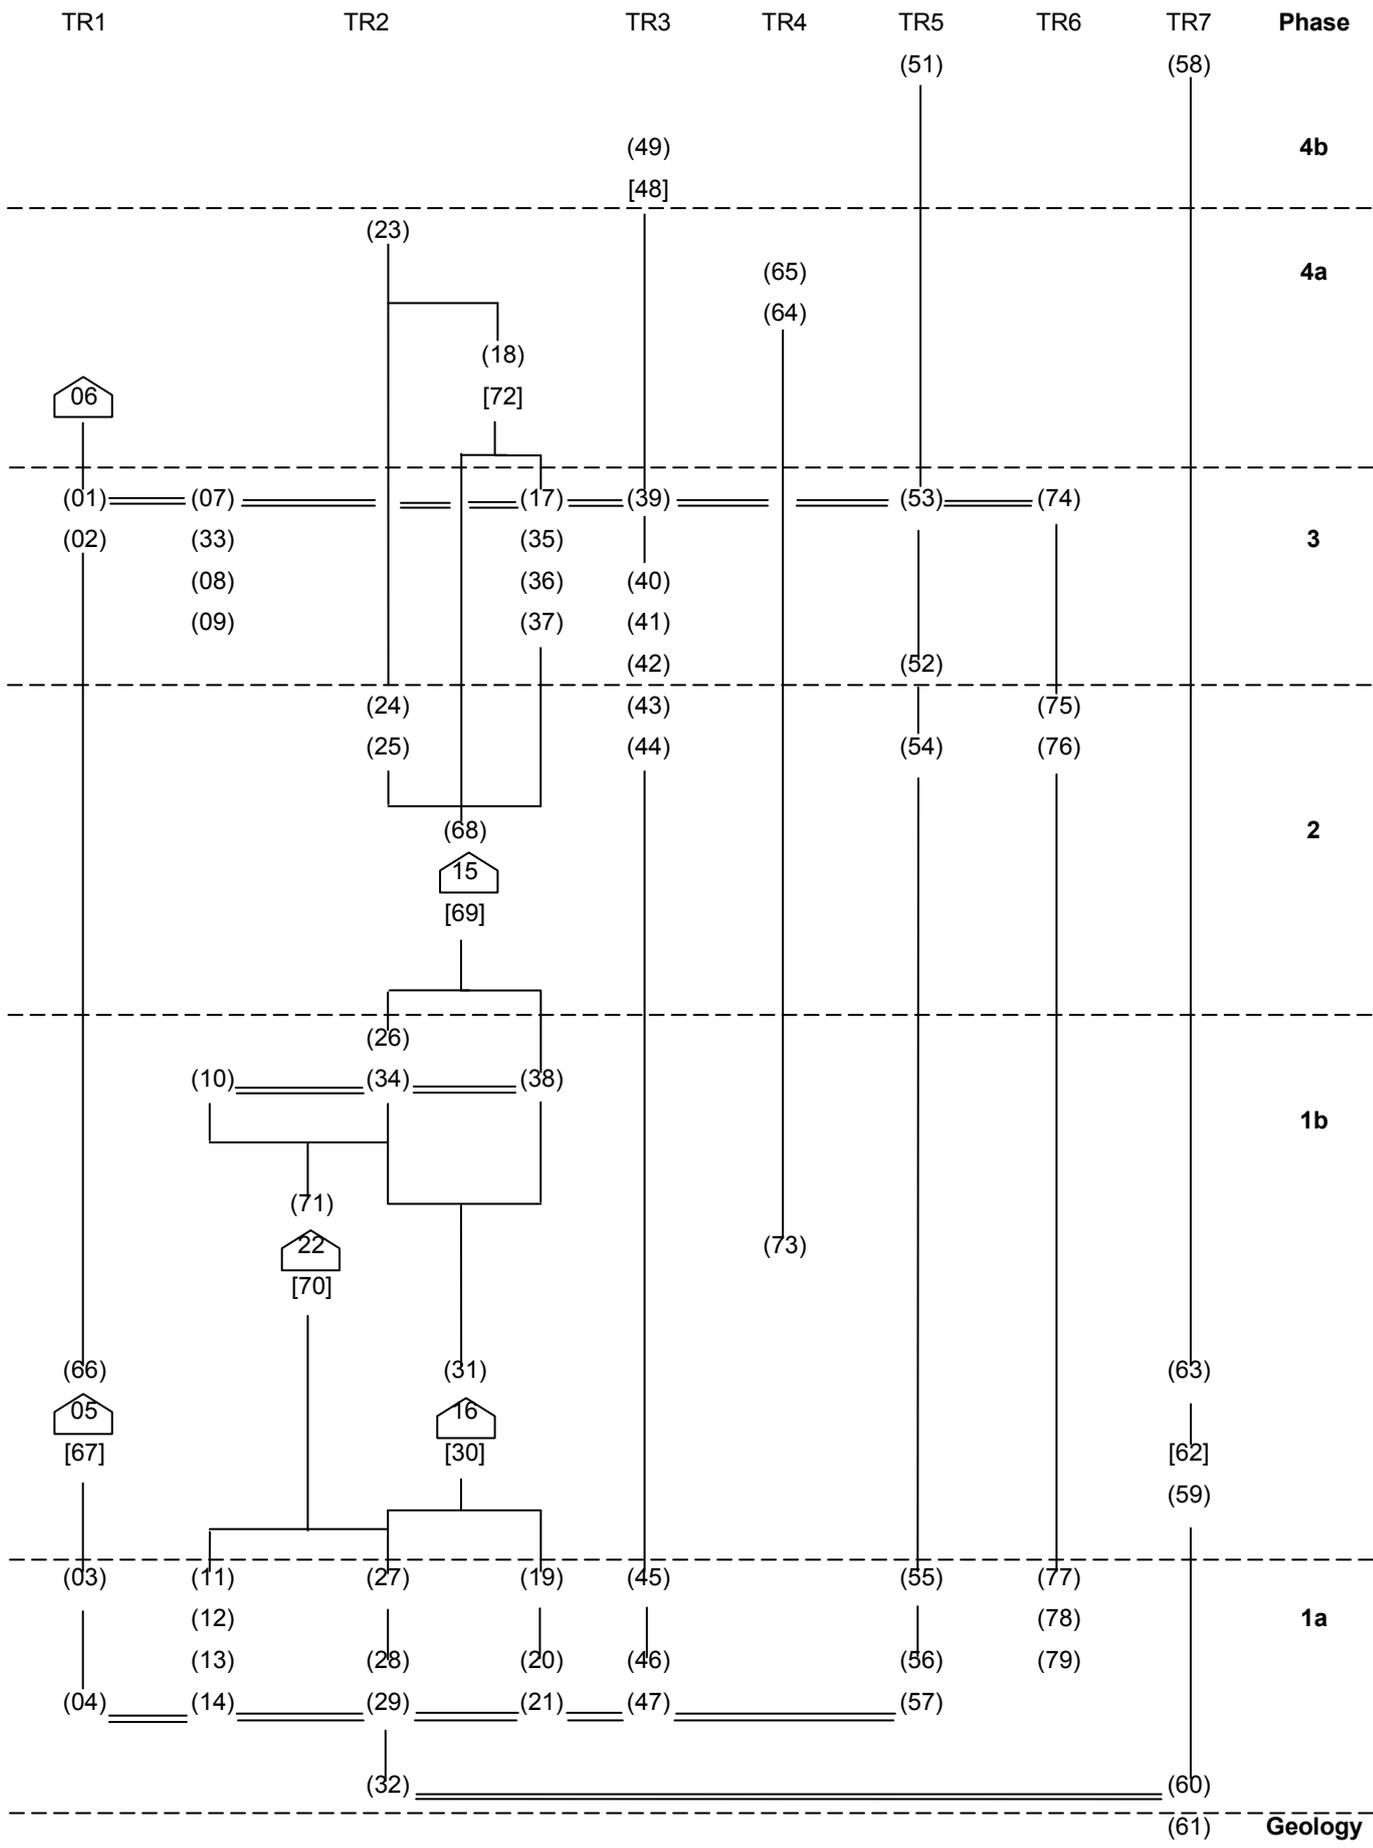
Stratigraphic Matrix

The conventions on the diagram used to show cuts, deposit and structures are those used on the site plans and section drawings. They are as follows:

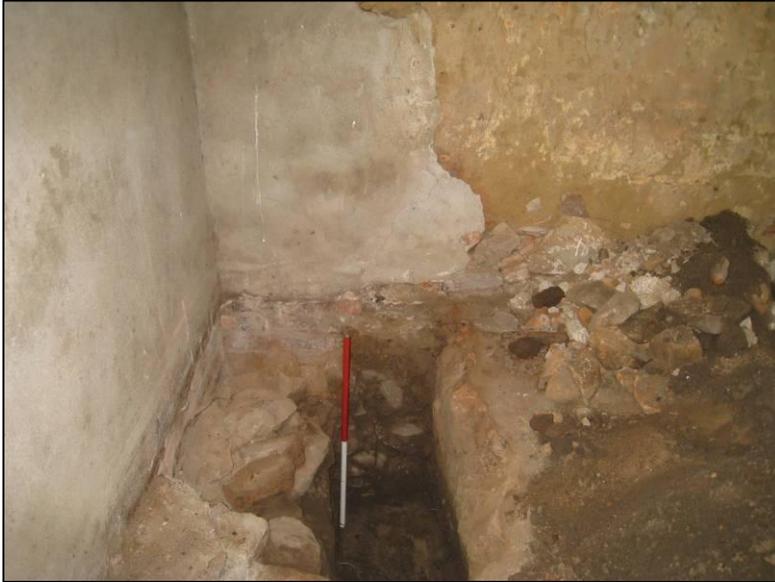
Trench 1 Room 1 looking east, showing foundations 05 and 06 of the east and north walls, respectively. Note the modern brick of the reconstructed north gable wall

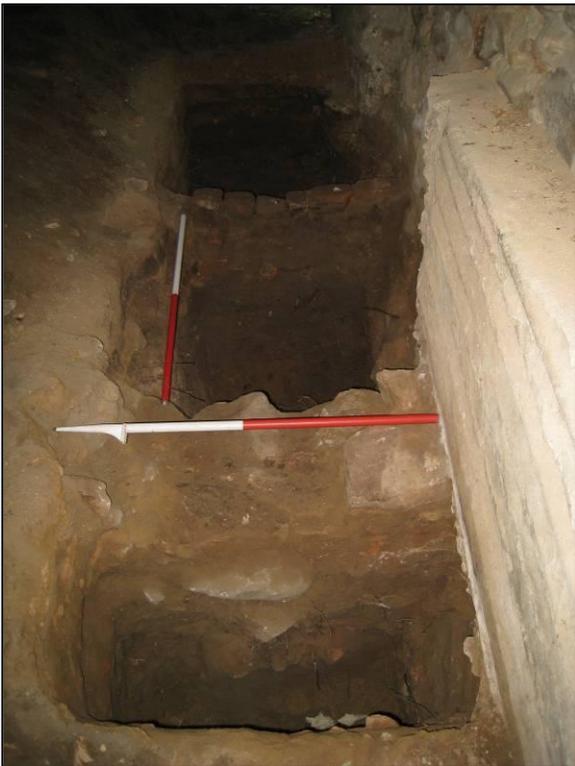
Trench 2 Room 2 looking south, showing stone wall 22 and brick wall 15

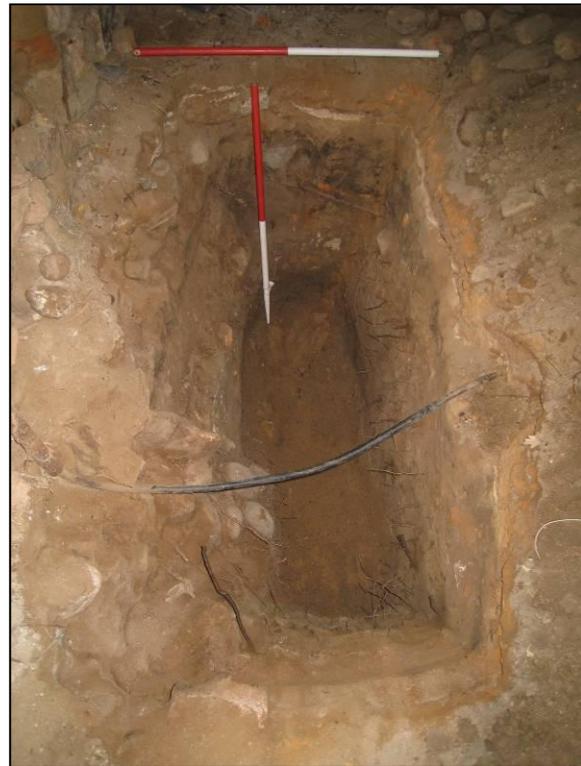
Trench 3 Room 3 looking north, note the electricity cable

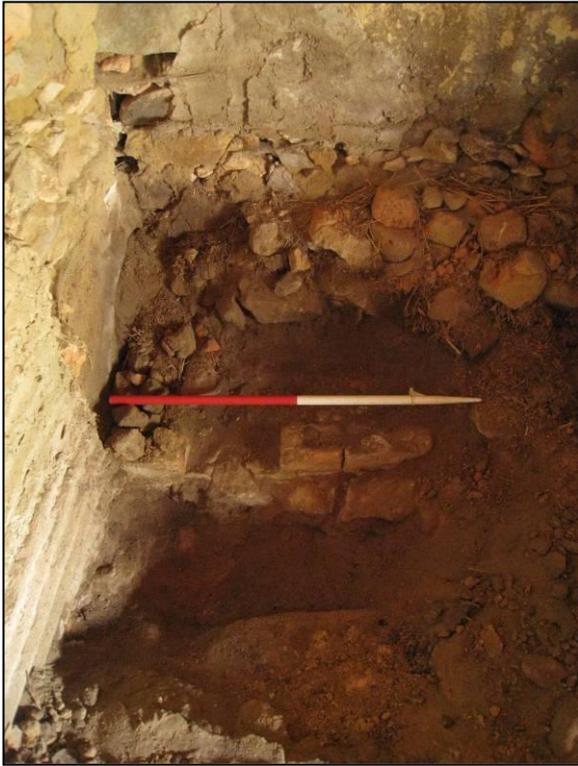
Trench 4 Room 2 looking south, showing modern and historic buttresses

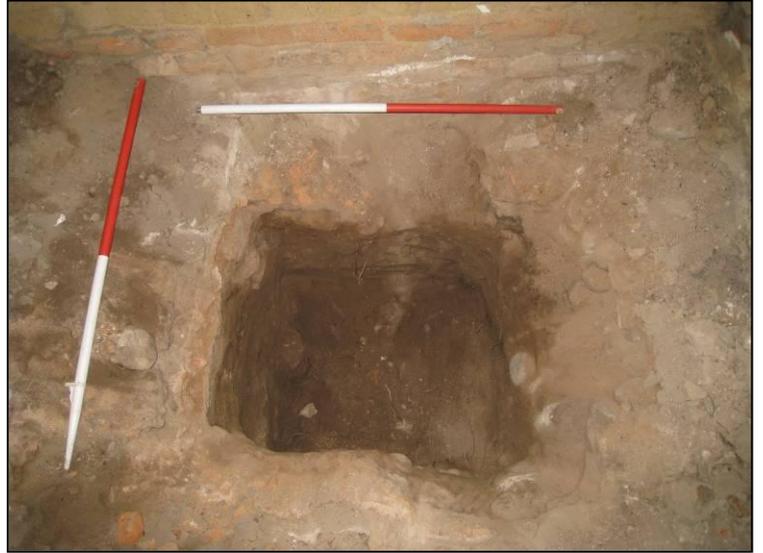
Trench 5 Room 3, looking south, note change in brick of internal wall from baked to unbaked

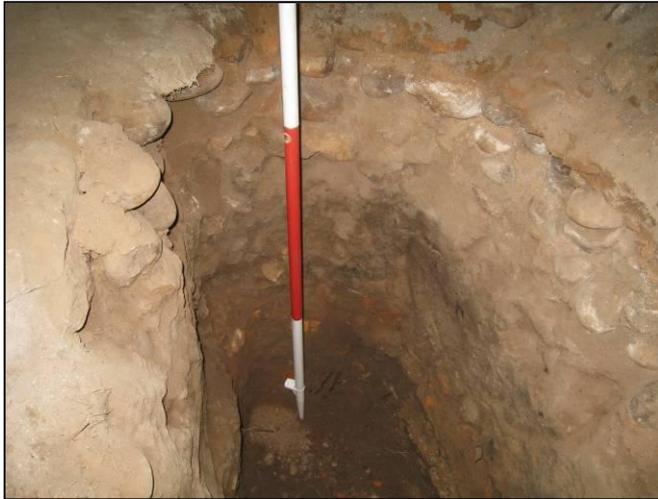
Trench 6 Room 3 looking south west, note cobble layer with traces of lime capping

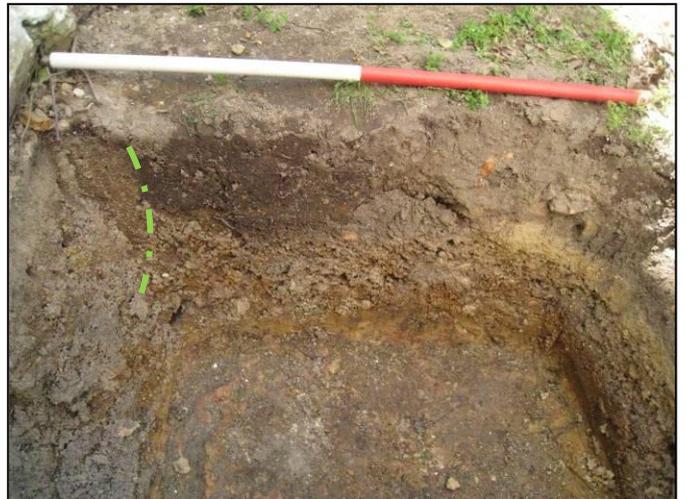
Trench 7 east of building looking north, showing foundation cut 62 indicated in green
