# **HERITAGE STATEMENT: PROPOSED UPGRADE OF THE BAYSIDE CANAL**

**CCA Environmental**

September 2008

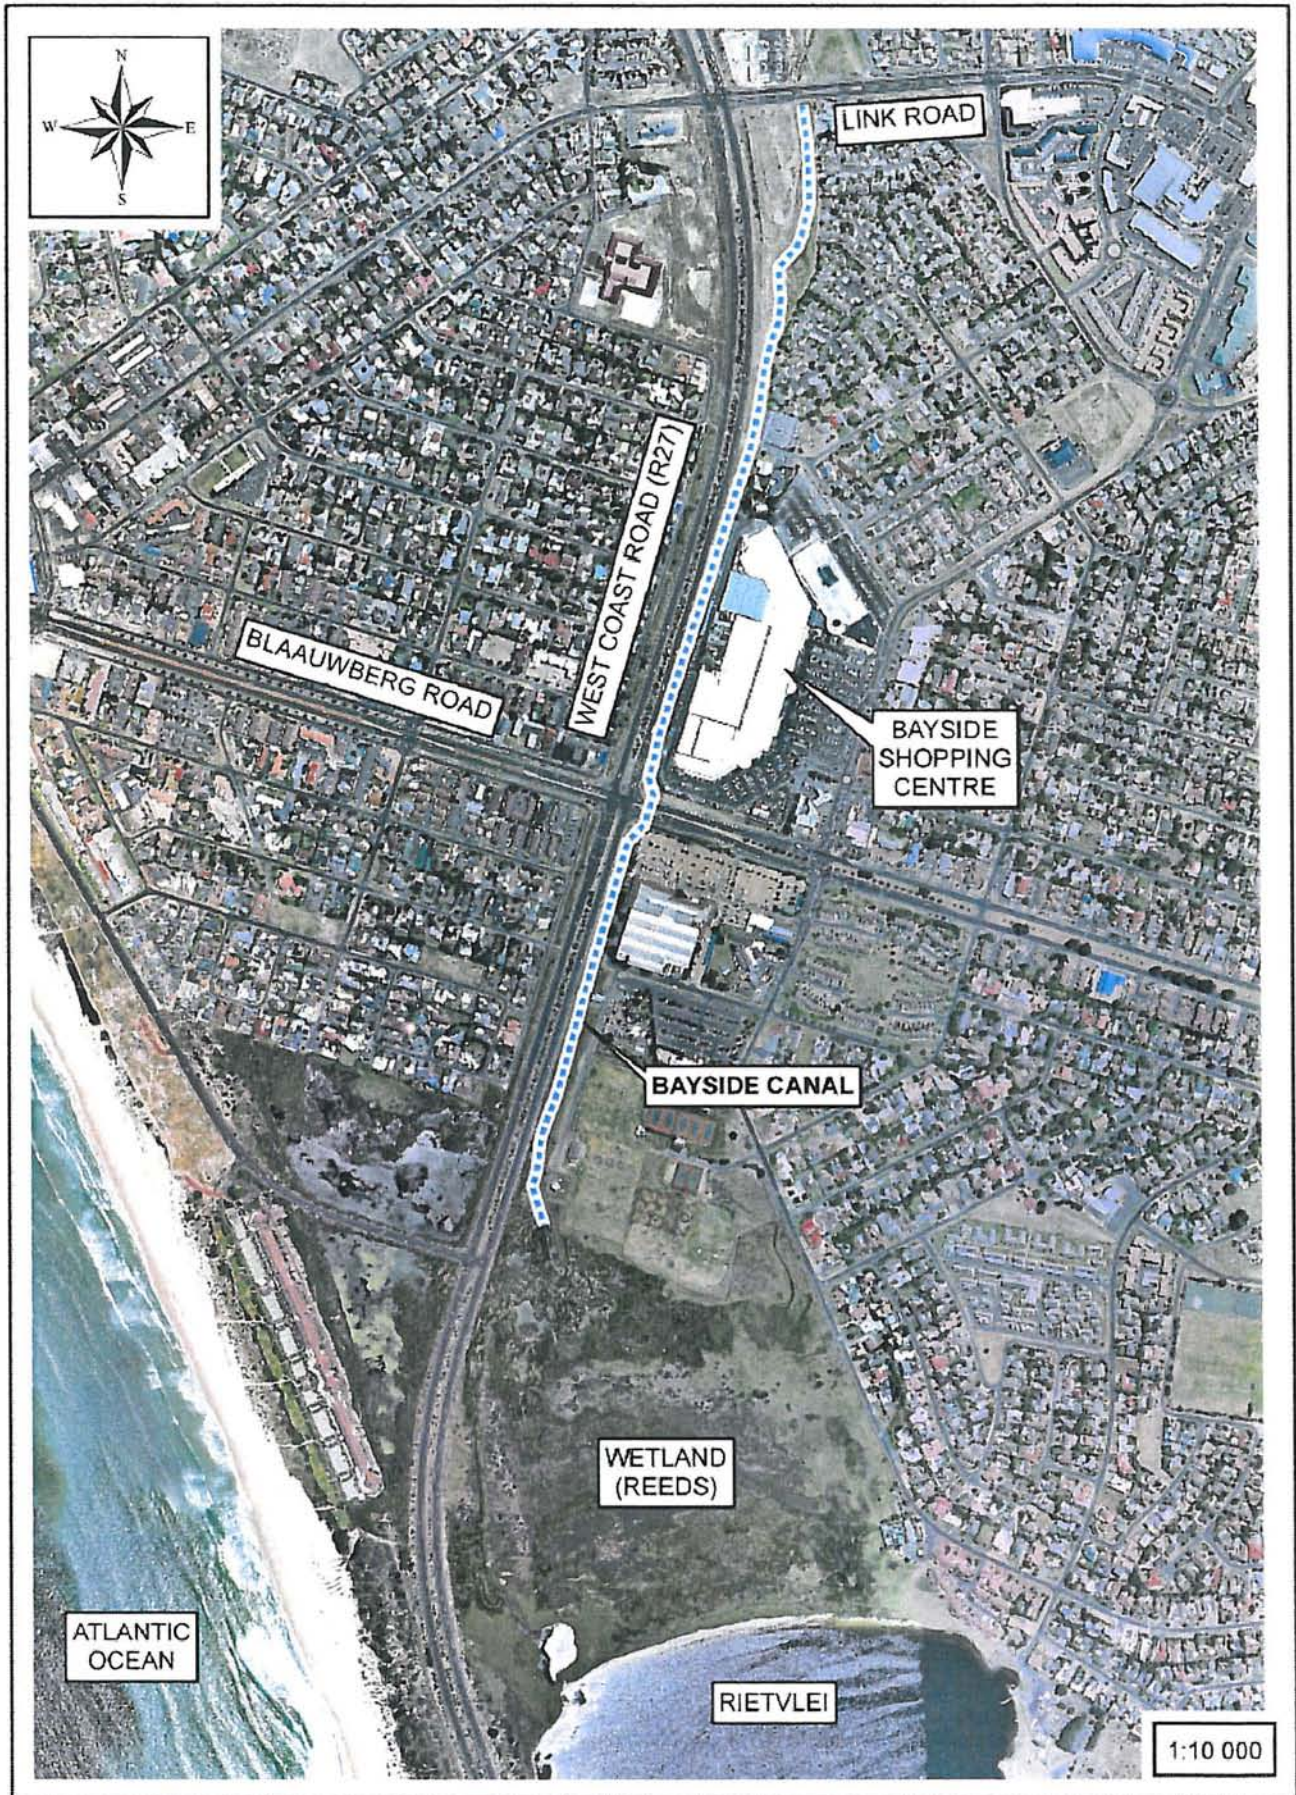
FIG 2

UPGRADING OF  
BAYSIDE CANAL

LOCALITY PLAN

Provision has to be made for expansion of suburbs and increased surface hardening in the areas that form the catchment area of the canal. The canal itself would have potential restrictions or choking areas removed, landscaping and widening of the unlined portions of the canal is a key element of the proposal, which along with encouragement of appropriate wetland vegetation (reed beds) will result in a generally more eco-friendly and effective facility. It is also proposed that an additional culvert be installed at the Blaauwberg Road crossing (See Figure 2 in Appendix).

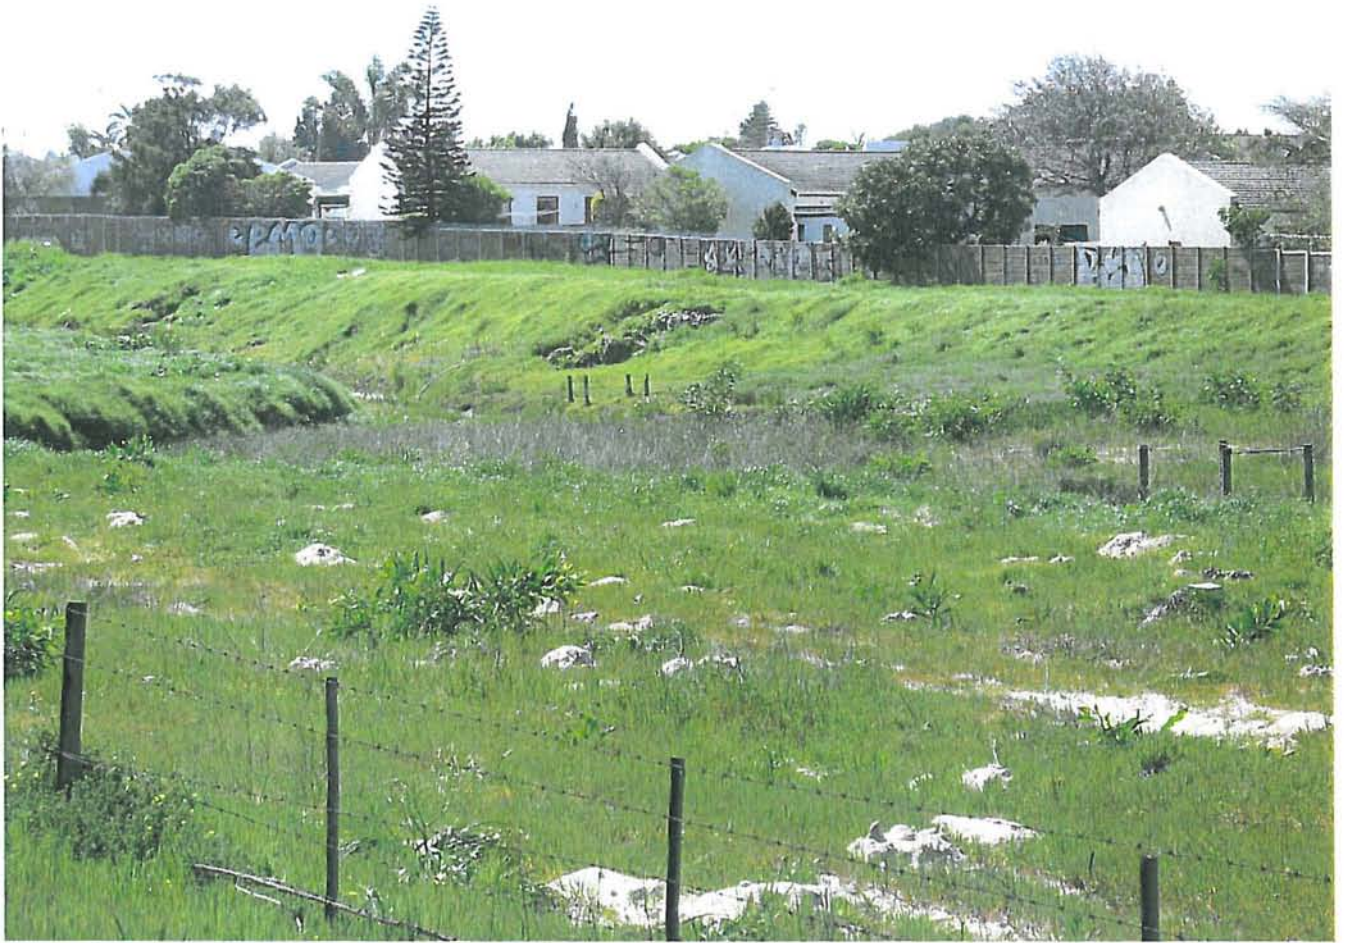
**Plate 1** Canal is situated in open Land adjacent to suburbia close to Link Rd

The receiving environment consists of a highly modified landscape between the R27 and recent Table View suburbia, including the Bay Side Mall and Pick and Pay. This narrow sandy strip of land takes on the appearance of non-descript open space, badly maintained and overgrown. The canal in its present form is illustrated on Plates 1 – 3 in Appendix A.

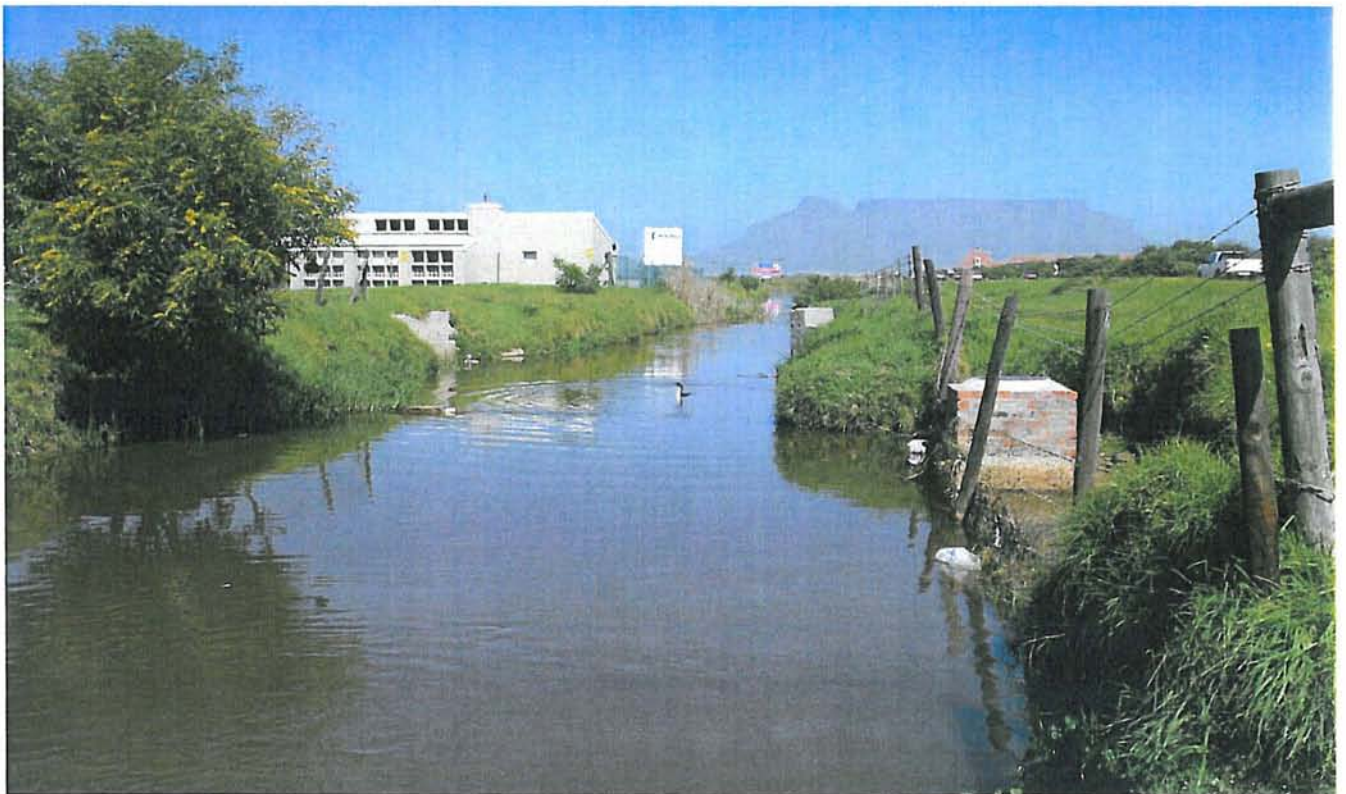
**Plate 2** The canal just before it enters Rietvlei. R27 is to the right

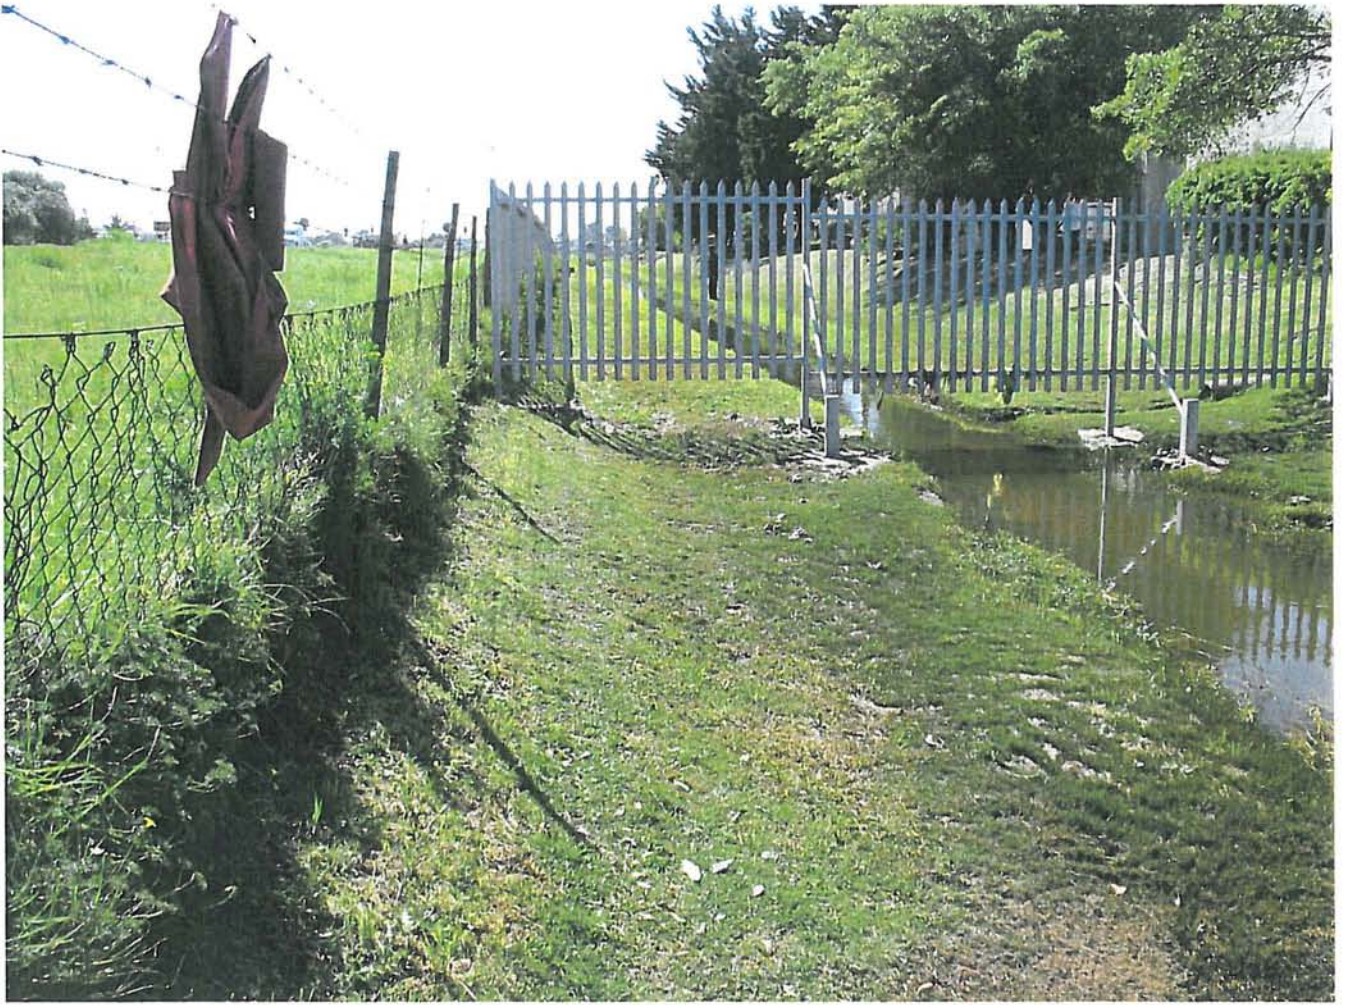
**Plate 3** Concrete lined section of the canal

The present canal is typically narrow with very steep sides and very little natural vegetation. Portions of it are canalized (with concrete channels) and some side slopes are infested with kikuyu grass.
