**A REPORT ON THE HERITAGE ASSESSMENT RELATED TO THE BEESHOEK  
MINE VILLAGE, NORTHERN CAPE PROVINCE**

***Assmang Beeshoek Mine***

**REPORT: AE1185**

***September 2011***

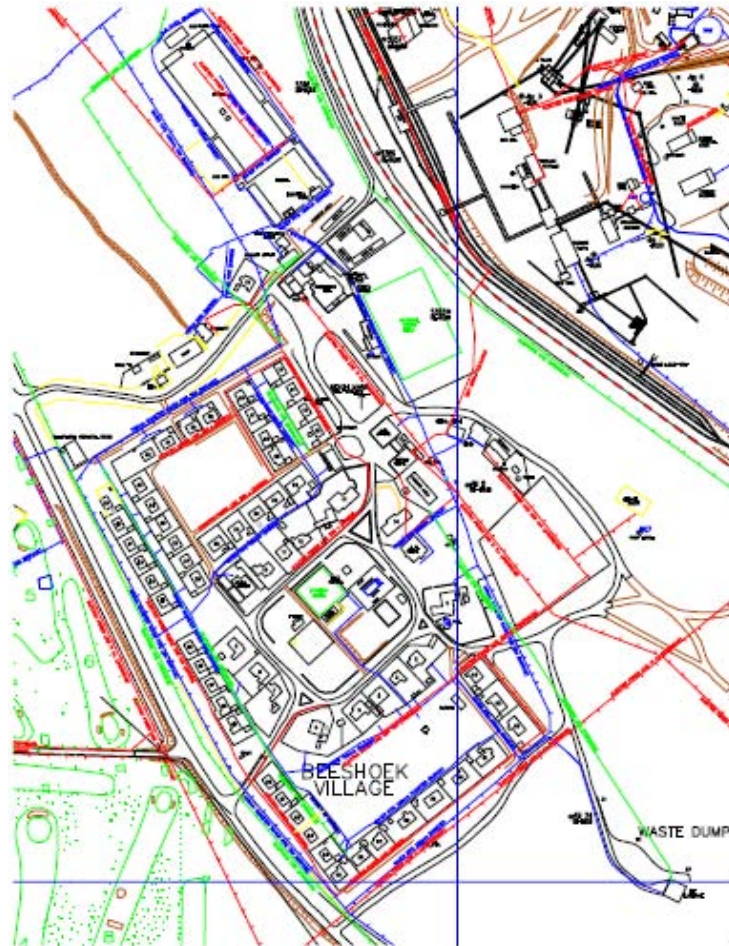
The Beeshoek village consists of two sections. The one lies to the south-west of the R385 road and dates to the era after 1970. Subsequently this section was not investigated. The second section lies to the north-east of the R385 road and was investigated. It consists of more than 80 buildings (Figure 4). These mostly date back to two different periods in time. Firstly buildings built from 1929 to the 1930's and secondly buildings erected during and after the 1970's.

**Figure 4** Plan of the investigated part of the Beeshoek Mine Village.

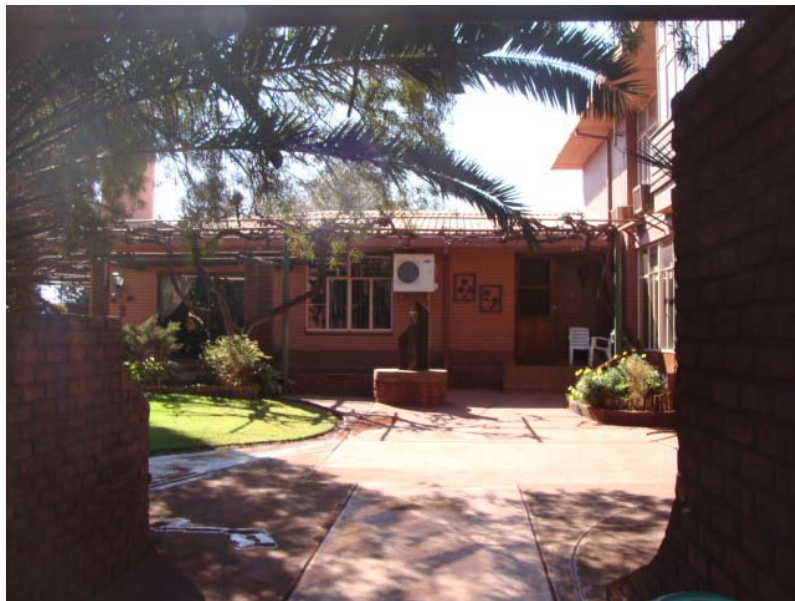
**Figure 9** House no 1.

The house was built during the 1960's – 1970's (Figure 9). The heritage significance is low.

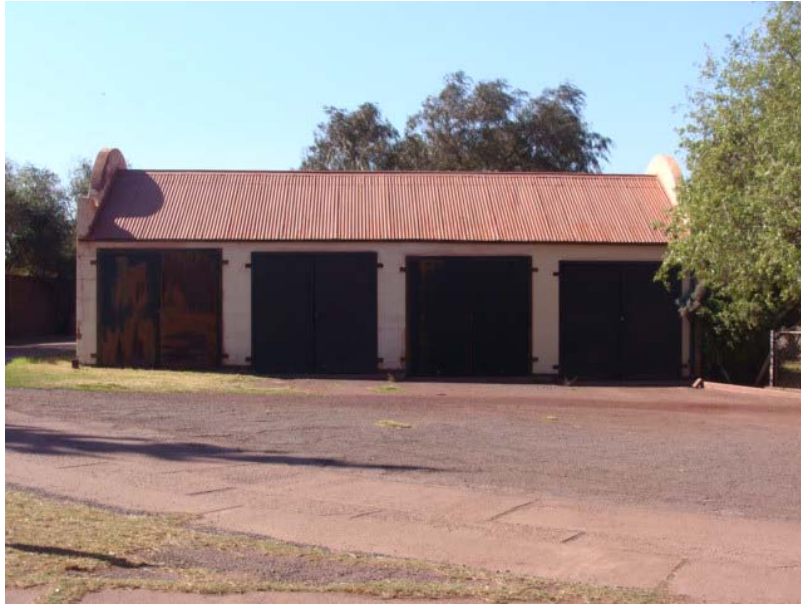
**Figure 10** Garages between houses no 1 and 2.

These date from the 1930's (Figure 10). Due to changes made thereto and it not being very unique it is given a rating of medium to low.

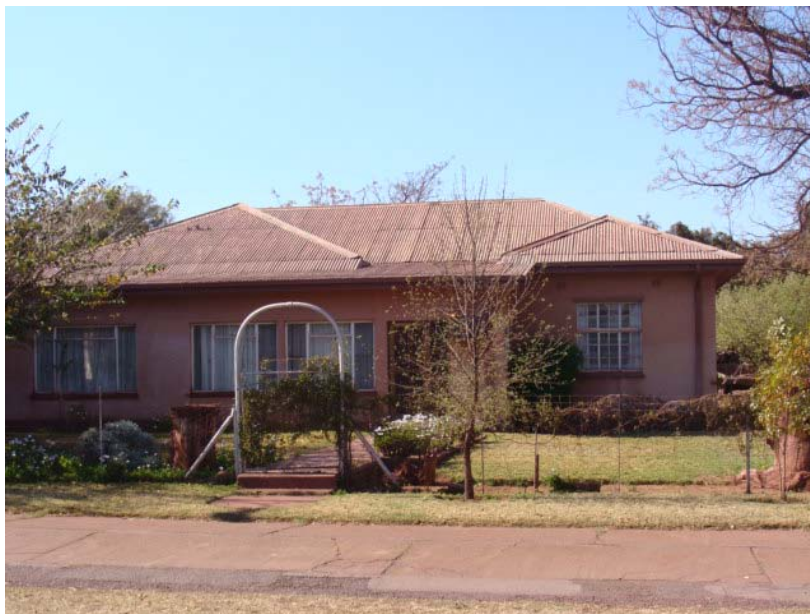
**Figure 11** House no 2.

The house was built during the 1930's (Figure 11). It has however been changed to a large extent and therefore receives a rating of medium to low.

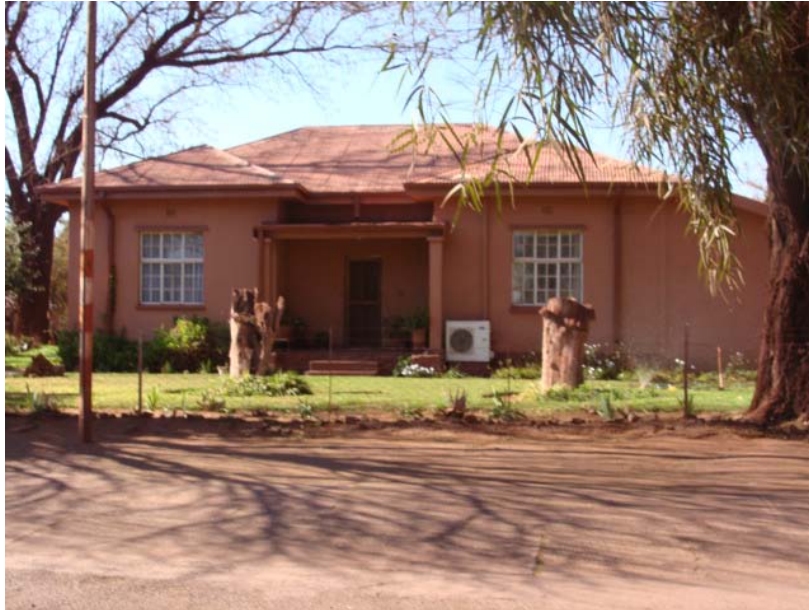
**Figure 12 House no 3.**

The house was also built during the 1930's (Figure 12). A lean-to was added on one side. It is not a very unique building from the time and therefore receives a rating of medium.

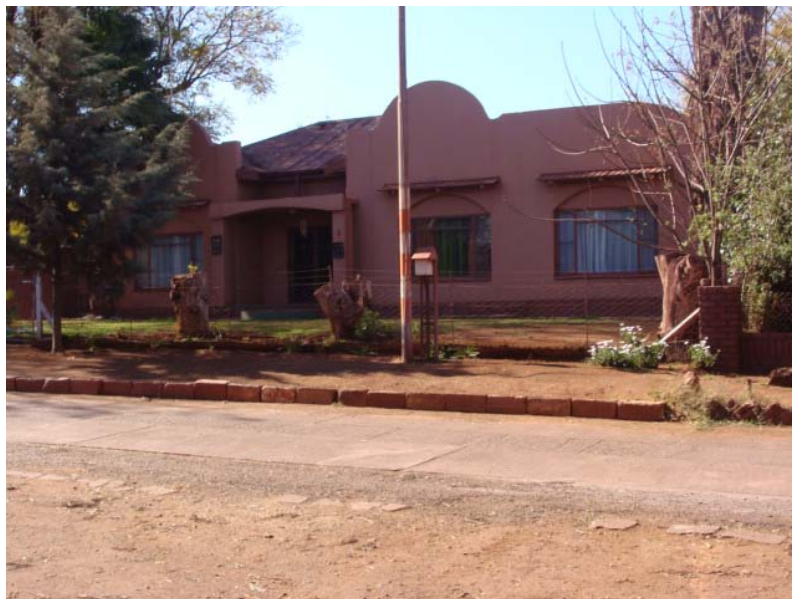
**Figure 13 House no 4.**

The house was built during the 1930's (Figure 13). It has however been changed by the addition of an extension on one side and by replacing original windows. It thus is not very unique and therefore receives a rating of medium to low.

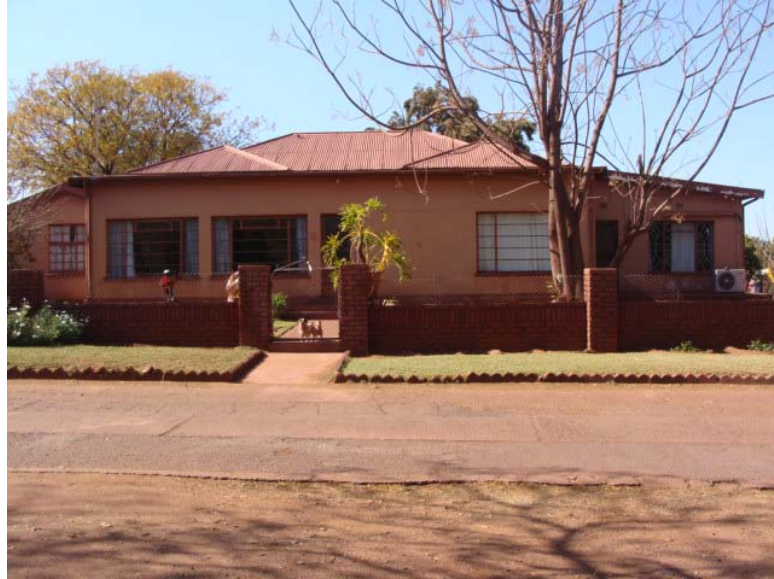
**Figure 14 House no 5.**

The house was also built during the 1930's (Figure 14). Addition to the house was made on both sides. It is not a very unique building from the time and therefore receives a rating of medium to low.

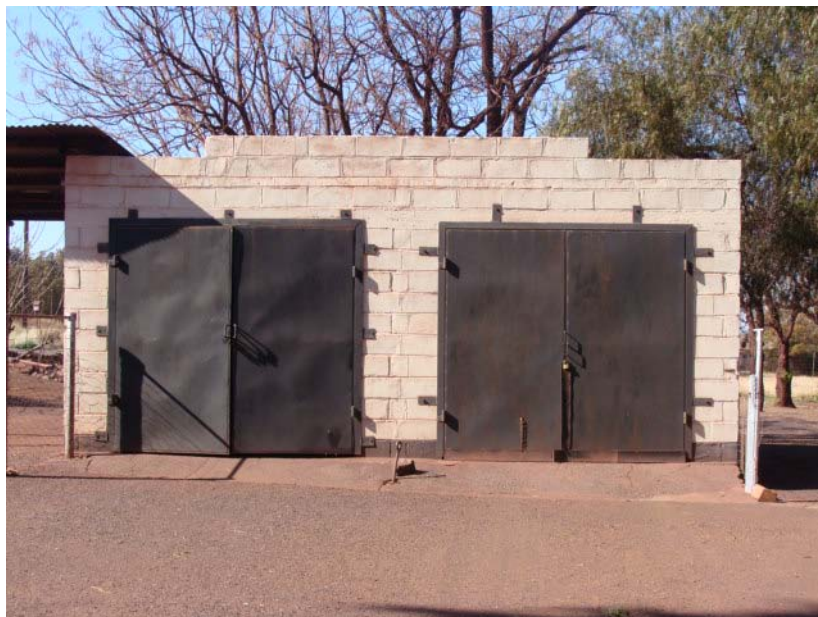
**Figure 15 Garages between houses no 5 and 6.**

The building dates to the 1940's (Figure 15). It has however been changed and is not unique. It therefore receives a rating of low.

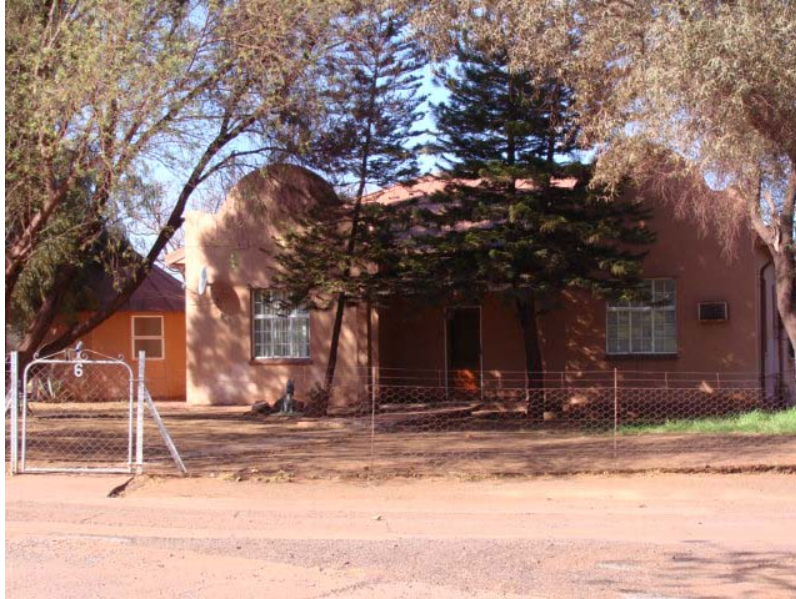
**Figure 16 House no 6.**

The house was also built during the 1930's (Figure 16). Limited changes have been made to the building. Therefore it receives a rating of medium to high.

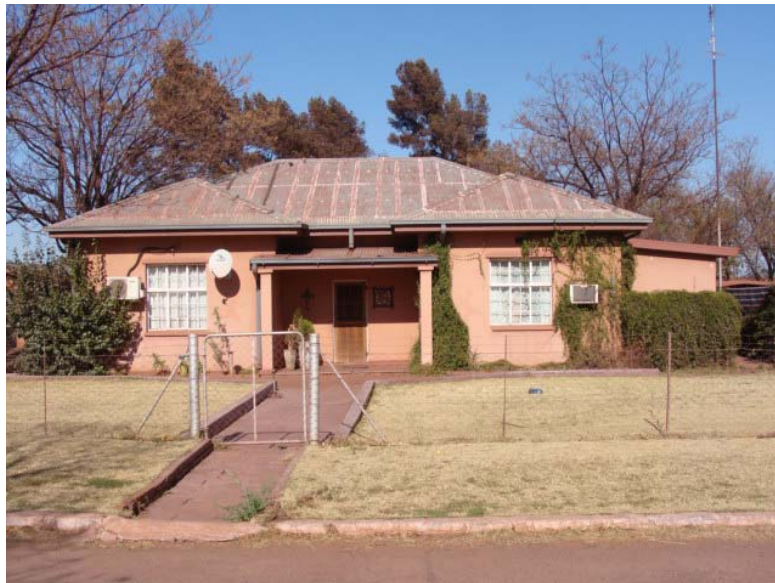
**Figure 17 House no 7.**

The house was built during the 1930's (Figure 17). Very few changes have been made to it through the years. Although it is not very unique, it is a good example of the architecture of the area. It therefore receives a rating of medium.

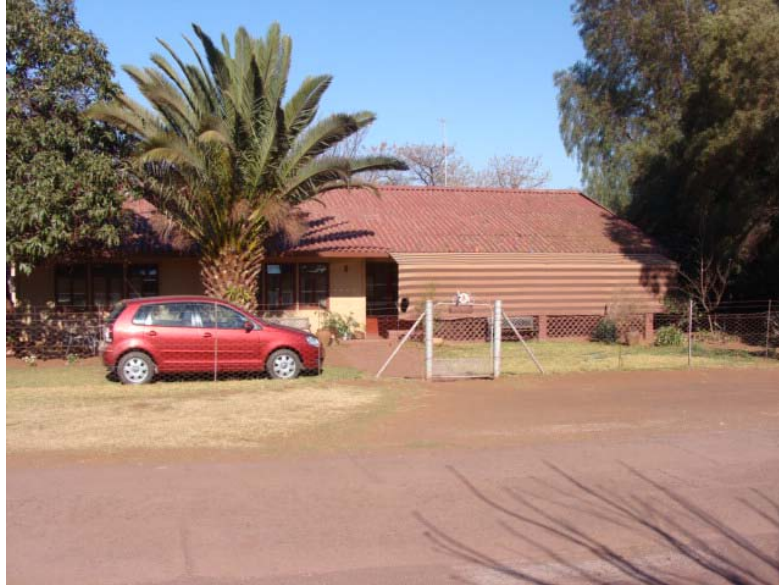
**Figure 18 House no 8.**

This is a pre-fabricated house made from asbestos and dating to the 1960's (Figure 18). It is not unique and therefore receives a rating of low.

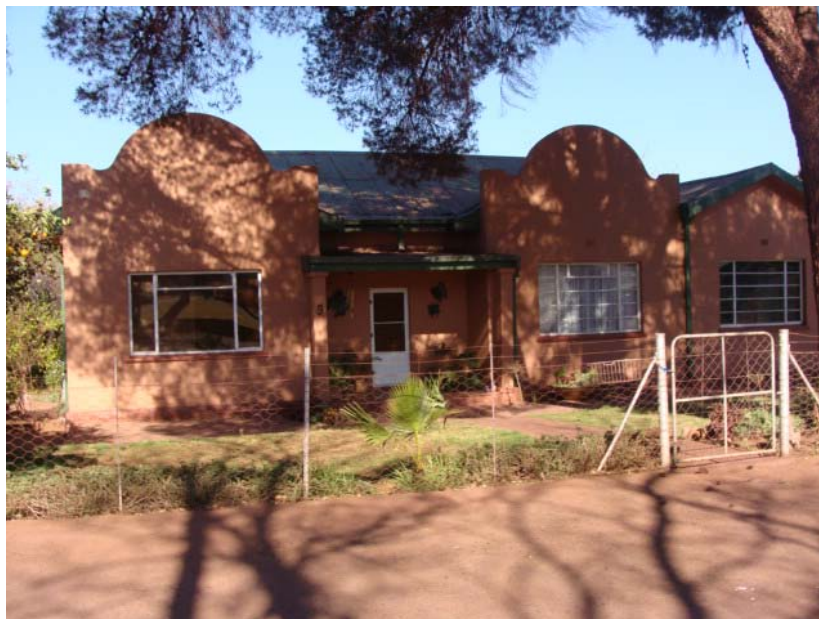
**Figure 19 House no 9.**

The house was built during the 1930's (Figure 19). It has however been changed to a large extent and therefore receives a rating of medium to low.

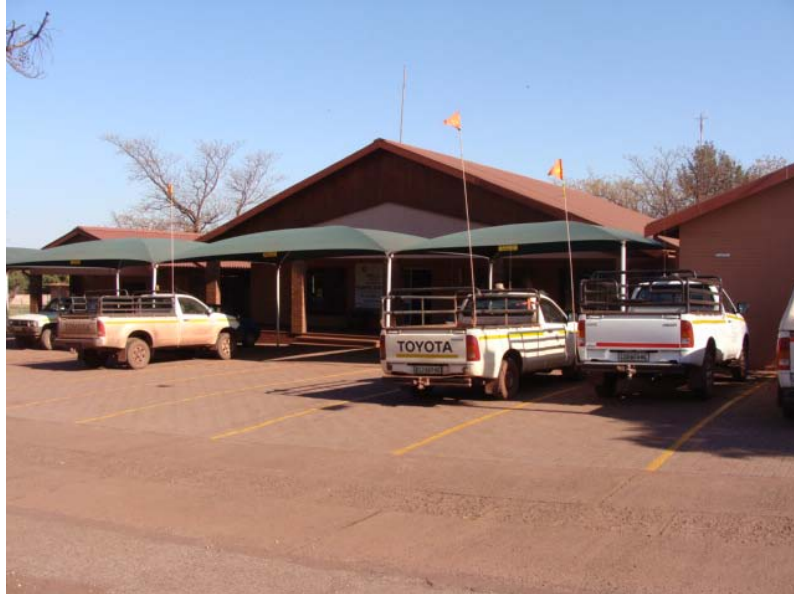
**Figure 20** Geology building.

The building was erected during the 1960's – 1970's (Figure 20). It has now specific uniqueness and therefore receives a rating of low.

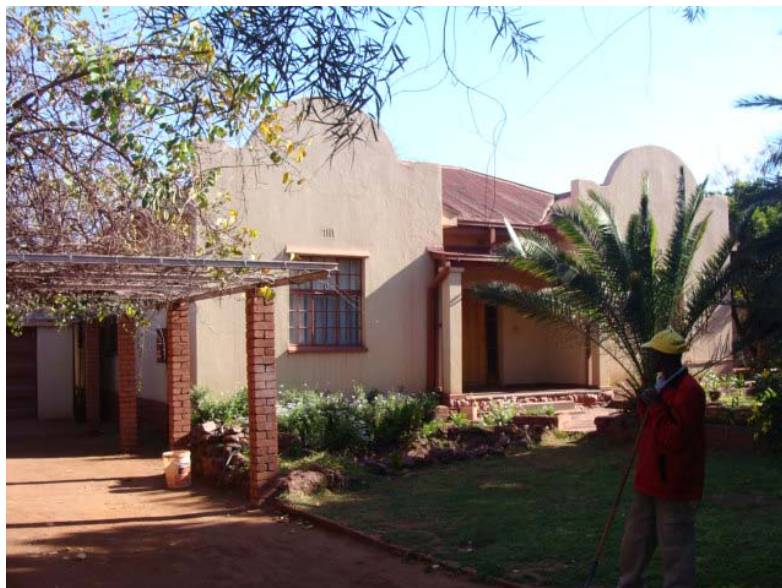
**Figure 21** House no 10.

The house was also built during the 1930's (Figure 21). Very few changes were made to it and it is an exceptional example of the architecture within this context. It therefore receives a rating of medium to high.

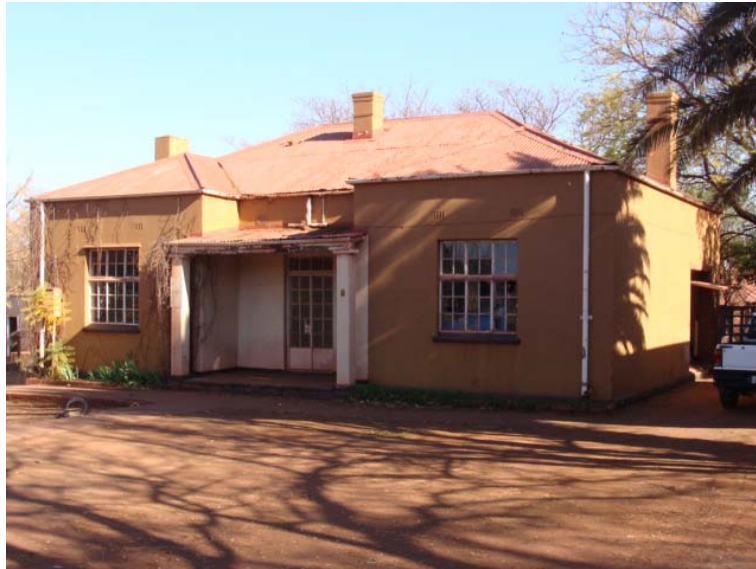
**Figure 22 House no 11.**

The house was built during the 1930's (Figure 22). Very few changes have been made to it throughout the years. It is an excellent example of the architecture within this context although it is not very unique on a broader scale. Unfortunately the house has been neglected and is in a bad condition. It therefore receives a rating of medium to high.

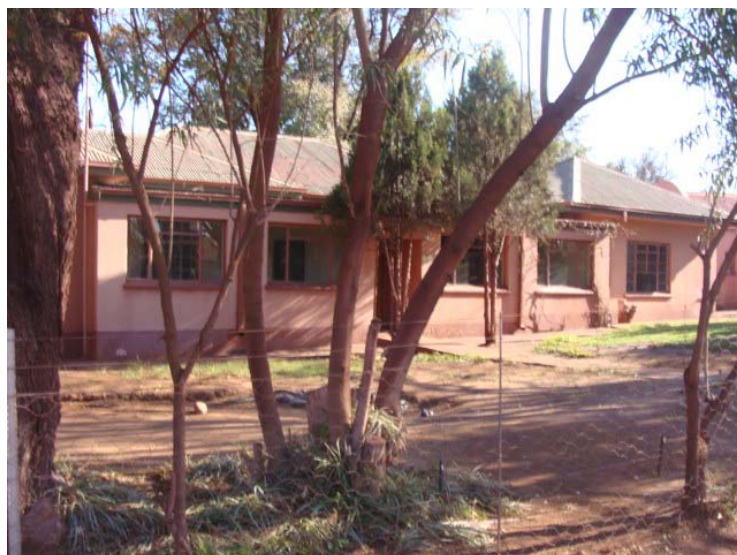
**Figure 23 House no 12.**

The house was also built during the 1930's (Figure 23). Many changes have been made to it including the addition wings on each side of the house. It therefore receives a rating of medium to low.

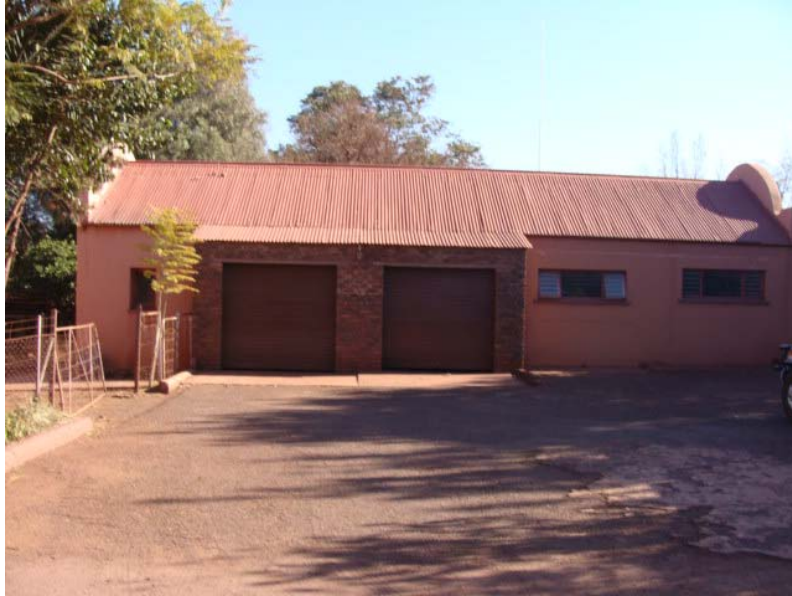
**Figure 24** Garages between houses no 12 and 13.

The building also dates to the 1930's (Figure 24). It has however been changed to a large extent and therefore receives a rating of medium to low.

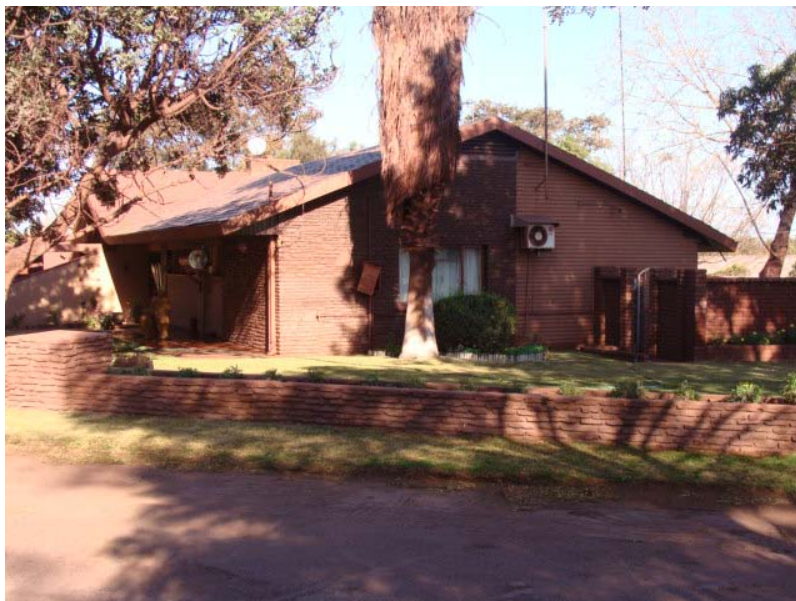
**Figure 25** House no 13.

The house was built during the 1960's – 1970's (Figure 25). It has no particular architectural significance and therefore receives a rating of low.

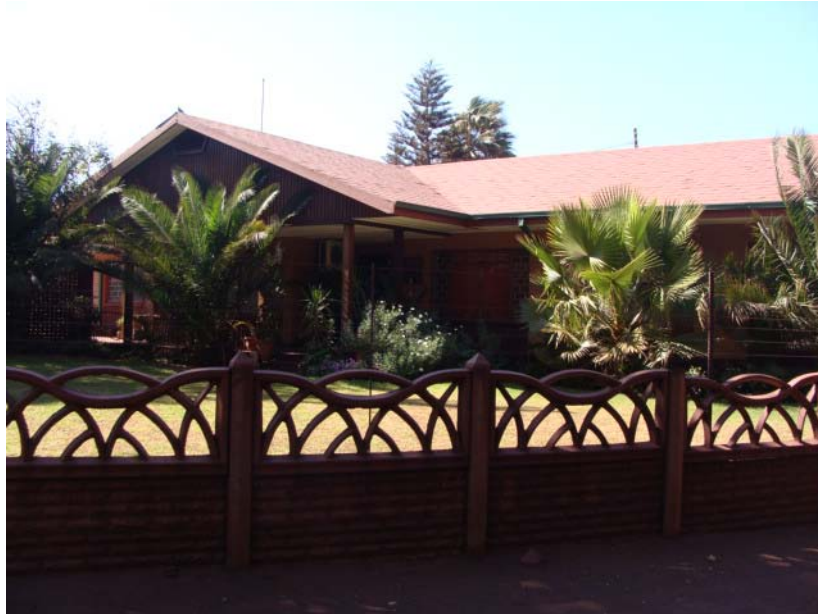
**Figure 26 House no 14.**

The house was built during the 1960's – 1970's (Figure 26). It has no particular architectural significance and therefore receives a rating of low.

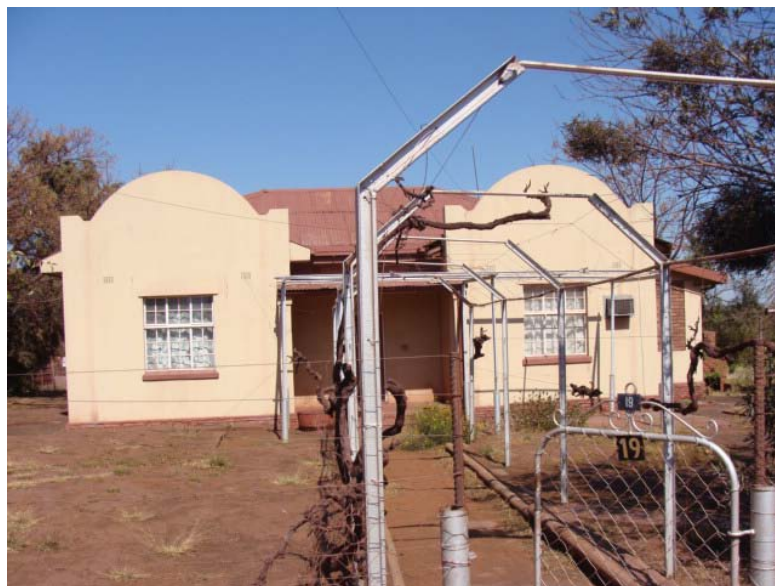
**Figure 27 House no 19.**

The house was built during the 1930's (Figure 27). It has not had many changes and is an excellent example of the architecture within the context of the mine village. It therefore receives a rating of medium to high.

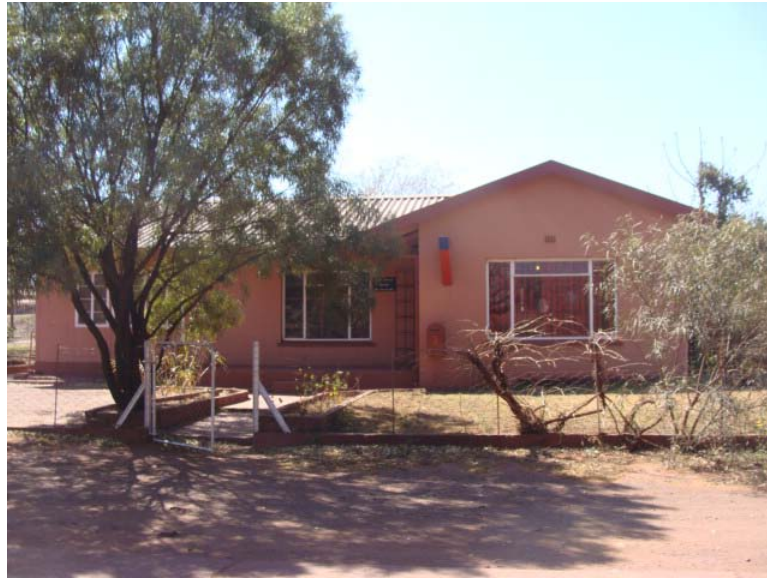
These are all pre-fabricated houses built from asbestos, with two exceptions being no 48 and 49 where face bricks were added around the asbestos walls. These all date to the 1970's, but three different examples were found (Figure 28-36), but some have additions. These houses all receive a rating of low.

**Figure 28** House no 20 is also used as post office.

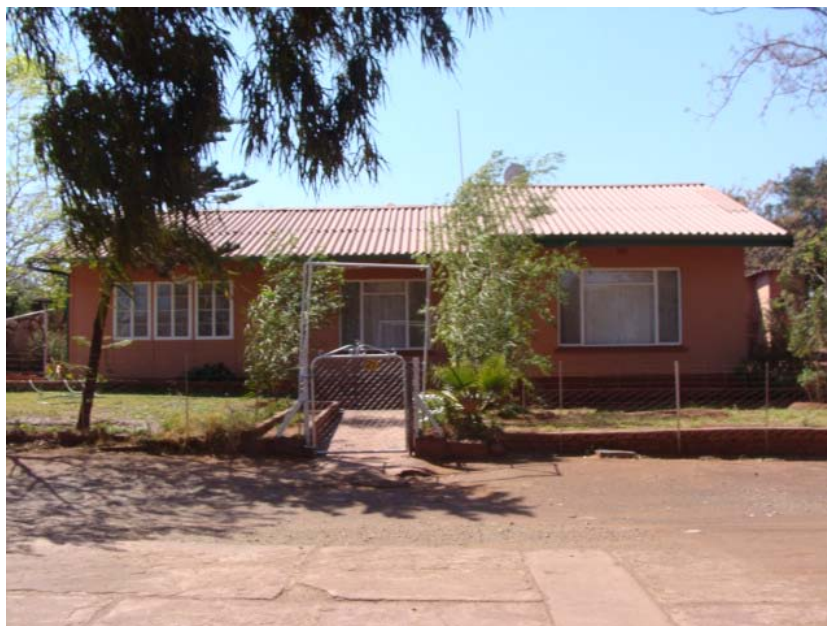
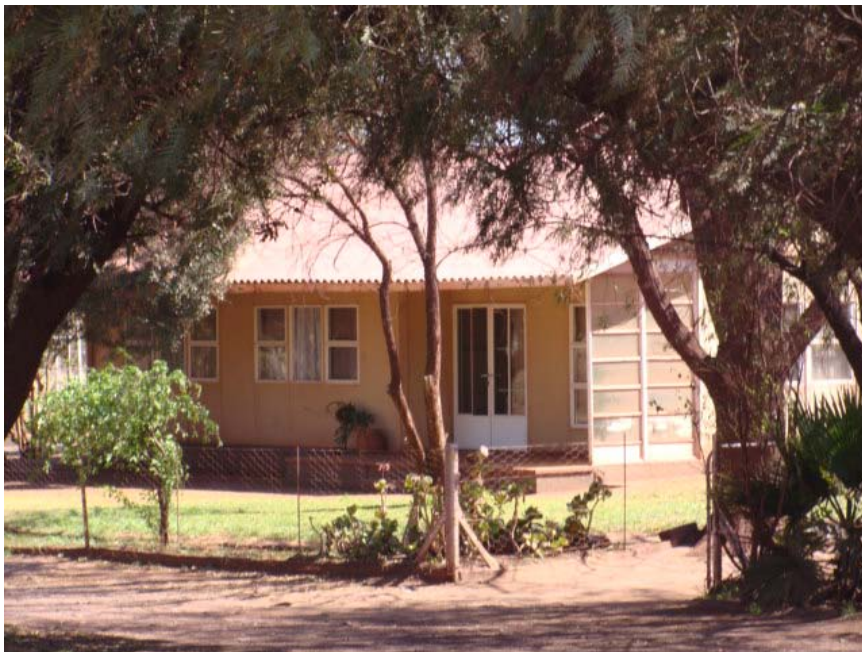
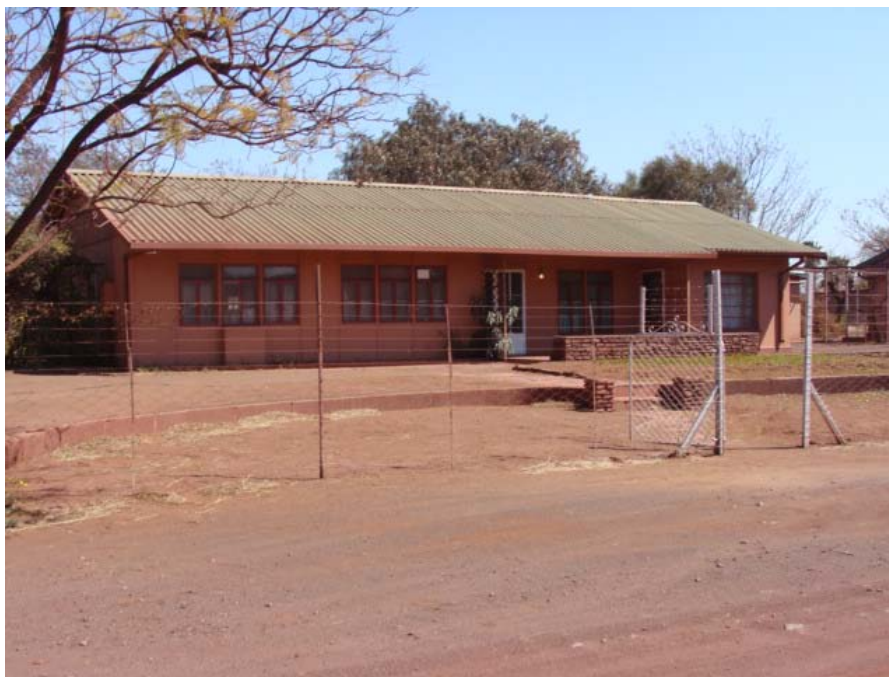
**Figure 29** House no 21, an example of the first type.

**Figure 33** House no 58, an example of the second type.

**Figure 35 House no 64, an example of the third type.**

- Any of these may be demolished during future developments. The Oppikoppi restaurant is most likely not to be influenced by the mining development.
- These building may all be demolishes and this report is largely seen as ample mitigation. However, in order to preserve specific information about an ere rapidly being demolished, it is recommended that the following building be document in detail – house no 21, 58 and 64 as examples of the three types of pre-fabricated buildings at Beeshoek.

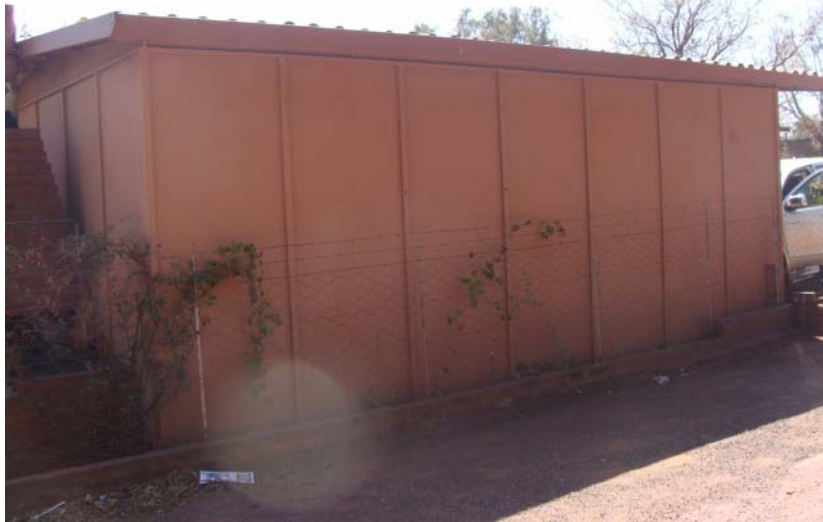
**Figure 30** Pre-fabricated garage at one of the houses.

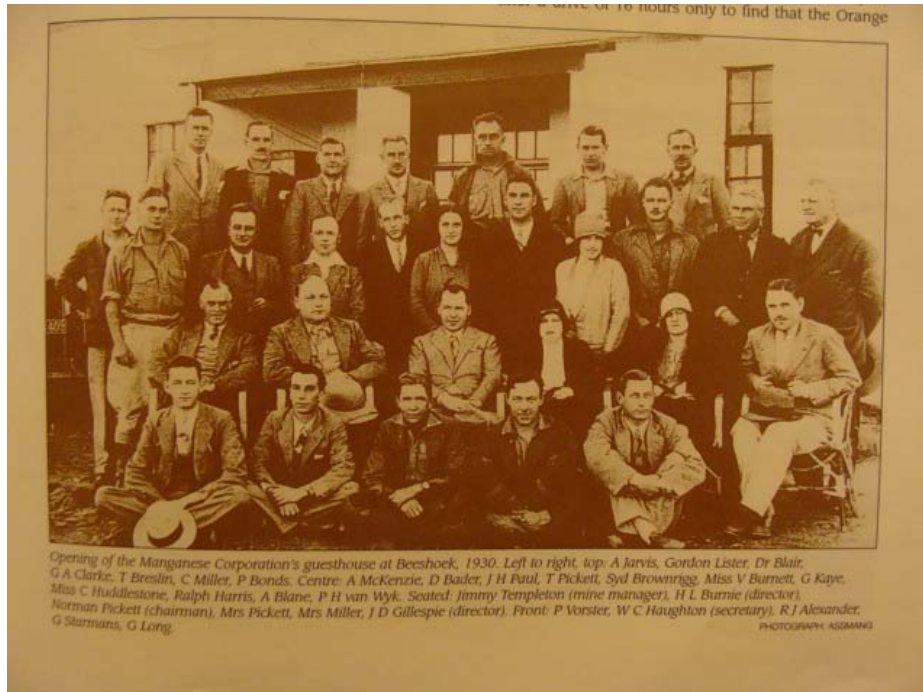
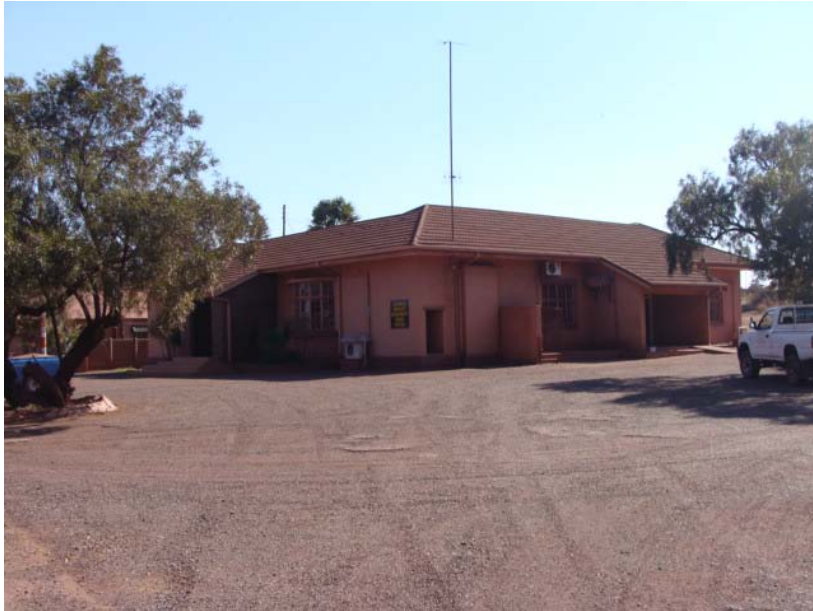
**Figure 38** The technical services building.

The building was built during the 1930's (Figure 37-38). It used to be the guest house at the mine. It has however been changed to a large extent and therefore receives a rating of medium to low.

**Figure 37 The technical services building when it was opened as a guest house in 1930 (Snyman 2000: 33).**

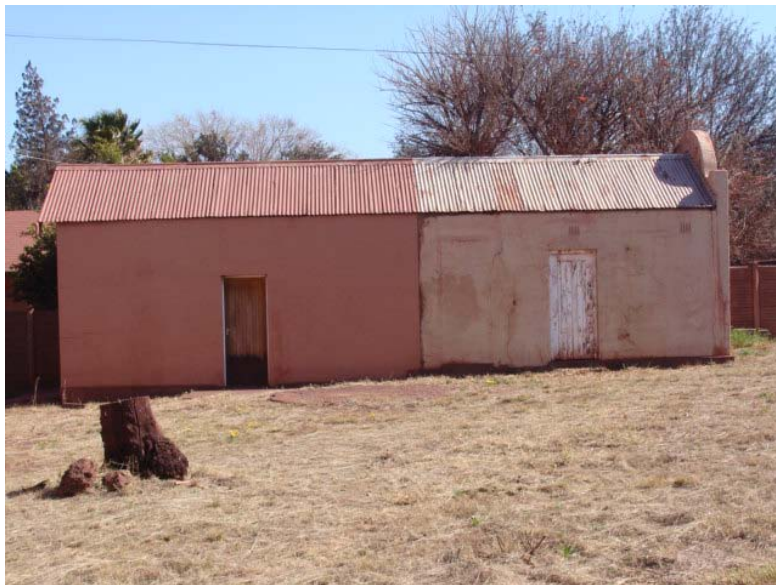
The building was also built during the 1930's (Figure 39). It was however extended later on. It is not a very unique building from the time and therefore receives a rating of medium to low.

**Figure 39** Outbuilding behind the technical services building. Note the later extension on the left hand side.

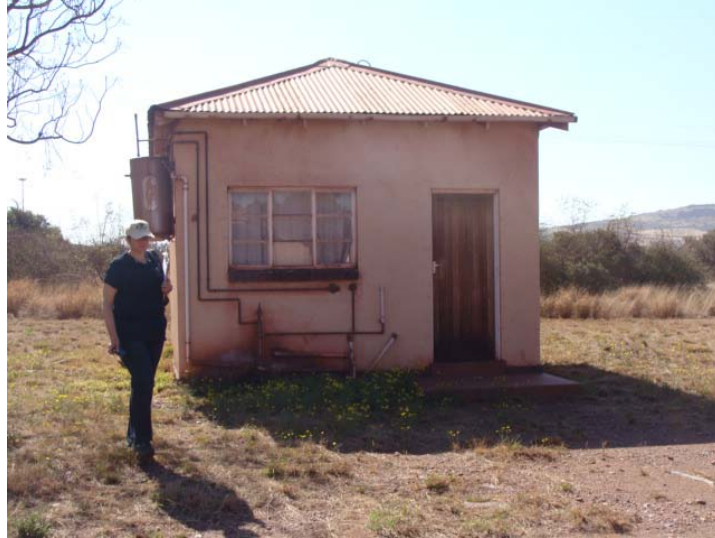
The first was probably built during the 1960's (Figure 40) whereas the second seem much older (Figure 41). It has no specific architectural uniqueness and therefore receives a rating of medium to low.

**Figure 40** Small outbuilding behind technical services building probably dating to the 1960's.

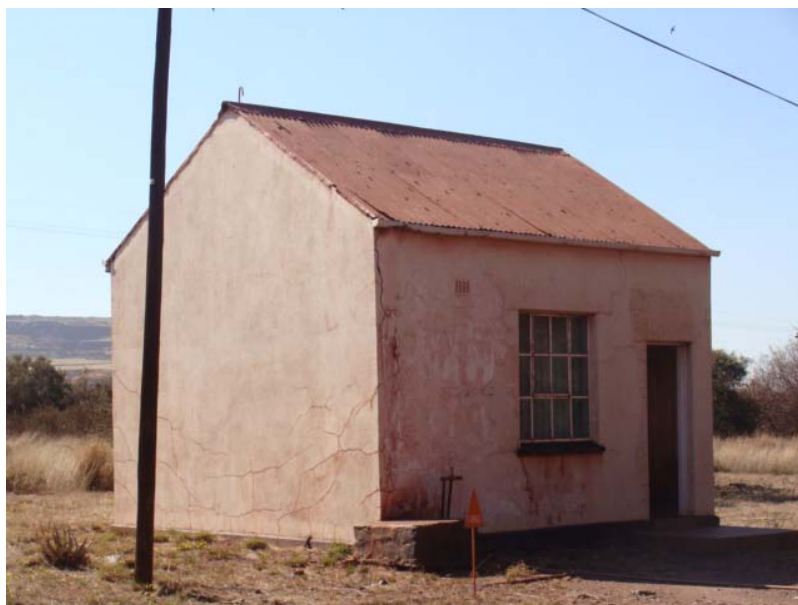
**Figure 41** Another, but older, outbuilding behind the technical services building.

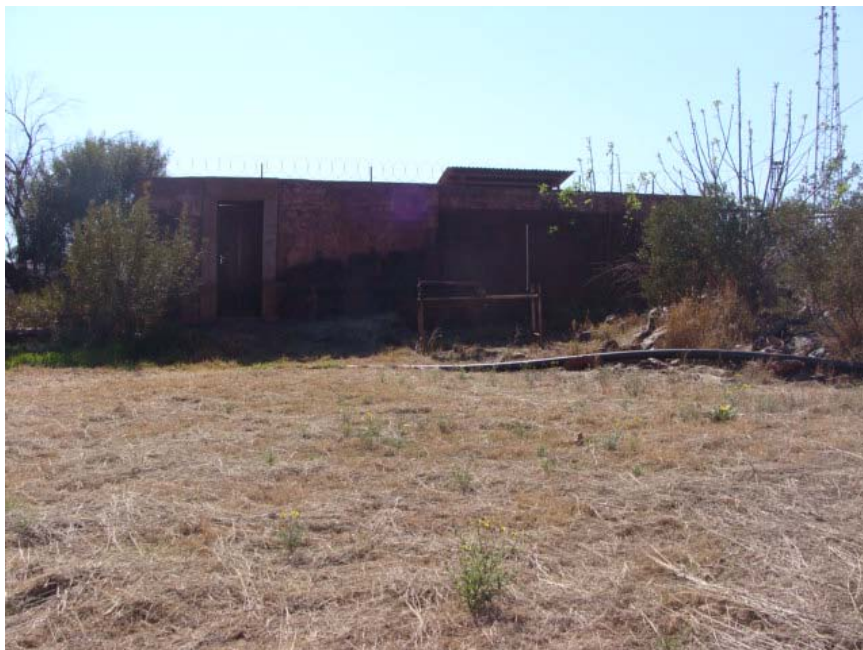
**Figure 43** The dam today.

The dam was also built during the 1930's (Figure 42-43). Today it serves as surveying station. It is not a very unique structure from the time and therefore receives a rating of medium to low.

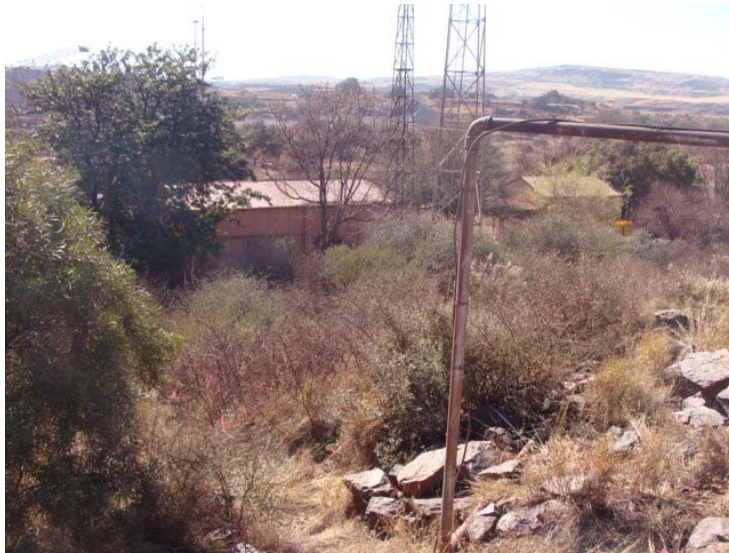
Between the railway line and the dam a number of building are situated (Figure 44). These all date to the 1960's – 1970's and are not very unique. It therefore receives a rating of low.

**Figure 44** Area with buildings between railway line and dam.

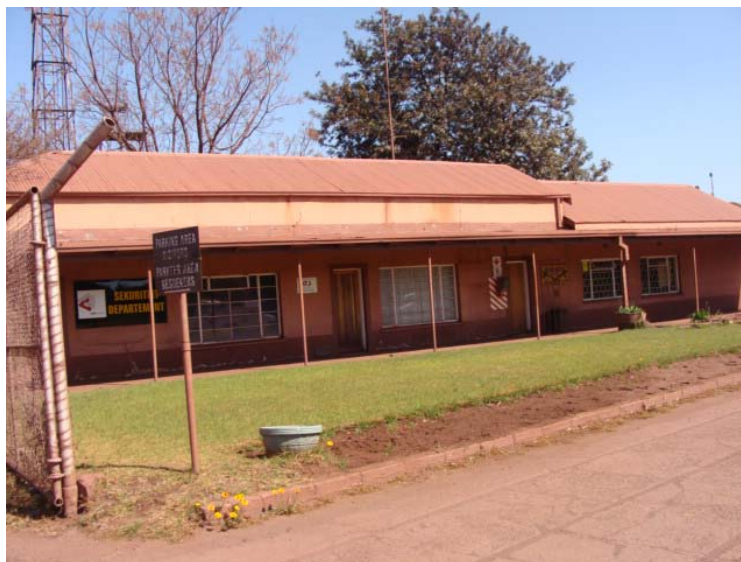
**Figure 45** The security building.

The building dates to the 1930's (Figure 45). It was however changed to a large extent and therefore receives a rating of low.

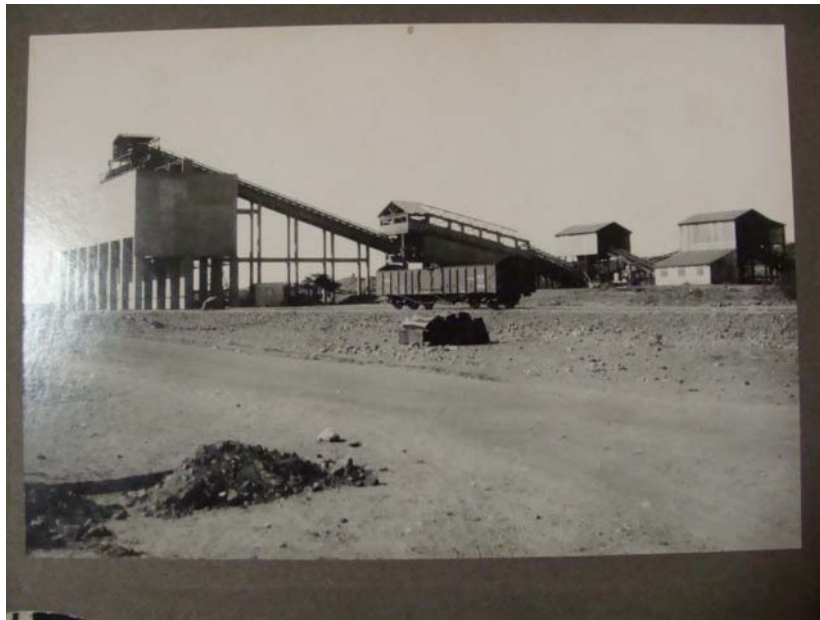
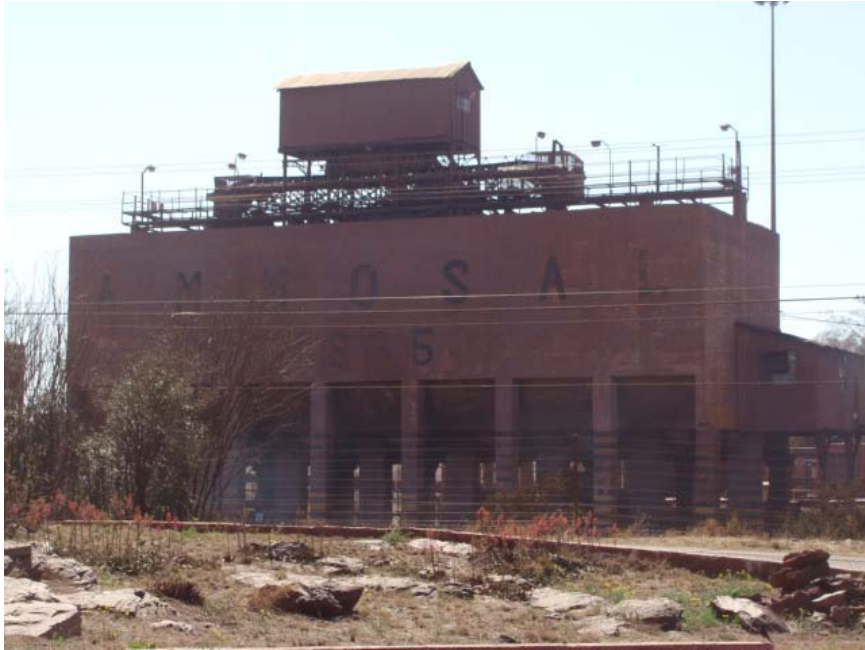
Two loading bins are found next to the railway line. The first (Figure 46-48) was built in 1929 - 1930. It has not been changed much and shows the date 1935, which is the date when ASSMANG came into being. It receives a rating of high.

**Figure 46** The loading bin dating from 1929/30 (ASSMANG Beeshoek collection).

**Figure 47** Revamped loading bin erected in 1929-1930 (Snyman 2000: 121).

**Figure 48** The 1929/30 loading bin.

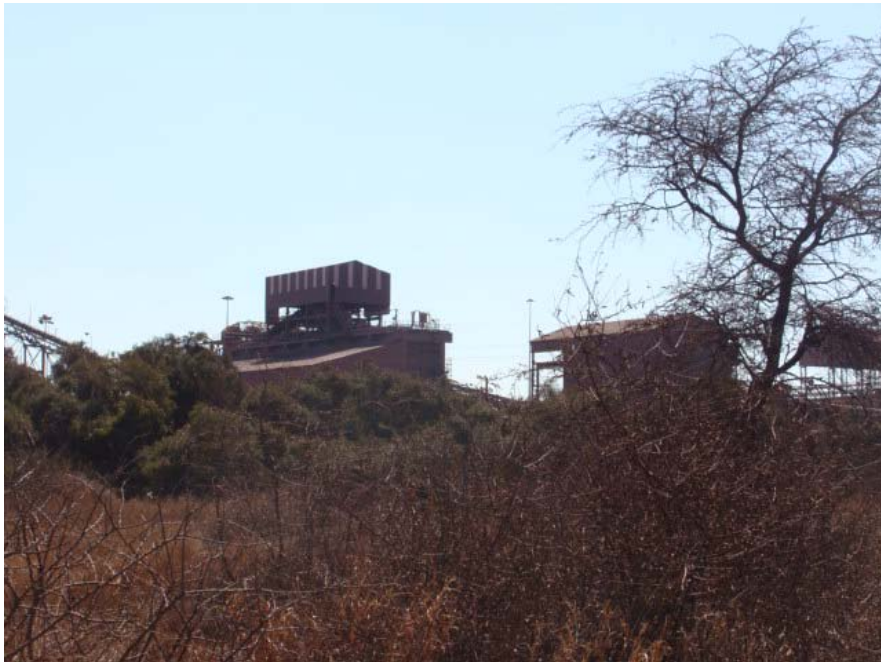
**Figure 49** The second loading bin.

The second (Figure 49) is much younger (probably the 1960's). It receives a rating of low.

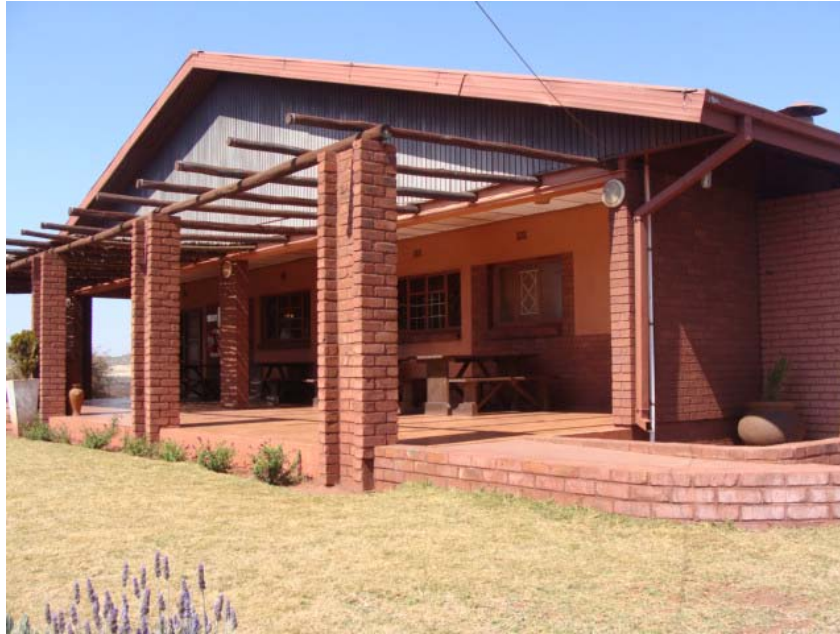
**Figure 50** Oppikoppi restaurant.

The restaurant was also built during the 1970's (Figure 50). It is not a very unique building and therefore receives a rating of low.

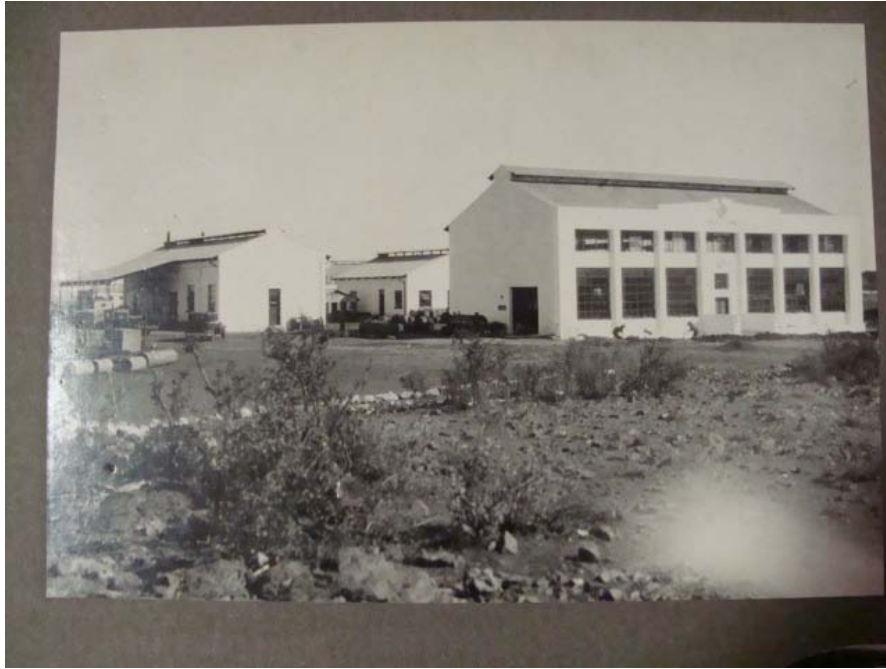
It is the single most important building on the mine from a heritage perspective and is one of very few examples of an industrial building with ART Deco elements and features. It therefore receives a rating of high.

**Figure 51** The power station with workshops to its left during the 1930's  
(ASSMANG Beeshoek collection)

**Figure 52** Inside of the power station (ASSMANG Beeshoek collection).

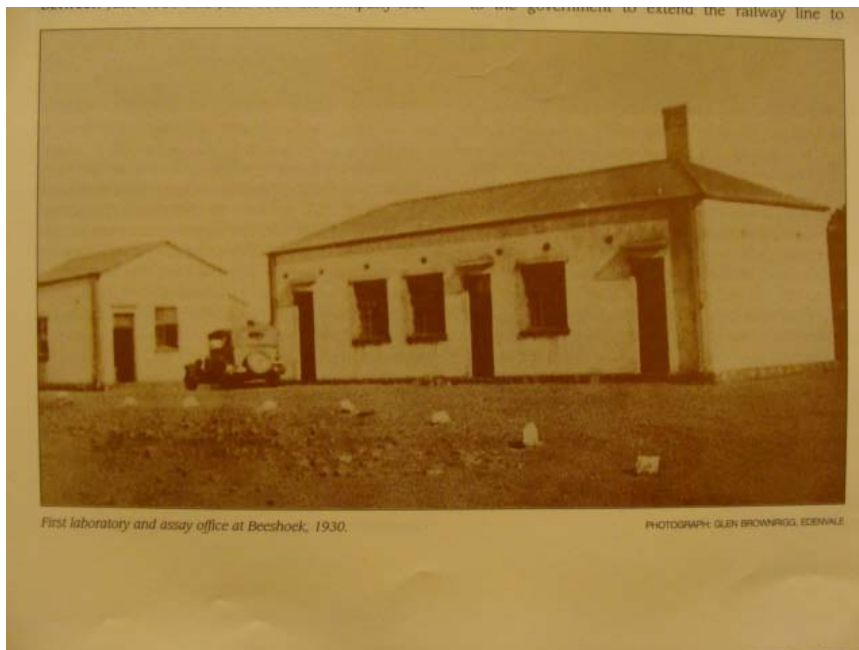
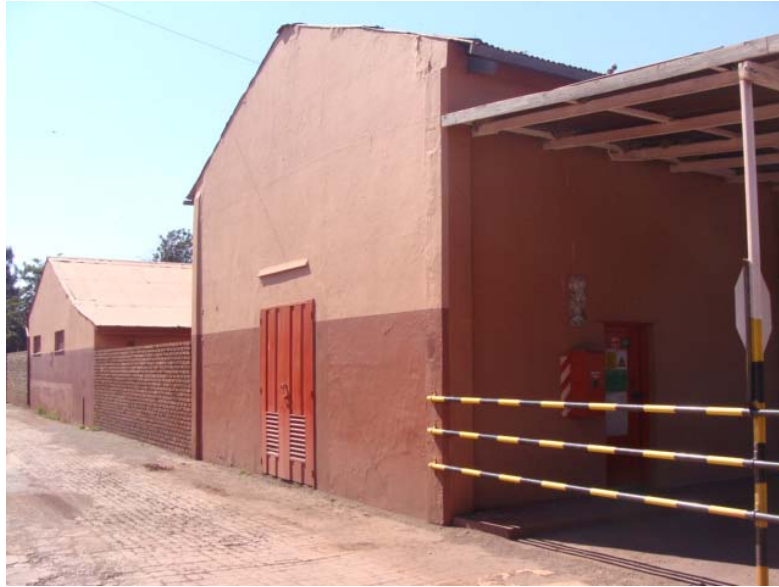
**Figure 59** The emergency services buildings.

This is industrial buildings which was erected during the 1930's – 1940's (Figure 58-59). It has however been changed to a large extent and therefore receives a rating of low.

**Figure 58** First laboratory and assaying office at Beeshoek in 1930 (Snyman 2000: 39).

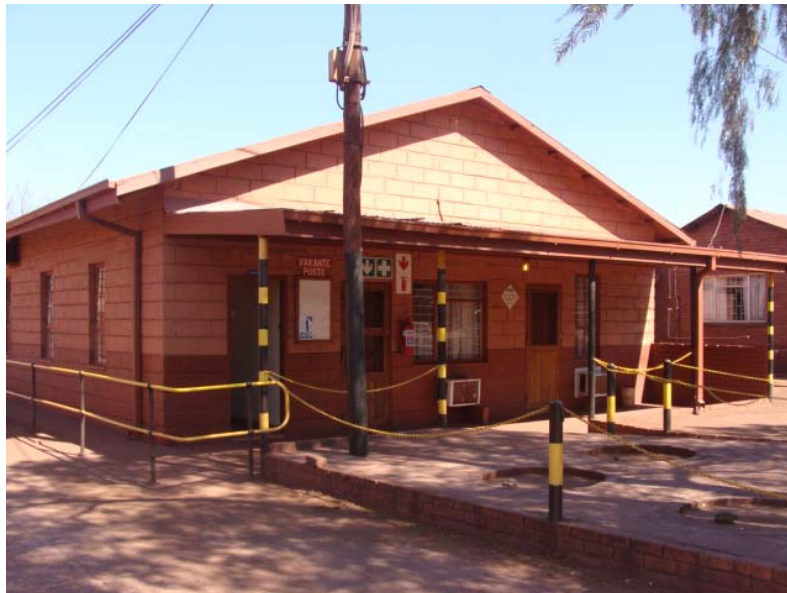
**Figure 60** HR building.

The building was built during the 1950's (Figure 60). It has no particular unique architectural characteristics and therefore receives a rating of low.
