**A REPORT ON THE HERITAGE ASSESSMENT RELATED TO THE BEESHOEK  
MINE VILLAGE, NORTHERN CAPE PROVINCE**

***Assmang Beeshoek Mine***

**REPORT: AE1185**

***September 2011***

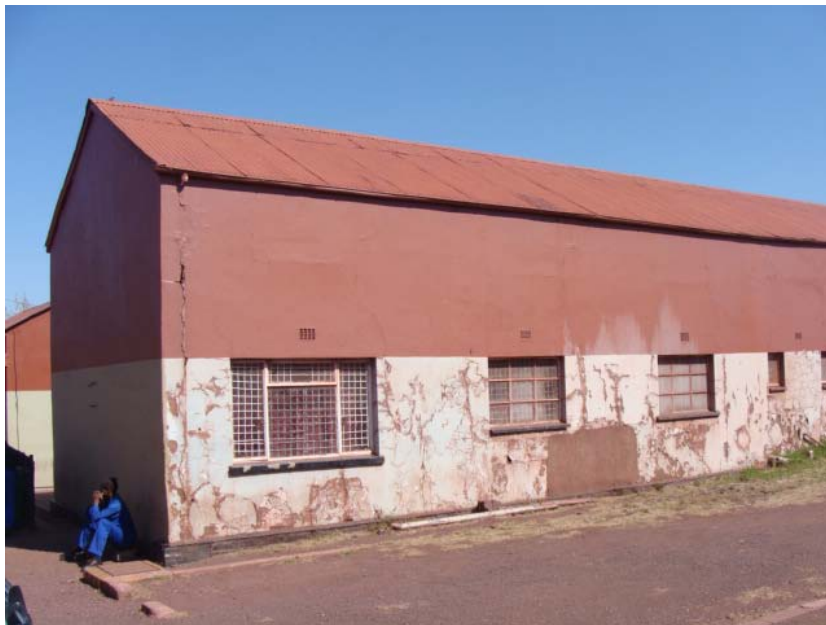
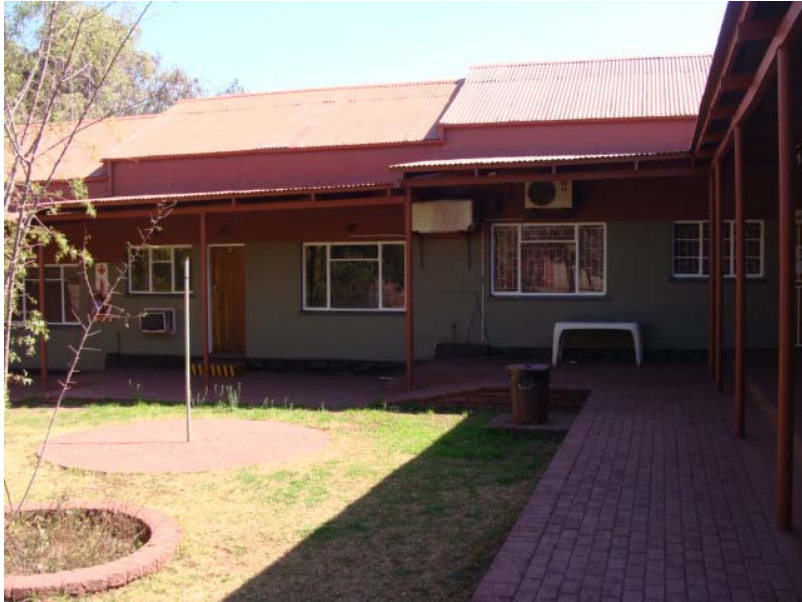
The compound was built in 1931. During the 1960's it was revamped and a wing was added (Figure 61-63). Unfortunately it was changed to such an extent that it receives a rating of medium to low.

**Figure 61** The compound during the 1960's (Snyman 2000: 129).

**Figure 63** Revamped inside of the compound.

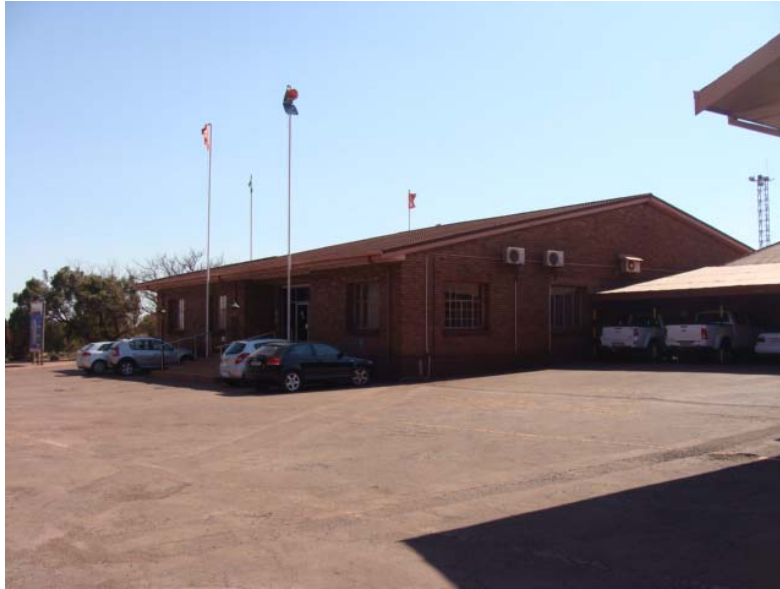
**Figure 65** The main office building.

The building dates to the 1930's (Figure 64-65). It has however been changed to a very large extent and therefore receives a rating of low.

**Figure 64** The main office building in 1986 (Snyman 2000: 138).

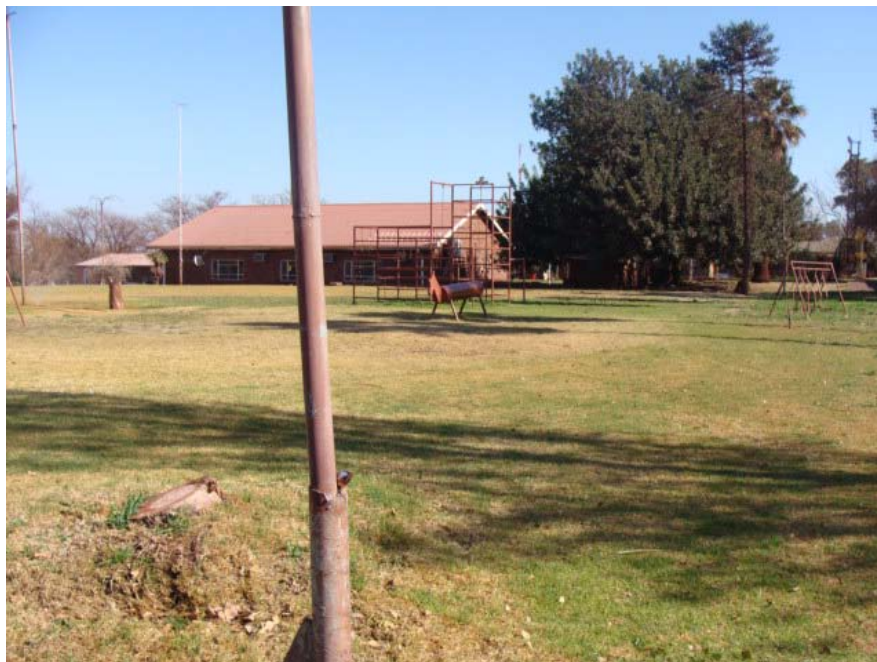
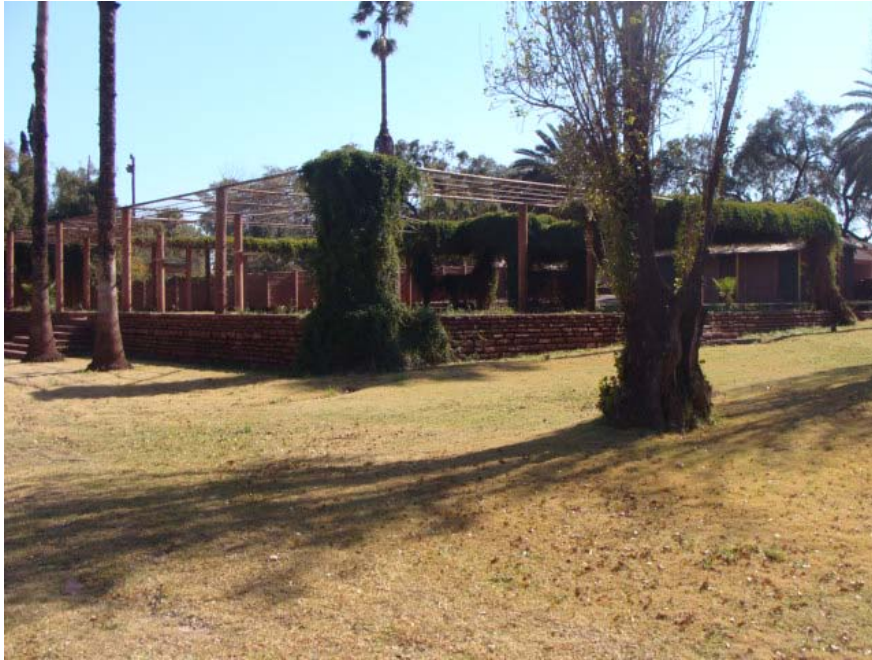
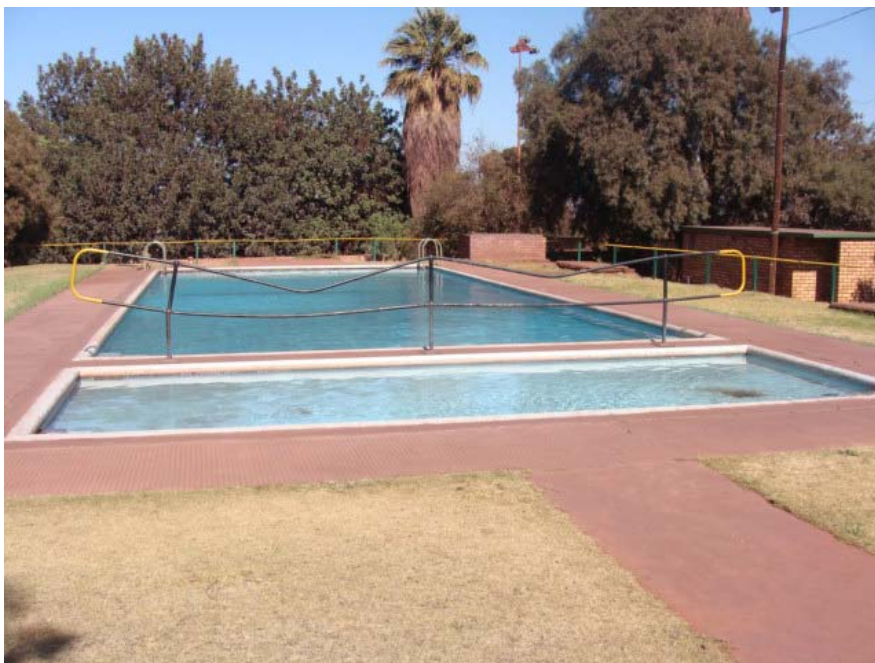
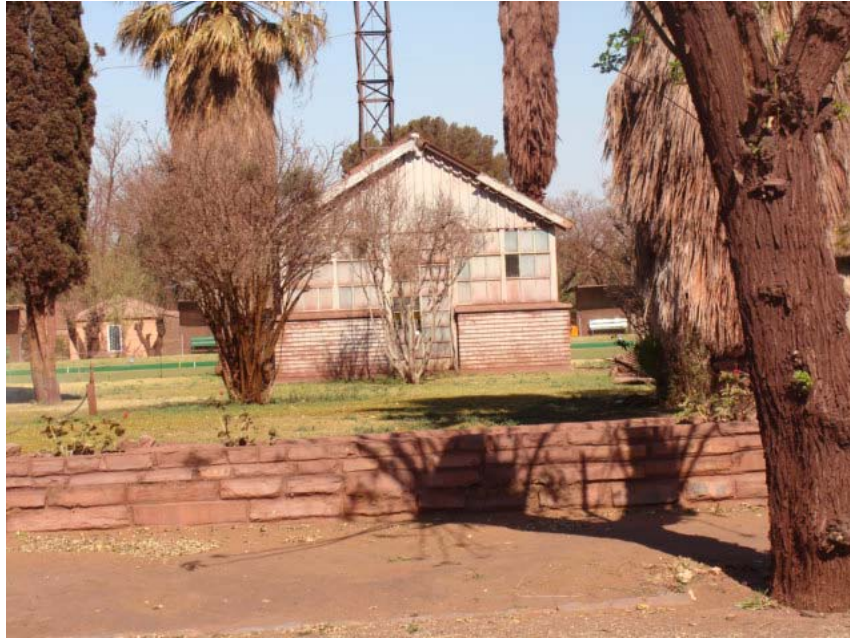
In the center of the village a recreation area was developed. It consists of a swimming pool, bowling green, green house and other features (Figure 66-69). These mostly date to after the 1950's and are not unique. It therefore receives a rating of low.

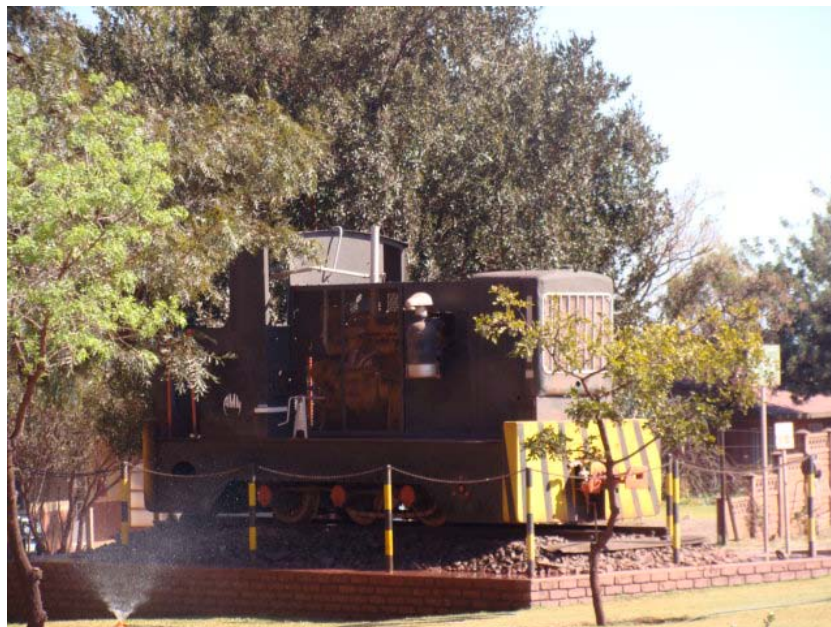
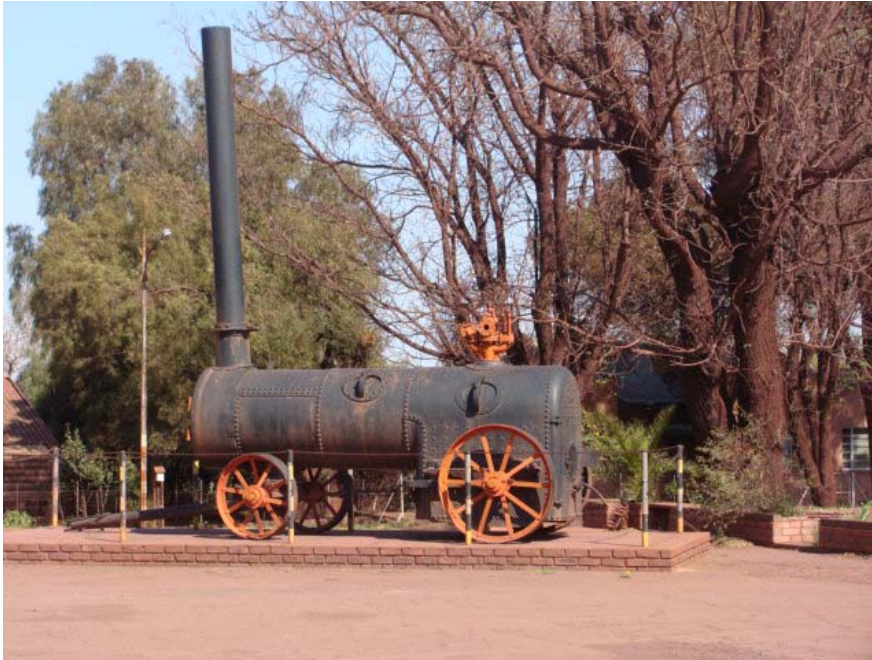
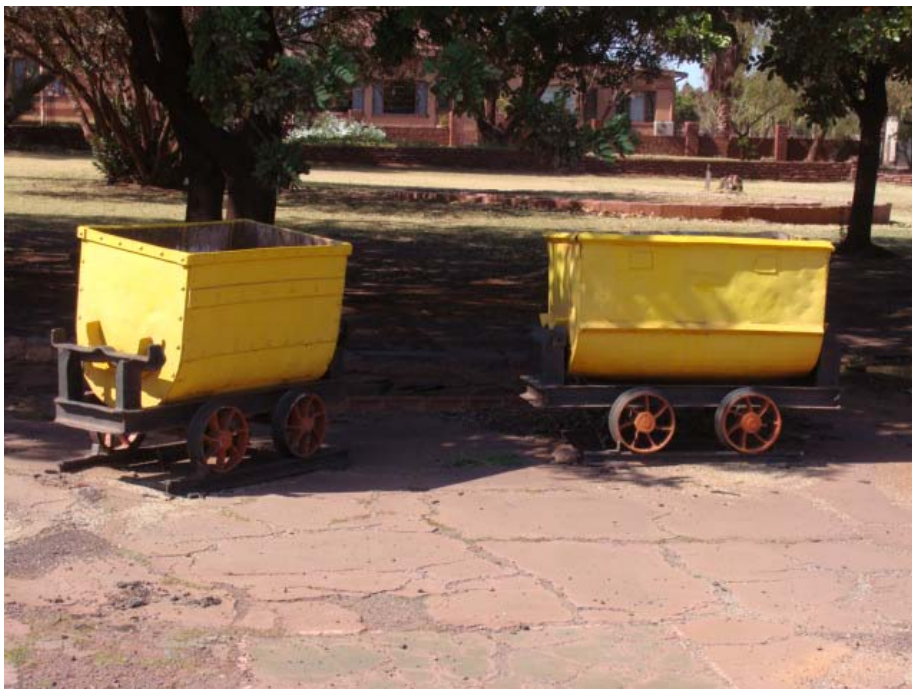
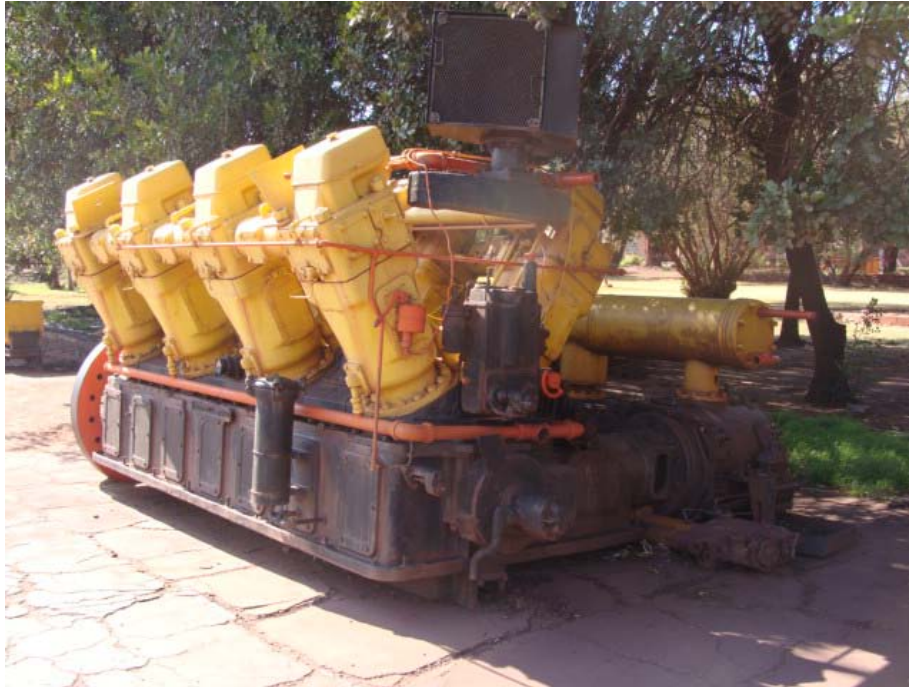
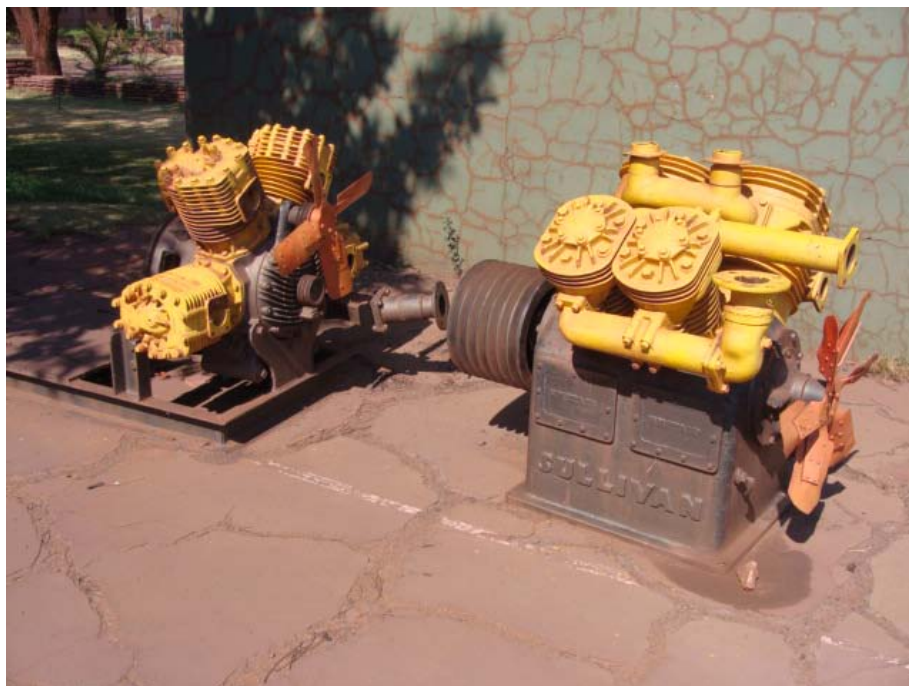
Various movable objects dating from the earlier history of the mine are displayed throughout the village. This include locomotives, coco pans, a compressor etc. (Figure 70-74). These are given a rating of high.
