PHASE 1 ARCHAEOLOGICAL IMPACT ASSESSMENT

**UTILIZATION OF BORROW PITS –  
CHRIS HANI DISTRICT MUNICIPALITY,  
EASTERN CAPE, SOUTH AFRICA**

**DATE:** 2011-03-01

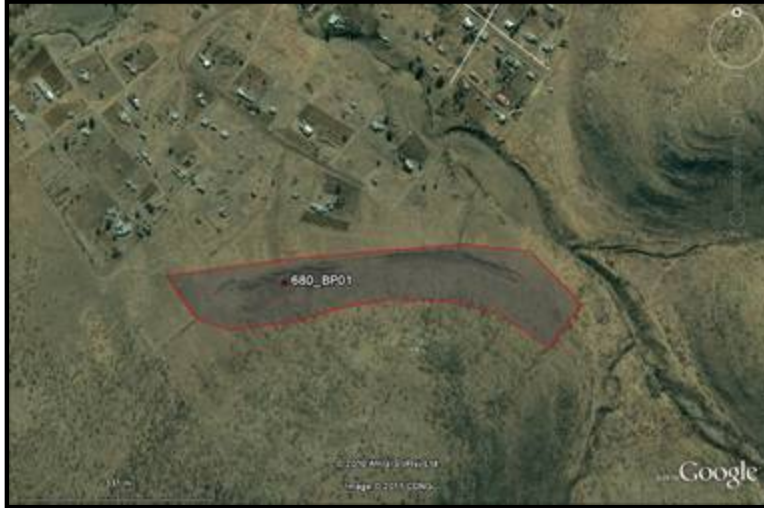
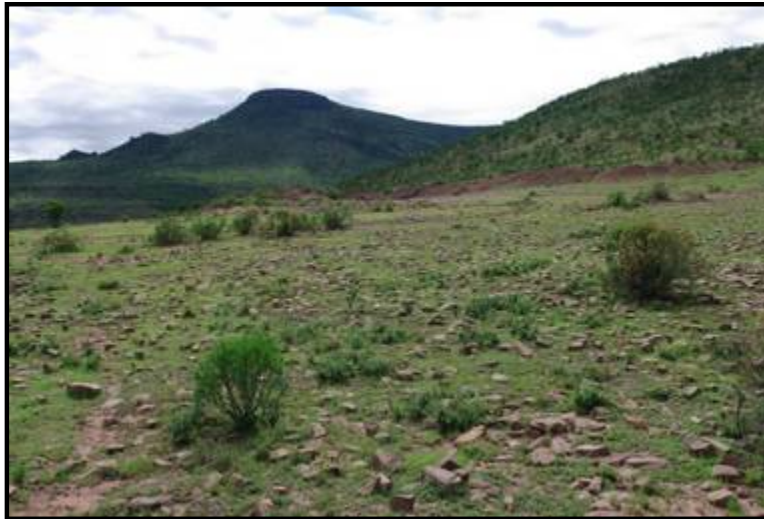
**Figure 4:** Borrow pit 680\_BP01

No archaeological or cultural heritage resources, as defined and protected under the NHRA 1999, were identified on the surface or within exposed sub-surface sections during Phase 1 AIA assessment of borrow pit 680\_BP01.

**Figure 5:** View of borrow pit 680\_BP01 from the western side of the assessed area

**RECOMMENDATIONS:** It is recommended that use of borrow pit 680\_BP01 proceeds as applied for without the developer having to comply with additional heritage compliance requirements.

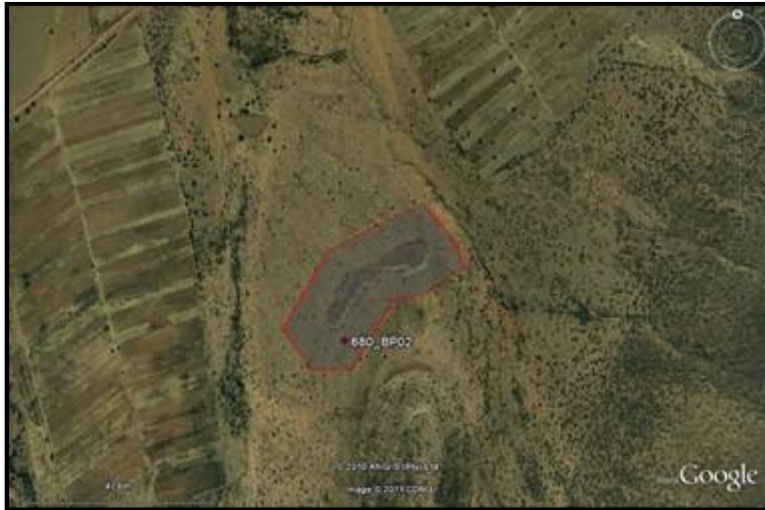
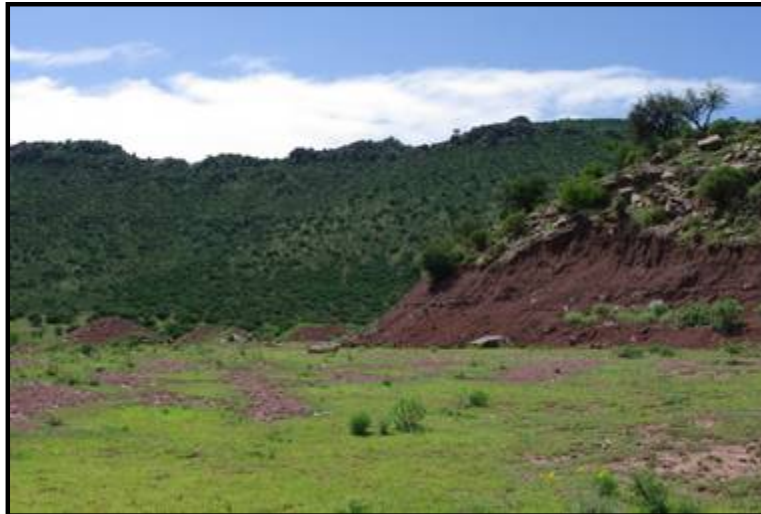
**Figure 6:** Borrow Pit 680\_02

No archaeological or cultural heritage resources, as defined and protected under the NHRA 1999, were identified on the surface or within exposed sub-surface sections during Phase 1 AIA assessment of borrow pit 680\_BP02.

**Figure 7:** View of a portion of the southern section of borrow pit 680\_BP02

**RECOMMENDATIONS:** It is recommended that use of borrow pit 680\_BP02 proceeds as applied for without the developer having to comply with additional heritage compliance requirements.

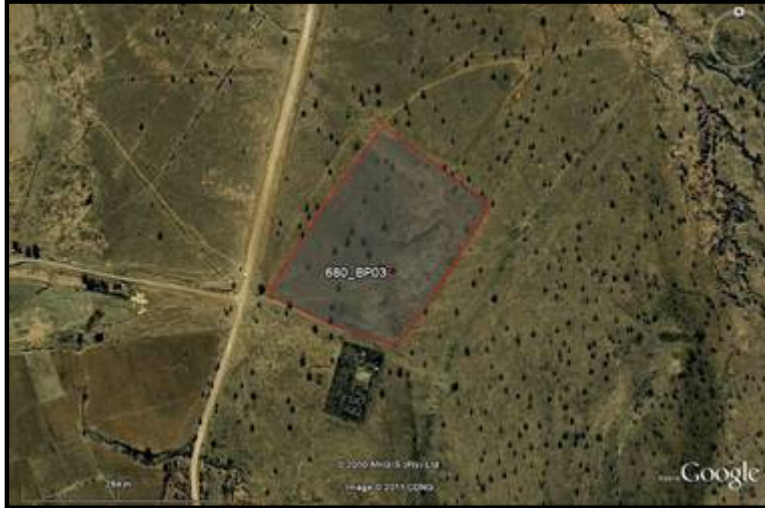
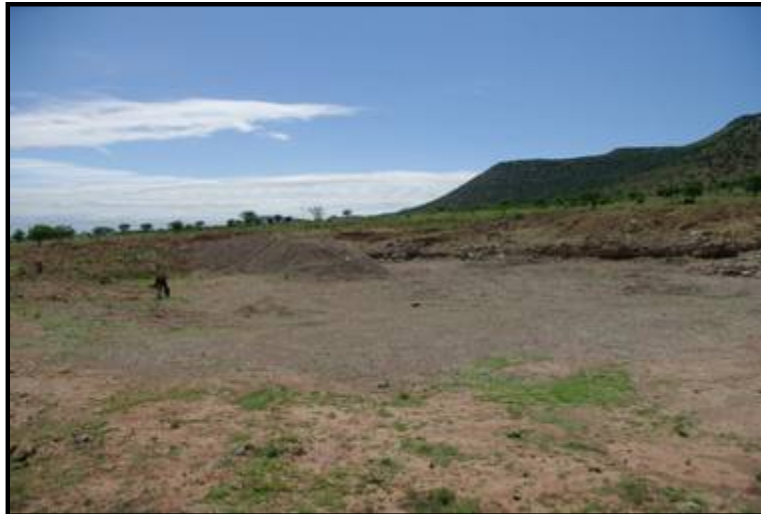
**Figure 8:** Borrow Pit 680\_03

No archaeological or cultural heritage resources, as defined and protected under the NHRA 1999, were identified on the surface or within exposed sub-surface sections during Phase 1 AIA assessment of borrow pit 680\_BP03.

**Figure 9:** General view of borrow pit 680\_BP03

**RECOMMENDATIONS:** It is recommended that use of borrow pit 680\_BP03 proceeds as applied for without the developer having to comply with additional heritage compliance requirements.

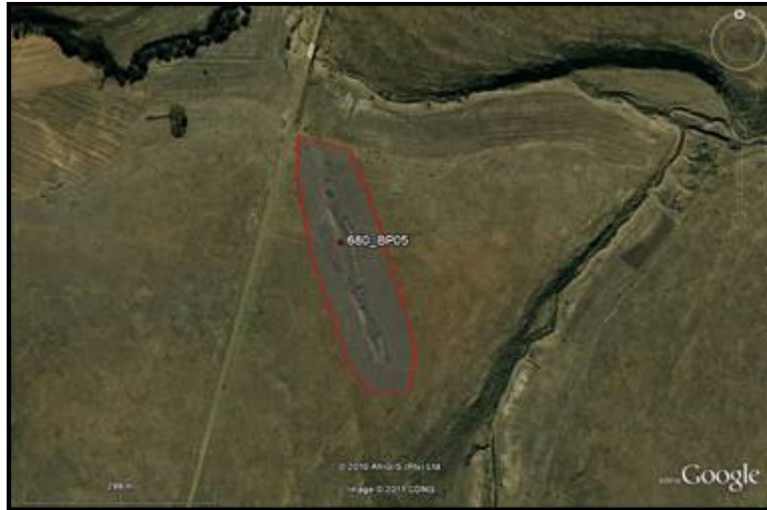
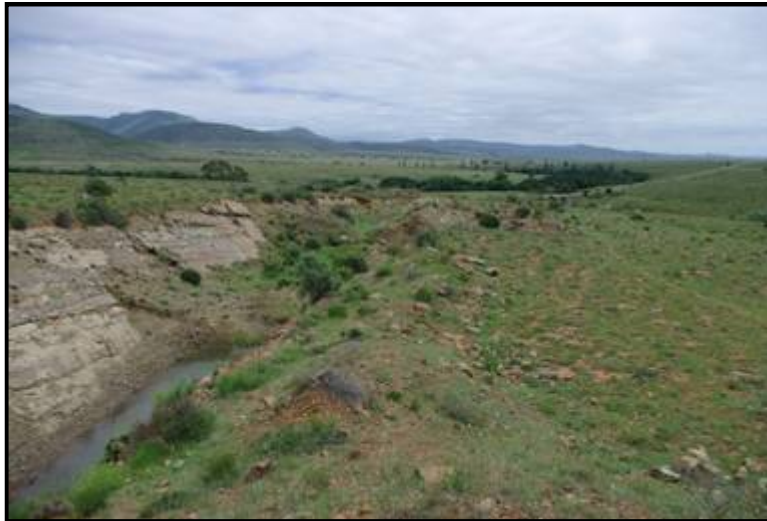
**Figure 10:** Borrow Pit 680\_05

No archaeological or cultural heritage resources, as defined and protected under the NHRA 1999, were identified on the surface or within exposed sub-surface sections during Phase 1 AIA assessment of borrow pit 680\_BP05.

**Figure 11:** General view of borrow pit 680\_BP05

**RECOMMENDATIONS:** It is recommended that use of borrow pit 680\_BP05 proceeds as applied for without the developer having to comply with additional heritage compliance requirements.

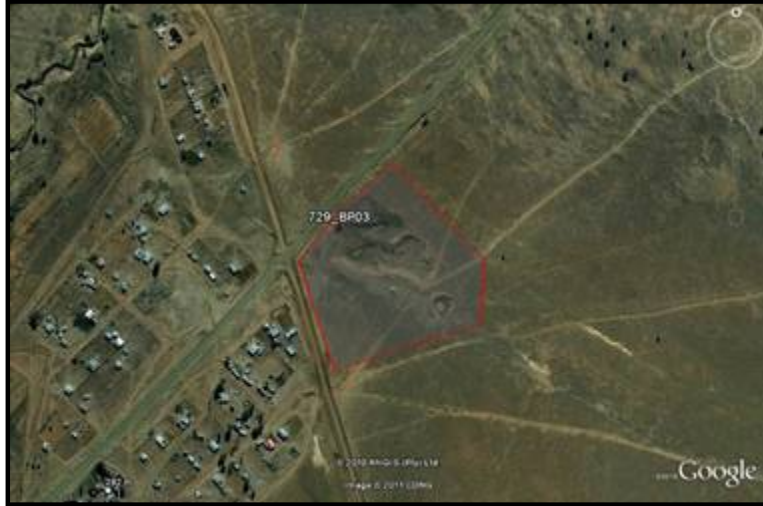
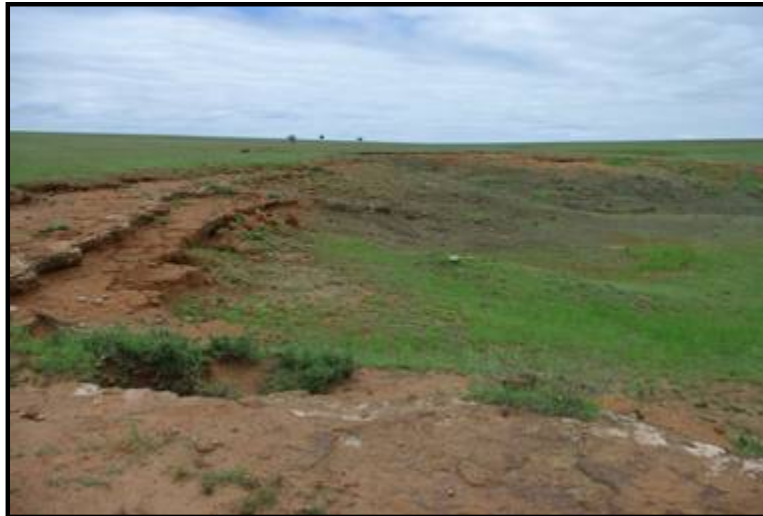
**Figure 13:** Borrow Pit 729\_BP03

No archaeological or cultural heritage resources, as defined and protected under the NHRA 1999, were identified on the surface or within exposed sub-surface sections during Phase 1 AIA assessment of borrow pit 729\_BP03.

**Figure 14:** General view of borrow pit 729\_BP03

**RECOMMENDATIONS:** It is recommended that use of borrow pit 729\_BP03 proceeds as applied for without the developer having to comply with additional heritage compliance requirements.

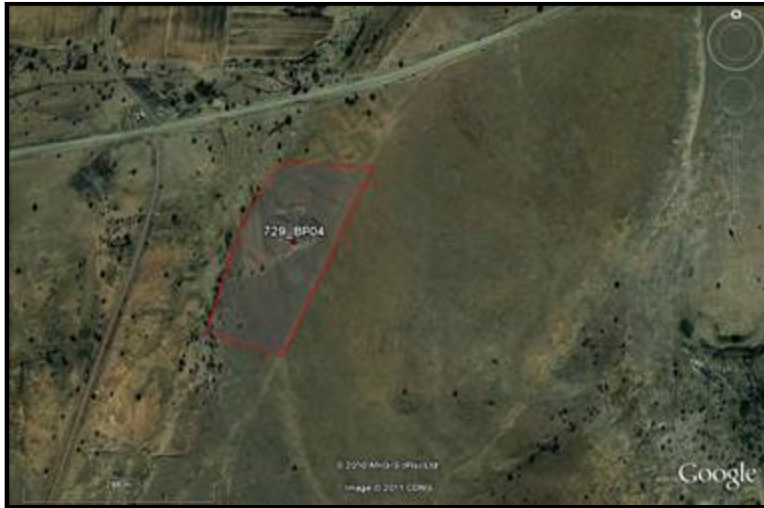
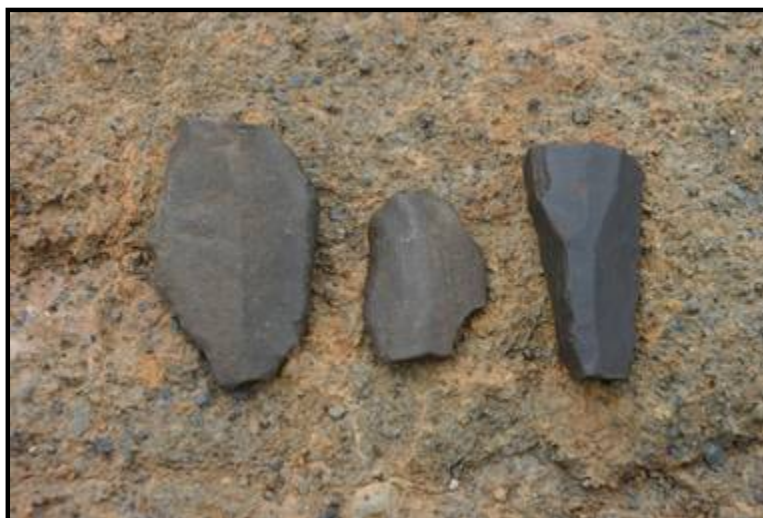
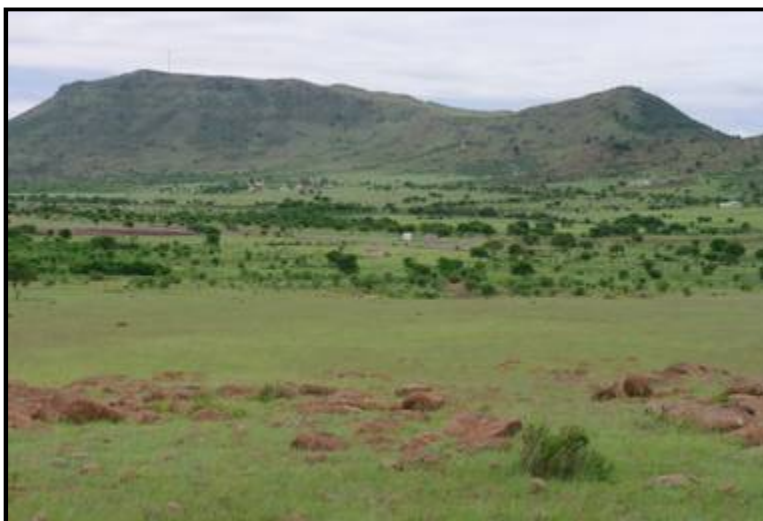
**Figure 15:** Borrow Pit 729\_BP04

A low quantity of Stone Age lithic artefacts were discovered in the grassy plain at borrow pit 729\_BP04. Artefact quantities were particularly low, and too low to attempt assignment of an estimated artefact ratio (artefacts: m<sup>2</sup>). Exposed sections at the borrow pit yielded a top approximate 10cm red-brown surface layer interpreted as the stratigraphic member containing the cultural material. No artefacts were identified in situ context within the layer at exposed borrow pit sections, inferred to be the direct result of particularly low artefact quantities. Based on typology and technology the low density 'feature' is assigned to the Middle Stone Age (MSA), with an emphasis on blade and flake types. The few on site artefacts can in general be described as of good technological quality, also the result of raw material used; very fine grained dolorite and lydianite (baked shale), known for its fairly good flaking qualities. Due to the presence of artefacts at the borrow pit assessment extended slightly beyond the boundaries of the assessment area, towards the west where a small drainage line characterizes the landscape and towards the east where rocky outcrops may have provided the original context of the artefacts. However, neither of these additionally assessed areas provided more information on the low density 'feature', and no more definite archaeological context or an actual archaeological 'site' locality could be identified.

Figure 17: MSA lithic artefacts from the borrow pit terrain

Figure 18: View of borrow pit 729\_BP04 from the rocky outcrops east of the borrow pit

**RECOMMENDATIONS:** The low density MSA Stone Age 'feature' at borrow pit 729\_BP04 comprises of an archaeological and cultural heritage resource as defined and protected under the NHRA 1999. The 'feature' is ascribed a SAHRA LOW SIGNIFICANCE and GENERALLY PROTECTED C FIELD RATING. It is recommended that (relevant portions of) the 'feature' be destroyed *in lieu* of the development without the developer having to apply for a SAHRA SITE DESTRUCTION PERMIT.

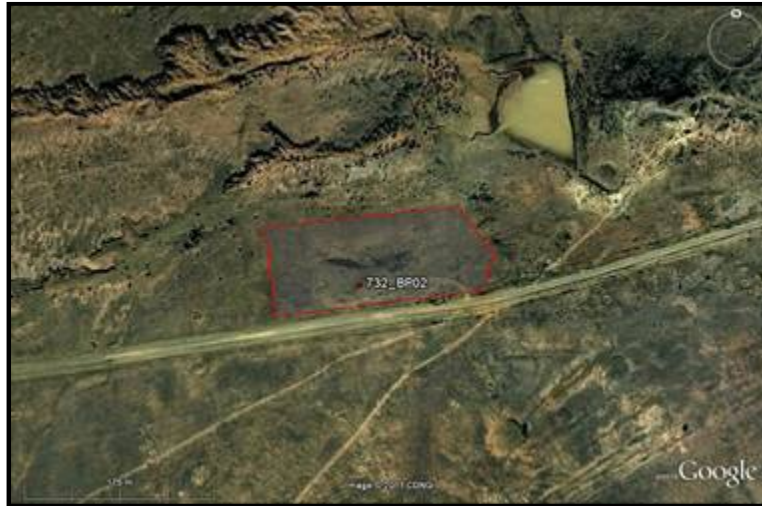
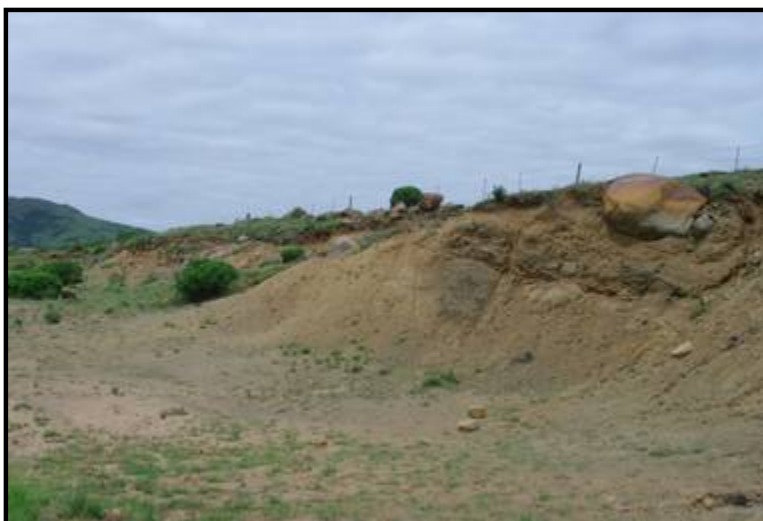
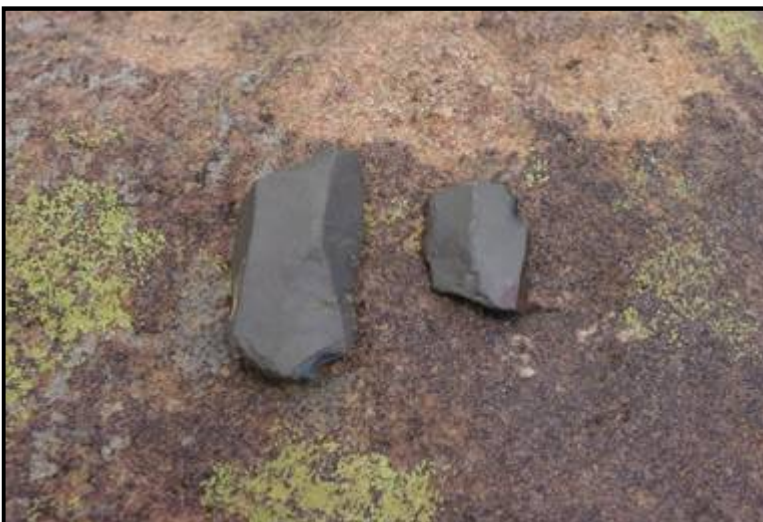
**Figure 20:** Borrow Pit 732\_BP02

A low presence of Middle Stone Age (MSA) lithic artefacts was present across the surface of the 732\_BP02 borrow pit terrain. Artefact quantities were particularly low; and too low to attempt an estimated artefact ratio (artefacts: m<sup>2</sup>). Artefacts are, based on typology and technology, ascribed to the MSA with a strong emphasis on blade and bladelet types, with lydianite or baked shale as preferred raw material type. Artefacts are inferred to be directly associated with the approximate 10cm red-brown top stratigraphic member, identified within exposed sections of the borrow pit, but no artefacts were identified in situ section. Identified artefacts were all collected from the surface. The assessment extended slightly towards the north of the assessment area where large erosion sections are directly associated with massive erosion gullies. Erosion section stratigraphy proved to be very similar to that of the borrow pit but inspection could not verify the top approximate 10cm stratigraphic member as the layer to which cultural material can exclusive be assigned, due in large to the lack of lithic material in situ section at the erosion gullies. Again only a few artefacts were collected and all within erosion gullies where they must have collected primarily as a result of water erosion (post-depositional impact) over many centuries.

**Figure 22:** An exposed section of borrow pit 732\_BP02

**Figure 23:** Lithic artefacts from the general terrain

**RECOMMENDATIONS:** The low density MSA Stone Age 'feature' at borrow pit 732\_BP02 comprises of an archaeological and cultural heritage resource as defined and protected under the NHRA 1999. The 'feature' is ascribed a SAHRA LOW SIGNIFICANCE and GENERALLY PROTECTED C FIELD RATING. It is recommended that (relevant portions of) the 'feature' be destroyed *in lieu* of the development without the developer having to apply for a SAHRA SITE DESTRUCTION PERMIT.

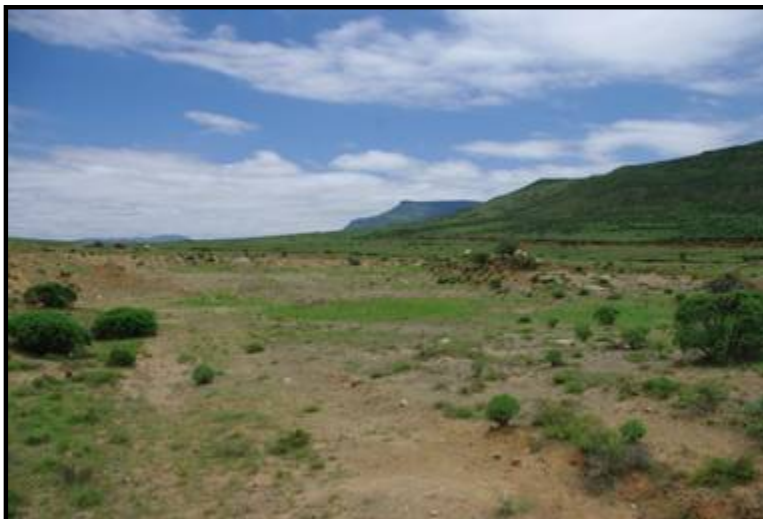
**Figure 21:** General view of borrow pit 732\_BP02, with large erosion gullies towards the north thereof

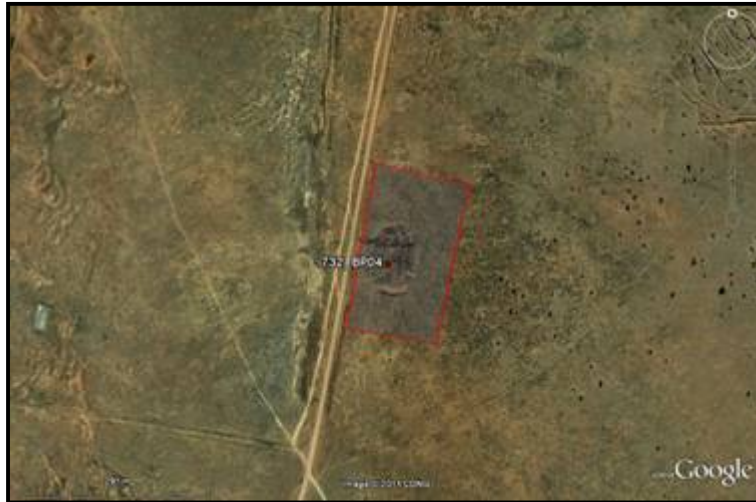
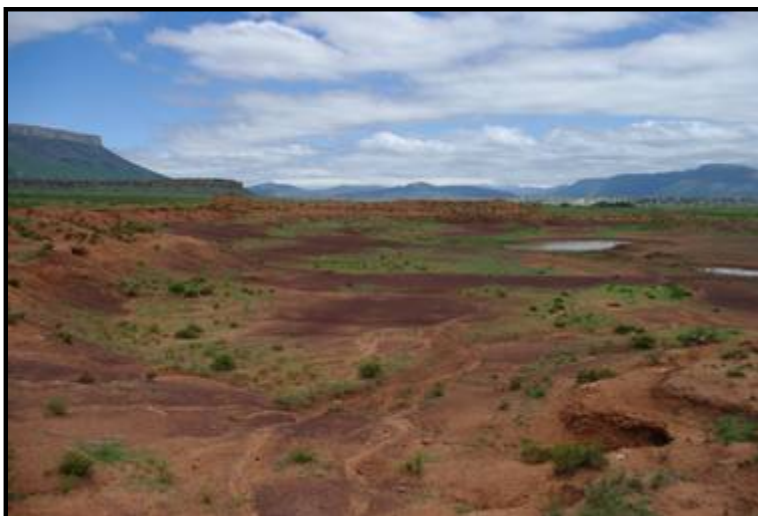
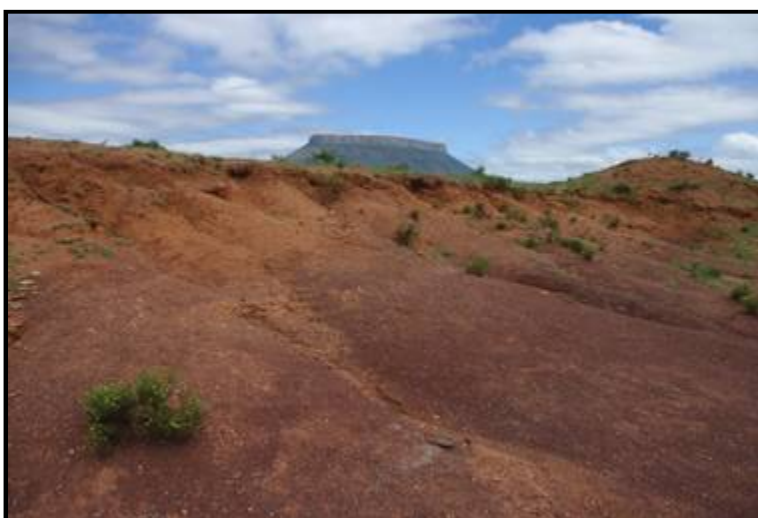
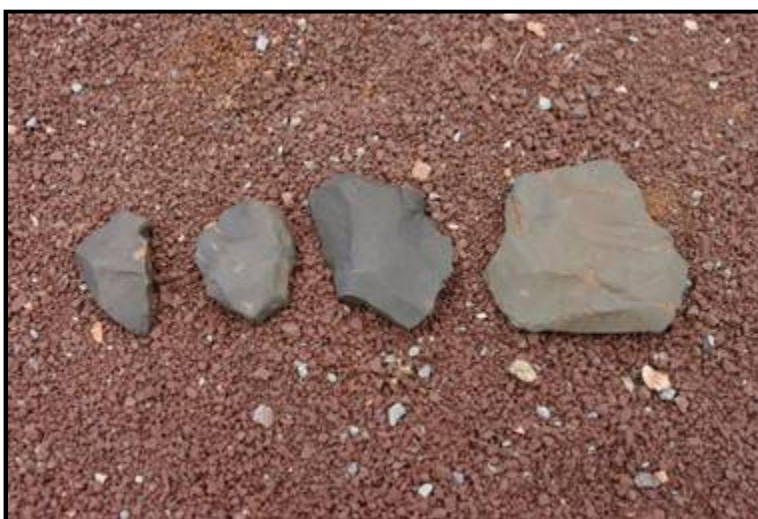
**Figure 24:** Borrow Pit 732\_BP04

No lithic artefacts were collected from the surface of the general borrow pit 732\_BP04 terrain, but a number of stone tools were found collected in the small erosion gullies of the borrow pit itself. Original artefacts contexts may well be closely associated with the top 10-15cm stratigraphic member of the exposed sections, but the lack of in situ material waves verification of the assumption. Clusters of artefacts, in approximate groups varying from 3-10 were recorded. The low density of artefacts encountered at the site together with the evident ex situ context thereof does not allow estimation of artefact ratios (artefacts: m<sup>2</sup>). Artefacts are preliminary, based on typology and technology, assigned to both the Middle Stone Age (MSA) and a macrolithic Later Stone Age (LSA). General flake types dominated the mixed assemblage and basic artefact size was used for preliminary Industry classification. Fine grained dolorite seems to have been the preferred raw material used to produce tools.

**Figure 25:** View of borrow pit 732\_BP04

**Figure 26:** Artefacts were encountered in small erosion gullies at the borrow pit sections

**Figure 27:** A selection of artefacts from borrow pit 732\_BP04

**RECOMMENDATIONS:** The low density MSA Stone Age 'feature' at borrow pit 732\_BP04 comprises of an archaeological and cultural heritage resource as defined and protected under the NHRA 1999. The 'feature' is ascribed a SAHRA LOW SIGNIFICANCE and GENERALLY PROTECTED C FIELD RATING. It is recommended that (relevant portions of) the 'feature' be destroyed *in lieu* of the development without the developer having to apply for a SAHRA SITE DESTRUCTION PERMIT.

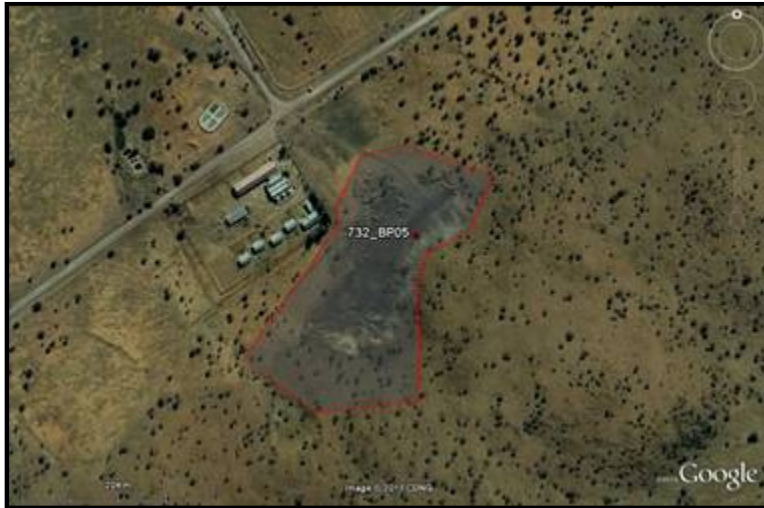
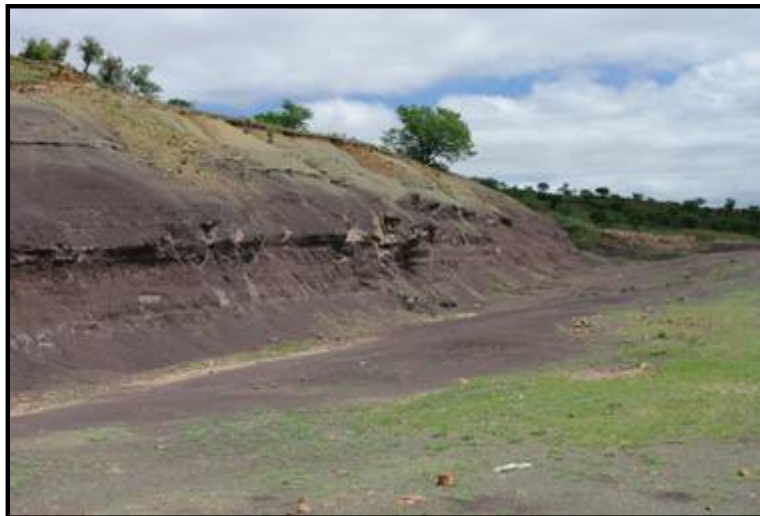
**Figure 28:** Borrow Pit 732\_BP05

No archaeological or cultural heritage resources, as defined and protected under the NHRA 1999, were identified on the surface or within exposed sub-surface sections during Phase 1 AIA assessment of borrow pit 732\_BP05.

**Figure 29:** View of borrow pit 732\_BP05

**RECOMMENDATIONS:** It is recommended that use of borrow pit 732\_BP05 proceeds as applied for without the developer having to comply with additional heritage compliance requirements.

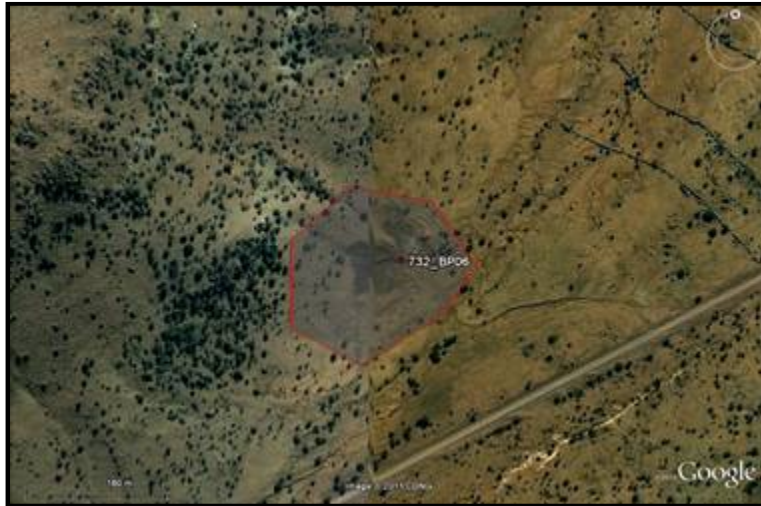
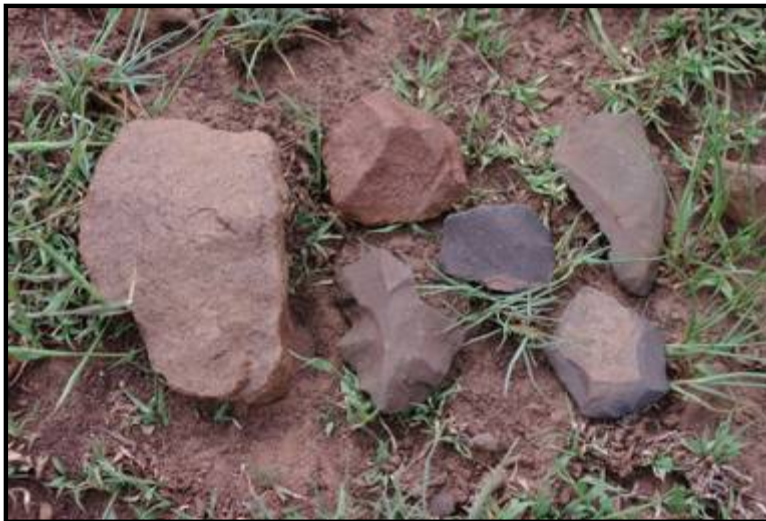
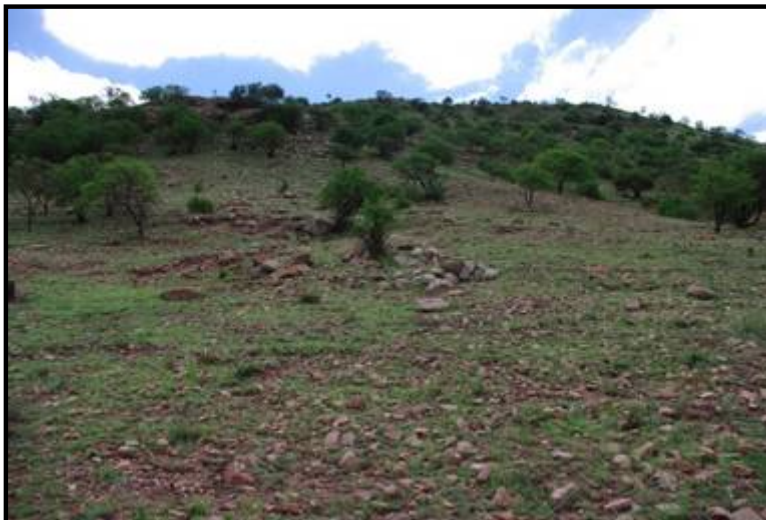
**Figure 30: Borrow Pit 732\_BP06**

Surface areas around borrow pit 732\_BP06 were characterized by a fairly high density of Stone Age artefacts, with approximate recorded artefact ratios of 3-7:1 (artefacts: m<sup>2</sup>). Artefact types include both Middle Stone Age (MSA) and macrolithic Later Stone Age (LSA) samples produced from a variety of raw material sources, with the flaking quality of raw material primarily determining preliminary interpretation regarding knapping technology: Technologically the assemblage varied from finely knapped flake and blade types to rough amorphous flakes. The surface collection represents a heavily lagged deposit, containing a mix of Industry type material identified amongst the loose stone rich geological context of the general terrain and nearby hill. Assessment extended towards the north-east and east of the assessment area in an attempt to determine if the hilly terrain associated therewith would have provided the original context of the artefacts and if stratified cultural members could be identified for the primarily ex situ material characterizing the development terrain. Assessment of the hill however only indicated that the lag Stone Age assemblage continues in a very similar manner across the hill and most probably well beyond that – ‘feature’ extent could not be determined.

**Figure 32:** Selected surface artefacts

**Figure 33:** View of the general stone rich surface context of the general borrow pit 732\_BP06 terrain

**RECOMMENDATIONS:** The MSA / macrolithic LSA lag deposit at borrow pit 732\_BP06 comprises of an archaeological and cultural heritage resource as defined and protected under the NHRA 1999. The site is ascribed a SAHRA LOW SIGNIFICANCE and GENERALLY PROTECTED C FIELD RATING. It is recommended that (relevant portions of) the site be destroyed *in lieu* of the development without the developer having to apply for a SAHRA SITE DESTRUCTION PERMIT.

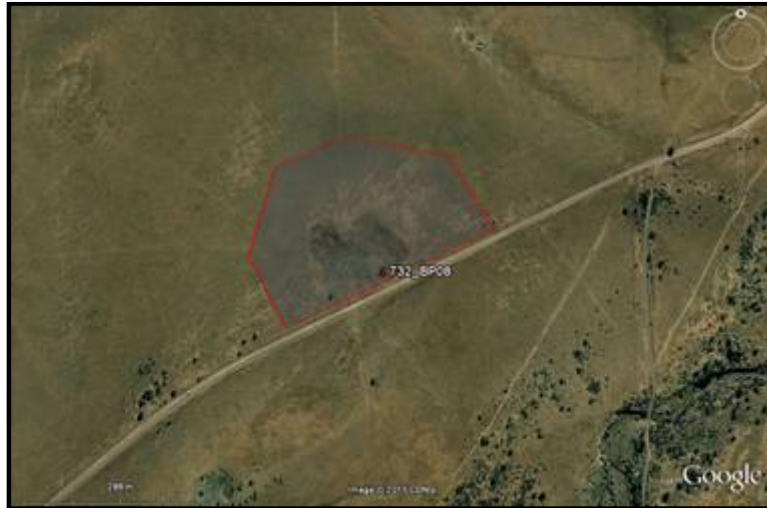
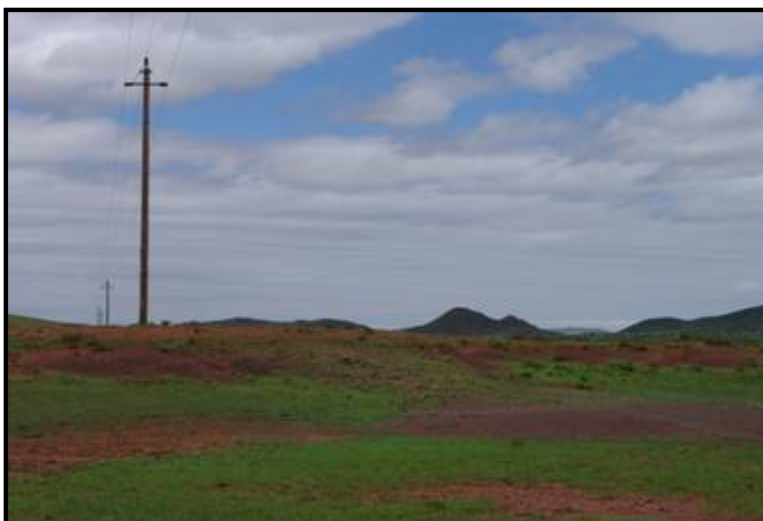
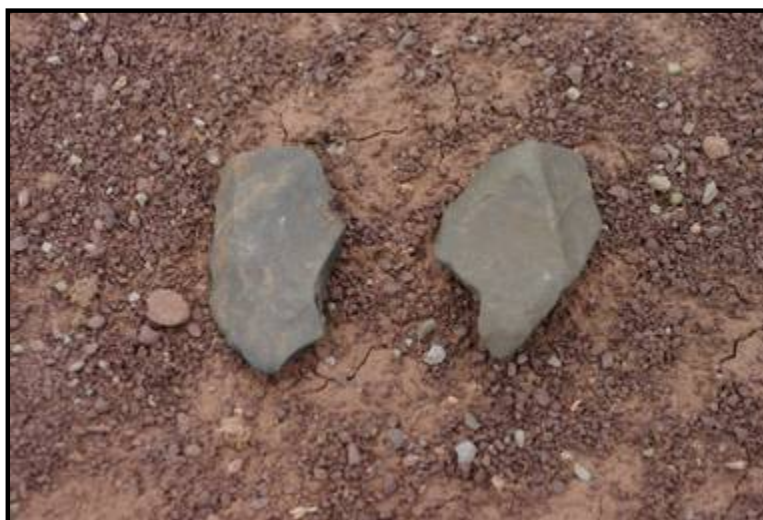
**Figure 34:** Borrow Pit 732\_BP08

Lithic artefacts were found on the surface of the borrow pit and clustered in small erosion gullies at borrow pit 732\_BP08. It is inferred that original artefacts contexts are closely associated with the top 10-15cm stratigraphic member of the exposed sections, but again, the lack of in situ encountered material wave verification of the assumption. Clusters of artefacts, in approximate groups varying from 2-5 were recorded. The low density of artefacts encountered at the site together with the evident ex situ context thereof does not allow estimation of artefact ratios (artefacts: m<sup>2</sup>). Artefacts are preliminary, based on typology and technology, assigned to the Middle Stone Age (MSA) with an emphasis on flake and bladelet types. General artefact size may indicate a temporal association with the latter part of the MSA. All artefacts encountered were produced from fine grained dolorite.

Figure 36: Exposed sections at borrow pit 732\_BP08

Figure 37: Selected artefacts from the general terrain

**RECOMMENDATIONS:** The low density MSA Stone Age 'feature' at borrow pit 732\_BP08 comprises of an archaeological and cultural heritage resource as defined and protected under the NHRA 1999. The 'feature' is ascribed a SAHRA LOW SIGNIFICANCE and GENERALLY PROTECTED C FIELD RATING. It is recommended that (relevant portions of) the 'feature' be destroyed *in lieu* of the development without the developer having to apply for a SAHRA SITE DESTRUCTION PERMIT.

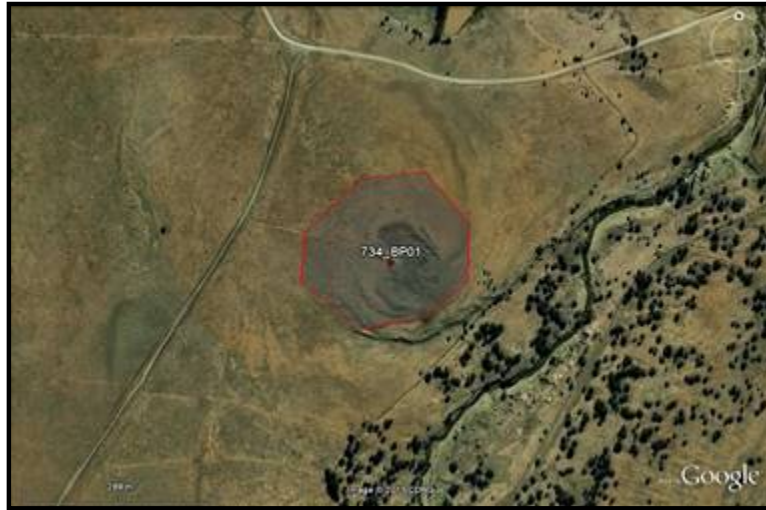
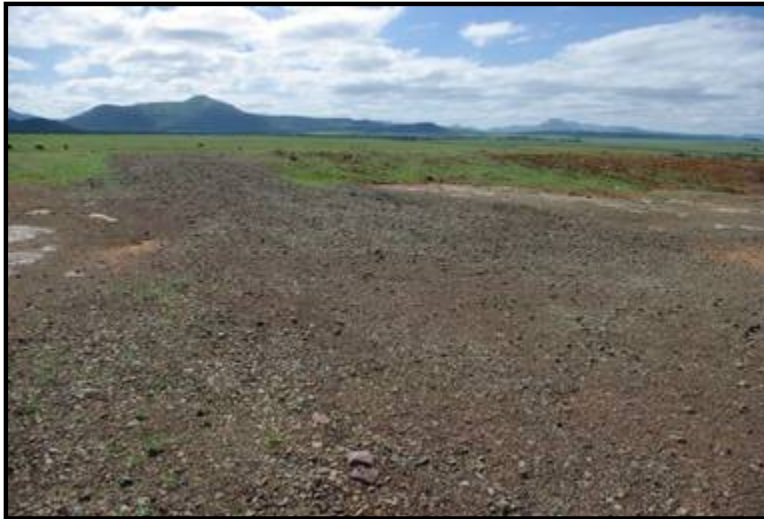
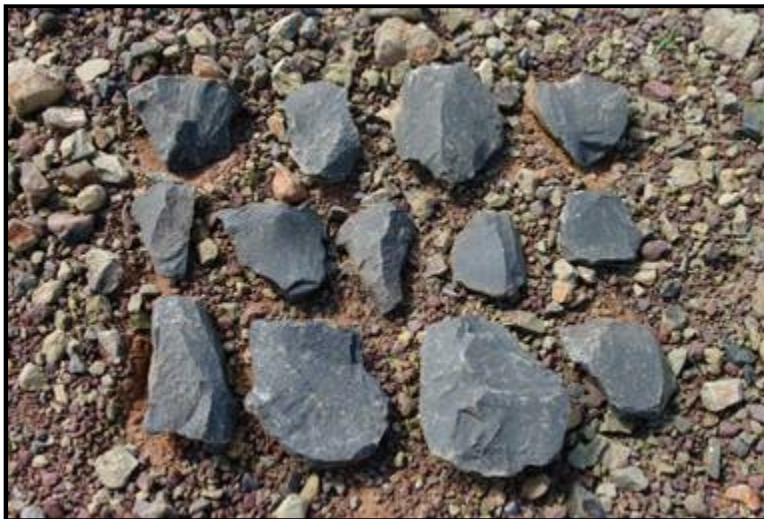
**Figure 39: Borrow Pit 734\_BP01**

A particularly low quantity of lithic artefacts, too low to ascribe an artefact ratio (artefacts: m<sup>2</sup>), were identified across the surface of the general borrow pit 734\_BP01 terrain. Surface artefacts were produced from lydianite (baked shale) and primarily ascribable to a very late MSA or macrolithic LSA typology. No stratigraphic context for these artefacts could be identified within exposed sections of the borrow pit, but their presence is inferred to be very closely linked to the topmost soil layer.

**RECOMMENDATIONS:** Stone Age deposits at borrow pit 734\_BP01 comprises of an archaeological and cultural heritage resource as defined and protected under the NHRA 1999. The lensed archaeological assemblage at the study site is ascribed a SAHRA LOW-MEDIUM SIGNIFICANCE and a GENERALLY PROTECTED C FIELD RATING.

**Figure 41:** The medium-rough grained dolomite (lens) intrusion in the primary shale sub-surface geological context

**Figure 42:** Selected artefacts from the shale lens

1. It is recommended that development at borrow pit 734\_BP01 be preceded by Phase 2 mitigation of the identified lensed MSA assemblage.
2. On site archaeological monitoring is recommended at the time of borrow pit exploitation to salvage and record artefacts that may well be encountered in lensed contexts.
3. Phase 2 archaeological mitigation and monitoring should be done by an ASAPA accredited CRM archaeologist under a SAHRA EXCAVATION PERMIT.

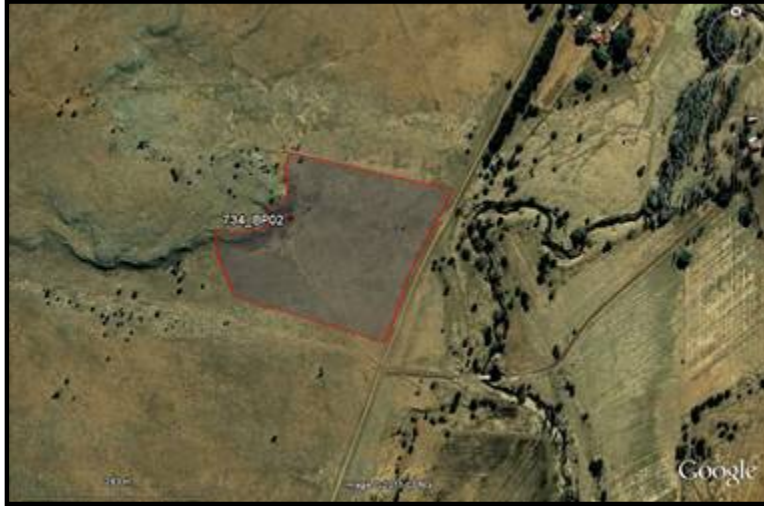
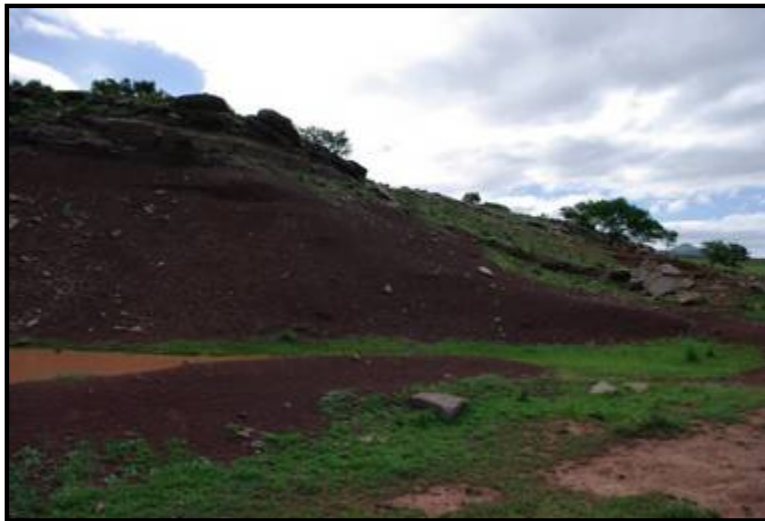
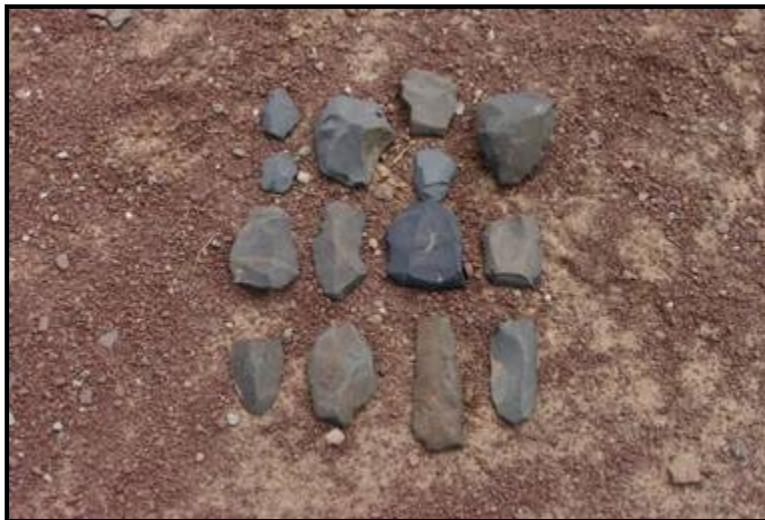
**Figure 43:** Borrow Pit 734\_BP02

An extremely low quantity of lithic artefacts, too low to attempt an artefact ratio (artefacts: m<sup>2</sup>), were encountered on the plain towards the east of borrow pit 734\_BP02. Based on typology and technology artefacts can be ascribed to a very late Middle Stone Age (MSA) or macrolithic Later Stone Age (LSA) temporal assignment, with fairly small flakes and blades dominating samples encountered. Artefacts were produced from a very fine grained dolorite. Towards the north-east, and in direct proximity to the borrow pit a cluster of artefacts, comprising of approximately 25-30 stone tools were found. The artefact cluster is however not associated with a paleosol or any other significant archaeological context and their presence are interpreted as a chance activity occurrence. No associated surface artefacts serves to enhance the significance of the find and no archaeological sub-surface context is inferred. Significant Stone Age activity may well have been centered closer to the Swart Klei River towards the east of the study site with samples sparsely scattered across the plain and at the cluster at the borrow pit interpreted as nothing more than extended site perimeter, evidencing fairly wide spread use of the palaeo-landscape.

**Figure 45:** General anthropically sterile surface and sections at the study site

**Figure 46:** A collection of artefacts from the cluster located north-east of the borrow pit

**RECOMMENDATIONS:** The low density MSA Stone Age 'feature' at borrow pit 734\_BP02 and the artefact scatter located north-east of the site comprises of archaeological and cultural heritage resources as defined and protected under the NHRA 1999. These 'features' are ascribed SAHRA LOW SIGNIFICANCE and GENERALLY PROTECTED C FIELD RATINGS. It is recommended that (relevant portions of) the 'features' be destroyed *in lieu* of the development without the developer having to apply for a SAHRA SITE DESTRUCTION PERMIT.

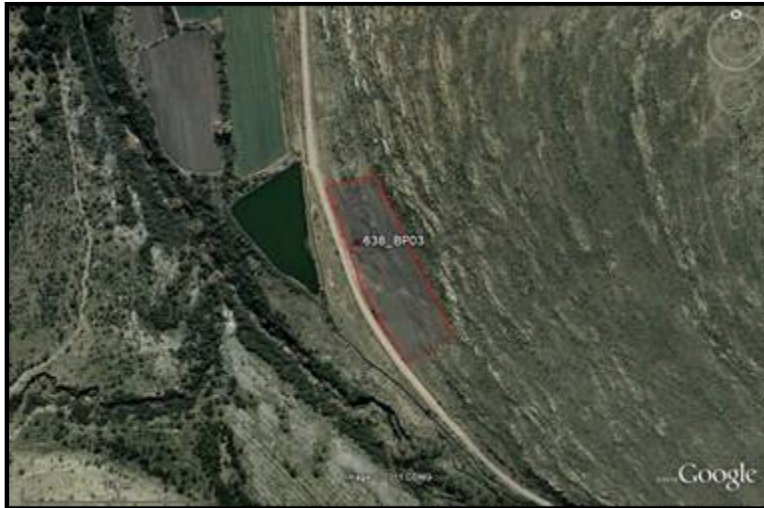
**Figure 48:** Borrow Pit 638\_BP03

No archaeological or cultural heritage resources, as defined and protected under the NHRA 1999, were identified on the surface or within exposed sub-surface sections during Phase 1 AIA assessment of borrow pit 638\_BP03.

**RECOMMENDATIONS:** It is recommended that use of borrow pit 638\_BP03 proceeds as applied for without the developer having to comply with additional heritage compliance requirements.

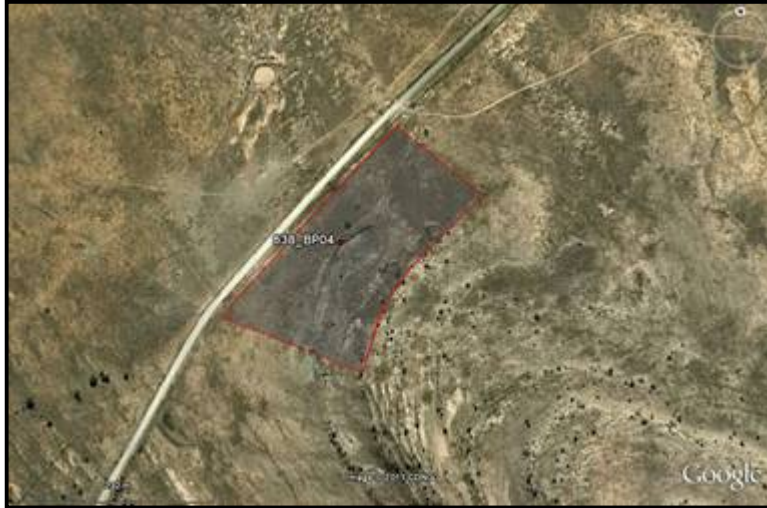
**Figure 50:** Borrow Pit 638\_BP04

No archaeological or cultural heritage resources, as defined and protected under the NHRA 1999, were identified on the surface or within exposed sub-surface sections during Phase 1 AIA assessment of borrow pit 638\_BP04.

**RECOMMENDATIONS:** It is recommended that use of borrow pit 638\_BP04 proceeds as applied for without the developer having to comply with additional heritage compliance requirements.

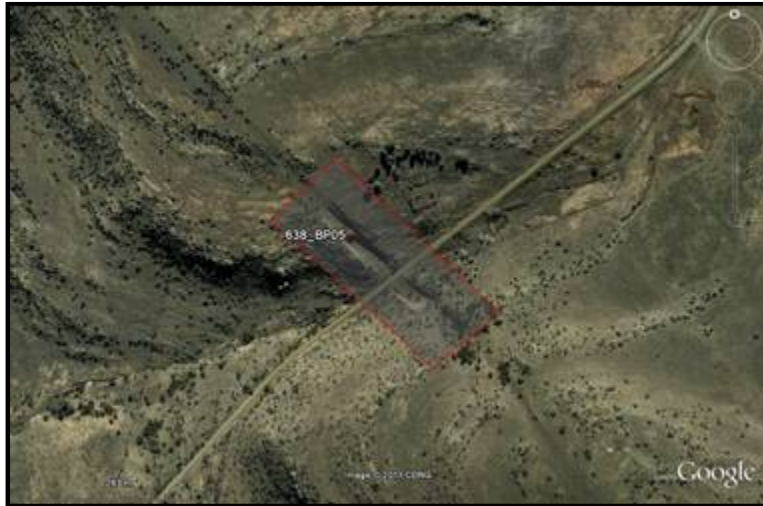
**Figure 52:** Borrow Pit 638\_BP05

No archaeological or cultural heritage resources, as defined and protected under the NHRA 1999, were identified on the surface or within exposed sub-surface sections during Phase 1 AIA assessment of borrow pit 638\_BP05.

**RECOMMENDATIONS:** It is recommended that use of borrow pit 638\_BP05 proceeds as applied for without the developer having to comply with additional heritage compliance requirements.

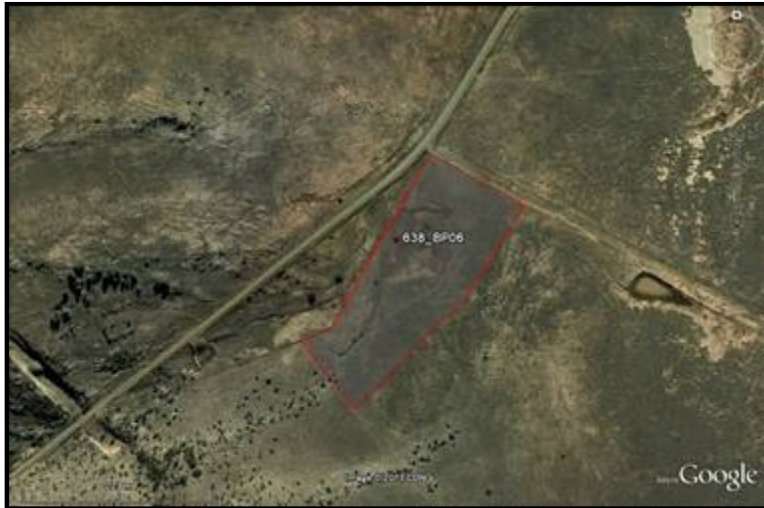
**Figure 54:** Borrow Pit 638\_BP06

No archaeological or cultural heritage resources, as defined and protected under the NHRA 1999, were identified on the surface or within exposed sub-surface sections during Phase 1 AIA assessment of borrow pit 638\_BP06.

**RECOMMENDATIONS:** It is recommended that use of borrow pit 638\_BP06 proceeds as applied for without the developer having to comply with additional heritage compliance requirements.

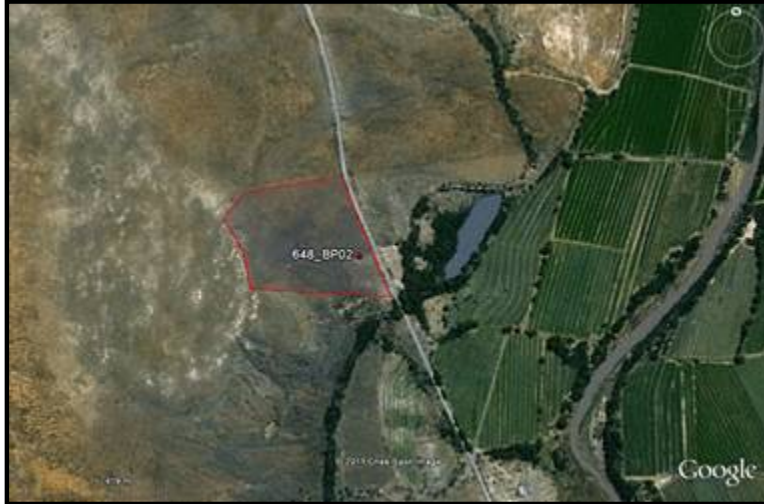
**Figure 59:** Borrow Pit 648\_BP02

No archaeological or cultural heritage resources, as defined and protected under the NHRA 1999, were identified on the surface or within exposed sub-surface sections during Phase 1 AIA assessment of borrow pit 648\_BP02.

**RECOMMENDATIONS:** It is recommended that use of borrow pit 648\_BP02 proceeds as applied for without the developer having to comply with additional heritage compliance requirements.

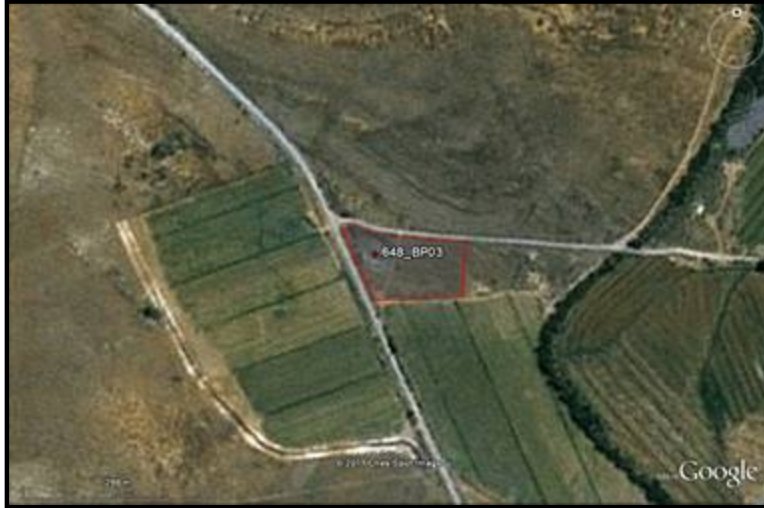
**Figure 61:** Borrow Pit 648\_BP03

No archaeological or cultural heritage resources, as defined and protected under the NHRA 1999, were identified on the surface or within exposed sub-surface sections during Phase 1 AIA assessment of borrow pit 648\_BP03.

**RECOMMENDATIONS:** It is recommended that use of borrow pit 648\_BP03 proceeds as applied for without the developer having to comply with additional heritage compliance requirements.

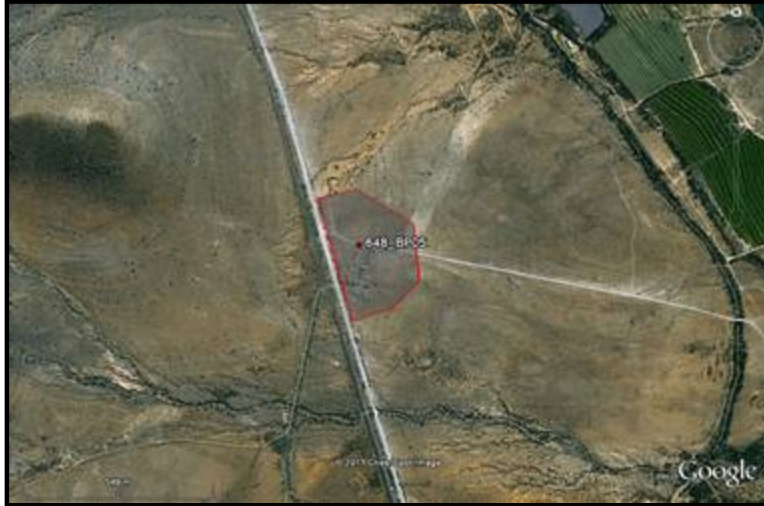
**Figure 63:** Borrow Pit 648\_BP05

No archaeological or cultural heritage resources, as defined and protected under the NHRA 1999, were identified on the surface or within exposed sub-surface sections during Phase 1 AIA assessment of borrow pit 648\_BP05.

**RECOMMENDATIONS:** It is recommended that use of borrow pit 648\_BP05 proceeds as applied for without the developer having to comply with additional heritage compliance requirements.

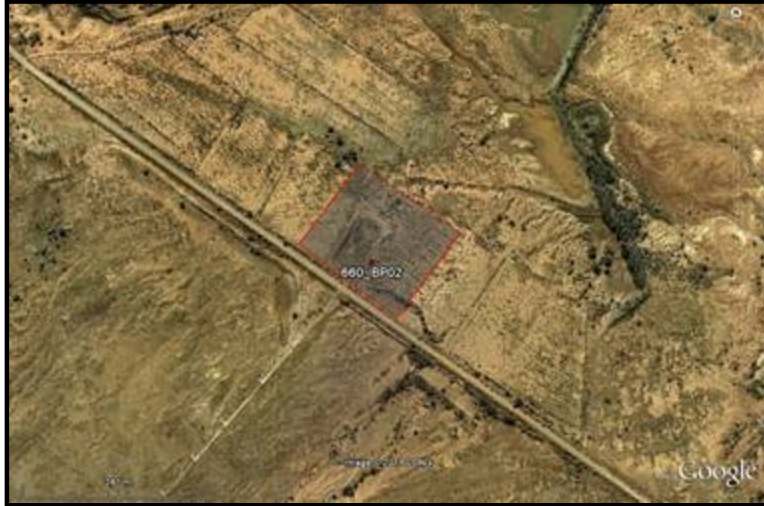
**Figure 66:** Borrow Pit 660\_BP02

The general borrow pit 660\_BP02 area is characterized by clusters of artefacts scattered together in patches varying between 16m<sup>2</sup>-25m<sup>2</sup> in size. Patches of artefacts contained fairly high quantities of lithics, in general varying from 10-17:1 in ratio (artefacts: m<sup>2</sup>). The dominant raw material used to produce artefacts comprise of lydianite (baked shale) and to a much lesser extent fine grained dolorite. Typologically and technologically the collections of artefacts are all ascribed to the latter part of the Middle Stone Age (MSA) or a macrolithic Later Stone Age (LSA), based primarily on artefact size. The collection contains some larger blade and bladelet types, but is dominated by smaller amorphous flakes and scrapers. Exposed sections of the borrow pit yielded a clear stratigraphy wherein the anthropic member is directly associated with the topmost approximate 10cm red-brown layer. The general good technological quality of the artefacts is directly ascribable to the raw material used.

**RECOMMENDATIONS:** Stone Age deposits at borrow pit 660\_BP02 comprises of an archaeological and cultural heritage resource as defined and protected under the NHRA 1999. Lithic assemblages at the study site are ascribed a SAHRA MEDIUM SIGNIFICANCE and a GENERALLY PROTECTED B FIELD RATING.

1. It is recommended that development at borrow pit 660\_BP02 be preceded by Phase 2 mitigation.
2. Phase 2 archaeological mitigation should be done by an ASAPA accredited CRM archaeologist under a SAHRA EXCAVATION PERMIT.
