PHASE 1 ARCHAEOLOGICAL IMPACT ASSESSMENT

**UTILIZATION OF BORROW PITS –  
CHRIS HANI DISTRICT MUNICIPALITY,  
EASTERN CAPE, SOUTH AFRICA**

**DATE:** 2011-03-01

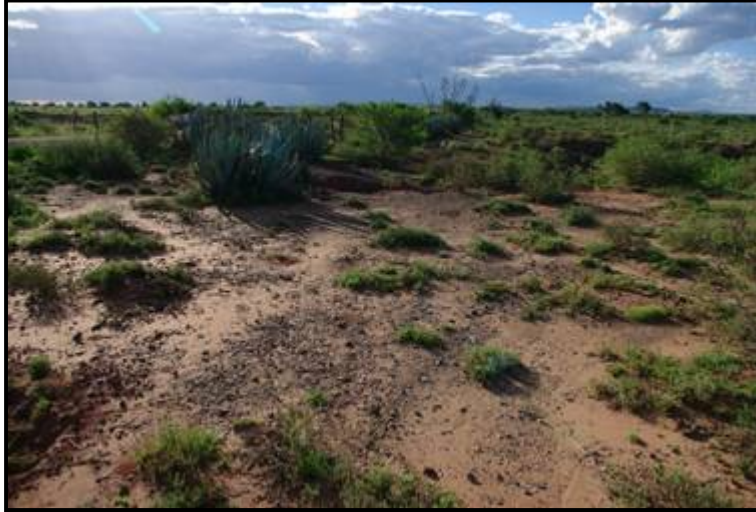
The general borrow pit 660\_BP02 area is characterized by clusters of artefacts scattered together in patches varying between 16m<sup>2</sup>-25m<sup>2</sup> in size. Patches of artefacts contained fairly high quantities of lithics, in general varying from 10-17:1 in ratio (artefacts: m<sup>2</sup>). The dominant raw material used to produce artefacts comprise of lydianite (baked shale) and to a much lesser extent fine grained dolorite. Typologically and technologically the collections of artefacts are all ascribed to the latter part of the Middle Stone Age (MSA) or a macrolithic Later Stone Age (LSA), based primarily on artefact size. The collection contains some larger blade and bladelet types, but is dominated by smaller amorphous flakes and scrapers. Exposed sections of the borrow pit yielded a clear stratigraphy wherein the anthropic member is directly associated with the topmost approximate 10cm red-brown layer. The general good technological quality of the artefacts is directly ascribable to the raw material used.

**Figure 67:** An artefact scatter characterizing the general borrow pit 660\_BP02 area

1. It is recommended that development at borrow pit 660\_BP02 be preceded by Phase 2 mitigation.
2. Phase 2 archaeological mitigation should be done by an ASAPA accredited CRM archaeologist under a SAHRA EXCAVATION PERMIT.

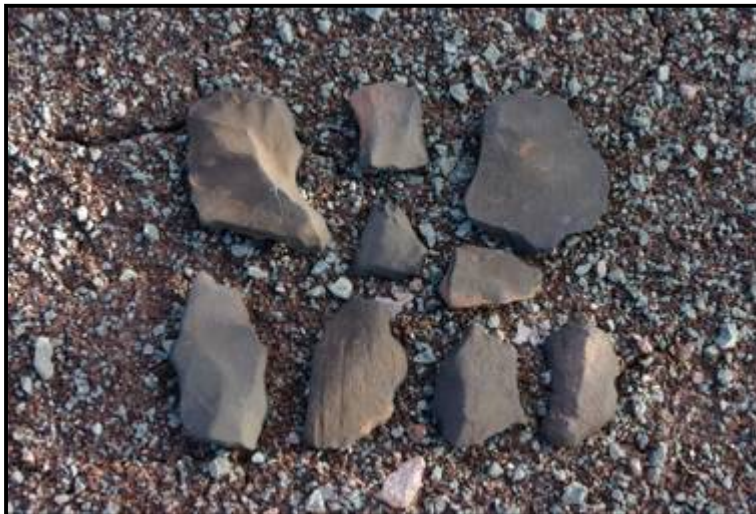
**Figure 68:** Selected artefacts from the study site

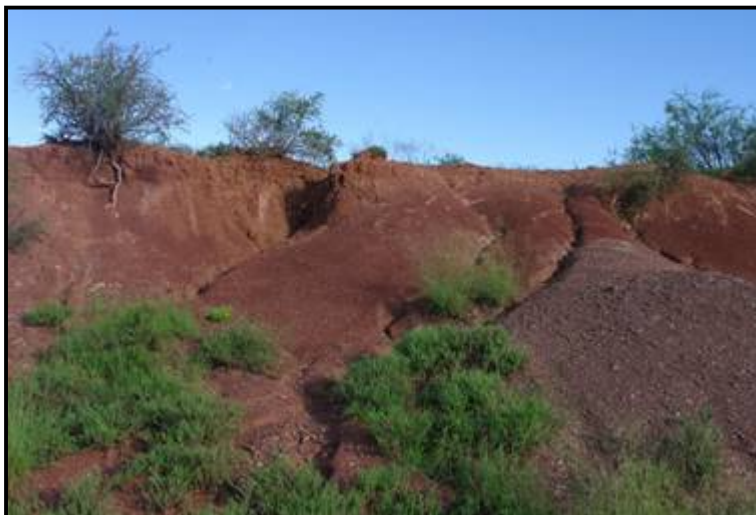
**Figure 69:** Borrow pit stratigraphy – the anthropic member is confined to the top approximate 10cm layer

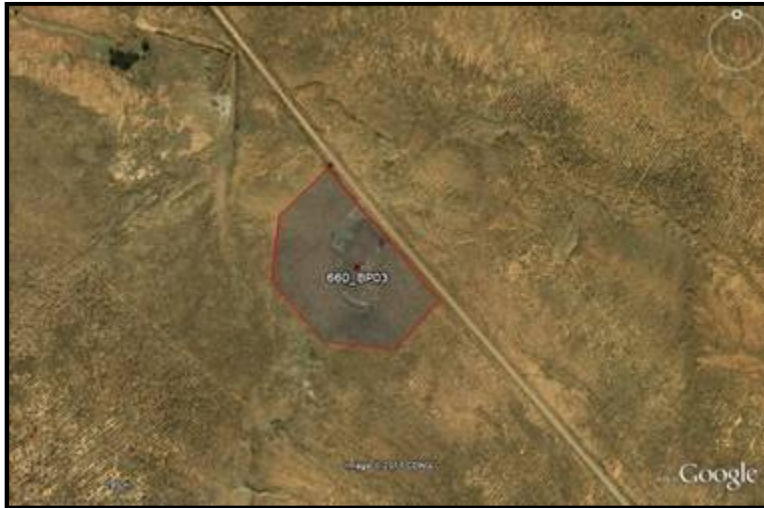
**Figure 70:** Borrow Pit 660\_BP03

No archaeological or cultural heritage resources, as defined and protected under the NHRA 1999, were identified on the surface or within exposed sub-surface sections during Phase 1 AIA assessment of borrow pit 660\_BP03.

**RECOMMENDATIONS:** It is recommended that use of borrow pit 660\_BP03 proceeds as applied for without the developer having to comply with additional heritage compliance requirements.

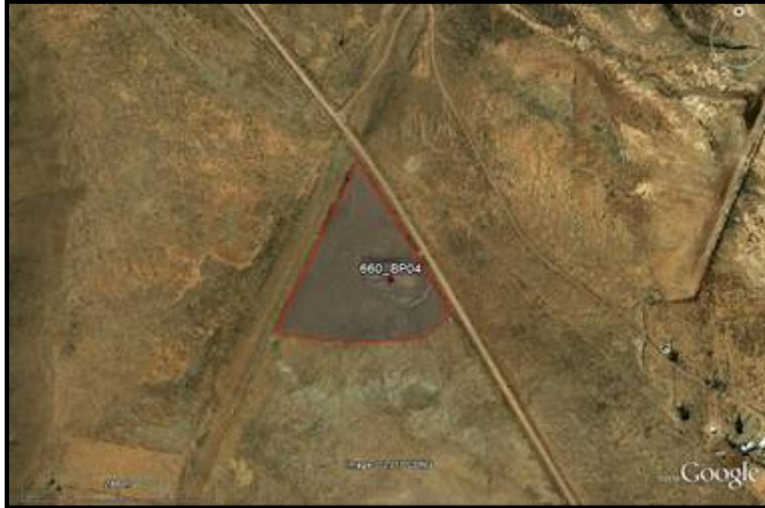
**Figure 72:** Borrow Pit 660\_BP04

No archaeological or cultural heritage resources, as defined and protected under the NHRA 1999, were identified on the surface or within exposed sub-surface sections during Phase 1 AIA assessment of borrow pit 660\_BP04.

**RECOMMENDATIONS:** It is recommended that use of borrow pit 660\_BP04 proceeds as applied for without the developer having to comply with additional heritage compliance requirements.

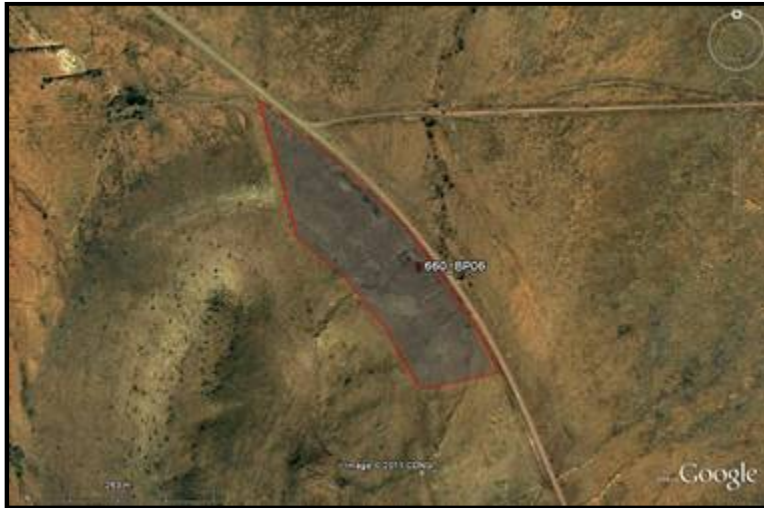
**Figure 74:** Borrow Pit 660\_BP06

No archaeological or cultural heritage resources, as defined and protected under the NHRA 1999, were identified on the surface or within exposed sub-surface sections during Phase 1 AIA assessment of borrow pit 660\_BP06.

**RECOMMENDATIONS:** It is recommended that use of borrow pit 660\_BP06 proceeds as applied for without the developer having to comply with additional heritage compliance requirements.

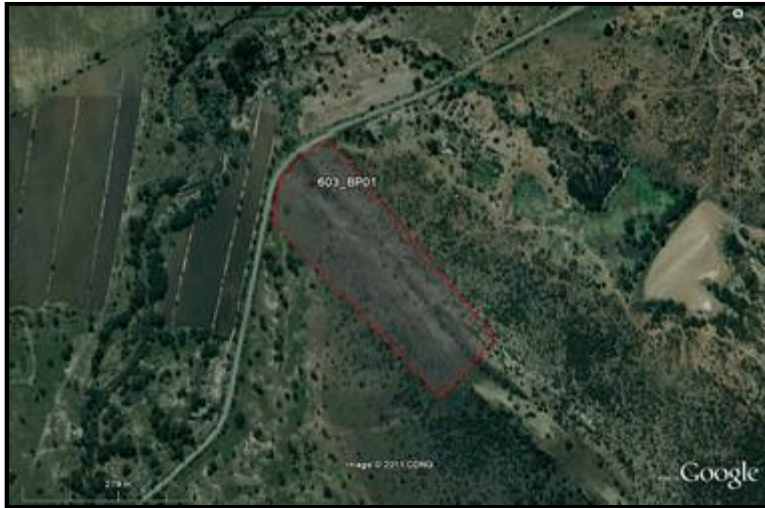
**Figure 77:** Borrow Pit 603\_BP01

No archaeological or cultural heritage resources, as defined and protected under the NHRA 1999, were identified on the surface or within exposed sub-surface sections during Phase 1 AIA assessment of borrow pit 603\_BP01.

**RECOMMENDATIONS:** It is recommended that use of borrow pit 603\_BP01 proceeds as applied for without the developer having to comply with additional heritage compliance requirements.

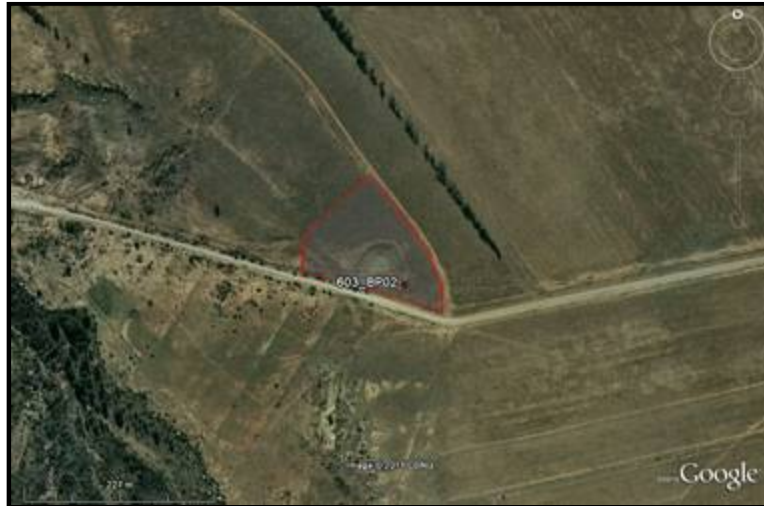
**Figure 79:** Borrow Pit 603\_BP02

A low density of Stone Age artefacts were found scattered amongst clusters of stone rich surface deposits appearing patch-patch on the surface of the general borrow pit 603\_BP02 area. Artefact densities within these scatters of stone rich deposits remained fairly low, on average not exceeding ratios of 3-4:1 (artefacts: m<sup>2</sup>) where present, but receding in quantity from the abovementioned ratio and absent within other areas. Identified artefacts had a noticeable rolled appearance. Based primarily on size, typology and technology the assemblage is ascribed an earlier to middle Middle Stone Age (MSA) assignment. Artefacts were produced from the variety of raw material present in the surface gravels. Borrow pit stratigraphy did not reveal a definite artefact member; artefacts may be loosely associated with the approximate top 20cm red-brown member, implying that a stone scatter was simply not exposed in situ section at the time of the assessment. Alternatively the artefact occurrence may be associated with a lagged deposit restricted to surface stone rich gravel occurrences and implying that the context of the assemblage has already been lost. The borrow pit 603\_BP02 artefact occurrence represents a low density Stone Age 'feature' rather than a 'site'.

**RECOMMENDATIONS:** The low density MSA Stone Age 'feature' at borrow pit 603\_BP02 comprises of an archaeological and cultural heritage resource as defined and protected under the NHRA 1999. The 'feature' is ascribed a SAHRA LOW SIGNIFICANCE and GENERALLY PROTECTED C FIELD RATING. It is recommended that (relevant portions of) the 'feature' be destroyed *in lieu* of the development without the developer having to apply for a SAHRA SITE DESTRUCTION PERMIT.

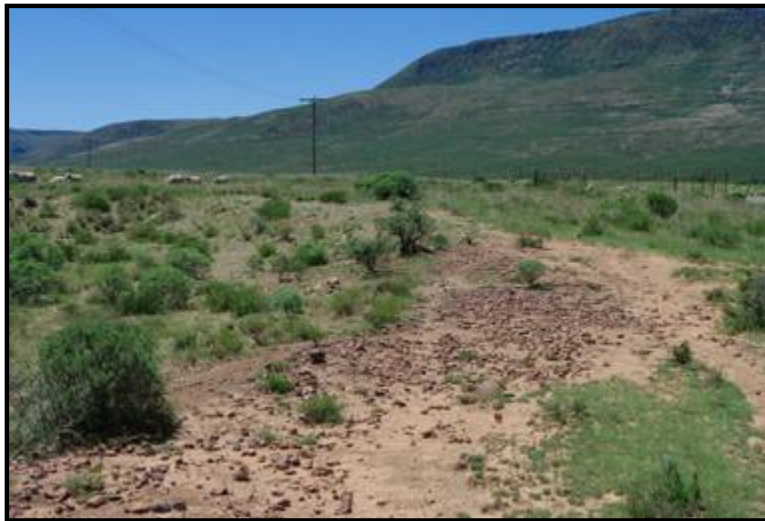
**Figure 81:** Stone rich surface scattered amongst which artefacts occurred

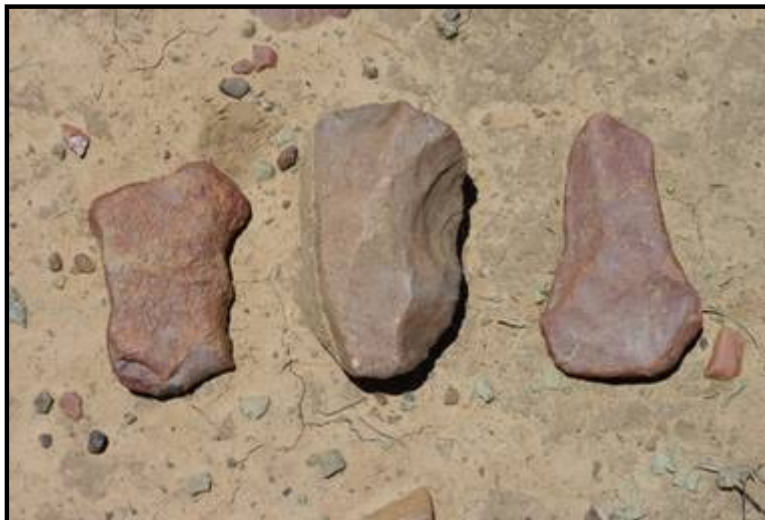
**Figure 82:** A selection of artefacts from the borrow pit 603\_BP02 area

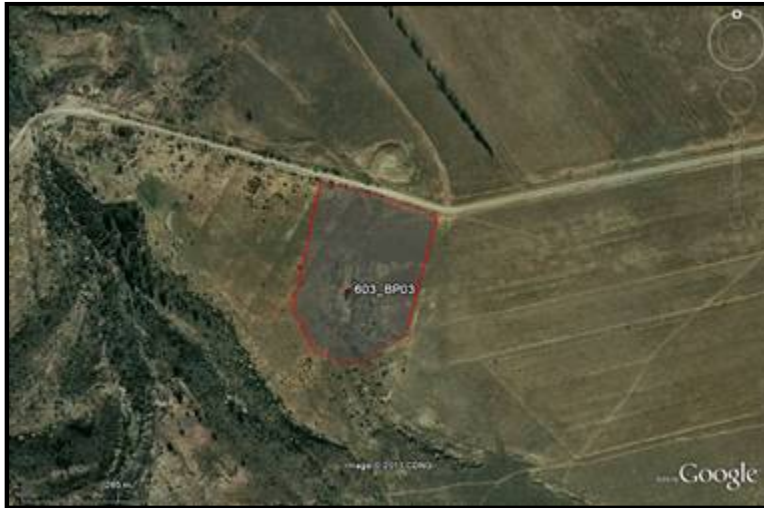
**Figure 83:** Borrow Pit 603\_BP03

Only a few artefacts were collected from the surface of the general borrow pit 603\_BP03 study site, with artefact ratios (artefacts: m<sup>2</sup>) by implication too low to attempt an approximate value. Encountered artefacts were in general fairly large. The find implies a continuation, albeit in even lower distribution, of the occurrence recorded at the borrow pit 603\_BP02 study site, situated immediately north of borrow pit 603\_BP03. The few lithics at the borrow pit 603\_BP03 study site is again, based on size, typology and technology, ascribed to the earlier to middle Middle Stone Age (MSA). Particularly low quantities of artefacts indicated a clear decrease in artefact ratios from low densities recorded at the borrow pit 603\_BP02 study site, while no possibility of a sub-surface context is inferred: No artefacts were found in exposed sections at the borrow pit itself, while inspection of piles of stones aligned to the east of the site and representing collected sub-surface stones yielded no artefacts.

**RECOMMENDATIONS:** The low density of MSA Stone Age lithics encountered at borrow pit 603\_BP03 is inferred to represent the perimeter of the 'feature' recorded at the borrow pit 603\_BP02 study site, and thus representing a continuation thereof. As for borrow pit 603\_BP02, the perimeter of the low density 'feature' recorded at the borrow pit 603\_BP03 study site is ascribed a SAHRA LOW SIGNIFICANCE and GENERALLY PROTECTED C FIELD RATING. It is recommended that development at the site proceeds without the developer having to apply for a SAHRA SITE DESTRUCTION PERMIT.

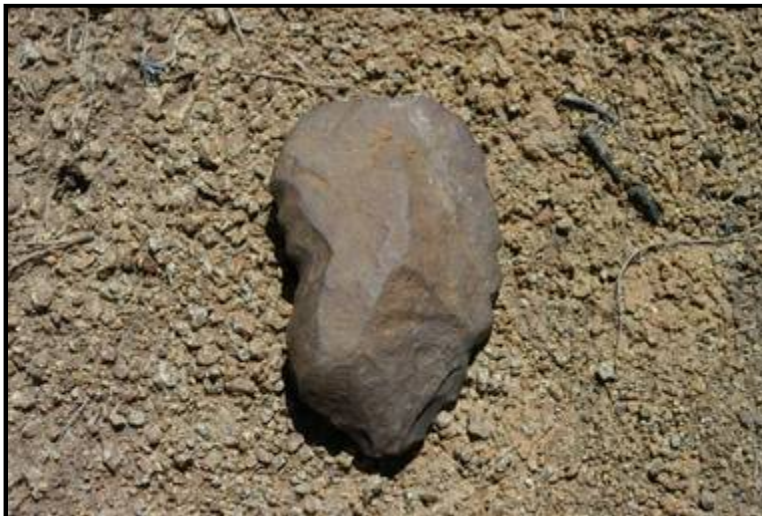
**Figure 85:** One of the few artefacts encountered at the borrow pit 603\_BP03 study site

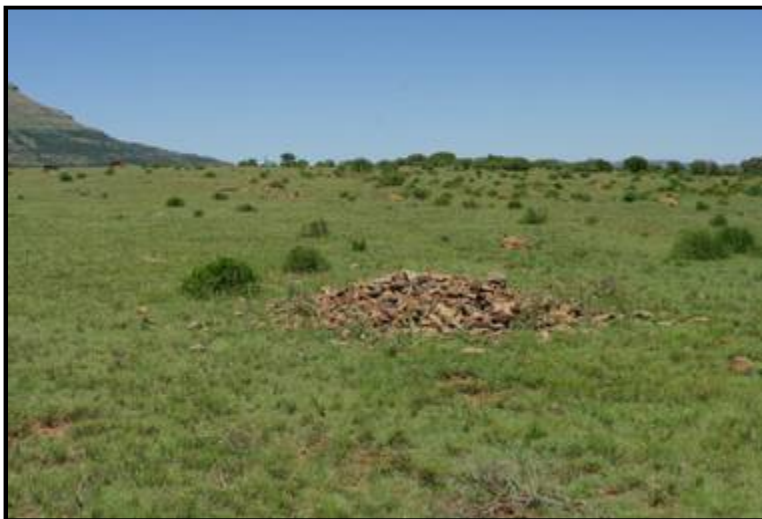
**Figure 86:** No artefacts were encountered within piles of stone located east of the borrow pit

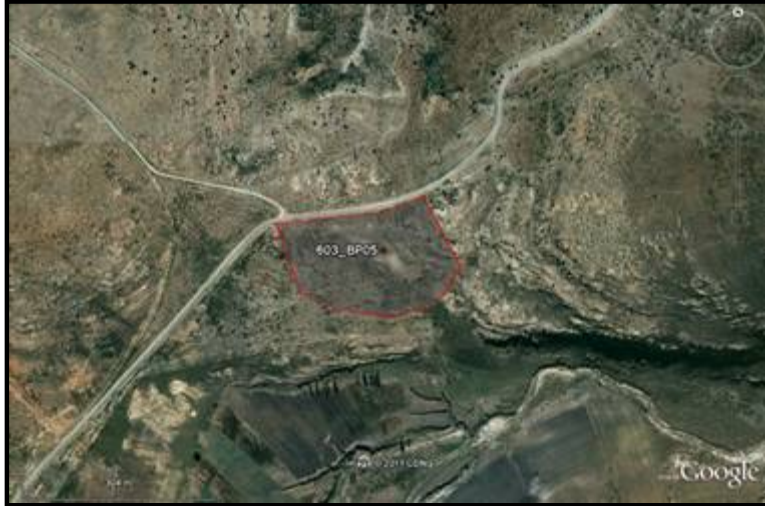
**Figure 87:** Borrow Pit 603\_BP05

No archaeological or cultural heritage resources, as defined and protected under the NHRA 1999, were identified on the surface or within exposed sub-surface sections during Phase 1 AIA assessment of borrow pit 603\_BP05.

**RECOMMENDATIONS:** It is recommended that use of borrow pit 603\_BP05 proceeds as applied for without the developer having to comply with additional heritage compliance requirements.

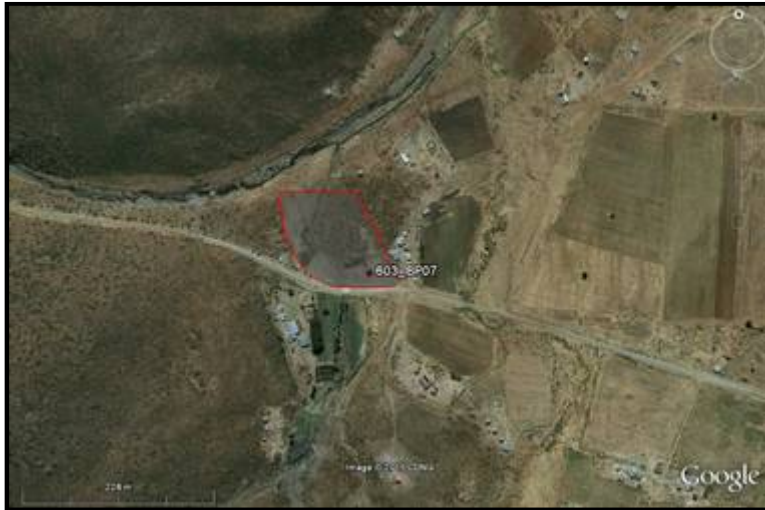
**Figure 89:** Borrow Pit 603\_BP07

No archaeological or cultural heritage resources, as defined and protected under the NHRA 1999, were identified on the surface or within exposed sub-surface sections during Phase 1 AIA assessment of borrow pit 603\_BP07.

**RECOMMENDATIONS:** It is recommended that use of borrow pit 603\_BP07 proceeds as applied for without the developer having to comply with additional heritage compliance requirements.

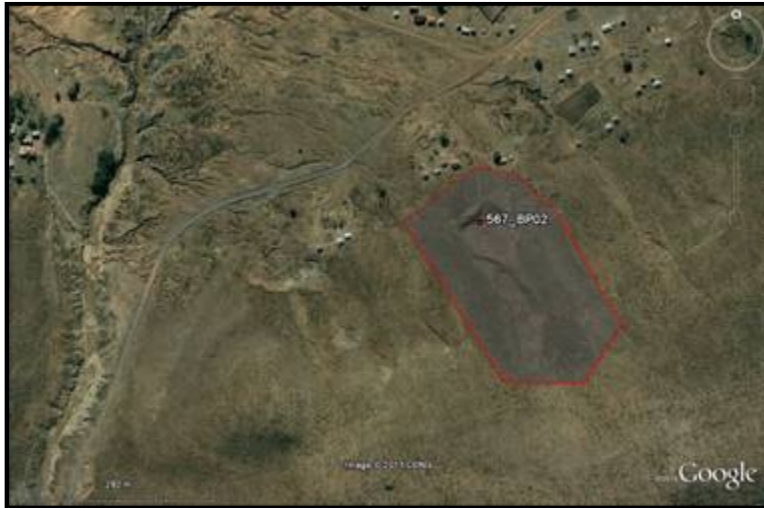
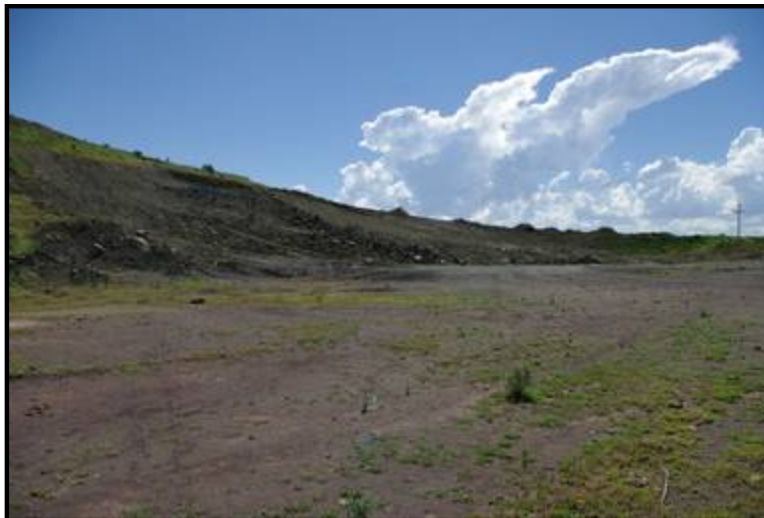
**Figure 92:** Borrow Pit 567\_BP02

No archaeological or cultural heritage resources, as defined and protected under the NHRA 1999, were identified on the surface or within exposed sub-surface sections during Phase 1 AIA assessment of borrow pit 567\_BP02.

**RECOMMENDATIONS:** It is recommended that use of borrow pit 567\_BP02 proceeds as applied for without the developer having to comply with additional heritage compliance requirements.

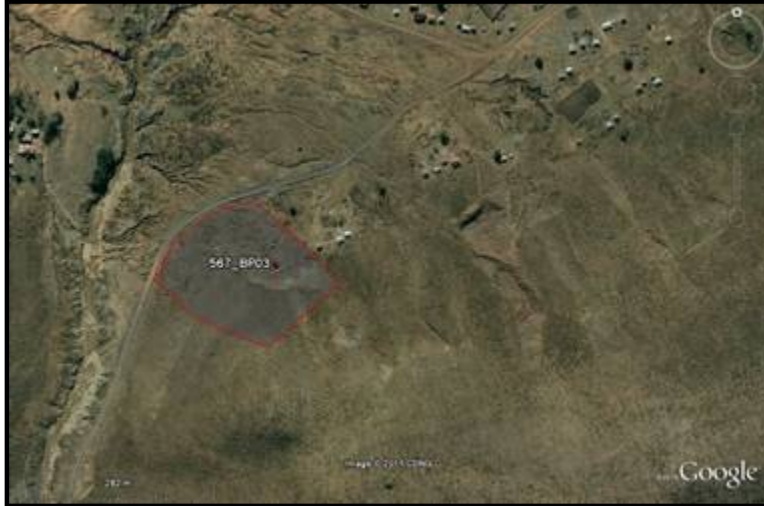
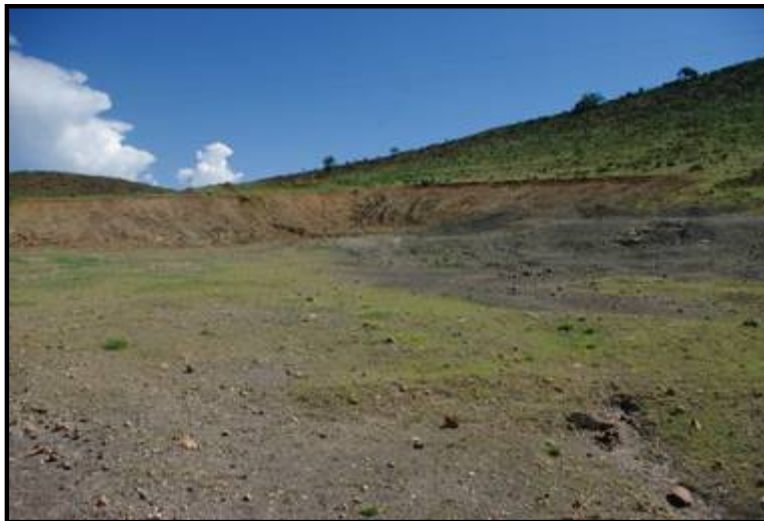
**Figure 94:** Borrow Pit 567\_BP03

No archaeological or cultural heritage resources, as defined and protected under the NHRA 1999, were identified on the surface or within exposed sub-surface sections during Phase 1 AIA assessment of borrow pit 567\_BP03.

**RECOMMENDATIONS:** It is recommended that use of borrow pit 567\_BP03 proceeds as applied for without the developer having to comply with additional heritage compliance requirements.

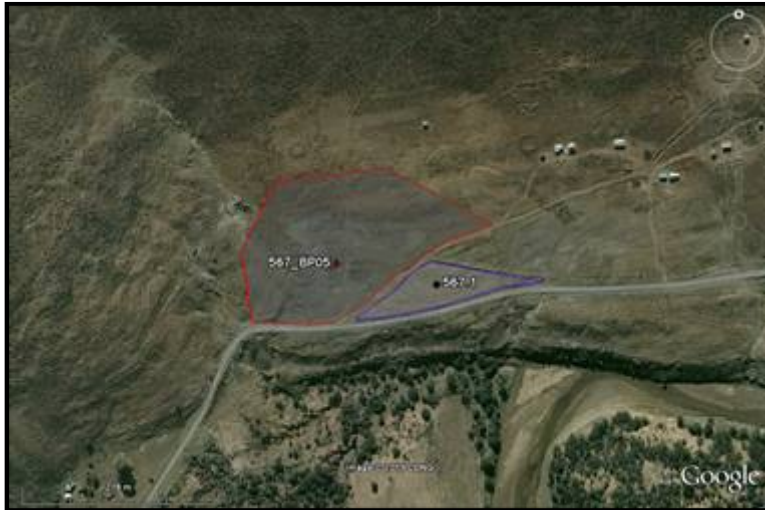
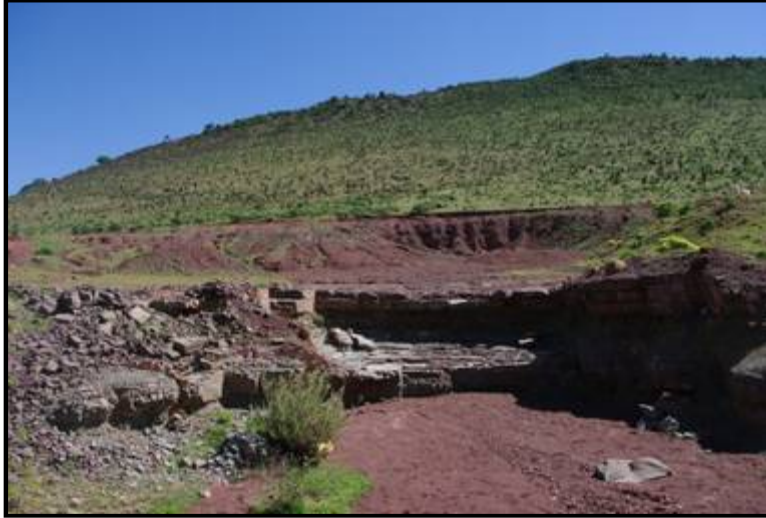
**Figure 96:** Borrow Pit 567\_BP05

No archaeological or cultural heritage resources, as defined and protected under the NHRA 1999, were identified on the surface or within exposed sub-surface sections during Phase 1 AIA assessment of borrow pit 567\_BP05.

Towards the south-east of the study site remains of what seems to be fairly ephemeral and quite recent Iron Age tradition remnants are present, characterized by stone foundation remains of circular and rectangular stock enclosures and a few huts. Wall remains were broken down / deteriorated to ground level and the general stone rich environment made identification of features almost impossible. It is inferred that the site have only been used for a brief period after which the emphasis probably moved north as evidenced by clear indications of stock enclosures towards the north of the study site, many of which are still in use today. No date can be assigned to the site, but based on general feature foundation evidence it is inferred that the site most probably do not have significant archaeological time depth and that the site was most probably only fairly recently occupied for a brief period (in a manner similar to what have been reported on regarding settlement of the general area, see van Ryneveld 2010a and 2010b). Despite the lack of inferred archaeological significance of the site graves may well be present and it is recommended that the general Site 567.1 terrain be conserved in situ.

**RECOMMENDATIONS:** Site 567.1 most probably post-dates archaeological temporal depth, no SAHRA Site Significance assignation is thus of relevance to the essentially contemporary heritage site. However, graves may well be present, a resource formally protected under the NHRA 1999. Graves would be assigned a SAHRA MEDIUM SIGNIFICANCE and a GENERALLY PROTECTED B FIELD RATING. Quarrying activities at borrow pit 567\_BP05 will not impact on Site 567.1: It is recommended that Site 567.1 be conserved in situ.

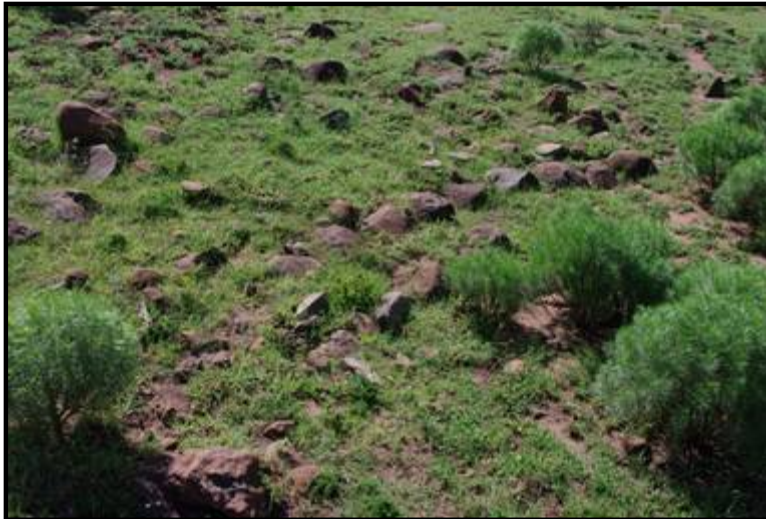
**Figure 98:** Foundation remains at Site 567.1

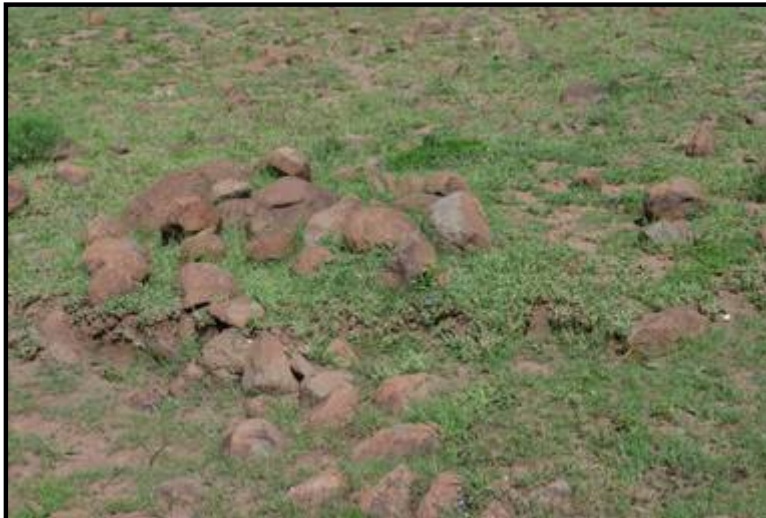
**Figure 99:** A possible grave from Site 567.1, but mound morphology remains dubious

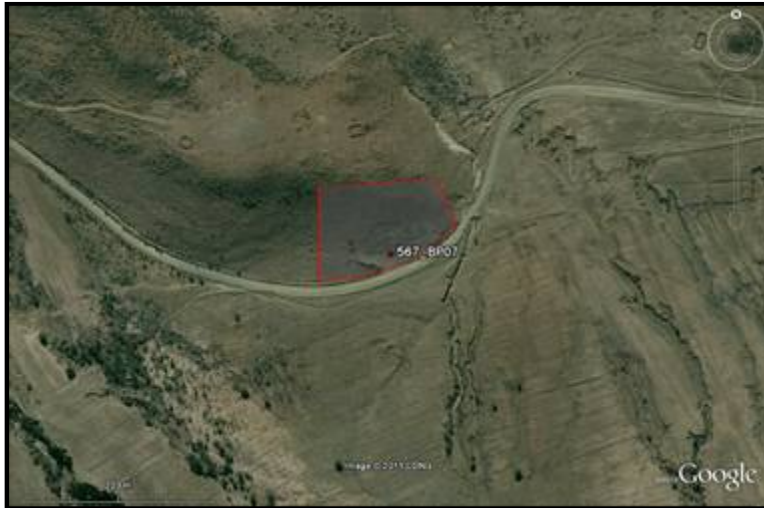
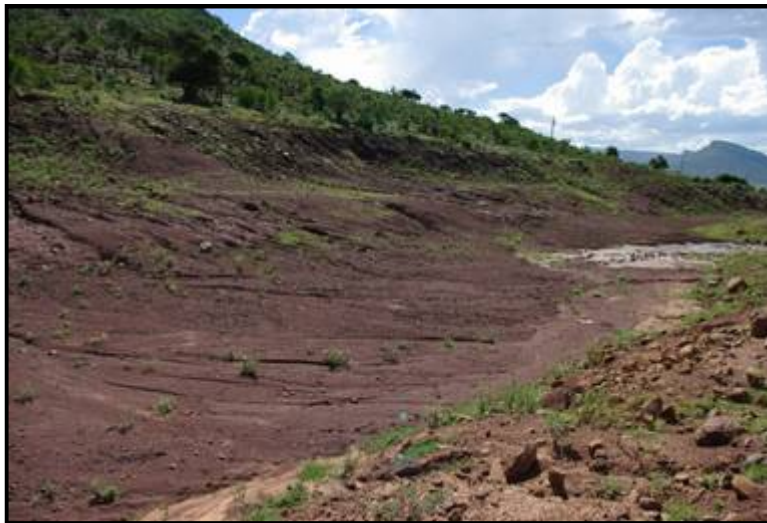
**Figure 100:** Borrow Pit 567\_BP07

No archaeological or cultural heritage resources, as defined and protected under the NHRA 1999, were identified on the surface or within exposed sub-surface sections during Phase 1 AIA assessment of borrow pit 567\_BP07.

**RECOMMENDATIONS:** It is recommended that use of borrow pit 567\_BP07 proceeds as applied for without the developer having to comply with additional heritage compliance requirements.

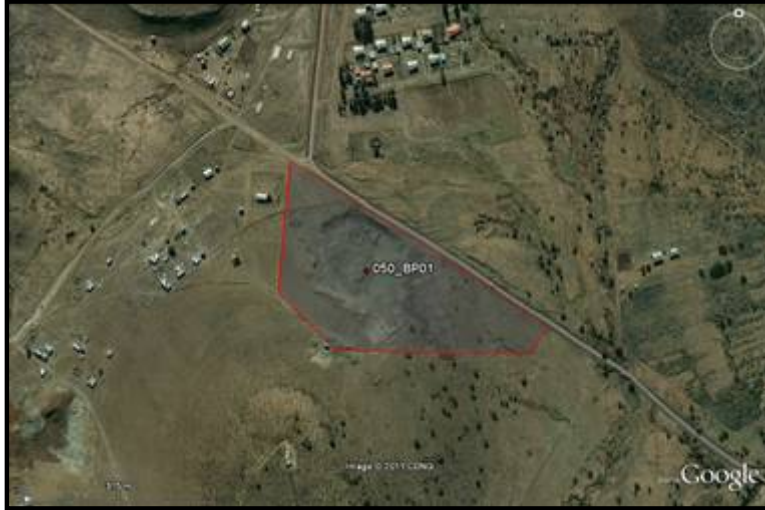
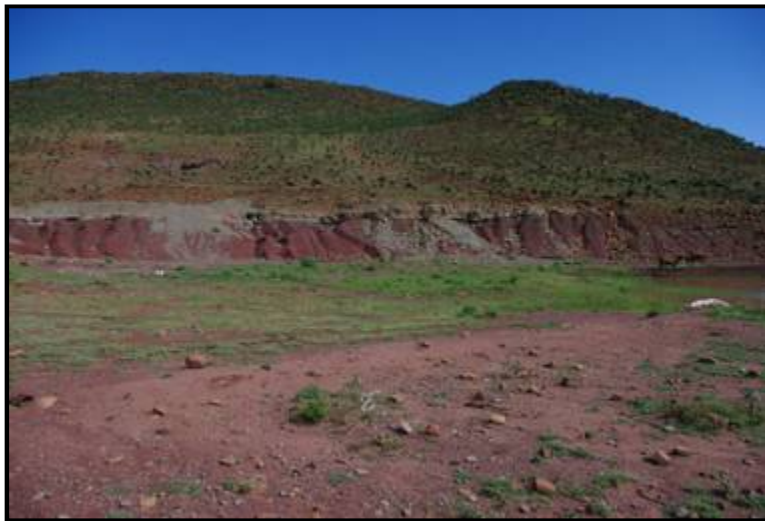
**Figure 103:** Borrow Pit 050\_BP01

No archaeological or cultural heritage resources, as defined and protected under the NHRA 1999, were identified on the surface or within exposed sub-surface sections during Phase 1 AIA assessment of borrow pit 050\_BP01.

**RECOMMENDATIONS:** It is recommended that use of borrow pit 050\_BP01 proceeds as applied for without the developer having to comply with additional heritage compliance requirements.

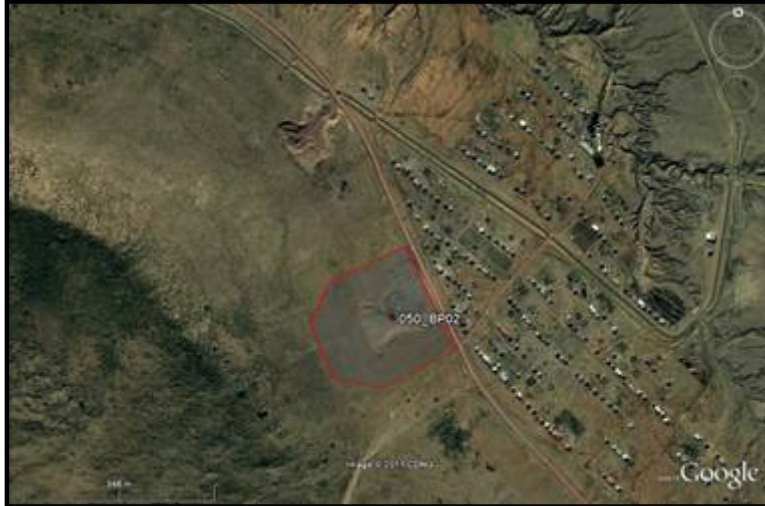
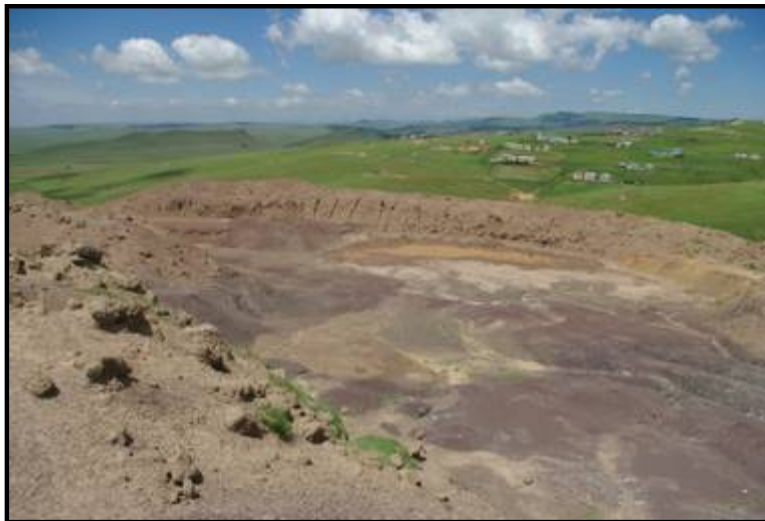
**Figure 105:** Borrow Pit 050\_BP02

No archaeological or cultural heritage resources, as defined and protected under the NHRA 1999, were identified on the surface or within exposed sub-surface sections during Phase 1 AIA assessment of borrow pit 050\_BP02.

**RECOMMENDATIONS:** It is recommended that use of borrow pit 050\_BP02 proceeds as applied for without the developer having to comply with additional heritage compliance requirements.

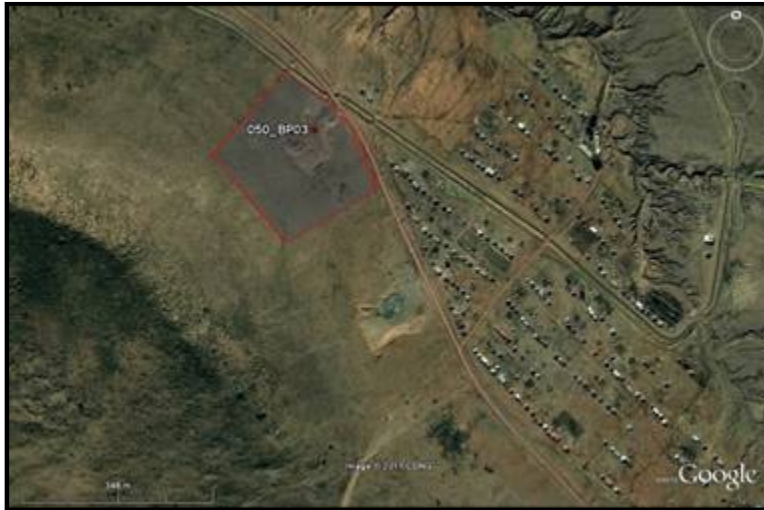
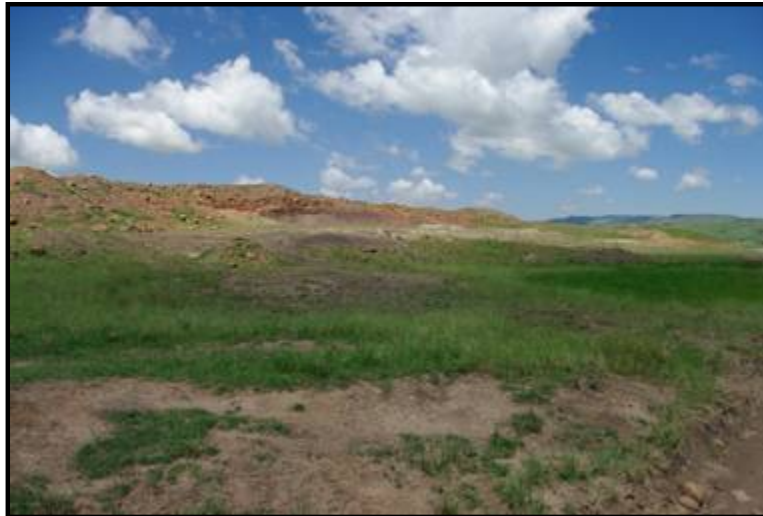
**Figure 107:** Borrow Pit 050\_BP03

No archaeological or cultural heritage resources, as defined and protected under the NHRA 1999, were identified on the surface or within exposed sub-surface sections during Phase 1 AIA assessment of borrow pit 050\_BP03.

**RECOMMENDATIONS:** It is recommended that use of borrow pit 050\_BP03 proceeds as applied for without the developer having to comply with additional heritage compliance requirements.

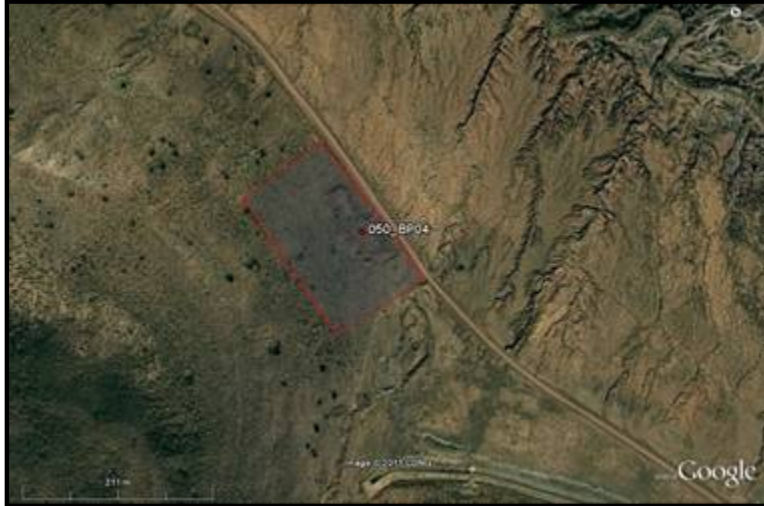
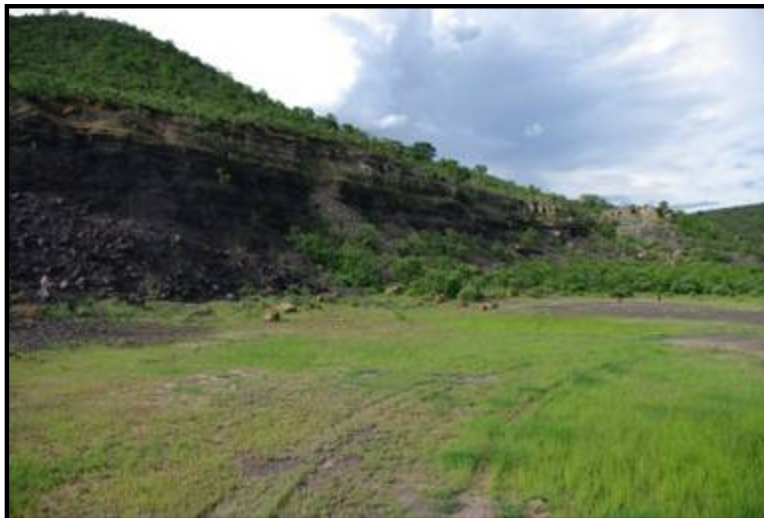
**Figure 109:** Borrow Pit 050\_BP04

No archaeological or cultural heritage resources, as defined and protected under the NHRA 1999, were identified on the surface or within exposed sub-surface sections during Phase 1 AIA assessment of borrow pit 050\_BP04.

**RECOMMENDATIONS:** It is recommended that use of borrow pit 050\_BP04 proceeds as applied for without the developer having to comply with additional heritage compliance requirements.

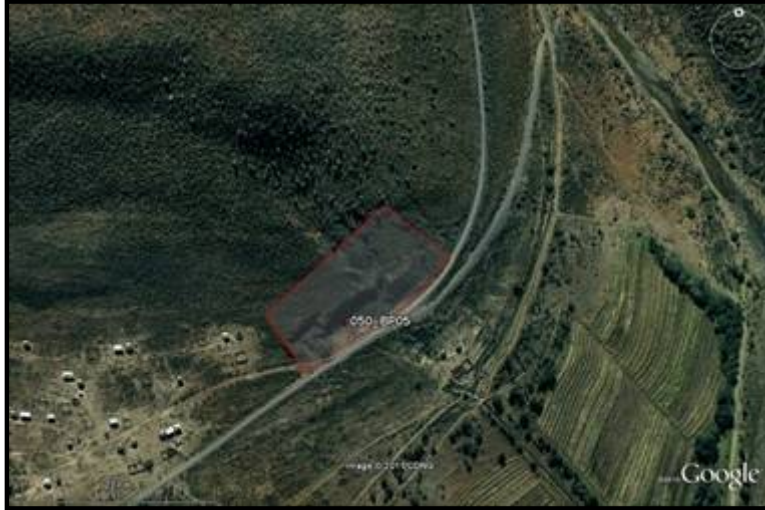
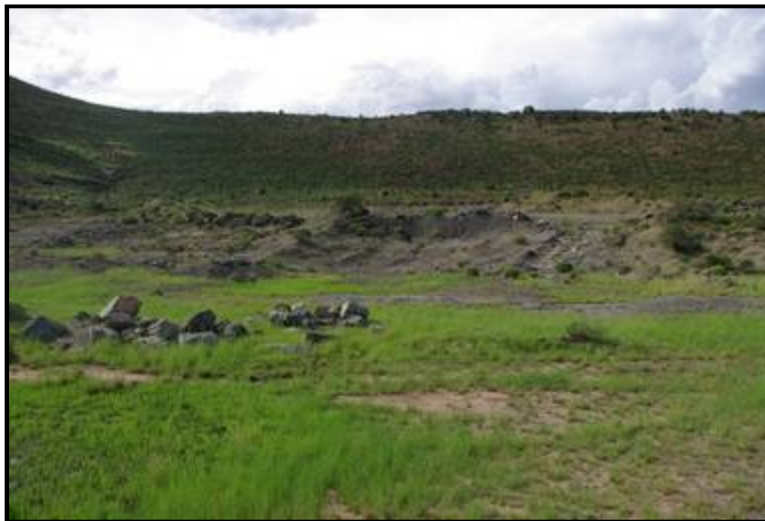
**Figure 111:** Borrow Pit 050\_BP05

No archaeological or cultural heritage resources, as defined and protected under the NHRA 1999, were identified on the surface or within exposed sub-surface sections during Phase 1 AIA assessment of borrow pit 050\_BP05.

**RECOMMENDATIONS:** It is recommended that use of borrow pit 050\_BP05 proceeds as applied for without the developer having to comply with additional heritage compliance requirements.

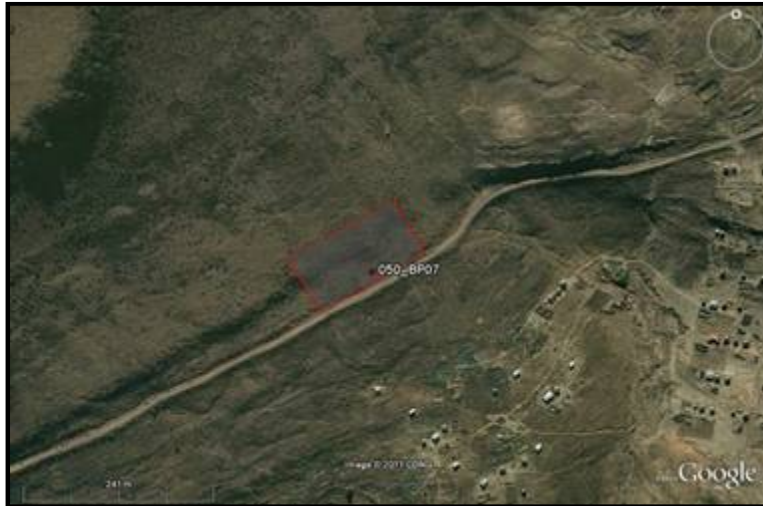
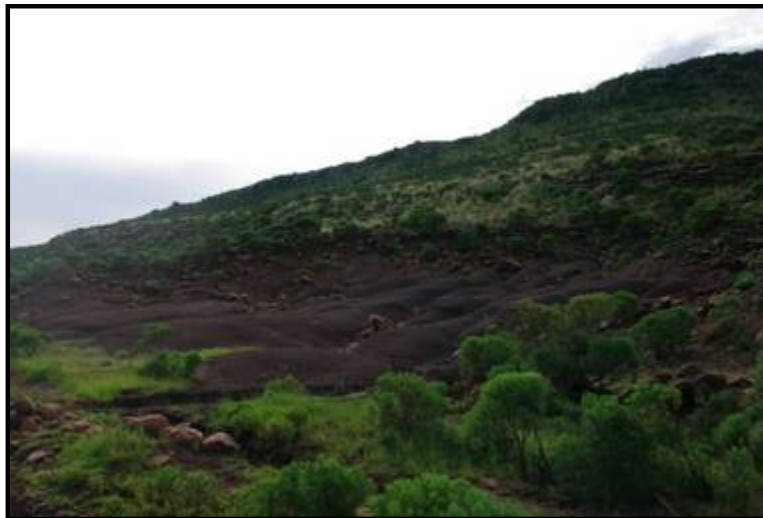
**Figure 113:** Borrow Pit 050\_BP07

No archaeological or cultural heritage resources, as defined and protected under the NHRA 1999, were identified on the surface or within exposed sub-surface sections during Phase 1 AIA assessment of borrow pit 050\_BP07.

**RECOMMENDATIONS:** It is recommended that use of borrow pit 050\_BP07 proceeds as applied for without the developer having to comply with additional heritage compliance requirements.

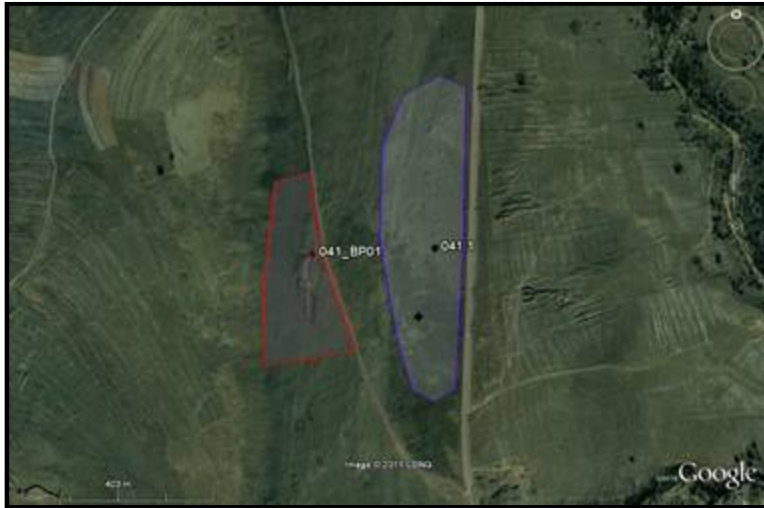
**Figure 116:** Borrow Pit 041\_BP01

No archaeological or cultural heritage resources, as defined and protected under the NHRA 1999, were identified on the surface or within exposed sub-surface sections during Phase 1 AIA assessment of the borrow pit 041\_BP01 study site.

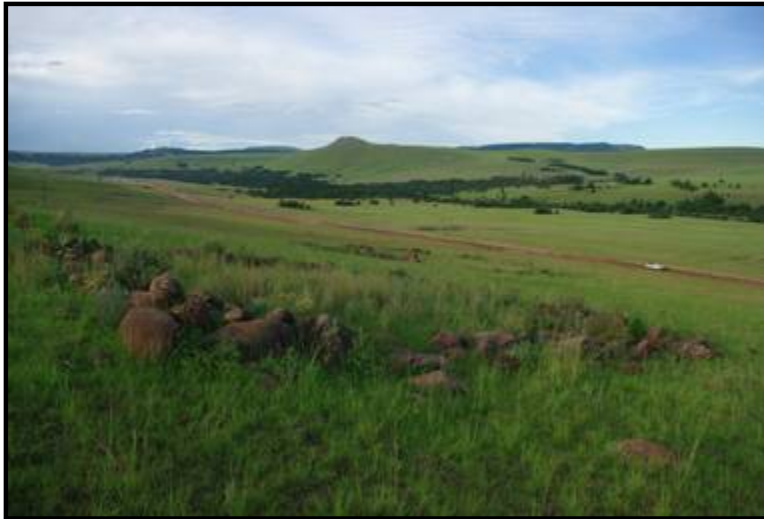
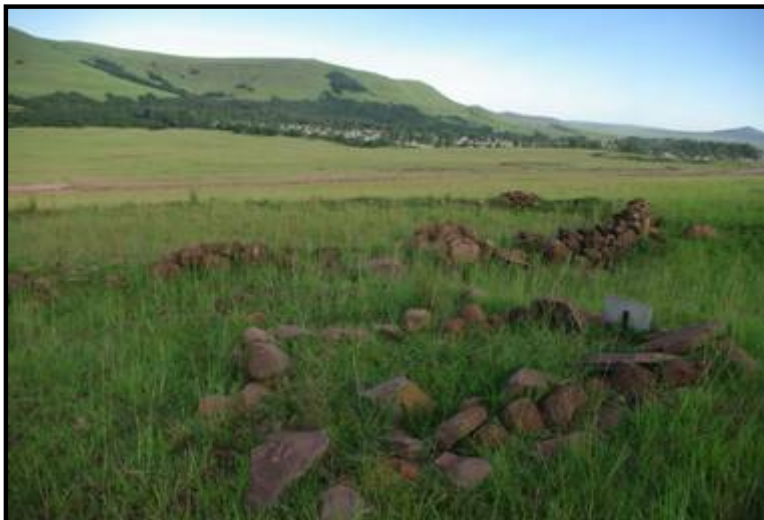
**Figure 118:** Remains of stone stock enclosures to the east of the borrow pit 041\_BP01 study site

**Figure 119:** Two graves located adjacent to a circular stock enclosure at Site 041.1

**RECOMMENDATIONS:** Site 041.1 comprises of an archaeological and cultural heritage resource as defined and protected by the NHRA 1999. Site 041.1 is ascribed a SAHRA LOW SIGNIFICANCE and a GENERALLY PROTECTED C FIELD RATING. The identified graves at Site 041.1 are ascribed a SAHRA MEDIUM SIGNIFICANCE and a GENERALLY PROTECTED B FIELD RATING. Development will not impact on the site: It is recommended that Site 041.1 be conserved in situ.

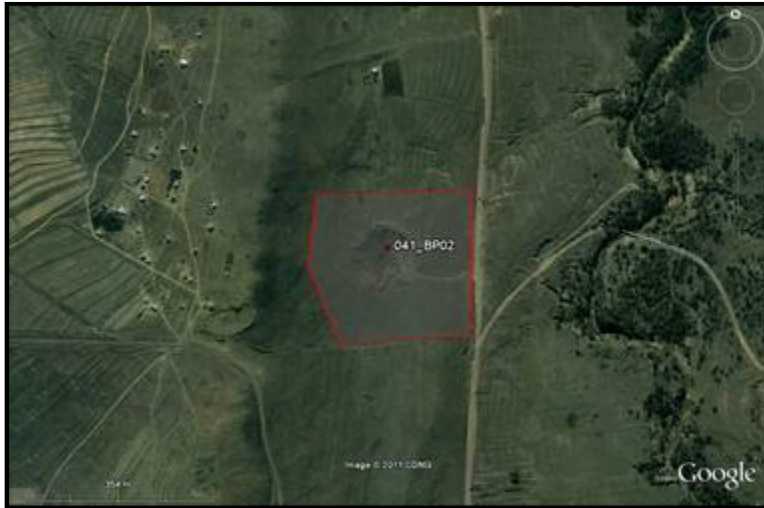
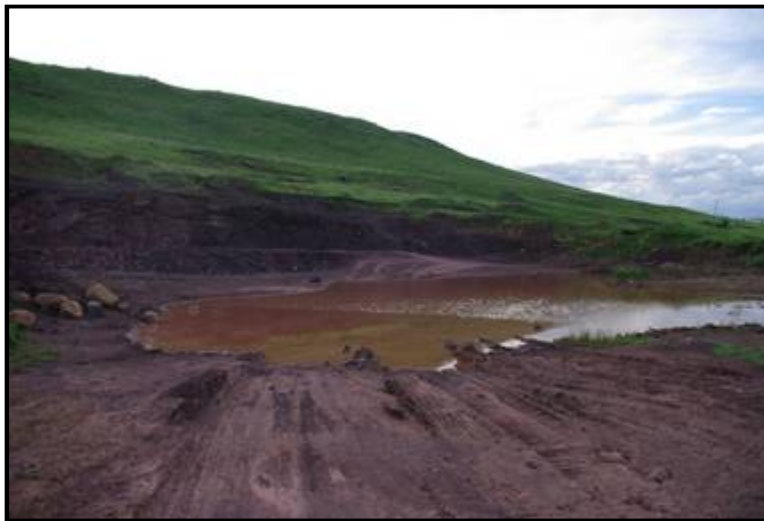
**Figure 120:** Borrow Pit 041\_BP02

No archaeological or cultural heritage resources, as defined and protected under the NHRA 1999, were identified on the surface or within exposed sub-surface sections during Phase 1 AIA assessment of borrow pit 041\_BP02. The general area is however characterized by fairly recent scattered rectangular stone stock enclosures, some of which are still in use. Stock enclosures in the vicinity of the borrow pit 041\_BP02 study site is inferred to indicate cultural continuity from Site 041.1 situated immediately south thereof.

**RECOMMENDATIONS:** It is recommended that use of borrow pit 041\_BP02 proceeds as applied for without the developer having to comply with additional heritage compliance requirements.

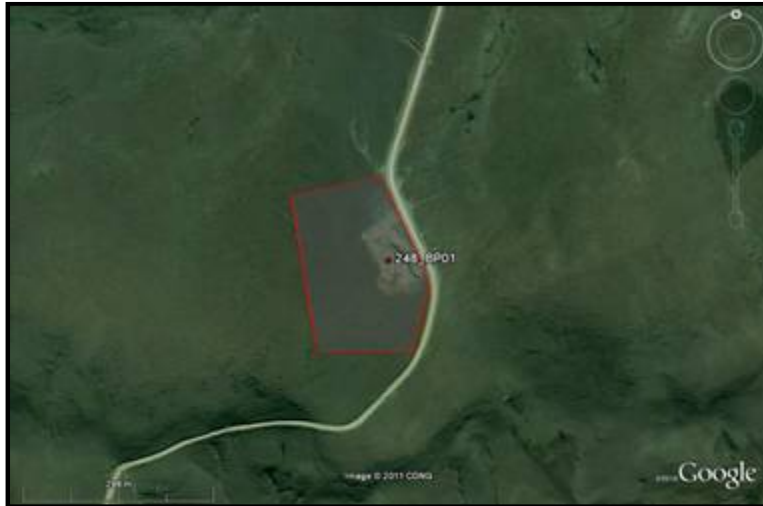
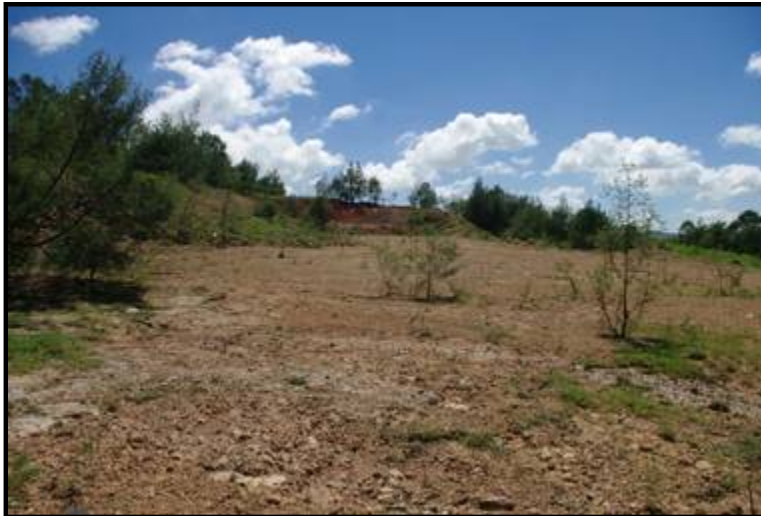
**Figure 123:** Borrow pit 247\_BP01

No archaeological or cultural heritage resources, as defined and protected under the NHRA 1999, were identified on the surface or within exposed sub-surface sections during Phase 1 AIA assessment of borrow pit 247\_BP01.

**RECOMMENDATIONS:** It is recommended that use of borrow pit 247\_BP01 proceeds as applied for without the developer having to comply with additional heritage compliance requirements.

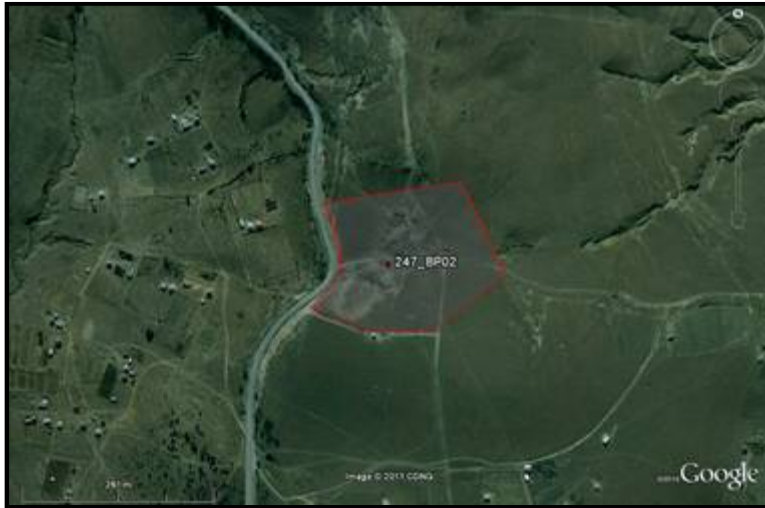
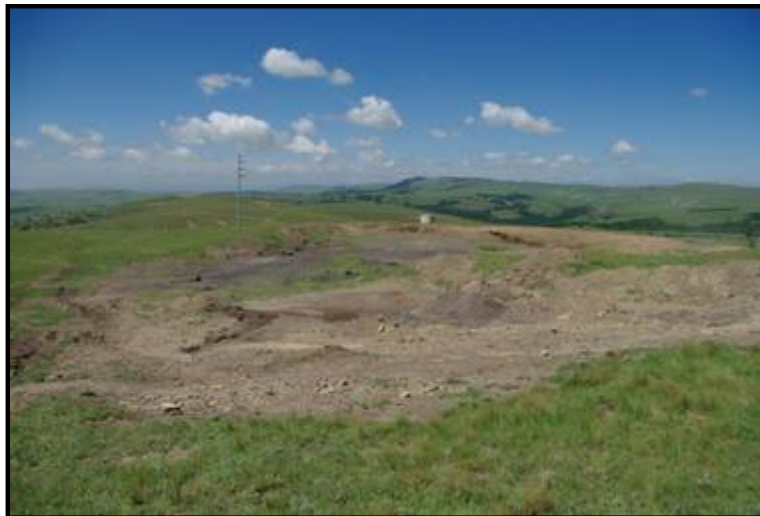
**Figure 125:** Borrow pit 247\_BP02

No archaeological or cultural heritage resources, as defined and protected under the NHRA 1999, were identified on the surface or within exposed sub-surface sections during Phase 1 AIA assessment of borrow pit 247\_BP02.

**RECOMMENDATIONS:** It is recommended that use of borrow pit 247\_BP02 proceeds as applied for without the developer having to comply with additional heritage compliance requirements.
