PHASE 1 ARCHAEOLOGICAL IMPACT ASSESSMENT

**UTILIZATION OF BORROW PITS –  
CHRIS HANI DISTRICT MUNICIPALITY,  
EASTERN CAPE, SOUTH AFRICA**

**DATE:** 2011-03-01

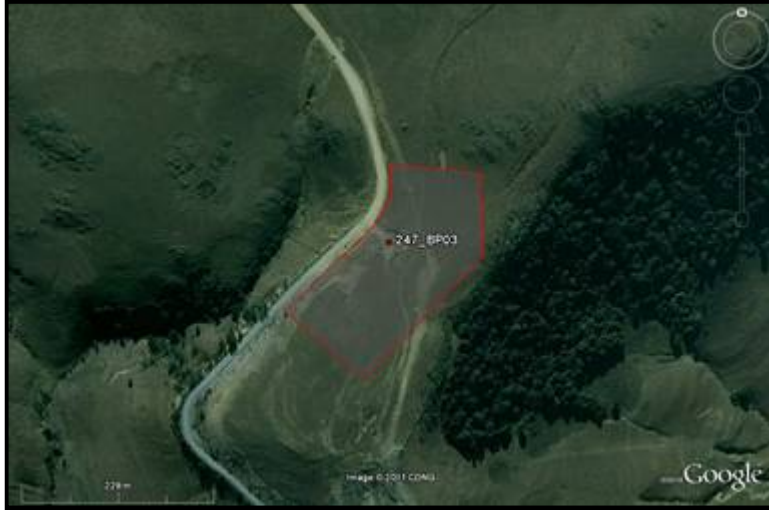
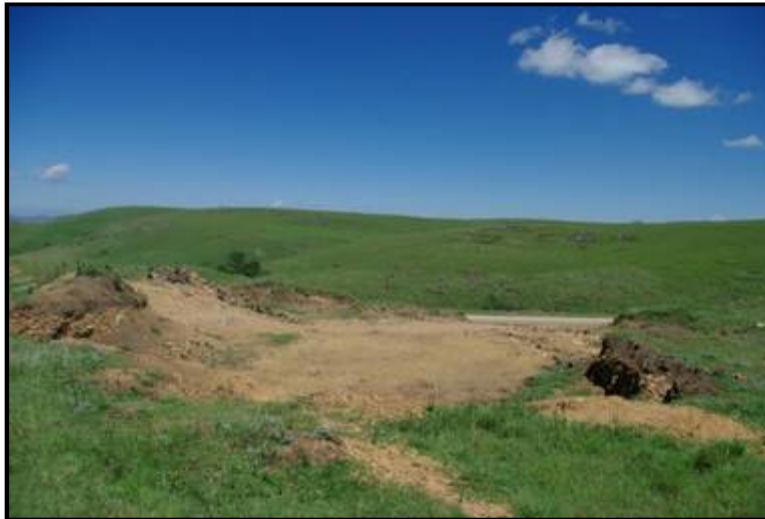
**Figure 127:** Borrow pit 247\_BP03

No archaeological or cultural heritage resources, as defined and protected under the NHRA 1999, were identified on the surface or within exposed sub-surface sections during Phase 1 AIA assessment of borrow pit 247\_BP03.

**RECOMMENDATIONS:** It is recommended that use of borrow pit 247\_BP03 proceeds as applied for without the developer having to comply with additional heritage compliance requirements.

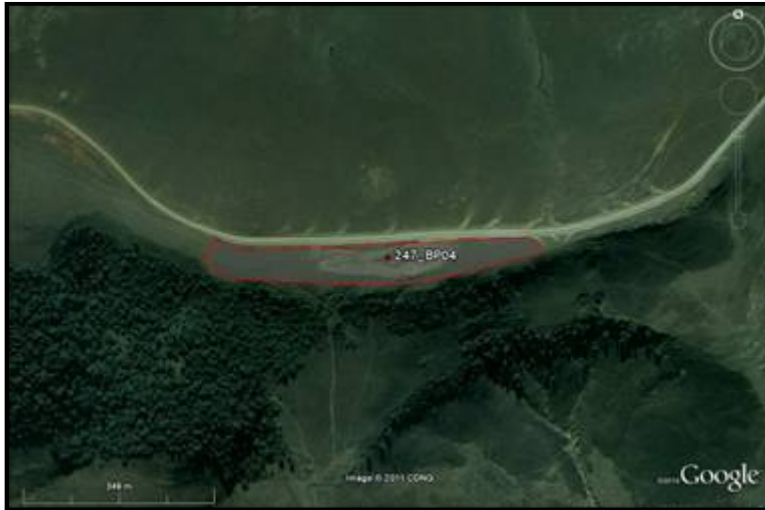
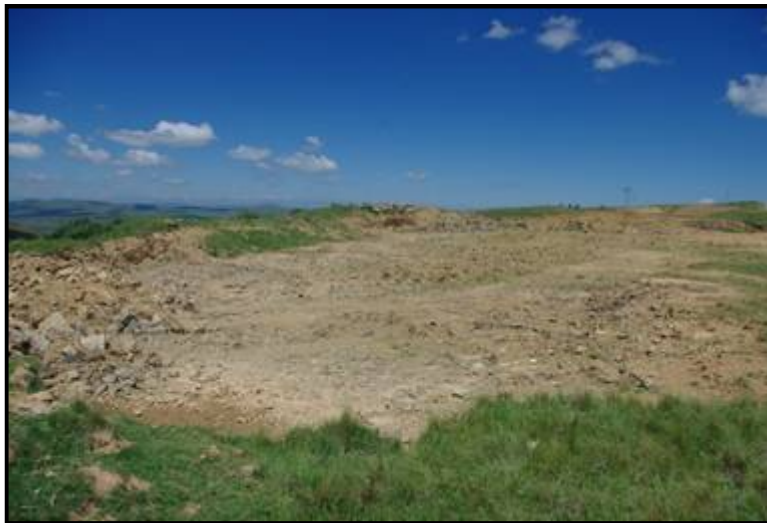
**Figure 129:** Borrow pit 247\_BP04

No archaeological or cultural heritage resources, as defined and protected under the NHRA 1999, were identified on the surface or within exposed sub-surface sections during Phase 1 AIA assessment of borrow pit 247\_BP04.

**RECOMMENDATIONS:** It is recommended that use of borrow pit 247\_BP04 proceeds as applied for without the developer having to comply with additional heritage compliance requirements.

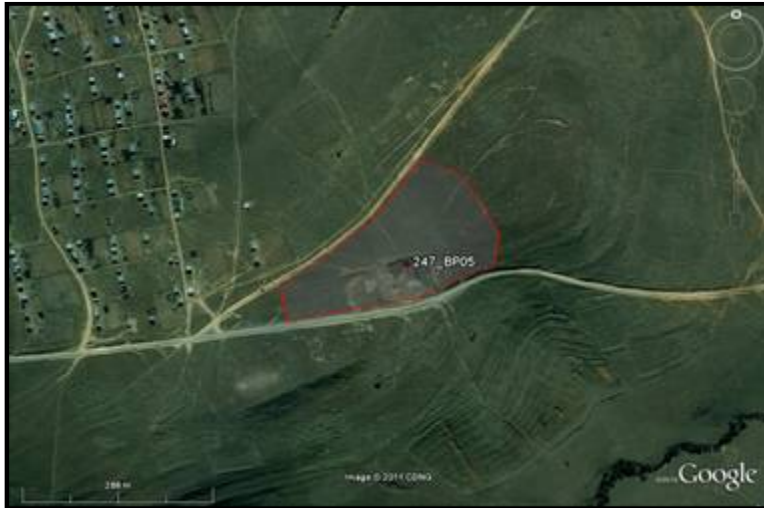
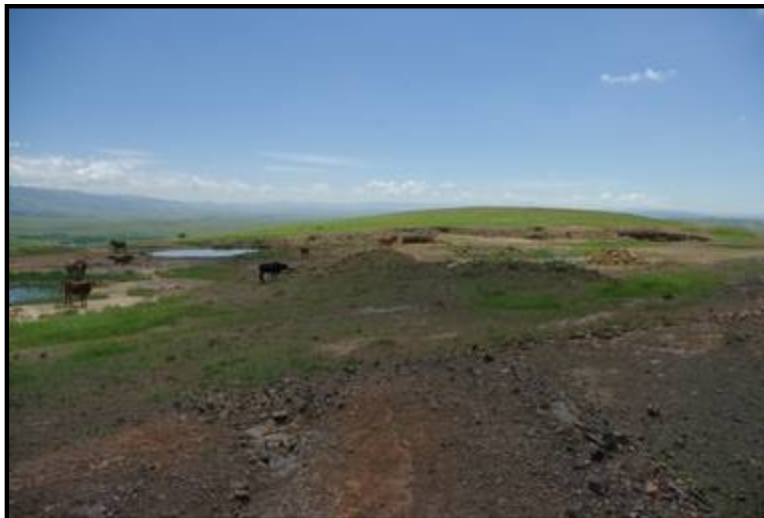
**Figure 131:** Borrow pit 247\_BP05

No archaeological or cultural heritage resources, as defined and protected under the NHRA 1999, were identified on the surface or within exposed sub-surface sections during Phase 1 AIA assessment of borrow pit 247\_BP05.

**RECOMMENDATIONS:** It is recommended that use of borrow pit 247\_BP05 proceeds as applied for without the developer having to comply with additional heritage compliance requirements.

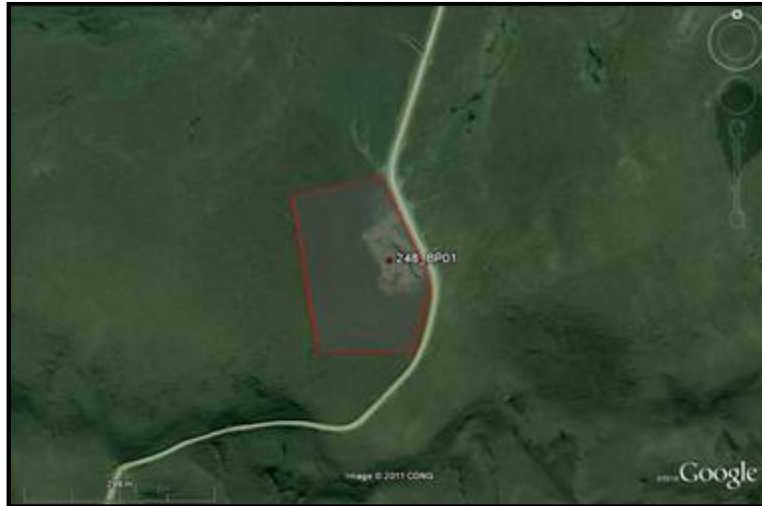
**Figure 134:** Borrow pit 248\_BP01

No archaeological or cultural heritage resources, as defined and protected under the NHRA 1999, were identified on the surface or within exposed sub-surface sections during Phase 1 AIA assessment of borrow pit 248\_BP01.

**RECOMMENDATIONS:** It is recommended that use of borrow pit 248\_BP01 proceeds as applied for without the developer having to comply with additional heritage compliance requirements.

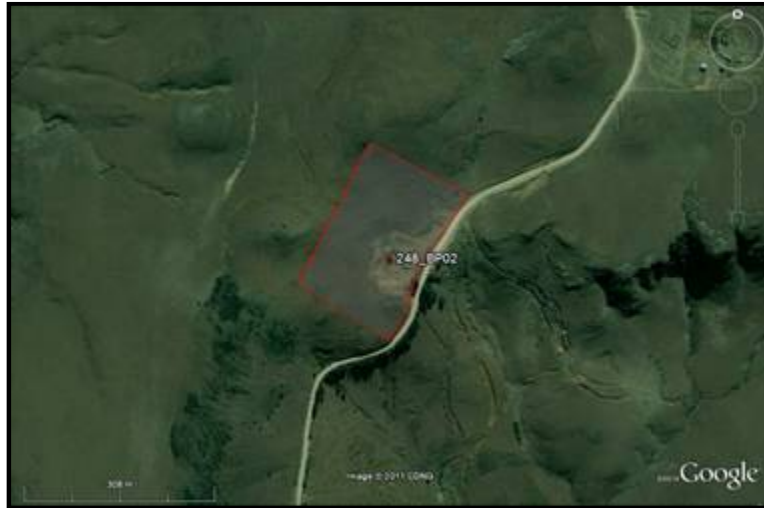
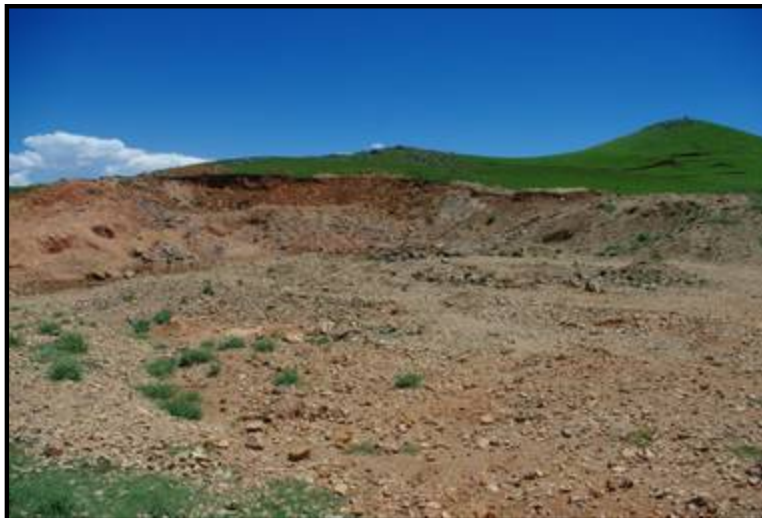
**Figure 136:** Borrow pit 248\_BP02

No archaeological or cultural heritage resources, as defined and protected under the NHRA 1999, were identified on the surface or within exposed sub-surface sections during Phase 1 AIA assessment of borrow pit 248\_BP02.

**Figure 137:** View of a portion of borrow pit 248\_BP02

**RECOMMENDATIONS:** It is recommended that use of borrow pit 248\_BP02 proceeds as applied for without the developer having to comply with additional heritage compliance requirements.

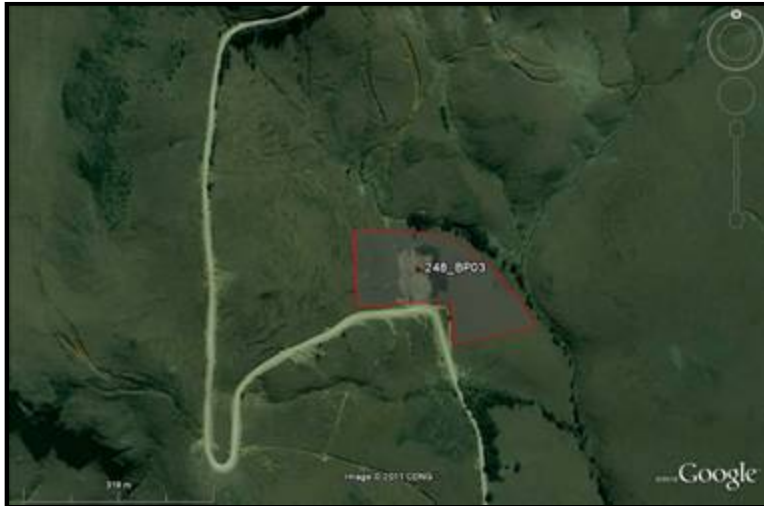
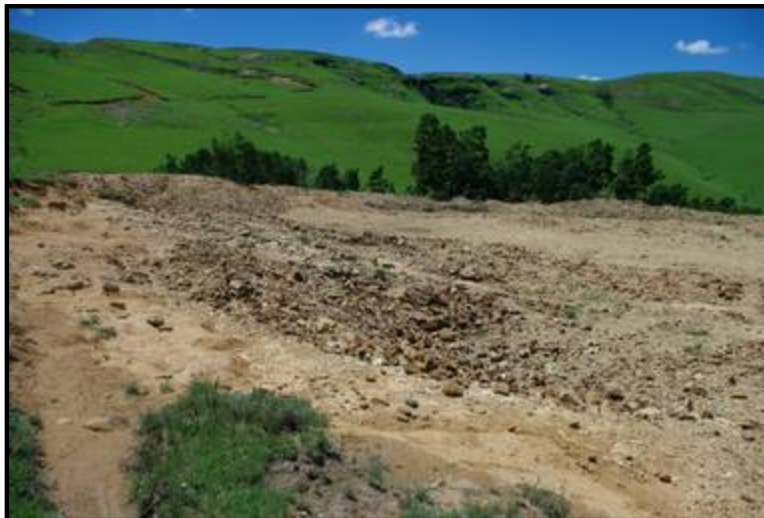
**Figure 138:** Borrow pit 248\_BP03

No archaeological or cultural heritage resources, as defined and protected under the NHRA 1999, were identified on the surface or within exposed sub-surface sections during Phase 1 AIA assessment of borrow pit 248\_BP03.

**Figure 139:** View of a portion of borrow pit 248\_BP03

**RECOMMENDATIONS:** It is recommended that use of borrow pit 248\_BP03 proceeds as applied for without the developer having to comply with additional heritage compliance requirements.

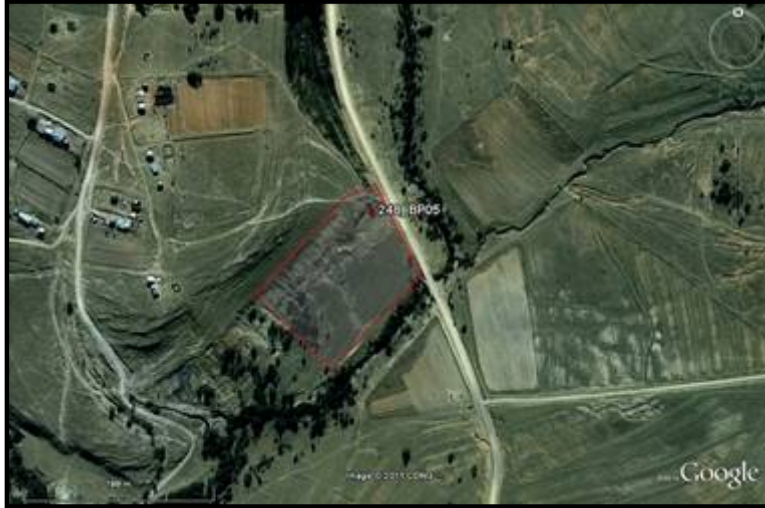
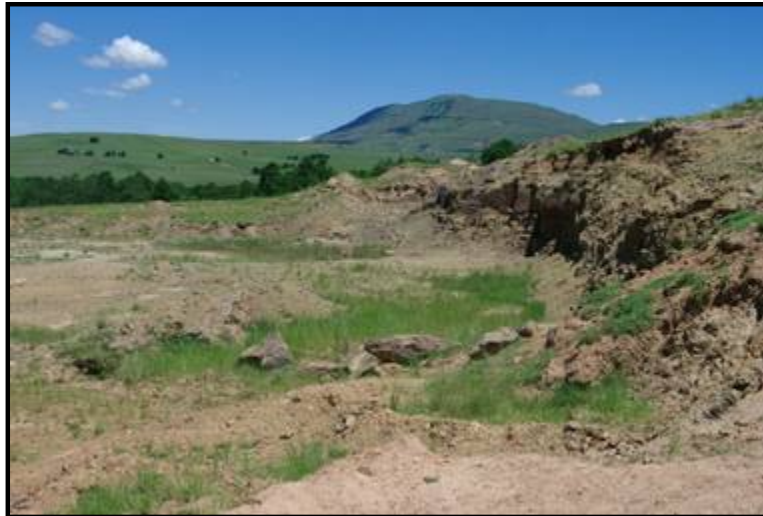
**Figure 140:** Borrow pit 248\_BP05

No archaeological or cultural heritage resources, as defined and protected under the NHRA 1999, were identified on the surface or within exposed sub-surface sections during Phase 1 AIA assessment of borrow pit 248\_BP05.

**Figure 141:** View of borrow pit 248\_BP05

**RECOMMENDATIONS:** It is recommended that use of borrow pit 248\_BP05 proceeds as applied for without the developer having to comply with additional heritage compliance requirements.

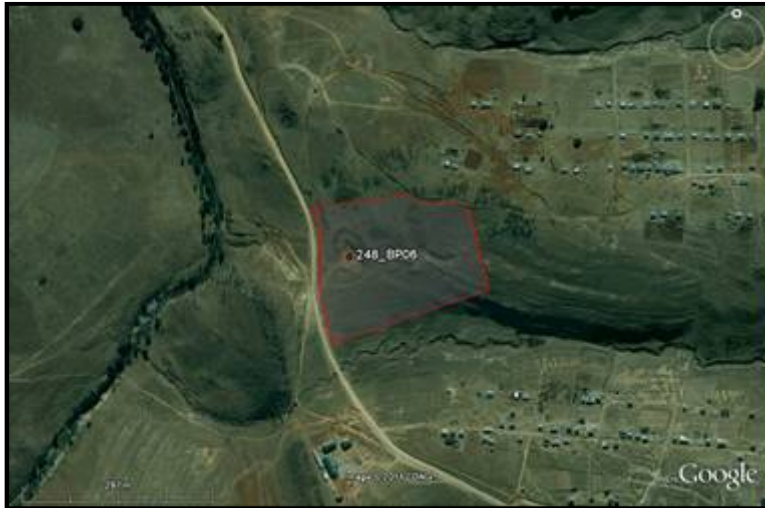
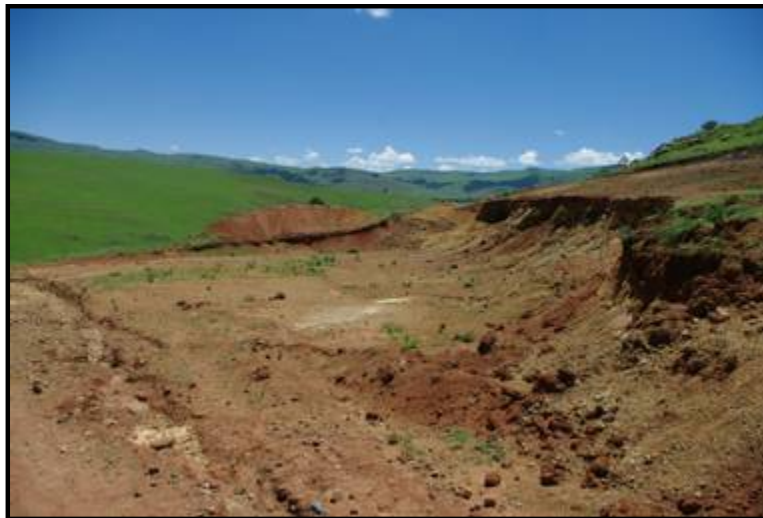
**Figure 142:** Borrow pit 248\_BP06

No archaeological or cultural heritage resources, as defined and protected under the NHRA 1999, were identified on the surface or within exposed sub-surface sections during Phase 1 AIA assessment of borrow pit 248\_BP06.

**Figure 143:** View of borrow pit 248\_BP06

**RECOMMENDATIONS:** It is recommended that use of borrow pit 248\_BP06 proceeds as applied for without the developer having to comply with additional heritage compliance requirements.

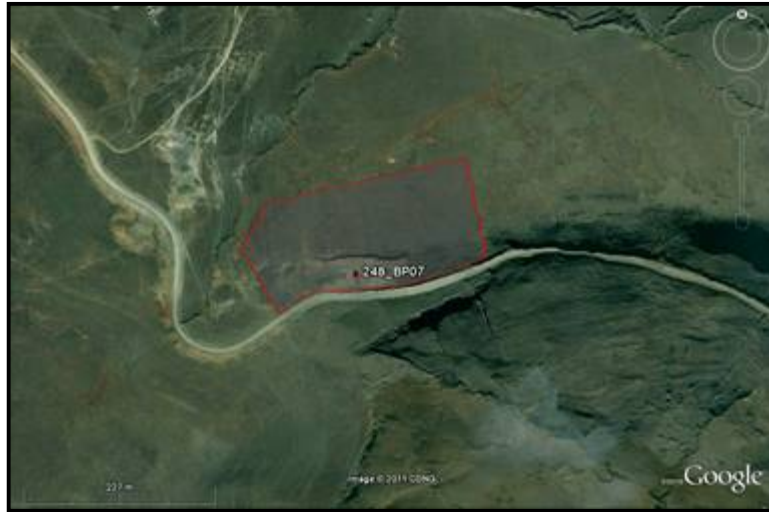
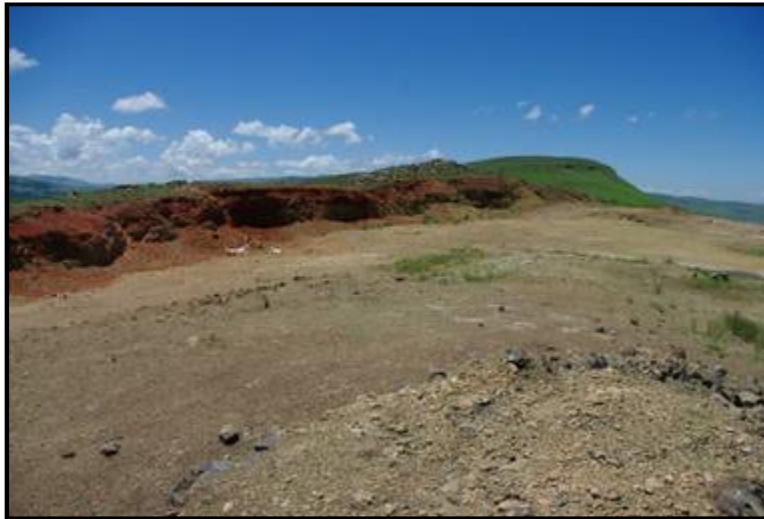
**Figure 144:** Borrow pit 248\_BP07

No archaeological or cultural heritage resources, as defined and protected under the NHRA 1999, were identified on the surface or within exposed sub-surface sections during Phase 1 AIA assessment of borrow pit 248\_BP07.

**Figure 145:** View of borrow pit 248\_BP07

**RECOMMENDATIONS:** It is recommended that use of borrow pit 248\_BP07 proceeds as applied for without the developer having to comply with additional heritage compliance requirements.

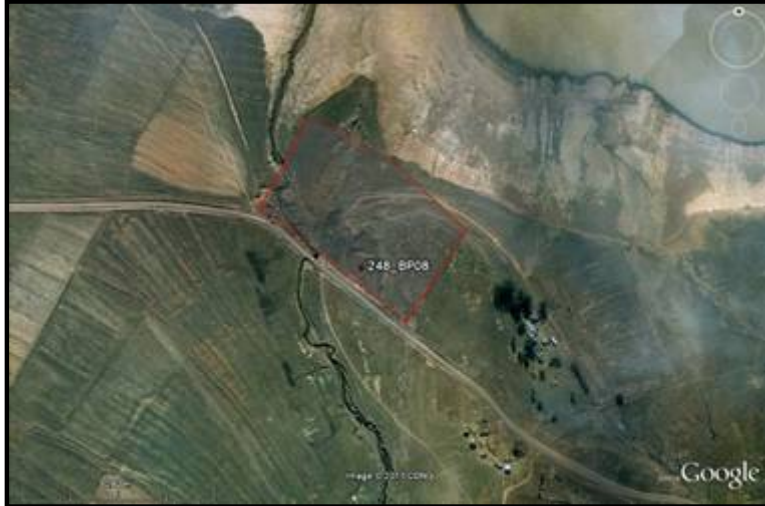
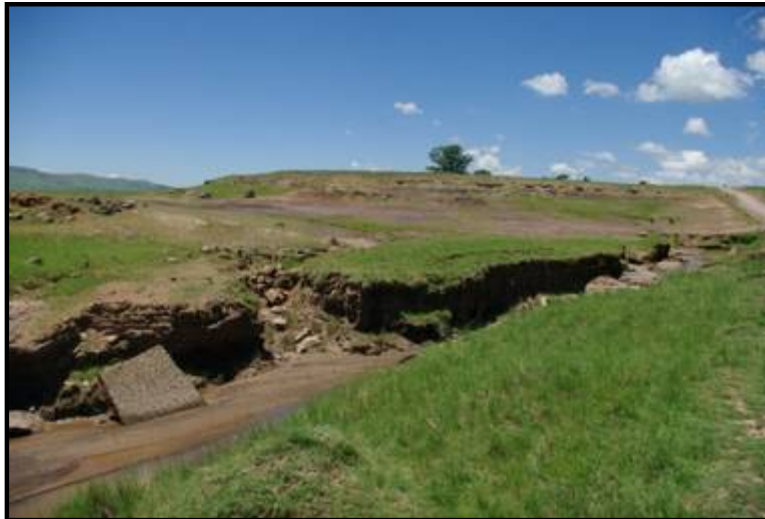
**Figure 146:** Borrow pit 248\_BP08

No archaeological or cultural heritage resources, as defined and protected under the NHRA 1999, were identified on the surface or within exposed sub-surface sections during Phase 1 AIA assessment of borrow pit 248\_BP08.

**Figure 147:** View of a portion of borrow pit 248\_BP08

**RECOMMENDATIONS:** It is recommended that use of borrow pit 248\_BP08 proceeds as applied for without the developer having to comply with additional heritage compliance requirements.

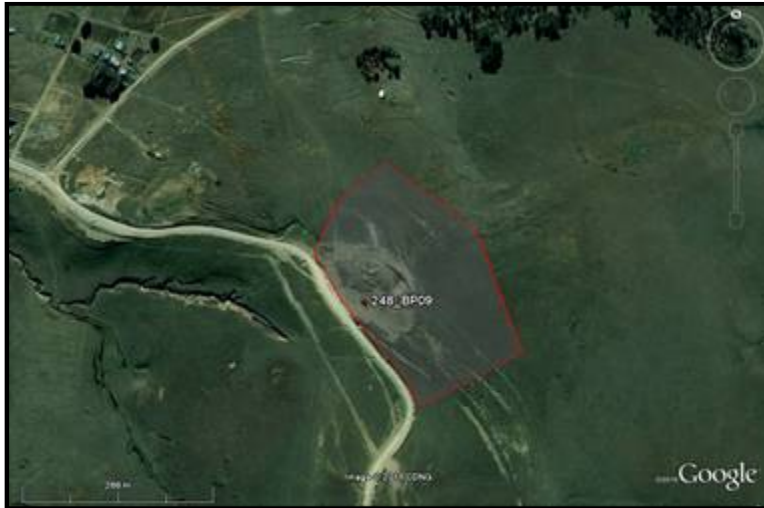
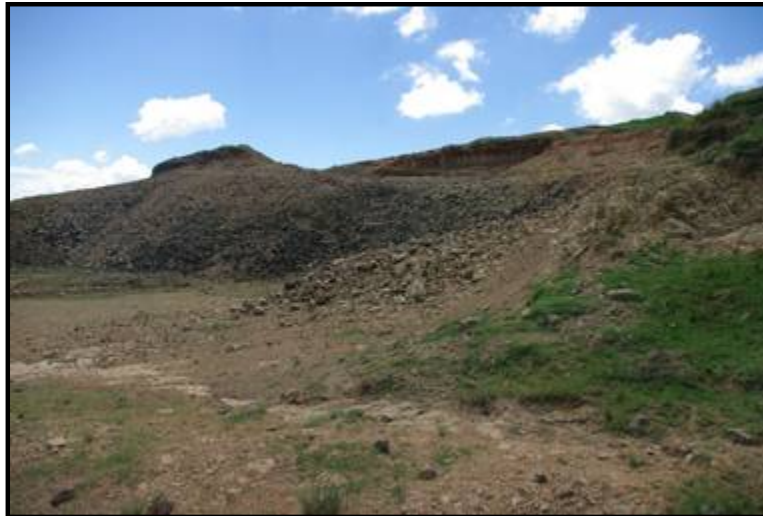
**Figure 148:** Borrow pit 248\_BP09

No archaeological or cultural heritage resources, as defined and protected under the NHRA 1999, were identified on the surface or within exposed sub-surface sections during Phase 1 AIA assessment of borrow pit 248\_BP09.

**Figure 149:** View of a portion of borrow pit 248\_BP09

**RECOMMENDATIONS:** It is recommended that use of borrow pit 248\_BP09 proceeds as applied for without the developer having to comply with additional heritage compliance requirements.

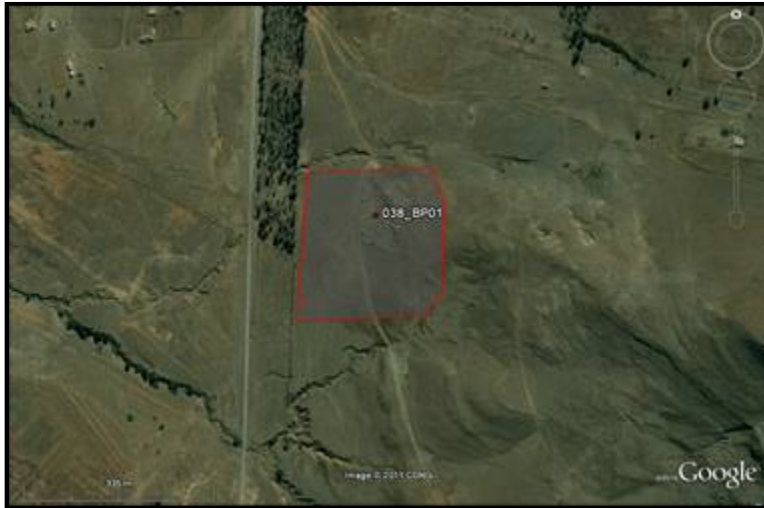
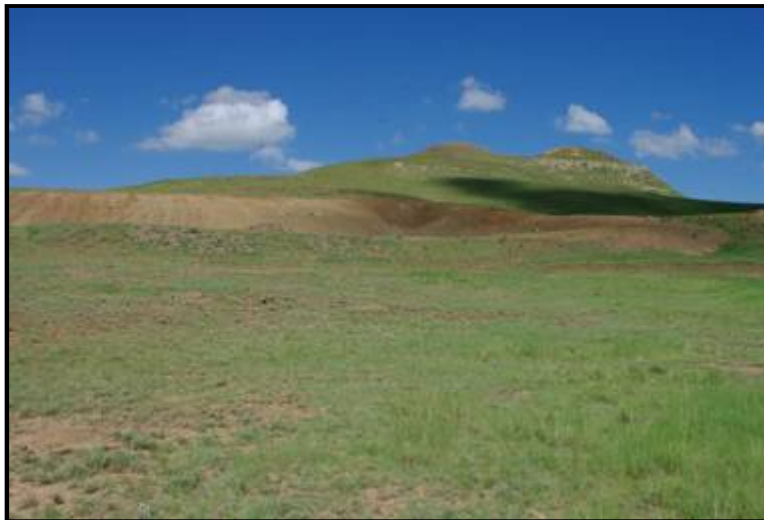
**Figure 151:** Borrow pit 038\_BP01

No archaeological or cultural heritage resources, as defined and protected under the NHRA 1999, were identified on the surface or within exposed sub-surface sections during Phase 1 AIA assessment of borrow pit 038\_BP01.

**Figure 152:** General view of borrow pit 038\_BP01

**RECOMMENDATIONS:** It is recommended that use of borrow pit 038\_BP01 proceeds as applied for without the developer having to comply with additional heritage compliance requirements.

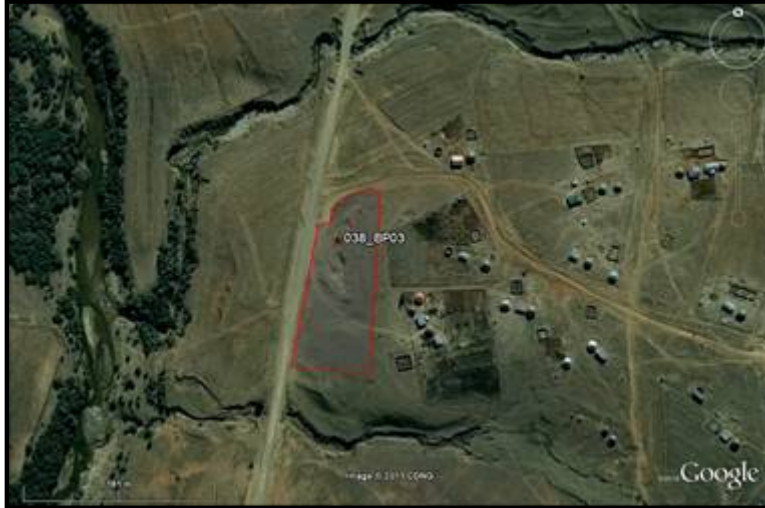
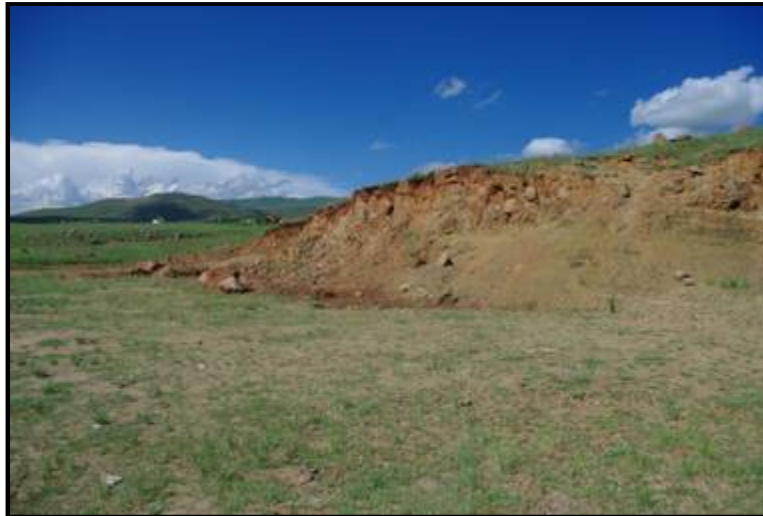
**Figure 153:** Borrow pit 038\_BP03

No archaeological or cultural heritage resources, as defined and protected under the NHRA 1999, were identified on the surface or within exposed sub-surface sections during Phase 1 AIA assessment of borrow pit 038\_BP03.

**Figure 154:** View of the northern portion of borrow pit 038\_BP03

**RECOMMENDATIONS:** It is recommended that use of borrow pit 038\_BP03 proceeds as applied for without the developer having to comply with additional heritage compliance requirements.

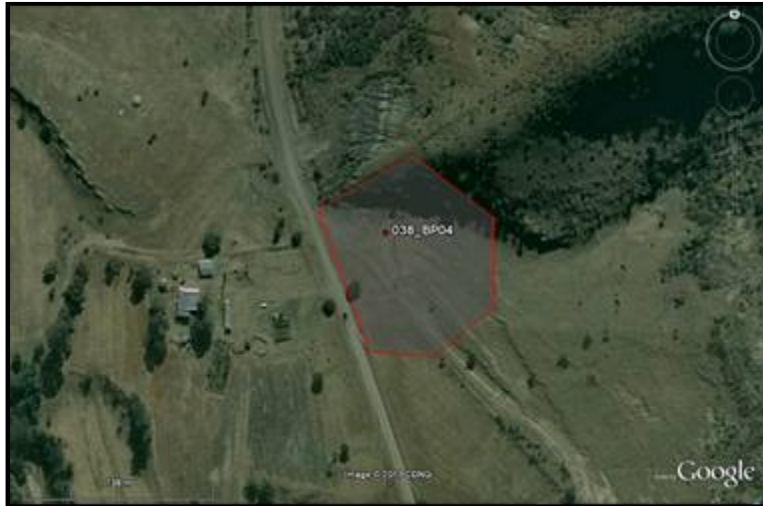
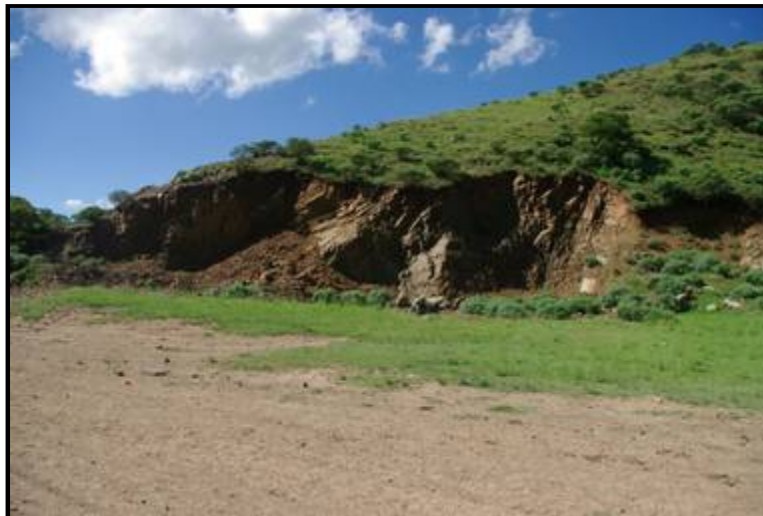
**Figure 155:** Borrow pit 038\_BP04

No archaeological or cultural heritage resources, as defined and protected under the NHRA 1999, were identified on the surface or within exposed sub-surface sections during Phase 1 AIA assessment of borrow pit 038\_BP04.

**Figure 156:** General view of borrow pit 038\_BP04

**RECOMMENDATIONS:** It is recommended that use of borrow pit 038\_BP04 proceeds as applied for without the developer having to comply with additional heritage compliance requirements.

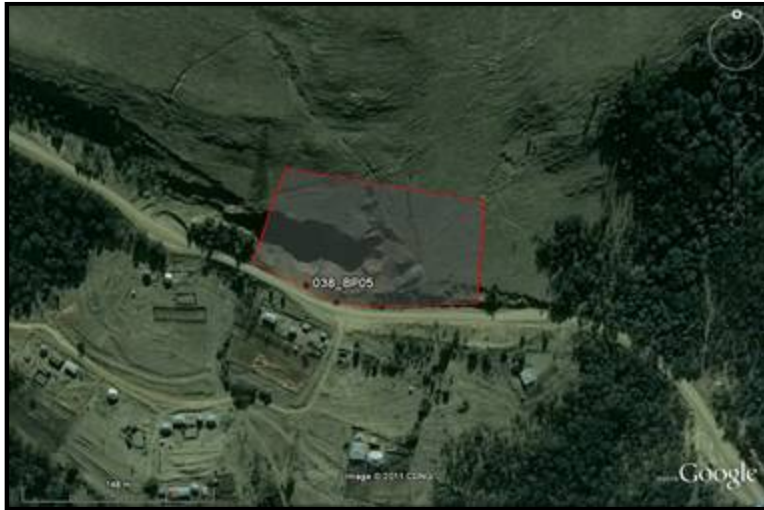
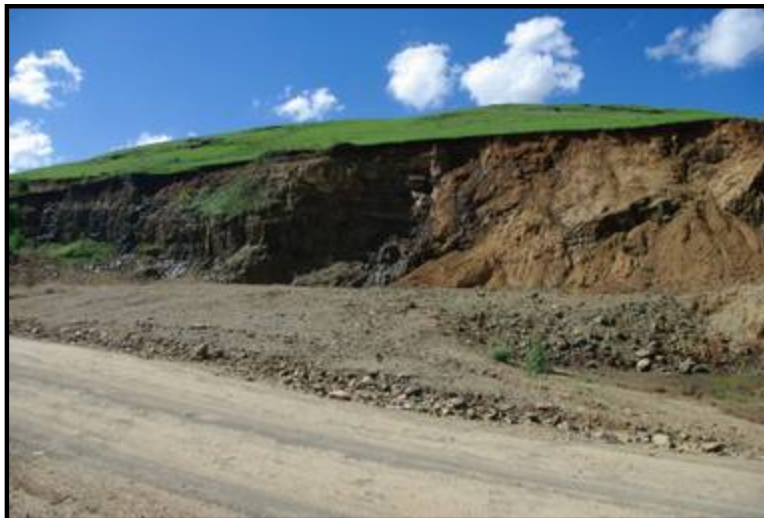
**Figure 157:** Borrow pit 038\_BP05

No archaeological or cultural heritage resources, as defined and protected under the NHRA 1999, were identified on the surface or within exposed sub-surface sections during Phase 1 AIA assessment of borrow pit 038\_BP05.

**Figure 158:** View of borrow pit 038\_BP05

**RECOMMENDATIONS:** It is recommended that use of borrow pit 038\_BP05 proceeds as applied for without the developer having to comply with additional heritage compliance requirements.

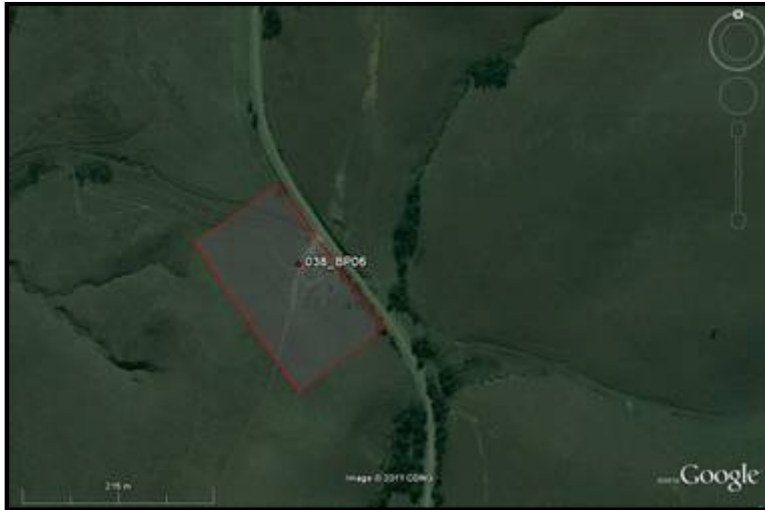
**Figure 159:** Borrow pit 038\_BP06

No archaeological or cultural heritage resources, as defined and protected under the NHRA 1999, were identified on the surface or within exposed sub-surface sections during Phase 1 AIA assessment of borrow pit 038\_BP06.

**RECOMMENDATIONS:** It is recommended that use of borrow pit 038\_BP06 proceeds as applied for without the developer having to comply with additional heritage compliance requirements.

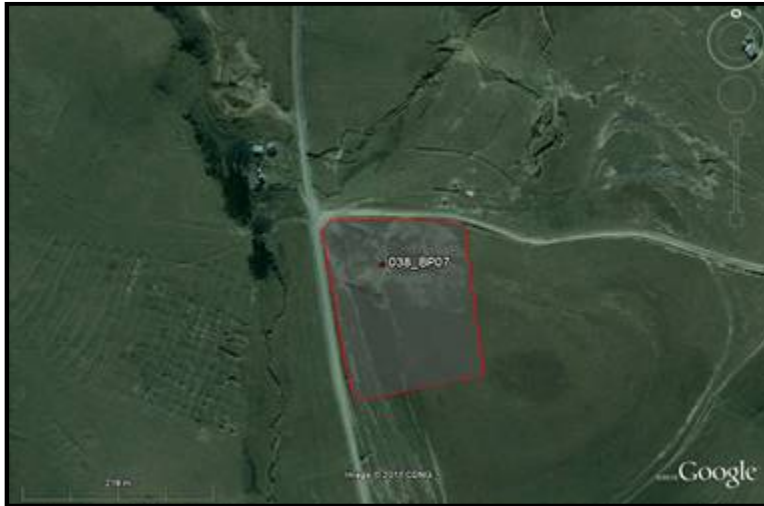
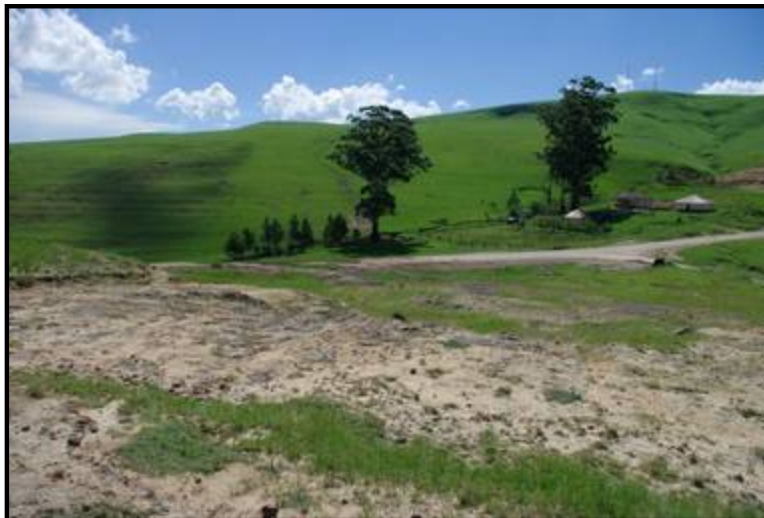
**Figure 160:** Borrow pit 038\_BP07

No archaeological or cultural heritage resources, as defined and protected under the NHRA 1999, were identified on the surface or within exposed sub-surface sections during Phase 1 AIA assessment of borrow pit 038\_BP07.

**Figure 161:** View of borrow pit 038\_BP07

**RECOMMENDATIONS:** It is recommended that use of borrow pit 038\_BP07 proceeds as applied for without the developer having to comply with additional heritage compliance requirements.

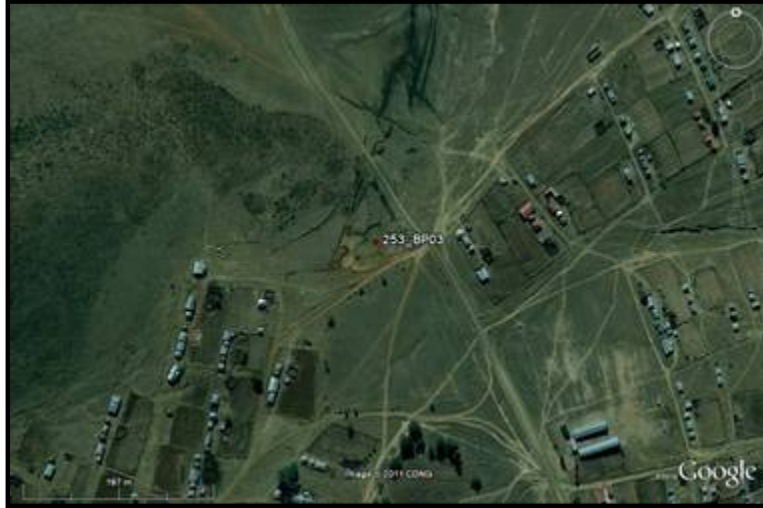
**Figure 163:** Borrow pit 253\_BP03

Borrow pit 253\_BP03 was not assessed due to inaccessible access roads as a result of the particularly wet late 2010 rainy season.

**RECOMMENDATIONS:** It is recommended that borrow pit 253\_BP03 be assessed at the time of development, by means of an archaeological site inspection / on site archaeological monitoring.

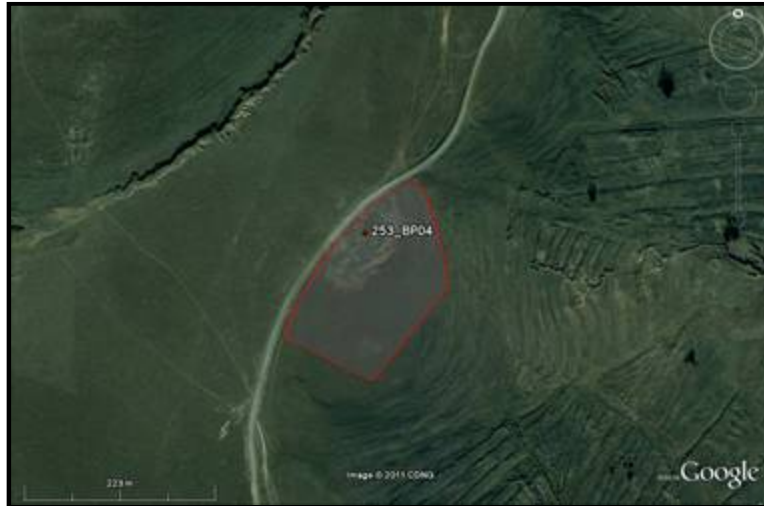
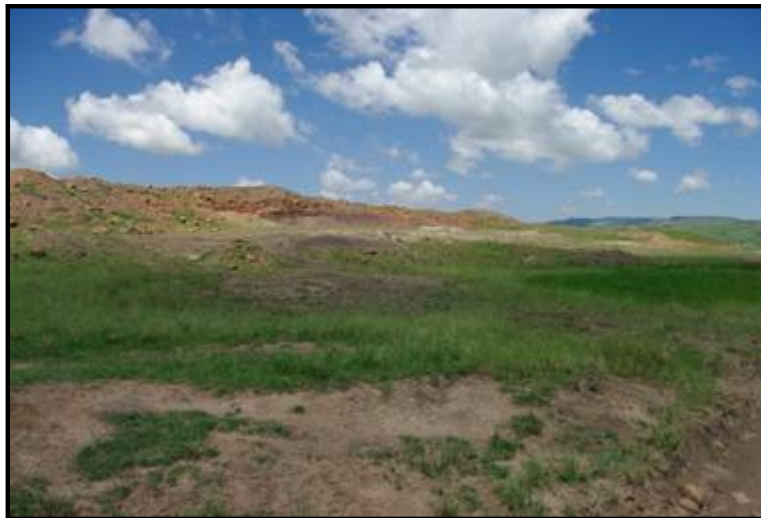
**Figure 164:** Borrow pit 253\_BP04

No archaeological or cultural heritage resources, as defined and protected under the NHRA 1999, were identified on the surface or within exposed sub-surface sections during Phase 1 AIA assessment of borrow pit 253\_BP04.

**Figure 165:** View of borrow pit 253\_BP04

**RECOMMENDATIONS:** It is recommended that use of borrow pit 253\_BP04 proceeds as applied for without the developer having to comply with additional heritage compliance requirements.

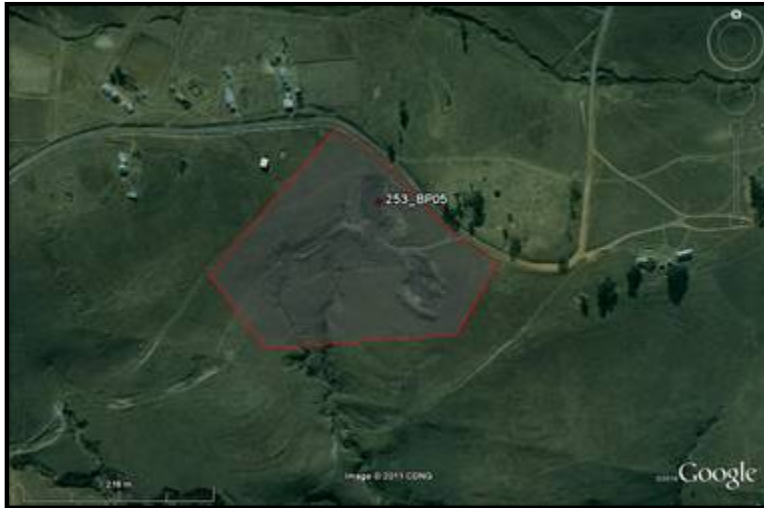
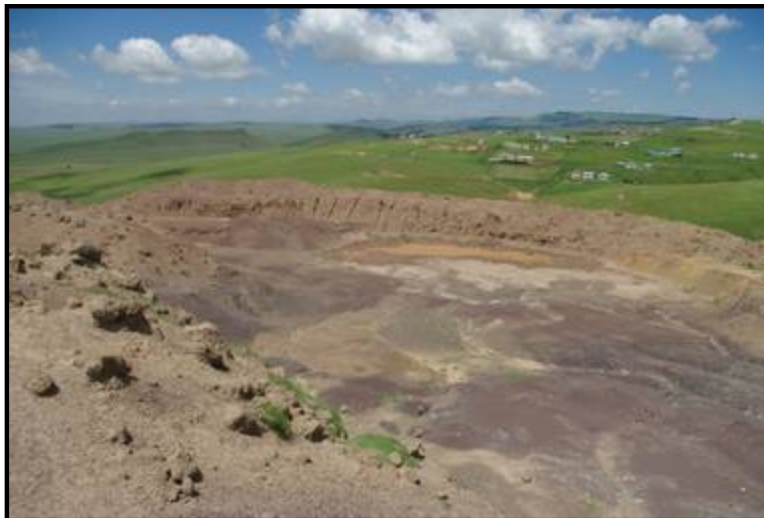
**Figure 166:** Borrow pit 253\_BP05

No archaeological or cultural heritage resources, as defined and protected under the NHRA 1999, were identified on the surface or within exposed sub-surface sections during Phase 1 AIA assessment of borrow pit 253\_BP05.

**Figure 167:** View from borrow pit 253\_BP05

**RECOMMENDATIONS:** It is recommended that use of borrow pit 253\_BP05 proceeds as applied for without the developer having to comply with additional heritage compliance requirements.

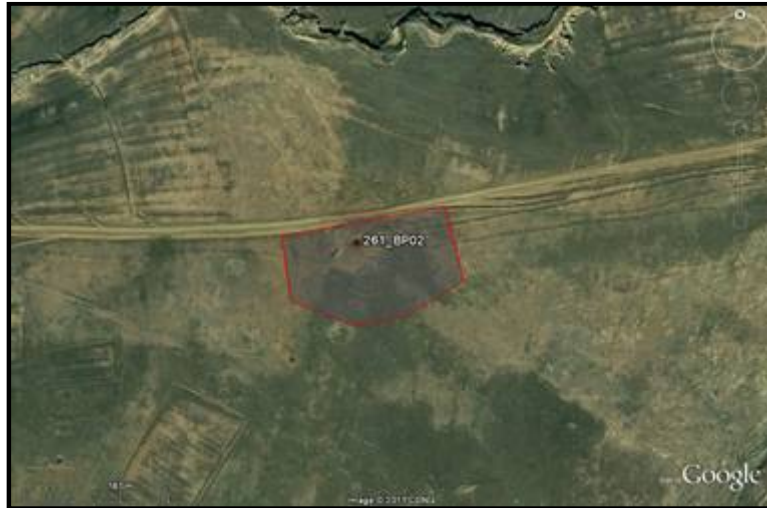
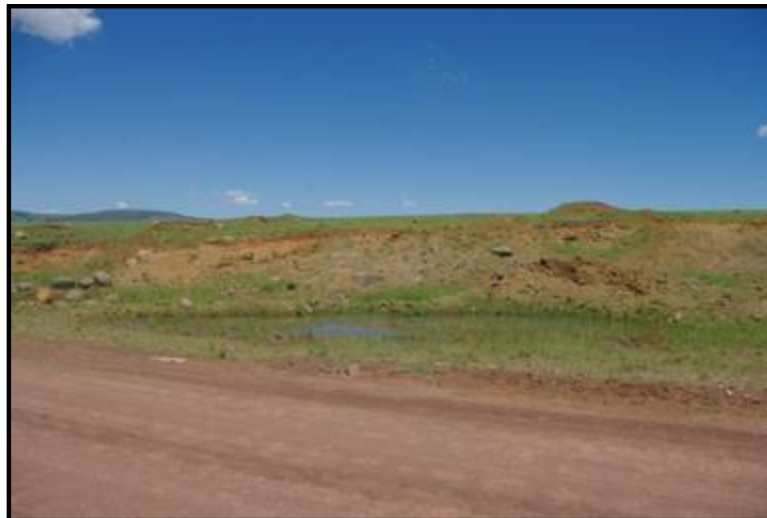
**Figure 169:** Borrow Pit 261\_BP02

No archaeological or cultural heritage resources, as defined and protected under the NHRA 1999, were identified on the surface or within exposed sub-surface sections during Phase 1 AIA assessment of borrow pit 261\_BP02.

**Figure 170:** General view of borrow pit 261\_BP02

**RECOMMENDATIONS:** It is recommended that use of borrow pit 261\_BP02 proceeds as applied for without the developer having to comply with additional heritage compliance requirements.

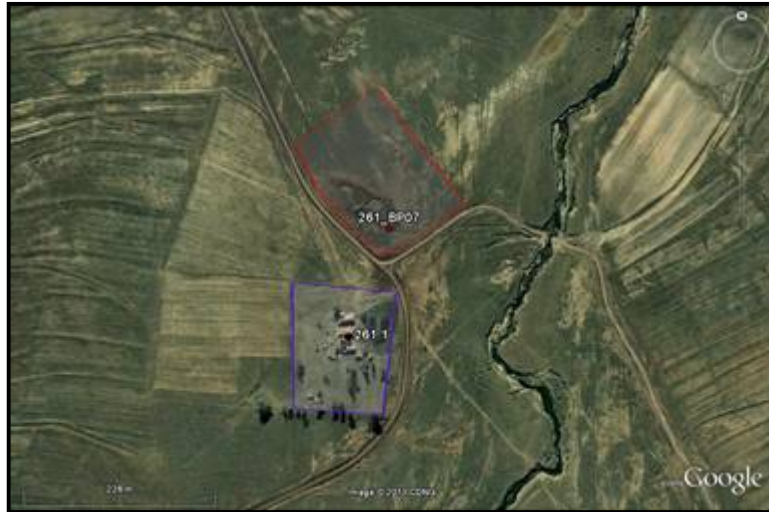
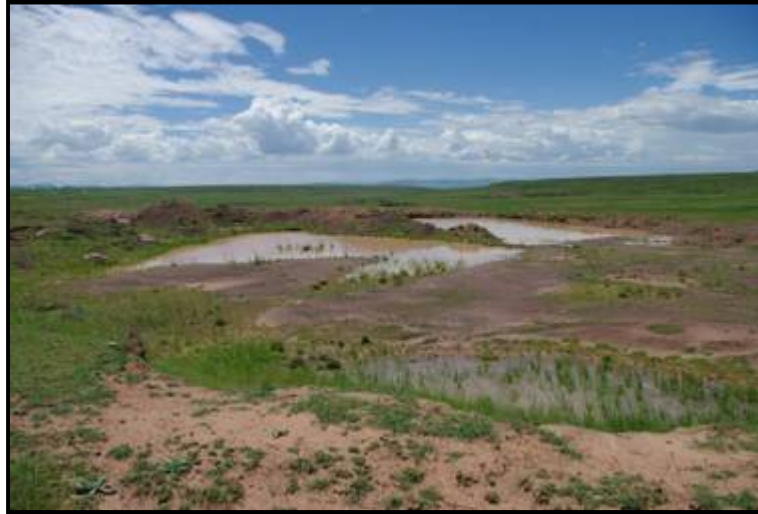
**Figure 171:** Borrow Pit 261\_BP07

No archaeological or cultural heritage resources, as defined and protected under the NHRA 1999, were identified on the surface or within exposed sub-surface sections during Phase 1 AIA assessment of the borrow pit 261\_BP07 study site area.

Figure 172: General view of borrow pit 261\_BP07

**RECOMMENDATIONS:** It is recommended that use of borrow pit 261\_BP07 proceeds as applied for without the developer having to comply with additional heritage compliance requirements.

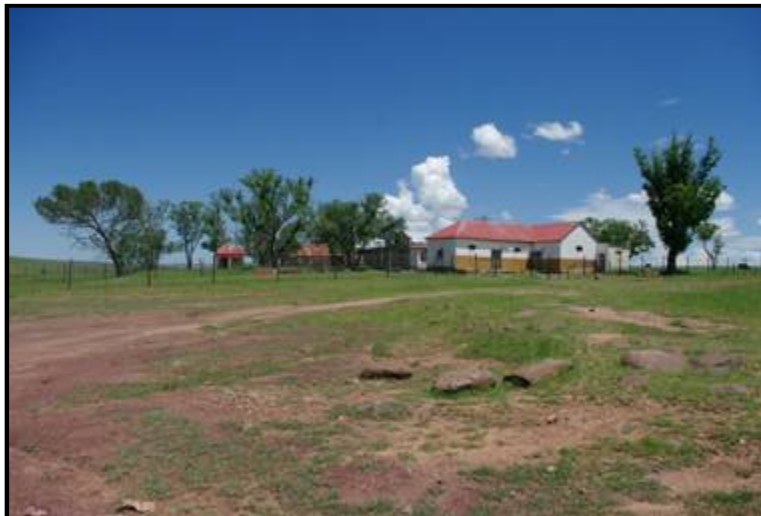
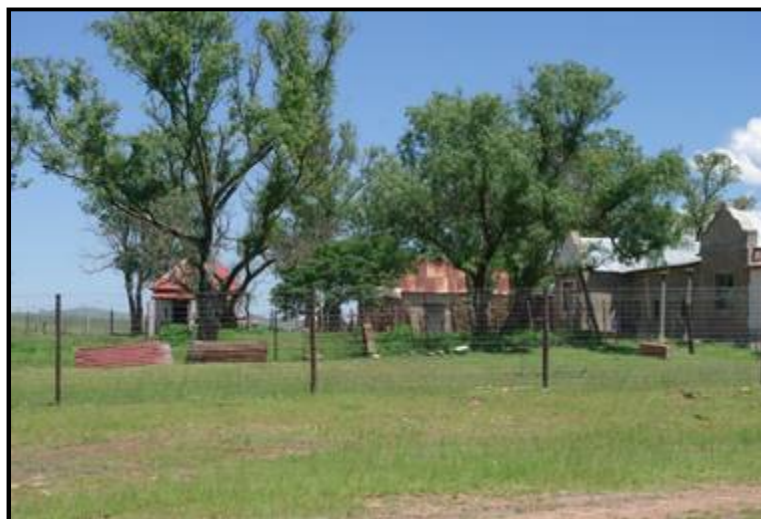
Site 261.1 comprises of an archaeological and cultural heritage resource as defined and protected under the NHRA 1999. The site is ascribed a SAHRA MEDIUM SIGNIFICANCE and a GENERALLY PROTECTED B FIELD RATING. Current conservation measures (fence with access gate) comply with SAHRA Minimum Site Conservation Standards. Utilization of borrow pit 261\_BP07 will not impact on Site 261.1

Figure 173: General view of the Site 261.1 Colonial Period homestead

Figure 174: Close-up of a selection of the structures at Site 261.1

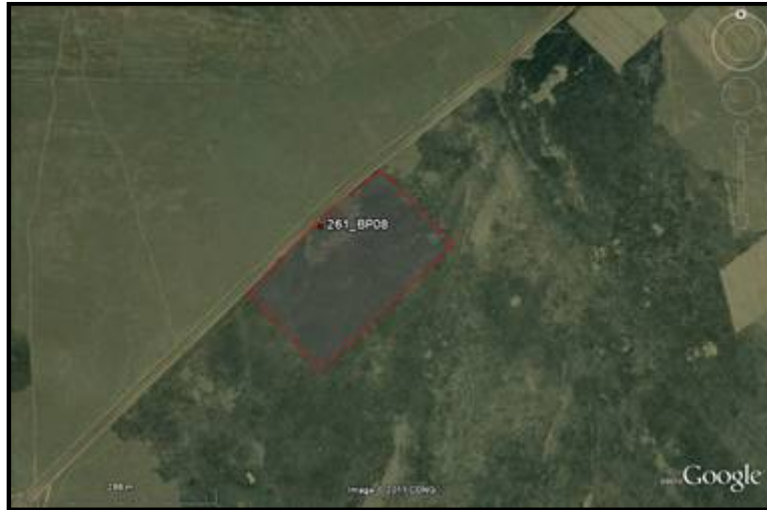
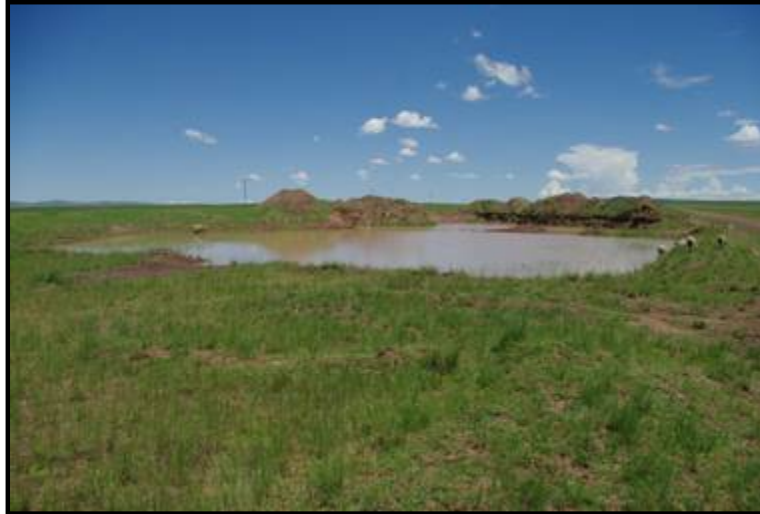
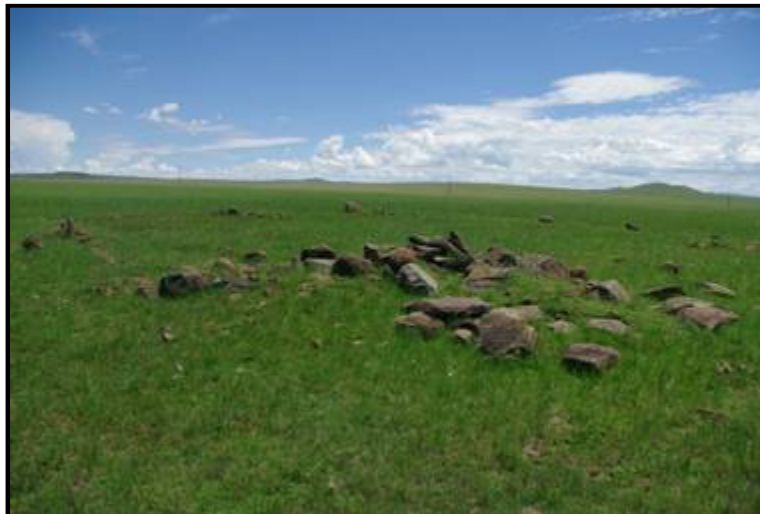
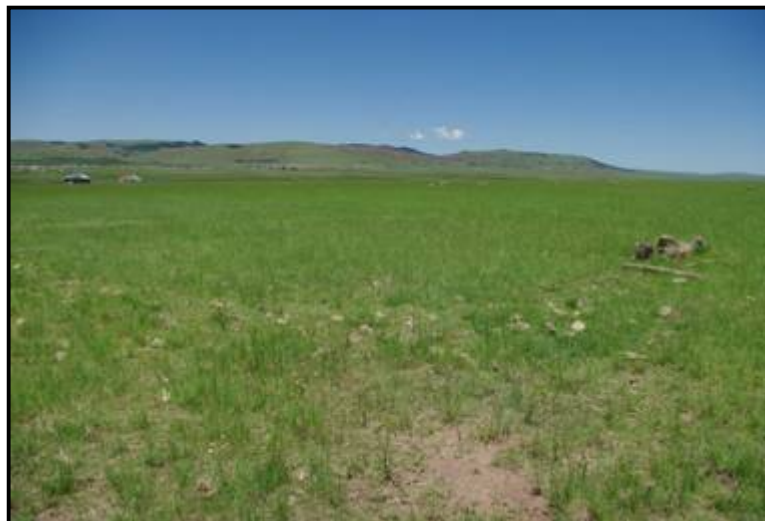
**Figure 175:** Borrow Pit 261\_BP08

The borrow pit 261\_BP08 area is characterized by scattered remains of a fairly recent homestead: Rectangular remains of stone stock enclosures are scattered around. A single fairly large circular kraal is inferred to have been present towards the north-east of the study site, characterized by a slight change in vegetation (grass color), a possible result of dung deposits. A number of huts may well have been present, identified by stone foundation remains, mounds and circular impressions. The existing borrow pit impacted on a portion of such a hut foundation; here part of the hut and associated verandah can still be identified, but the remainder thereof has already been destroyed by quarrying activities at the borrow pit. The assumption of a recent date for the site is supported in large by the high degree of rectangular structures, but also by the absence of any graves – implying a short occupation period. The site is not of archaeological significance, but community consultation is recommended before continued use of the borrow pit.

**Figure 176:** General view of borrow pit 261\_BP08

**Figure 177:** Rectangular stone stock enclosure remains at borrow pit 261\_BP08

**Figure 178:** A selection of site features at borrow pit 261\_BP08

**RECOMMENDATIONS:** It is recommended that use of borrow pit 261\_BP08 proceeds as applied for without the developer having to comply with additional heritage compliance requirements. Utilization of the site should be preceded by community consultation.

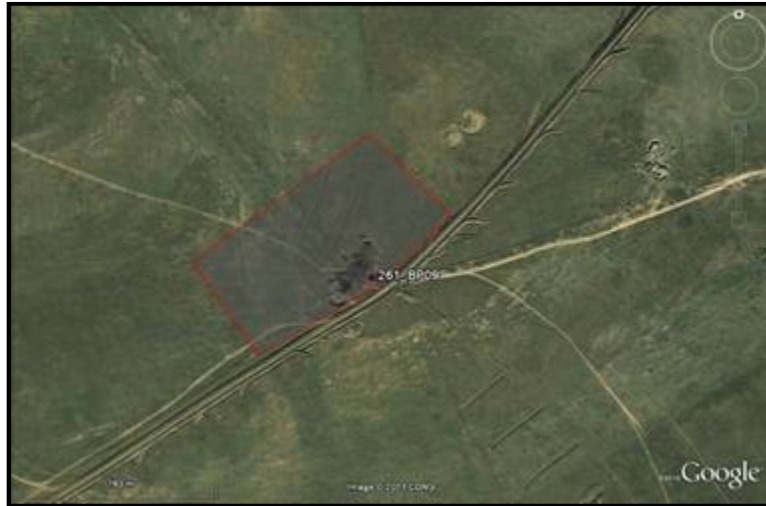
**Figure 179:** Borrow Pit 261\_BP09

No archaeological or cultural heritage resources, as defined and protected under the NHRA 1999, were identified on the surface or within exposed sub-surface sections during Phase 1 AIA assessment of borrow pit 261\_BP09. The remains of 2 fairly large circular stone stock enclosures are situated towards the north-east of the study, these features will not be impacted on during utilization of the borrow pit

**RECOMMENDATIONS:** It is recommended that use of borrow pit 261\_BP09 proceeds as applied for without the developer having to comply with additional heritage compliance requirements.
