PHASE 1 ARCHAEOLOGICAL IMPACT ASSESSMENT

**UTILIZATION OF BORROW PITS –  
CHRIS HANI DISTRICT MUNICIPALITY,  
EASTERN CAPE, SOUTH AFRICA**

**DATE:** 2011-03-01

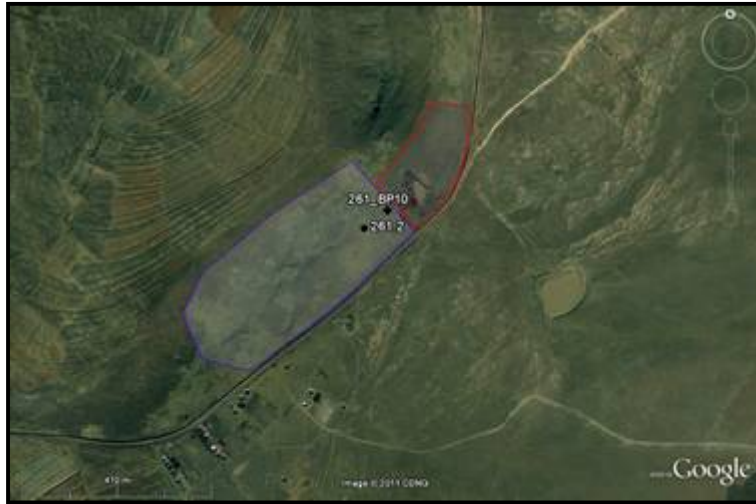
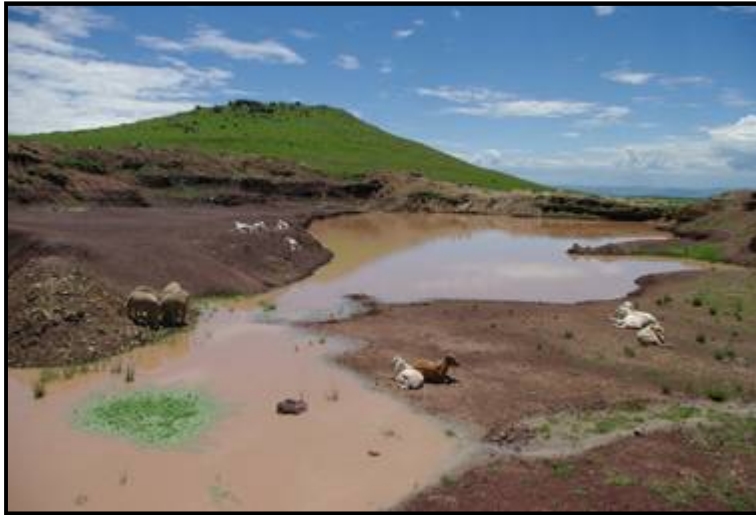
**Figure 180:** Borrow Pit 261\_BP10

No archaeological or cultural heritage resources, as defined and protected under the NHRA 1999, were identified on the surface or within exposed sub-surface sections during Phase 1 AIA assessment of the immediate borrow pit 261\_BP10 study site.

**Figure 181:** General view of borrow pit 261\_BP10

**RECOMMENDATIONS:** It is recommended that use of borrow pit 261\_BP10 proceeds as applied for, without the developer having to comply with additional heritage compliance requirements.

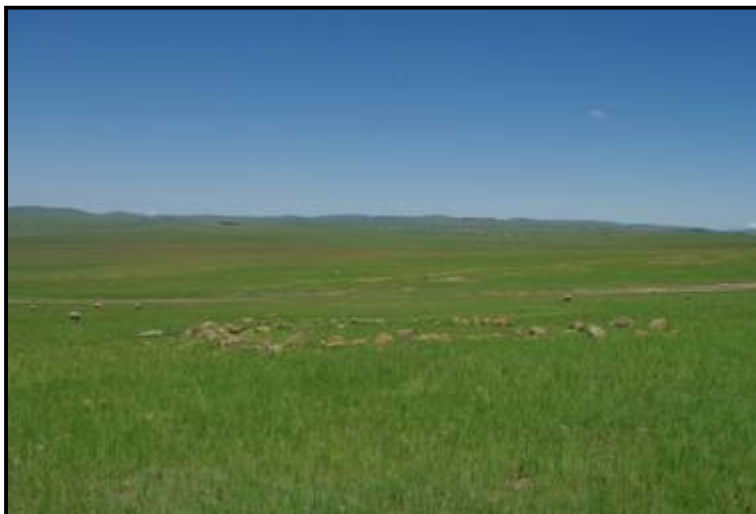
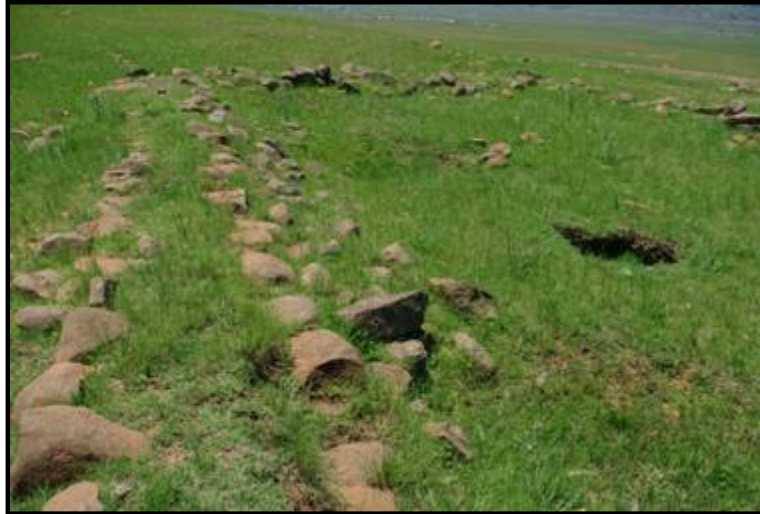
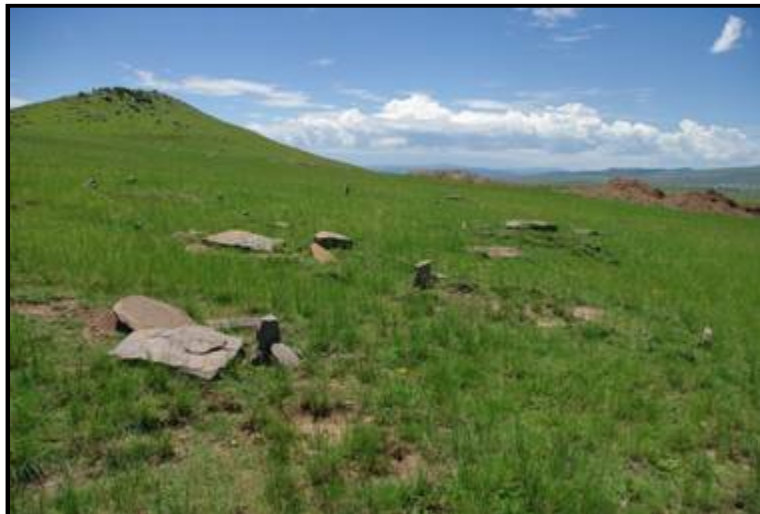
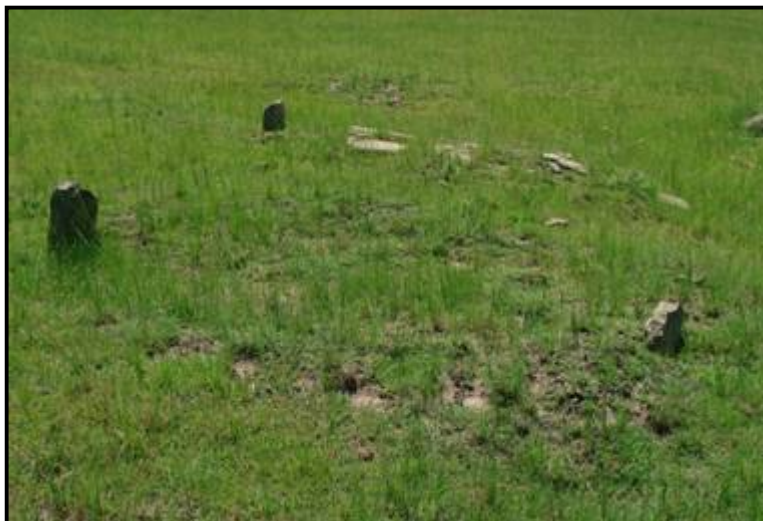
A large Iron Age site, Site 261.2 is situated to the immediate south-west of the study site, with the site proper located at approximately S31°56'46.3"; E27°53'48.6". Here stone foundations are indicative of a large circular stock enclosure, with at least 3 smaller circular stock enclosures in the immediate vicinity. Associated residential remains constitute hut mounds and foundation walls, but thick vegetation obscured visibility to a degree negatively affecting basic site feature identification.

Site 261.2 comprises of an archaeological and cultural heritage site as defined and protected by the NHRA 1999. The site is ascribed a SAHRA LOW-MEDIUM SIGNIFICANCE and a GENERALLY PROTECTED C FIELD RATING. The grave site directly associated with the Iron Age remains is ascribed a SAHRA MEDIUM SIGNIFICANCE and a GENERALLY PROTECTED B FIELD RATING. Despite fairly close proximity of the cemetery to the proposed study site fencing of the borrow pit for EMP purposes will ensure conservation of the site without additional partial site conservation measures (such as formal conservation of the cemetery), implying also no impact on the archaeological site.

**Figure 182:** View of selected site features from Site 261.2

**Figure 183:** Stock enclosure remains at Site 261.2

**Figure 184:** View of the Site 261.2 cemetery, with more recent graves in the foreground

**Figure 185:** Close-up of some of the older graves from the Site 261.2 cemetery

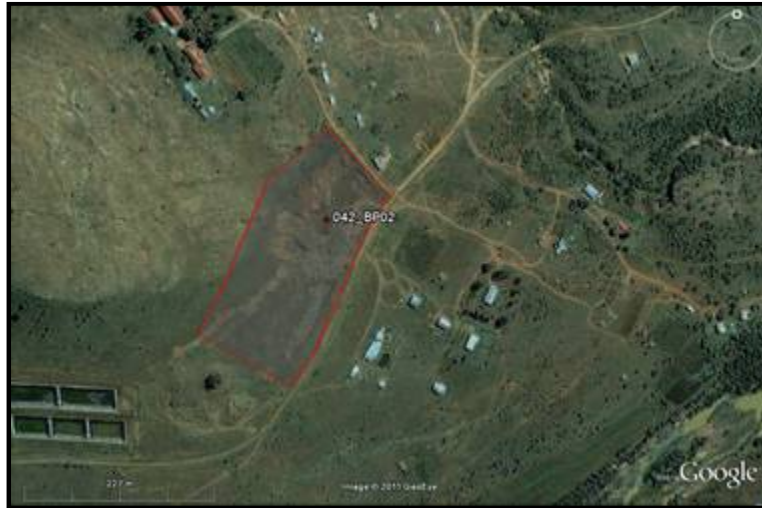
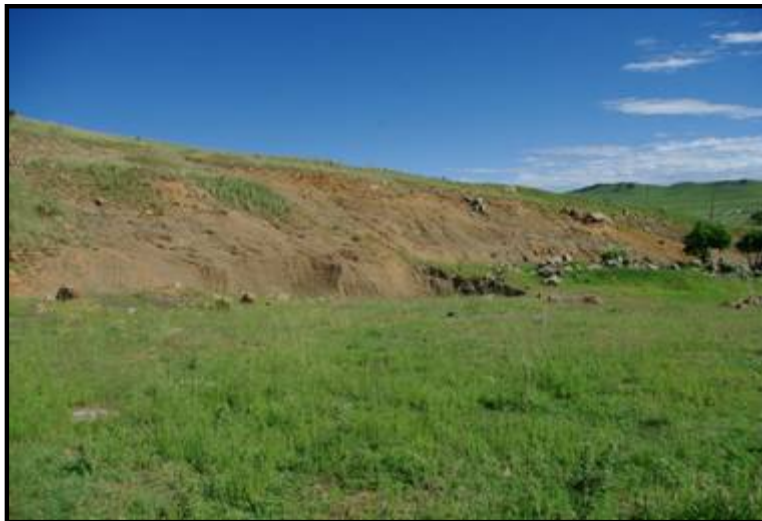
**Figure 187:** Borrow Pit 042\_BP02

No archaeological or cultural heritage resources, as defined and protected under the NHRA 1999, were identified on the surface or within exposed sub-surface sections during Phase 1 AIA assessment of borrow pit 042\_BP02.

**Figure 188:** View of a portion of borrow pit 042\_BP02

**RECOMMENDATIONS:** It is recommended that use of borrow pit 042\_BP02 proceeds as applied for without the developer having to comply with additional heritage compliance requirements.

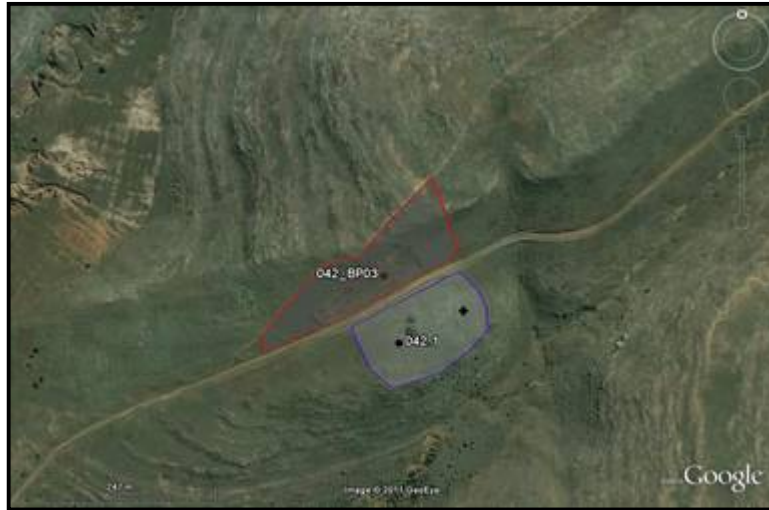
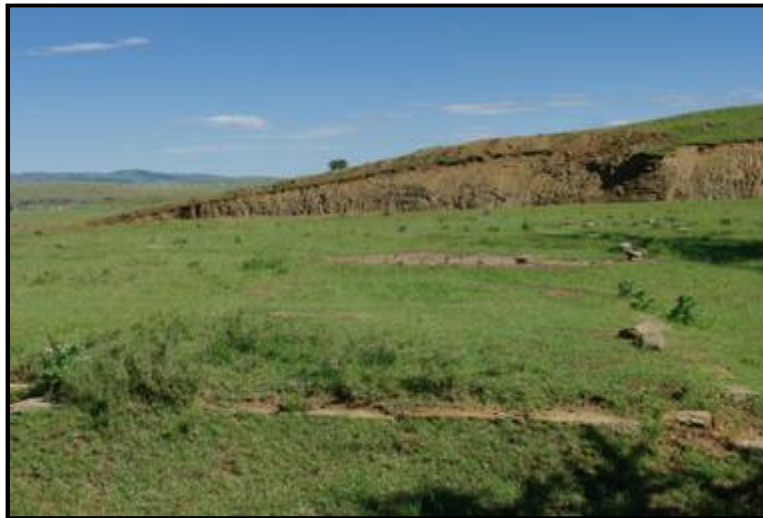
**Figure 189:** Borrow Pit 042\_BP03

No archaeological or cultural heritage resources, as defined and protected under the NHRA 1999, were identified on the surface or within exposed sub-surface sections during Phase 1 AIA assessment of the borrow pit 042\_BP03 study site.

The general area north-east of the study site, and north-east of the gravel access road demarcating the borrow pit site extent is characterized by a number of sparsely scattered dominating rectangular stone stock enclosure remains. These remains are inferred to be of fairly recent origin based on the post-Colonial Iron Age adaptation with an emphasis on square or rectangular structure shapes. The general area north-east of the study site was only briefly assessed; very visible stock enclosure remains are often associated with circular hut remains comprising of hut foundations, mounds or indents / depressions. No associated cemeteries or burial places were identified; but based on the essential 'spot assessment' methodology applied to the area the presence of such sites cannot be excluded. Utilization of borrow pit 042\_BP03 will not impact on the fairly recent Iron Age remains situated north-east of borrow pit 042\_BP03 or possible associated cemetery or grave sites; remains will be conserved *in situ*.

Figure 190: View of borrow pit 042\_BP03

**RECOMMENDATIONS:** It is recommended that use of borrow pit 042\_BP03 proceeds as applied for without the developer having to comply with additional heritage compliance requirements.

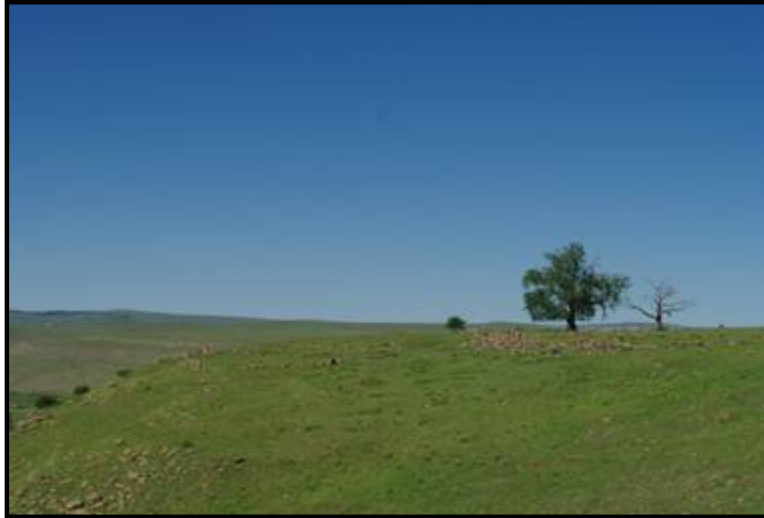
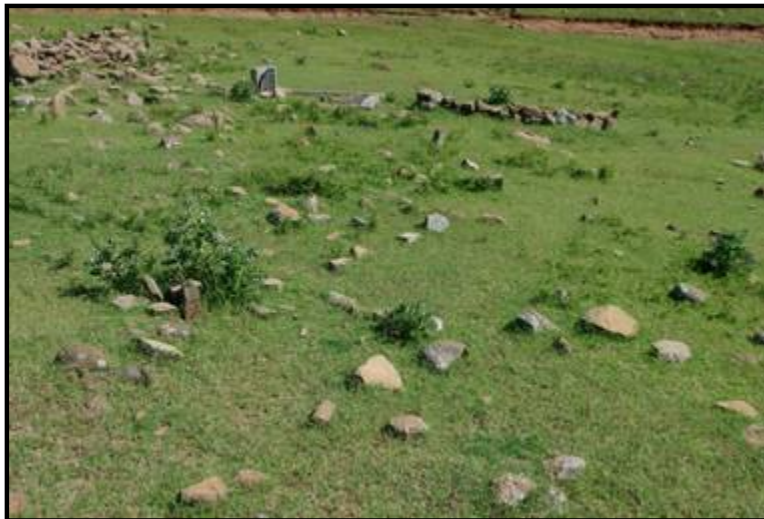
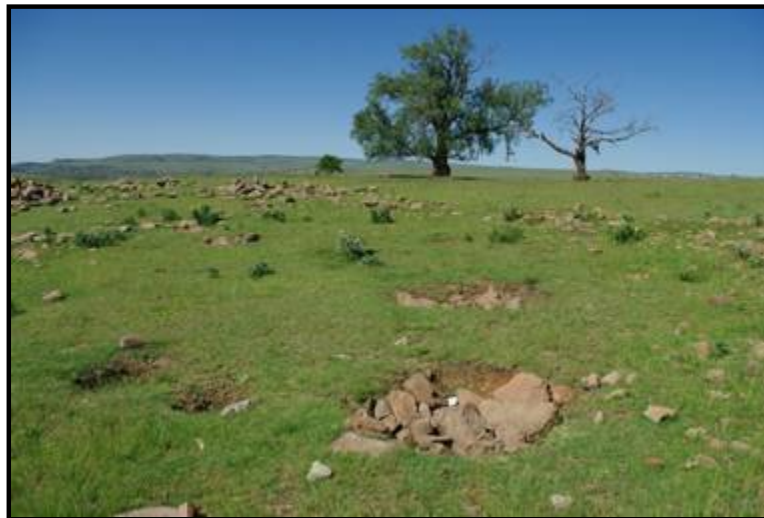
Residential remains are clustered towards the west of the site and west of the trees; at least 5 circular hut remains were identified associated with foundation remains of square / rectangular shaped structures. A table-like stone stacked feature is still standing and situated roughly midway between the residential and stock enclosure remains, perhaps indicative of a 'meeting place' locality. Site layout directly contravenes the Central Cattle Pattern (CCP) and is based on 2 spatial groupings: Stock enclosures to the east, residential areas to the west, with a clear open space demarcating these localities (centrally characterized by the locality of the trees and the table-like structure).

Figure 191: General view of Site 042.1

Figure 192: The cemetery area at Site 042.1

Figure 193: Portion of the stock enclosure cluster, with grain storage pit areas visible inside the enclosures

*In situ* conservation is recommended for Site 042.1, implying that measures should be taken to ensure that the site is conserved as is. In order to ensure that utilization of the borrow pit, or associated development impact spill-over do not impact on the site, it is recommended that the developer erect signage at the site, south of borrow pit 042\_BP03 and Road 042, stating that the area is a 'no-go' zone (no entry sign).

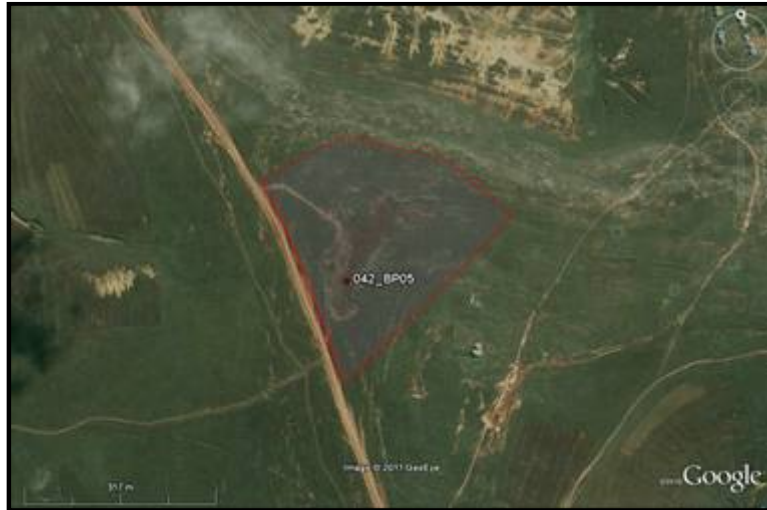
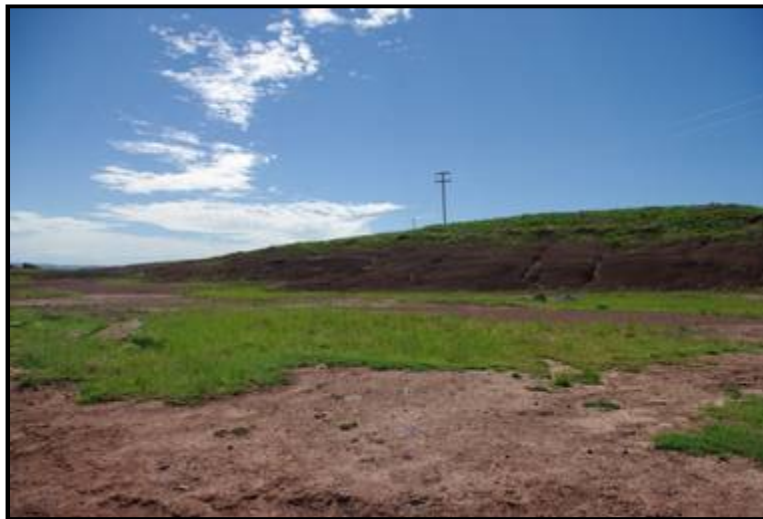
**Figure 194:** Borrow Pit 042\_BP05

No archaeological or cultural heritage resources, as defined and protected under the NHRA 1999, were identified on the surface or within exposed sub-surface sections during Phase 1 AIA assessment of borrow pit 042\_BP05.

**Figure 195:** View of borrow pit 042\_BP05

**RECOMMENDATIONS:** It is recommended that use of borrow pit 042\_BP05 proceeds as applied for without the developer having to comply with additional heritage compliance requirements.

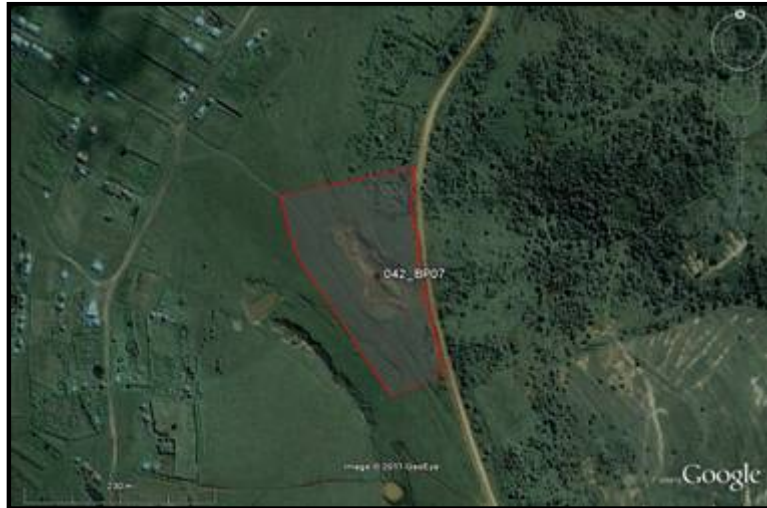
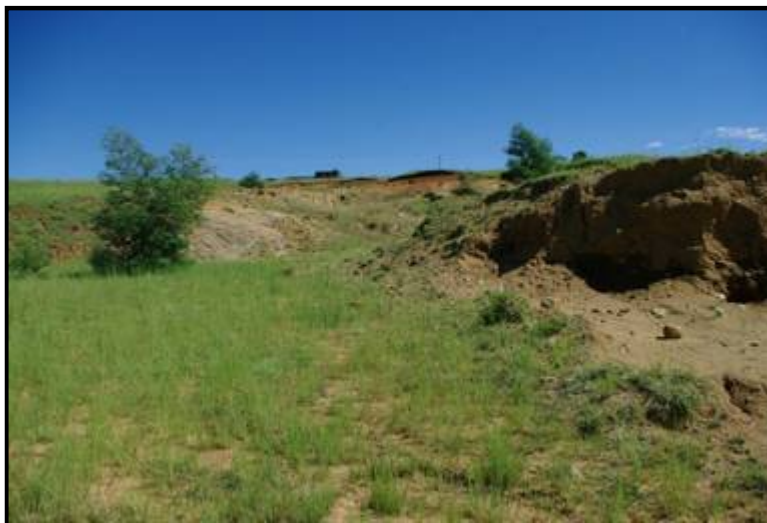
**Figure 196:** Borrow Pit 042\_BP07

No archaeological or cultural heritage resources, as defined and protected under the NHRA 1999, were identified on the surface or within exposed sub-surface sections during Phase 1 AIA assessment of borrow pit 042\_BP07. (Contemporary stock enclosure remains characterized the north-eastern part of the assessment area and the general area north-east thereof).

**Figure 197:** View of a portion of borrow pit 042\_BP07

**RECOMMENDATIONS:** It is recommended that use of borrow pit 042\_BP07 proceeds as applied for without the developer having to comply with additional heritage compliance requirements.

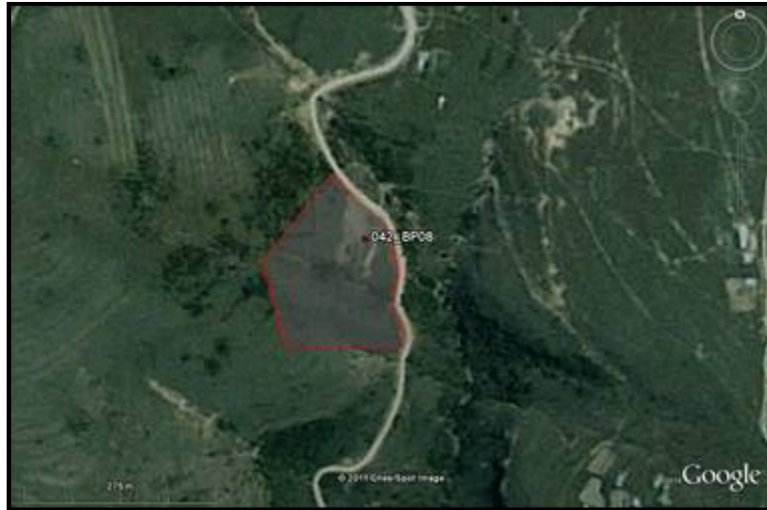
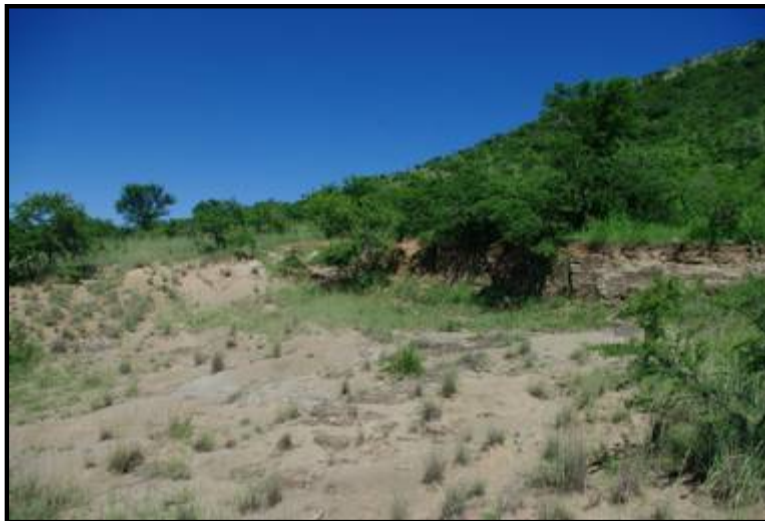
**Figure 198:** Borrow Pit 042\_BP08

No archaeological or cultural heritage resources, as defined and protected under the NHRA 1999, were identified on the surface or within exposed sub-surface sections during Phase 1 AIA assessment of borrow pit 042\_BP08.

**Figure 199:** View of a portion of borrow pit 042\_BP08

**RECOMMENDATIONS:** It is recommended that use of borrow pit 042\_BP08 proceeds as applied for without the developer having to comply with additional heritage compliance requirements.

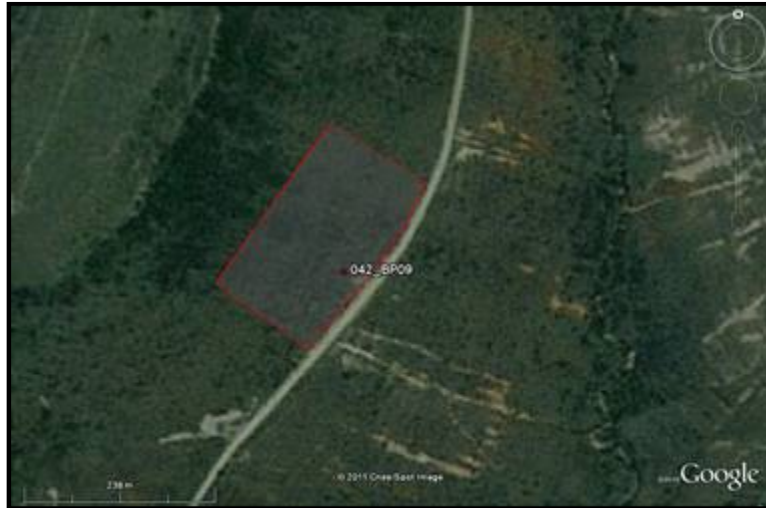
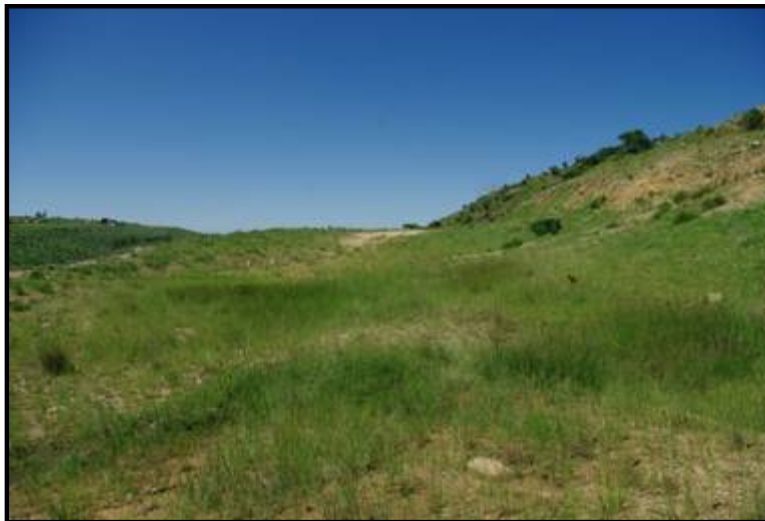
**Figure 200:** Borrow Pit 042\_BP09

No archaeological or cultural heritage resources, as defined and protected under the NHRA 1999, were identified on the surface or within exposed sub-surface sections during Phase 1 AIA assessment of borrow pit 042\_BP09.

**Figure 201:** General view of borrow pit 042\_BP09

**RECOMMENDATIONS:** It is recommended that use of borrow pit 042\_BP09 proceeds as applied for without the developer having to comply with additional heritage compliance requirements.

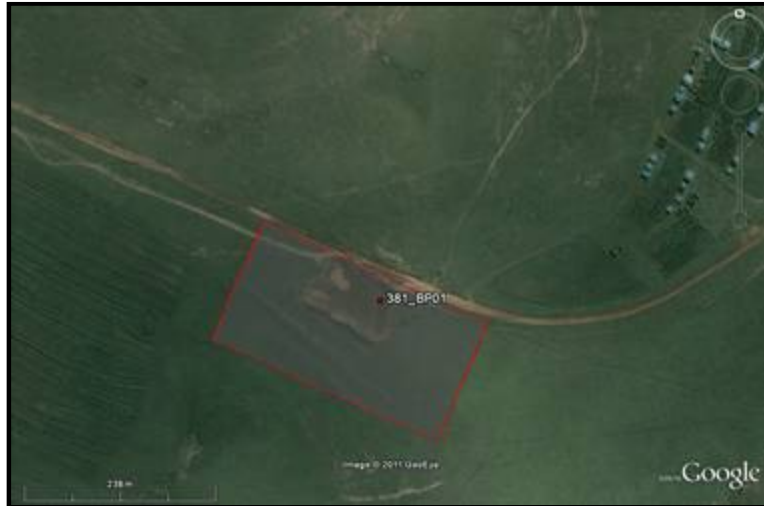
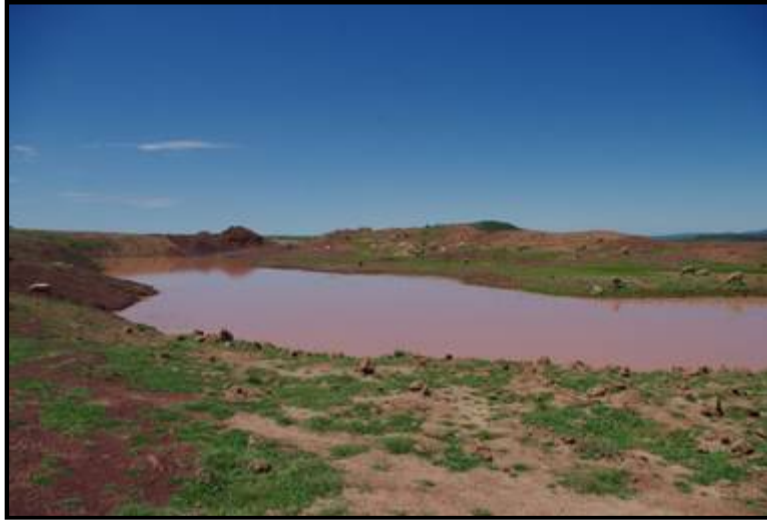
**Figure 203:** Borrow Pit 381\_BP01

No archaeological or cultural heritage resources, as defined and protected under the NHRA 1999, were identified on the surface or within exposed sub-surface sections during Phase 1 AIA assessment of the borrow pit 381\_BP01 study site.

**Figure 204:** View of borrow pit 381\_BP01

**RECOMMENDATIONS:** It is recommended that use of borrow pit 381\_BP01 proceeds as applied for without the developer having to comply with additional heritage compliance requirements.

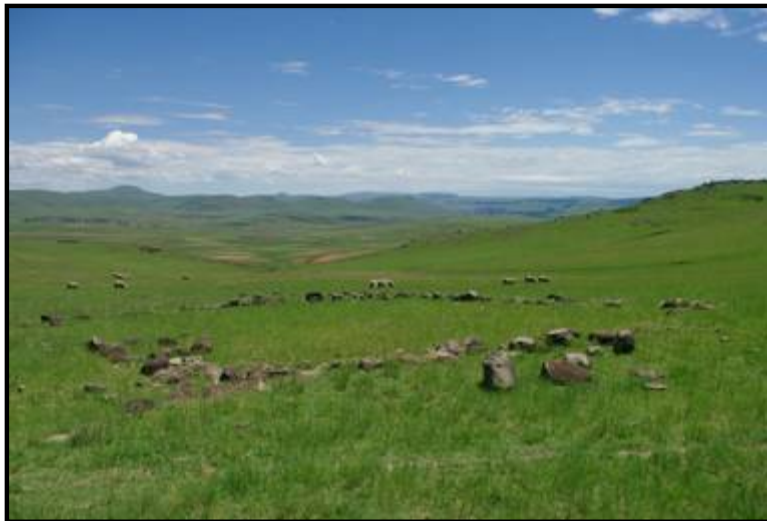
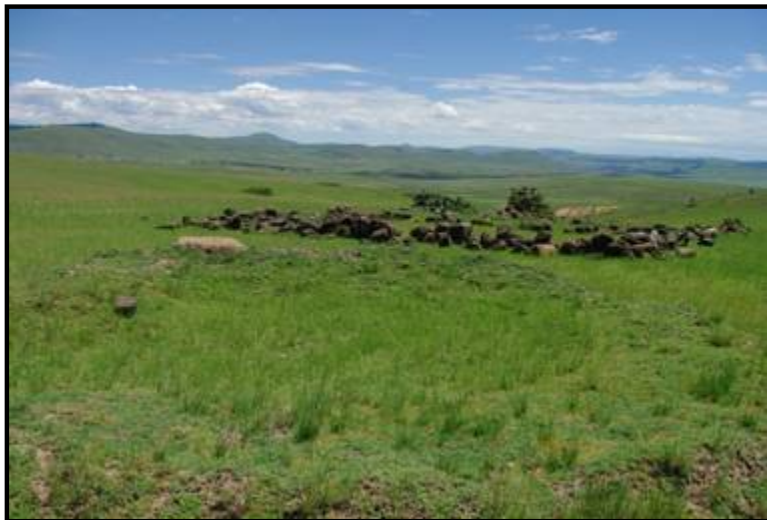
The general area towards the north of the study site and north of Road 381 is characterized by a fairly high quantity of widely scattered Iron Age remains comprising primarily of quite visible rectangular stone stock enclosure remains. In addition circular hut foundations, mounds and indents are indicative of associated occupation, often clustered in close proximity to the stock enclosures. The emphasis on rectangular stock enclosure structure shapes indicates a recent date for the site. This inference of recent occupation is supported by the lack of identified cemeteries or burial places in direct proximity to any of the clusters of residential remains or the traditional practice of graves being located immediately adjacent to stock enclosures. The general area, not forming part of the study site and based on proximity thereto not inferred to be impacted on during utilization of borrow pit 381\_BP01 was not subjected to Phase 1 AIA level of inspection and graves may well be present; but not threatened by development impact.

**Figure 205:** Rectangular stone stock enclosure remains characterizing the general area north of Road 381

**Figure 206:** Residential and stone stock enclosure remains from north of Road 381

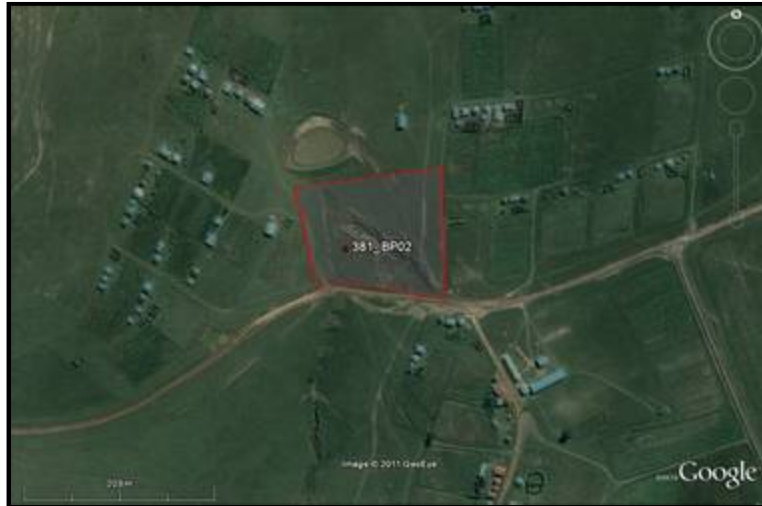
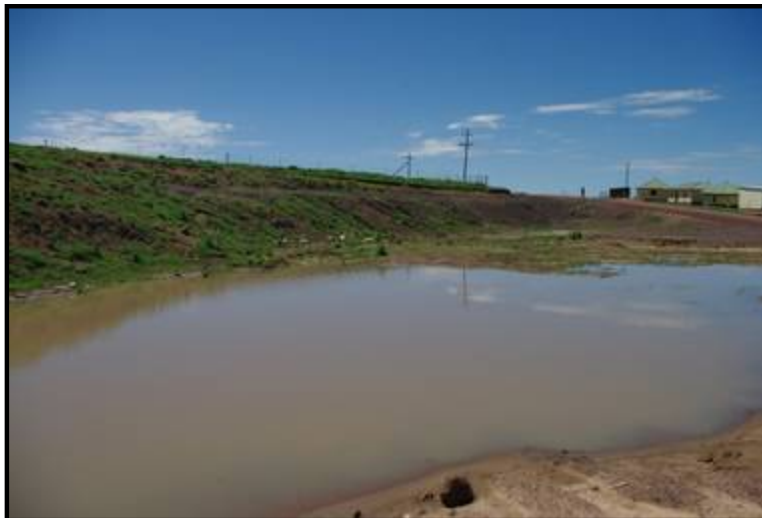
**Figure 207:** Borrow Pit 381\_BP02

No archaeological or cultural heritage resources, as defined and protected under the NHRA 1999, were identified on the surface or within exposed sub-surface sections during Phase 1 AIA assessment of borrow pit 381\_BP02.

**Figure 208:** View of borrow pit 381\_BP02

**RECOMMENDATIONS:** It is recommended that use of borrow pit 381\_BP02 proceeds as applied for without the developer having to comply with additional heritage compliance requirements.
