11 Buitengracht Street

Archaeological Monitoring:
Erf 798 Cape Town

*Prepared for TCI Property Developers
November 2005*

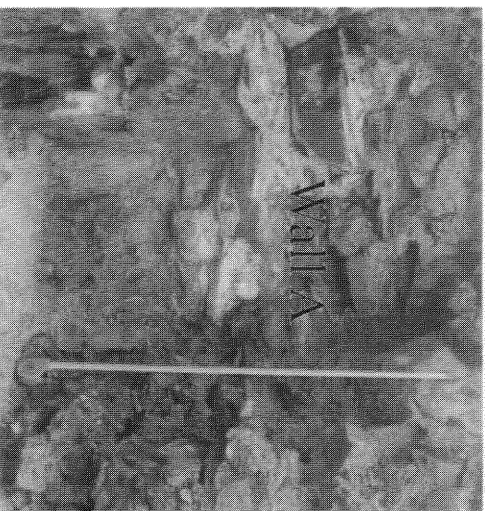
Between the concrete piles on the north-west section alongside Buitengracht Street, a slate stone foundation wall, Wall A, was visible. It consisted of up to 5 courses of square/rectangular slate blocks, bonded with a modern cement mortar. Figure 2 shows the extent of the wall in the north-east section.

Photo 2-3: Wall A, between two concrete piles, near the northern corner (left), and near the western corner of the site (right). Tape extended to 1m.

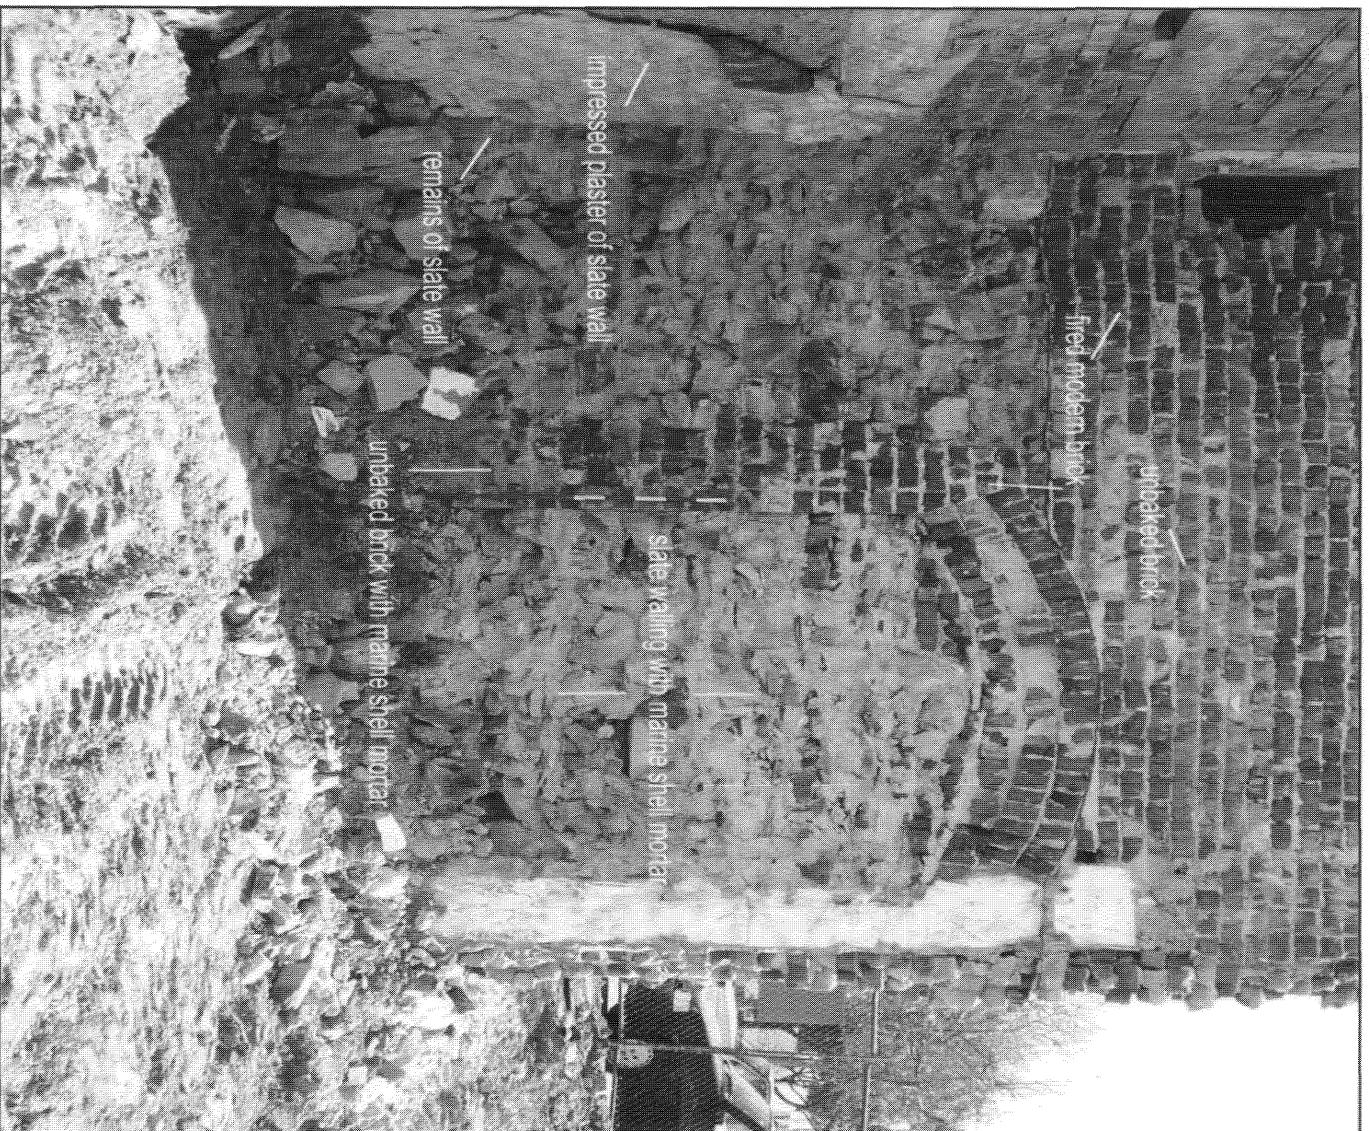
The in-situ remains of a 19th century brick and stone wall, with 20th century brickwork on top, was uncovered during the demolition of the former showroom in the western corner of the site. The walling consisted of at least three phases of construction (photos 4 and 5). The earliest was a low-temperature fired clay brick and slate stone walling with shell tempered mortar, typical of 19th century construction.

Built directly onto this wall was an early 20th century construction consisting of well-fired brickwork arches. The upper, second floor brickwork consisted of later 20th century brickwork and some re-used older 19th century, under-fired bricks.

Photo 4: South east facing section of standing wall

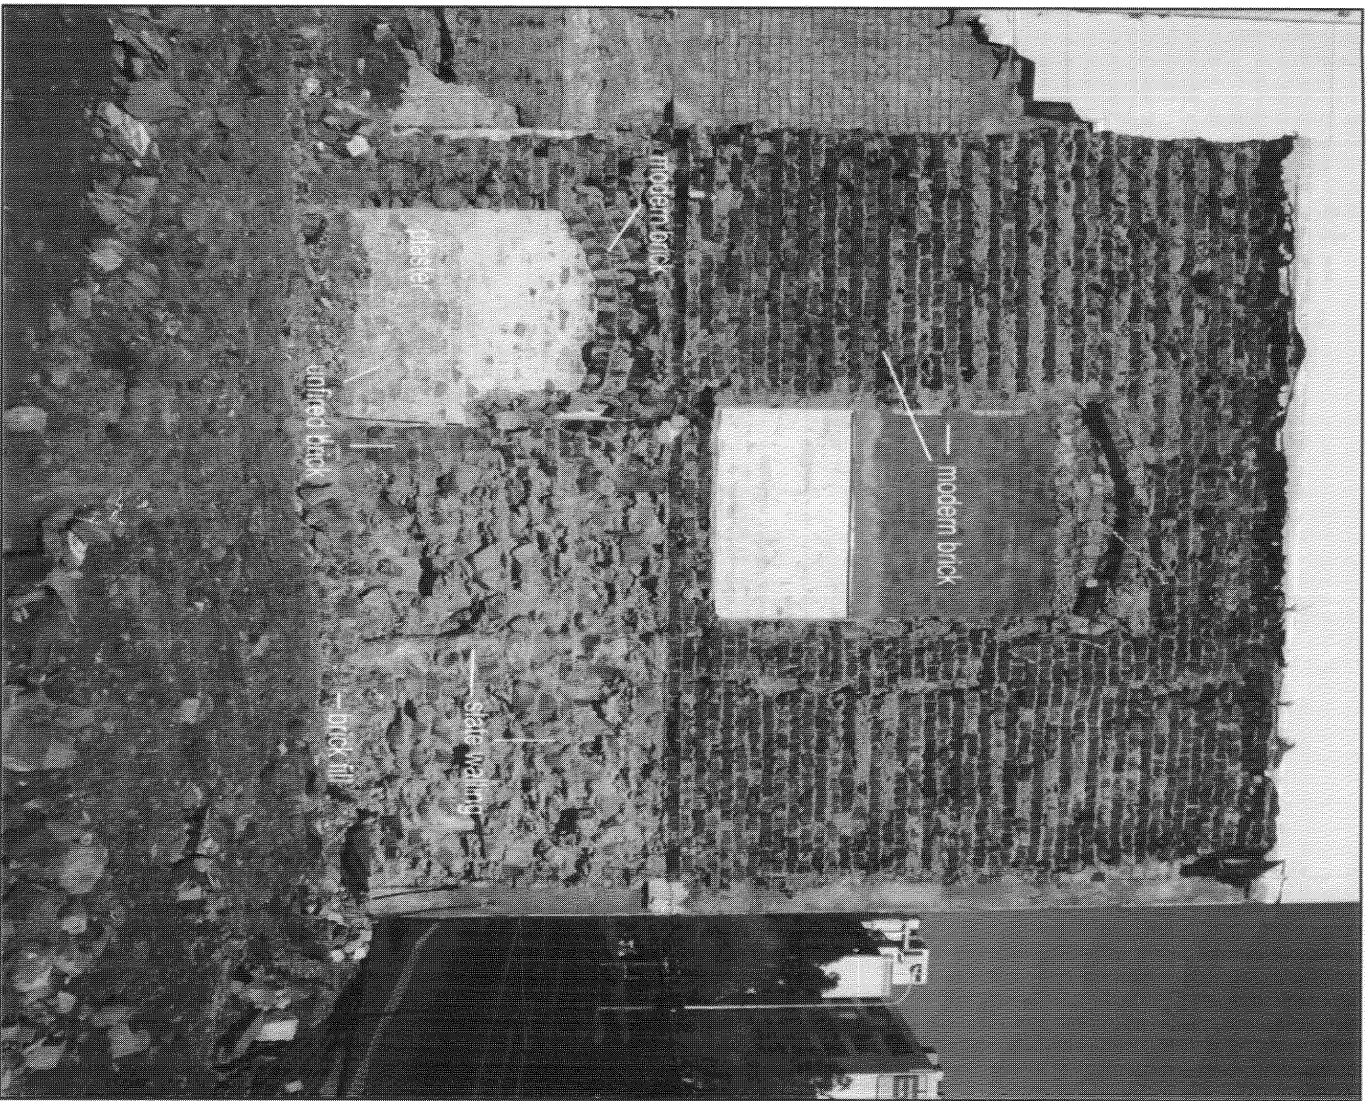
Photo 5: North east facing section of standing wall
