PHASE 1 ARCHAEOLOGICAL IMPACT ASSESSMENT

**WATER SUPPLY BACKLOG IN CHDM:
CLUSTER 2, PHASE 1, SCHEMES 27, 28 & 29,
COFIMVABA, EASTERN CAPE, SOUTH AFRICA**

DATE: 2010-07-01

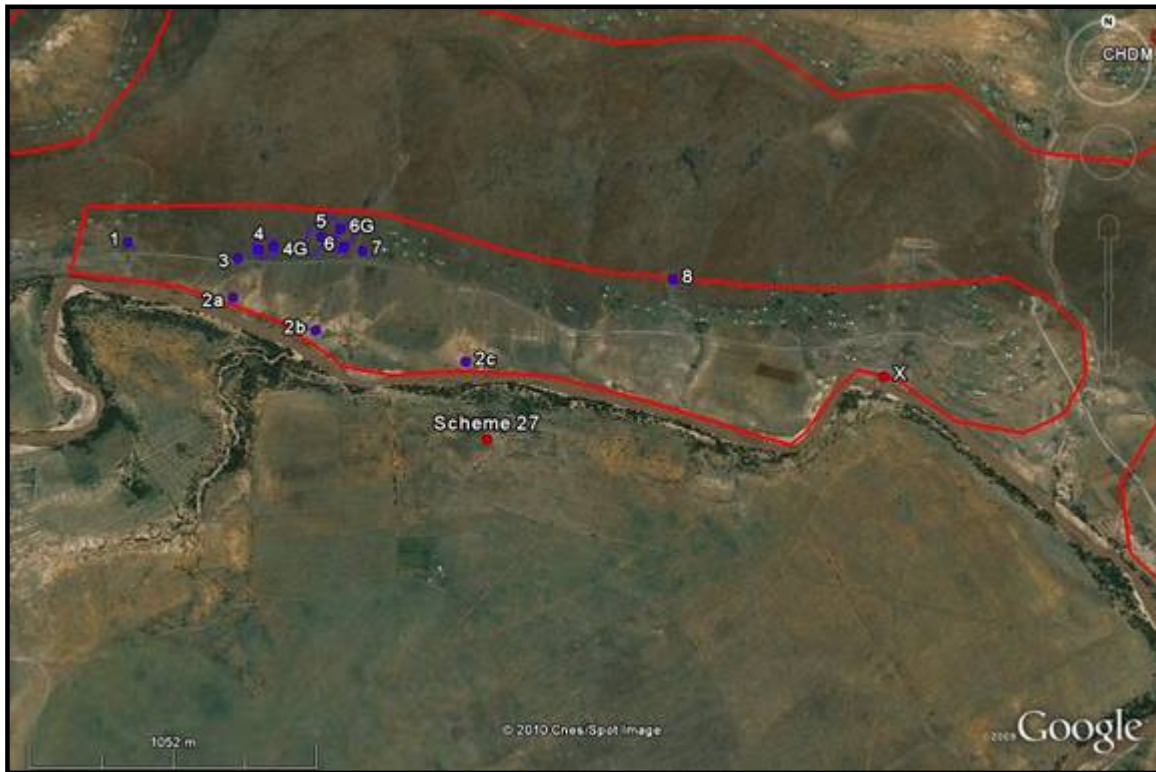
Figure 8: Scheme 27 - Phase 1 AIA findings

The proposed Scheme 27 development centers on the present day Nyongwana Village.

Eight (8) archaeological and cultural heritage resources, as defined and protected under the NHRA 1999, were identified during assessment of the Scheme 27 development area. The presence of resources are primarily ascribable to proximity of the Wit Kei River and surface stone rich deposits to the north thereof, largely north of the Scheme 27 access road, characterizing a much more undulated landscape.

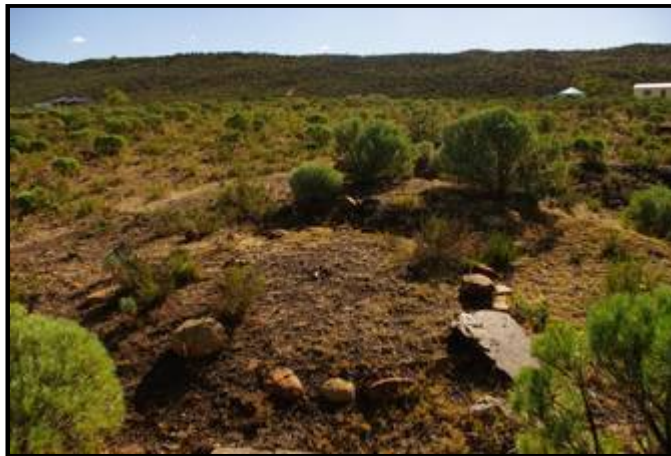
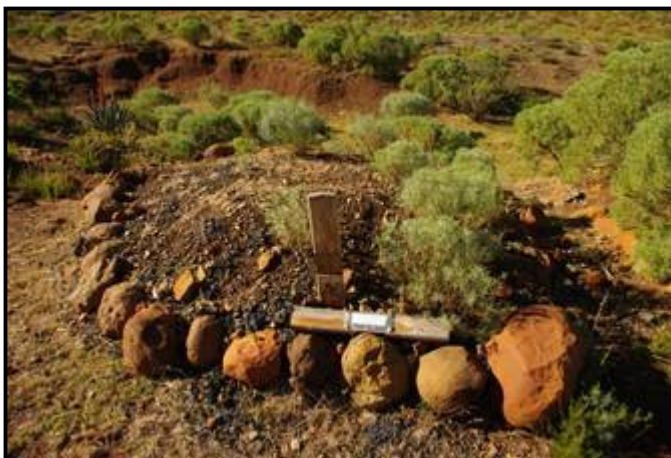
Figure 15: General view of Site 27.1

Figure 16: The northern most grave of Site 27.1, characterized by the headstone

Site 27.1 is ascribed a SAHRA *Medium Significance* and *Generally Protected B Field Rating*: The site should thus either be conserved or mitigated (exhumation and re-internment) prior to development. The proposed line route is planned north of the site locale, implying that the site will be conserved. Based on Xhosa cultural values and customs and current land-use, formal site conservation (permanent fencing) is not recommended. The developer may consider temporary conservation measures during the construction phase.

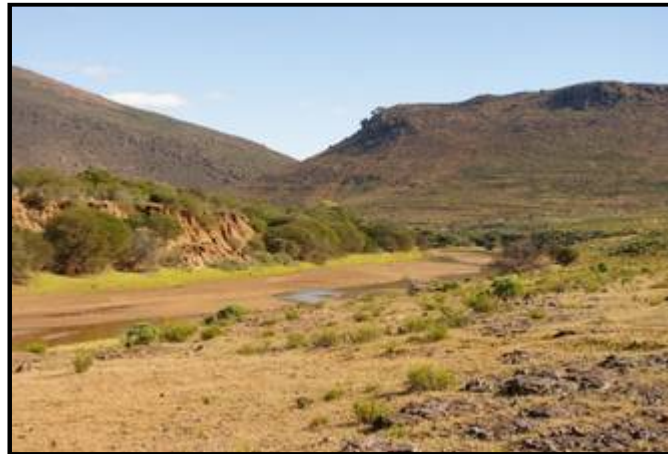
Figure 17: Shale outcrops displaying low density Stone Age artefacts along the banks of the Wit Kei River

The Site 27.2 features are ascribed a SAHRA *Low Significance* and *Generally Protected C Field Rating*: The features should be conserved or destroyed under a SAHRA APM Unit *Site Destruction Permit*. Proposed development will however not impact on any of the features, implying site conservation. Based on current land-use and community access to water no formal conservation (permanent fencing) is recommended.

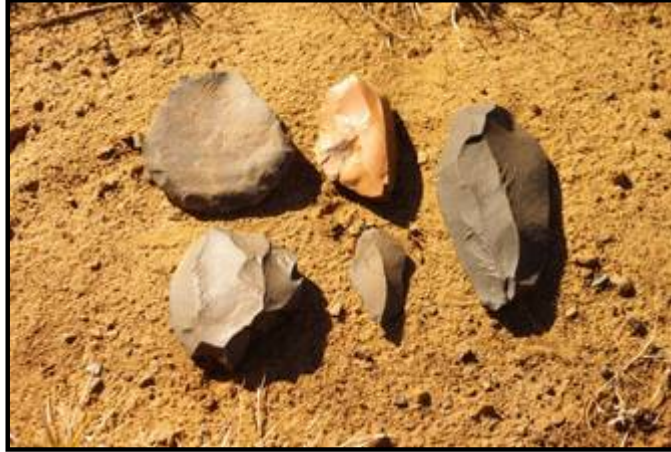
Figure 18: Stone Age artefacts samples from the Site 2 features

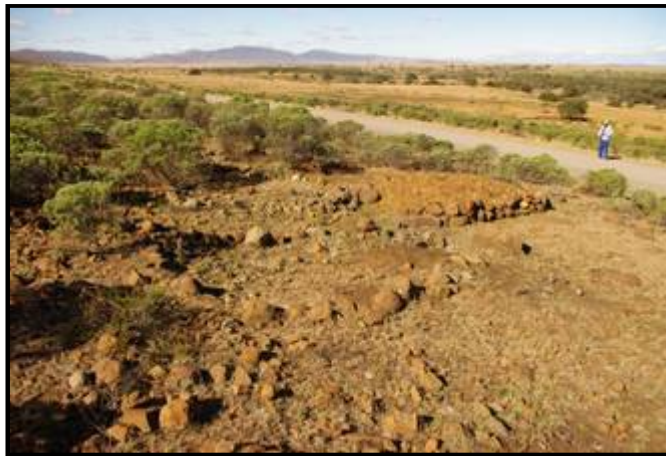
Figure 21: General view of Site 27.3

Site 27.3 is ascribed a SAHRA *Medium Significance* and *Generally Protected B Field Rating*: The site should either be conserved or mitigated (exhumation and re-internment) prior to development. The proposed line route will run north of the site; the site will thus be conserved. Based on proximity to the road, Xhosa cultural values and customs and current land-use, formal site conservation (permanent fencing) is not recommended. The developer may consider temporary conservation measures during the construction phase.

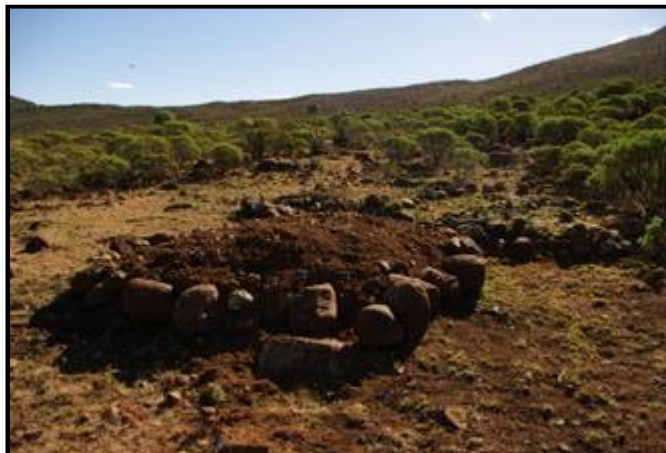
Figure 22: View of the 3 graves of Site 27.3 with the recent high earth filled grave in the foreground

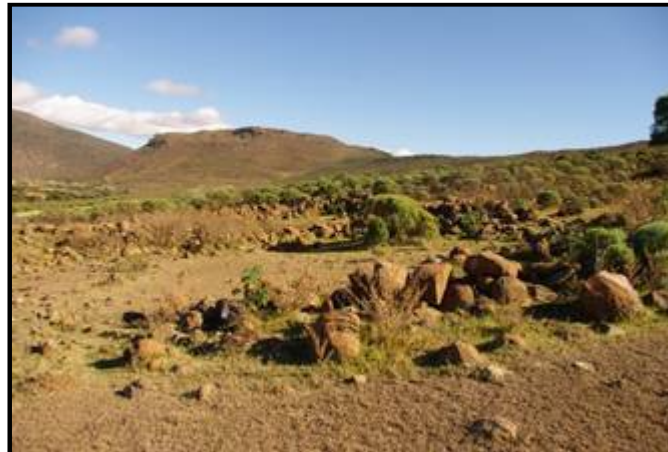
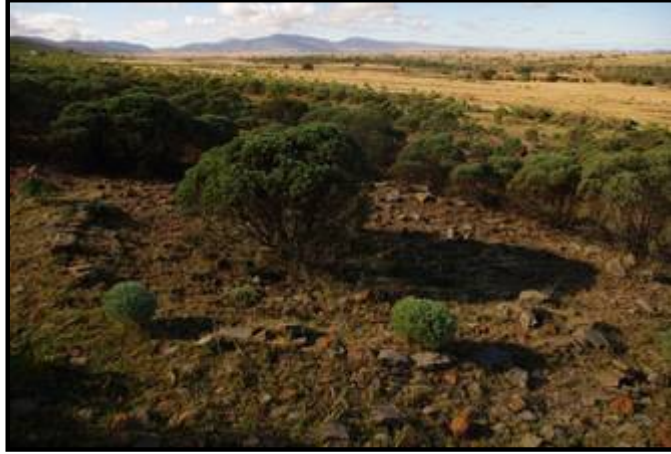
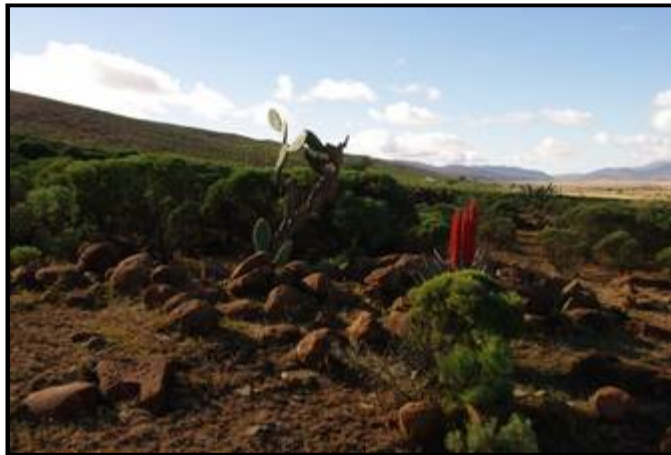
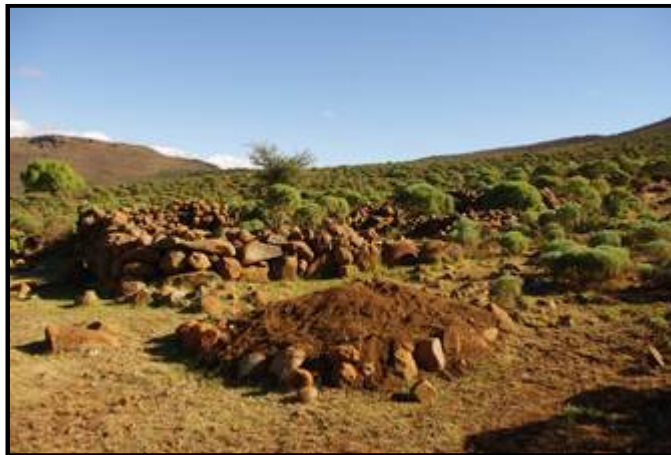
Iron Age stone walling of Site 27.4 dates to the Colonial Period, based on the presence of a combination of circular and rectangular structure remains at the approximate 90x90m site. About 8-9 stone walled features were identified in the general Site 4 area, in various states of decay and ranging from wall remains still standing to a level of about 1m while at other places simple hut foundation remains were all that is left of former habitation. Cultural overlay may be present at the site, but without further investigation it would be difficult to verify. In general however the majority of clearly identifiable circular features (at least 5) may indicate a slightly older age; rectangular features are very similar in design to those in contemporary use. No artefactual material was found in association with the site; the presence of surface decorated ceramic ware would have been particularly useful in site identification and temporal variation. To the north east of the site a seemingly quite contemporary grave (4G – S31°56'01.5"; E27°18'03.5") is situated in direct proximity to rectangular 'kraal' remains.

Figure 23: Two circular stone features at Site 27.4

Figure 24: Foundation remains of a circular stone, most probably residential, structure

Figure 25: Remains of a heavily decayed circular stone feature

Figure 26: A quite recent grave (4G) in direct proximity to rectangular 'kraal' remains

Site 27.4 is ascribed a SAHRA *Medium Significance* and *Generally Protected B Field Rating*: The site should either be conserved or mitigated (sample excavation) prior to development. The proposed line route will cut through the general area from the road towards the north-west; the site may thus easily be conserved by taking heritage concerns into account when finalizing the line route. Based on Xhosa cultural values and customs and current land-use, formal site conservation (permanent fencing) is not recommended. The developer may consider temporary conservation measures during the construction phase.

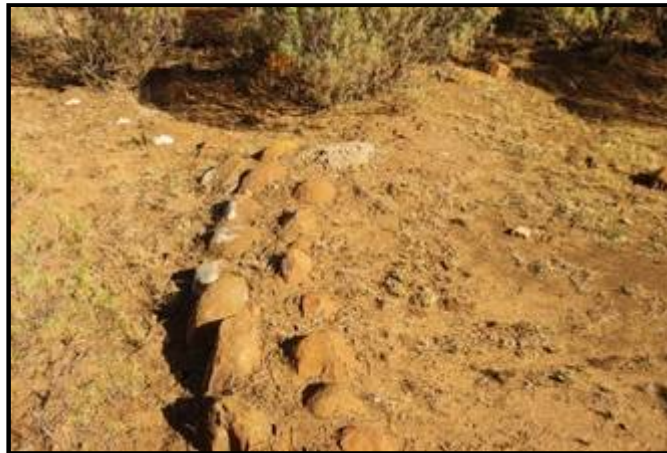
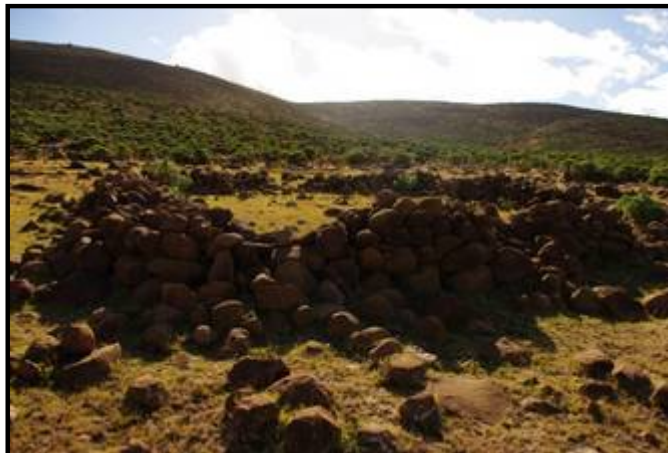
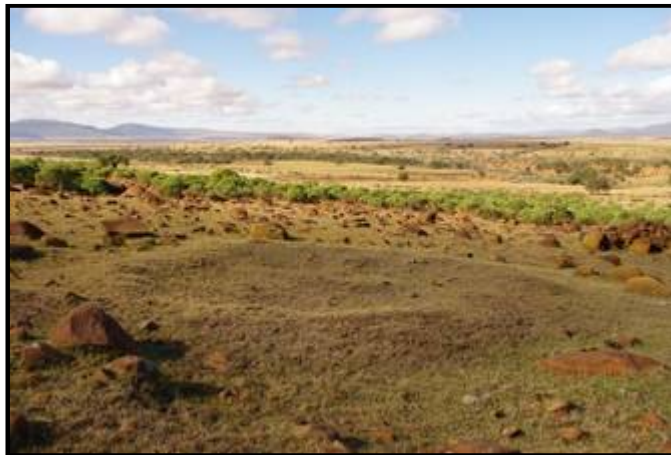
The remains of at least 8 'kraal' structures were found comprising the Site 27.5 area, an area of approximately 200x90m in size. Some structures are circular and some rectangular in shape, implying an Iron Age traditional affiliation of the Colonial Period. Structures were found in various stages of decay; from foundation mounds, to foundation remains and erect walls in places up to approximately 1m. Cultural overlay is inferred; oral histories and further scientific excavation may shed light on practices on continuing use of sites. No artefacts were found in association with the site.

Figure 27: Close-up of circular foundation remains at Site 27.5

Figure 28: A circular stone 'kraal' structure at Site 27.5

Figure 31: Foundation mounds towards the north eastern extremity of Site 27.5

Site 27.5 is ascribed a SAHRA *Medium Significance* and *Generally Protected B Field Rating*: The site should either be conserved or mitigated (sample excavation) prior to development. The site will be conserved by the development. Based on Xhosa cultural values and customs and current land-use, formal site conservation (permanent fencing) is not recommended. The developer may consider temporary conservation measures during the construction phase.

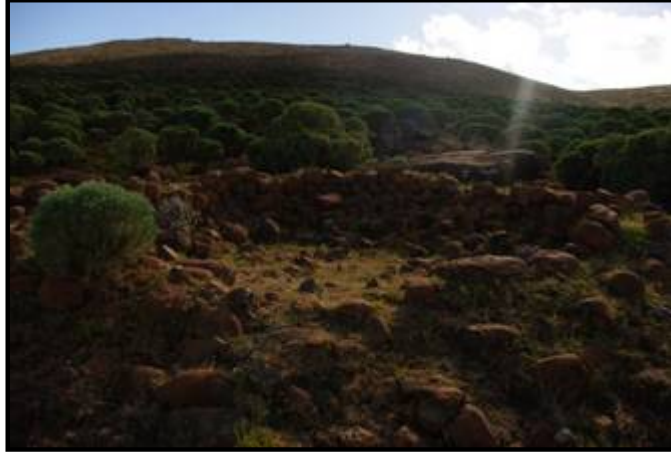
Figure 29: One of the circular stone structures of Site 27.5; with the original entrance in the front

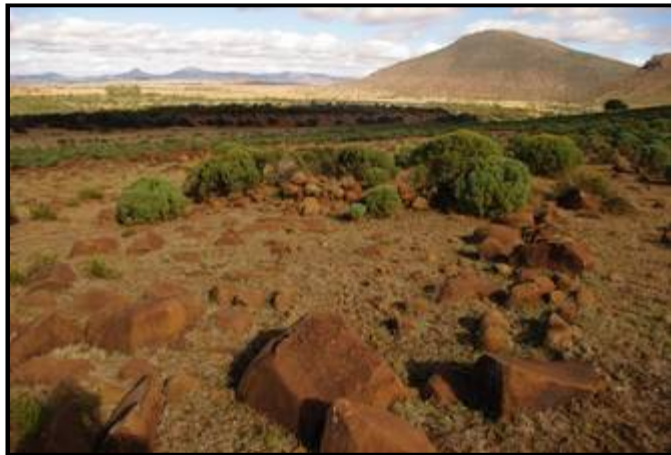
Figure 30: Remains of a rectangular structure comprising the Site 27.5 area

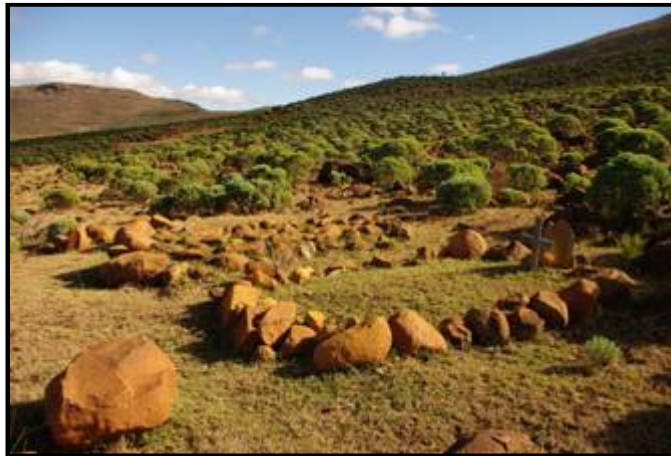
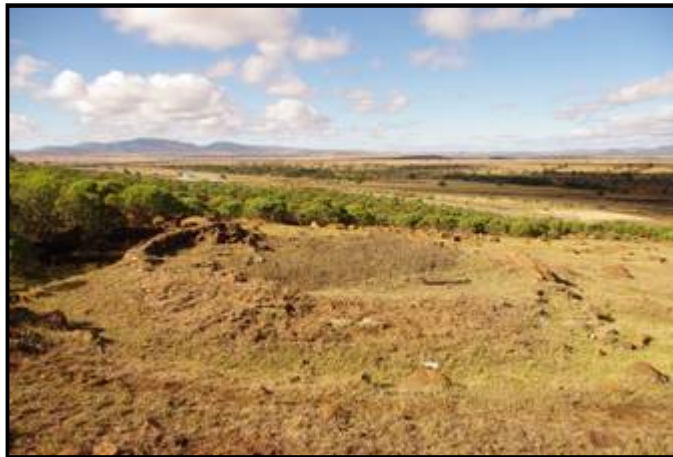
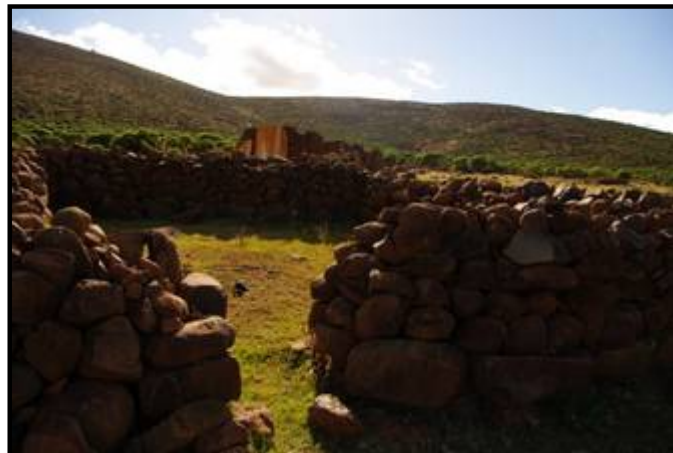
Site 27.6 constitutes a relatively recent Colonial Period Iron Age homestead. A small cemetery is located (6G) at S31°55'59.1"; E27°18'14.3" towards the west of the site. Immediately east thereof remains of the original hut is still clearly visible in direct association with foundation mounds inferred to have been a small rectangular 'kraal' and towards the south of the hut a relatively large, well preserved rectangular 'kraal' is clearly visible. Very little artefacts were found on site, mainly comprising of rusted metal of household and farming nature. The site may well not pre-date 100 years, implying that it is not formally protected under the NHRA 1999; relative dating due to continuing cultural practices are extremely difficult. However, the site remains culturally an important heritage resource, for the very reason mentioned above.

Figure 32: The 6G cemetery at Site 27.6

Figure 34: Foundation remains of a rectangular 'kraal' structure, also indication subsequent additions to the original structure

Figure 35: The well-preserved large rectangular 'kraal' structure to the south of the hut

Site 27.6 is ascribed a SAHRA *Medium Significance* and *Generally Protected B Field Rating*: The site should either be conserved or mitigated (sample excavation) prior to development. Development will not impact on the site; the site will by implication be conserved. Again Xhosa cultural values and customs and current land-use does not warrant formal site conservation (permanent fencing). The developer may however consider temporary conservation measures during the construction phase.

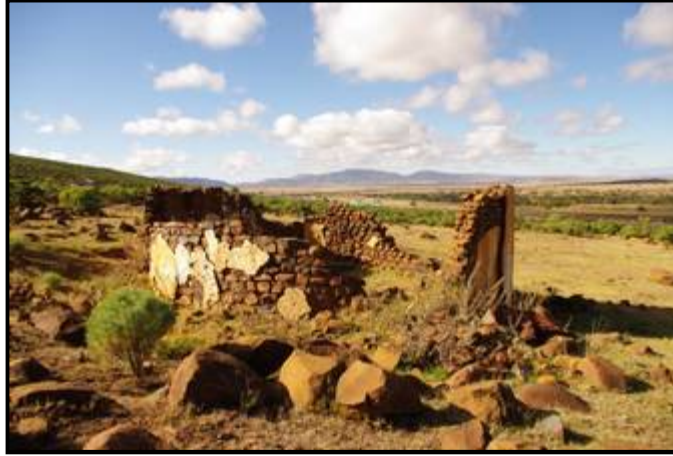
Figure 33: Hut remains at Site 27.6

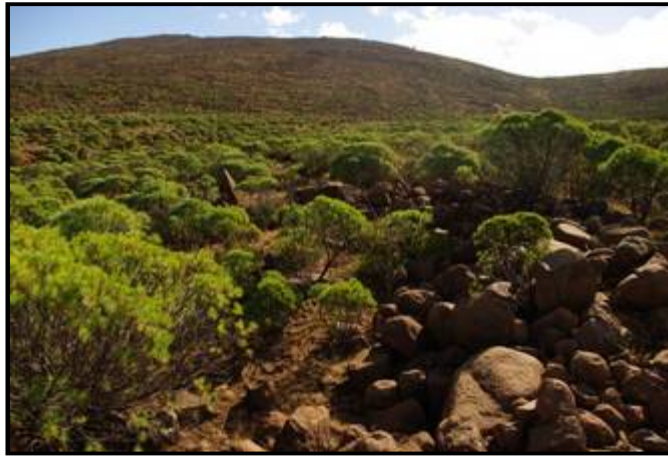
Figure 36: Stone wall remains at Site 27.7

Site 27.7 is ascribed a SAHRA *Low Significance* and *Generally Protected C Field Rating*: The site should either be conserved or destroyed under a SAHRA APM Unit *Site Destruction Permit*. Development will not impact on the site; the site will by implication be conserved. Based on Xhosa cultural values and customs and current land-use, formal site conservation (permanent fencing) is not recommended. The developer may consider temporary conservation measures during the construction phase.

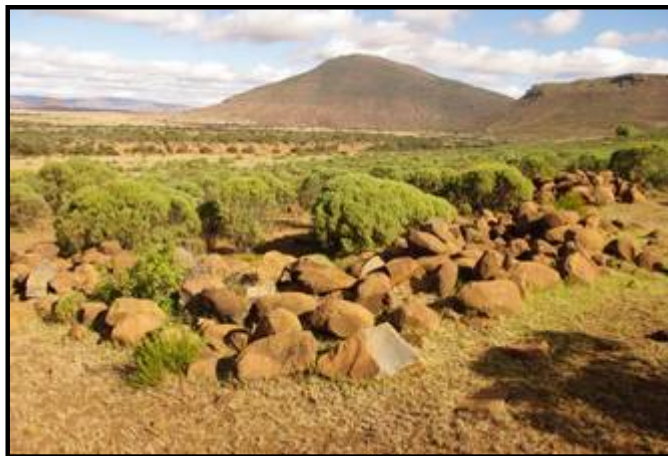
Figure 37: Two joining rectangular structure remains at Site 27.7

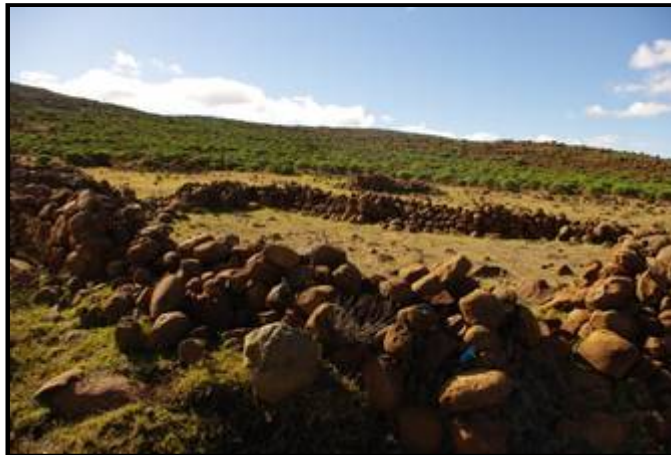
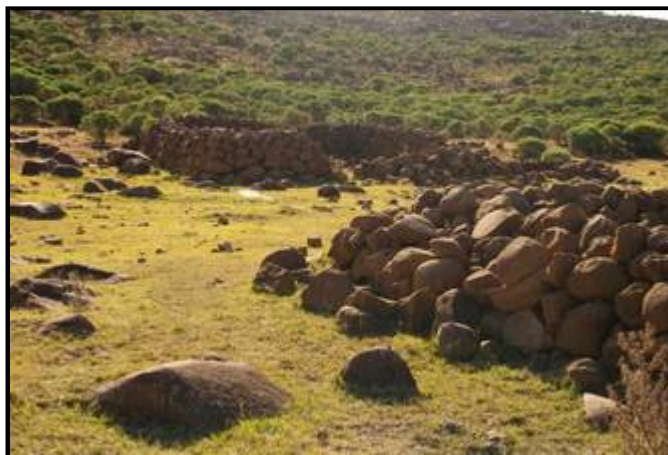
Site 27.8 is situated immediately east of the water tank but with the development not having impacted on the site, neither does the gravel access road leading thereto. The site comprises of 6 relatively large, reasonably well preserved stock enclosures. No associated archaeological artefacts were found in the vicinity of the site. At present dating is impossible but the site is culturally assigned to the Iron Age, and with the majority of the 'kraal' structures being rectangular in shape they evidently belong to the Colonial Period and recent or continuous use thereof may well be inferred.

Figure 38: General view of Site 27.8

Figure 39: Close-up of some of the Site 27.8 structures

Site 27.8 is ascribed a SAHRA *Low Significance* and *Generally Protected C Field Rating*: The site should either be conserved or destroyed under a SAHRA APM Unit *Site Destruction Permit*. Development upgrading in the vicinity of the site will not impact negatively thereon. Again Xhosa cultural values and customs and current land-use does not warrant formal site conservation (permanent fencing). The developer may however consider temporary conservation measures during the construction phase.

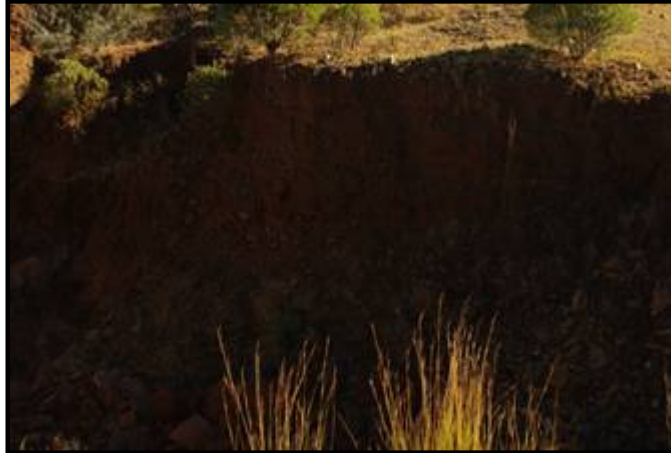
Figure 41: Evidence of rich Stone Age deposits underlying current agricultural fields at a depth of more than 1m in the southern part of the development area

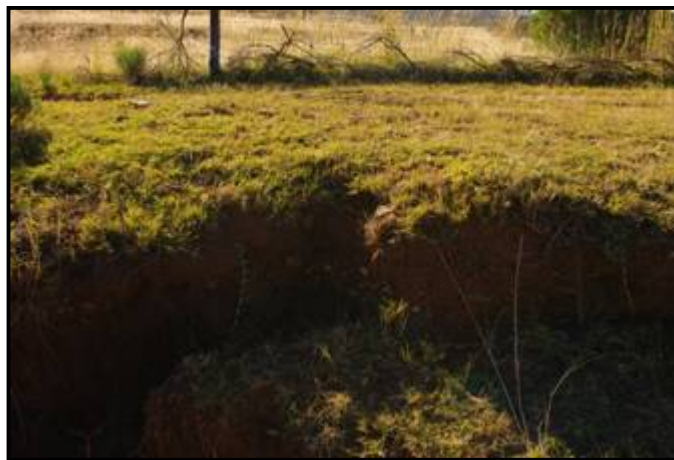
Figure 42: A rich Stone Age layer identified at a depth of 20cm below the present day surface towards the northern central part of the development area. Deposits are not impacted on by current farming activities

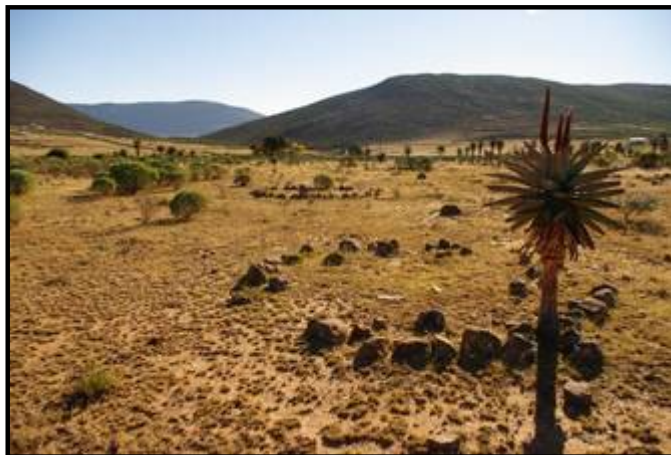
Figure 51: Circular structure remains on the lower slopes of the site

Site 28.1 is ascribed a SAHRA *Medium Significance* and *Generally Protected B Field Rating*: The site should either be conserved or mitigated (sample excavation) prior to development. The site is situated west of the proposed development area and will by implication not be impacted on. Based on Xhosa cultural values and customs and current land-use it is not recommended that the site be formally conserved (permanently fenced).

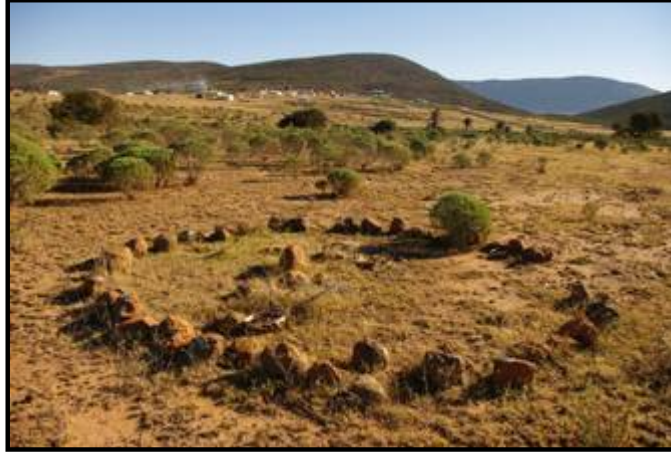
Figure 52: Close-up of one of the structure remains

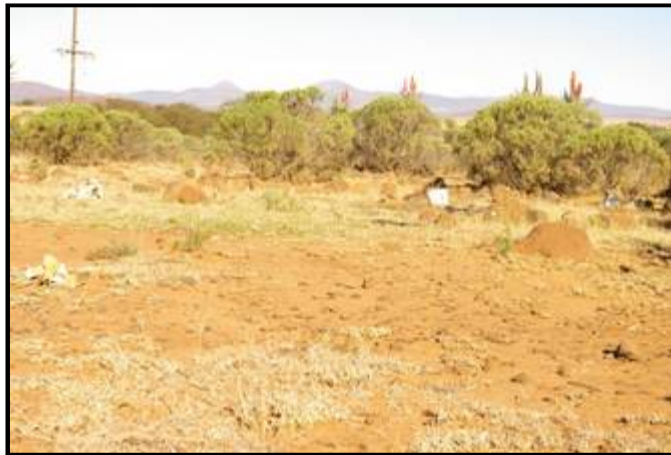
Figure 53: *In situ* context of Stone Age artefacts in relation to Iron Age remnants at Site 28.1

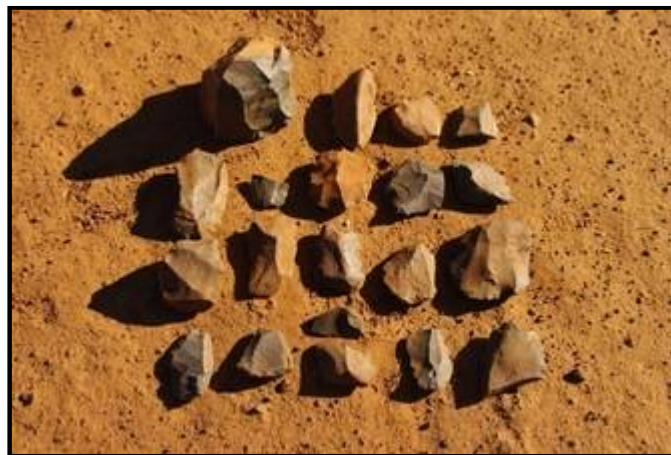
Figure 54: A selection of Stone Age artefacts from Site 28.1

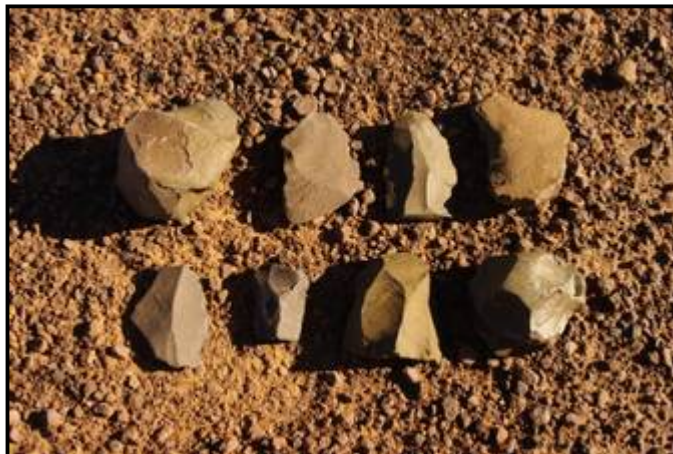
Figure 56: Selected Stone Age artefacts from Site 28.2

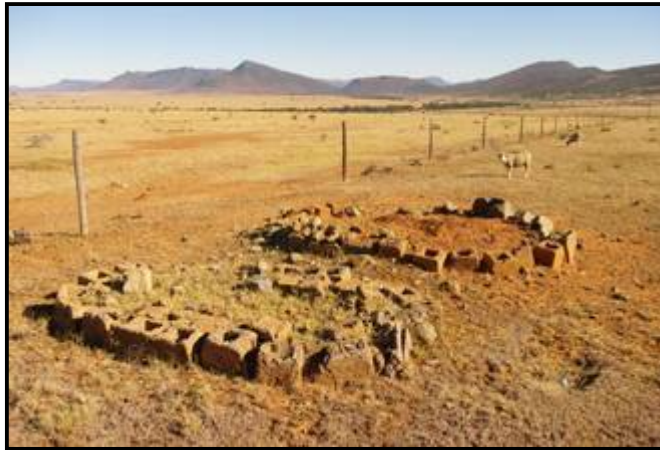
Figure 57: General view of Site 28.3

Based on the recent date of Site 28.3 a SAHRA Site Significance rating is irrelevant. The site will be conserved by the development, with the current line route running north of the site. Formal conservation (permanent fencing) of the site is not recommended based on Xhosa cultural values and customs and inferred direct ancestral ties between the site and the population living in the direct vicinity thereof.

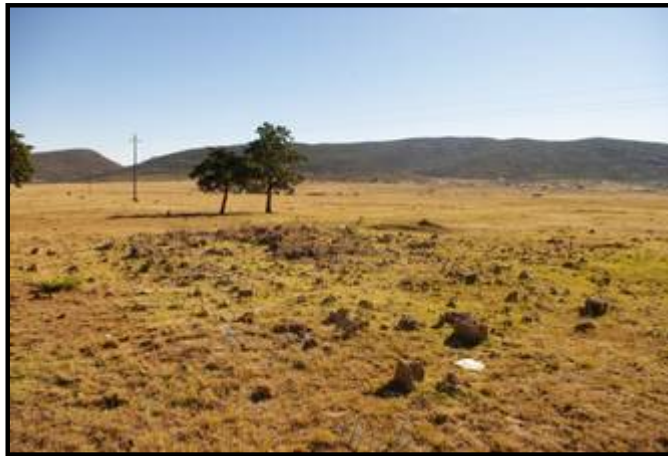
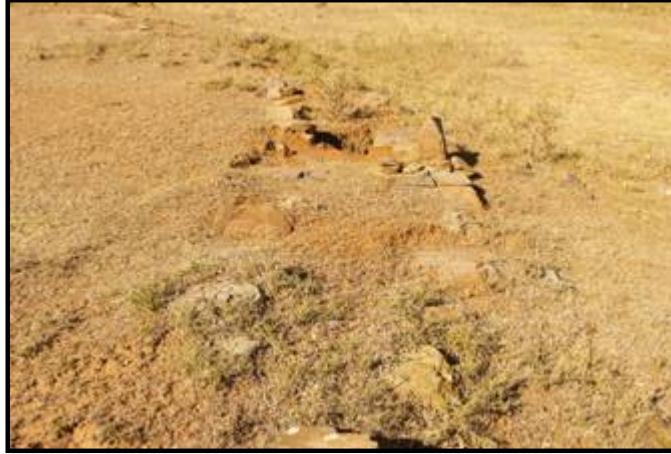
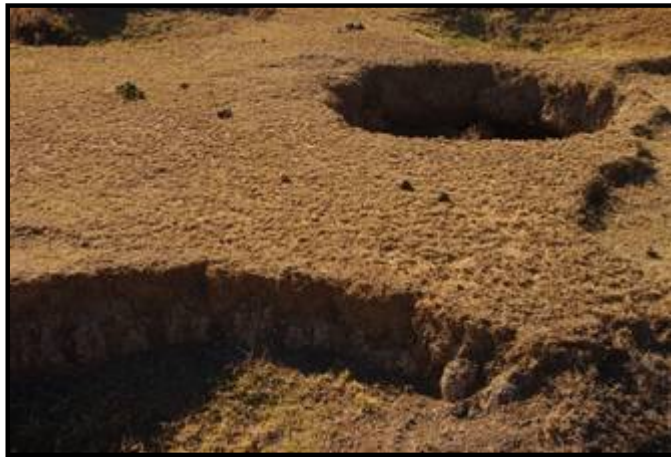
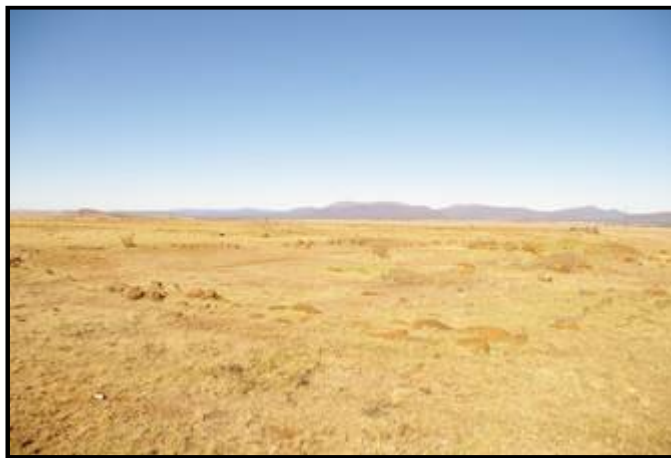
Figure 58: Residential remains at Site 28.4

Figure 59: Foundation remains of a circular residential structure at Site 28.4

Figure 60: A clearly identifiable koprolite member at the circular stock enclosure

Figure 61: Stone walled remains of a large rectangular 'kraal' structure

Site 28.4 is ascribed a SAHRA *Medium Significance* and *Generally Protected B Field Rating*: The site should either be conserved or mitigated (sample excavation) prior to development. Development will not impact on the site; the site will by implication be conserved. Again Xhosa cultural values and customs and current land-use does not warrant formal site conservation (permanent fencing). The developer may however consider temporary conservation measures during the construction phase.

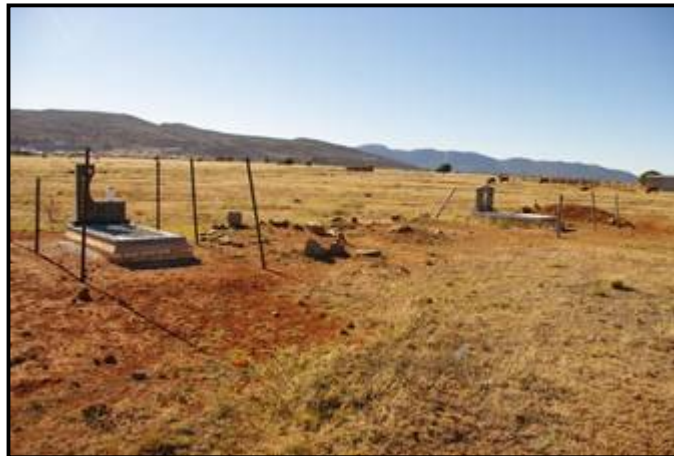
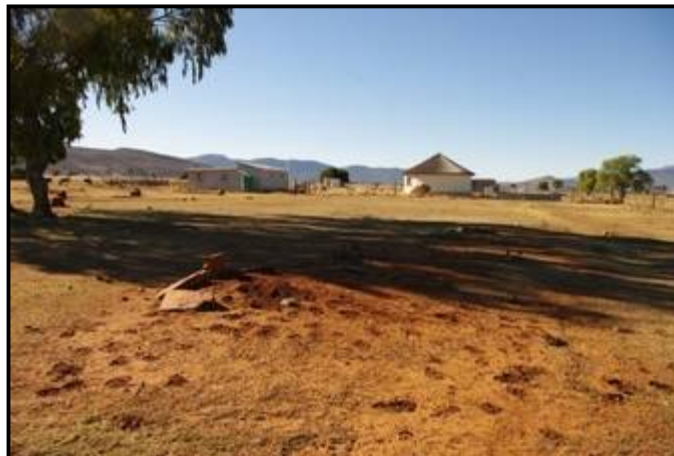
Figure 62: View of the younger component of Site 28.5

Figure 63: View of the older component of Site 28.5

Site 28.5 is ascribed a SAHRA *Medium Significance* and *Generally Protected B Field Rating*: The site should either be conserved or mitigated (exhumation and re-internment) prior to development. The existing line route runs north of the site; the site will thus be conserved. Based on proximity to the road, Xhosa cultural values and customs and current land-use, formal site conservation (permanent fencing) is not recommended. The developer may consider temporary conservation measures during the construction phase.

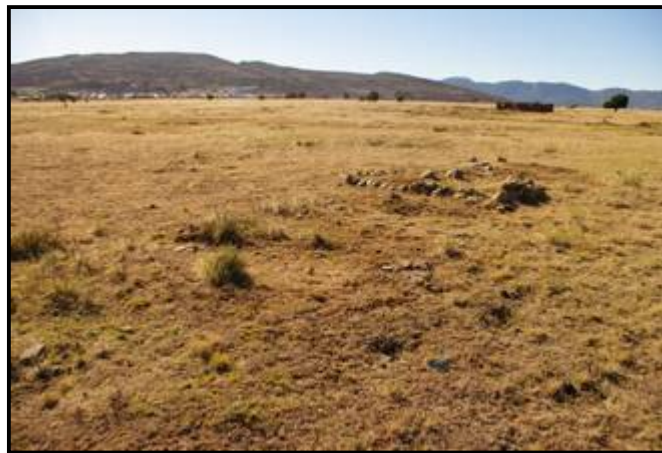
Figure 64: General view of Site 28.6

Site 28.6 is ascribed a SAHRA *Medium Significance* and *Generally Protected B Field Rating*: The site should either be conserved or mitigated (exhumation and re-internment) prior to development. The existing line route runs south of the site closely following the road alignment; the site will thus be conserved. Based on proximity to the road, Xhosa cultural values and customs and current land-use, formal site conservation (permanent fencing) is not recommended. The developer may consider temporary conservation measures during the construction phase.

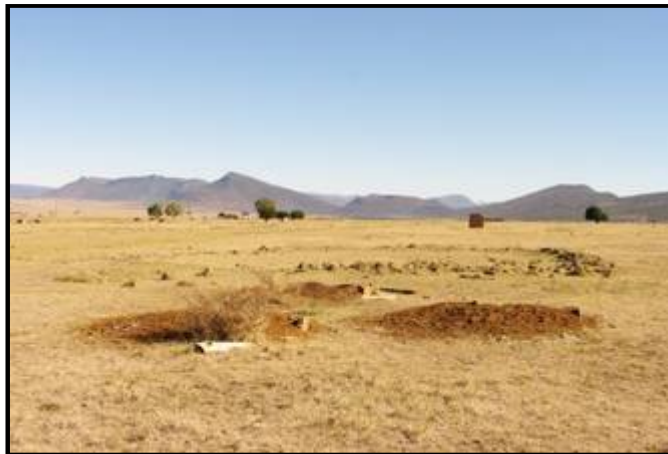
Site 28.7 comprises of a fairly small, approximate 8x5m rectangular stock enclosure, or 'kraal' remains, identifiable only by means of its foundation stones. No associated artefacts were discovered in association with the structure. In addition 3 earth mounds indicate the localities of 3 associated graves. The graves are not typically stone outlined, but do have small, un-inscribed stone headstones. The site is inferred to be of very recent origin, most probably post-dating 60 years of age.

Figure 65: General view of Site 28.7 with the graves in the foreground and the structure remains towards the background

Site 28.7 is inferred to post-date 60 years of age. A SAHRA Site Significance rating is thus irrelevant. However the site, particularly the graves are of cultural significance. The site will not be impacted on by the proposed development. Based on proximity to the road, Xhosa cultural values and customs and current land-use, formal site conservation (permanent fencing) is not recommended. The developer may consider temporary conservation measures during the construction phase.

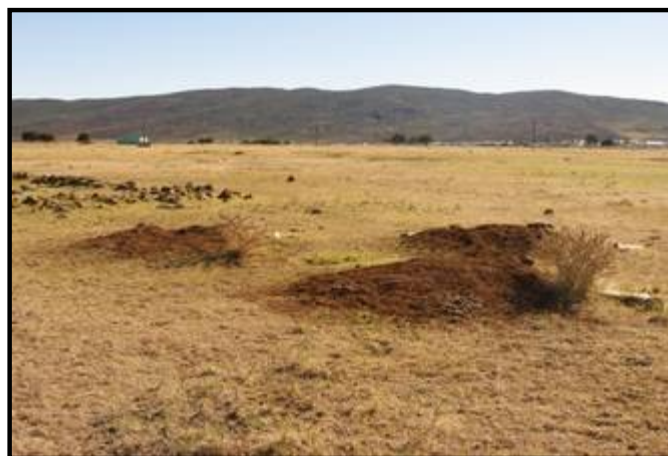
Figure 66: Close-up of the Site 28.7 graves

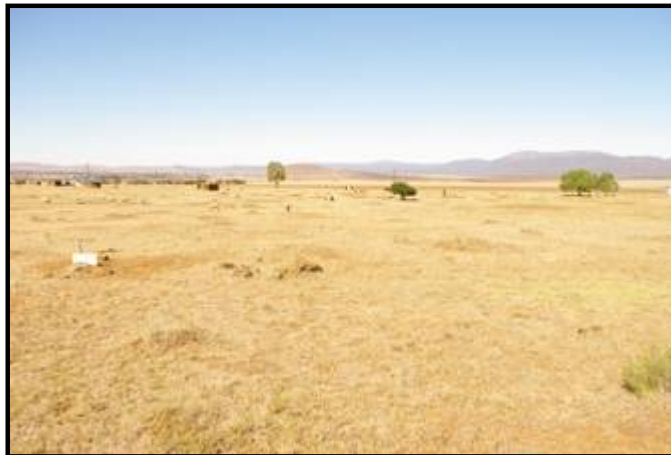
The large Site 28.8 cemetery start just south of an old rectangular stock enclosure, typified only by its raised level and foundation wall remains and stretches south towards the access road. The cemetery is informally arranged with a number of graves, most probably reaching hundreds in number. Towards the central part of the cemetery graves are roughly aligned in rows, many of which seem to be of quite significant age. These graves are mostly identifiable only by slight rectangular changes in surface exposures demarcated in cases by headstones, some of which have headstones with inscriptions. Towards the outer perimeter of the site graves decrease in number and are more haphazardly arranged. Many of these graves may be more recent in origin and typically identifiable by stone outlines and raised earth in-fills. At least 1 grave comprises of a modern granite grave, individually fenced. The cemetery is interpreted to have served the now removed village of Emaqameni and Lower Bilatye, immediately surrounding it. The majority of the graves at the site is inferred to predate 60 years of age, implying overall formal protection of the site. A few odd graves were observed outside the demarcated perimeter of the site and seeming 'modern' burial practices may result in increasing graves situated more randomly in the general area. More graves may also be expected in direct proximity to contemporary homesteads.

Figure 67: View of the central part of the Site 28.8 cemetery

Site 28.8 is ascribed a SAHRA *Medium Significance* and *Generally Protected B Field Rating*: The site should either be conserved or mitigated (exhumation and re-internment) prior to development. The existing line route runs south of the site closely following the road alignment; the site will thus be conserved. Based on proximity to the road, Xhosa cultural values and customs and current land-use, formal site conservation (permanent fencing) is not recommended. The developer may consider temporary conservation measures during the construction phase.

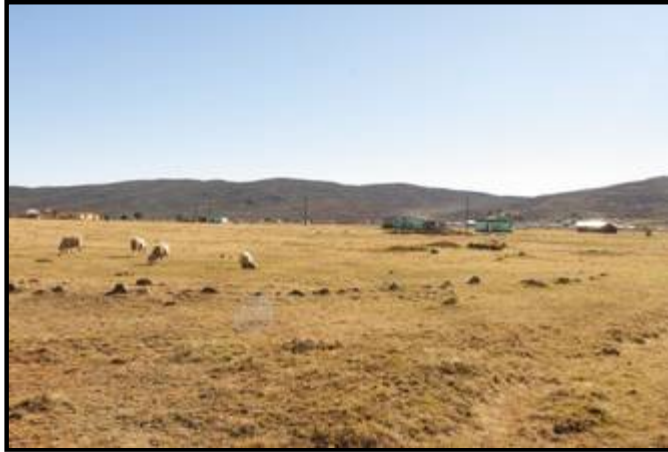
Figure 68: View of the northern part of the Site 28.8 cemetery with some graves located in the old rectangular stock enclosure

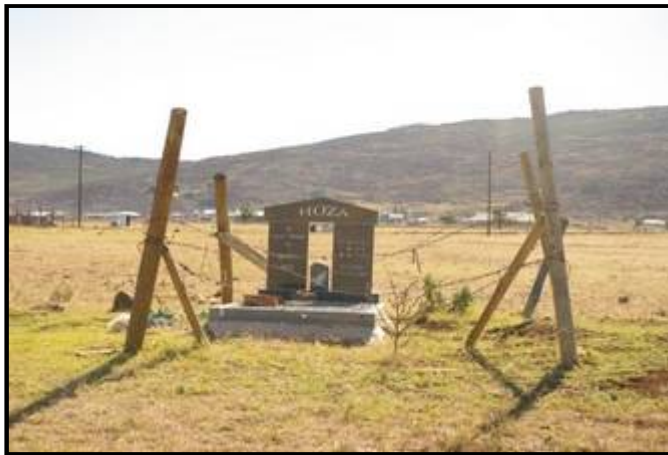
Figure 69: A very recent, modern grave at Site 28.8

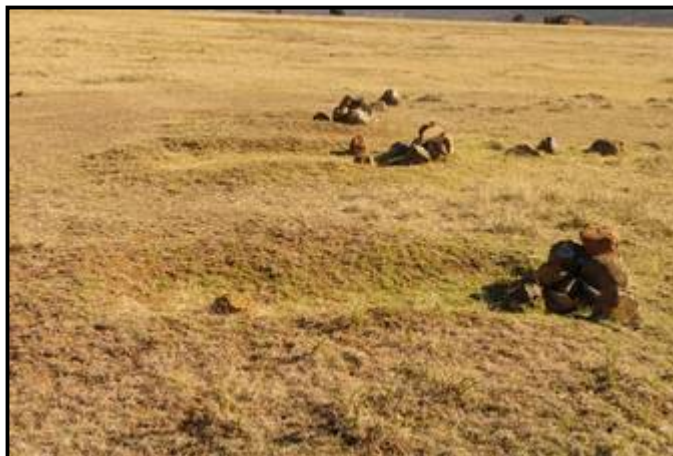
Figure 70: Typical graves at Site 28.8, characterized by rectangular indentations and piled stone headstones

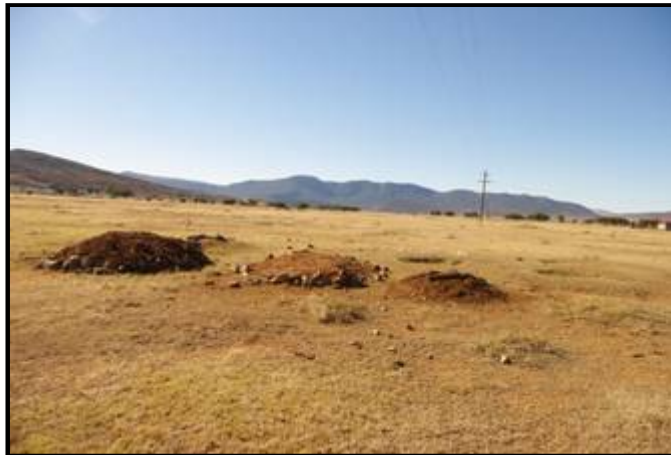
Figure 71: General view of Site 28.9

The Site 28.9 graves are inferred to post-date 60 years of age. A SAHRA *Site Significance* rating is thus irrelevant. The site is however of cultural significance. The site is situated to the east of the proposed line route and will not be impacted on by development. Based on proximity to the road, Xhosa cultural values and customs and current land-use, formal site conservation (permanent fencing) is not recommended. The developer may consider temporary conservation measures during the construction phase.

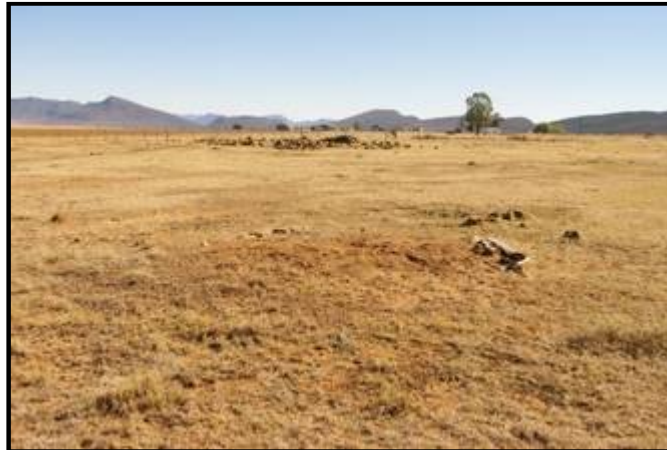
Figure 72: The 2 graves comprising Site 28.10

Site 28.10 is ascribed a SAHRA *Medium Significance* and *Generally Protected B Field Rating*: The site should either be conserved or mitigated (exhumation and re-internment) prior to development. The site is situated east of the planned line route and will not be impacted on by development. Again based on Xhosa cultural values and customs and current land-use, formal site conservation (permanent fencing) is not recommended. The developer may consider temporary conservation measures during the construction phase.

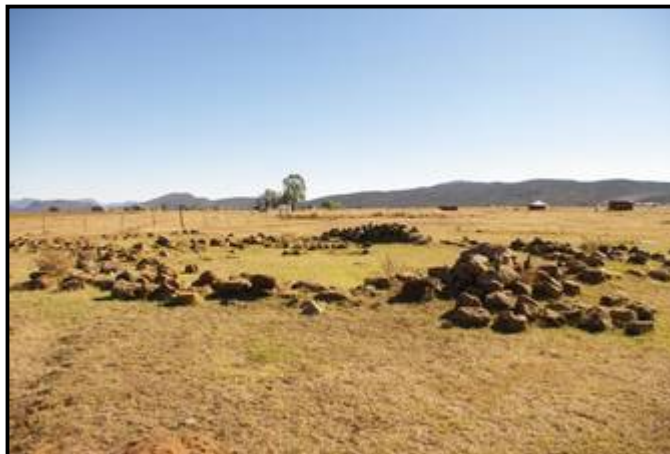
Figure 73: Stone walling located north-east of the graves are not inferred to be associated therewith

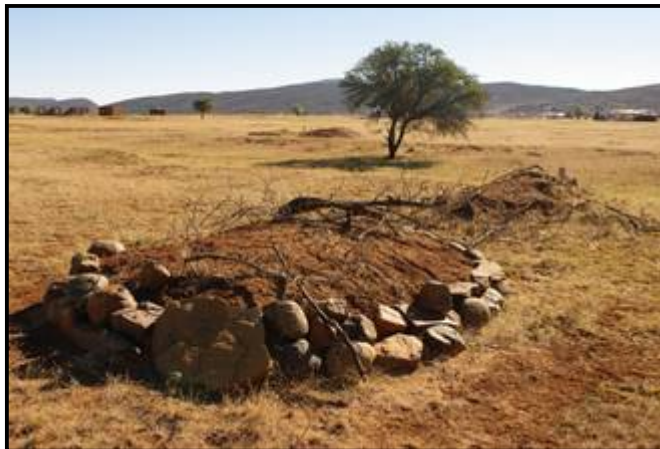
Figure 74: General view of Site 28.11

Site 28.11 is ascribed a SAHRA *Medium Significance* and *Generally Protected B Field Rating*: The site should either be conserved or mitigated (exhumation and re-internment) prior to development. The site is situated north-east of the proposed line route and will be conserved by the development. Based on proximity to the road, Xhosa cultural values and customs and current land-use, formal site conservation (permanent fencing) is not recommended. The developer may consider temporary conservation measures during the construction phase.

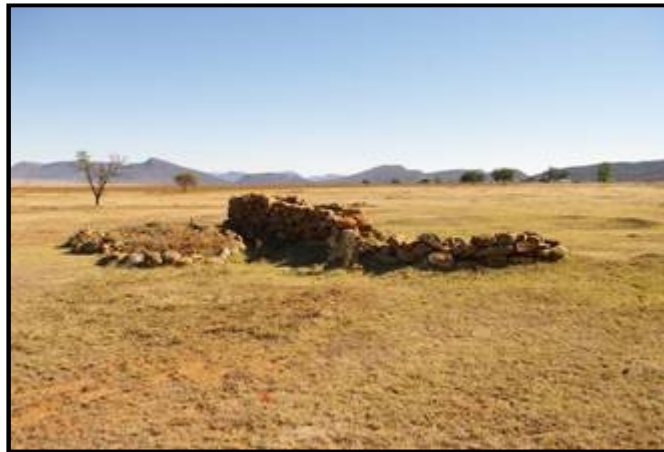
Site 28.12 is typified by the remains of 2 circular stock enclosures; the 1st is characterized only by mound remains while a partial wall is visible at the other. Three (3) graves are located immediately adjacent to the still standing portion of the wall. Approximately 15m to the north-east thereof 4 additional graves are located in close proximity to one another. The graves are inferred to be culturally associated with the 'kraal' remains nearby. All graves are stone outlined and earth filled. Collapsed fill may represent relative age of the graves, but are in all well kept. Decaying grave-goods are indicative of ancestral associations with nearby populations.

Figure 75: General view of Site 28.12

Site 28.12 is ascribed a SAHRA *Medium Significance* and *Generally Protected B Field Rating*: The site should either be conserved or mitigated (sample excavation and exhumation and re-internment of graves) prior to development. Development will not impact on the site; the proposed line route will run north of the site adjacent to the existing road alignment; site will by implication be conserved. Again Xhosa cultural values and customs and current land-use does not warrant formal site conservation (permanent fencing). The developer may however consider temporary conservation measures during the construction phase.

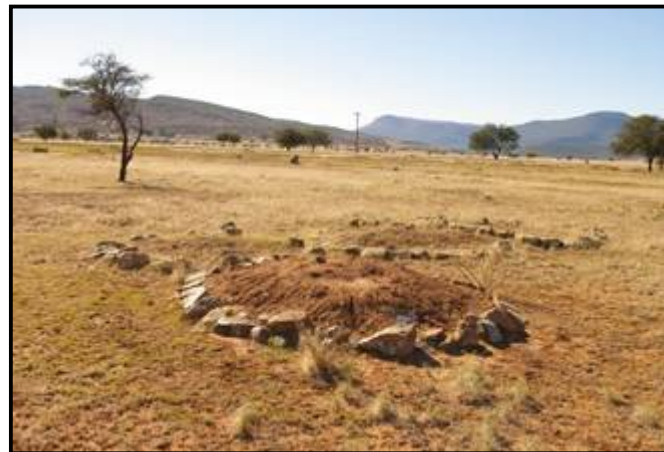
Figure 76: The 4 graves located north-east of the main site

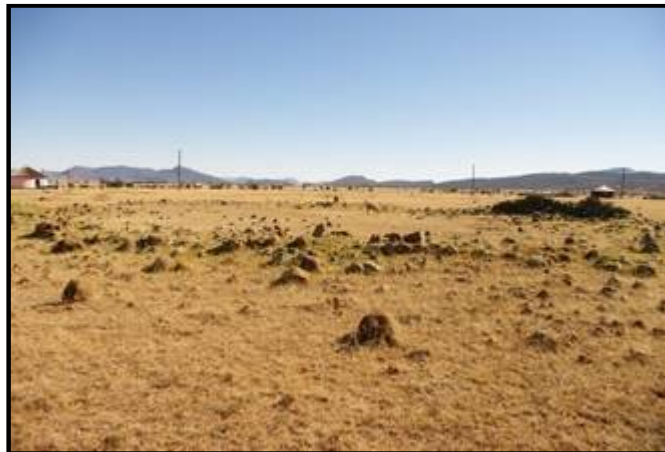
Figure 77: General view of Site 28.13

Site 28.13 is ascribed a SAHRA *Medium Significance* and *Generally Protected B Field Rating*: The site should either be conserved or mitigated (sample excavation) prior to development. Development will not impact on the site; the site will by implication be conserved. Again Xhosa cultural values and customs and current land-use does not warrant formal site conservation (permanent fencing). The developer may however consider temporary conservation measures during the construction phase.

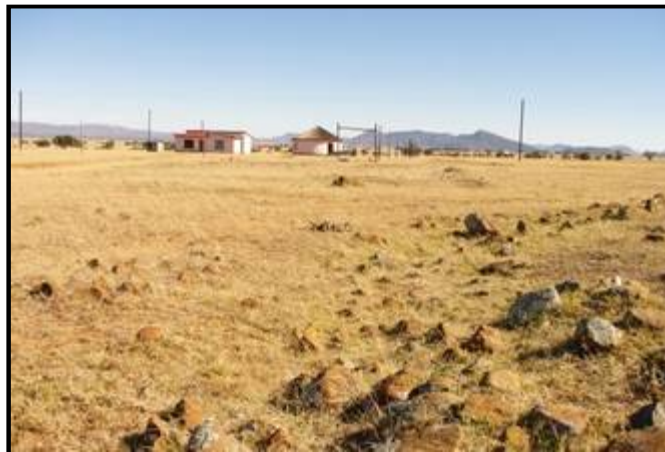
Figure 78: Rectangular structure indications to the west of the stock enclosure
