PHASE 1 ARCHAEOLOGICAL IMPACT ASSESSMENT

**WATER SUPPLY BACKLOG IN CHDM:
CLUSTER 2, PHASE 1, SCHEMES 27, 28 & 29,
COFIMVABA, EASTERN CAPE, SOUTH AFRICA**

DATE: 2010-07-01

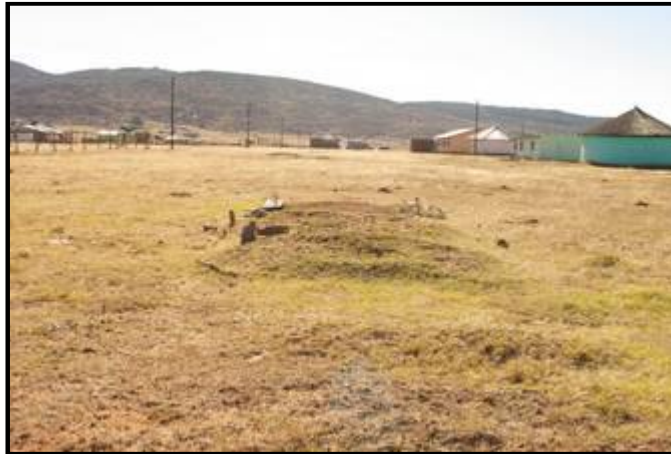
Figure 79: General view of Site 28.14 from south to north

Site 28.14 is ascribed a SAHRA *Medium Significance* and *Generally Protected B Field Rating*: The site should either be conserved or mitigated (exhumation and re-internment) prior to development. The proposed line route will run towards the west of the site and the site will thus be conserved. Based on proximity to the road, Xhosa cultural values and customs and current land-use, formal site conservation (permanent fencing) is not recommended. The developer may consider temporary conservation measures during the construction phase.

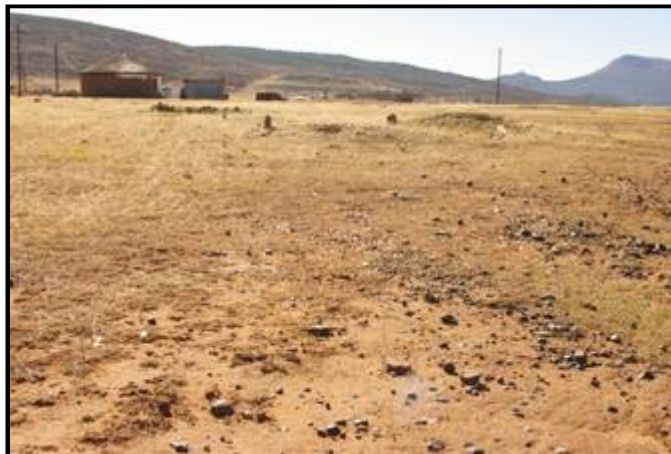
Figure 80: Selected graves from Site 28.14

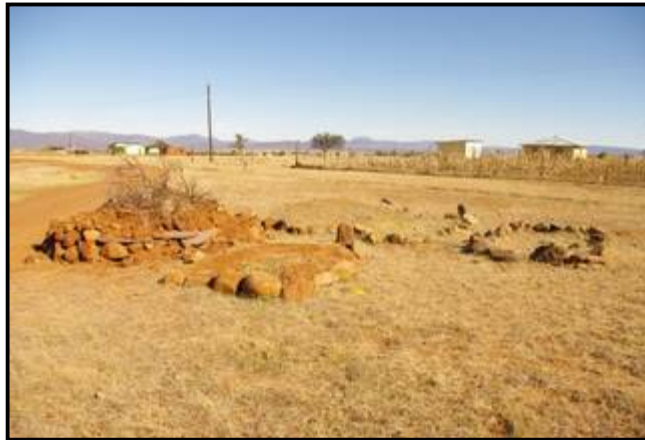
Figure 81: View of the more contemporary portion of Site 28.15

Site 28.15 is ascribed a SAHRA *Medium Significance* and *Generally Protected B Field Rating*: The site should either be conserved or mitigated (exhumation and re-internment) prior to development. The proposed line route will run towards the east of the site and the site will thus be conserved. Based on proximity to the road, Xhosa cultural values and customs and current land-use, formal site conservation (permanent fencing) is not recommended. The developer may consider temporary conservation measures during the construction phase.

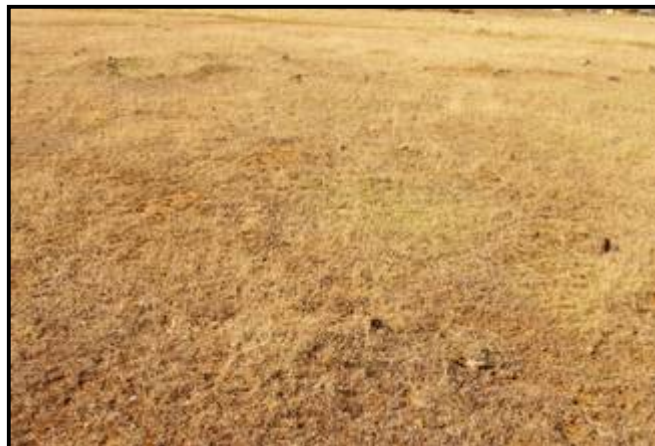
Figure 82: The hardly distinguishable graves of the older portion of Site 28.15

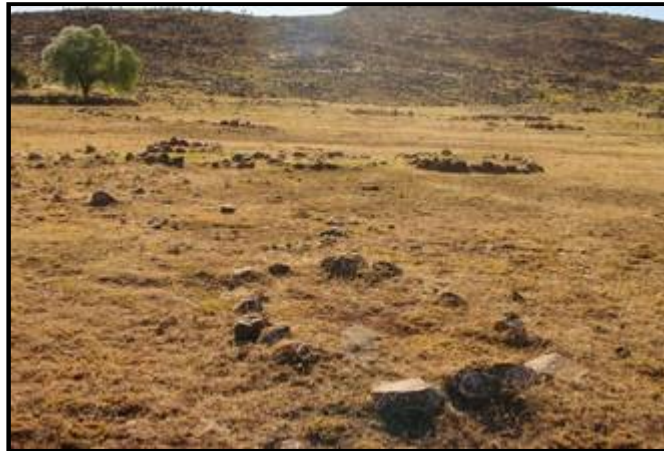
Figure 83: The more contemporary portion of the Site 28.16 cemetery

Site 28.16 is ascribed a SAHRA *Medium Significance* and *Generally Protected B Field Rating*: The site should either be conserved or mitigated (exhumation and re-internment) prior to development. The site will not be impacted on by the proposed development. Based on proximity to the road, Xhosa cultural values and customs and current land-use, formal site conservation (permanent fencing) is not recommended. The developer may consider temporary conservation measures during the construction phase.

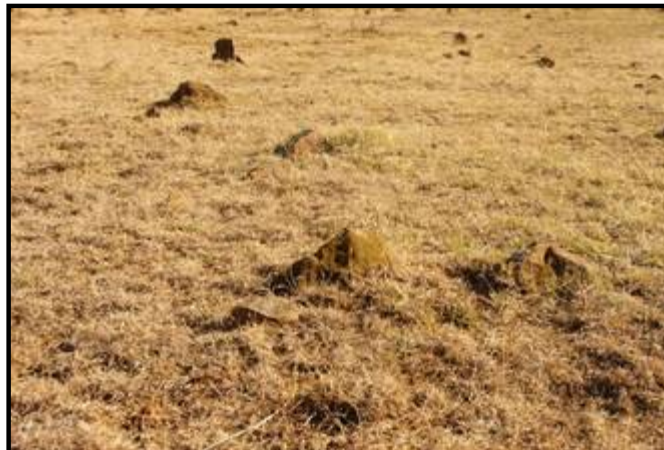
Figure 84: Older graves at Site 28.16

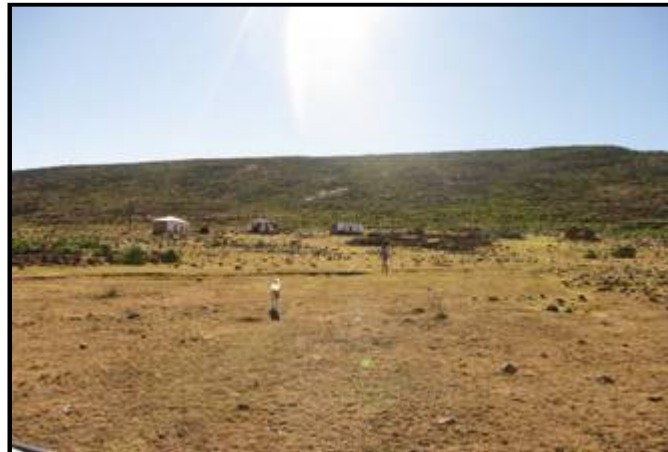
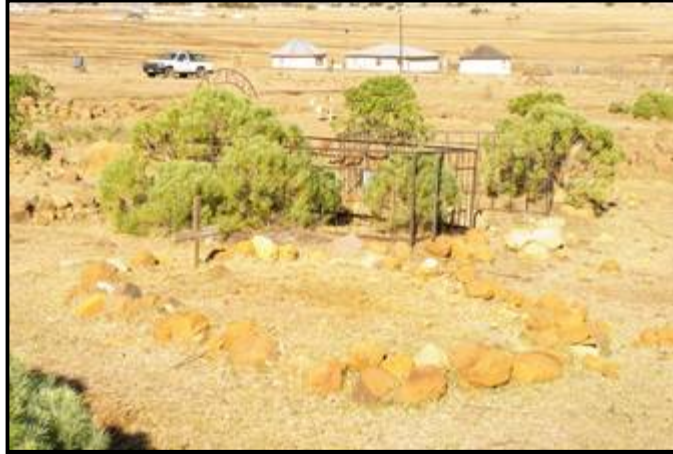
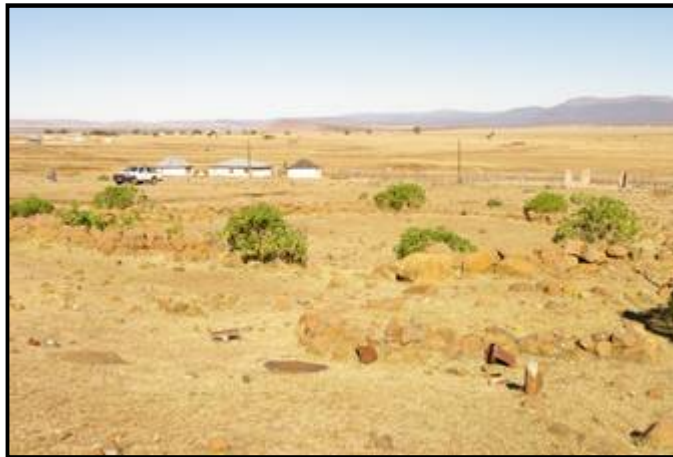
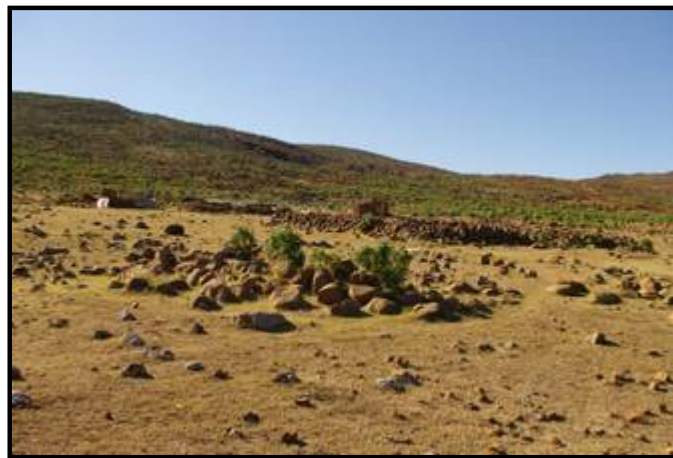
Figure 85: General view of Site 28.17

Figure 86: Fairly recent graves towards the east of Site 28.17

Figure 87: Rectangular stock enclosures towards the south of Site 28.17

Figure 88: View of the original site proper, inferred to pre-date 100 years of age

Site 28.17 is ascribed a SAHRA *Medium Significance* and *Generally Protected B Field Rating*: The site should either be conserved or mitigated (sample excavation) prior to development. Development will not impact on the site. Again Xhosa cultural values and customs and current land-use does not warrant formal site conservation (permanent fencing). The developer may however consider temporary conservation measures during the construction phase.

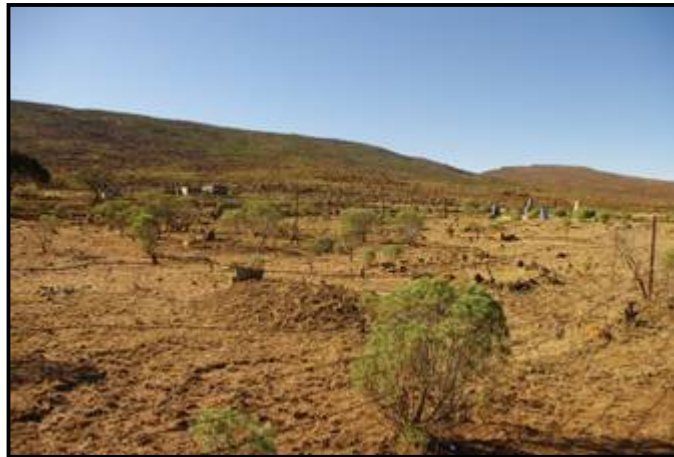
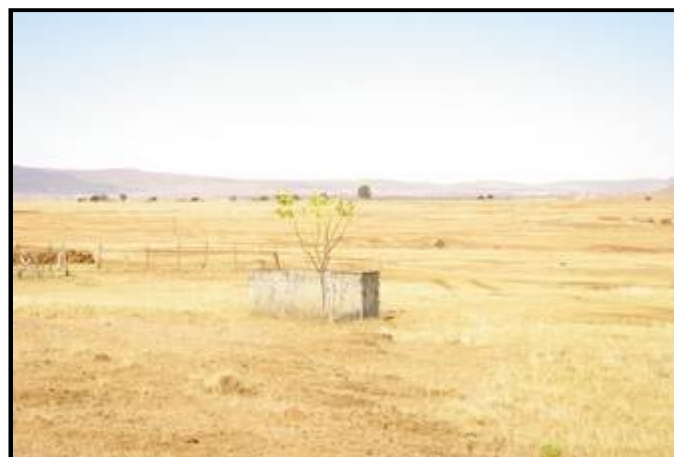
Site 28.18 is ascribed a SAHRA *Medium Significance* and *Generally Protected B Field Rating*: The site is at present fenced, complying with basic SAHRA minimum standards for conservation.

Figure 89: The formally fenced cemetery, Site 28.18

Figure 90: The fenced feature located south-east of Site 28.18

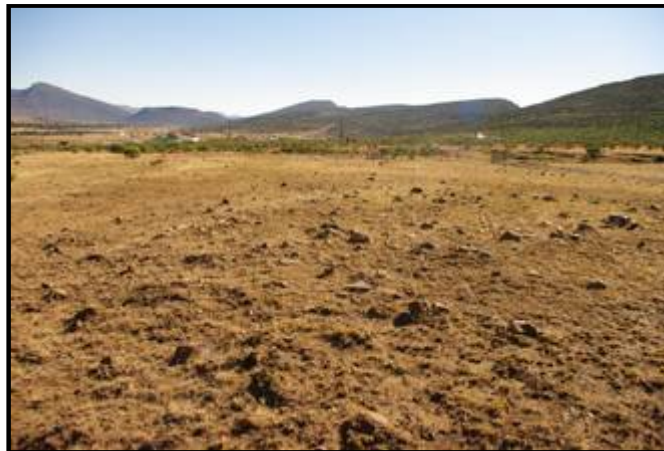
Figure 91: General view of Site 28.19

Site 28.19 is ascribed a SAHRA *Medium Significance* and *Generally Protected B Field Rating*: The site should either be conserved or mitigated (exhumation and re-internment) prior to development. Existing water related infrastructure is situated north of the site; the site will thus be conserved by the proposed development. Based on proximity to the road, Xhosa cultural values and customs and current land-use, formal site conservation (permanent fencing) is not recommended. The developer may consider temporary conservation measures during the construction phase.

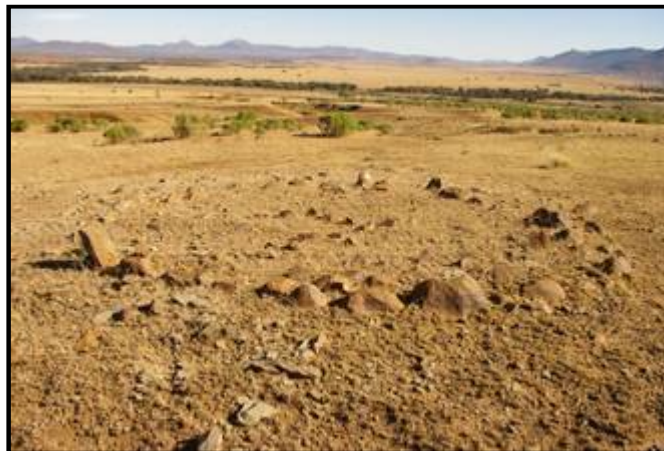
Figure 92: Close-up of one of the stone outlined graves

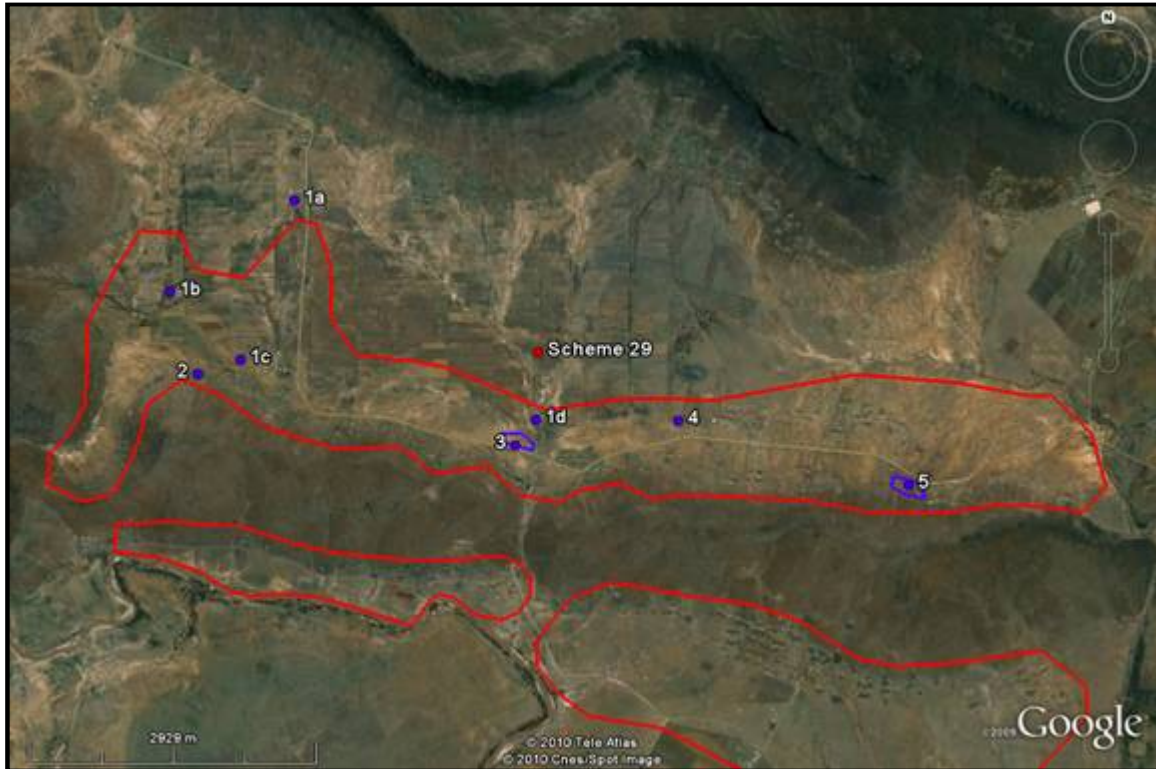
Figure 93: Scheme 27 - Phase 1 AIA findings

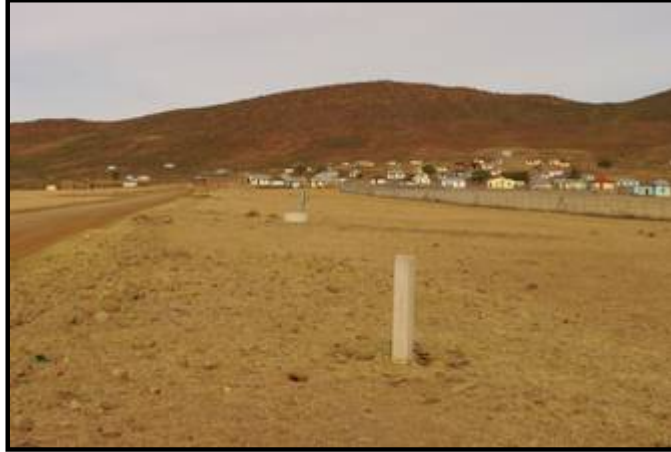
Figure 94: Existing water infrastructure in the vicinity of Esihlabeni Village

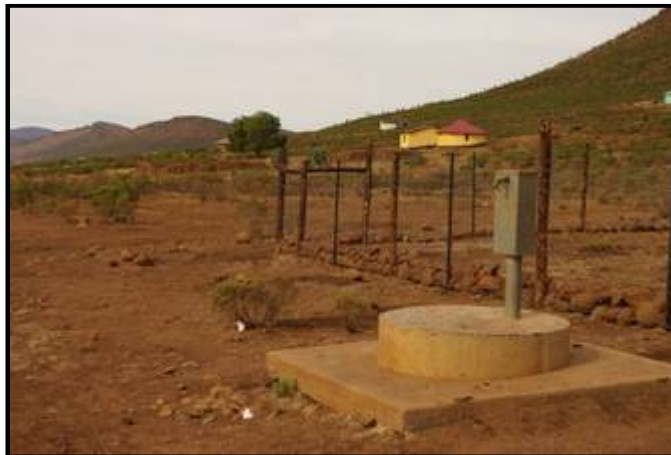
Figure 96: Existing water infrastructure at Kabisweni Village

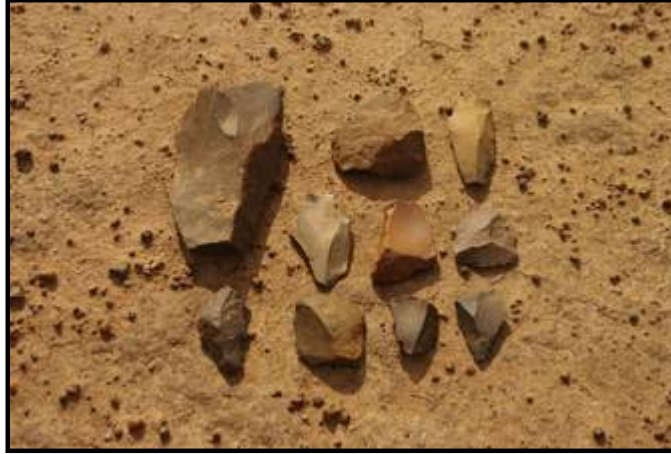
Figure 100: A selection of artefacts from the Site 29.1 'features'

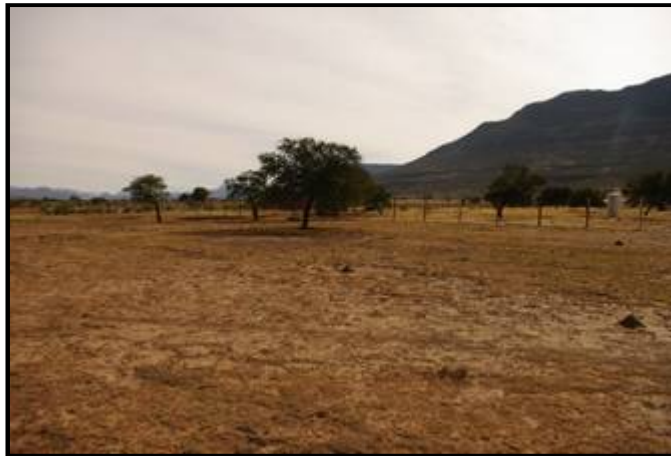
Stone Age material identified was in all cases represented by very low concentrations of deposits. The highest artefact ratios (artefacts: m²) were recorded at Site 29.1a and Site 29.1d with ratios approximating on average 1:1 to 1-5:25, with even lower quantities recorded at Sites 29.1b and 29.1c. At Site 29.1c artefacts were found within large erosion sections, but sections did not yield a clear anthropic layer; again supporting the extremely low artefact quantities recorded that will make identification of a cultural member very difficult. Alternatively the very low number of lithic artefacts may be indicative of a primarily secondary context to the cultural material identified at the terrain. Extremely low artefact ratios recorded in effect does not qualify the locales as 'sites' but rather as low density Stone Age 'features'.

Figure 101: General view of the Site 29.1a Stone Age 'feature'

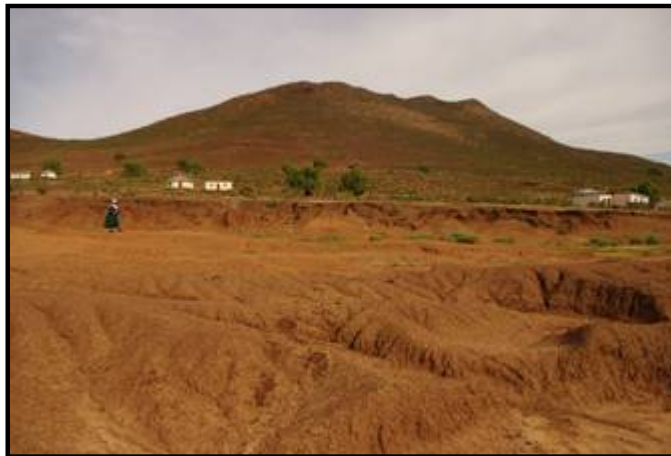
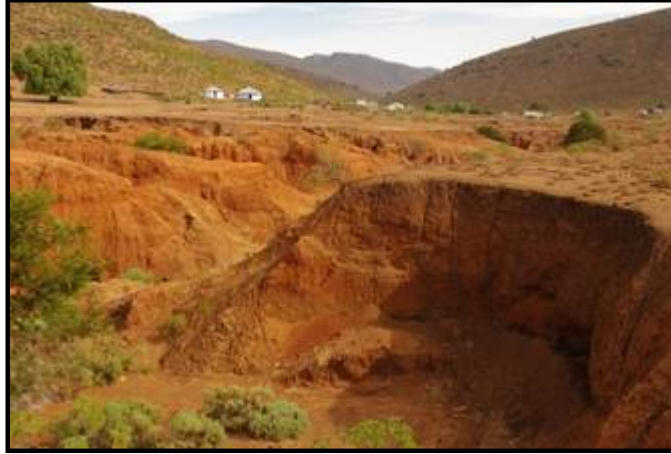
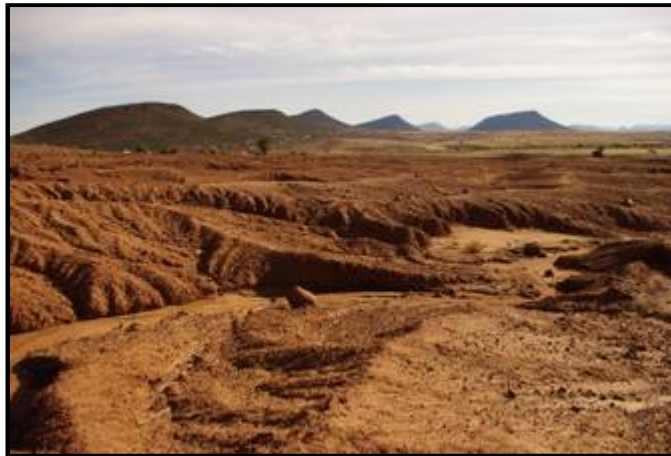
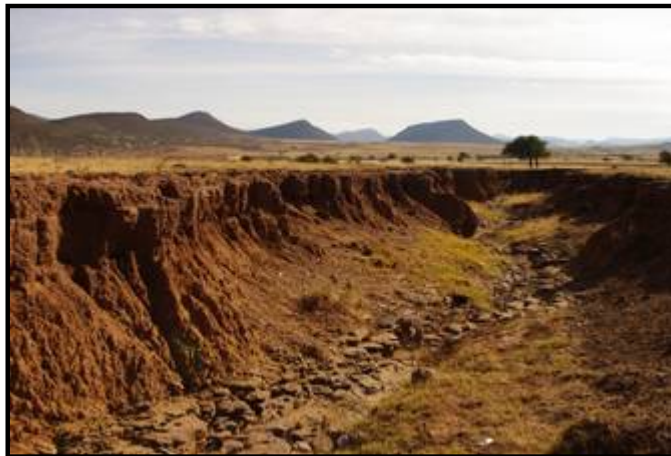
Figure 102: Erosion gullies at a now dry section of the Duzé

Figure 103: Exposed sections in excess of 2m at erosion gullies of the Duze River

Figure 104: Large erosion gullies of the Mbizana River

Figure 105: Exposed sections in the vicinity of Site 29.1d

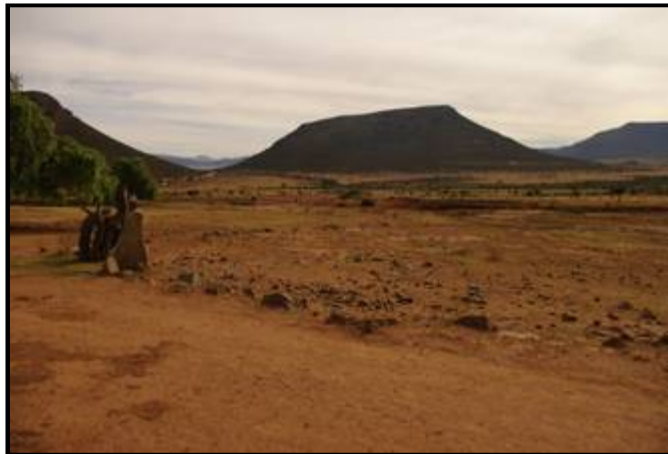
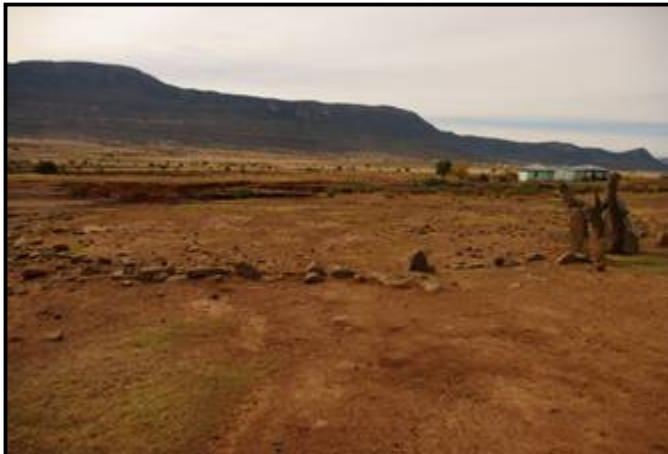
Site 29.2 consists of the remains of 2 circular stock enclosures or 'kraals'. The site is situated within the village of Esihlabeni and is interpreted as either an early cattle 'outpost' or it may represent part of an early settlement. With the assessment not having been done to a level of inspection of individual homestead yards associated residential remains may well be present in the general vicinity. The archaeological remains are identifiable by raised platforms and foundation walls. The southern-most enclosure has prominent upright standing entrance stones and wooden gate posts are interpreted as a sign of continuous site usage. The exact date of the site is unknown; it may or may not pre-date 60 years of age. However, cultural continuity is confirmed, increasing the significance of the site.

Figure 106: General view of Site 29.2

Figure 107: Site 29.2 – with the original entrance to one structure clearly visible

Site 29.2 is ascribed a SAHRA *Medium Significance* and *Generally Protected B Field Rating*: The site should either be conserved or mitigated (sample excavation) prior to development. Development will not impact on the site; the site will by implication be conserved. Xhosa cultural values and customs and current land-use does not warrant formal site conservation (permanent fencing). The developer may however consider temporary conservation measures during the construction phase.

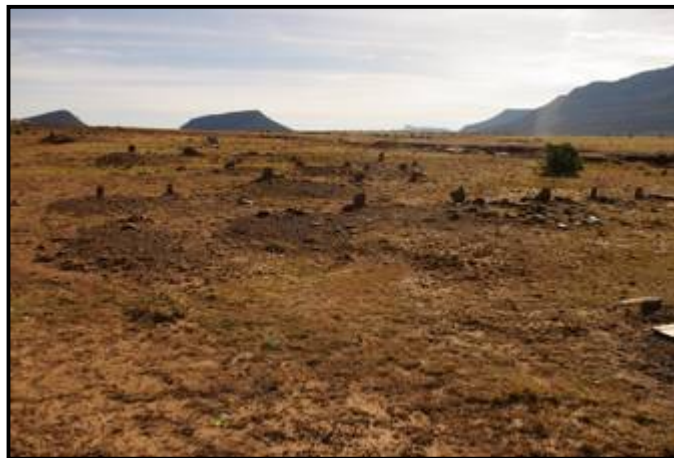
Figure 108: Some of the older graves at Site 29.3

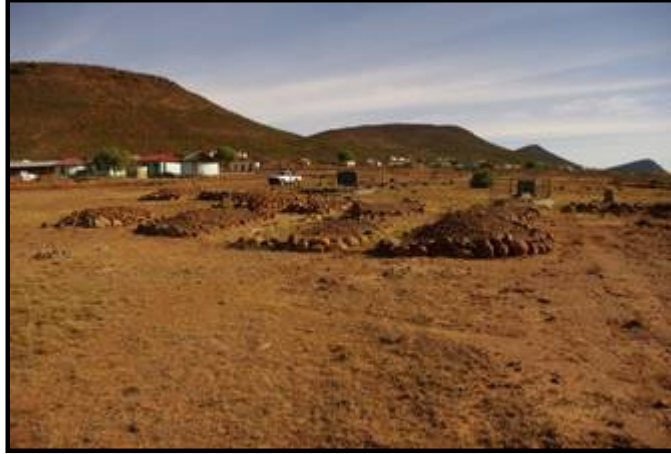
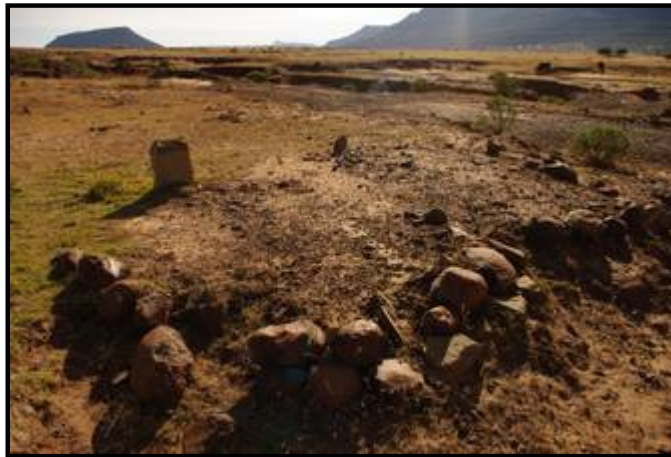
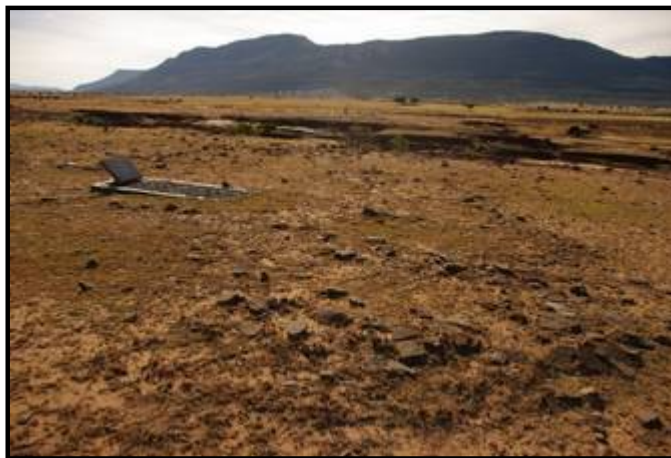
Figure 109: Younger graves at Site 29.3

Figure 110: Two graves at Site 29.3 with some older graves visible in the background

Figure 111: A clearly identifiable old and very modern grave at Site 29.3

Site 29.3 is ascribed a SAHRA *Medium Significance* and *Generally Protected B Field Rating*: The site should thus either be conserved or mitigated (exhumation and re-internment) prior to development. In situ conservation is recommended: Upgrading of existing water infrastructure in the vicinity of the site need not impact on the site. Based on continuous use of the site by surrounding villages, formal site conservation (permanent fencing) should be negotiated with villagers. If not agreed by villagers at least temporary fencing of the site (pole with danger tape demarcations) should be put in place prior to commencement of work in the area to ensure that development do not impact on any of the graves.

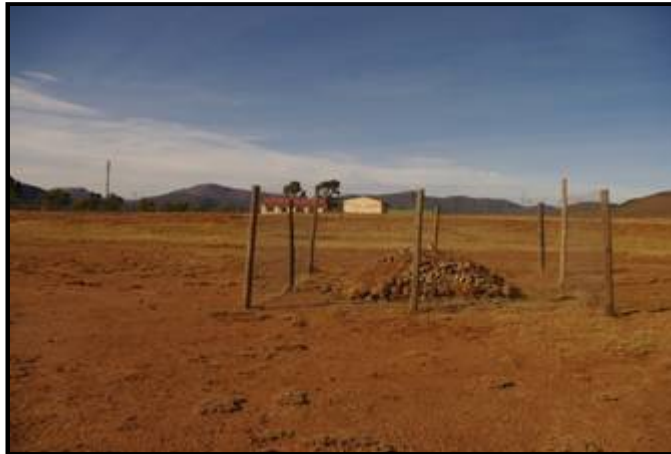
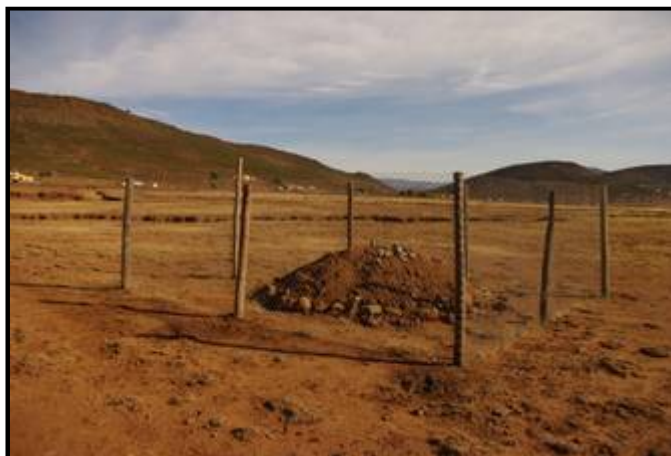
Figure 112: General view of the Site 29.4 grave

Figure 113: View of Site 29.4

Site 29.4 post-dates 60 years of age and is not formally protected under the NHRA 1999: A SAHRA *Site Significance* rating is thus irrelevant. Development will however not impact on the site, formally conserved by means of a fence.

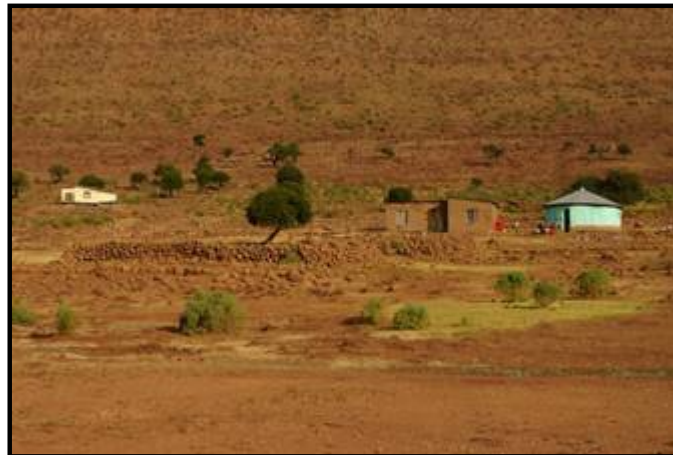
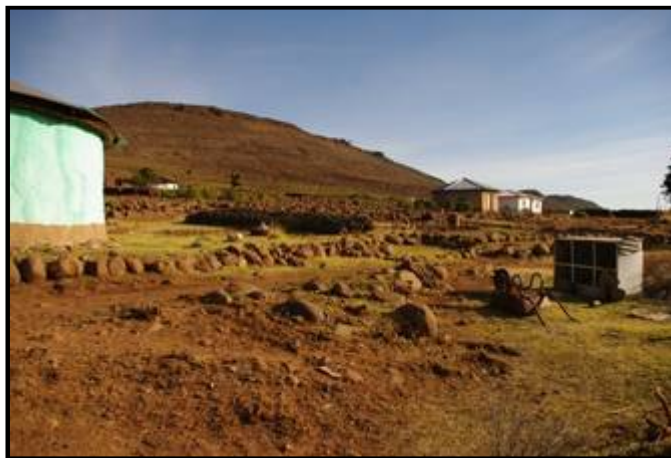
Figure 114: Contemporary infrastructure and stone walled remains of Site 29.5

Figure 117: Evident cultural overlay at Site 29.5

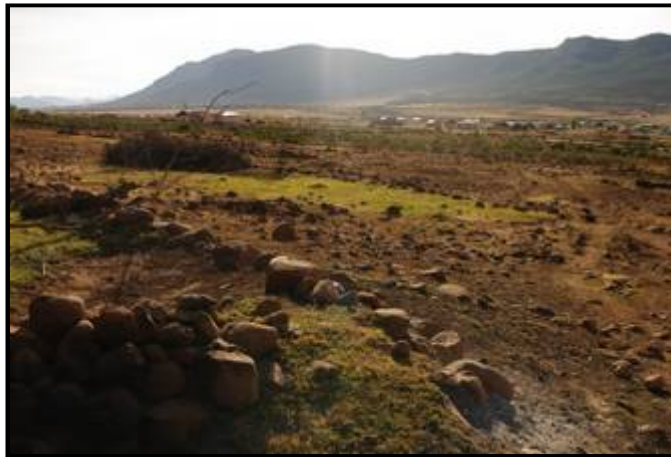
Site 29.5 is identifiable by stone walled remains across a quite significant, approximate 350x150m area. A high degree of cultural overlay is evident. What seems to be former circular residential and stock enclosure remains and terracing are overlain by later to contemporary circular and rectangular stone walled foundations. The general site area was however devoid of associated temporal artefacts. A small area towards the east of the site may be representative of the former informal family cemetery area, typified by a few upright headstones. The present day infrastructure is characterized by 2 residential units and 2 rectangular stock enclosures, the property of Mr. Sihandane Ciki. Mr Ciki confirmed that he was born at the site, and so was his father, but was uncertain of the number of generations which his family had been living at the site and merely pointed out that 'for a long time before his father lived there'. From the number of stone ruins at the site quite substantial time depth can be reasonably be inferred. This is in addition supported by Mr. Ciki's comment of 'from a time when a lot less people lived in the valley' and the absence of similar high density sites in the general development area. The site represents a perfect example of cultural overlay where through traditional inheritance law the eldest son becomes heir to the original homestead property; in essence negatively affecting the archaeological significance of the site. The archaeological site is re-settled by the present day Ciki family and also the property of Mr. Cik (legal land owner). Aside from existing impact on the site by the Ciki family the site will not be further disturbed by the proposed development.

Figure 116: View of extensive stone walled remains comprising the extent of Site 29.5
