A LETTER OF RECOMMENDATION FOR A FULL PHASE 1 ARCHAEOLOGICAL HERITAGE IMPACT ASSESSMENT FOR THE PROPOSED CONSTRUCTION OF A STORM WATER OUTLET FROM ZONE'S 1 & 2 AT THE COEGA INDUSTRIAL DEVELOPMENT ZONE NEAR PORT ELIZABETH, NELSON MANDELA BAY MUNICIPALITY, EASTERN CAPE PROVINCE

Prepared for: Coega Industrial Development Corporation (Pty) Ltd

Compiled by: Dr Johan Binneman

Date: March 2010

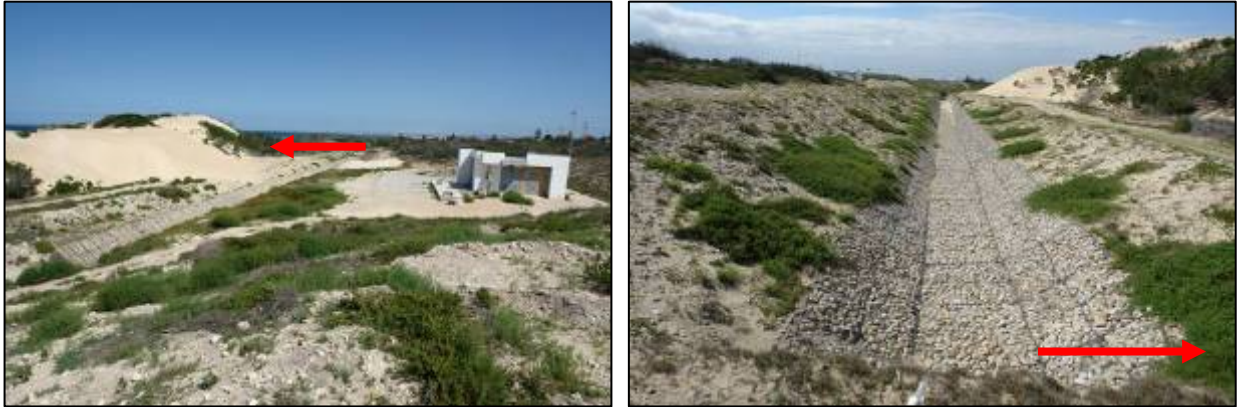
Figs 1-2. General views of the existing north-east (left) and south-west (right) open storm water channel. Note the large scale disturbances caused by the construction of the channel to the coastal dunes and surrounding landscape. The red arrow marks the location and direction from where the proposed channel through the dunes to the coast will be constructed.

It is a sensitive area for archaeological sites and the development must be closely managed and monitored to avoid any further damage to sites/materials. The north-easterly open channel was constructed through the coastal dunes. This is also clearly visible on the aerial photographs and photographs taken during the construction (Mazizi Msutu and Associates April 2007) (Maps 2-3). This construction took place without a heritage impact assessment as required by the National Heritage Resources Act (Act No. 25 of 1999, section 38). It is unknown how many archaeological sites were destroyed, but if the rich shell midden complex, a 100 metres north-east of the constructed channel and proposed outlet is anything to go by, then it must have been a fair number.

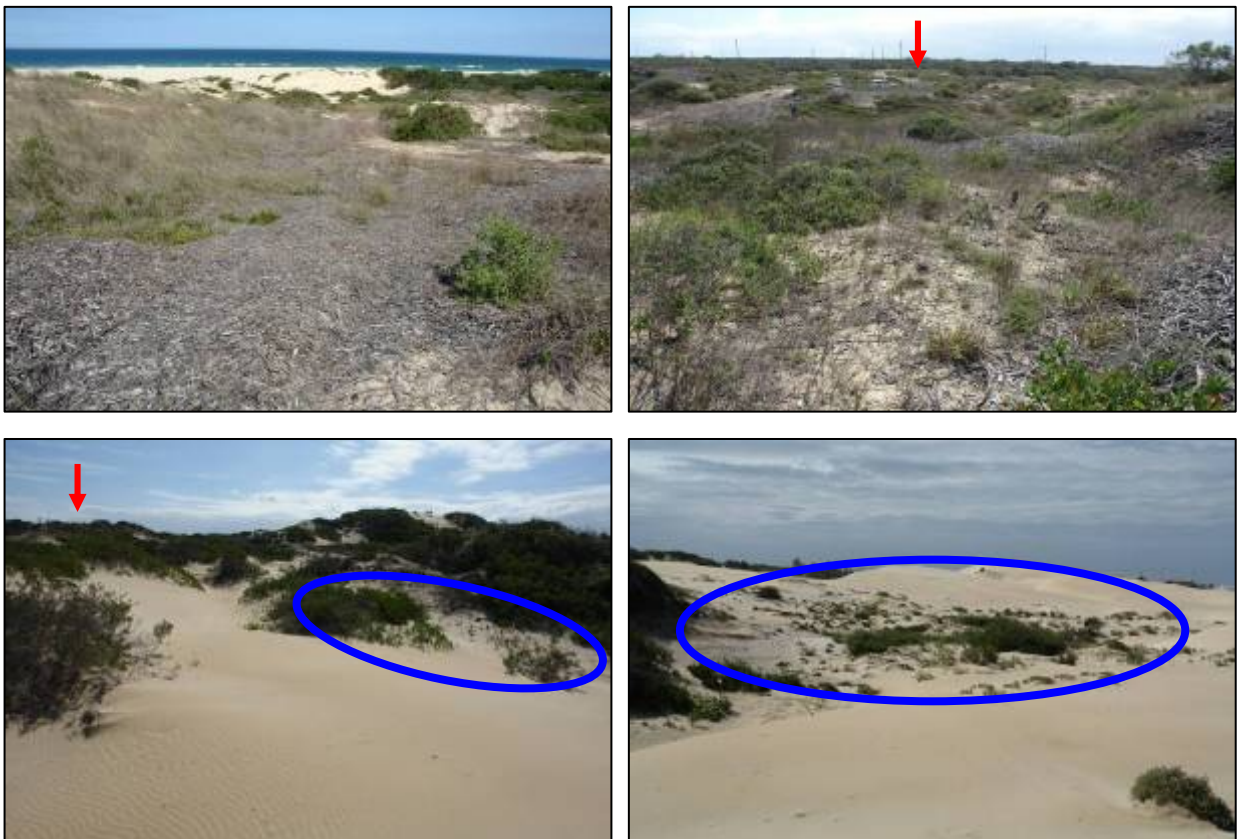
Figs 3-6. General views from the start of the proposed open storm water channel towards the beach (top left), from the beach towards the existing channel indicated by the red arrow (top right), a shell midden close to where the channel will be constructed marked by a blue oval (bottom left) and a complex of shell middens within 100 metres from the development (bottom right).

The area where the proposed storm water outlet across the dunes will be constructed is an extremely sensitive archaeological terrain with a large shell midden complex in close proximity.

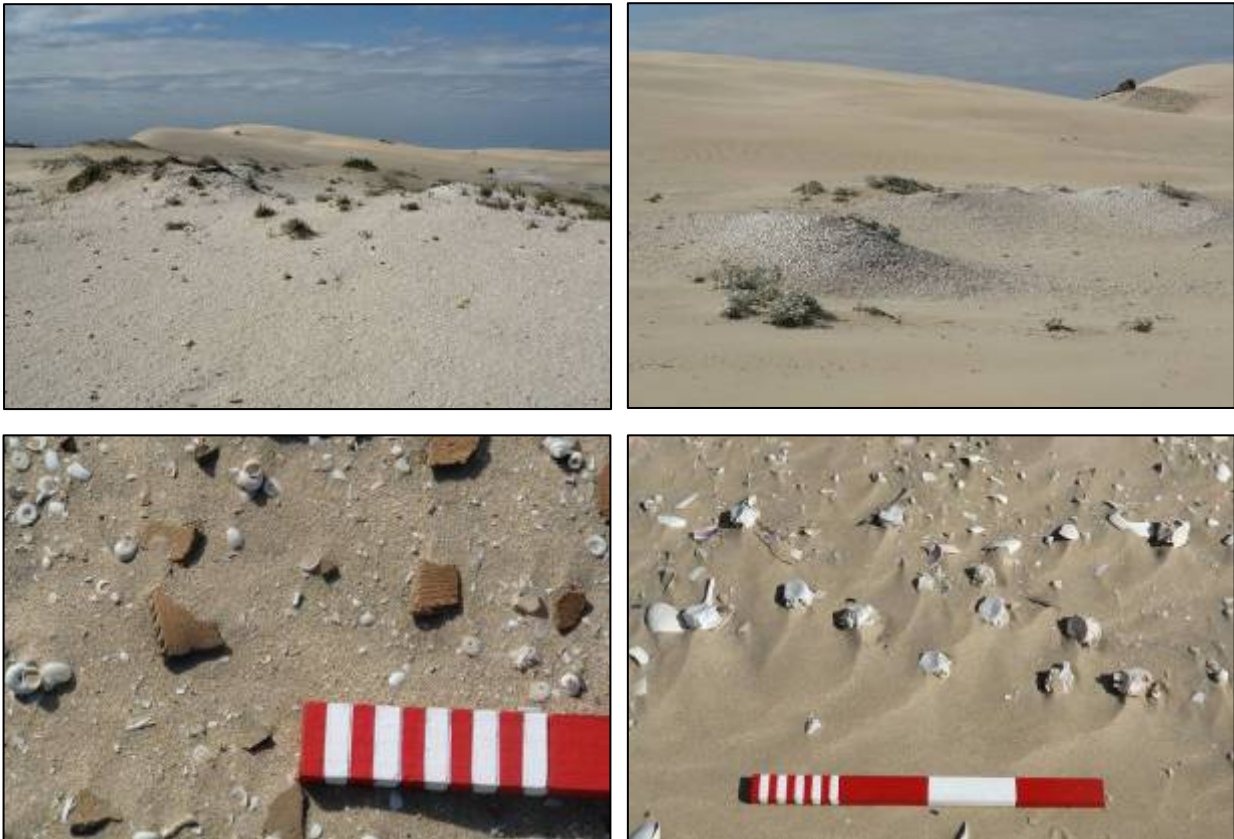
There are a large number of individual shell middens (more than 20) and shell scatters situated close to the proposed development (Fig 7-8). These shell middens are the most important and the best preserved complex between the Sunday's River and Port Elizabeth. The majority of the shell middens are dominated by *Donax serra* (white mussel) marine shell remains, but there are a few with large numbers of *Solen capensis* (pencil bait) remains as well. The middens are also rich in bone remains (juvenile seal, tortoise and mammal remains) and cultural remains

(stone tools and Later Stone Age Khoi herder pottery) (Figs 9-10). The shell middens date approximately from the past 6 000 years. The presence of juvenile seal remains are of particular interest because there are breeding colonies on the nearby islands and it would provide important information of pre-colonial settlement patterns along this part of the coast.

Figs 3-6. Views of some of the shell middens (top), decorated Khoekhoen pottery (bottom left) and seal remains (bottom right).

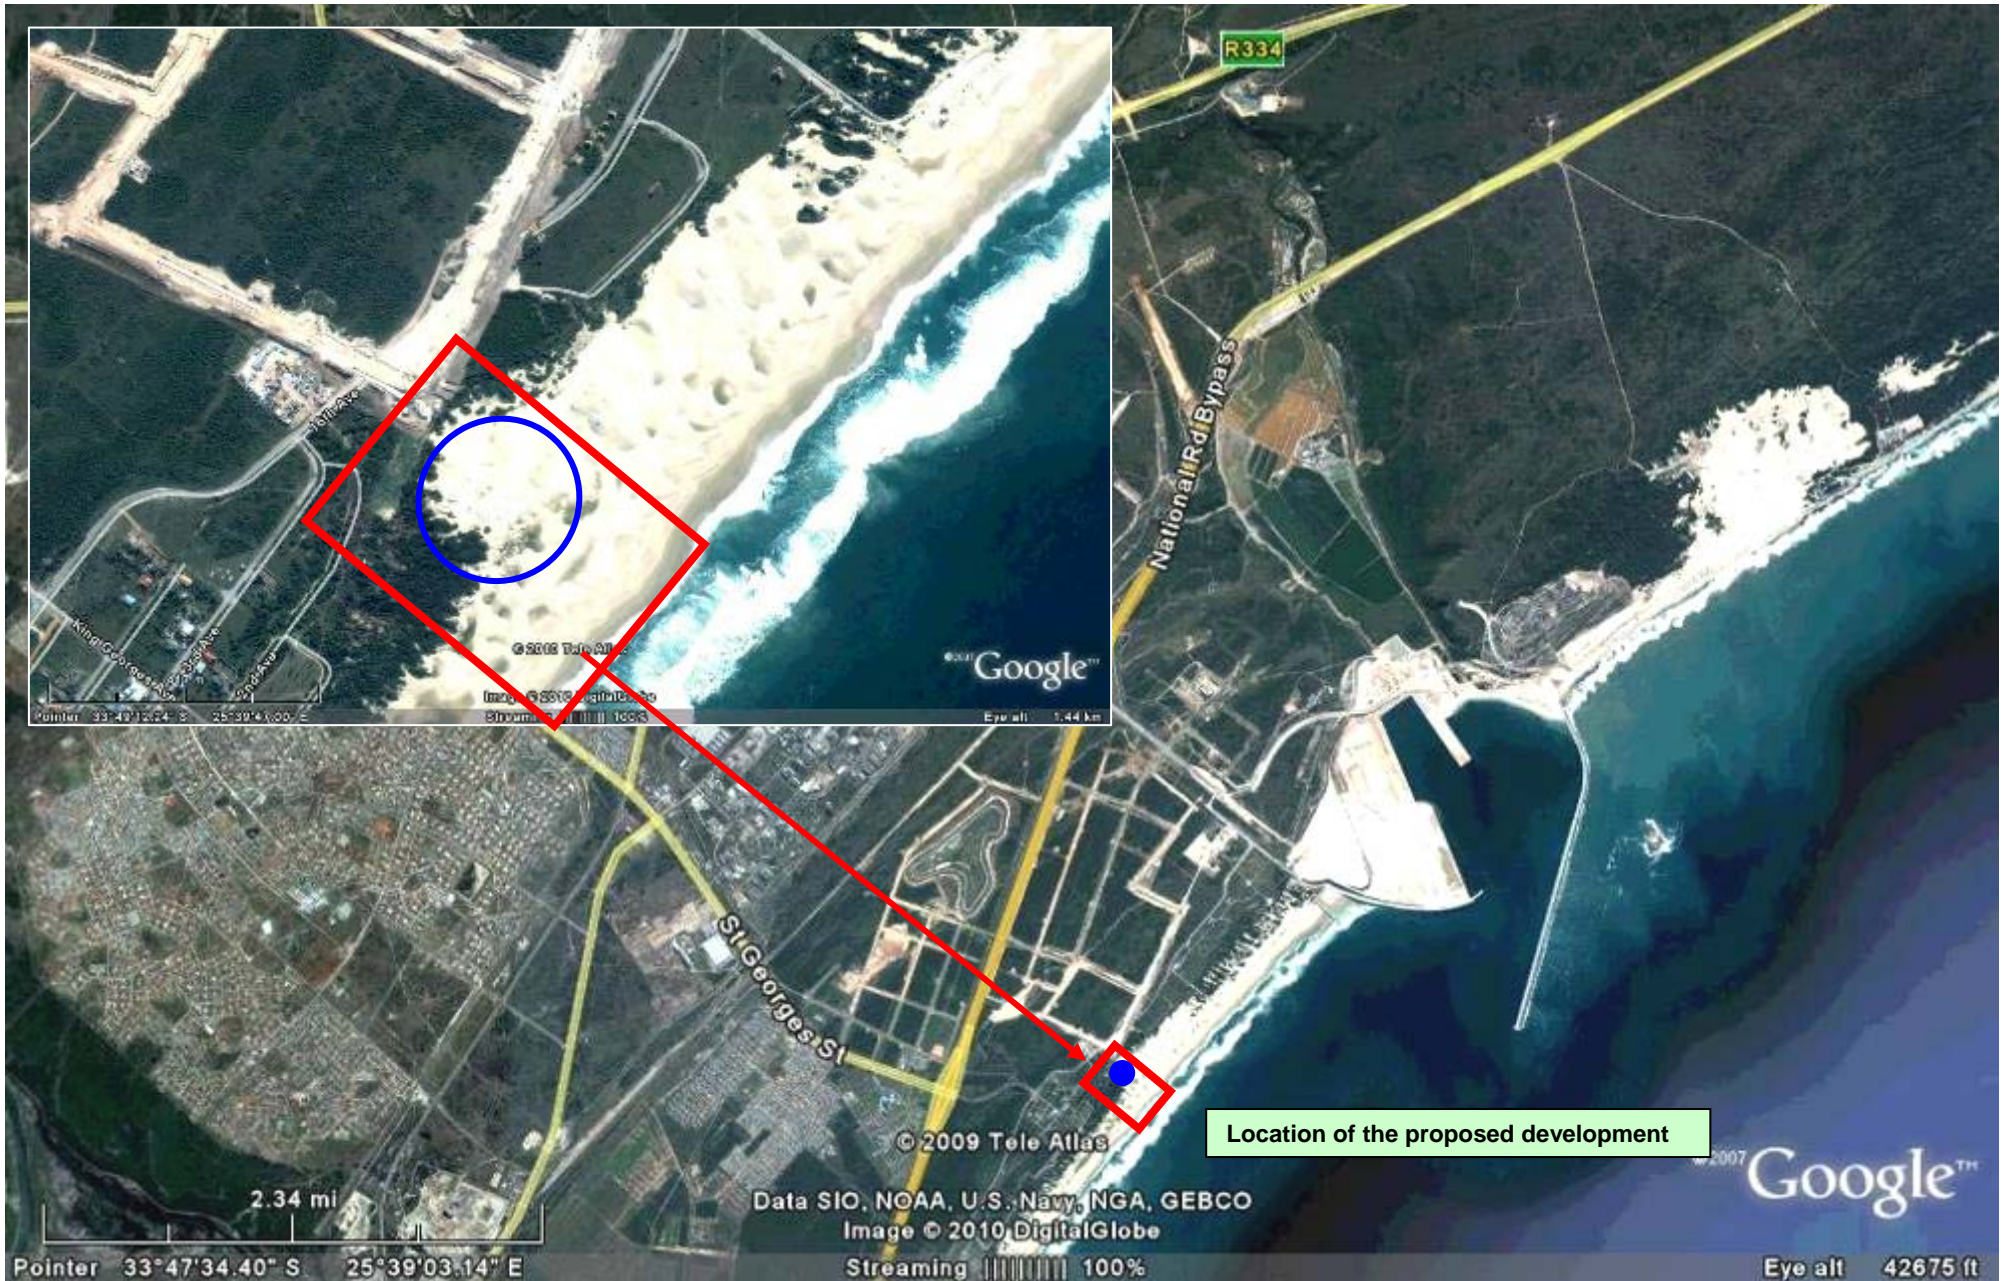
Map 2. Aerial photographs indicating the location of the proposed development. The blue dot and circle mark the shell midden complex.
