**A PHASE 1 ARCHAEOLOGICAL HERITAGE IMPACT ASSESSMENT OF ZONE 5  
IN THE COEGA INDUSTRIAL DEVELOPMENT ZONE FOR THE PROPOSED  
CONSTRUCTION OF A MANGANESE SMELTER, NEAR PORT ELIZABETH,  
NELSON MANDELA BAY MUNICIPALITY, EASTERN CAPE PROVINCE**

**Date:** March 2010  
**Revised:** May 2010

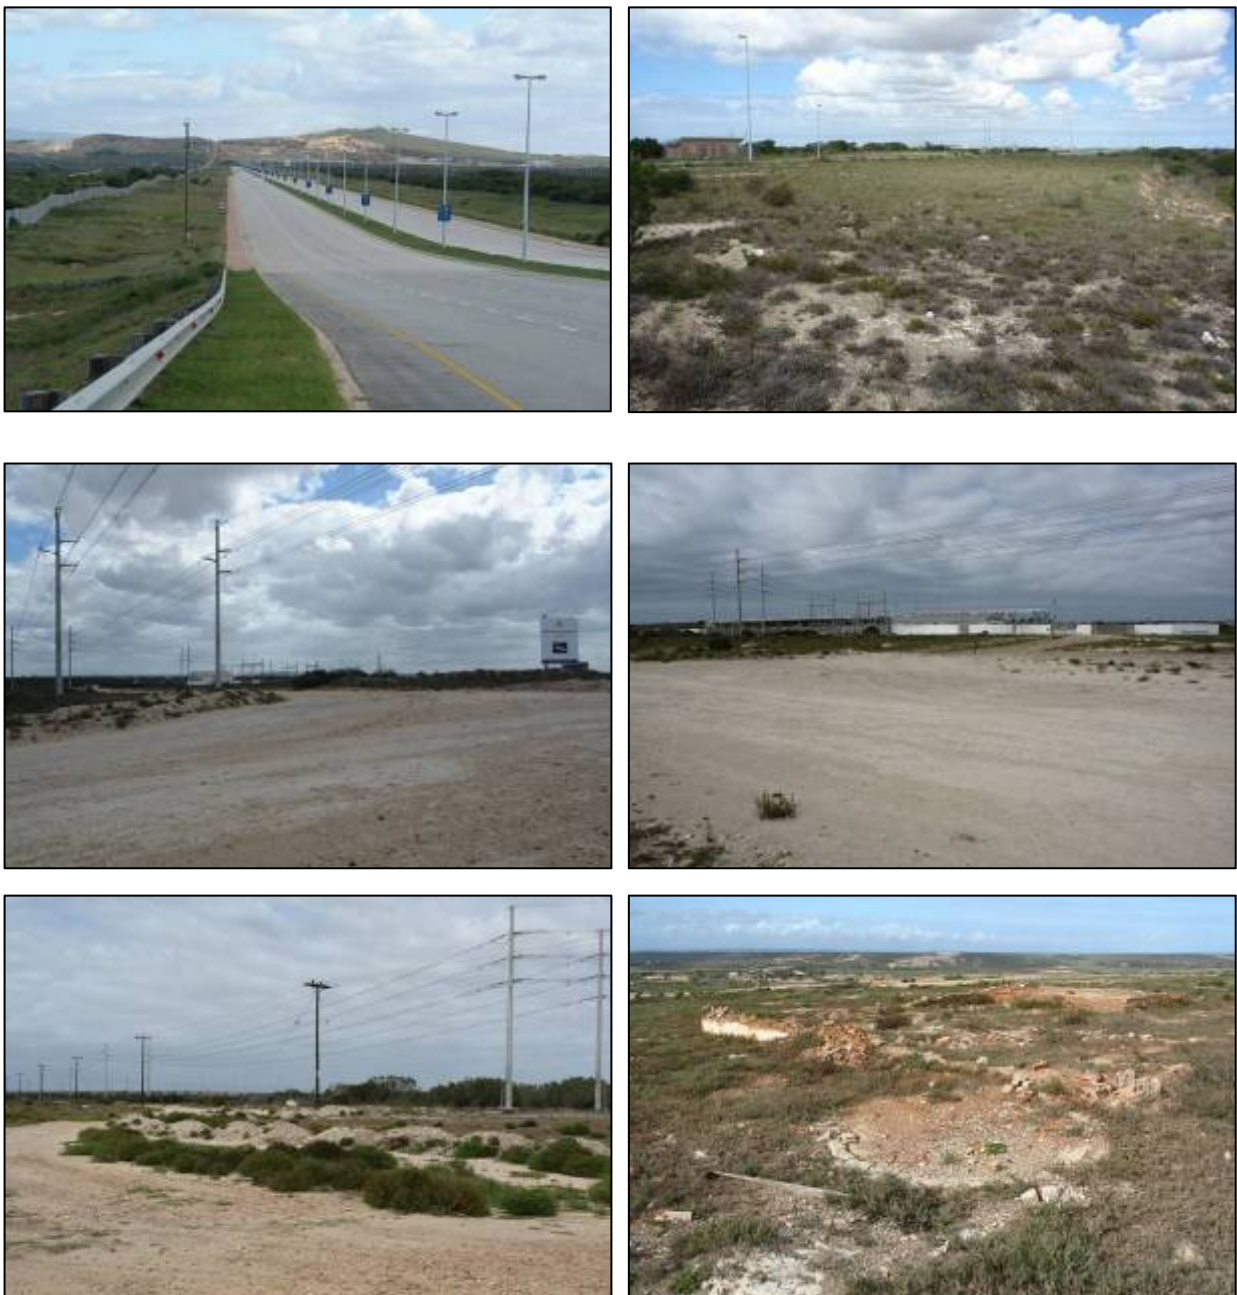
**Figs 1-4. Different views of the large scale damage caused recently to the landscape by the development of the infrastructure in Zone 5.**

The dense vegetation made it almost impossible to find archaeological sites/material. Ironically the only areas that could be investigated were the 40 metre wide cleared strips adjacent to roads and drainage channels and other features. Unfortunately these strips were further disturbed by the construction of water pipe lines and drainage channels. If there were any archaeological sites these were totally destroyed (Figs 7-12).

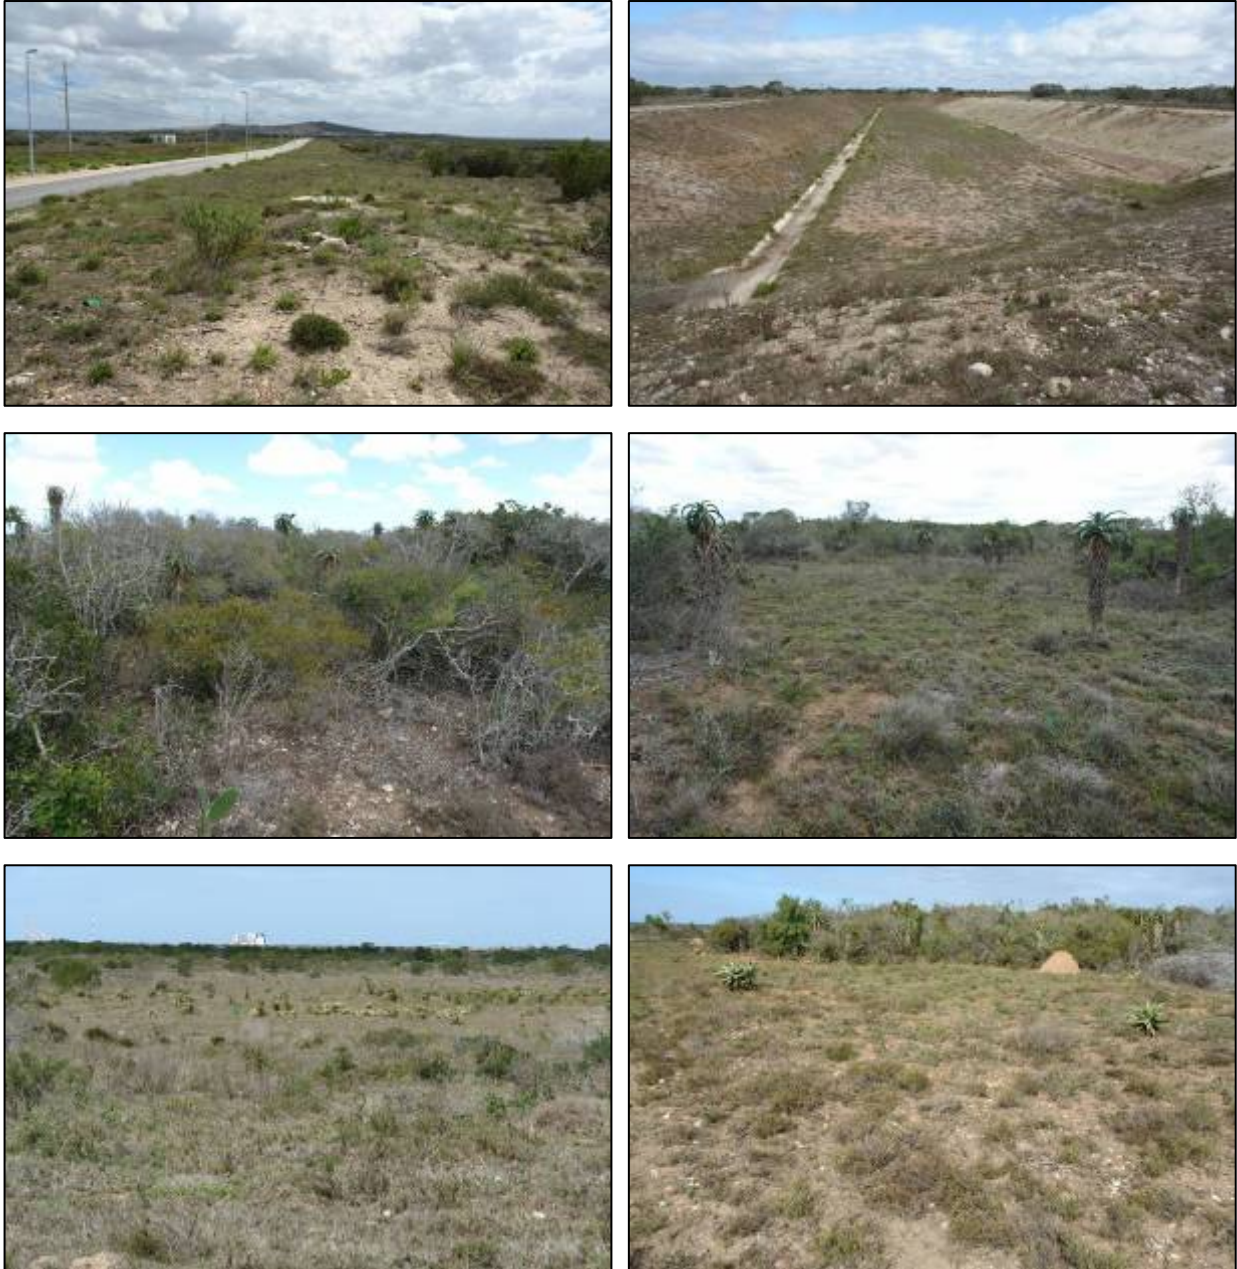
**Figs 7-12. Different views of the large scale damage caused by clearing of the landscape and the dense natural vegetation in Zone 5.**

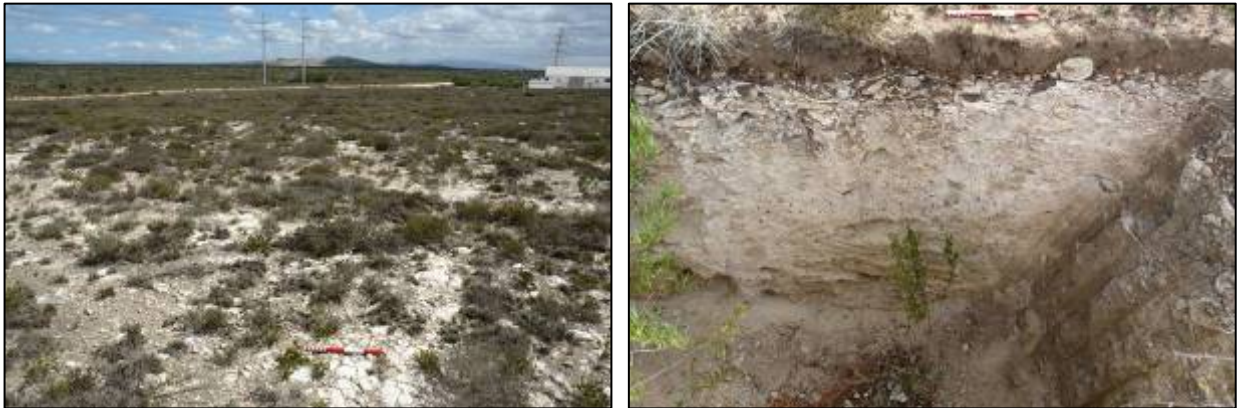
In spite of the large scale clearing and levelling activities, occasional quartzite Middle Stone Age stone tools with typical faceted striking platforms were found, especially where pebble/cobble gravels were exposed. The stone tools are situated in the thin layer of top soil which covers the underlying hard calcrete deposits, or on the surface where the calcrete is exposed. The tools were mainly small 'informal' flakes and chunks with few cores, points and blades. Although many flakes displayed utilization damage, few were 'formally' retouched. No spatial patterning or activity areas such as 'manufacturing' sites were located, although such sites may exist but were not be visible. All stone tools were in secondary context and not associated with any other remains (Figs 13-18).

**Figs 13-14). Exposed calcrete (left) and a test pit showing the thin layer of soil on top of the calcrete (right).**

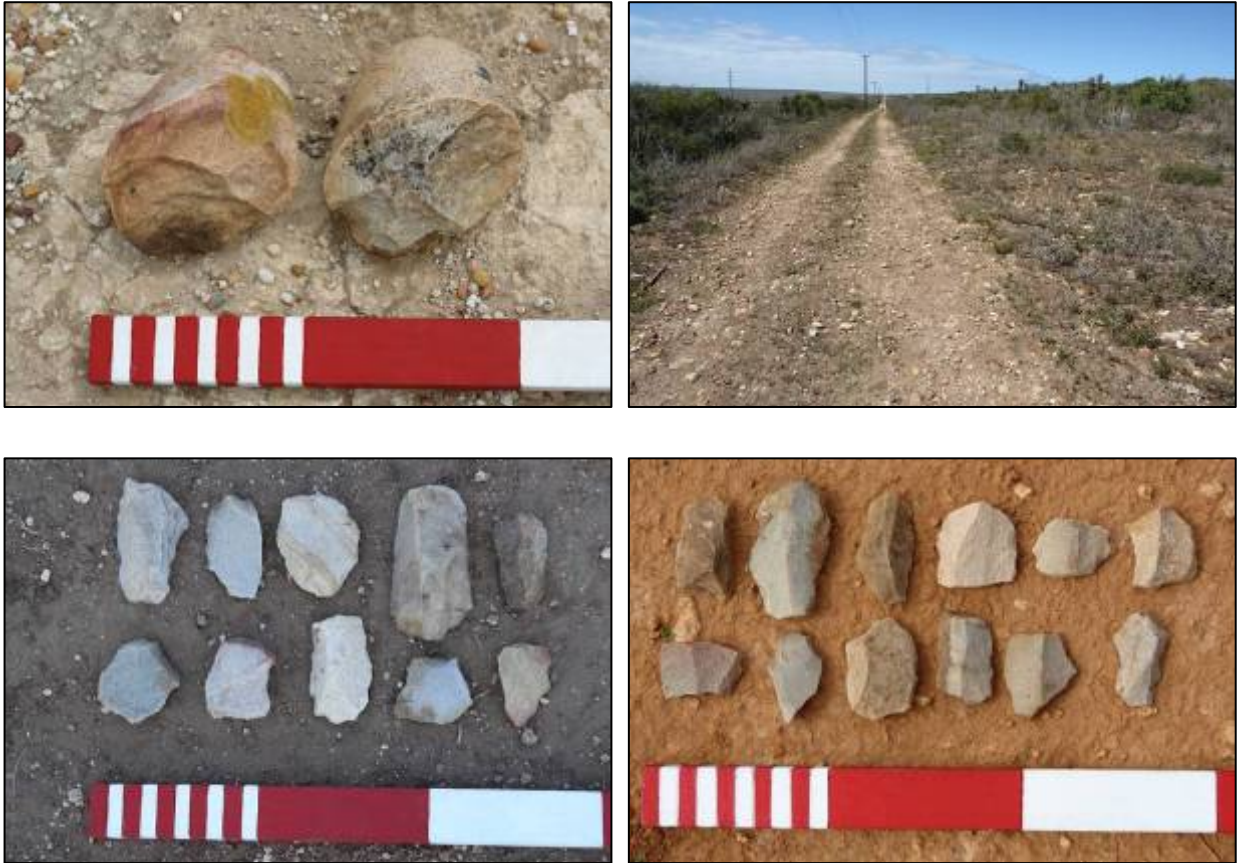
**Figs 15-19. Flaked cobbles found on exposed calcrete (top left), exposed gravel in a track (top right) and Middle Stone Age stone tools found in these gravels (bottom.).**

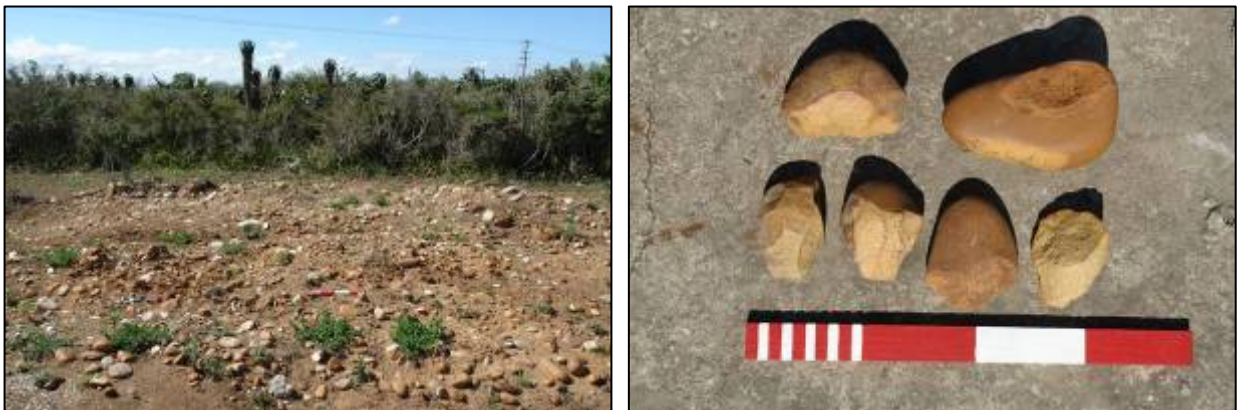
**Figs 19-20. Gravel exposed by earth moving activities (left). Note the dense vegetation in the background. A few examples of the stone tools retrieved from the exposed gravel (right).**

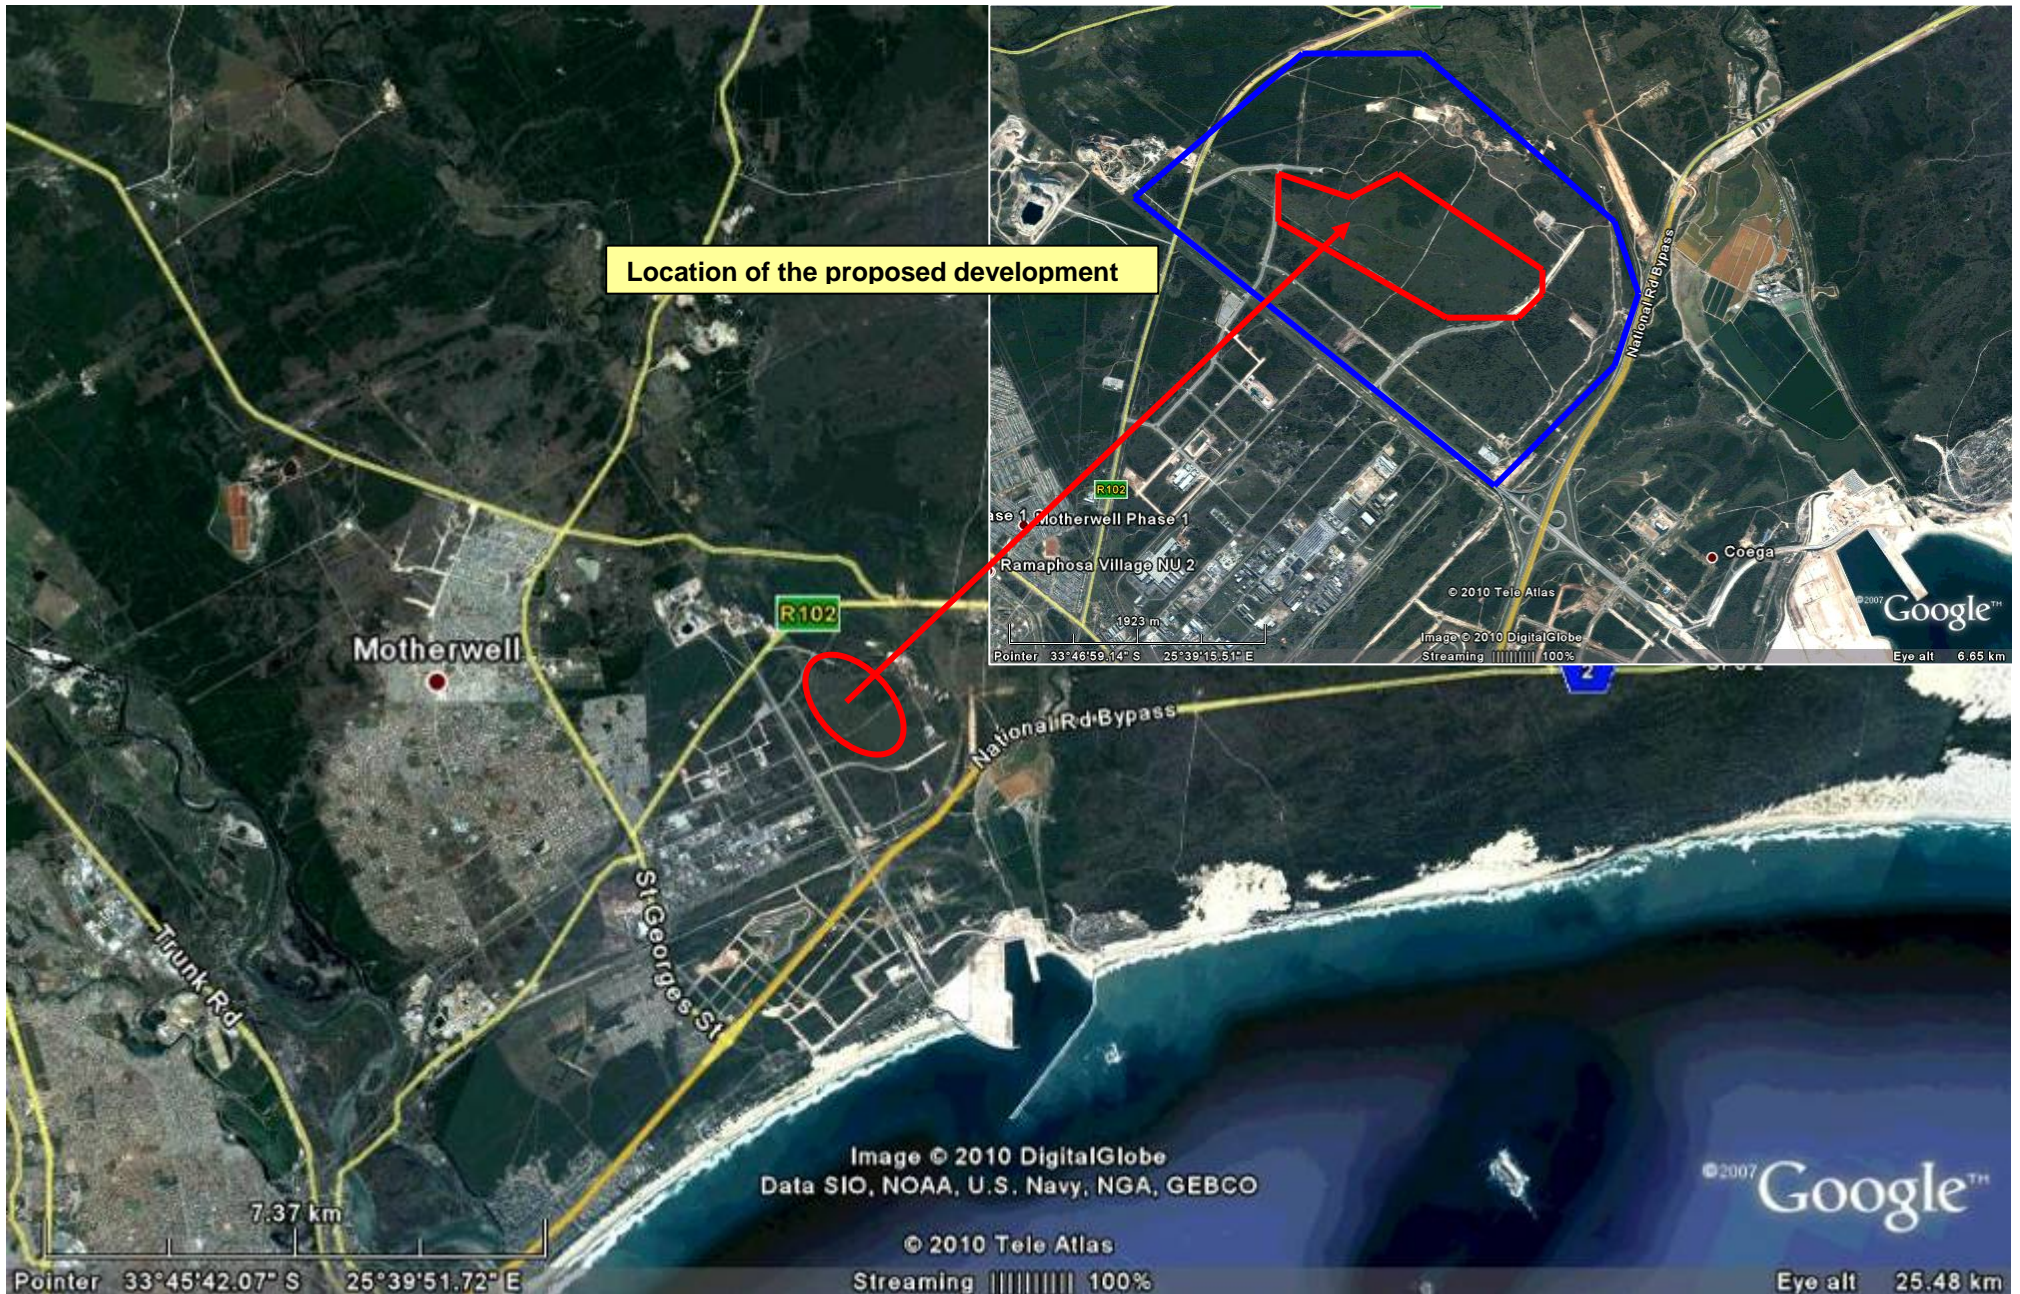
Map 2. Aerial photographs of the location of the proposed development. The blue lines mark Zone 5 and the red outlines the approximate size of the footprint.
