# ARCHAEOLOGICAL INVESTIGATION THE PROPOSED REHABILITATION OF THE N9 FROM WOLWEFONTEIN TO COLESBERG AND THE PROPOSED CONSTRUCTION OF THE N1/N9 ACCESS INTERCHANGE AT COLESBERG NORTHERN PROVINCE

# **CCA ENVIRONMENTAL (Pty) Ltd**

# South African National Roads Agency Limited (SANRAL)

> FEBRUARY 2009

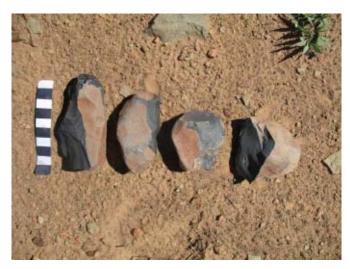
A dispersed scatter of Later Stone Age (LSA) tools were documented in a patch of open ground directly alongside the fence line south of the Engen Garage in Colesberg. The tools include several flakes, one small round core, one retouched flake, a chunk and one weathered Middle Stone Age (MSA) flake (Figures 3 and 4).

A few dispersed tools, all in dolerite, were documented over the remainder of the site. These include a patinated MSA blade and several more LSA flakes and chunks found on patches of exposed ground.

The archaeological remains have been rated as having low local significance.

Figure 3. Scatter of tools south of Engen Garage Figure 4. Collection of stone tools. Scale is in cm

With regard to the proposed rehabilitation of the N9 in the Colesberg area and the proposed new grade separated N1/N9 access interchange at Colesberg, in the Northern Cape Province, no archaeological mitigation is required, and the project should be allowed to proceed.

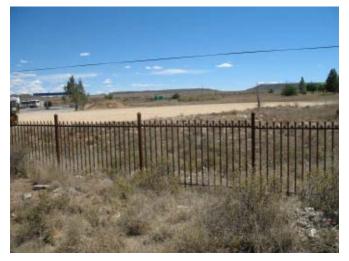
Apart from a small, dispersed scatter of Later Stone Age (LSA) tools recorded on the proposed site in March 2008, no additional archaeological remains were documented during the assessment of the second proposed alternative interchange in November 2008. The receiving environment is in a severely degraded condition (refer to Figures 5 and 6.

Figure 5. Site for the proposed alternative Interchange. View facing east

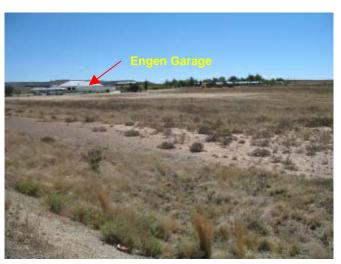
Figure 6. Site for the proposed alternative interchange. View facing southwest from the N1
