# **PHASE 1 HERITAGE IMPACT ASSESSMENT**

**PROPOSED BORROW PIT NO.2 ASSOCIATED  
WITH THE MAINTENANCE OF ROAD D1399 IN  
GROBLERSDAL, SEKHUKHUNE DISTRICT  
MUNICIPALITY OF LIMPOPO PROVINCE.**

**July 2008**

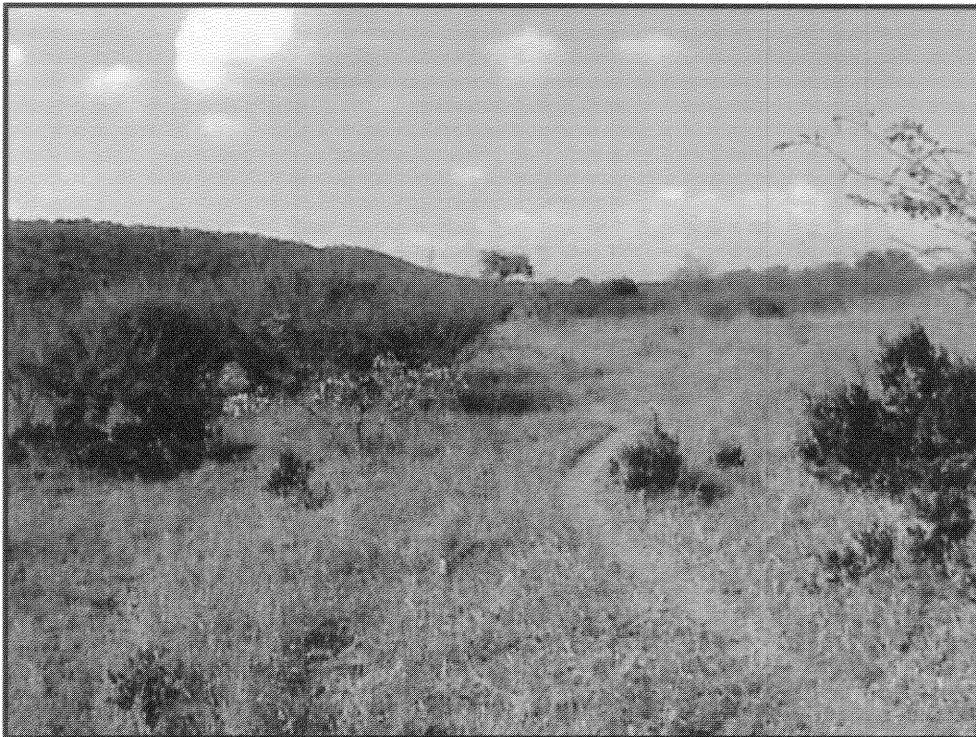
**Figure 1:** View of a Proposed borrow pit site.

No heritage resources, or any archaeological materials, were identified within the vicinity of the borrow pit site.

Therefore, the discovery of previously undetected subsurface heritage remains on the site during extracting of gravel material must be reported to the South African Heritage Resources Agency (SAHRA) or the archaeologist, and may require further mitigation measures.

We recommend that the South African Heritage Resources Agency should be notified if human remains falling under the National Heritage Resources Act (Act No 25 of 1999) are accidentally uncovered during the use of the identified borrow pit.
