PHASE 1 ARCHAEOLOGICAL ASSESSMENT DIE BALKE, STELLENBOSCH (portion 3 of farm 104

Prepared for
Prosperito Pty Ltd
September 2008

Executive summary

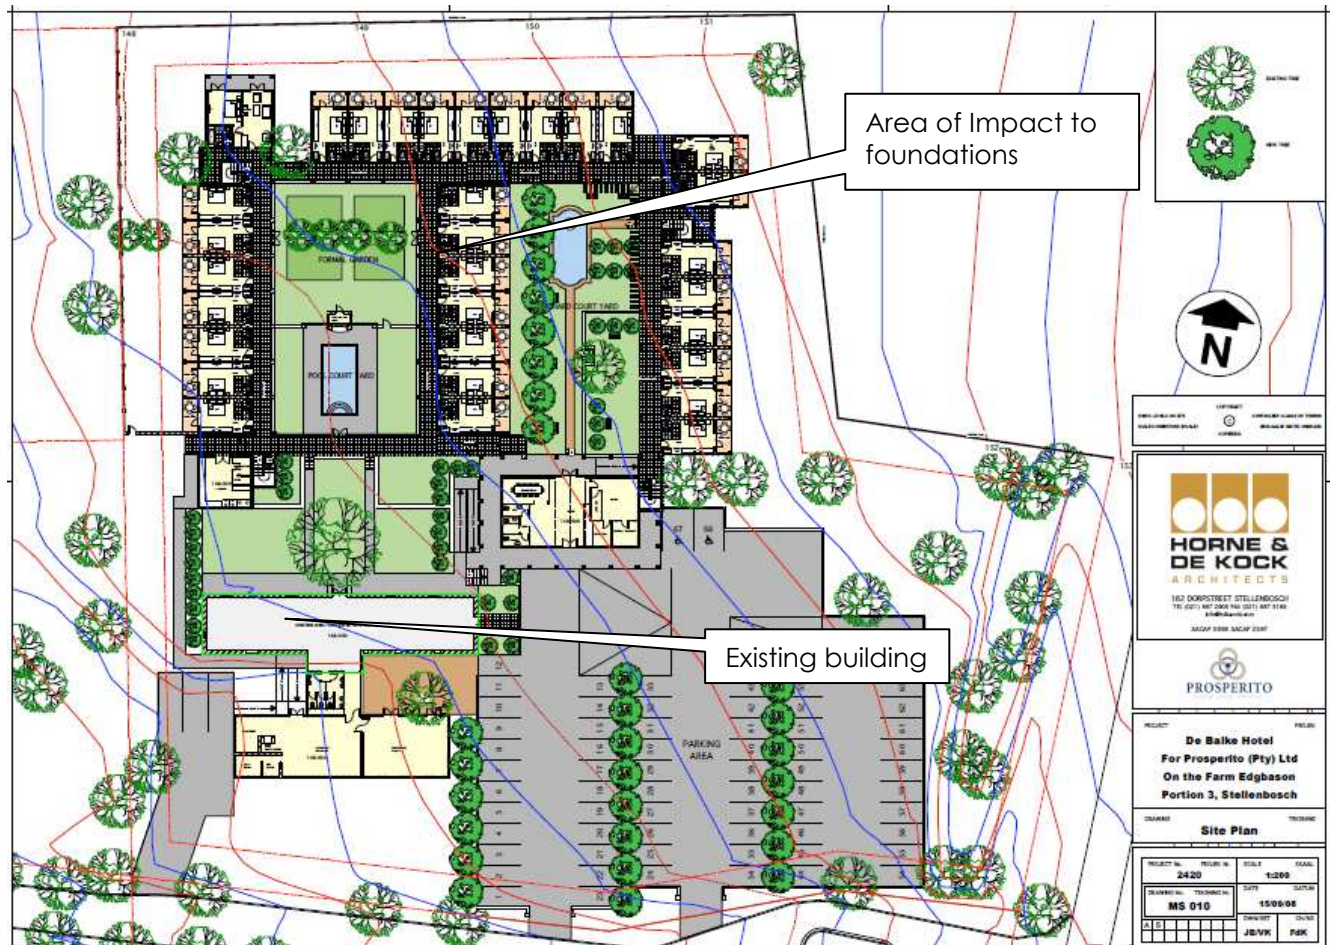
Figure 2. The development proposal. The identified area where old foundations will be impacted is indicated.

The proponent wishes to construct a boutique hotel on the site (Figure 2). The proposal sees the retention of the Barn and resumption of its use as a restaurant/pub. The focus of the accommodation units falls within what used to be the old *werf* between the two barns. The units are to be organized around a courtyard garden and swimming pool (Figure 2). The implications of the development proposal could result in impacts to archaeological material, notably the possible footprint of the dwelling house that was identified by Vos (2008) to potentially exist below surface.

The surviving wall footing that exists on site will be impacted by the development proposal.

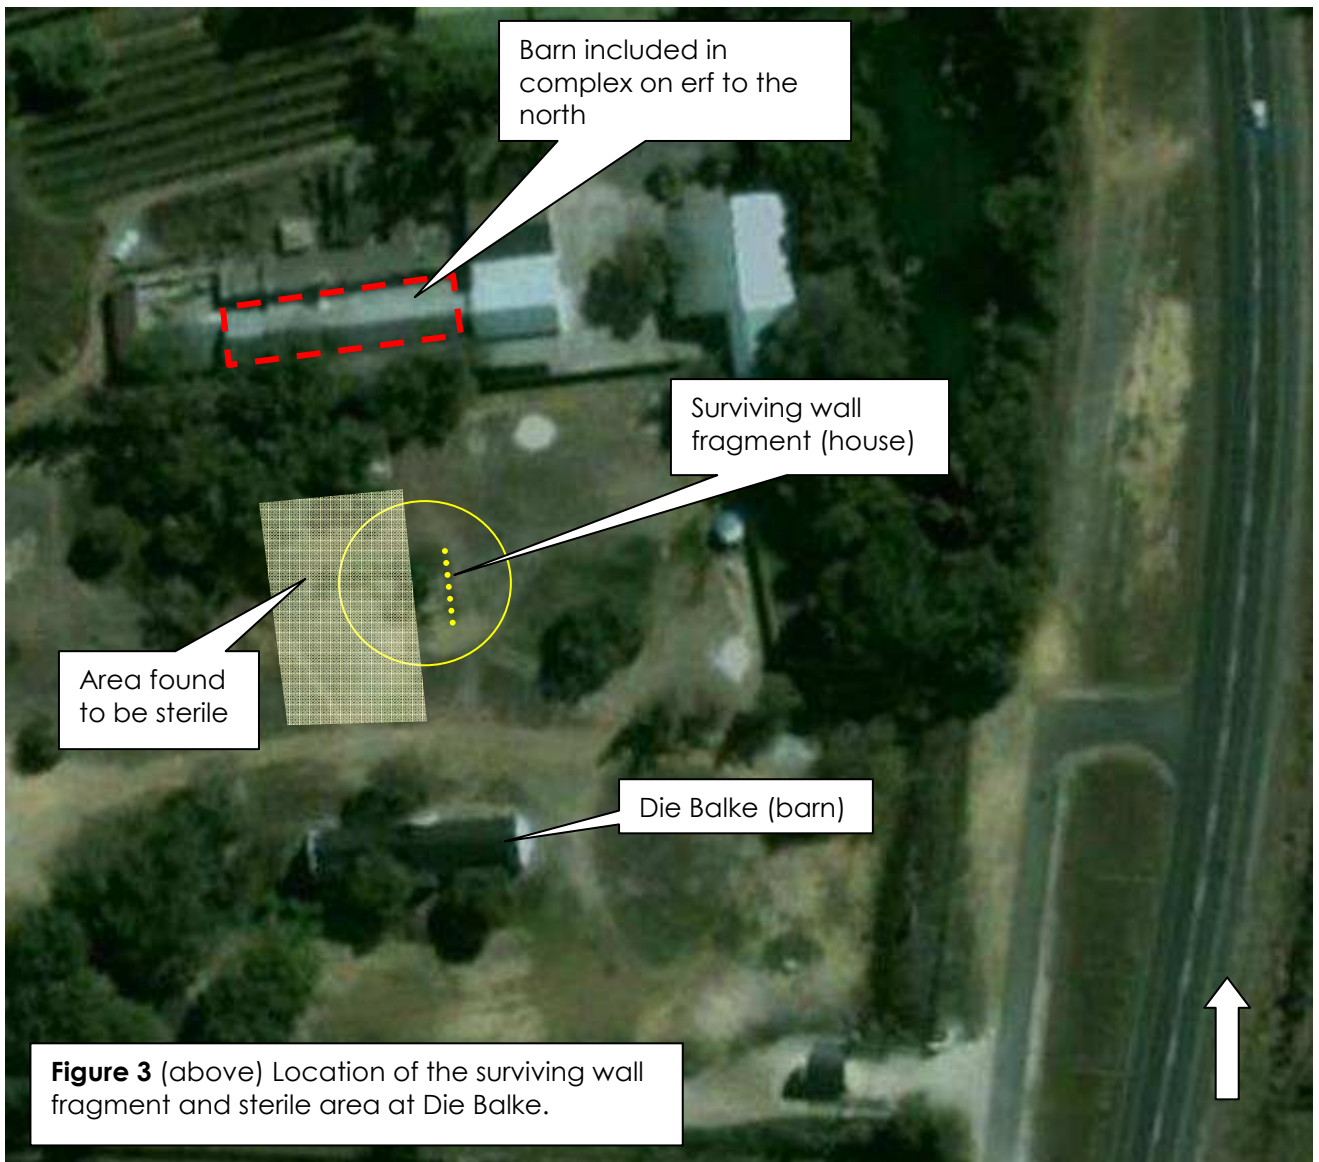
Stone foundation fabric that exists on the site represents, in all likelihood is a remnant of the footings of the dwelling house. A stone alignment is visible for approximately 4m as well as possibly a corner (dense grass cover restricted its visibility). It is anticipated that much of the archaeological signature of this structure has been previously disturbed (Figure 3)

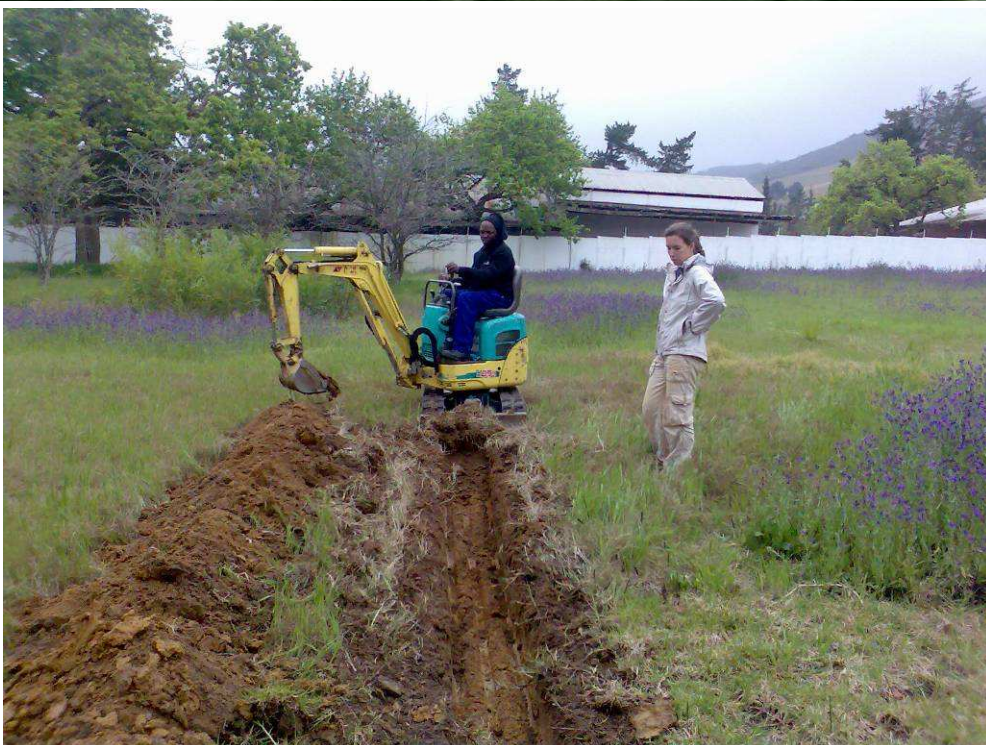
Plate 1 Checking the status of sub-surface soils using a micro-excavator.

Vegetation and shallow overburden was judiciously cleared using a micro-mechanical excavator (Yanmar SV08) and sub-surface conditions examined. Three cuts were made across the study area (Plate 1)) and subsurface conditions examined. No archaeological material of any kind was disturbed or affected. Visual inspection revealed an alignment (under thick grass) of stones in the area estimated to have been occupied by the dwelling house. As these constituted archaeological material, they were not disturbed.

The three cuttings were excavated to depths of 300-400mm at which point in-situ clays were encountered that were hard enough to cause excavator refusal. The shallow soil depths containing recent debris are indicative that the *werf* area has been scraped by mechanical excavation in the past.
