**REPORT ON THE PHASE ONE ARCHAEOLOGICAL  
INVESTIGATION OF ASPECTS OF THE SITE KNOWN AS  
*DIE BRON* IN MALMESBURY**

Prepared for  
**Malmesbury Transitional Council**  
March 1995

Prepared by  
**Archaeology Contracts Office**  
Department of Archaeology  
University of Cape Town  
Private Bag Rondebosch  
7700

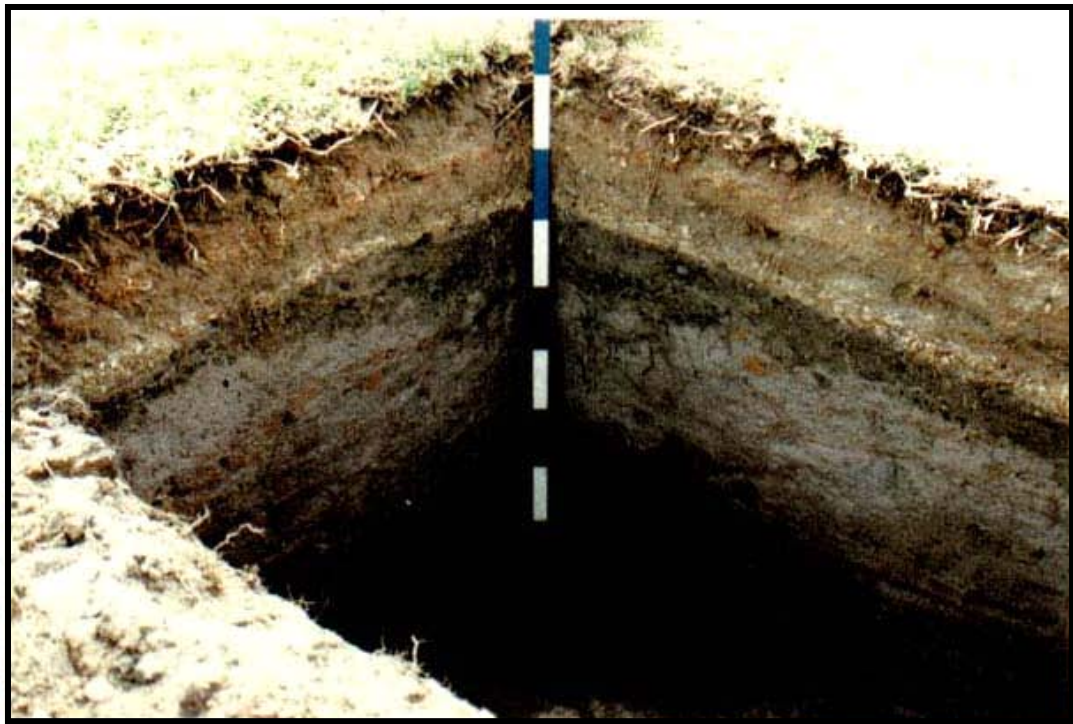
Three test holes (A, B and C) were positioned on the grassy area adjacent to the gravel servitude road that traverses the site. Plate 1 shows test hole A. Sections show that in all the tests the uppermost 300mm was composed of introduced material, such as clay, ash and charcoal and fragmented building rubble. Below this level a loose grey granular soil grading towards a finer brown soil was found. This is *in situ* material and is presumably what was used for cultivation when the church gardens were established.

**Plate 1** Test Hole A showing the upper fills and lower grey *in situ* soils.

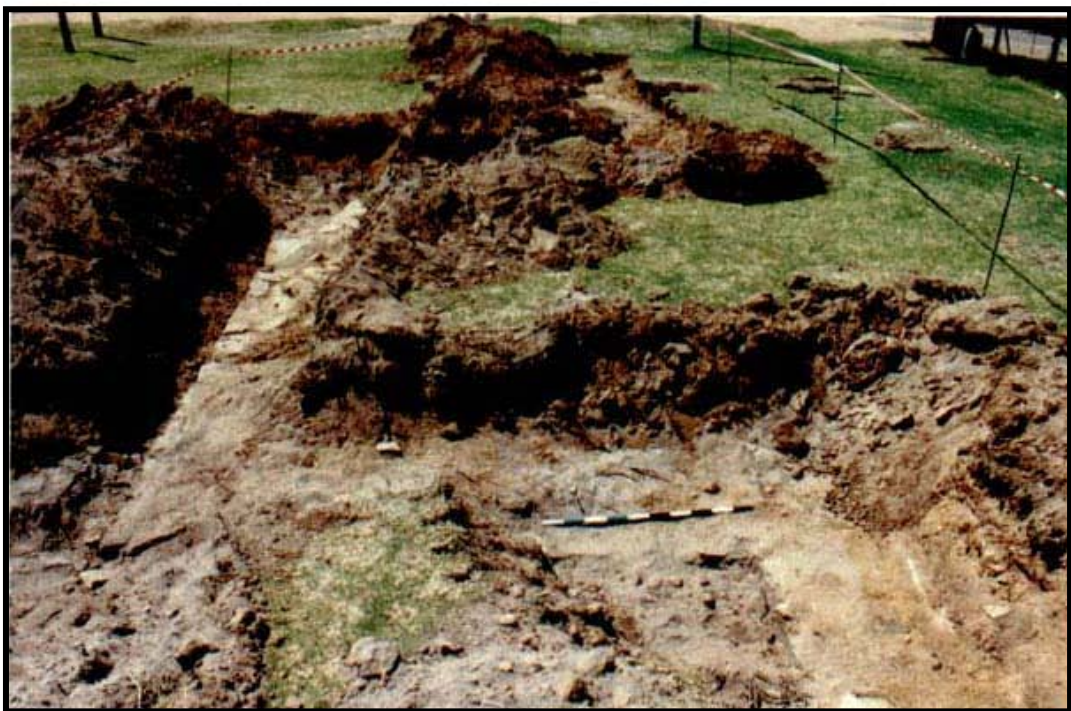
A second line of test holes was located parallel to the fence of Gordon's Court in the vicinity of two palm trees. It was immediately evident that were close to a demolition as the soil contained quantities of building rubble. The remains of a stone foundation were found in one hole. After discussions with the Transitional Council it was agreed that they would make a mechanical excavator and operator available to explore the extent of the foundations. Several trenches were excavated and enough of the foundation was exposed to allow comparison with the building that appeared on the plan of the house from the deeds office. Trenches and foundation can be seen in Plate 2. Various points on the foundation were surveyed to allow accurate plotting. The location of the foundations are shown in Figure 4. Foundations in excess of one meter in width were constructed with slabs of Table Mountain Sandstone and had been dug down into the loose grey substrate. Photographs from various sources showing the residence are shown in Plates 3, 4 and 5.

**Plate 2** The foundation of the residence.

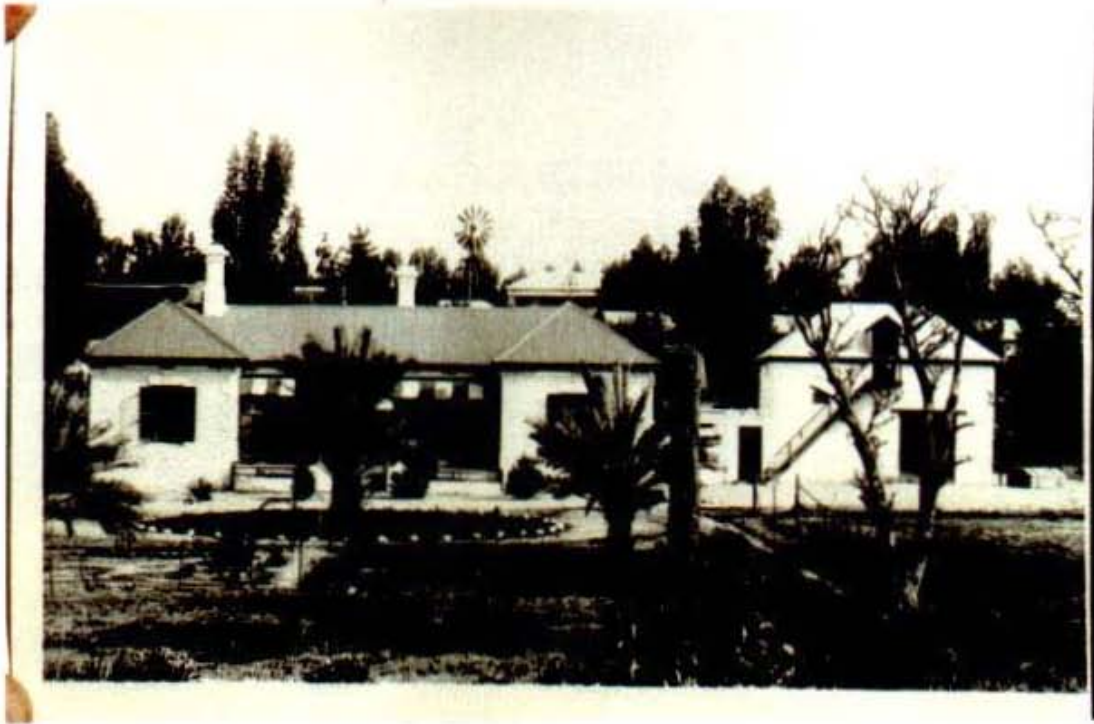
**Plate 3** The Residence on the Bron site (now demolished). Copy of a photograph in the Malmesbury Museum.

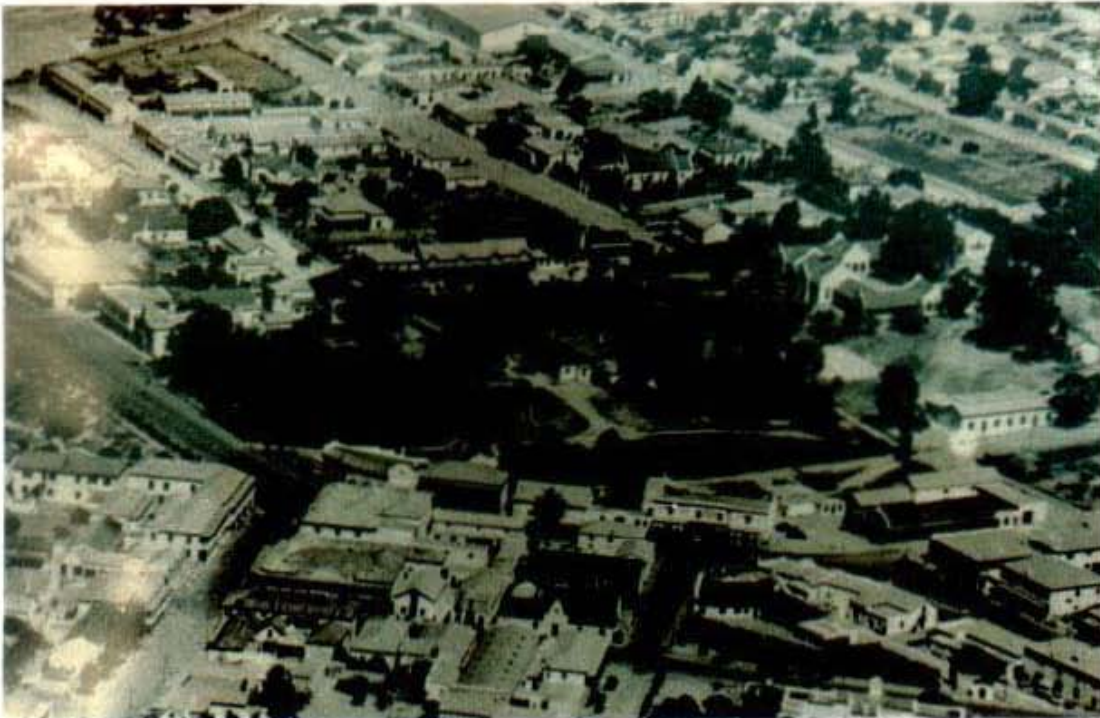
**Plate 4** Aerial photograph of part of Malmesbury showing the residence and part of the baths. Copy of a framed print in the Malmesbury Museum.

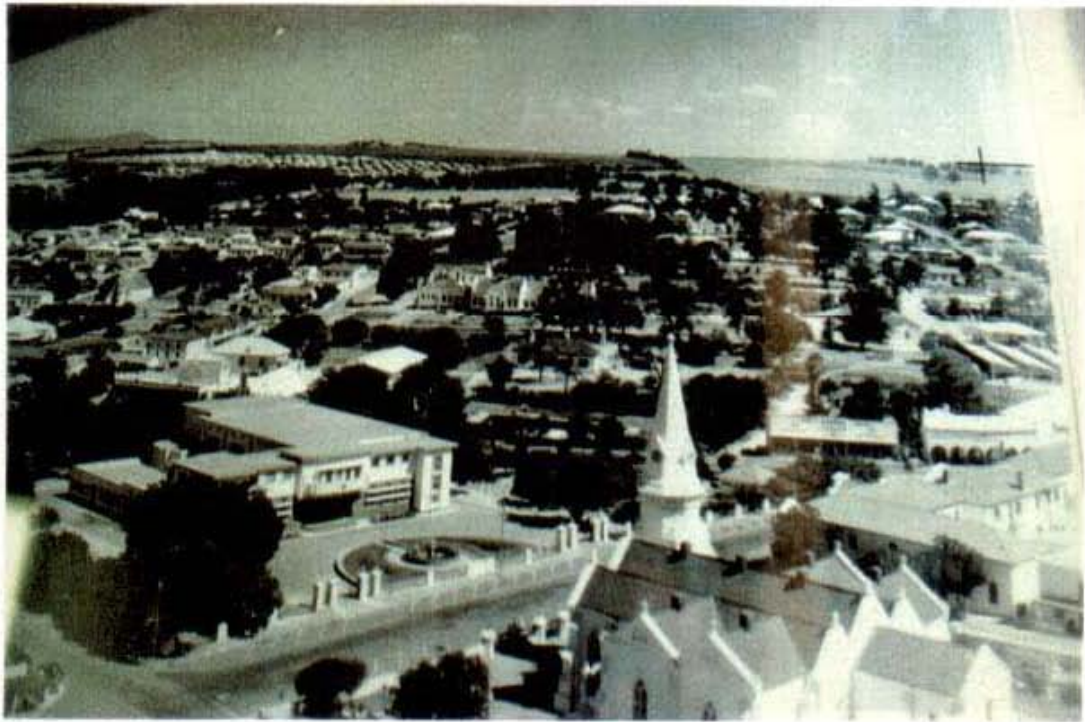
**Plate 5** Aerial photograph of part of Malmesbury showing the residence and part of the baths. Copy of a framed print at the Malmesbury Transitional Council.

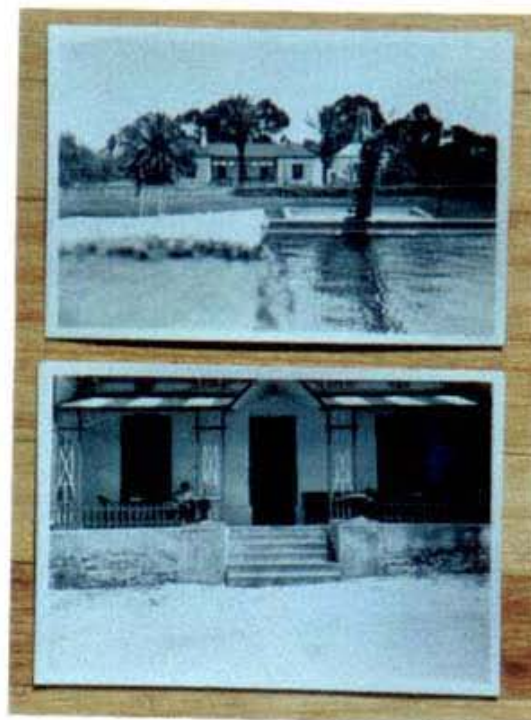
**Plate 6** A view of the old boardinghouse and detail of front stoep c1947. Copy of photographs in possession of Mrs Coo Du Plessis.

A single test hole was excavated in the vicinity of the spring to ascertain if anything remained of the old bathhouse. Part of a concrete foundation was exposed and the position surveyed. Informants suggested that the old mineral bath had been demolished along with the rest of the building. Photographs showing the bathhouse are shown in Plates 6, 7 and 8.

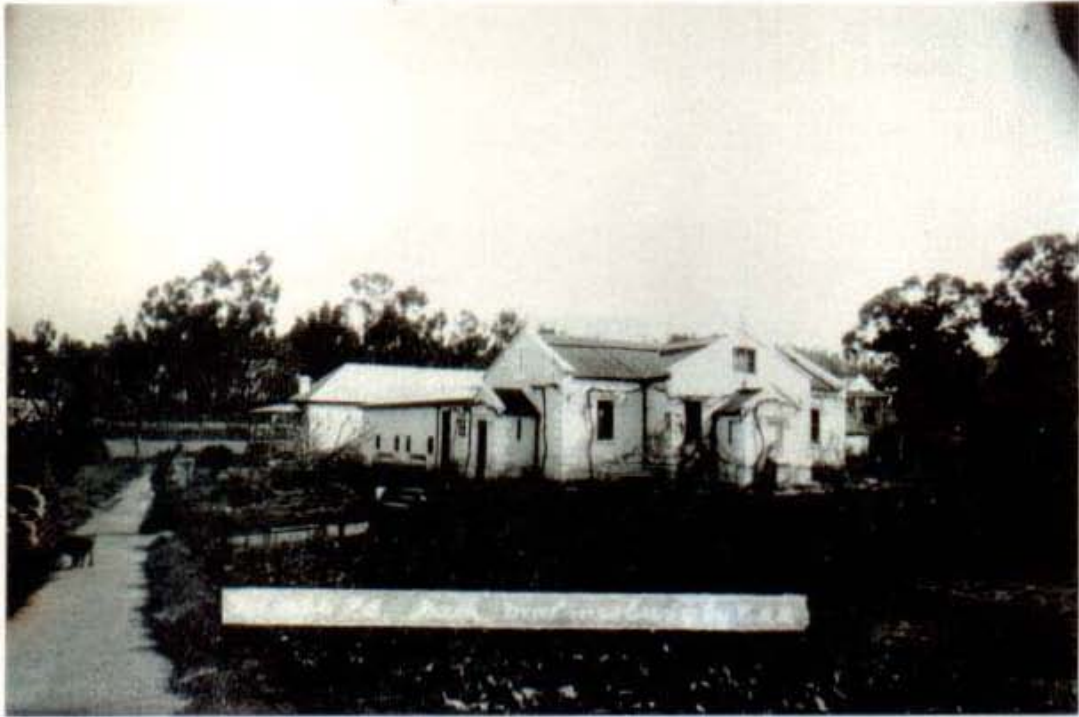
**Plate 7** The mineral water bathhouse. Copy of a photograph in the Malmesbury Museum.
