Archaeological monitoring of Erf 141664, Cape Town, bounded by Rutgers, Chapel and Stuckeris Streets

(HWC Reference No: HM/CAPE TOWN/
Erf 141664 Permit No. 2008/07/03)

October 2008

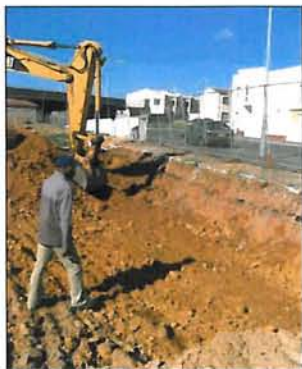
Figure 4: Section C

The mechanical excavation started in Section C on 4 August 2008. It was immediately apparent that the natural clay was very high and situated 250-300mm below the original ground level (indicated by a layer of tarmac) and the likelihood of finding intact archaeological material was low. Nothing of archaeological interest was found in this section.

The height of the *in situ* clays suggest that either the foundations of the buildings (demolished in the 1970s) were very shallow, or considerable re-landscaping had taken place after the demolitions, removing most of the foundations and top soil.

The level of the original road surface is visible in the middle right of the photograph. This road level relates to before the 1970s demolitions and forced removals from District 6.

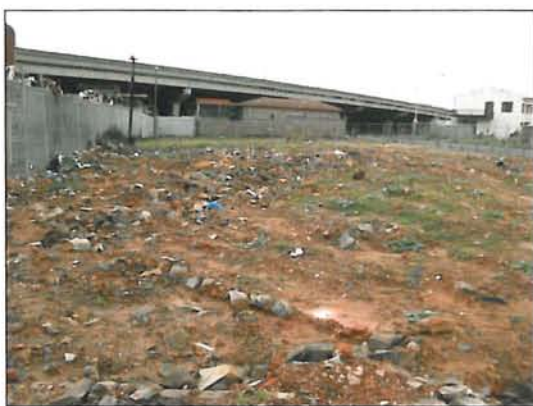
Figure 5: View of the site before start of mechanical excavation and monitoring, looking towards the Eastern Boulevard flyover.

Mechanical excavation in Section B was started 12 August 2008. In May 2008 the surface bed of a portion of the house was removed. Concentrations of slate (blue stone) could be seen on the surface of the ground indicating where older foundations were; these were somewhat disturbed due to the movement of the mechanical excavator over the site (Figure 5).

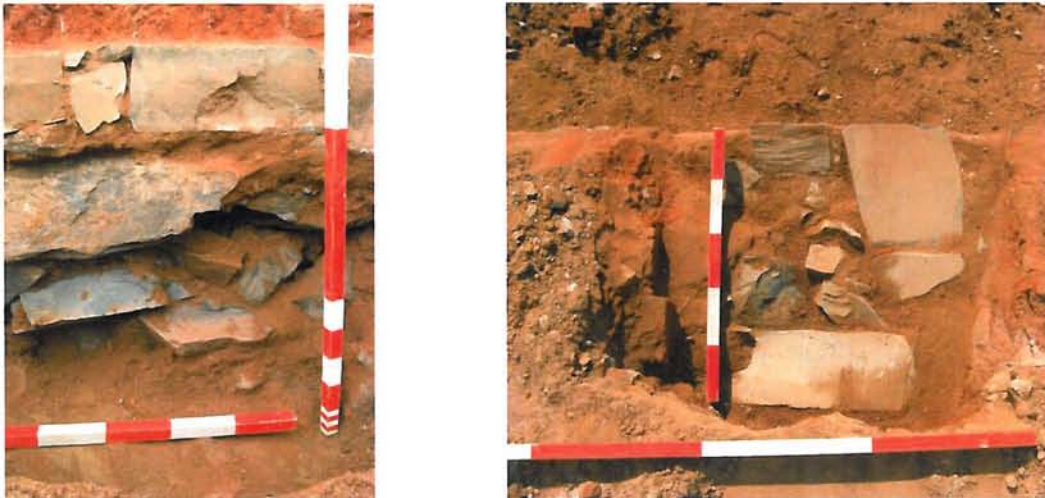
Figure 7: The foundation of the building was formed by slate rubble topped by a course of roughly dressed slate (Photograph on left). The image to the right shows the width of the walls and illustrated the construction method: roughly dressed blocks on the exterior, the interior of the wall filled by smaller chunks of rock, set in a clay/lime mortar.

Foundation thickness for the exterior wall is 530mm, while interior walls appear to vary between 430-500mm. The rubble foundation was approximately 500mm deep, although in the area of the ditch it was considerably deeper. Brick rubble immediately above the course of slate indicates that the walling was entirely of brick and unlike earlier buildings, not partially of stone.

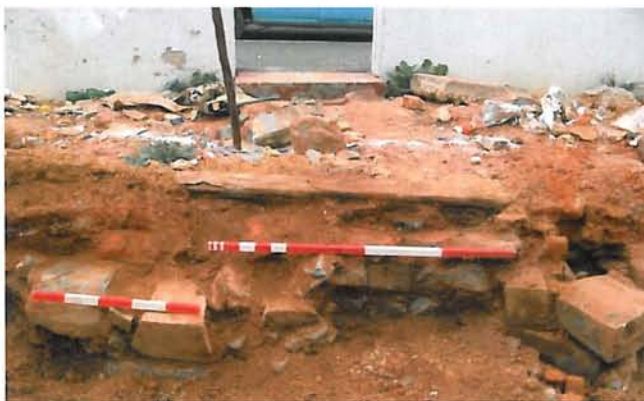
Figure 8: The base of the wooden doorframe was still visible. These features were protected by the layer of cement which covered the area between the front of the house and the stoep wall.

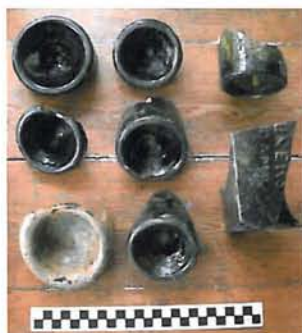
Figure 10: Bottle bases. The bottle on the top right is an Ohlssons Brewery bottle: Ohlssons was already well established at the Cape by 1879 (Saitowitz & Lastovica 1998).

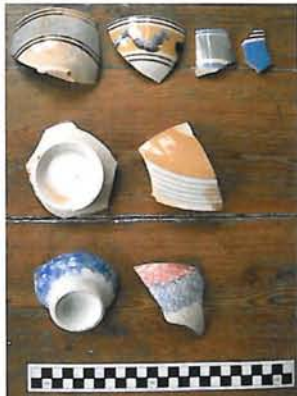
Figure 13: Industrial slipwares

The following images are of a selection of refined earthenwares which were typically manufactured in England and were commonly available at the Cape from the late 18th century onwards. There was only 1 small shard of Asian porcelain in the collection. The assemblage, although small, appears to be mostly early/mid 19th century; which would be consistent with the filling in of the ditch prior to the construction of the building as suggested by Pistorius (2006) 1878-1898.
