ARCHAEOLOGICAL IMPACT ASSESSMENT OF A RUINED STRUCTURE ON REM ERF 329, NOORDHOEK, SIMONSTOWN MAGISTERIAL DISTRICT, WESTERN CAPE

(Assessment conducted under Section 38 (1) of the
National Heritage Resources Act (No. 25 of 1999) as a freestanding AIA)

15 January 2009

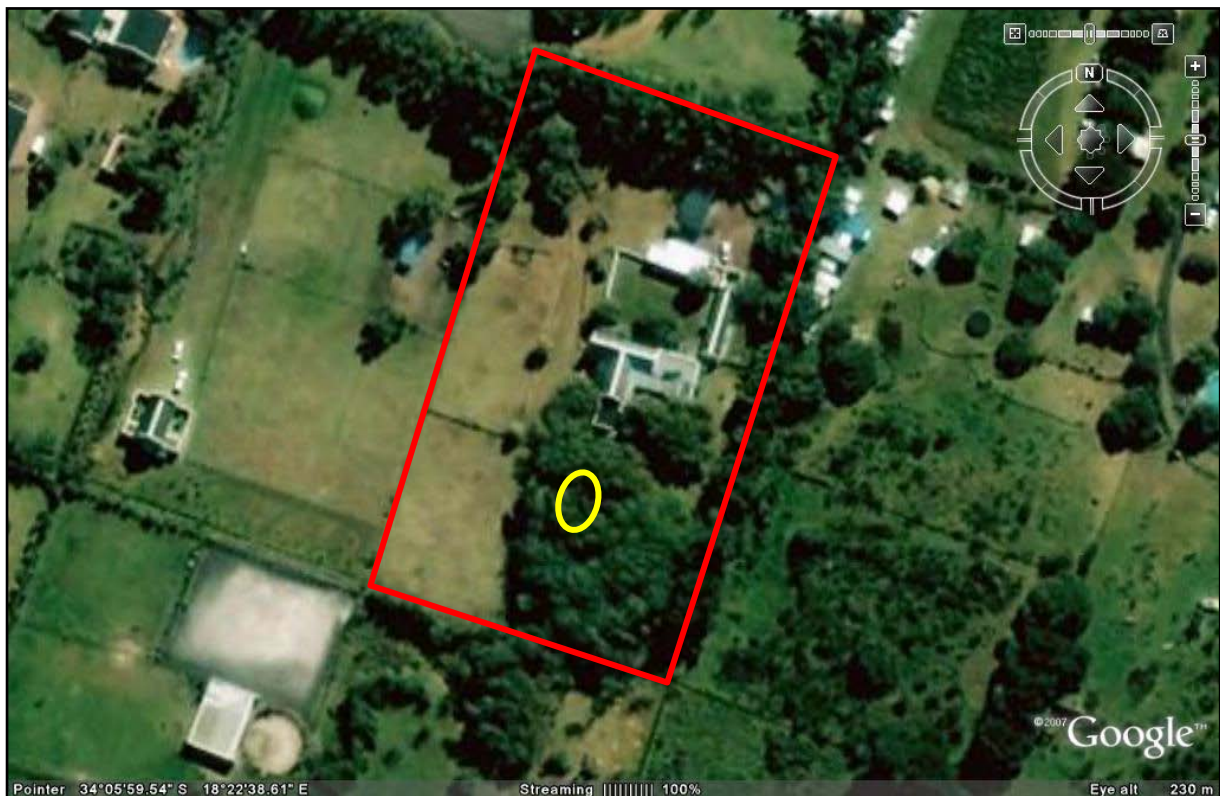
Figure 2: Aerial photograph from Google Earth showing the boundaries of the property (in red) and the location of the ruined structure (in yellow). The end of Oranje Road is at the northern corner of the property.

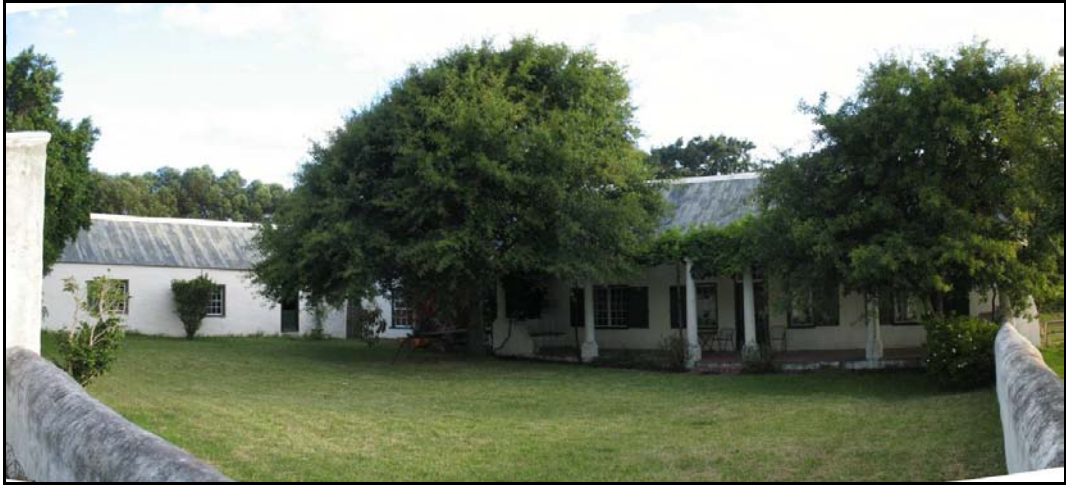
Figure 3: View of the front of the main dwelling (right) and an outbuilding (left). All structures are just over 20 years old.

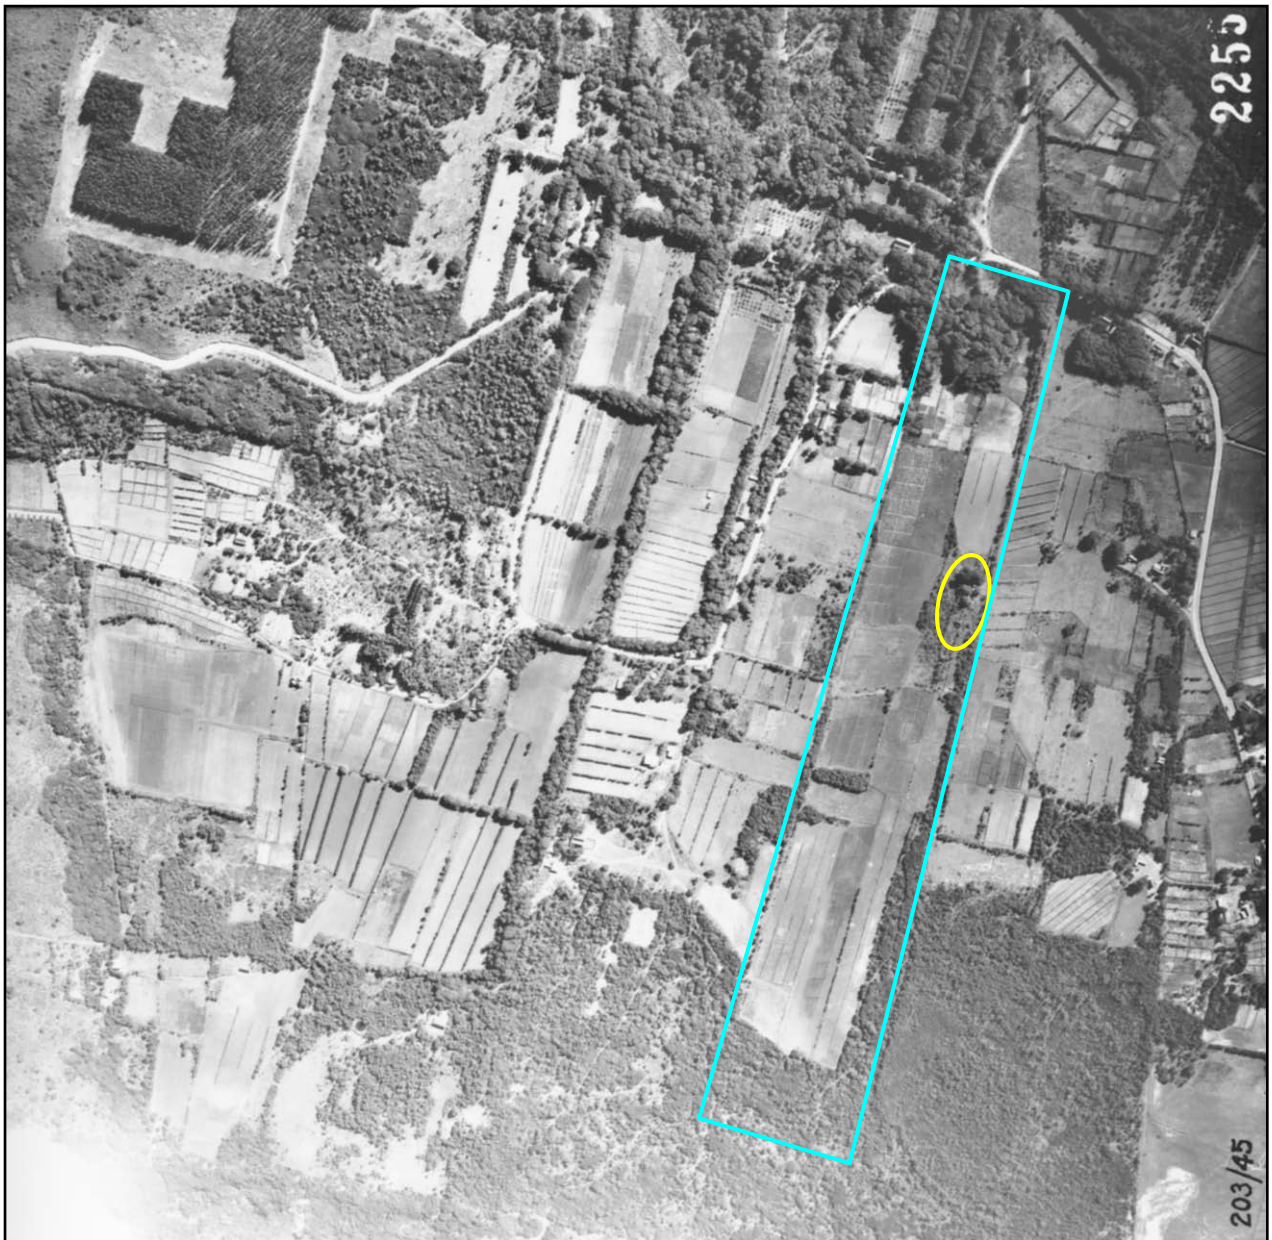
Figure 7: 1945 Aerial photograph of the central Noordhoek area with the subject property marked in yellow. The turquoise rectangle represents Lot C of Lot 1 of Farm 933 De Goede Hoop as mapped in Surveyor General drawing No. 534 of 1856 (see below). The U-shaped road in the centre of the photograph is Avondrust Circle and Chapman's Peak Drive runs out the left side. The original configuration of Noordhoek Main Road lies along the right edge of the photograph and extends into what is now Village Lane. The main road was later redirected south of Village Lane to run straight across to Chapman's Peak Drive.

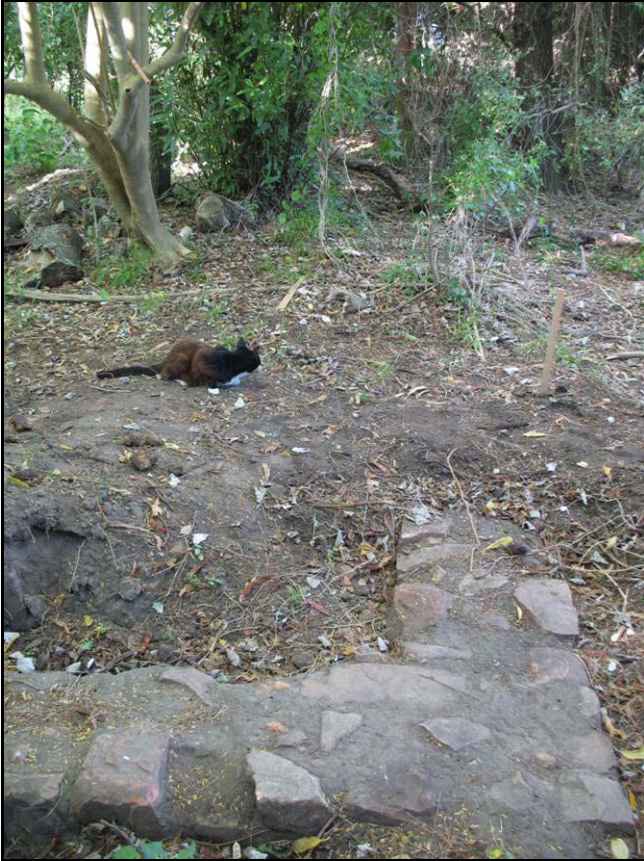
After initial discovery, the ruined structure was revealed at two points only. One is a corner (Figure 9) and the other a sidewall (Figure 10). Insufficient walling was visible to be able to determine the overall extent of the structure. The walls are approximately 35 cm thick.

Figure 9: The corner of the ruined structure.

- Reconstruction on the original foundations may be carried out provided that archaeological excavation and suitable recording of all extant structural material is undertaken beforehand; and
- An inventory of artefactual material found on the property should be made in order to determine more precisely the date of occupation of the structure and hence document some of the history of the site.

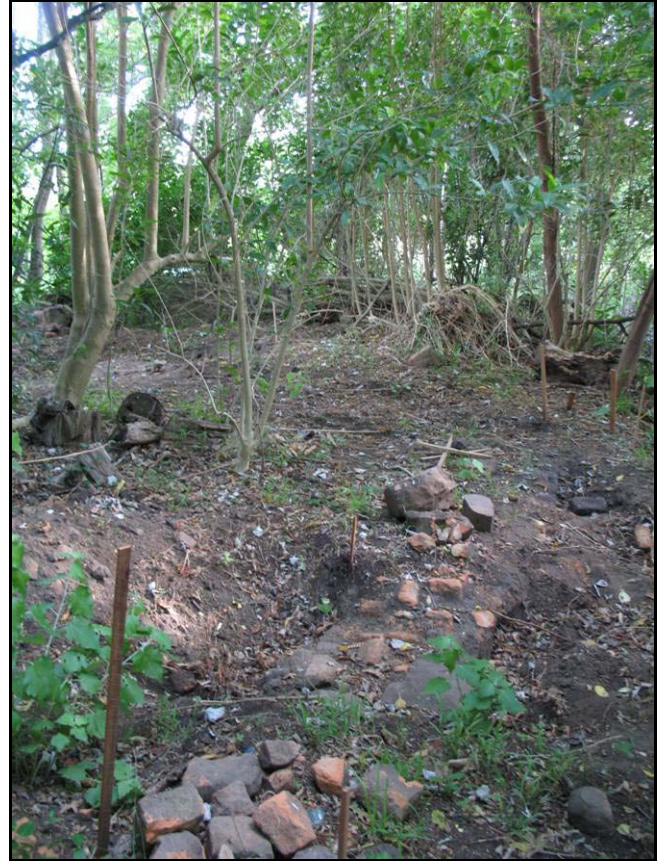
1. The stone walling present could represent the foundations of the original structure, since there are soft, orange clay bricks present above the stone work in one area which must relate to walls; or
2. The visible stone work could represent the lower parts of the walls with the foundations still being buried. This latter interpretation is supported by the fact that an irrigation furrow was dug past the site in the mid-20th century and the excavated soil was dumped over the ruin. As such there is no clear indication of original ground height.

Figure 10: The exposed sidewall with clay bricks.
