PROJECT 2011/3

**HERITAGE IMPACT ASSESSMENT REPORT: INSTALLATION
OF LONG-HAUL DARK FIBRE DUCTING INFRASTRUCTURE
ALONG THE N 2 BETWEEN DURBAN AND EAST LONDON,
KWA-ZULU NATAL AND EASTERN CAPE PROVINCES**

DATE: 11 February 2011

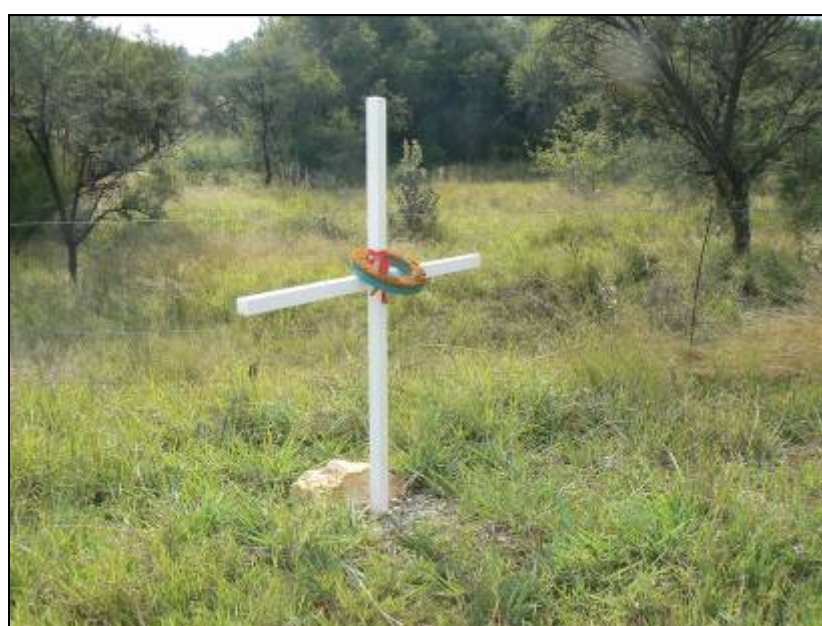
FIGURE 15: Mzike River memorial cross

Mzike River memorial cross (Section Mount Frere-Qumbu)	31°9'1.44"S 28°52'2.28"E	Low local	Medium to neutral (depends on duct location)	Memorial cross on west side of N 2. Mitigation: Photograph current situation, then remove memorial before trenching and installation and replace afterwards during surface rehabilitation.
	Tsolo Commonage memorial (Section Qumbu-Mthatha)	31°19'44.25"S 28°48'23.85"E	Low local	Medium to neutral (depends on duct location)	T-shaped memorial, west side of N 2. Mitigation: Photograph current situation, then remove memorial before trenching and installation and replace afterwards during surface rehabilitation.
	Kei Pass memorial cross (Section Butterworth-Kei River)	32°24'52.31"S 27°59'3.47"E	Low local	Medium to neutral (depends on duct location)	Memorial cross on west side of N 2. Mitigation: Photograph current situation, then remove memorial before trenching and installation and replace afterwards during surface rehabilitation.

2. Where crosses and memorials in the road reserve are affected, the current situation must be photographed, then remove cross (and any plaques etc) before trenching and installation and replace afterwards during surface rehabilitation.

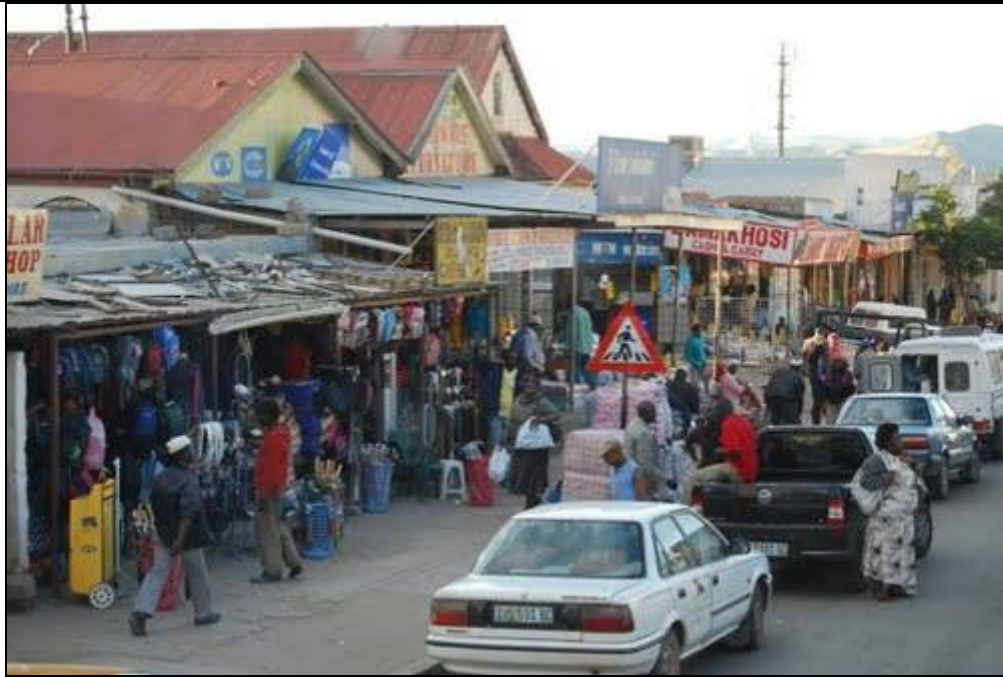
FIGURE 16: Mount Frere Main Street with old buildings

Old shops and other buildings, main street, Mount Frere	-		Medium local	Low to neutral (depends on duct location)	Mitigation: Photograph and document current situation before trenching. Monitor damage to structures and buildings during trenching, installation and surface rehabilitation.
St John's Cathedral, Alexandria Street (Mthatha)		31°35'32.97"S 28°47'19.90"E	High local	Low to neutral (depends on duct location)	Avoid and mitigation: Photograph and document current situation before trenching. Monitor damage during trenching, installation and surface rehabilitation.
Other old buildings, N2 and Alexandria street, (Mthatha)	-		Low local	Low to neutral (depends on duct location)	Avoid and mitigation: Photograph and document current situation before trenching. Monitor damage to structures and buildings during trenching, installation and surface rehabilitation.
Mandela House (Qunu)		31°48'20.65"S 28°36'20.95"E	High national	Outside duct corridor	50 m south of N 2. Ensure access during installation work.

3. Where historic buildings and structures are affected, the current situation must be photographed/documentated before installation starts. Monitor damage (caused by vibrations, dust, flying debris etc) during trenching, installation and rehabilitation.

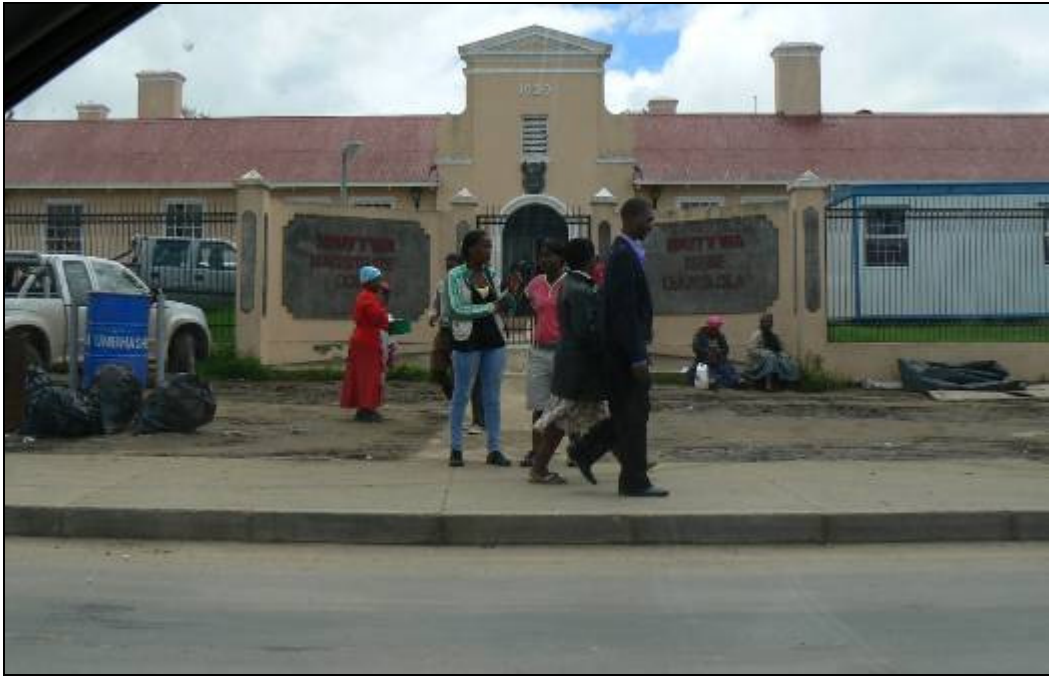
FIGURE 19: Dutywa Magistrate's Court

Dutwya Magistrate's Court		32°5'56.31"S 28°18'16.34"E	Medium local	Outside duct corridor	1929 building, north side. Ensure access during installation.
Dutywa Post Office		32°5'57.46"S 28°18'18.20"E	Low local	Low to neutral (depends on duct location)	South of N 2. Avoid and mitigation: Photograph and document current situation before trenching. Monitor damage to building during trenching, installation and surface rehabilitation.
Dutywa War Memorial		32°5'57.85"S 28°18'16.83"E	Medium local	Low to neutral (depends on duct location)	South of N 2. Avoid and mitigation: Photograph and document current situation before trenching. Monitor damage to building during trenching, installation and surface rehabilitation.

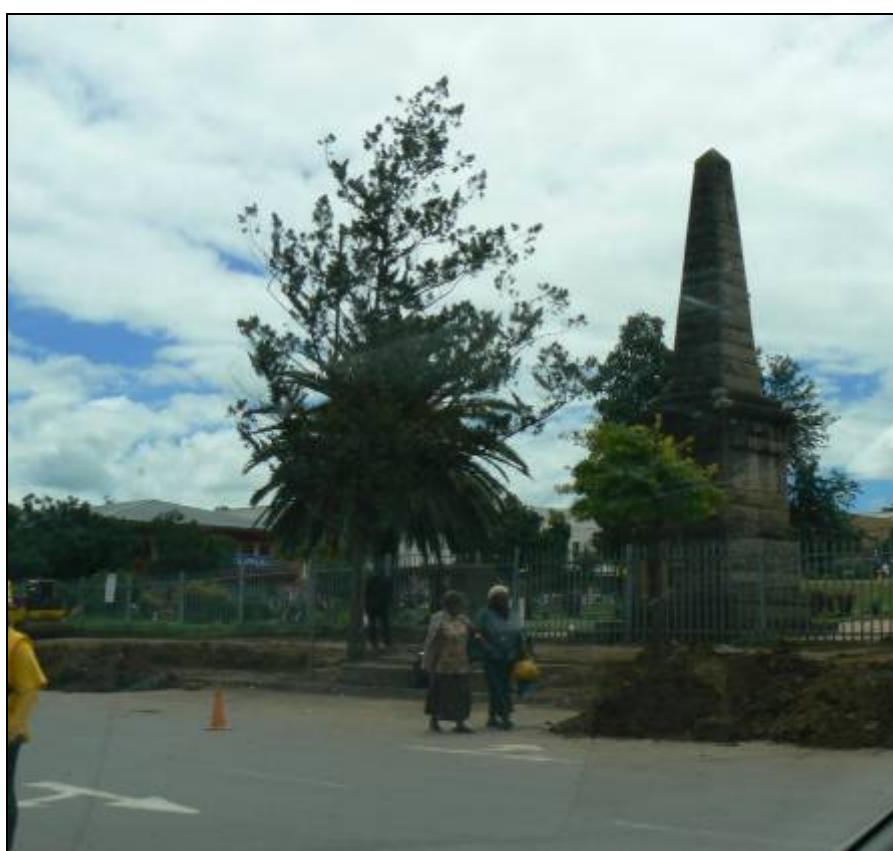
FIGURE 22: Butterworth Memorial

Butterworth Monument	32°19'56.16"S 28° 8'42.22"E	High local	Low to neutral (depends on duct location)	North of N 2. Avoid and mitigation: Photograph and document current situation before trenching. Monitor damage to structure during trenching, installation and surface rehabilitation.
	Other old buildings (Butterworth)	-	Low local	Low to neutral (depends on duct location)	Avoid and mitigation: Photograph and document current situation before trenching. Monitor damage to structures and buildings during trenching, installation and surface rehabilitation.
	Kei Pass memorial cross (Section Butterworth-Kei River)	32°24'52.31"S 27°59'3.47"E	Low local	Low to neutral (depends on duct location)	Memorial cross on west side of N 2. Mitigation: Photograph current situation, then remove memorial before trenching and installation and replace afterwards during surface rehabilitation.
	Old Transkei Border Post (Kei River)	32°30'18.39"S 27°58'48.46"E	Low local	Low to neutral (depends on duct location)	Now Kei Ultra City. Avoid and mitigation: Photograph and document current situation before trenching. Monitor damage to structures and buildings during trenching, installation and surface rehabilitation.

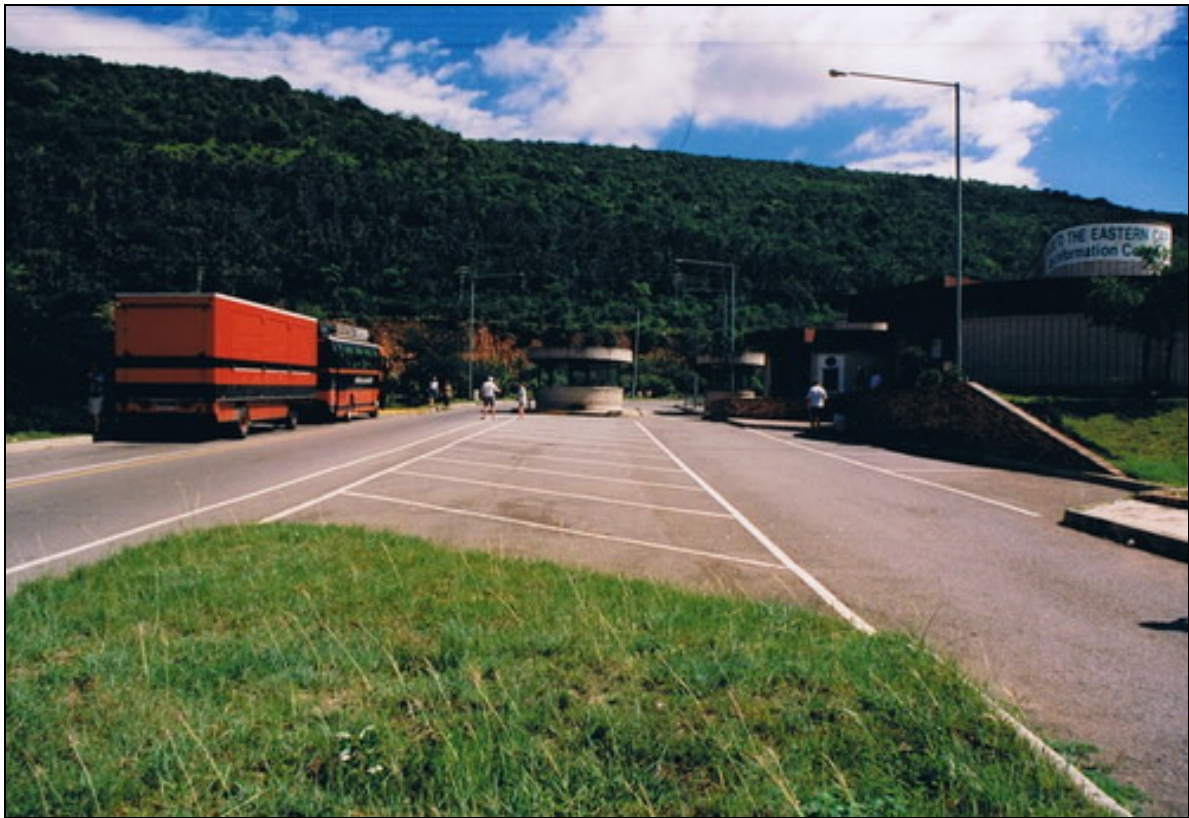
FIGURE 23: Old Transkei border post, Great Kei River Bridge

Old Transkei Border Post (Kei River)		32° 30'18.39"S 27° 58'48.46"E	Low local	Low to neutral (depends on duct location)	Now Kei Ultra City. Avoid and mitigation: Photograph and document current situation before trenching. Monitor damage to structures and buildings during trenching, installation and surface rehabilitation.
