ARCHAEOLOGICAL SITE INSPECTION REPORT

GRAVES DISCOVERED DURING UPGRADING OF THE R72 FROM PORT ELIZABETH TO PORT ALFRED, EASTERN CAPE, SOUTH AFRICA

DATE: 2010-03-12

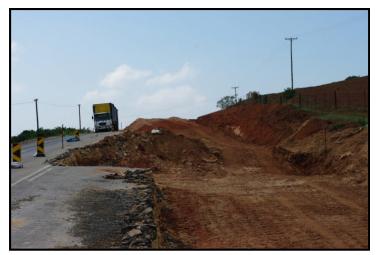
Figure 2: General view of the R72 Aurecon upgrading project in progress

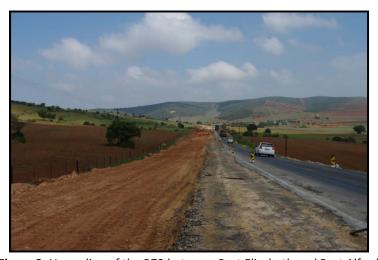
Figure 3: Upgrading of the R72 between Port Elizabeth and Port Alfred

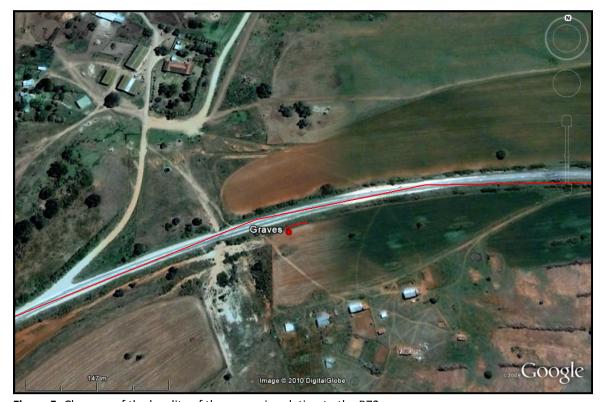
Earth moving activities along the R72 by the Aurecon construction team exposed 6/7 grave-like sockets along an approximate 20m road cutting from S33°35′57.4″; E26°02′31.1″ in the west to S33°35′57.3″; E26°02′31.8″ in the east. Operation in the vicinity of the find was immediately ceased and a low impact temporary fence, constructed with pole and red and white danger tape, erected to demarcate the area as a 'no-go' zone. Construction impacted on the grave-like socket features only to a level of exposing feature outlines, with only very limited bone exposed from Grave 7. By implication all features and their contents are at present still in-tact.

Figure 5: Close-up of the locality of the graves in relation to the R72

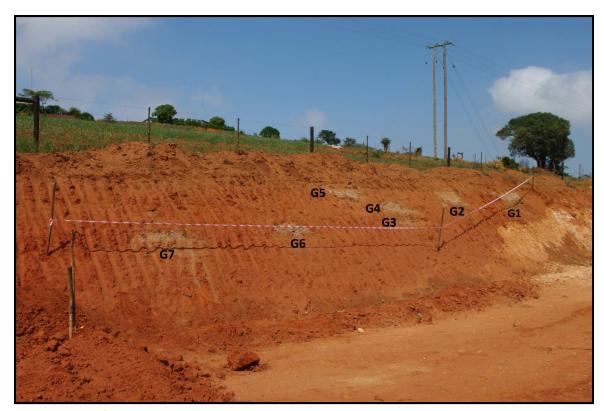
Figure 6: View of the grave site discovered along the R72

The site is not visible from the surface, with the immediately adjacent surface area being an agricultural field. The features were found in horizontal context between 1m below the present day surface and on average above 1.5m from the scraped Aurecon road construction level. The site may thus well extent further underneath the agricultural field or the current exposure may be representative of total site extent.

Site conservation is motivated by the fact that further development towards the south, the impacted slope with grave-like socket remains, won't be necessary and upgrading development can be focused to the north of the find. The existing Aurecon construction road level would need to be raised by 60cm, which will not affect the site. In addition current development impact only affected the infill feature outlines and not to an extent that the integrity of the graves were affected.

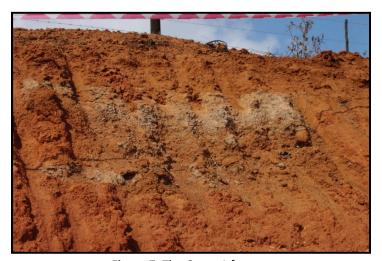
Figure 7: The Grave 1 feature

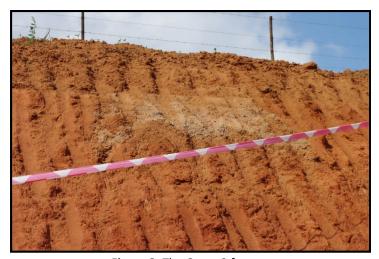
Figure 8: The Grave 2 feature

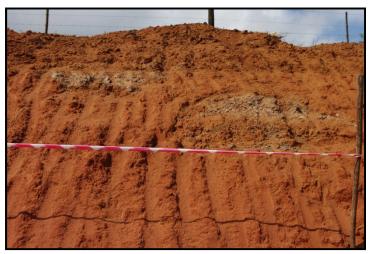
Figure 9: The small Grave 3 feature, underneath Grave 4 (interpreted as one locality) and the Grave 5 feature to the left

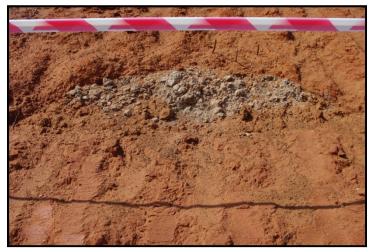
Figure 10: The Grave 6 feature

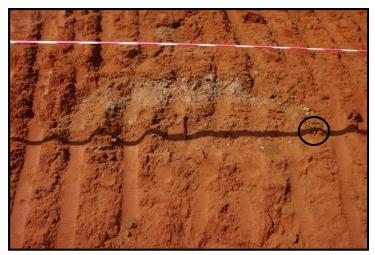
With development having only impacted on the very outline of the features, no human remains were exposed. Bones were found having been washed from the Grave 7 feature and identified on site as:

- 1) A chicken (Gallus Gallus / Gallus domesticus) scapula; and
- 2) A small tibia (probably also chicken).

Figure 11: The Grave 7 feature

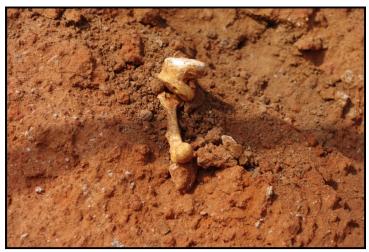
In addition, originally thought to have been a human metatarsal with a related tarsal bone, turned out to be, after slight clearing of loose soil, nothing more than a small *in situ* distal femur and tibia. The bones may also be chicken.

Figure 12: In situ bones (femur and tibia) from the Grave 7 feature
