# 1<sup>st</sup> Phase study

CULTURAL HERITAGE RESOURCES IMPACT ASSESSMENT FOR PROPOSED NEW 400 kV ESCOM POWER LINE BETWEEN HENDRINA POWER STATION AND GUMENI.

February 2010

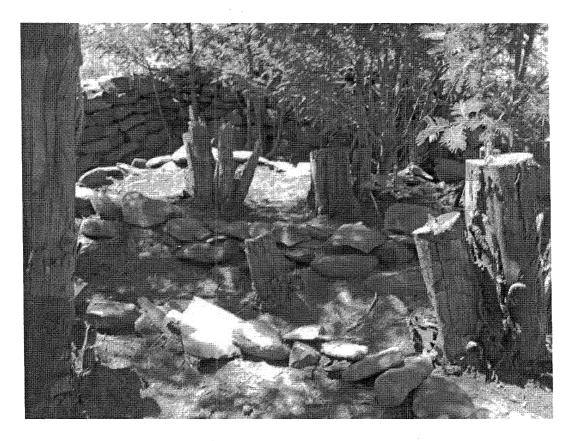
Photo 01. Graves at Gumeni substation.

- **5.1.** (See photo 1 front page.) During the fencing of the Gumeni site, the contractor busy with the construction of the Gumeni substation discovered two graves. These were visited and may date to between 80 and 120 years old. The reason for assuming these dates is that the trees that have grown in the graves cannot be much younger than 60 years and that it appears to be the graves of Christianised black people.
  - **5.1.1. Suggested mitigation.** The graves are not hampering any important construction work. It is therefore suggested that an area of twenty by twenty meters is fenced off around the grave site with the same fencing material that the contractor is using on the site. All stone walling and vegetation should be left in place.

- **5.1.2.** Alternative mitigation. ESCOM may wish to have the graves relocated in a modern facility
- **5.1.1.** Waypoint T200 TO T199. (See photo 6 on page 12.) A cattle enclosure associated with the farmstead situated at T201 is located close to T200. It has already partially been disturbed by the building of the existing line.

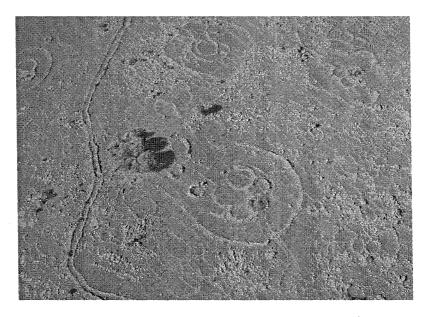
Photo 03. This is a typical view of Later Iron Age sites in the area taken in the dry season with minimal grass coverage. With the present survey it was nearly impossible to photograph sites owing to high precipitation and exceptional vegetation coverage.

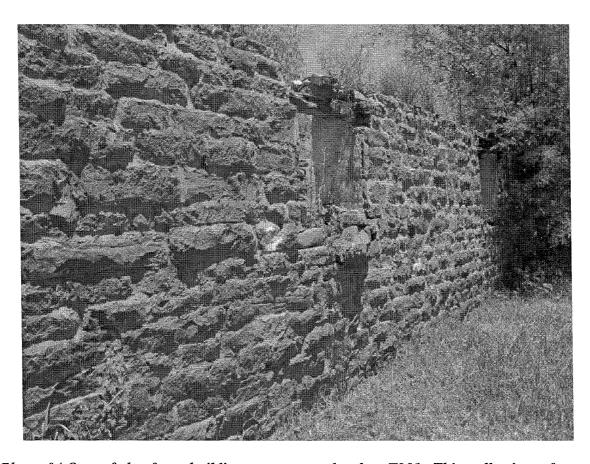
- **5.2.** Waypoint T201. (See photo's 4 and 5 on page 11) This pylon is situated in or near an old farmyard with graves dating to the early part of the twentieth century. Several structures form a formal farmyard that includes a small cemetery, formal orchards and formal fields that were brought under flood irrigation by water furrows.

Photo 04.One of the farm buildings at proposed pylon T201. This collection of buildings, graves and orchards date to the period between circa 1870 and 1940.

- **5.2.1. Suggested mitigation.** The pylon T201 must be moved to the east...
- **5.2.2. Alternative mitigation.** ESCOM may wish to have the complex demolished by method of second phase impact assessment and application for destruction through SAHRA.

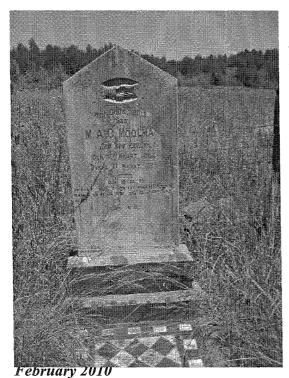
Photo 05.One of the graves at proposed pylon T201.

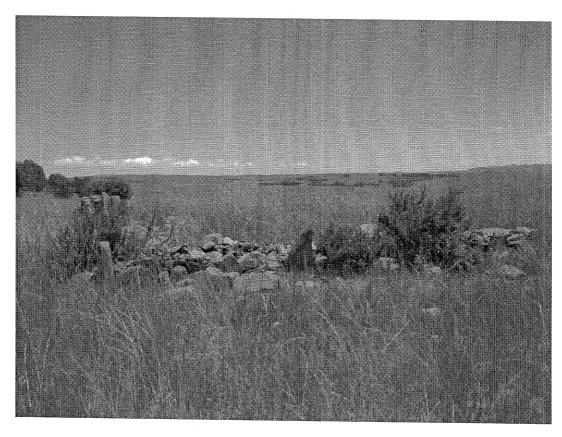
Photo 06. The cattle enclosure at proposed pylon T200.

- **5.1.1..1. Suggested mitigation.** The area must be demarcated for the period of construction.
  - **5.1.1.2. Alternative mitigation.** ESCOM may wish to have the complex demolished by method of second phase impact assessment and application for destruction through SAHRA.

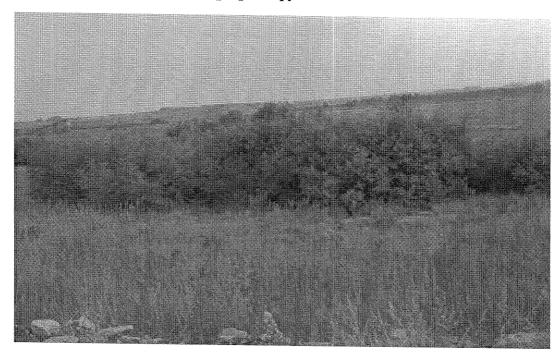
- **5.3.** Waypoint T197 TO T196. (See photo 7 on page 12.) A Later Iron Age Site<sup>4</sup> is located next to an existing road under the proposed power line.

Photo 07. Overgrown hilltop beyond Later Iron Age site between T197 and T196. The sites are not easily perceived in the landscape by untrained eyes especially after a good rain season. This is why it is necessary to demarcate the sites with proper 'safety fencing', especially during construction.

- **5.3.1. Suggested mitigation.** The areas must be demarcated for the period of construction.
  - **5.3.2. Alternative mitigation.** ESCOM may wish to have the complex demolished by method of second phase impact assessment and application for destruction through SAHRA.

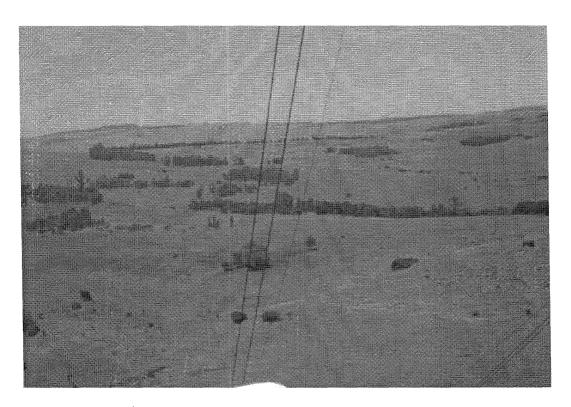
- **5.4.** Waypoint T191 TO T190. (See photo 8 on page 13.) A large L.I.A. site is located next to an existing road under the proposed power line. There is also a large complex of similar L.I.A. homesteads to the south of pylon T190 that may be influenced during construction. This is an extremely sensitive area

- **5.4.2. Alternative mitigation.** ESCOM may wish to have the complex demolished by method of second phase impact assessment and application for destruction through SAHRA.
- **5.5.** Waypoint T189 TO T188. (See photo 8 on page 13.) A L.I.A. site is located under the proposed power line. There is also a large complex of similar L.I.A. homesteads both to the south of, and to the north of pylons T189 and T188 that may be influenced during construction.

Pylon T188 also appear to be located within an L.I.A. enclosure

This is an extremely sensitive area

Photo 08.Looking down from pylon T187 onto the valley that is filled with Later Iron Age enclosures. This is an exceptionally sensitive area.

- 5.4.1. Suggested mitigation. The areas must be demarcated for the period of construction, and all construction roads must be planned with the input of a heritage specialist.

- **5.5.1.** Suggested mitigation. Pylon T188 must be moved towards the east and out of the L.I.A. enclosure. The areas must be demarcated for the period of construction, and all construction roads must be planned with the input of a heritage specialist.

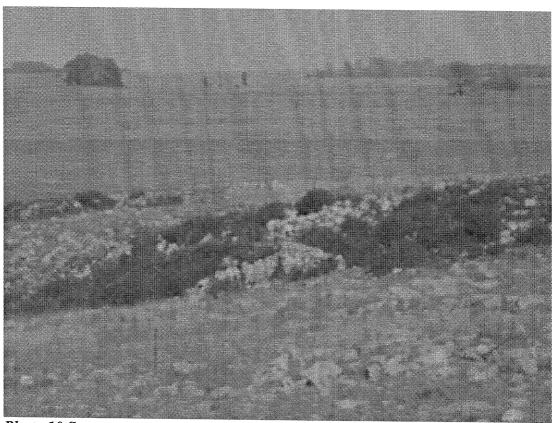
- **5.7.** Waypoint T149 TO T148. (See photo's 9 and 10 on pages 13 and 14.) A circular stone structure as well as some walling is located under the proposed power line, as well in close proximity to pylon T149. These may either be associated with the second South African War<sup>5</sup> or may be associated with irrigation structures. This is a sensitive area

Photo 10.Stone structure next to Klein Komatie River at proposed pylon T149.

- **5.7.1. Suggested mitigation.** Pylon T149 must be moved. The areas must be demarcated for the period of construction.
  - **5.7.2. Alternative mitigation.** ESCOM may wish to have the structures demolished by method of second phase impact assessment and application for destruction through SAHRA.

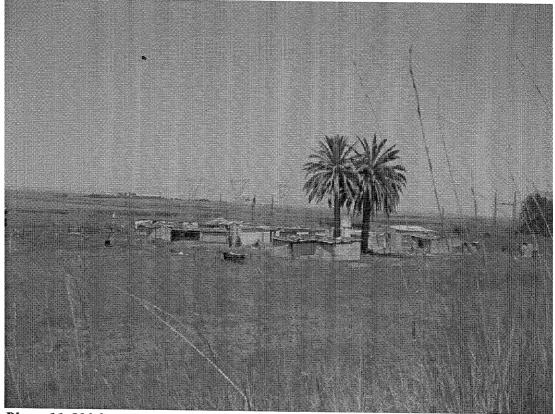
- **5.9.** Waypoint T101 TO T100. (See photo 11 on page 13.) The ruins of an old farmstead are located in close proximity of the proposed power line, especially pylon T100. There is little left of the old dwelling, but opportunistic temporary settlers have occupied the site. As many as 30 people may live here at present. This is an extremely sensitive social issue.

Photo 11.Old farmyard near proposed pylon T100. Note large informal settlement that will be situated within a few meters from the proposed pylon.

- **5.9.1. Suggested mitigation from a heritage perspective.** Pylon T100 must be moved westwards. The areas must be demarcated for the period of construction.

- **5.9.2.** Alternative mitigation from a heritage perspective. ESCOM may wish to have the complex demolished by method of second phase impact assessment and application for destruction through SAHRA.
