**The archaeological survey of Halkirk  
Farm, Sub 485 and Sub 486 (of 337) of  
the Farm Albinia No. 957**

**For Halkirk Farm (Pty) Ltd**

**Date: 15 April 2006**

**Umlando: Archaeological Tourism and Resource  
Management**

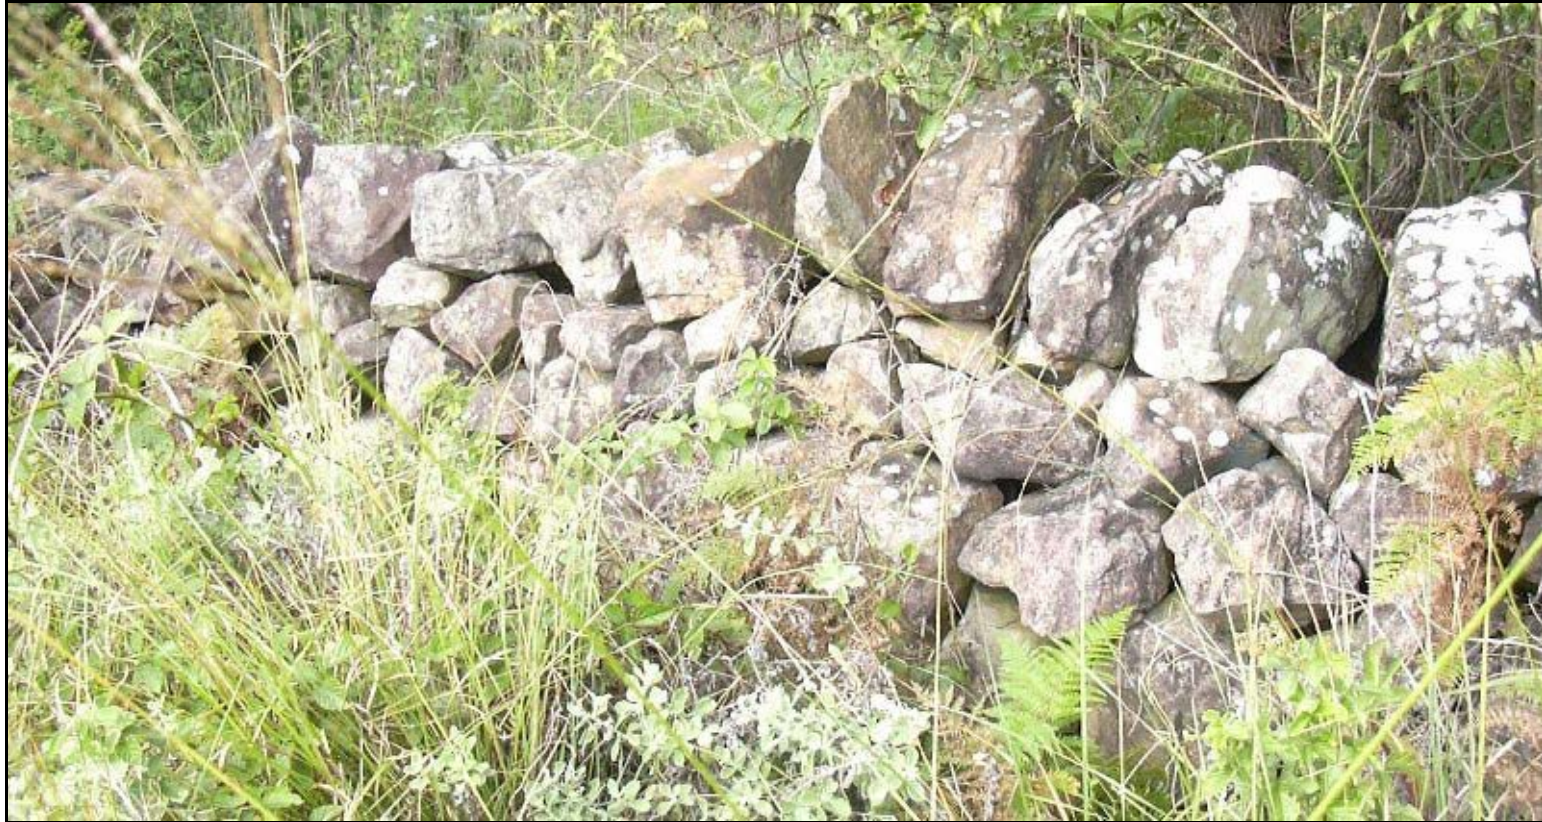
**Figure 2: Example of the Dry Stone Walling**

The wall runs along Old Main Road (fig. 2). The wall can be classified as dry stonewalling and is believed to have been erected when it was part of Gillits farm. The wall is thus older than 60 years and is protected by the KwaZulu-Natal Heritage Act. The Deeds map (Fig. 1) does not indicate any buildings or ruins on the property.

The walling does not appear to be of high quality, and is in various stages of disrepair. Furthermore, the walling has been “robbed” in the recent past. The walling is of low significance and we do not believe further mitigation would be required.

Umlando surveyed the area proposed for development: Sub 485 and Sub 486 (of 337) of the Farm Albinia No. 957. No archaeological sites or artefacts were observed, and only parts of an old dry stonewall were recorded. The walling does not appear to be significant and is a property marker. The walling is probably older than 60 years and the developer will need to apply for a permit from Amafa KwaZulu-Natal for the destruction of this wall.

We do not believe any further mitigation is required.
