Archaeological Impact Assessment

Title: Municipal Housing Project, Heidelberg.

Proposal to develop housing erven on six sites within the urban area of Heidelberg.

26 May 2009

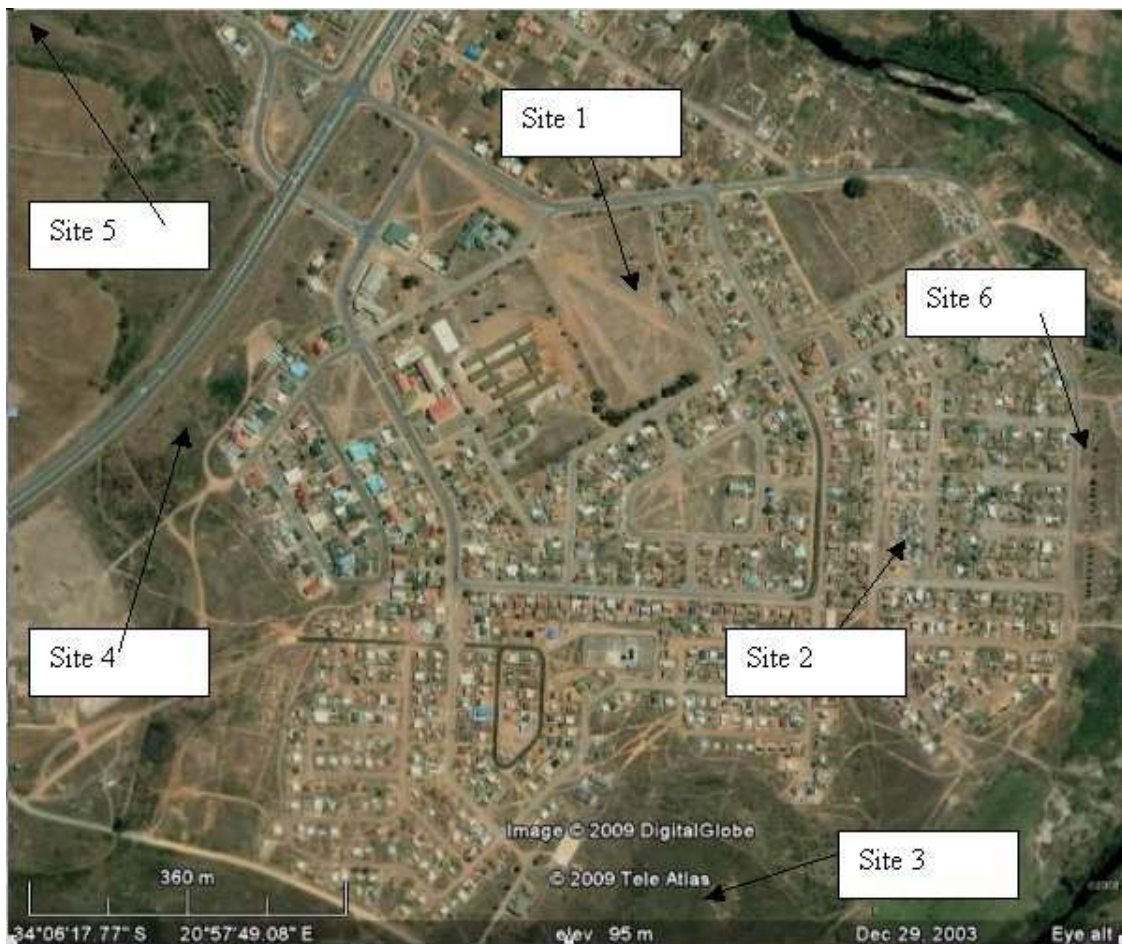
Fig. 3. Aerial view of the sites in relation to the urban development of Heidelberg

All the sites are south of the N2 except Site 5 and all are within the urban edge of the town. These are the infilling of areas available for housing development.

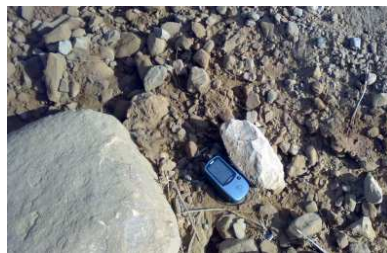
The only archaeological remains observed were a large Acheulian biface in a wash of gravels on the margin of Site 3. In exposures of terrace cobble gravels bifaces and other Acheulian artefacts may occur but in the case of an isolated find the significance is rated as low.

Fig. 4. Acheulian artefact on Site 3

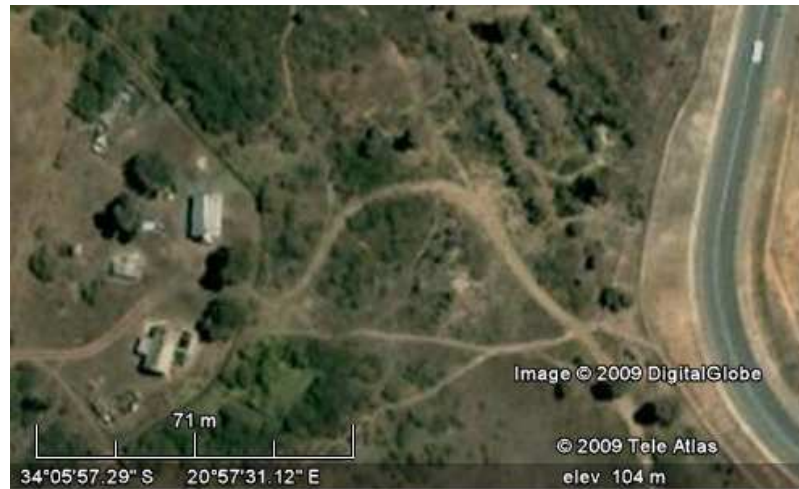
There are no structures on the properties except on the southern end of Site 5. This is significant because the two structures, a small house and a horse stable (perdestal), are older than 70 years, the age of one of the occupants who has lived there all his life. The style of vernacular architecture and stone construction is further indication of their age. The house, which is occupied but was locked at the time of the visit, appears to be in reasonable condition. The perdestal with various lean-to additions is also occupied but is in poorer structural condition and needs attention. These buildings and a buffer zone around them should be excluded from the rest of the development with provisions made in planning for their restoration and conservation.

Fig. 5. Aerial view of the two structures forming a small farmyard (werf) on Site 5.

The main recommendation is that the two structures on Site 5 be conserved as outlined above.

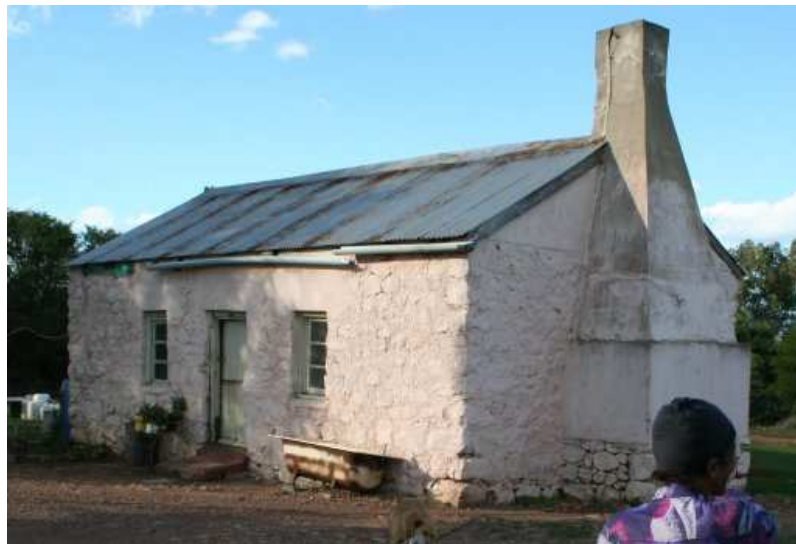
Fig. 6. Site 5, stone house in traditional style that is part of the farmyard

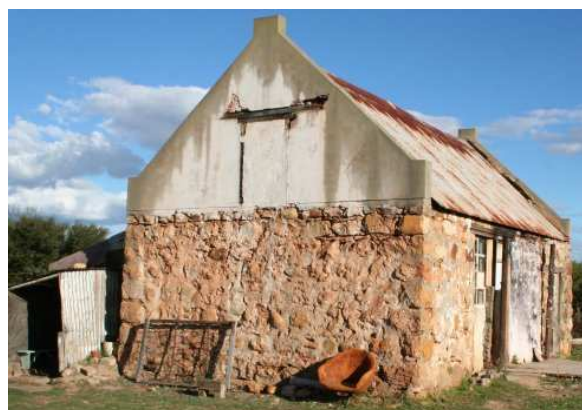
Fig. 7. Site 5, stone horse stable (perdestal) needs some attention to the structure.
