### **1<sup>st</sup> Phase study**

#### **CULTURAL HERITAGE RESOURCES IMPACT ASSESSMENT FOR PROPOSED NEW 400 kV ESCOM POWER LINE BETWEEN HENDRINA POWER STATION AND GUMENI.**

**February 2010**

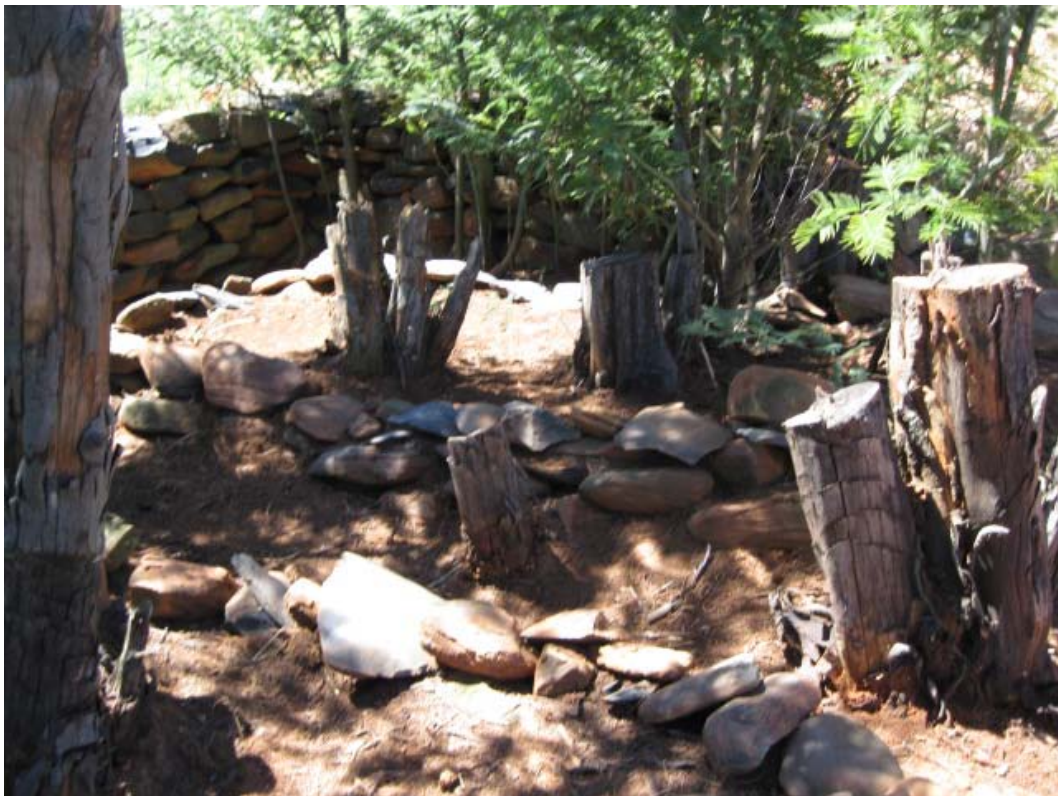
*Photo 01. Graves at Gumeni substation.*

**5.1. (See photo 1 front page.)** During the fencing of the Gumeni site, the contractor busy with the construction of the Gumeni substation discovered two graves. These were visited and may date to between 80 and 120 years old. The reason for assuming these dates is that the trees that have grown in the graves cannot be much younger than 60 years and that it appears to be the graves of Christianised black people.

**5.1.1. Suggested mitigation.** The graves are not hampering any important construction work. It is therefore suggested that an area of twenty by twenty meters is fenced off around the grave site with the same fencing material that the contractor is using on the site. All stone walling and vegetation should be left in place.

**5.1.2. Alternative mitigation.** ESCOM may wish to have the graves relocated in a modern facility

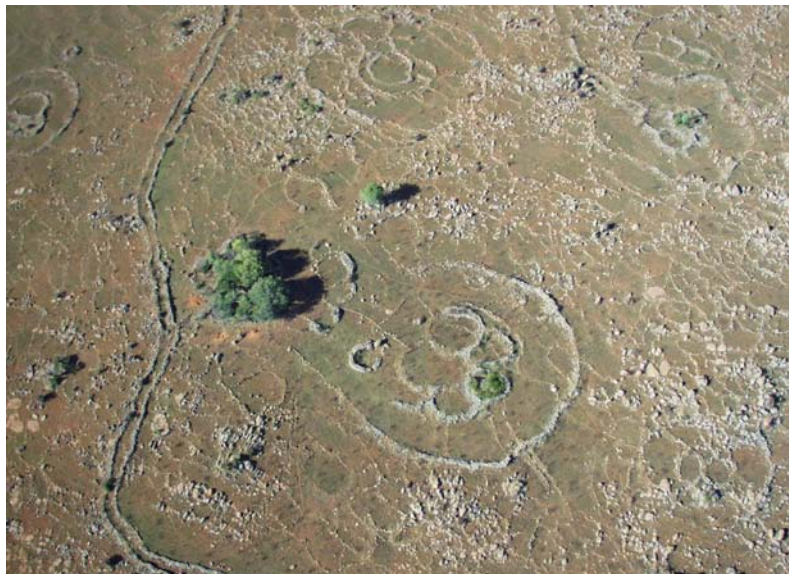
*Photo 03. This is a typical view of Later Iron Age sites in the area taken in the dry season with minimal grass coverage. With the present survey it was nearly impossible to photograph sites owing to high precipitation and exceptional vegetation coverage.*

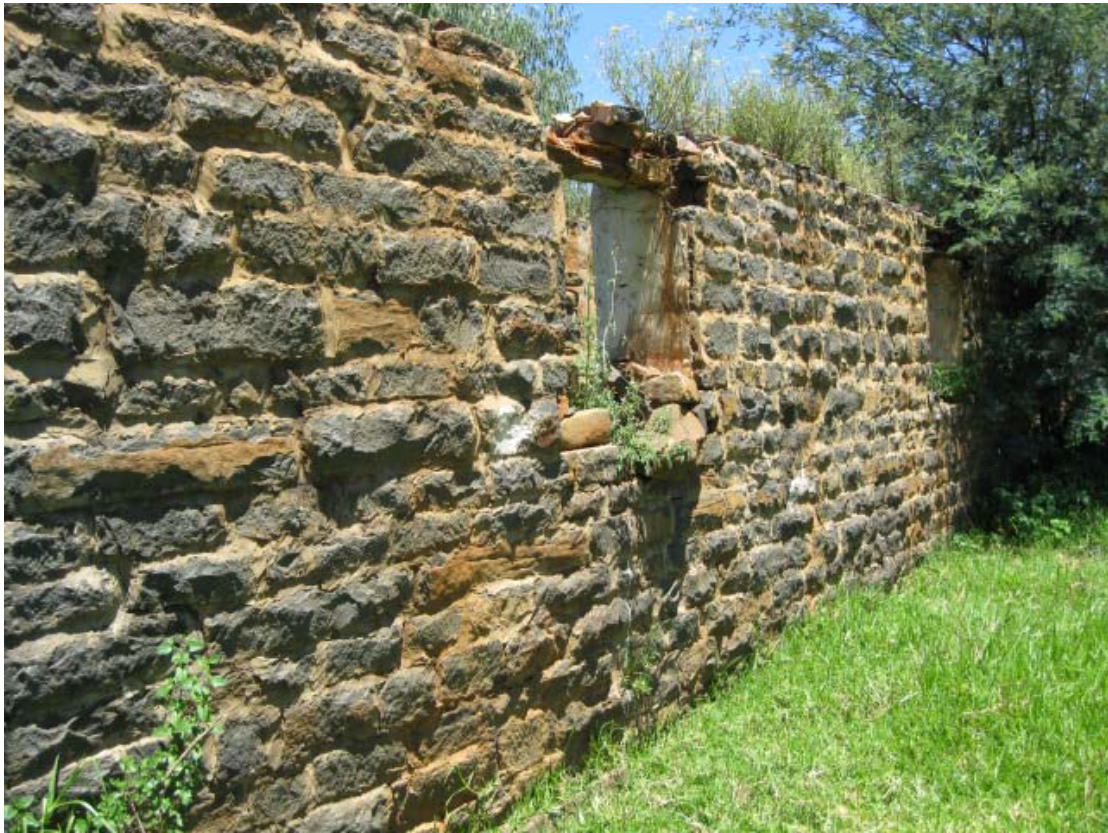
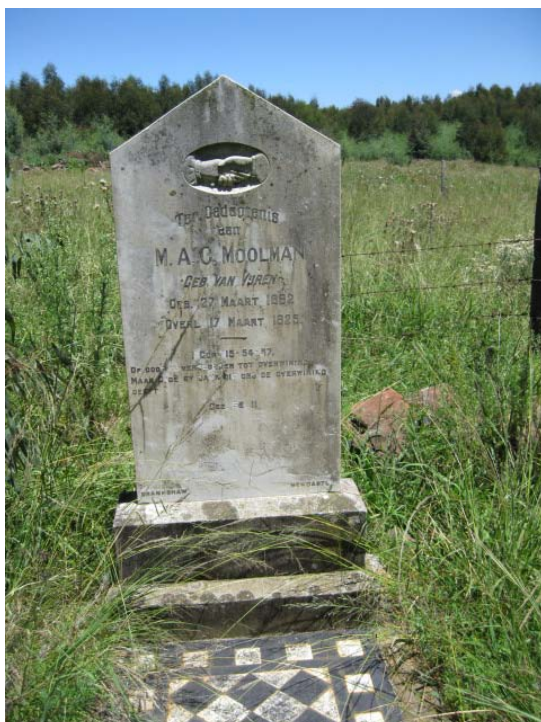
**5.2. Waypoint T201. (See photo's 4 and 5 on page 11)** This pylon is situated in or near an old farmyard with graves dating to the early part of the twentieth century. Several structures form a formal farmyard that includes a small cemetery, formal orchards and formal fields that were brought under flood irrigation by water furrows.

*Photo 04. One of the farm buildings at proposed pylon T201. This collection of buildings, graves and orchards date to the period between circa 1870 and 1940.*

*Photo 05. One of the graves at proposed pylon T201.*

**5.2.1. Suggested mitigation.** The pylon T201 must be moved to the east..

**5.2.2. Alternative mitigation.** ESCOM may wish to have the complex demolished by method of second phase impact assessment and application for destruction through SAHRA.

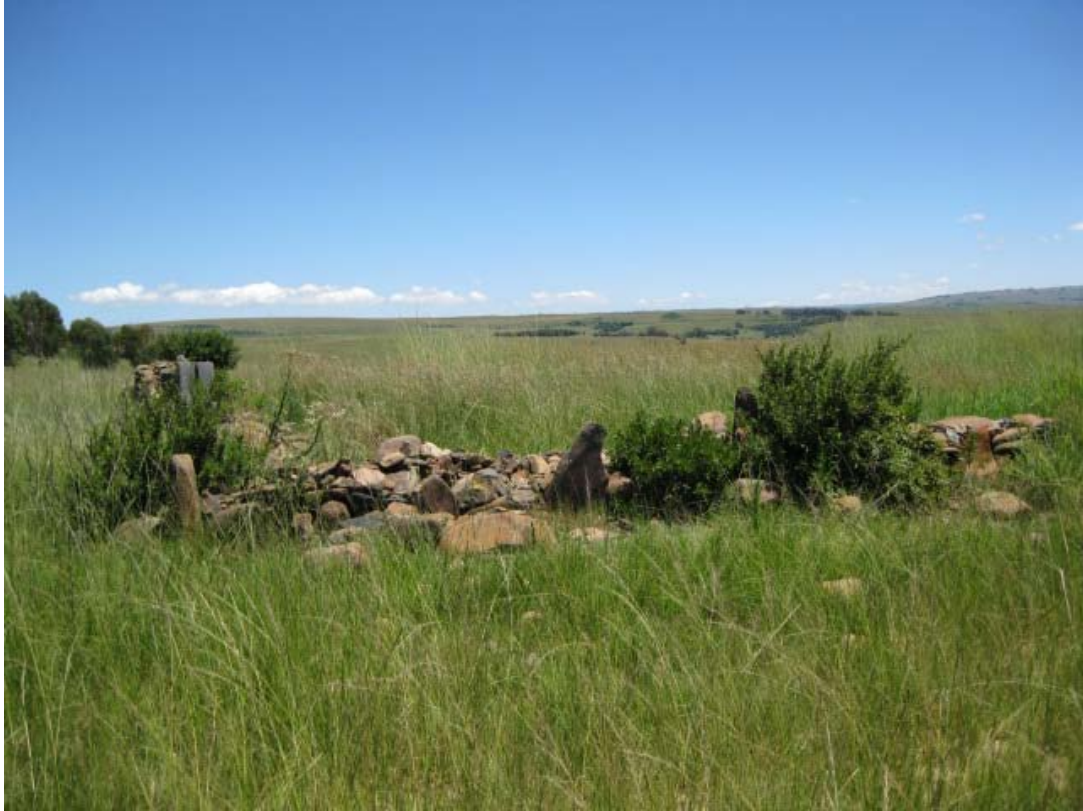
**5.1.1. Waypoint T200 TO T199. (See photo 6 on page 12.)** A cattle enclosure associated with the farmstead situated at T201 is located close to T200. It has already partially been disturbed by the building of the existing line.

*Photo 06. The cattle enclosure at proposed pylon T200.*

**5.1.1.1. Suggested mitigation.** The area must be demarcated for the period of construction.

**5.1.1.2. Alternative mitigation.** ESCOM may wish to have the complex demolished by method of second phase impact assessment and application for destruction through SAHRA.

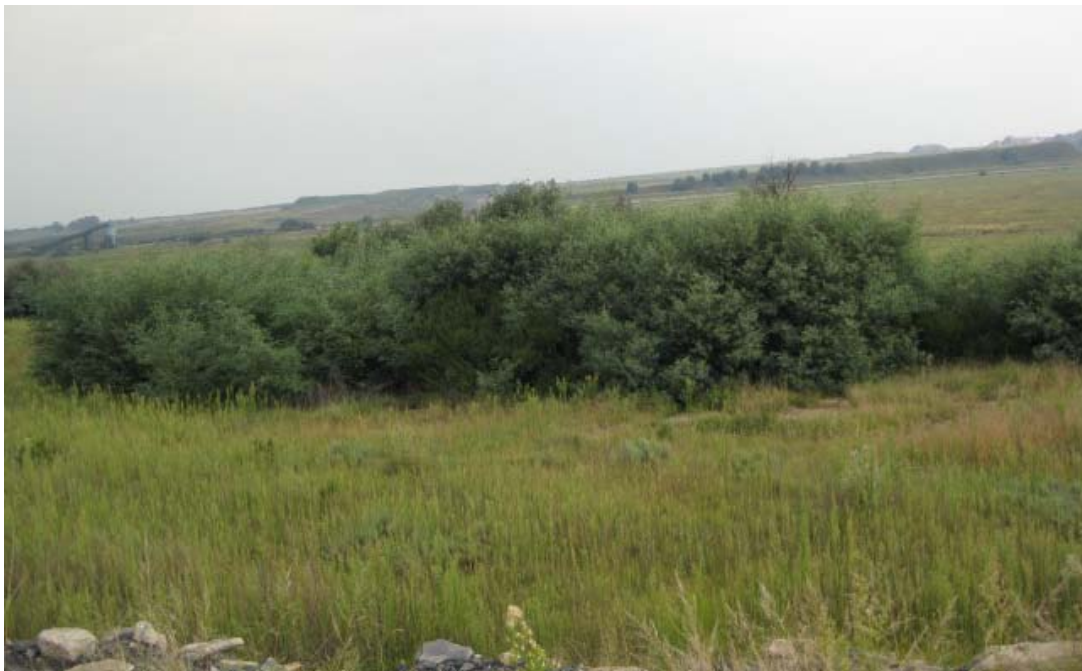
**5.3. Waypoint T197 TO T196. (See photo 7 on page 12.)** A Later Iron Age Site<sup>4</sup> is located next to an existing road under the proposed power line.

*Photo 07. Overgrown hilltop beyond Later Iron Age site between T197 and T196. The sites are not easily perceived in the landscape by untrained eyes especially after a good rain season. This is why it is necessary to demarcate the sites with proper 'safety fencing', especially during construction.*

**5.3.1. Suggested mitigation.** The areas must be demarcated for the period of construction.

**5.3.2. Alternative mitigation.** ESCOM may wish to have the complex demolished by method of second phase impact assessment and application for destruction through SAHRA.

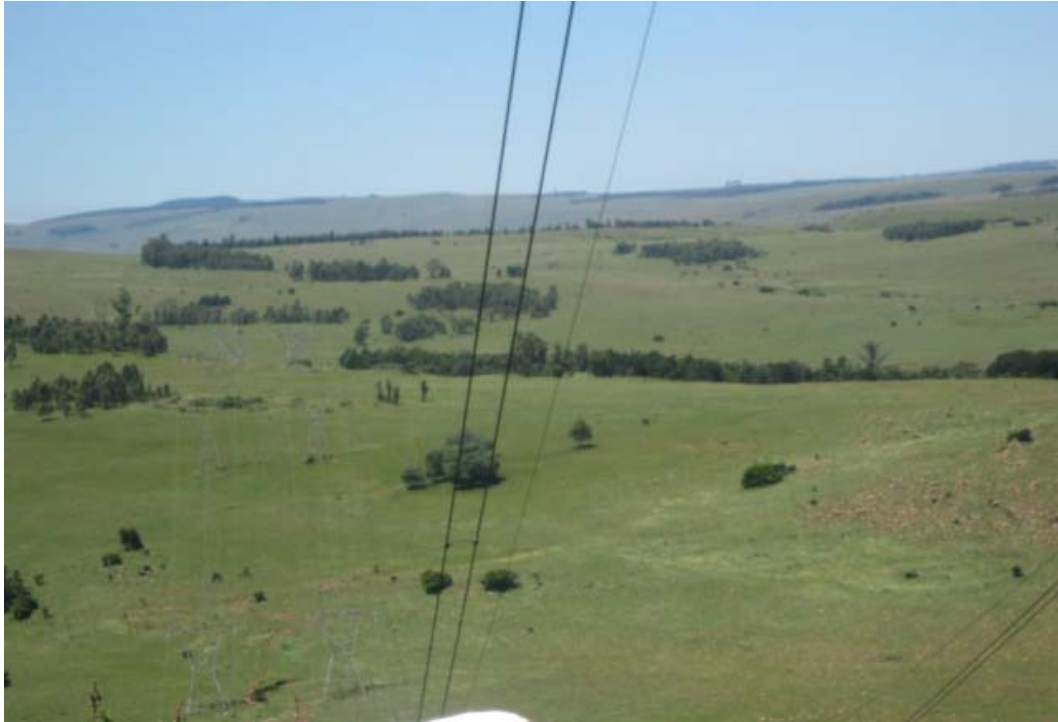
**5.4. Waypoint T191 TO T190. (See photo 8 on page 13.)** A large L.I.A. site is located next to an existing road under the proposed power line. There is also a large complex of similar L.I.A. homesteads to the south of pylon T190 that may be influenced during construction. *This is an extremely sensitive area*

**5.5. Waypoint T189 TO T188.** (See photo 8 on page 13.) A L.I.A. site is located under the proposed power line. There is also a large complex of similar L.I.A. homesteads both to the south of, and to the north of pylons T189 and T188 that may be influenced during construction.

Pylon T188 also appear to be located within an L.I.A. enclosure

*This is an extremely sensitive area*

*Photo 08. Looking down from pylon T187 onto the valley that is filled with Later Iron Age enclosures. This is an exceptionally sensitive area.*

**5.4.1. Suggested mitigation.** The areas must be demarcated for the period of construction, *and all construction roads must be planned with the input of a heritage specialist.*

**5.4.2. Alternative mitigation.** ESCOM may wish to have the complex demolished by method of second phase impact assessment and application for destruction through SAHRA.

**5.5.1. Suggested mitigation.** Pylon T188 must be moved towards the east and out of the L.I.A. enclosure. The areas must be demarcated for the period of construction, *and all construction roads must be planned with the input of a heritage specialist.*

**5.5.2. Alternative mitigation.** ESCOM may wish to have the complex demolished by method of second phase impact assessment and application for destruction through SAHRA.

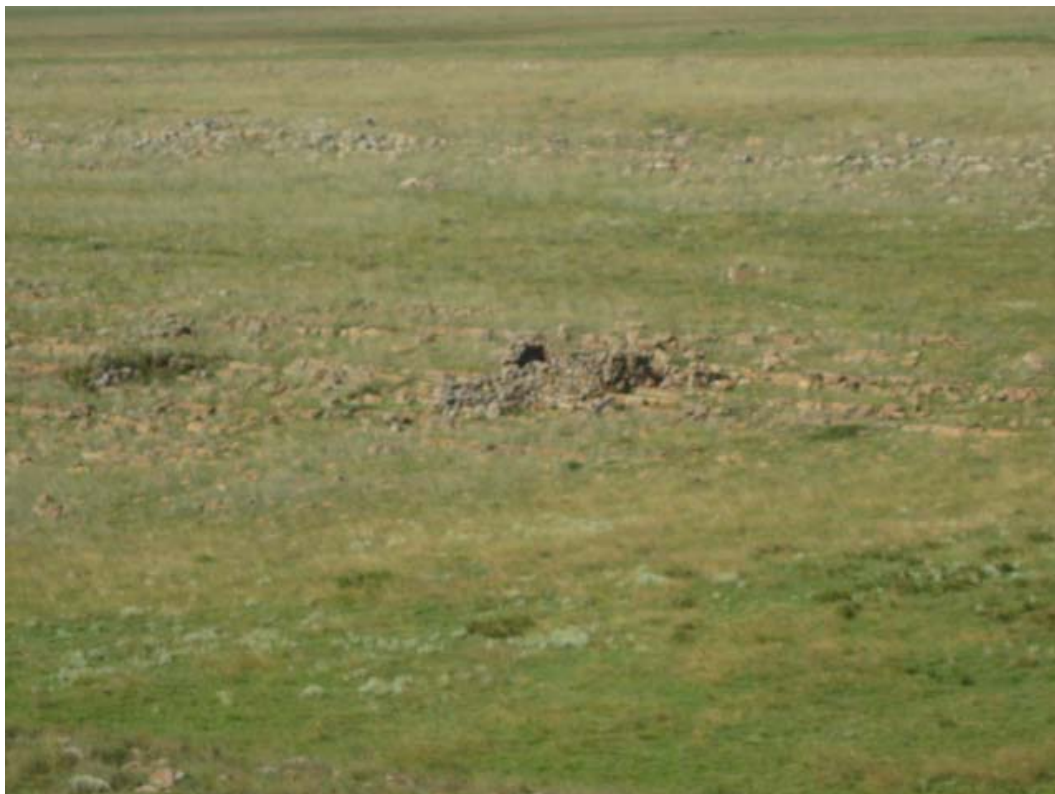
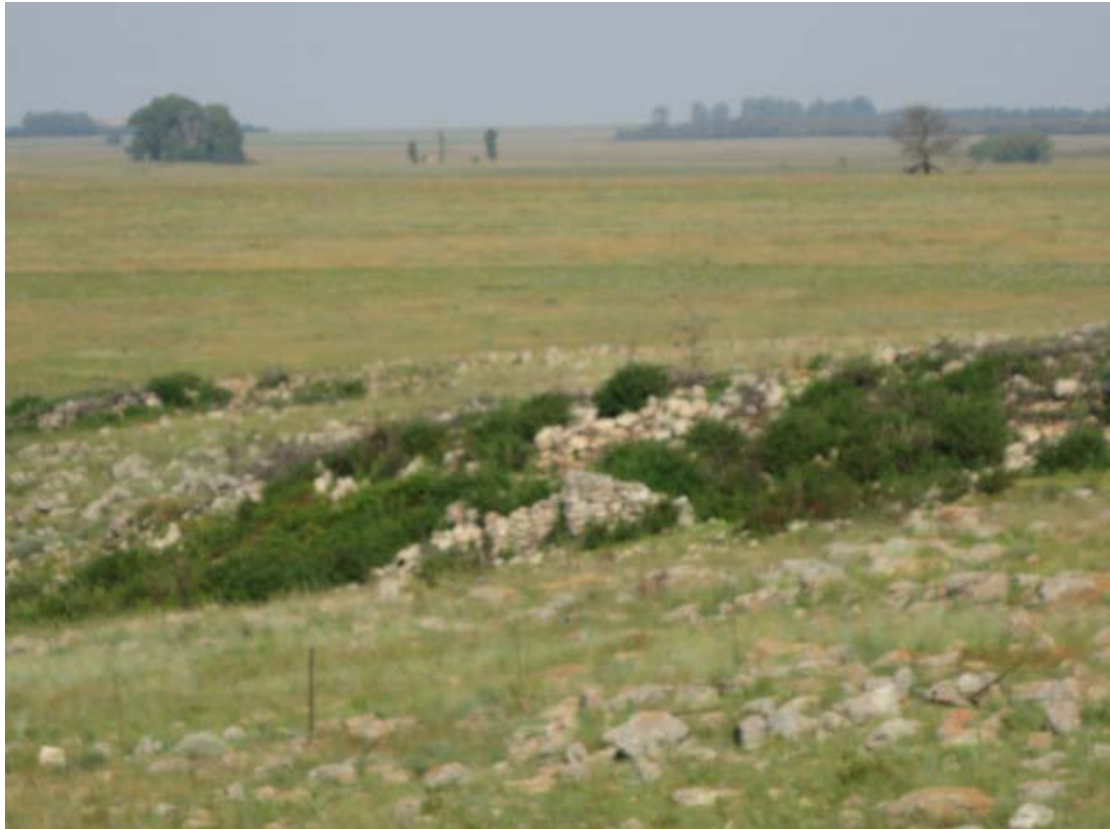
**5.7. Waypoint T149 TO T148.** (See photo's 9 and 10 on pages 13 and 14.) A circular stone structure as well as some walling is located under the proposed power line, as well in close proximity to pylon T149. These may either be associated with the second South African War<sup>5</sup> or may be associated with irrigation structures. *This is a sensitive area*

*Photo 09. Circular stone structure next to Klein Komatie River at proposed pylon T148.*

*Photo 10. Stone structure next to Klein Komatie River at proposed pylon T149.*

**5.7.1. Suggested mitigation.** Pylon T149 must be moved. The areas must be demarcated for the period of construction.

**5.7.2. Alternative mitigation.** ESCOM may wish to have the structures demolished by method of second phase impact assessment and application for destruction through SAHRA.

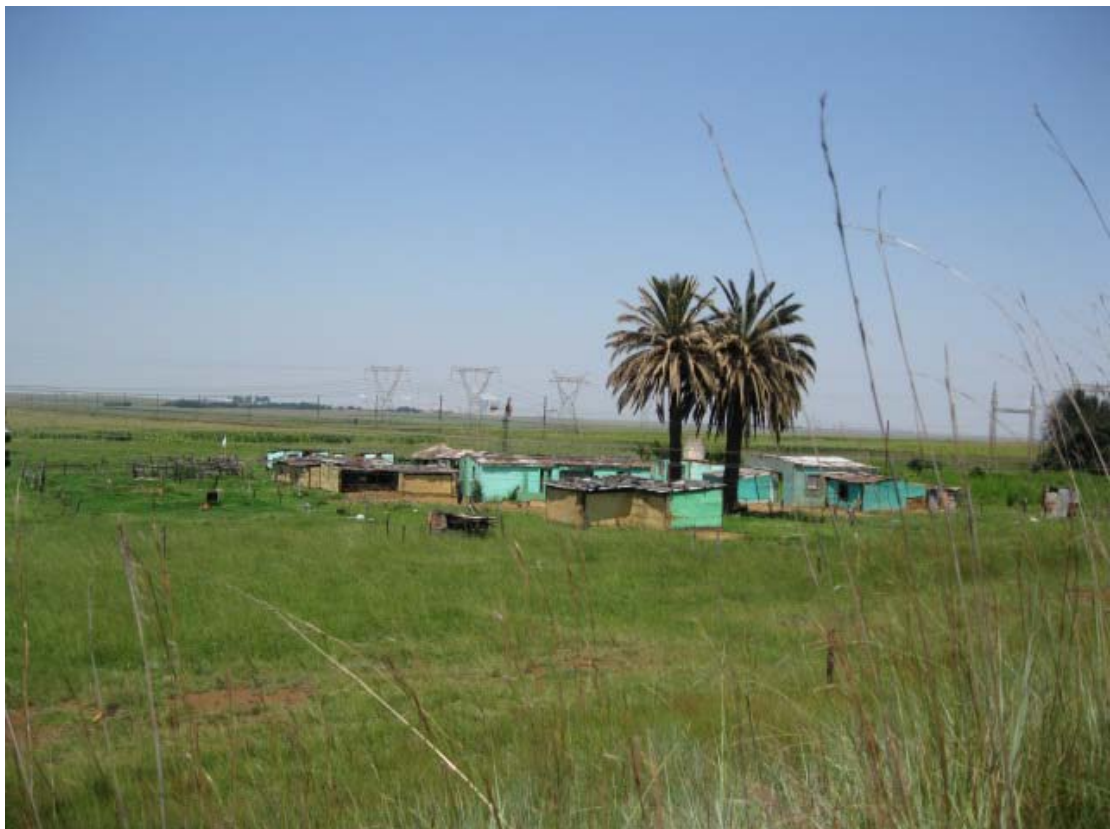
**5.9. Waypoint T101 TO T100.** (*See photo 11 on page 13.*) The ruins of an old farmstead are located in close proximity of the proposed power line, especially pylon T100. There is little left of the old dwelling, but opportunistic temporary settlers have occupied the site. As many as 30 people may live here at present. ***This is an extremely sensitive social issue.***

*Photo 11. Old farmyard near proposed pylon T100. Note large informal settlement that will be situated within a few meters from the proposed pylon.*

**5.9.1. Suggested mitigation from a heritage perspective.** Pylon T100 must be moved westwards. The areas must be demarcated for the period of construction.

**5.9.2. Alternative mitigation from a heritage perspective.** ESCOM may wish to have the complex demolished by method of second phase impact assessment and application for destruction through SAHRA.
