5 December 2009

The Nature Conservation Corporation
Units 1 & 2, 4 Stibitz Street
Westlake Business Park
Westlake
7945

**FEEDBACK ON SITE INVESTIGATION TO POSSIBLE HERITAGES SITES ON
THE HYDRA-PERSEUS ESKOM POWER LINE, NORTHERN CAPE PROVINCE**

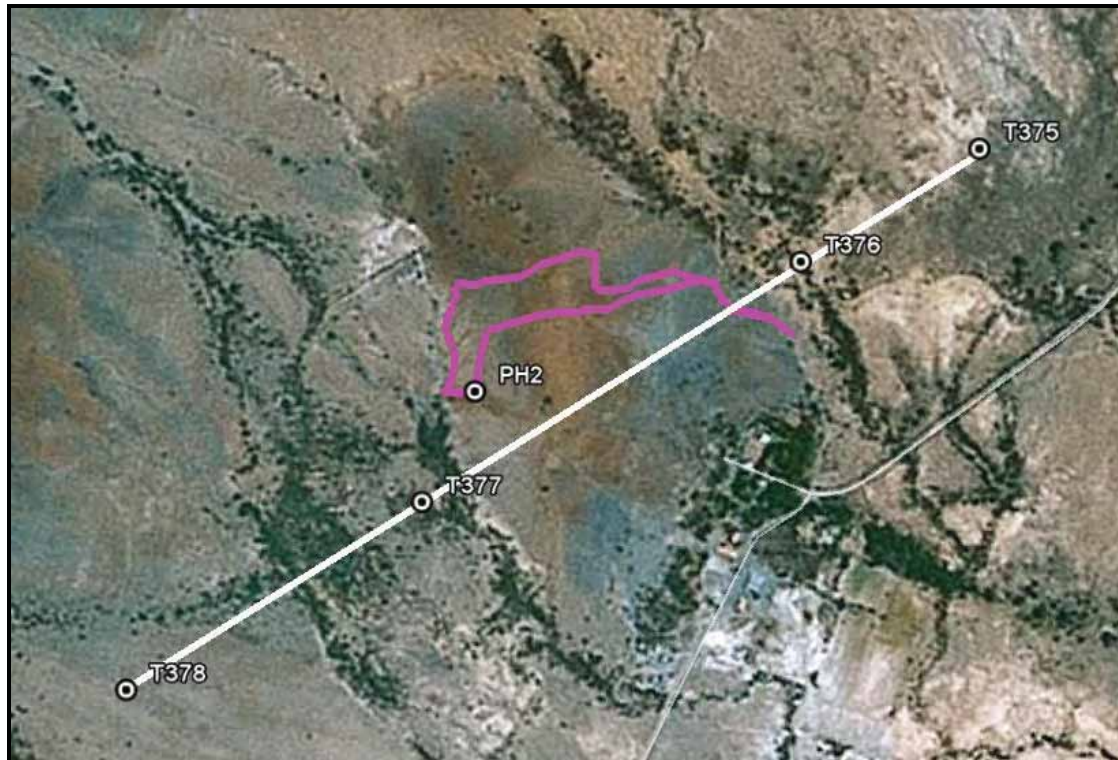
pylon positions were available. A section of the area was however covered as an existing cemetery was indicated in the area by the local residents.

Figure 1 – Alignment of line (white) and area covered due to possible realignment not available during site visit – PH2 indicating cemetery

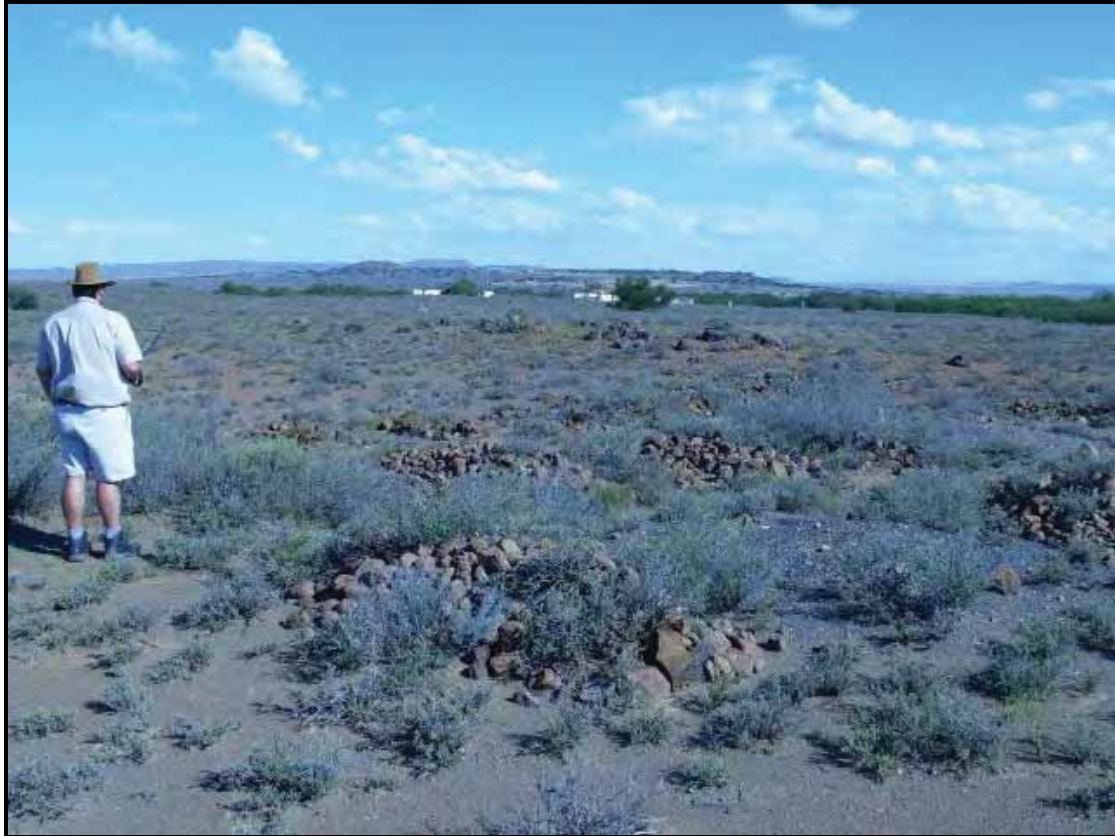
The site is that of a cemetery consisting of 17 stone packed graves aligned east-west. The current farm workers on the farm had no indication of the family relatives of these graves.

Figure 2 – Site PH2, stone packed graves in foreground and farmstead visible in background

- The cemetery needs to be fenced and a buffer of 20 meters be left around the site and adequate access be provided for the family to visit the graves;
- The realignment needs to take the position of the cemetery into consideration and avoid it at all cost.
- The ECO need to be on site during construction in the specific areas;
- In the event that the cemetery will have to be impacted on and the need arise for the relocation of the cemetery a full graves relocation process must be followed; and
- It is further recommended that the realignment be surveyed by a professional archaeologist to identify any historical and archaeological finds in the servitude of the alignment.

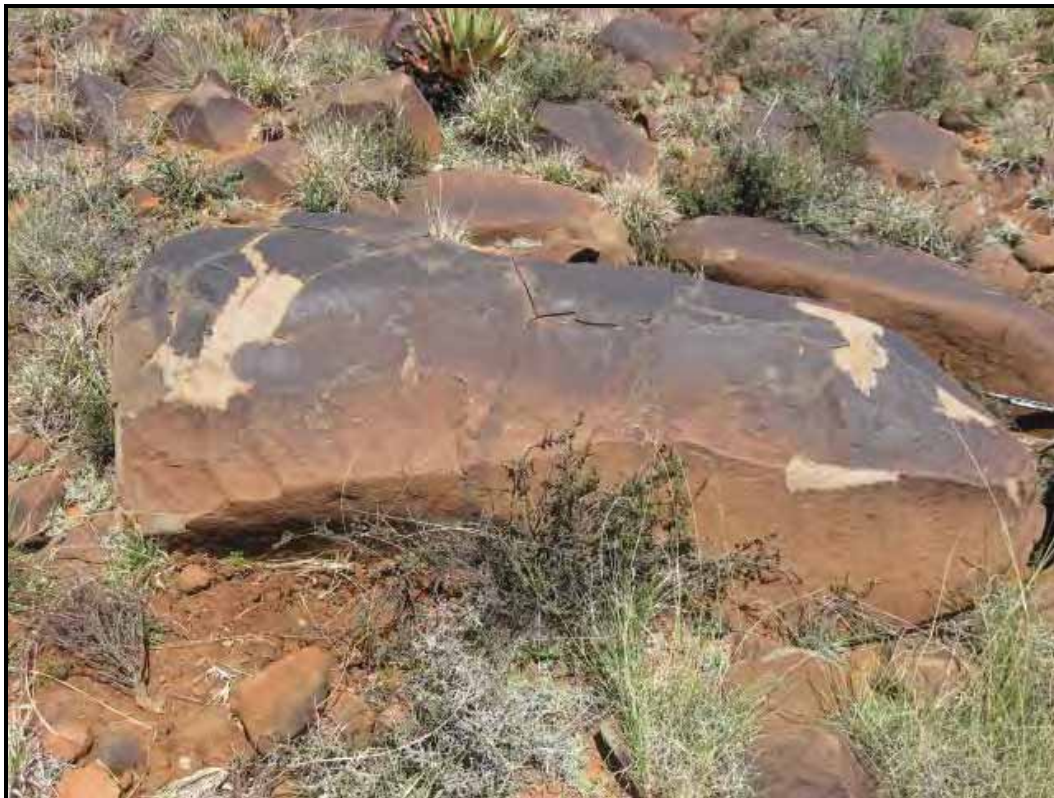
Figure 5 – Site PH1, single stone with engraving on

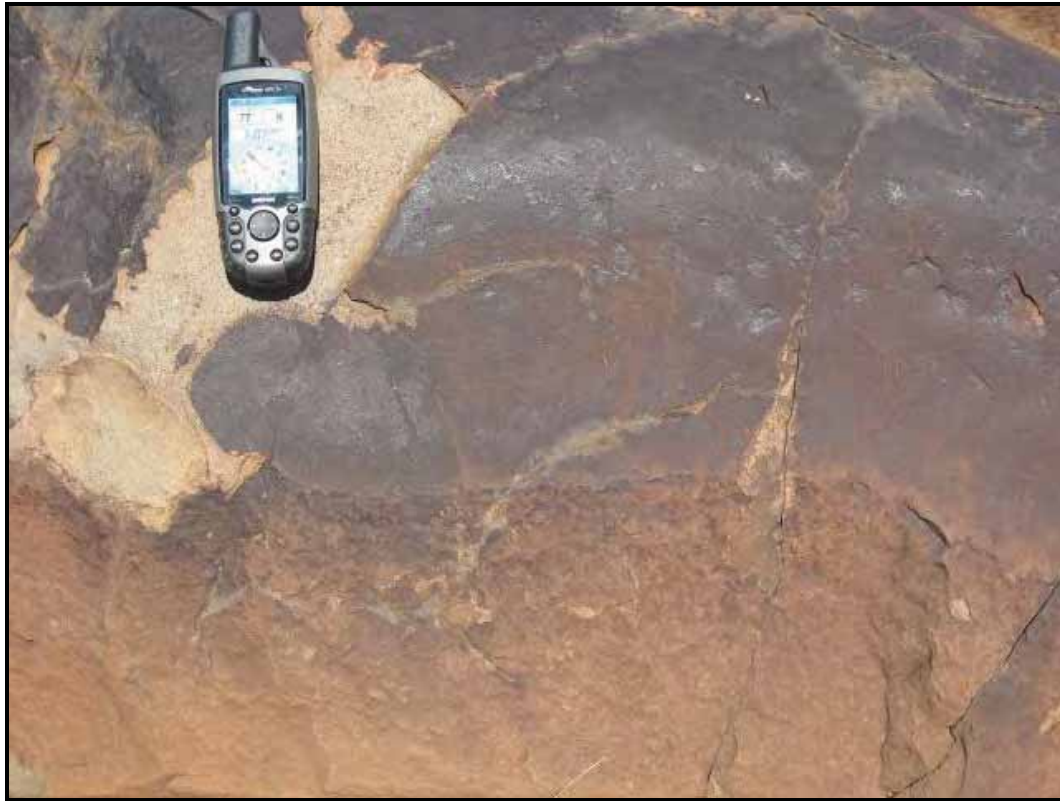
The site is situated between pylon T425 and T426, and is that of a single stone engraving of an unidentified animal with the head section weathered away.

Figure 6 – Site PH1, engraving of single unidentified animal on rock

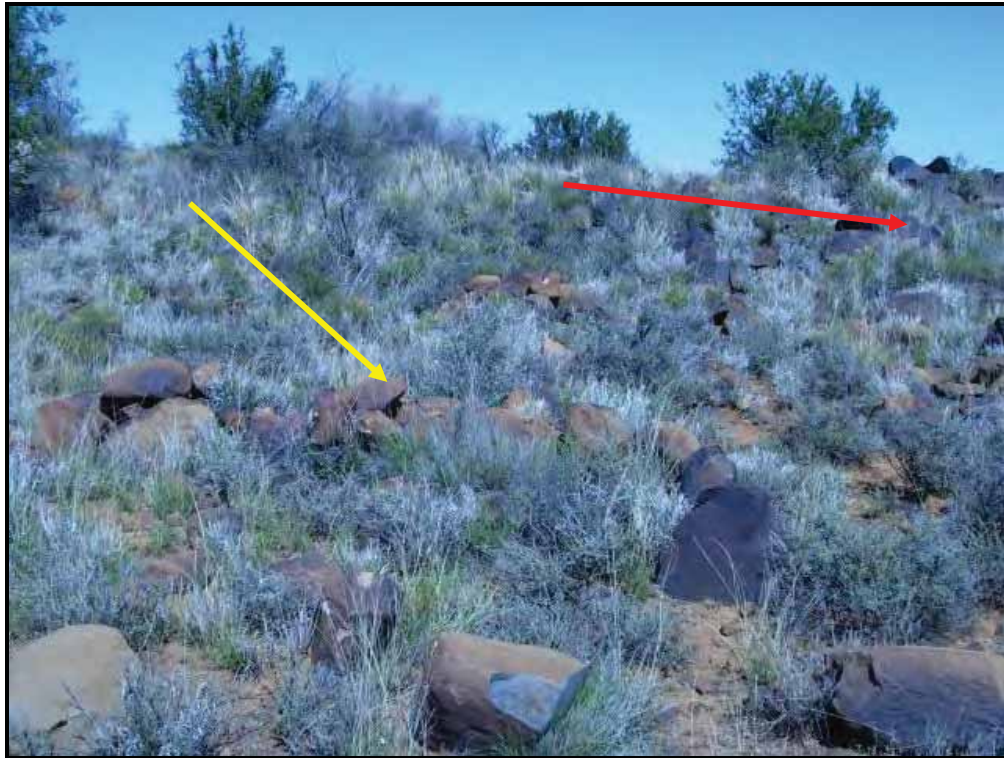
Site PH3 is situated close to pylon T420, on a small rocky ridge to the north-west of the current pylon position. The site consist of two rock engravings being geometric line engravings(**Figure 8**) and one of a very feint set of unidentified animals (**Figure 9**).

Figure 8 – Site PH3, position of low stone packed wall (yellow) and engravings (red)

The site does have major conservation value and any activities that may impact on the site must be diverted.

- The two sites needs to be fenced and a buffer of 5 meters be left around the sites;
- Any access routes need to be diverted around the sites;
- The ECO need to be on site during construction in the specific areas.

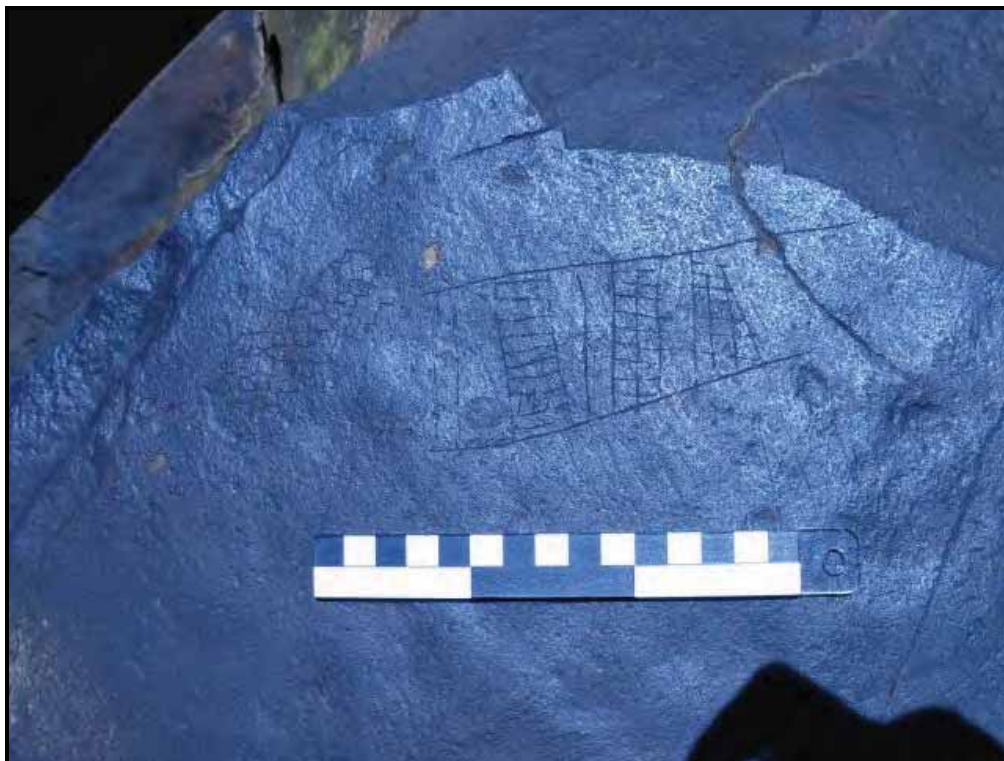
Figure 9 – Site PH3, geometric engravings on rock

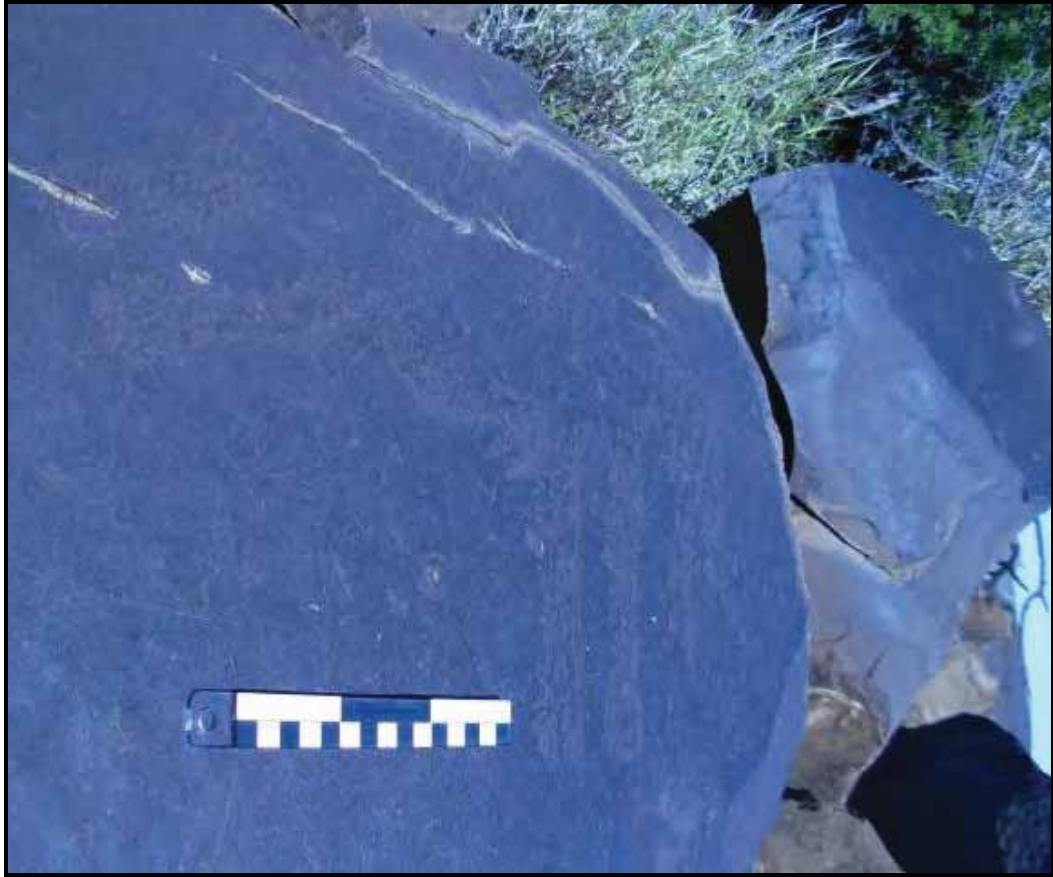
Figure 10 – Site PH3, engravings of two unidentified animals on rock

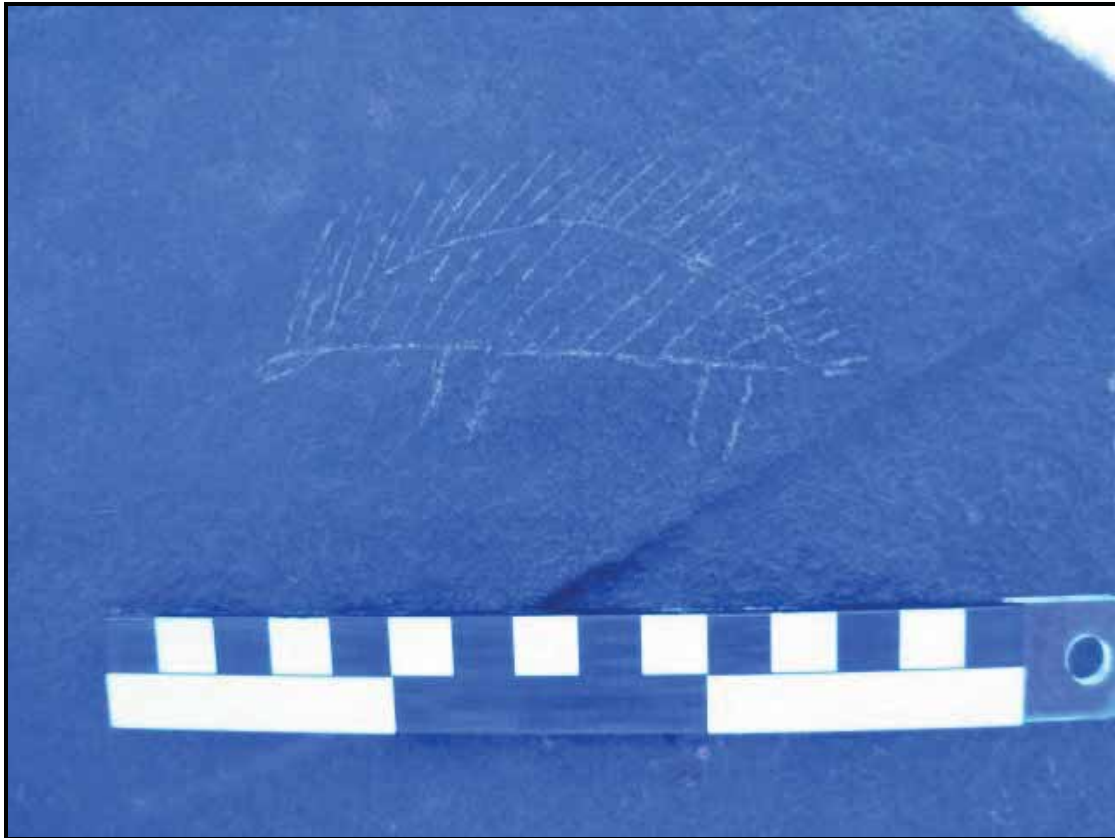
Site PH5 is situated close to pylon T415, on a small rocky ridge to the west of the current pylon position. The site consist of one rock engraving of a porcupine (**Figure 13**).

Figure 13 – Site PH5, engraving of porcupine on rock

The site does have major conservation value and any activities that may impact on the site must be diverted.

- The site needs to be fenced and a buffer of 5 meters be left around the sites;
- Any access routes need to be diverted around the sites;
- The ECO need to be on site during construction in the specific areas.

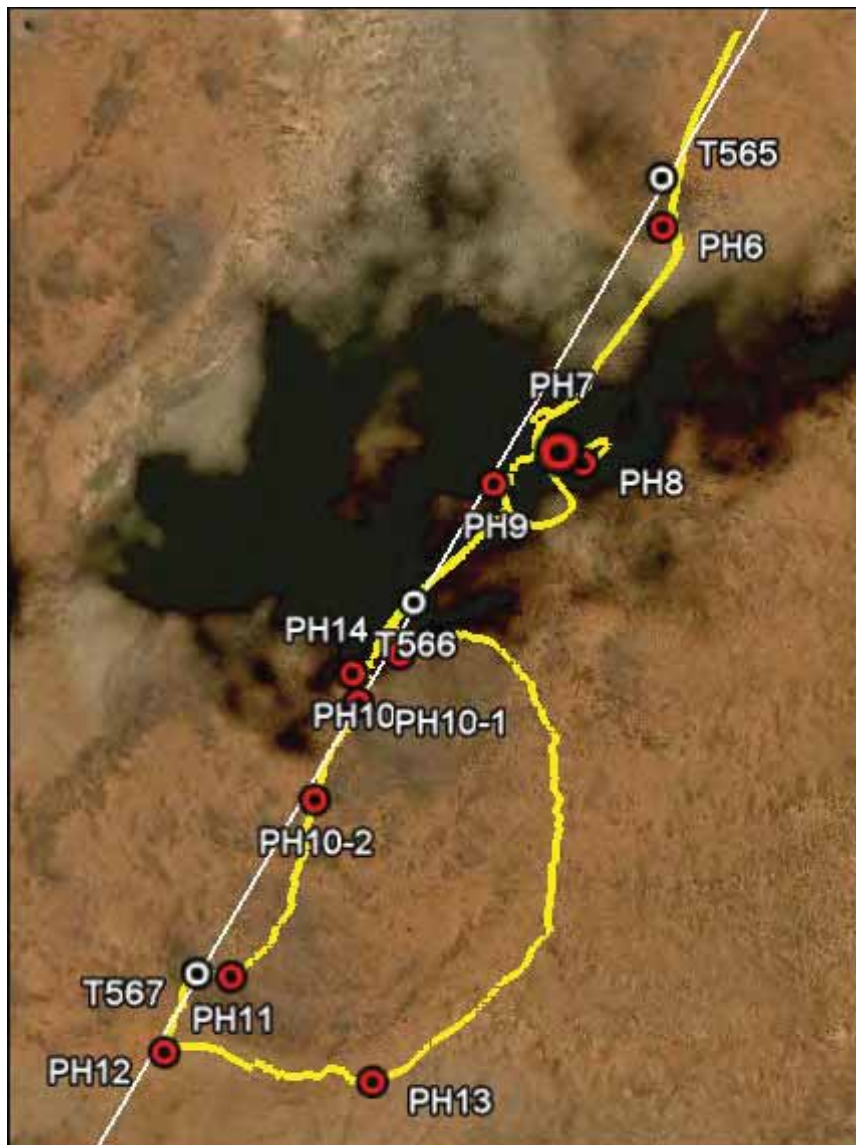
The alignment is situated on the farm *Roode Kraal 106*. The alignment traverses a low rising ridge running from north-east to south-west. The investigation was prompted by the discovery of a single Martini-Henry shell casing on the ridge in the region of site **PH11**. A walk through of the current cleared access route and diverted access routes where done.

Figure 14 – Alignment T565 to T568 with sites identified

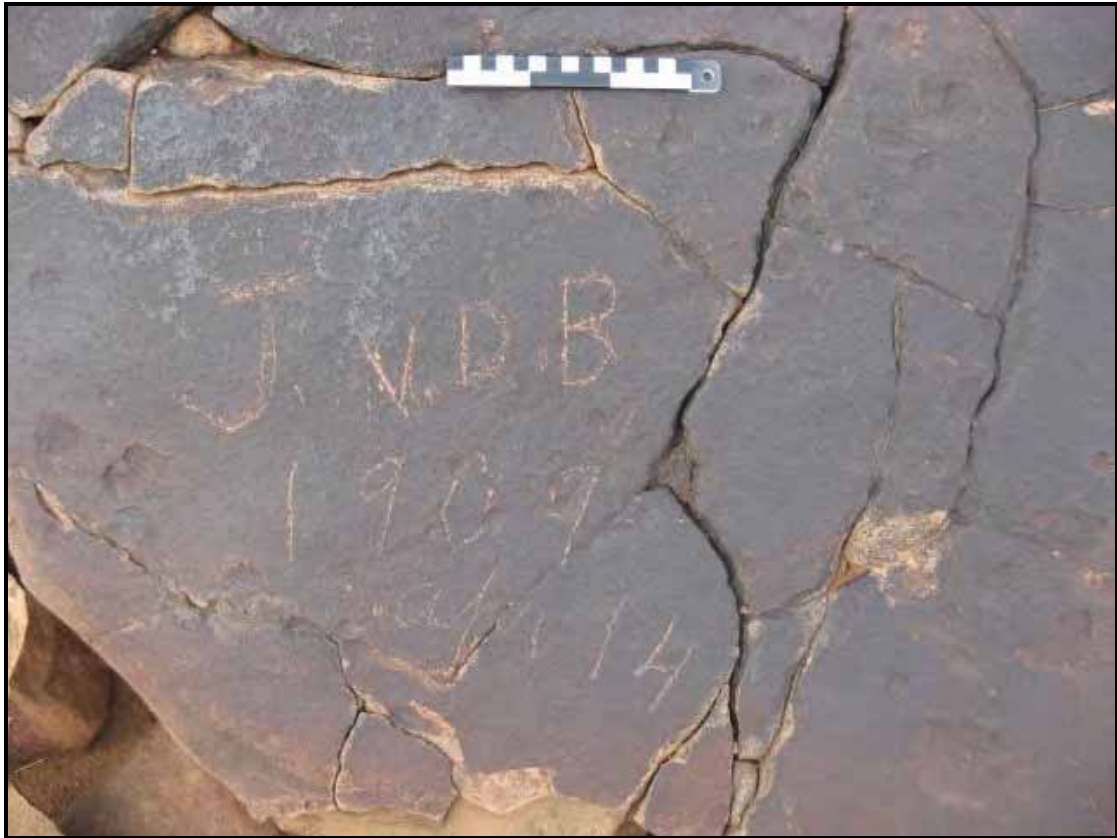
Site No	Description	Significance
PH6	Rock engraving – Inscription “J.v.d.B, 1909 April 14”. Possibly referring to J van den Berg.	Highly significant
PH7	Rock engraving - of what seems to be an eland on a western facing rock face some 20 metres from the new access route.	Highly significant
PH8	Rock engravings – close to PH7, of irregular markings done on the rock	Highly significant

Figure 15 – PH6, Rock engraving dated 1909

The sites do have major conservation value and any activities that may impact on the site must be diverted.

- The sites needs to be fenced and a buffer of 5 meters be left around the sites;
- Any access routes need to be diverted around the sites;
- The area of the ridge must be seen as a no-go area, excluding the section already disturbed during the construction activity prior to the site visit
- The ECO need to be on site during construction in the specific areas.
- All travelling around the ridge must be kept to single corridor of the already disturbed road areas.
- The new position of pylon T567 towards T568 is in the vicinity of PH12. This area has a medium density of lithics and needs to be managed through a surface collection of all lithics, with the appropriate methodology done by a professional archaeologist.

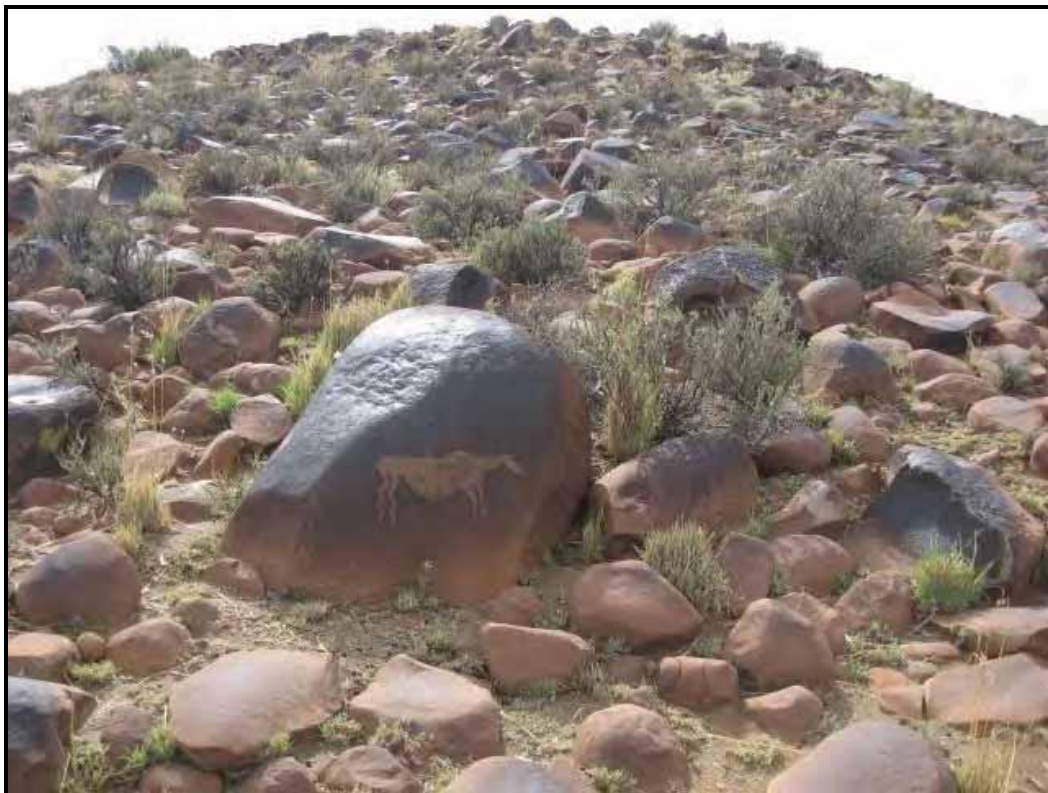
Figure 16 – PH7 - Rock engraving between T565 and T566

Figure 17 – Close-up of engraving

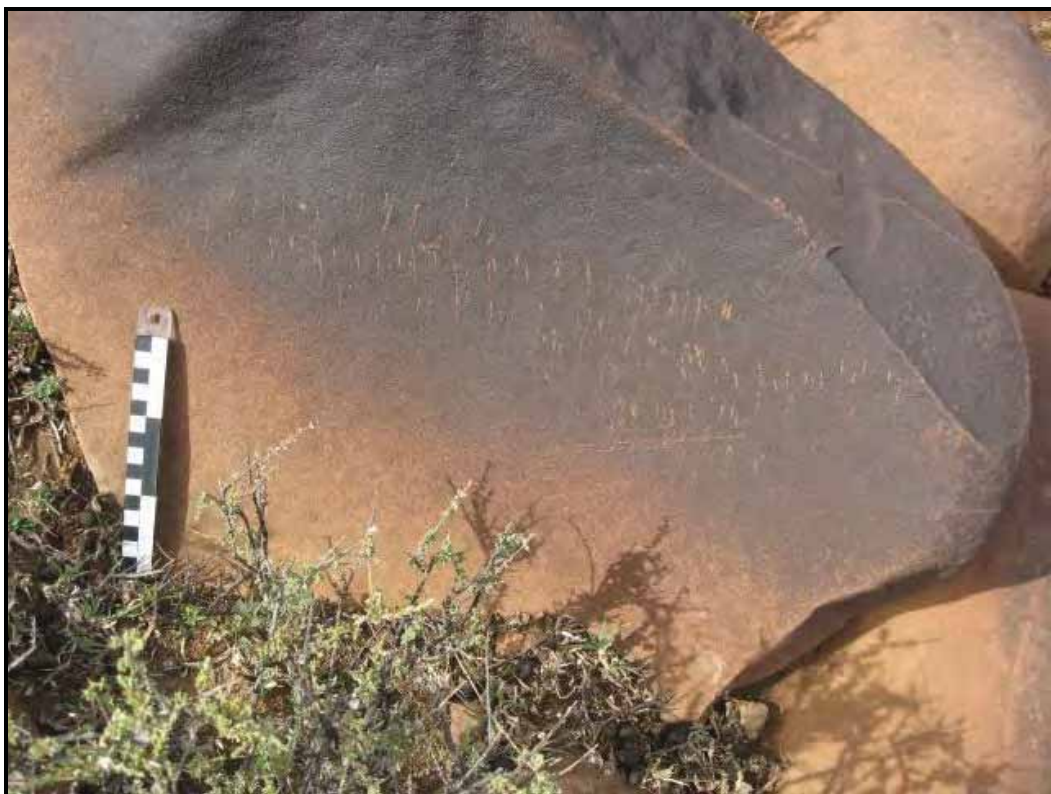
Figure 18 – Rock markings at PH8

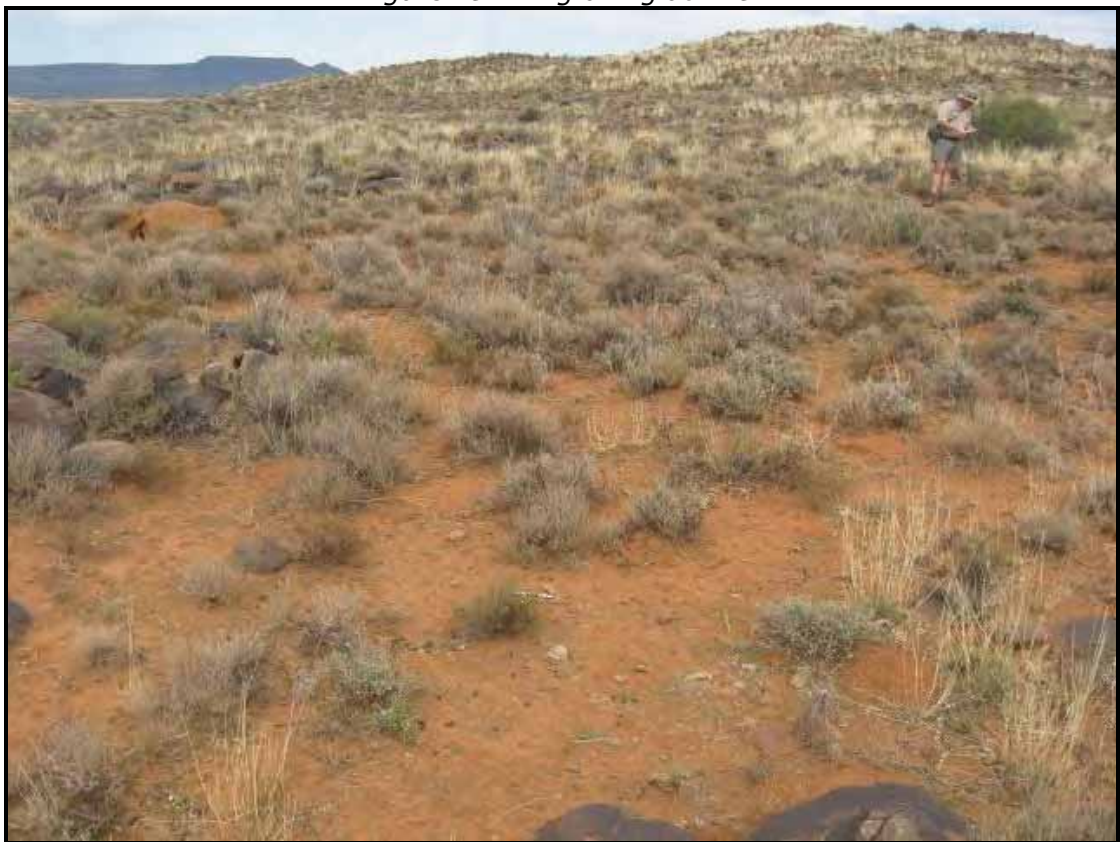
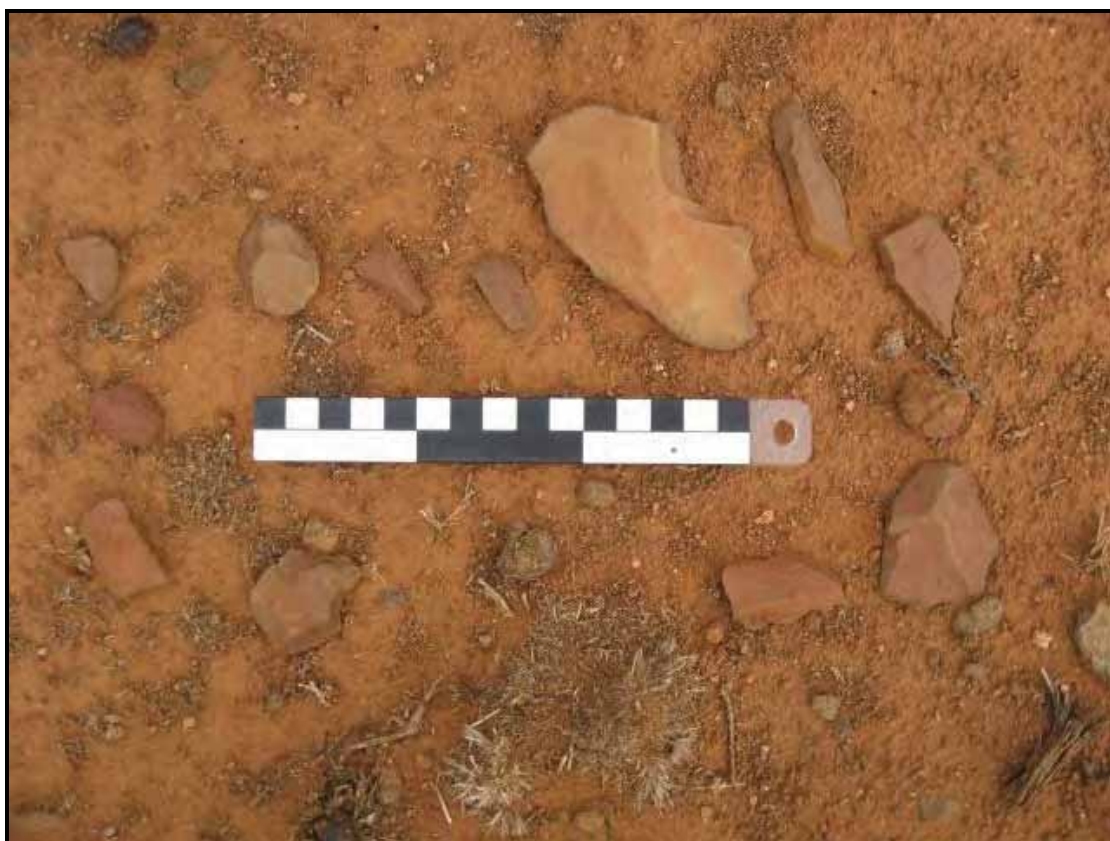
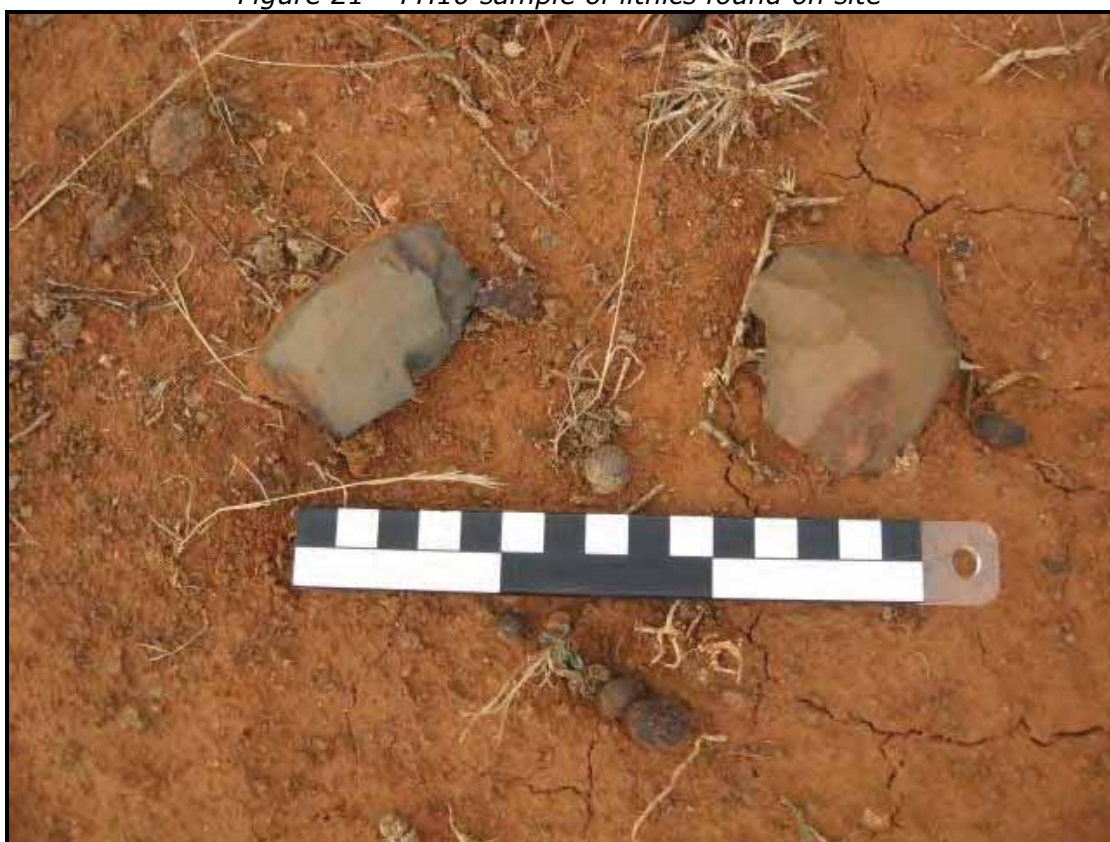
face.	
PH9	Rock engraving – Reading “S.W.J”	<i>Highly significant</i>
PH10-1	Start of large, high density scatter of Middle Stone Age lithics	<i>Highly significant</i>
PH10-2	End of large, high density scatter of Middle Stone Age lithics	<i>Highly significant</i>
PH11	Large very high density of Middle Stone Age lithics, radius of approximately 10 metres. As well as a possible knapping site. Also a single low stone wall is present on site. A single Martini-Henri casing was found on the site.	<i>Highly significant</i>
PH12	Area of medium density lithic scatters	<i>Medium significance</i>
PH13	Area of medium density lithic scatters	<i>Medium significance</i>
PH14	Two low circular stone walls. Some remains of glass and a corned beef can lid was found on site. The absence of any further evidence cannot confirm and discount its association with the South African War. The possibility does however exist that it could be associated with herder shelters.	<i>Medium significance</i>

Figure 20 – PH10 general view of site

Figure 21 – PH10 sample of lithics found on site

Figure 22 – PH10 examples of lithic cores found on site

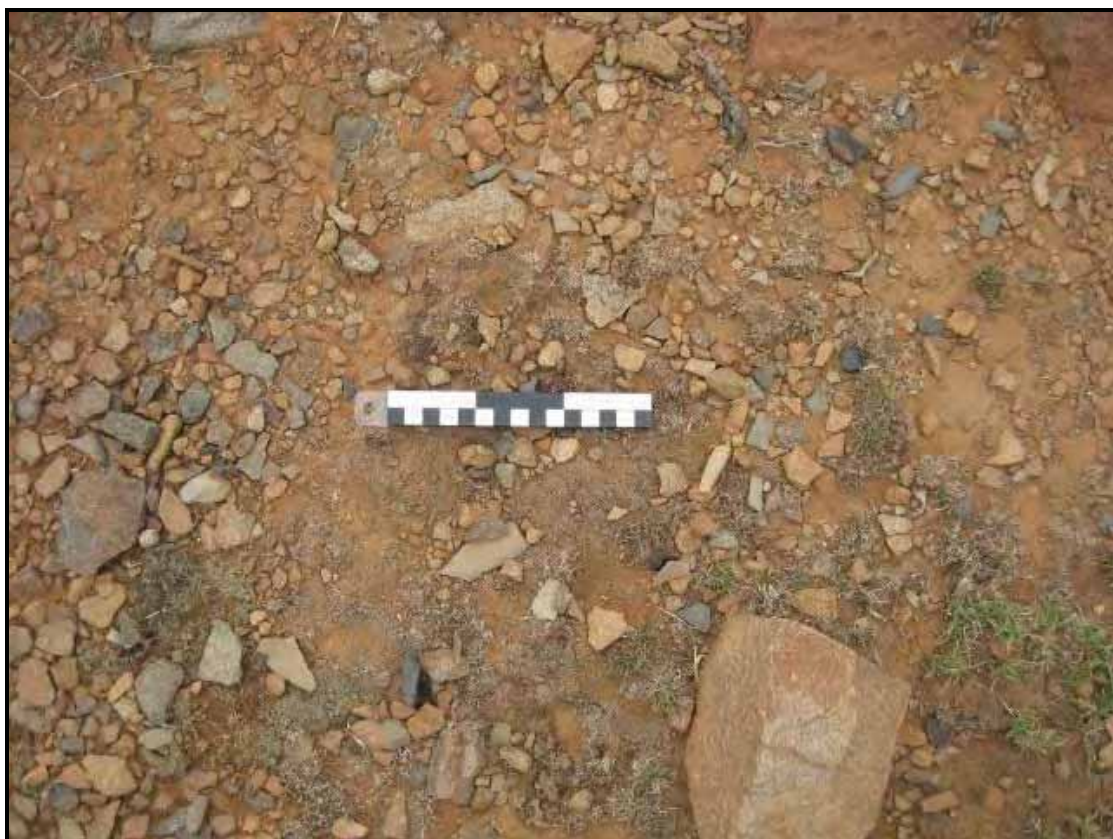
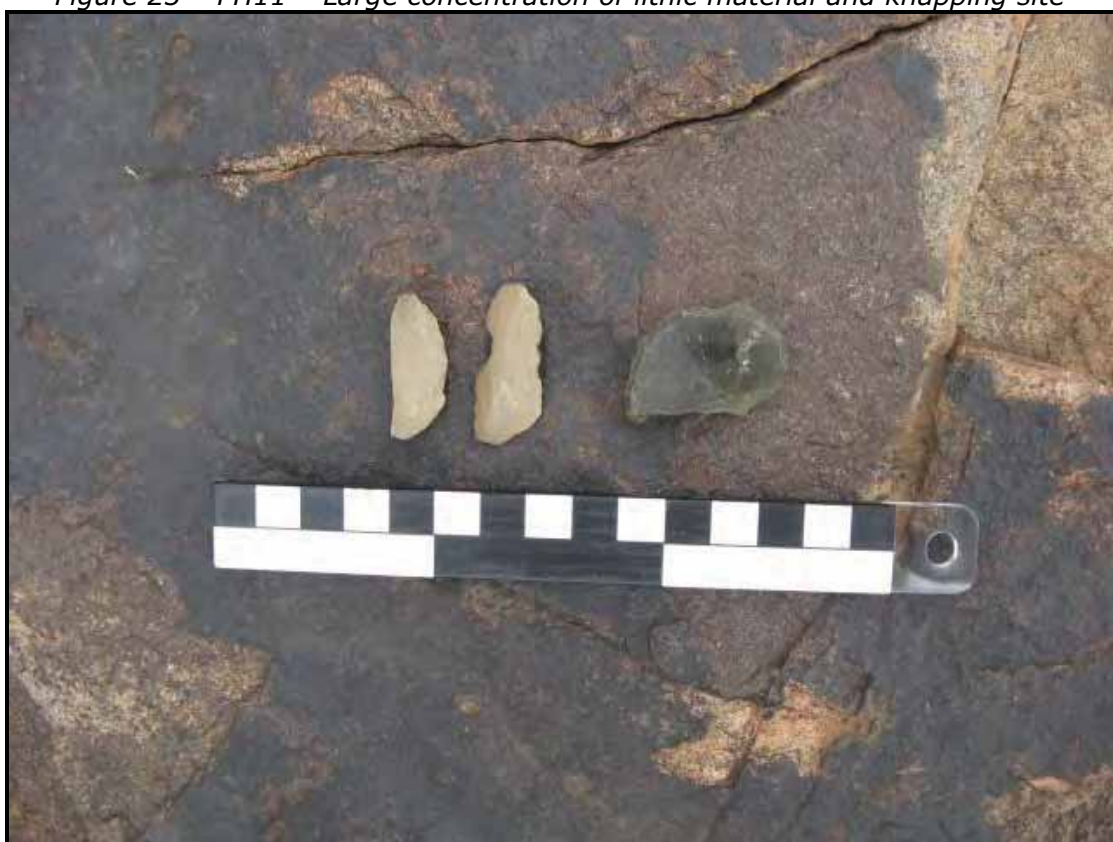
Figure 23 - PH11 - Large concentration of lithic material and knapping site

Figure 24 - PH11 - Stone and glass Lithics found on site

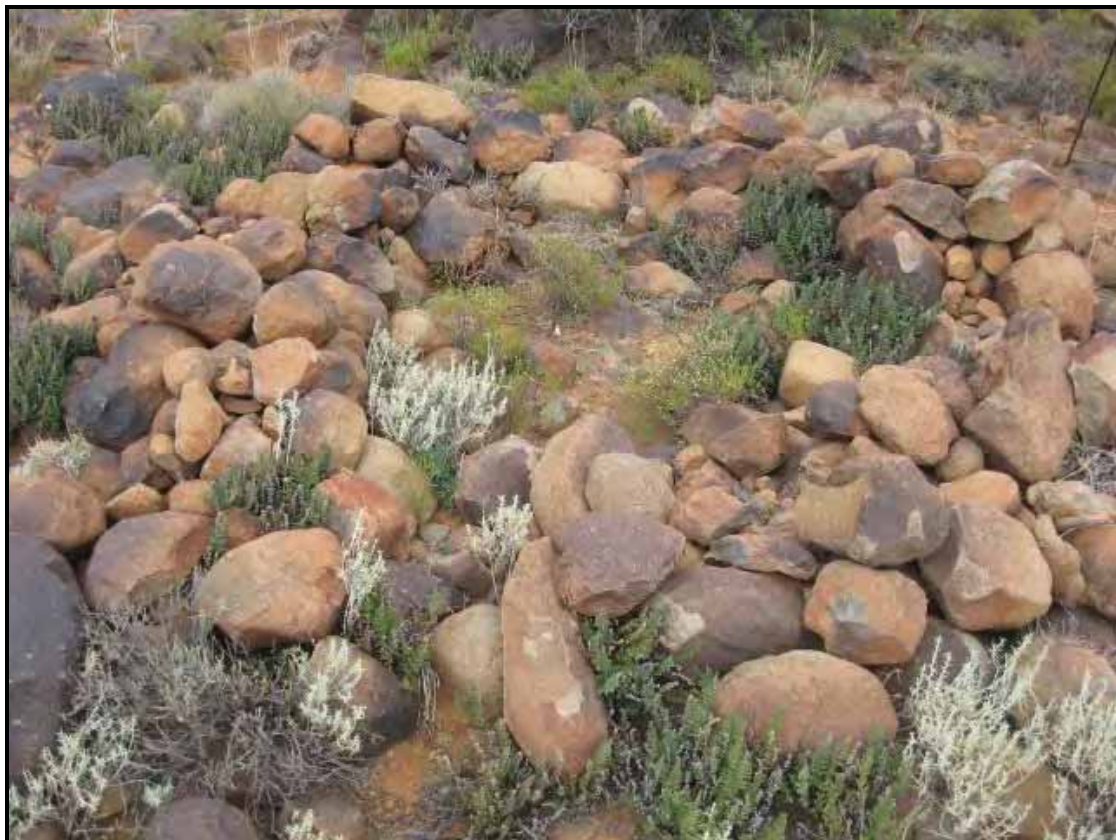
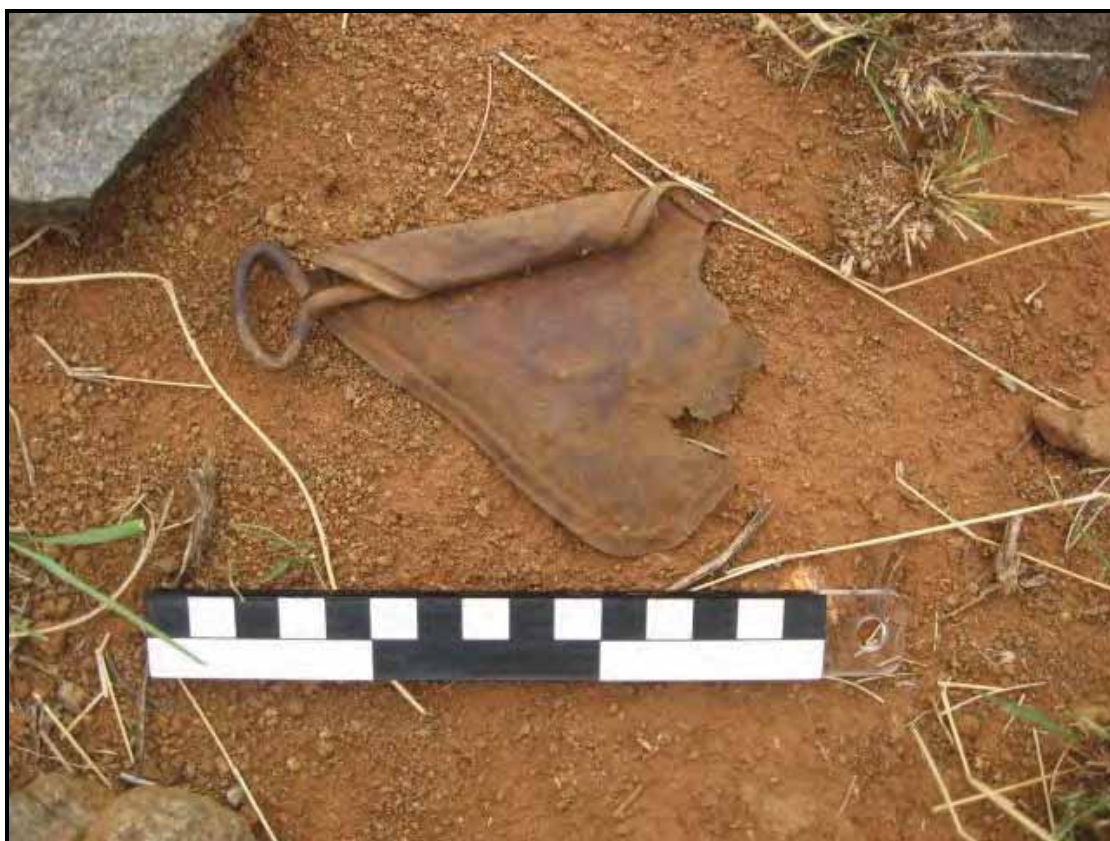
Figure 25 – PH14 – Position of walling and construction area

Figure 26 – PH14 – Stone walling close-up

Figure 27 – PH14 – Corned beef can lid

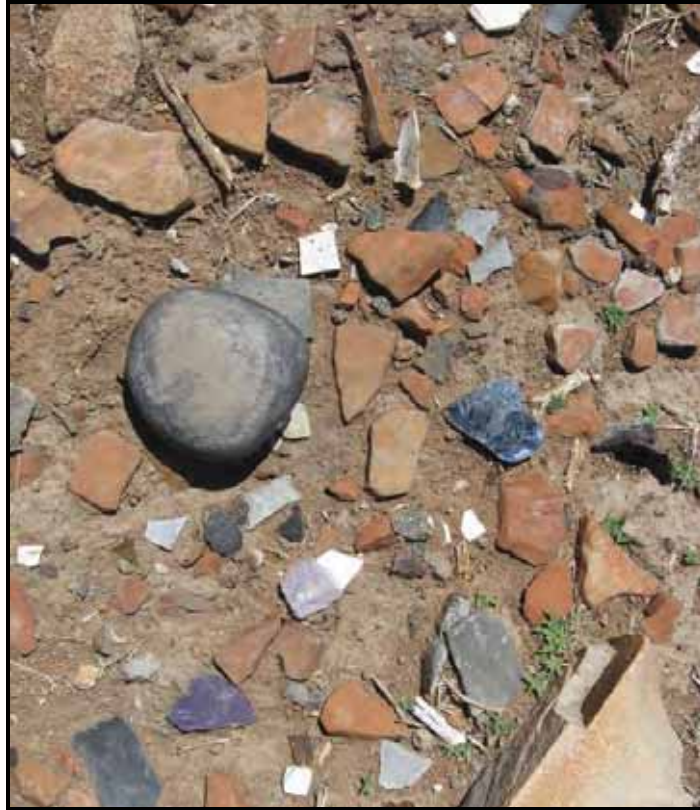
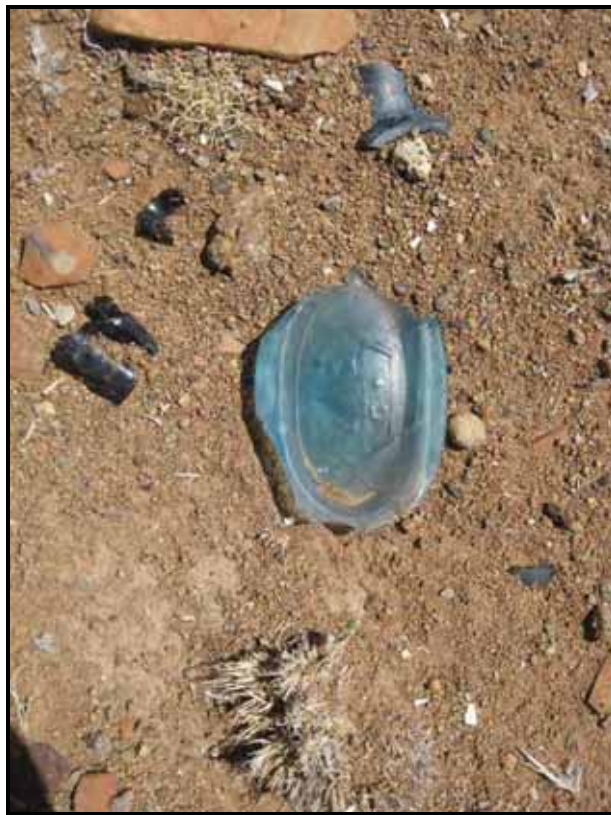
The alignment is situated on the farm *Nuwe Tafelkop 189*. The alignment traverses a drainage line running from north-east to south-west under the alignment. The alignment runs to the east of the ruins of historical farmstead possibly dating 1850 to 1900. The glass and ceramic remains and shell casing found in the ash midden at PH15 shows association with this time period.

Figure 29 – PH15 – remains of ash midden

Figure 30 – PH14 – Glass pièces in midden

The site does have major conservation value and any activities that may impact on the site must be diverted.

- The sites needs to be seen as a no-go area;
- Any access routes need to be diverted around the sites;
- The ECO need to be on site during construction in the specific areas;
- All travelling around the site must be kept to single corridor of the already disturbed road areas;
- The pylon T491 will be moved toward the south and will still be out of reach of the stonewalling of the paddock (**PH20**);
- It is however recommended that a buffer as close as possible to 5 metres from the stone walling be kept.
- The excavations around T492 up to T490 needs to be monitored by a professional archaeologist for the presence of earlier stone ages find, as the finds of the acheulean hand axes indicate the possibility of further finds.

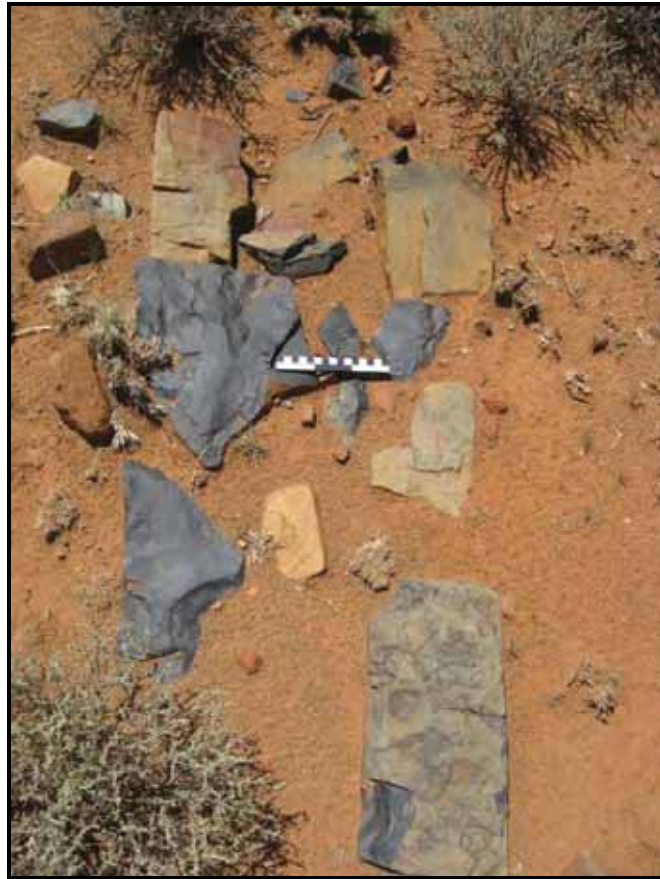
The farmstead consists of a midden (**PH15**), the ruins of two houses (**PH16 and 17**), livestock kraal (**PH18**), a very well constructed rock and dam wall (**PH19**) as well as a stone walled cultivating paddock of approximately 220x90m (**PH20**).

Figure 31 – PH16 – Stone work in foundation of house

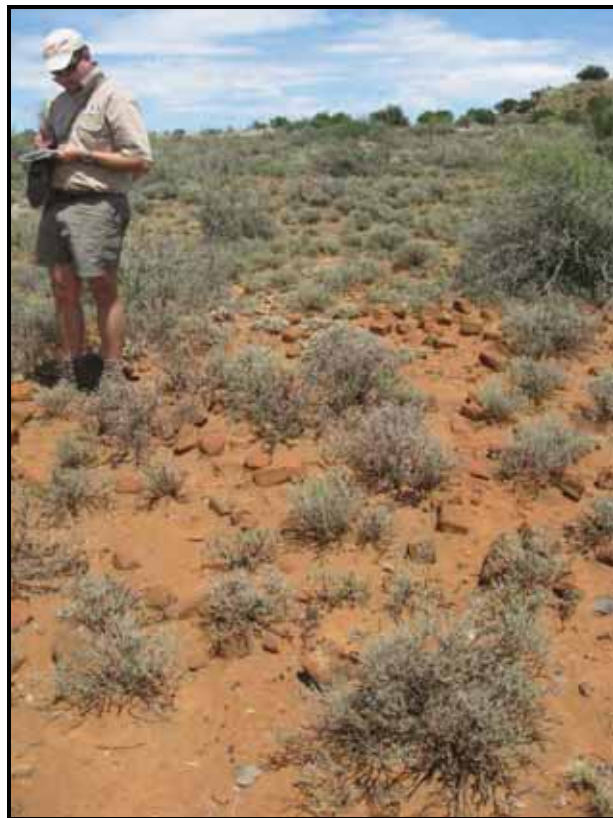
Figure 32 – PH17 – Sun baked bricks on ruin of house

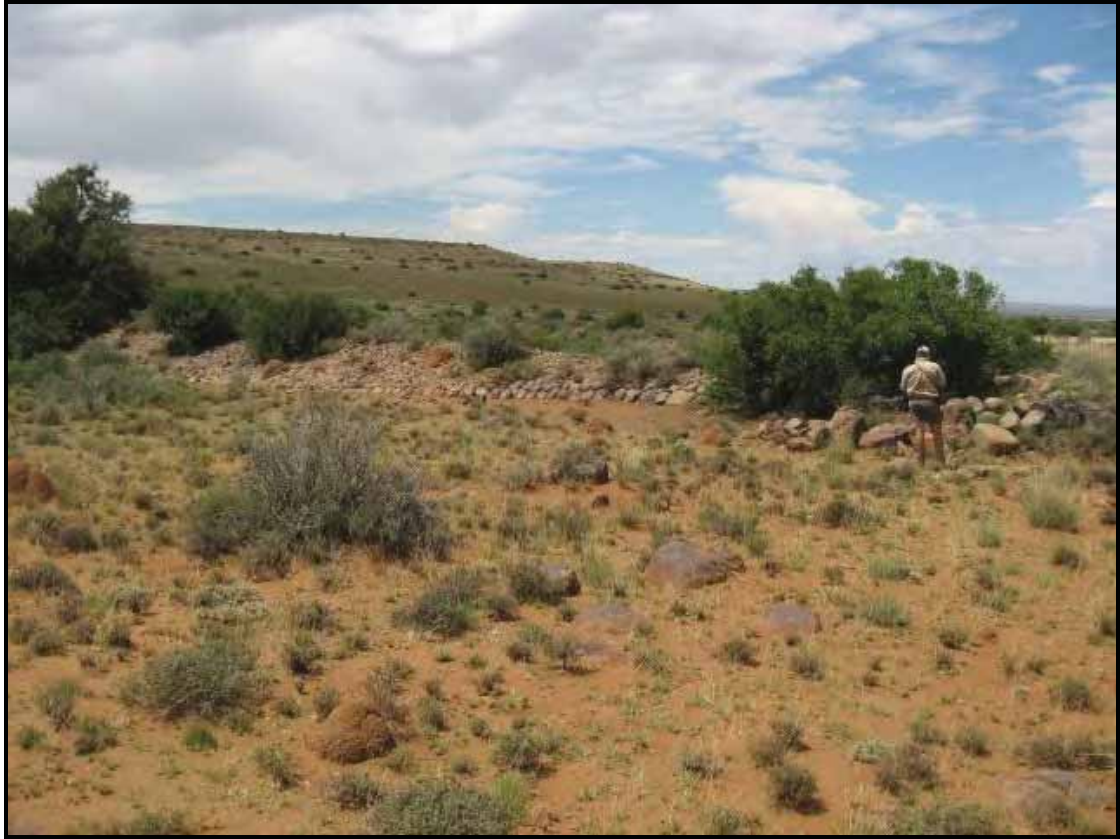
Figure 33 – PH19 – View of dam wall
