5 December 2009

The Nature Conservation Corporation
Units 1 & 2, 4 Stibitz Street
Westlake Business Park
Westlake
7945

**FEEDBACK ON SITE INVESTIGATION TO POSSIBLE HERITAGES SITES ON
THE HYDRA-PERSEUS ESKOM POWER LINE, NORTHERN CAPE PROVINCE**

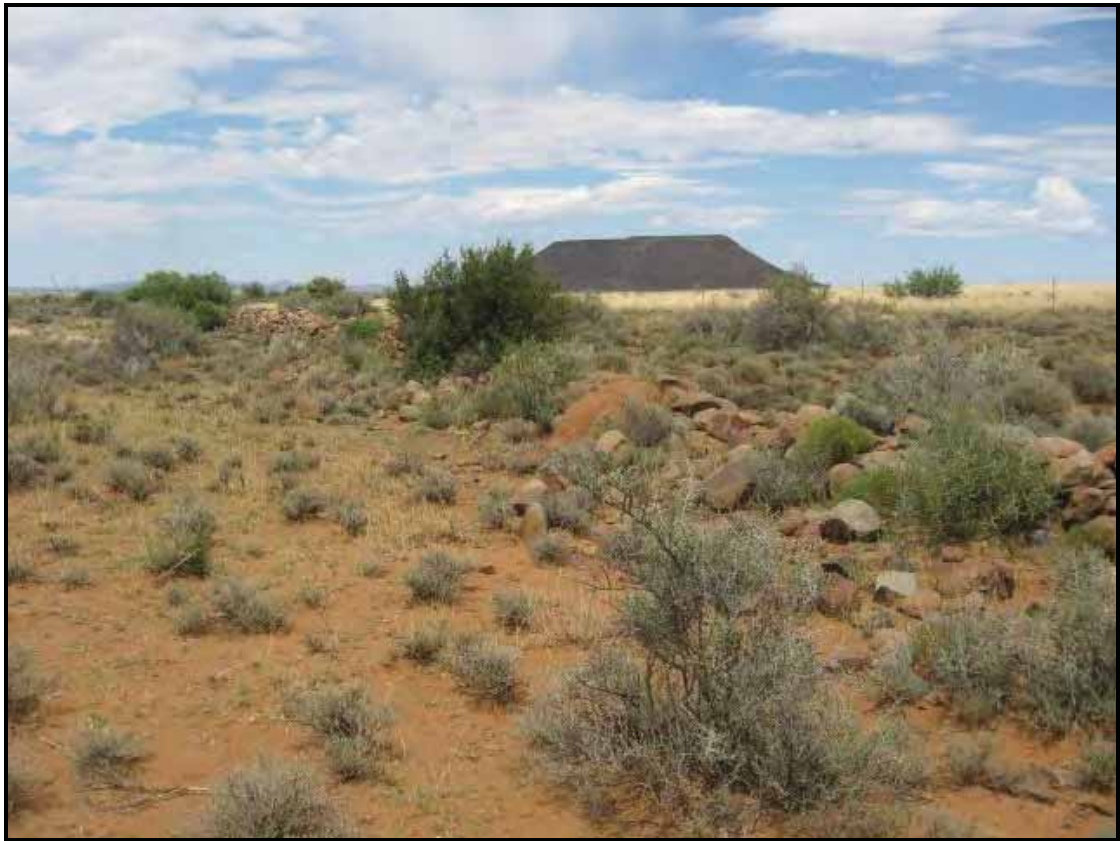
The farmstead consists of a midden (**PH15**), the ruins of two houses (**PH16 and 17**), livestock kraal (**PH18**), a very well constructed rock and dam wall (**PH19**) as well as a stone walled cultivating paddock of approximately 220x90m (**PH20**).

Figure 34 – PH20 – Stone walling of paddock

The site does have major conservation value and any activities that may impact on the site must be diverted.

- The sites needs to be seen as a no-go area;
- Any access routes need to be diverted around the sites;
- The ECO need to be on site during construction in the specific areas;
- All travelling around the site must be kept to single corridor of the already disturbed road areas;
- The pylon T491 will be moved toward the south and will still be out of reach of the stonewalling of the paddock (**PH20**);
- It is however recommended that a buffer as close as possible to 5 metres from the stone walling be kept.
- The excavations around T492 up to T490 needs to be monitored by a professional archaeologist for the presence of earlier stone ages find, as the finds of the acheulean hand axes indicate the possibility of further finds.

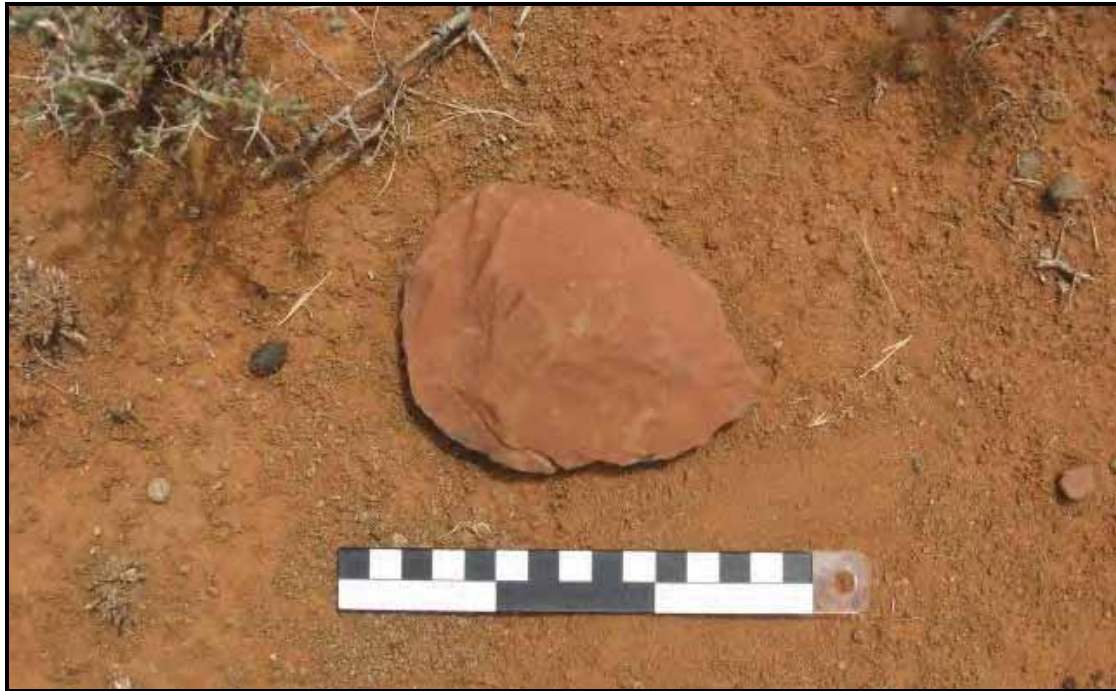
In the vicinity of pylon T592 two Acheulean stone tools were identified probably dug out during the construction of the dam wall.

Figure 35 – PH20 at T491 – Acheulean hand axe from excavation of dam wall
