# ARCHAEOLOGICAL IMPACT ASSESSMENT, KLEINBOSCH FARM 9/1576, DAL JOSAPHAT

submitted in terms of Section 38(8) of the NHRA (1999) for  
KLEINBOSCH FARM 9/1576, DAL JOSAPHAT PAARL

23 November 2021

Prepared by Katie Smuts of Rennie Scurr Adendorff for Malherbe Rust Architects

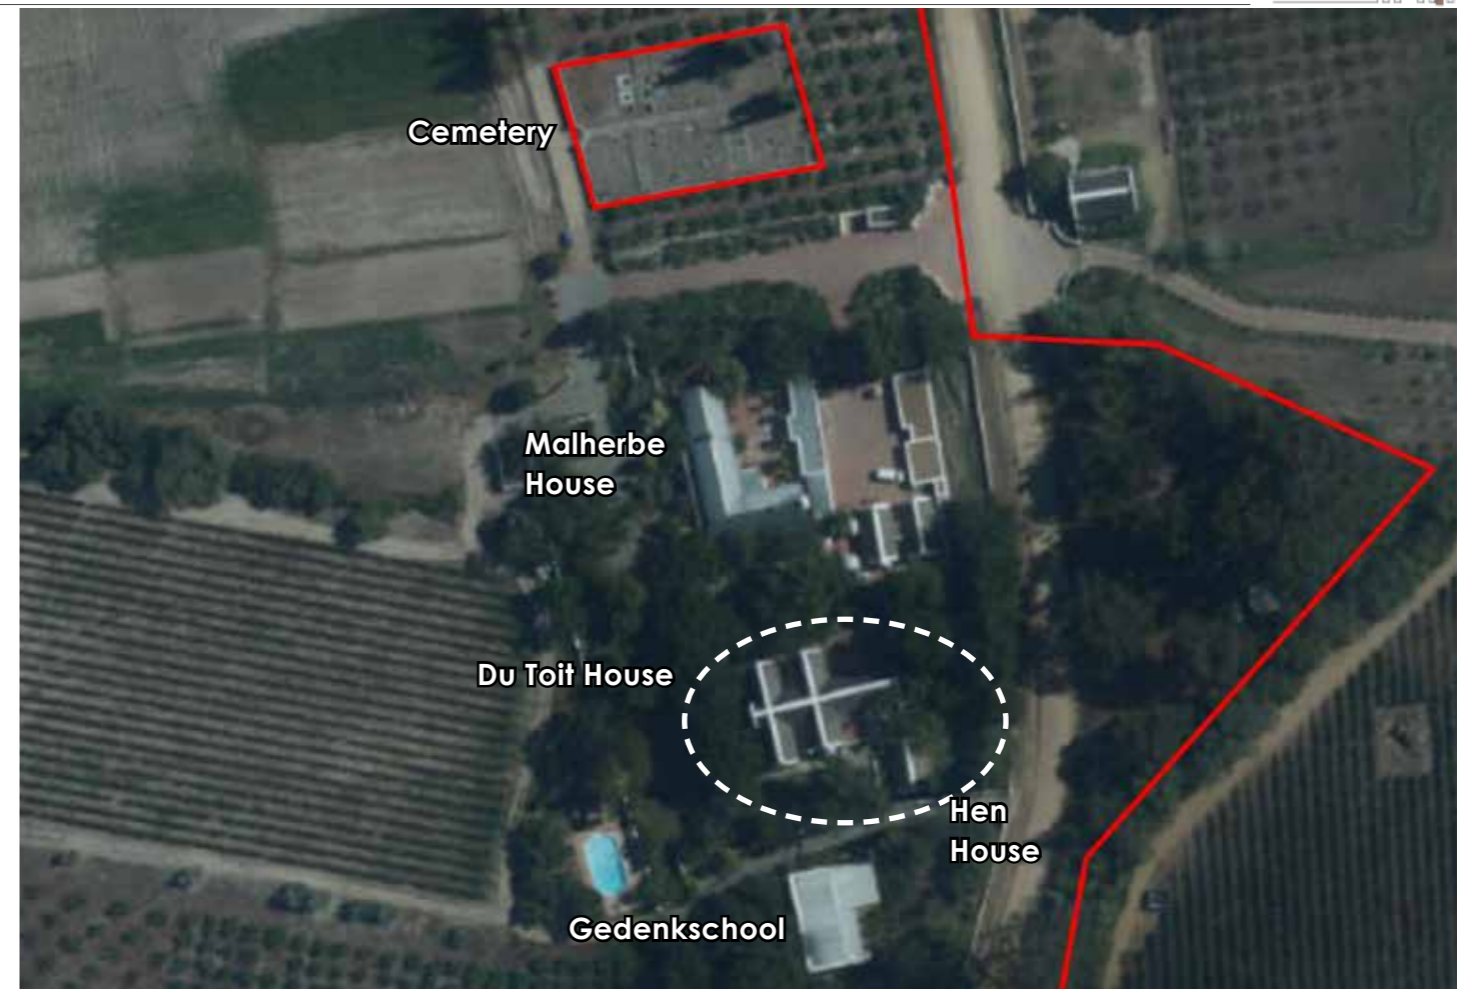
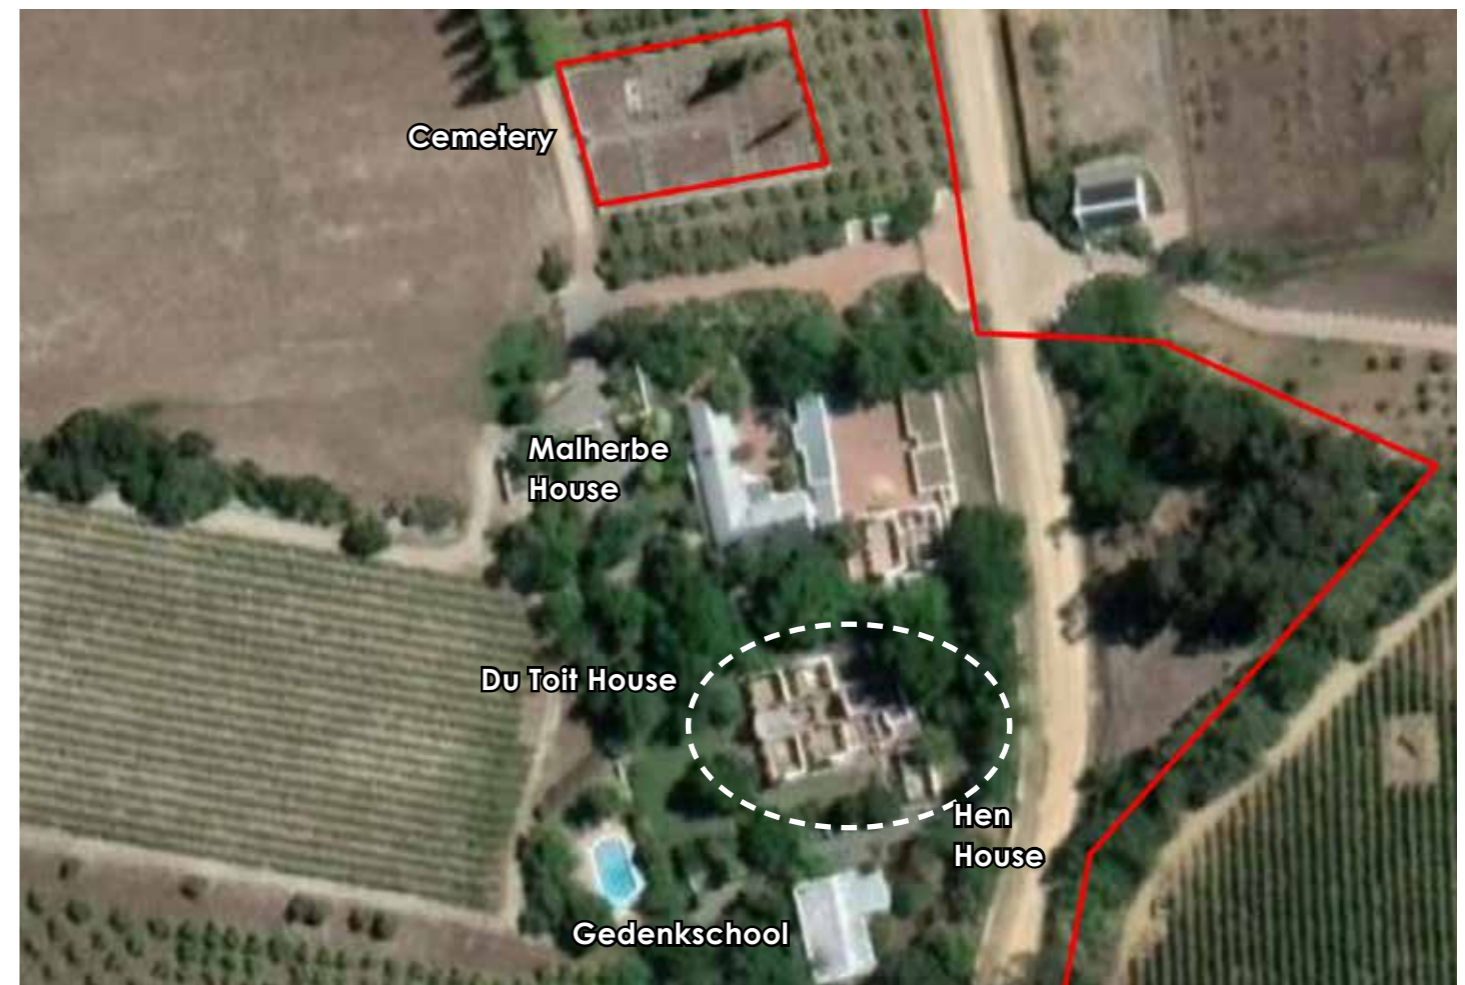
Figure 1. Aerial images of Kleinbosch werf before (top) and after (below) the 2017 fire; werf components indicated (CFM, 2021).

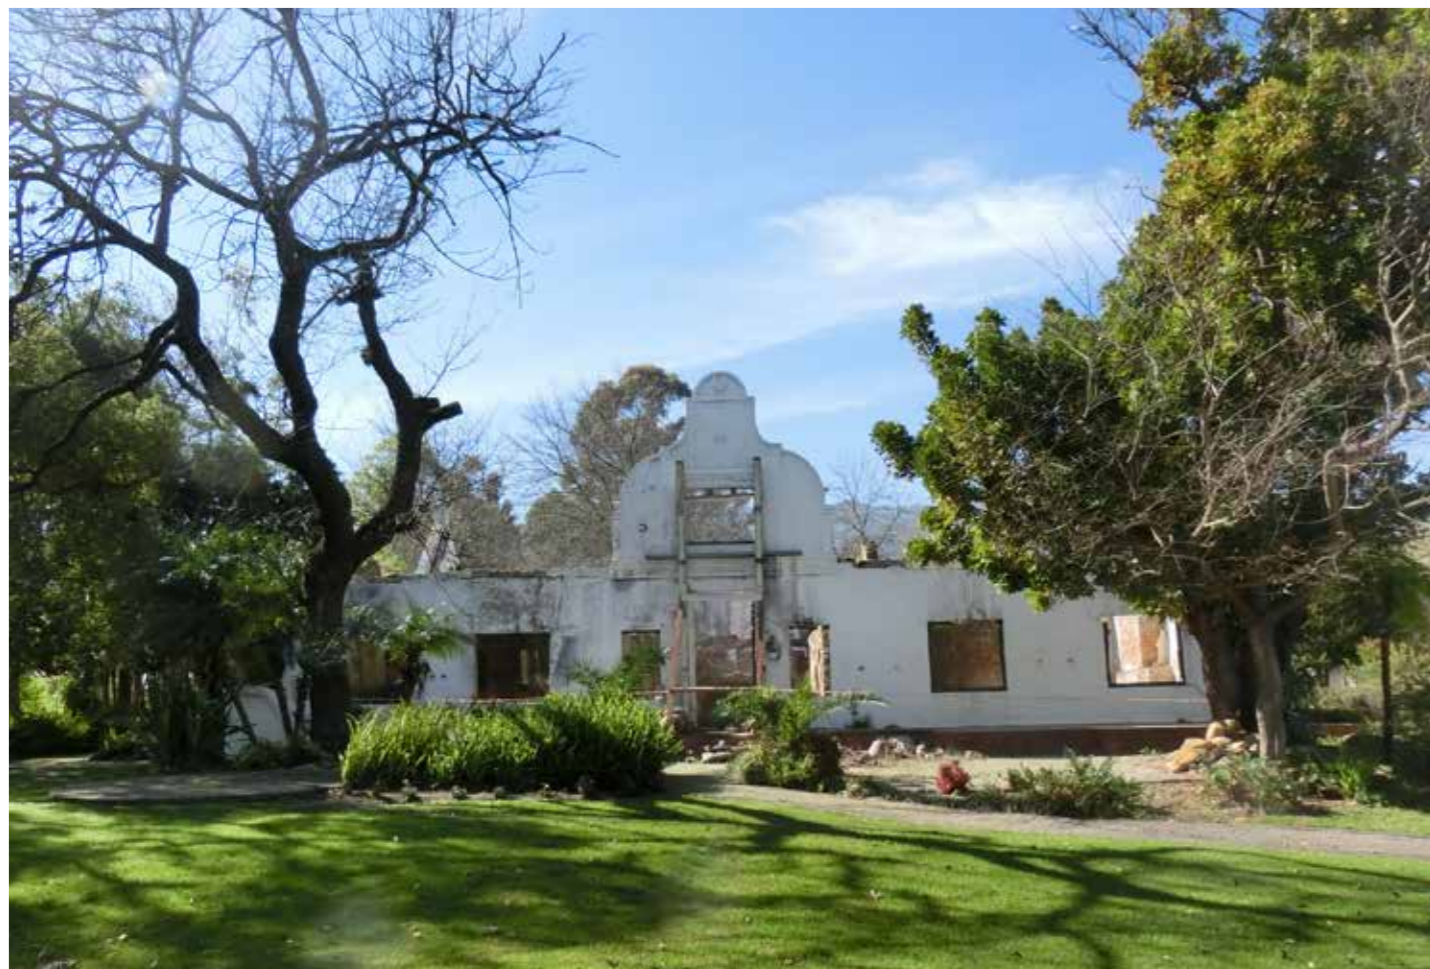
Figure 4. Du Toit House (RSA, 2021)

In 1910 the De Toit House was still thatched, the southern gable end was still half-hipped, with a small, four-paned window in the loft. The thatch was replaced with corrugated sheeting, and ventilators were inserted in the loft by 1920. The southern stoep seat was demolished, and the stoep brought round to the south of the building in cement and brick by 1930.

The 1970s alterations for new owner, Peter Youngusband, were begun under Gawie Fagan. Fagan stripped interior and exterior plaster, and drew up plans, however Fagan's involvement was ended and records of this work are not available; M.Mamachos completed the project. These interventions effected a restoration to the late C18th, later layering associated with the C19th history of the house, the GRA and Gedenkschool were removed. Casement windows replaced the 1892 sash windows throughout, and the garage opening of the tail became a window. Batavian tiles were laid in the kitchen, and gable ends were built on the front wing. Rotten floorboards and all exterior woodwork were replaced with replica joinery. A new fireplace was created in the south western wing, and beams throughout the structure were replaced where this was deemed necessary.

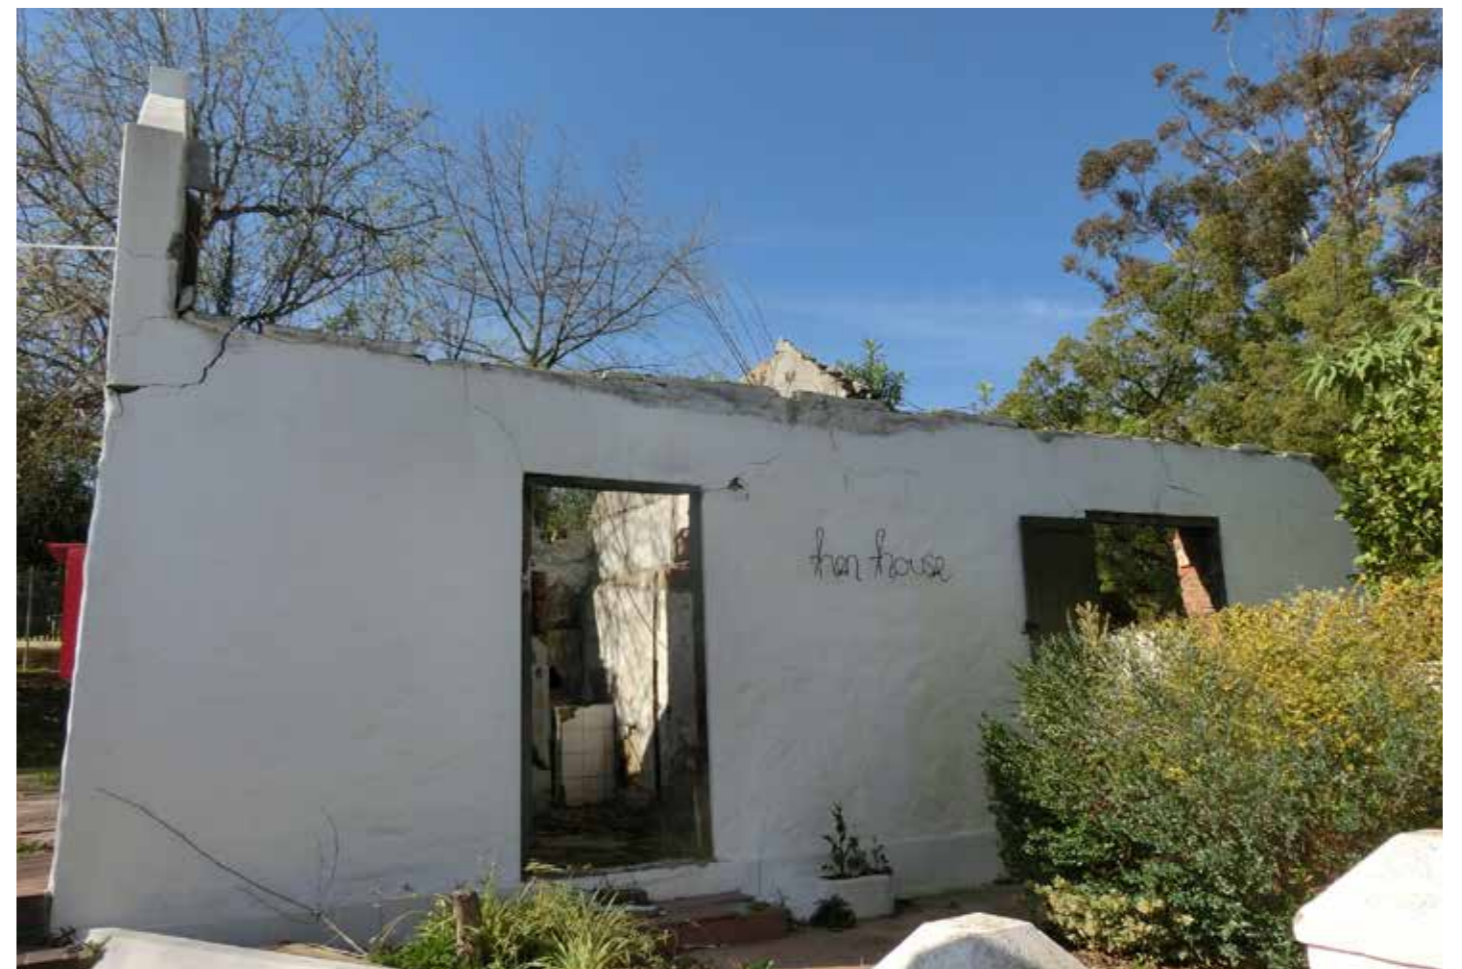
Figure 6. The Hen House (RSA, 2021)

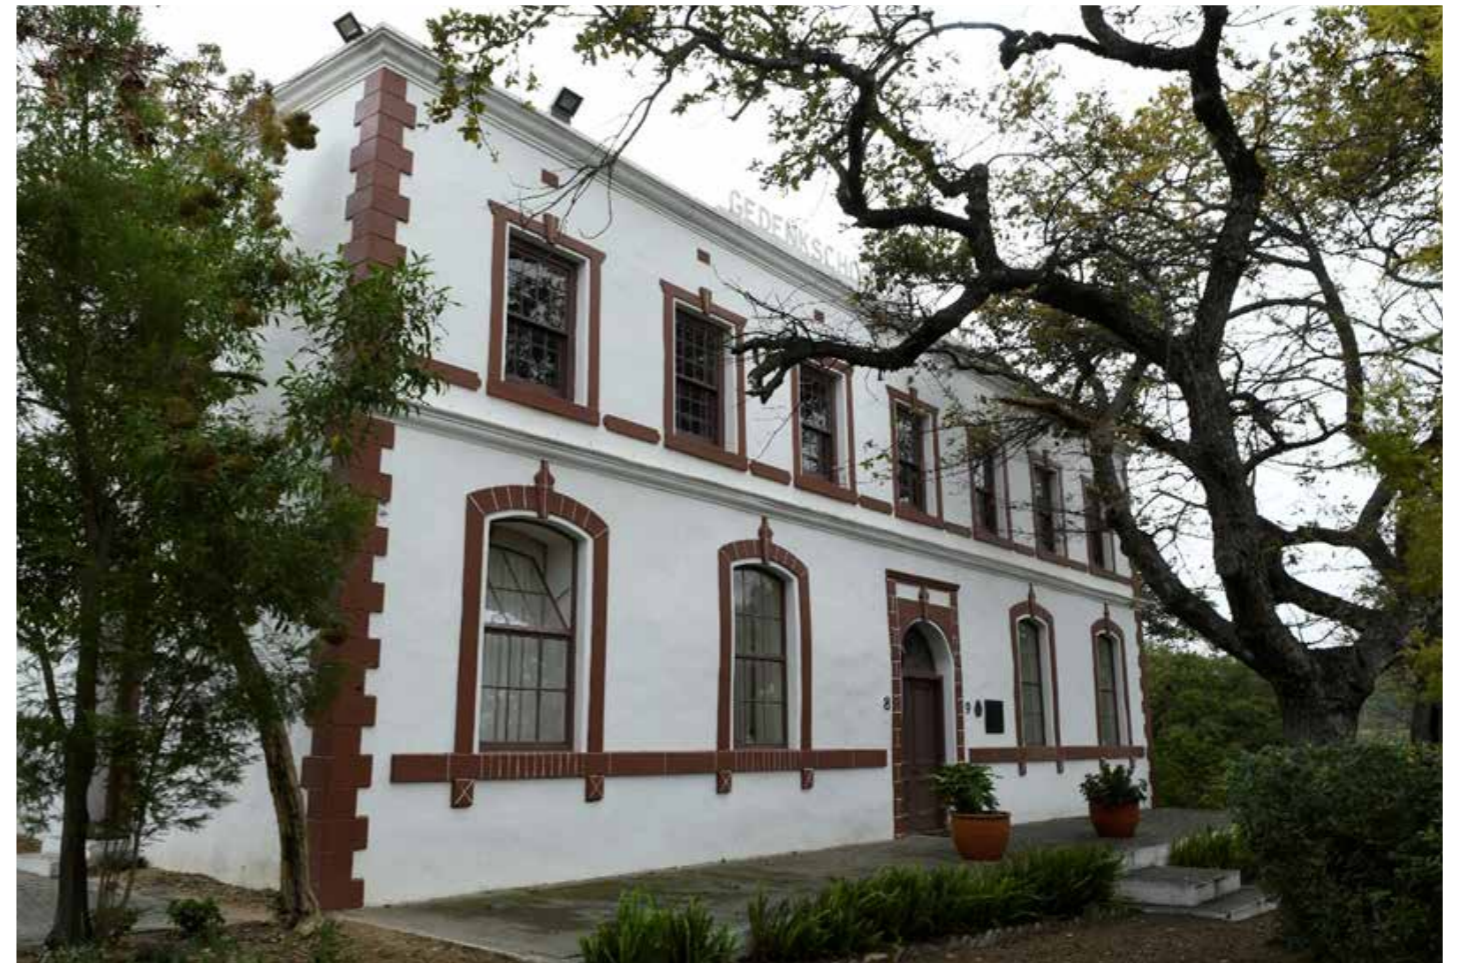
Figure 7. The Gedenkschool (Malherbe, 2021)

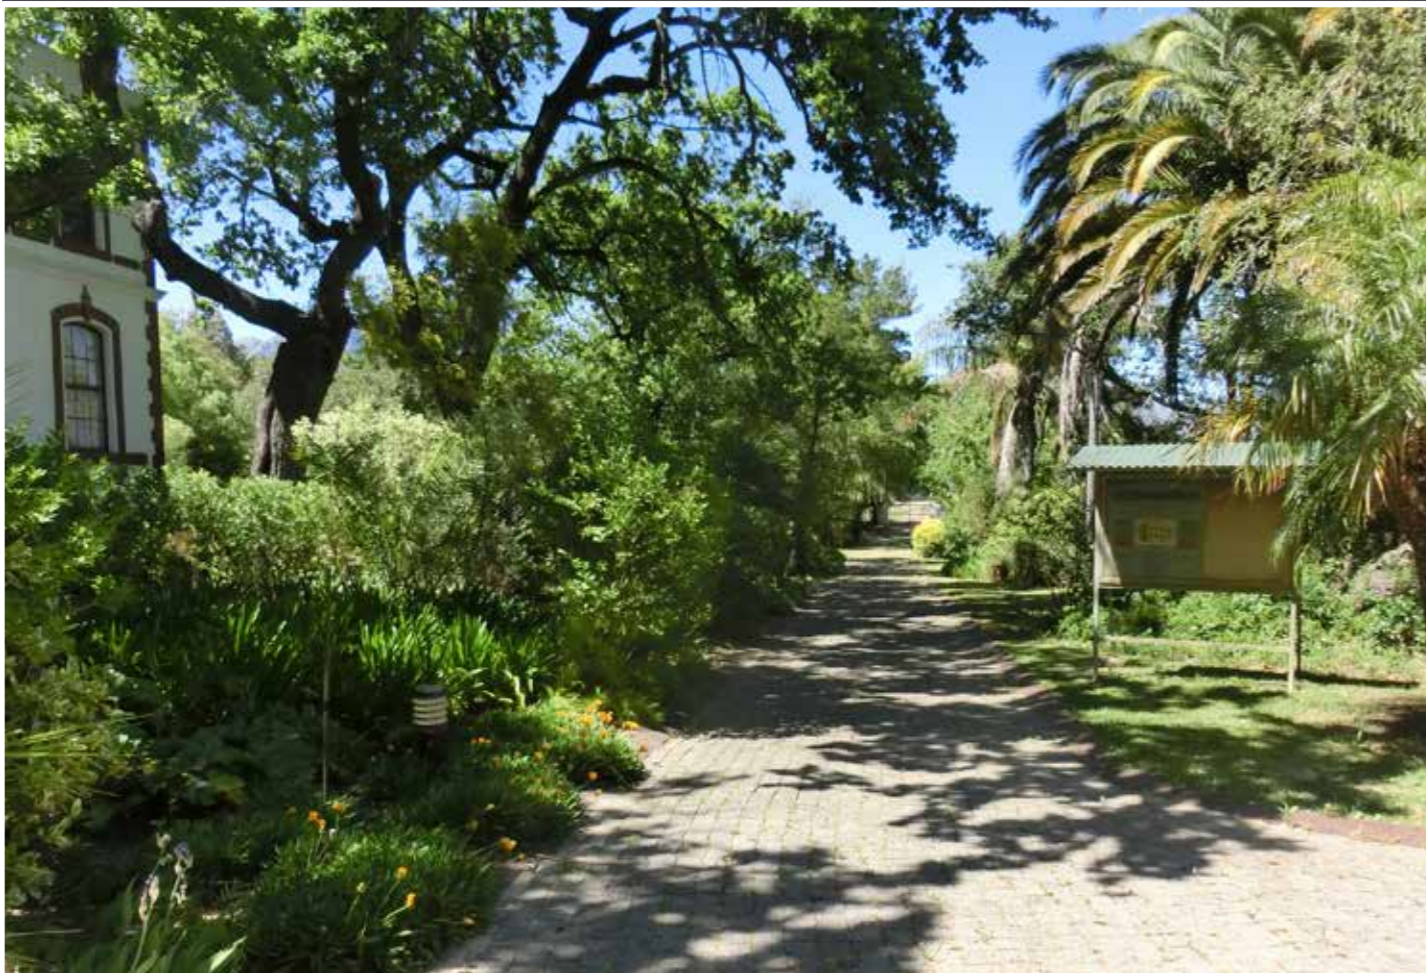
Figure 8. Alignment of old wapid west of the Gedenkschool (RSA, 2021)

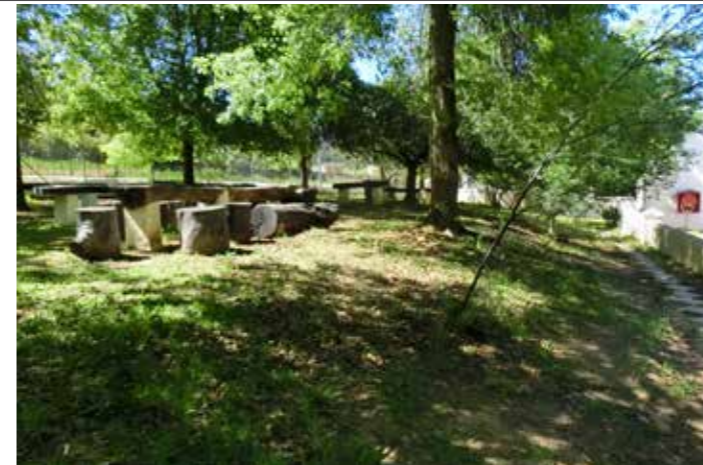
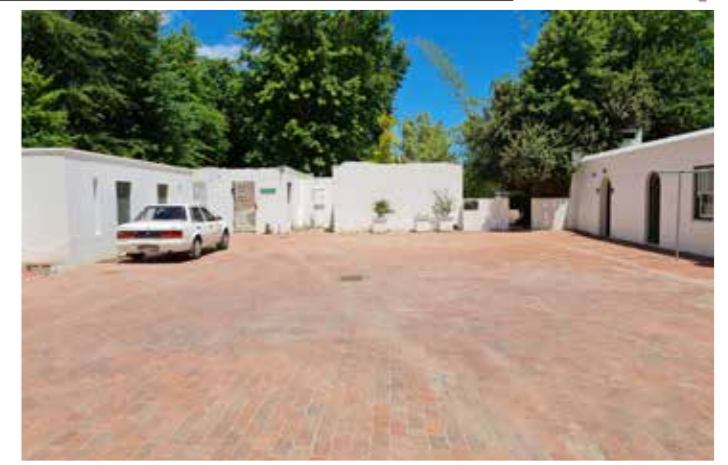
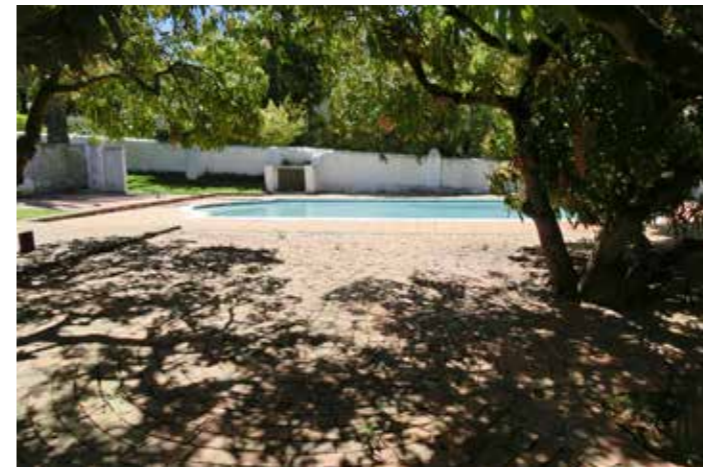
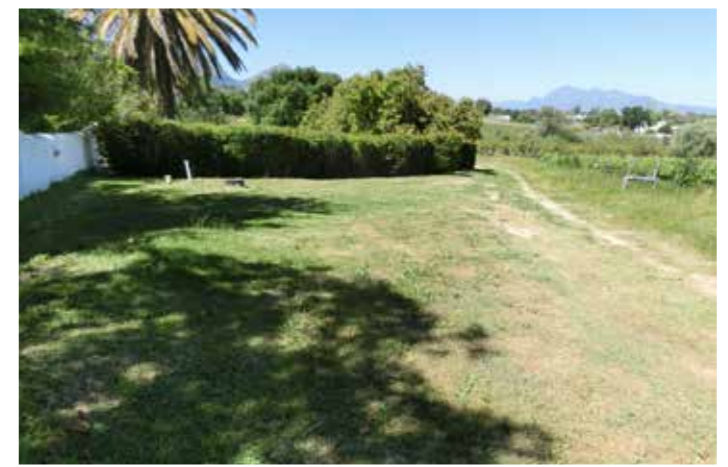
Figure 10. Picnic area east of Du Toit, and swimming pool south west (left); service buildings east of Malherbe House and lawn area west (right) (RSA, 2021; top right Fick, 2021)

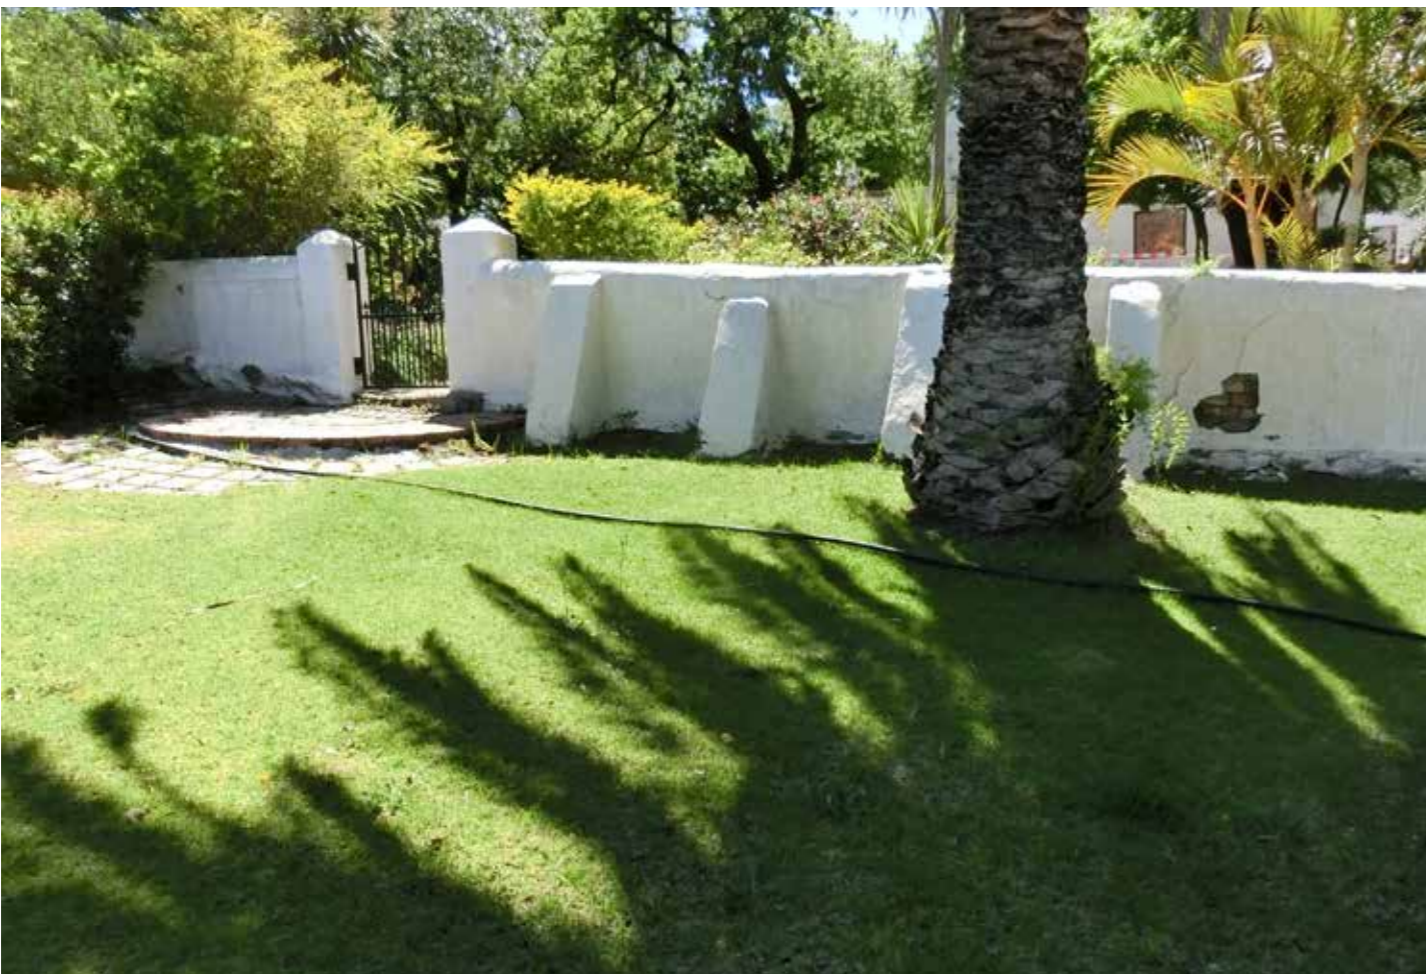
Figure 9. Historic werf walling west of Du Toit House (RSA, 2021)

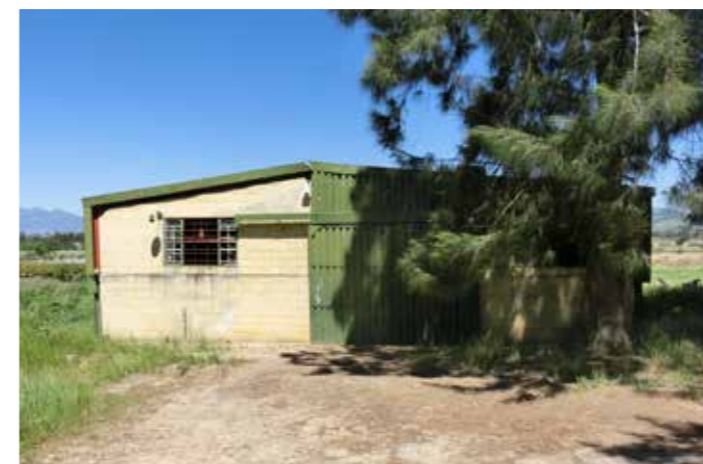
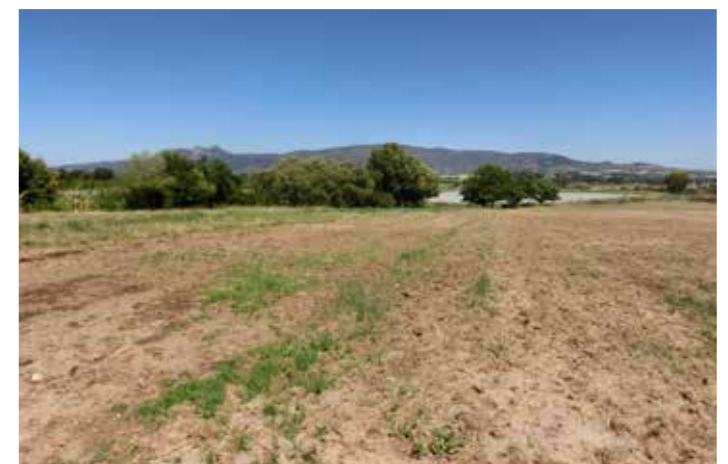
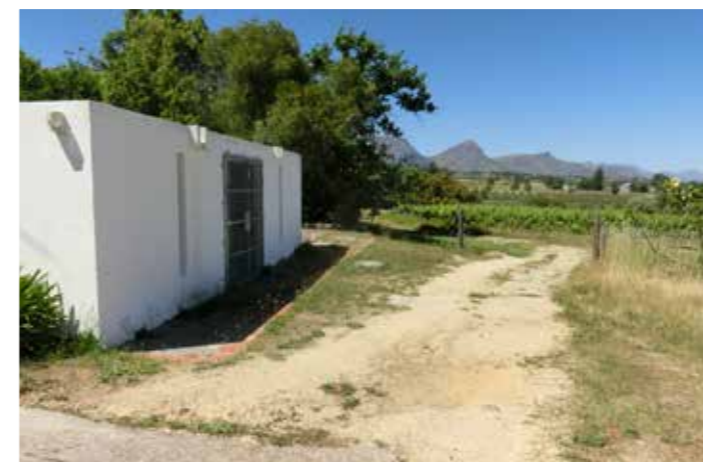
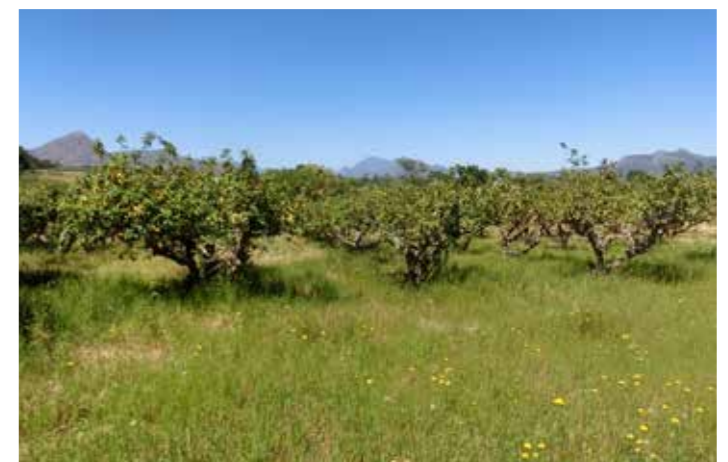
Figure 11. Modern shed and outbuilding (left); fields and orchards (right) (RSA, 2021)

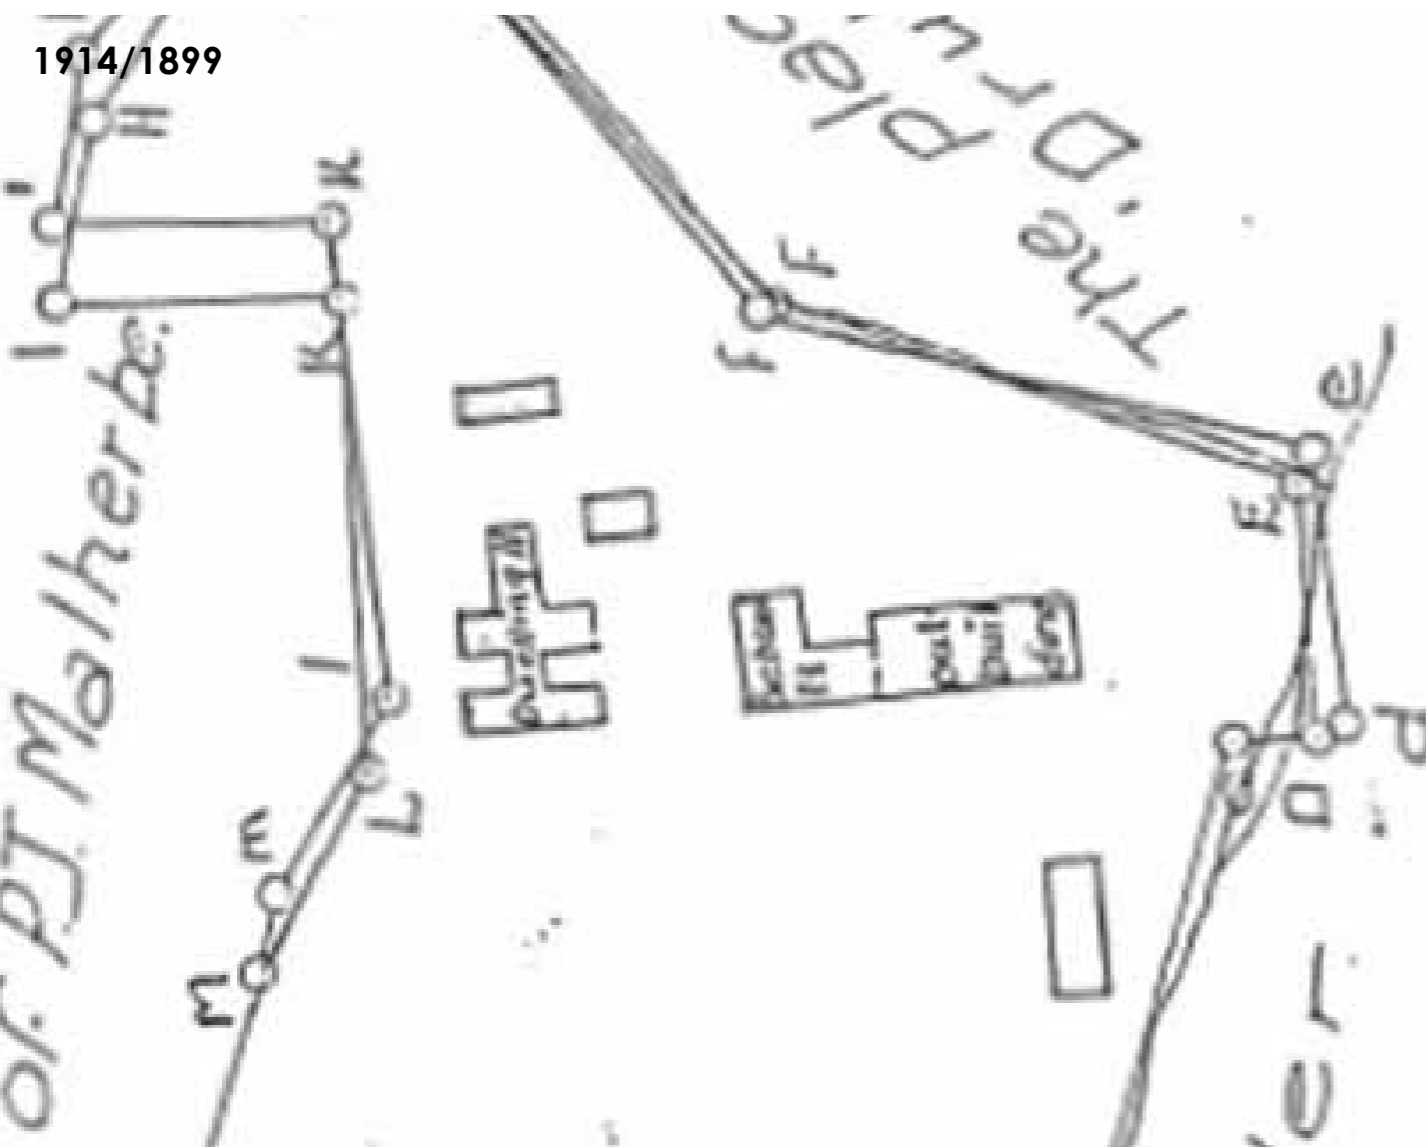
Figure 15. De Kleinebosch werf 1898 survey diagram showing Du Toit House, the fowl run, the Gedenkschool and the boarding house; an unidentified structure is indicated east of Du Toit House (CSG, 2021)

The building by 1830 was a long rectangular structure orientated NS, with a smaller structure aligned perpendicular to it at the southern end. In the second half of the C19th, the original cellar building was extended to incorporate the smaller structure, and this southern portion became a dwelling. At the time the Gedenkschool took ownership in 1881, they transformed the cellar portion at north into the school with two rooms divided by a folding partition, and adding a second floor accessed by an external staircase on the north wall. The southern part of the building became the Assistant Teacher's House, which was extended eastwards in 1898, and its existing thatch roof was replaced with corrugated sheeting. Between 1917 and 1920, the classroom portion was altered, with a back wall extended eastwards, new stairs built and double coach-doors installed. The entire upper story was demolished in 1920, and after the demise of the school, the building was utilised as a fruit packing shed, with the southern portion converted into an unroofed kraal. The top floor of the structure was reinstated in 2002.

A new cellar was built opposite the Gedenkschool to the south, to replace the functionality lost through the remodelling of that building. This cellar was itself transformed into a 10 roomed boarding house for the growing school in 1893s. By 1899, the building was already in need of repairs and renovations; it subsequently fell into disrepair and was demolished in the early C20th.

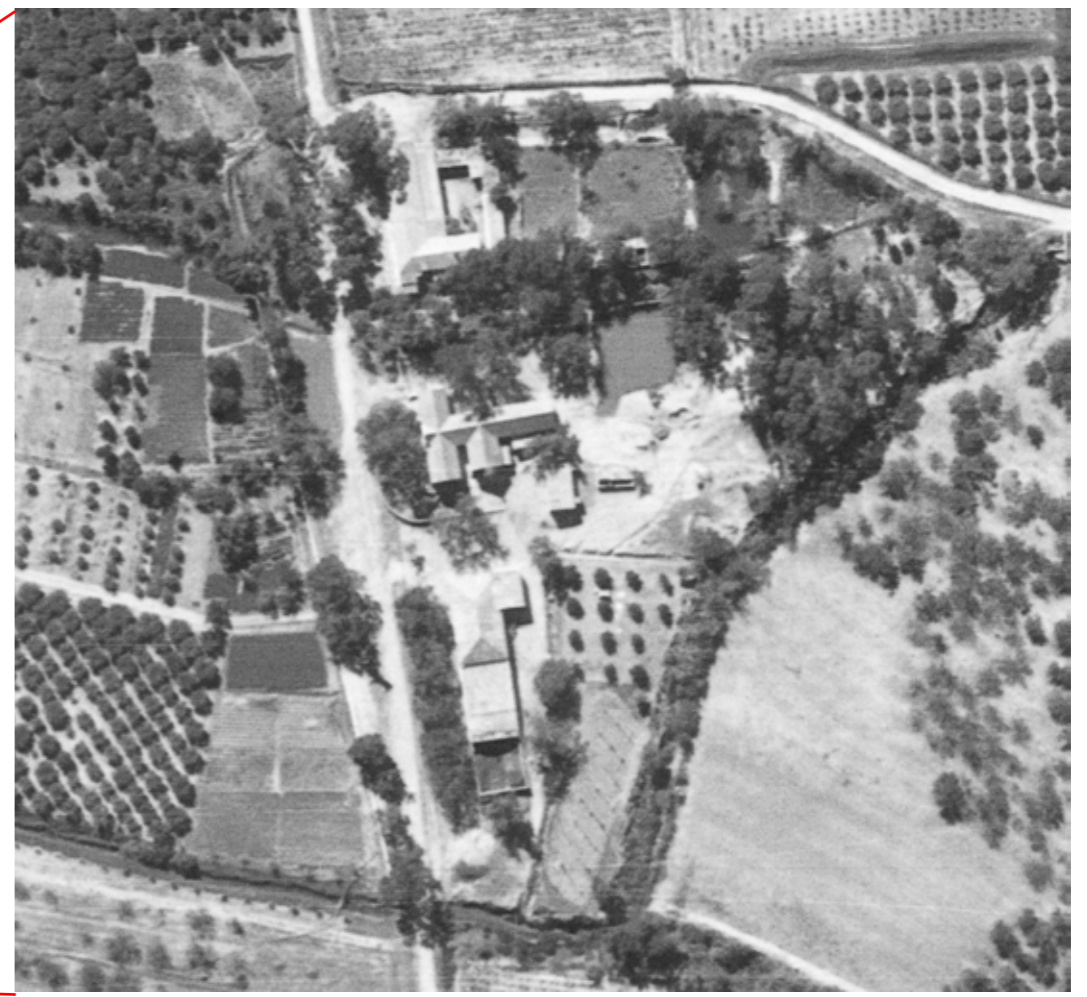
Figure 16. 1938 and 1945 aerals showing the development area (left) and werf (insert); the area of the proposed new agricultural werf is indicated in yellow (NGI, 2021)

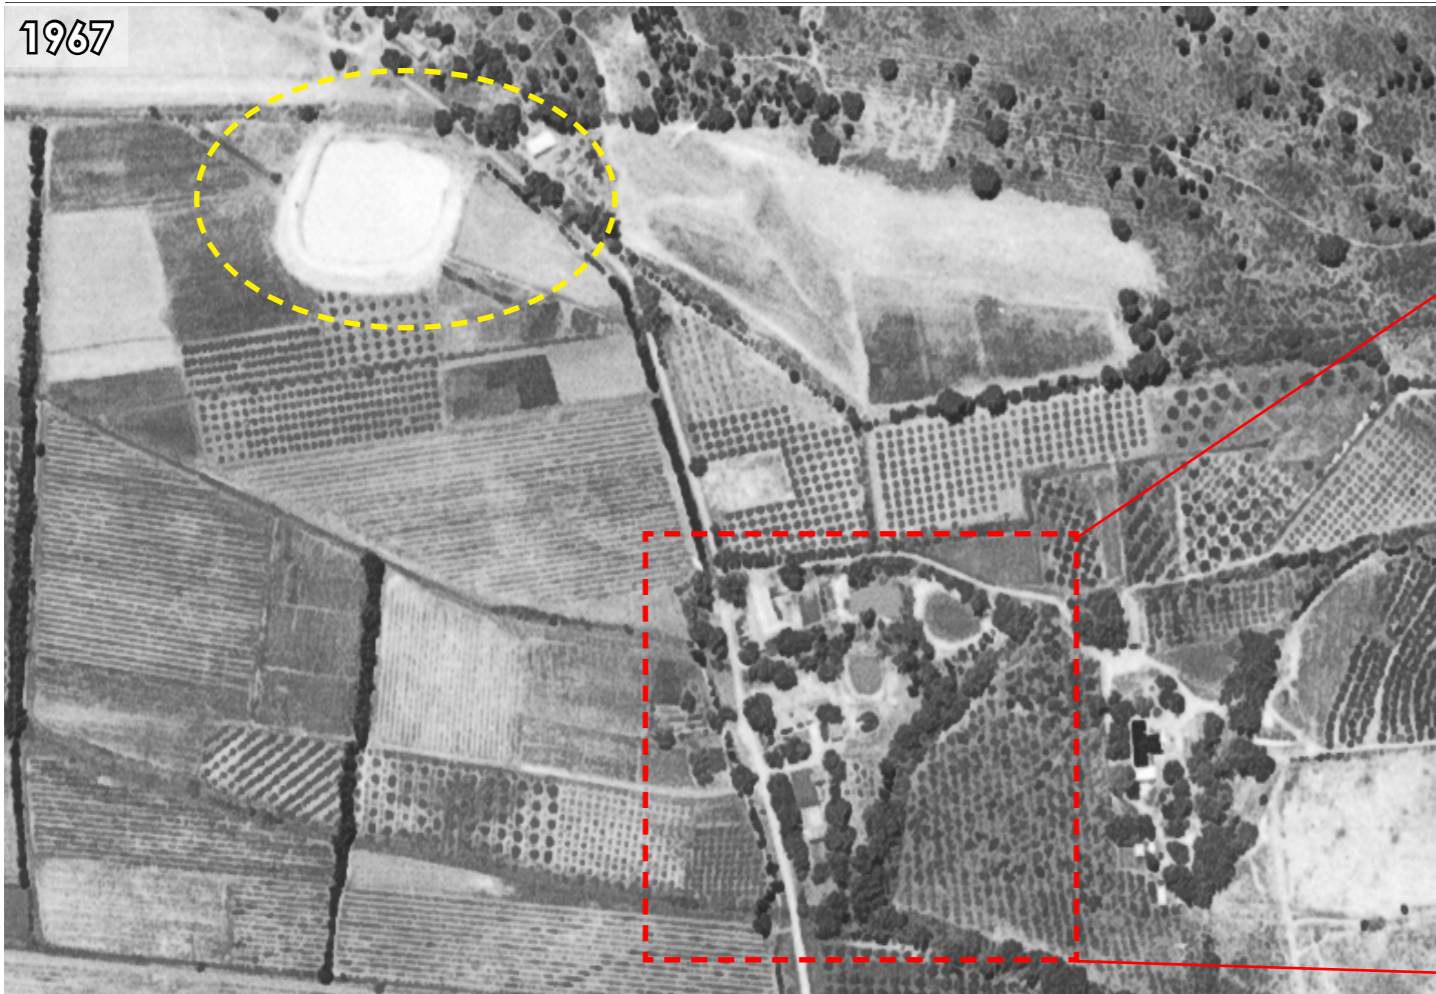
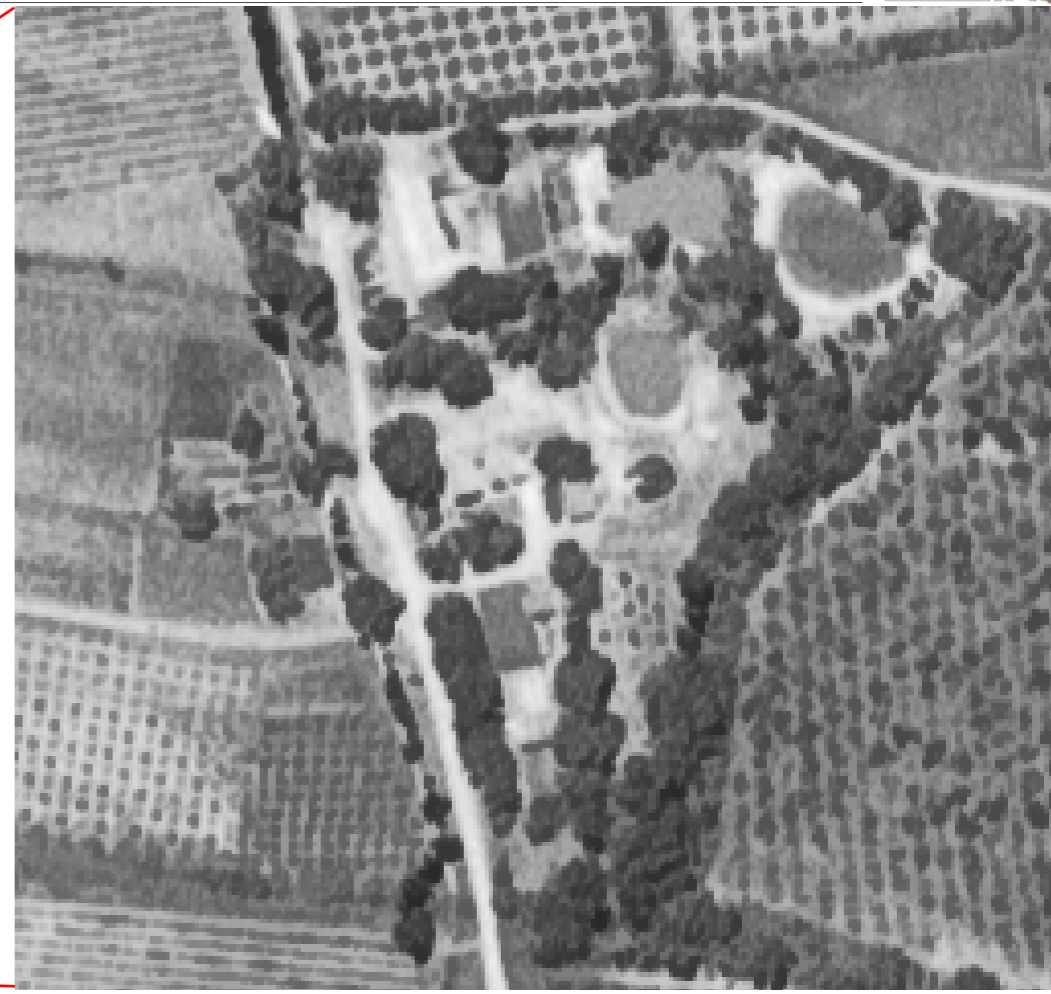
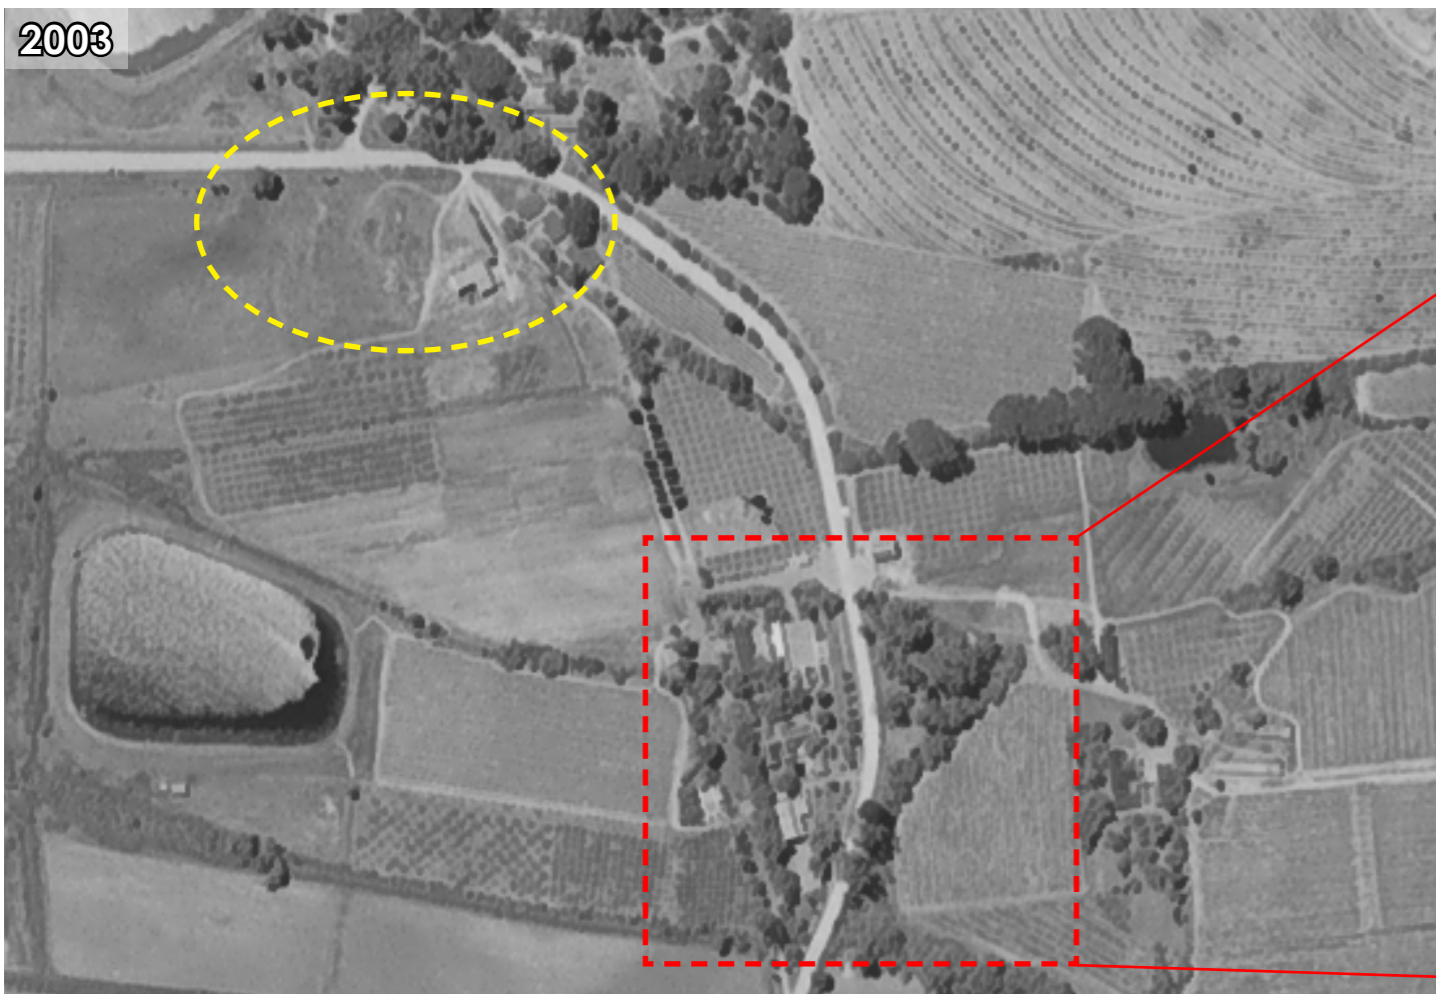
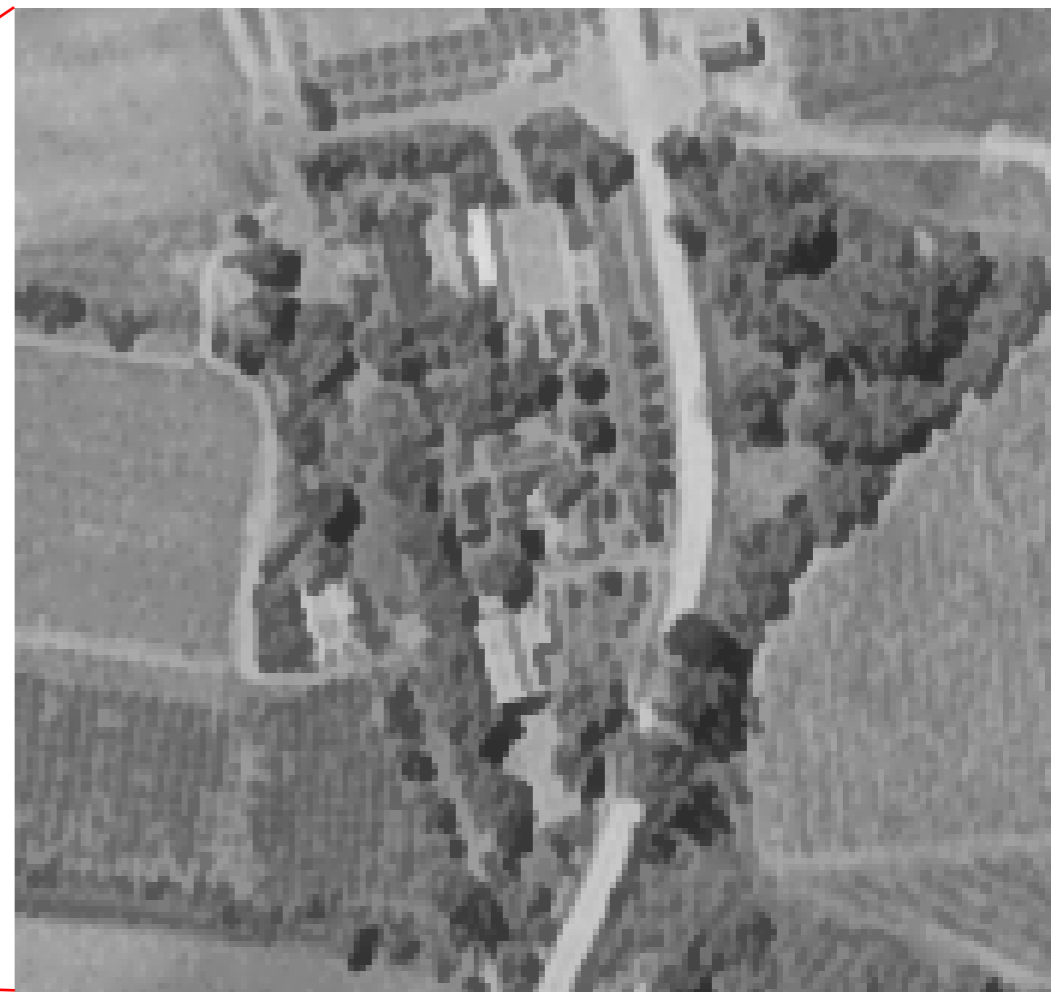
Figure 17. 1967 and 2003 aerals showing the development area (left) and werf (insert); the area of the proposed new agricultural werf is indicated in yellow (NGI, 2021)

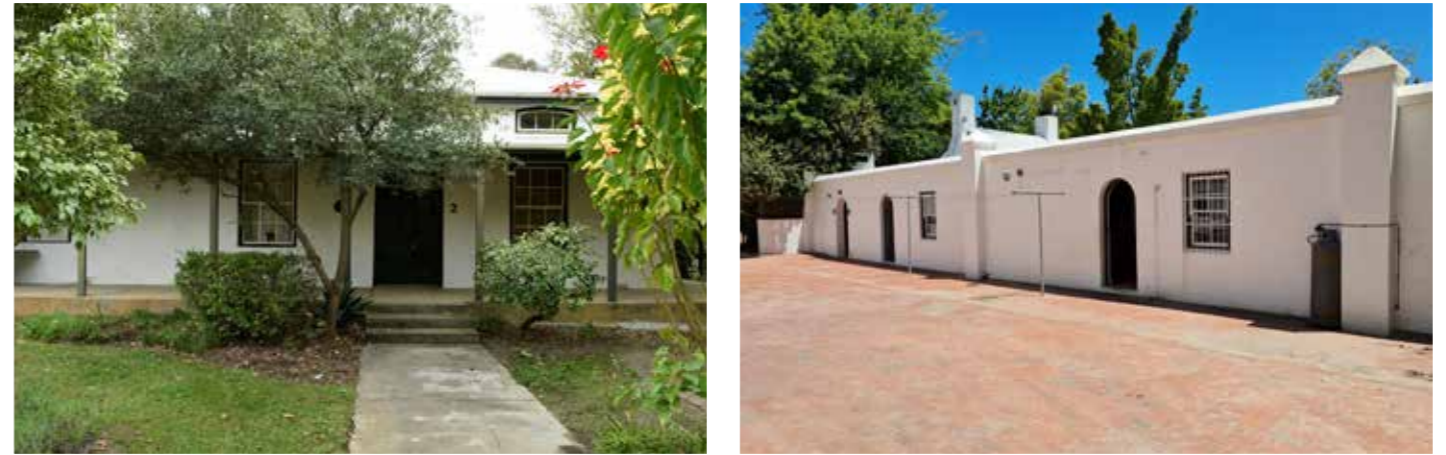
Examination of the area surrounding the house reveals that the surrounding ground is landscaped to west, and paved at east in the modern service and restaurant area. No evidence exists for demolished structures or features, or any cultural material.

Figure 18. Malherbe House landscaped front garden (Malherbe, 2021), and paved area between the modern service buildings at rear (Fick, 2021)

The area behind the house was developed in 2001 as the restaurant and service area of the redeveloped werf at that time. These structures were gutted by the fire, but are not of any heritage significance. Again, the area surrounding these buildings is entirely paved, and no evidence could be identified for either remnant structures or features, nor cultural material.

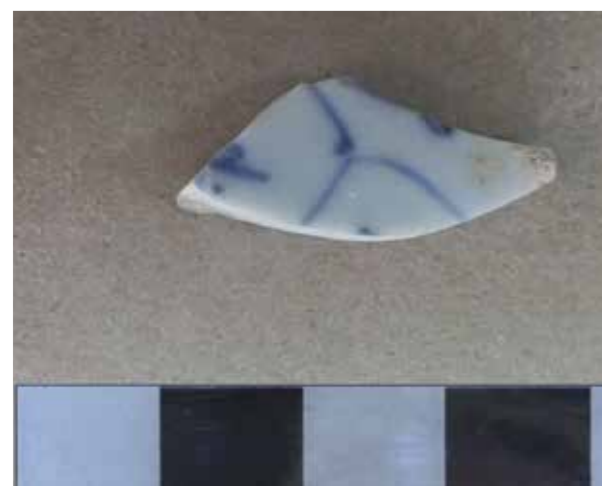
Figure 19. Sherd of Asian porcelain retrieved from Du Toit House fabric (RSA, 2021)

No evidence was identified for demolished structures or features, nor was any cultural material identified. A single sherd of underglaze blue and white Asian porcelain was retrieved from the wall of the south eastern wing of the house, and this is reported on in the phasing report (*Ibid*).
