# ARCHAEOLOGICAL IMPACT ASSESSMENT, KLEINBOSCH FARM 9/1576, DAL JOSAPHAT

submitted in terms of Section 38(8) of the NHRA (1999) for  
KLEINBOSCH FARM 9/1576, DAL JOSAPHAT PAARL

23 November 2021

Prepared by Katie Smuts of Rennie Scurr Adendorff for Malherbe Rust Architects

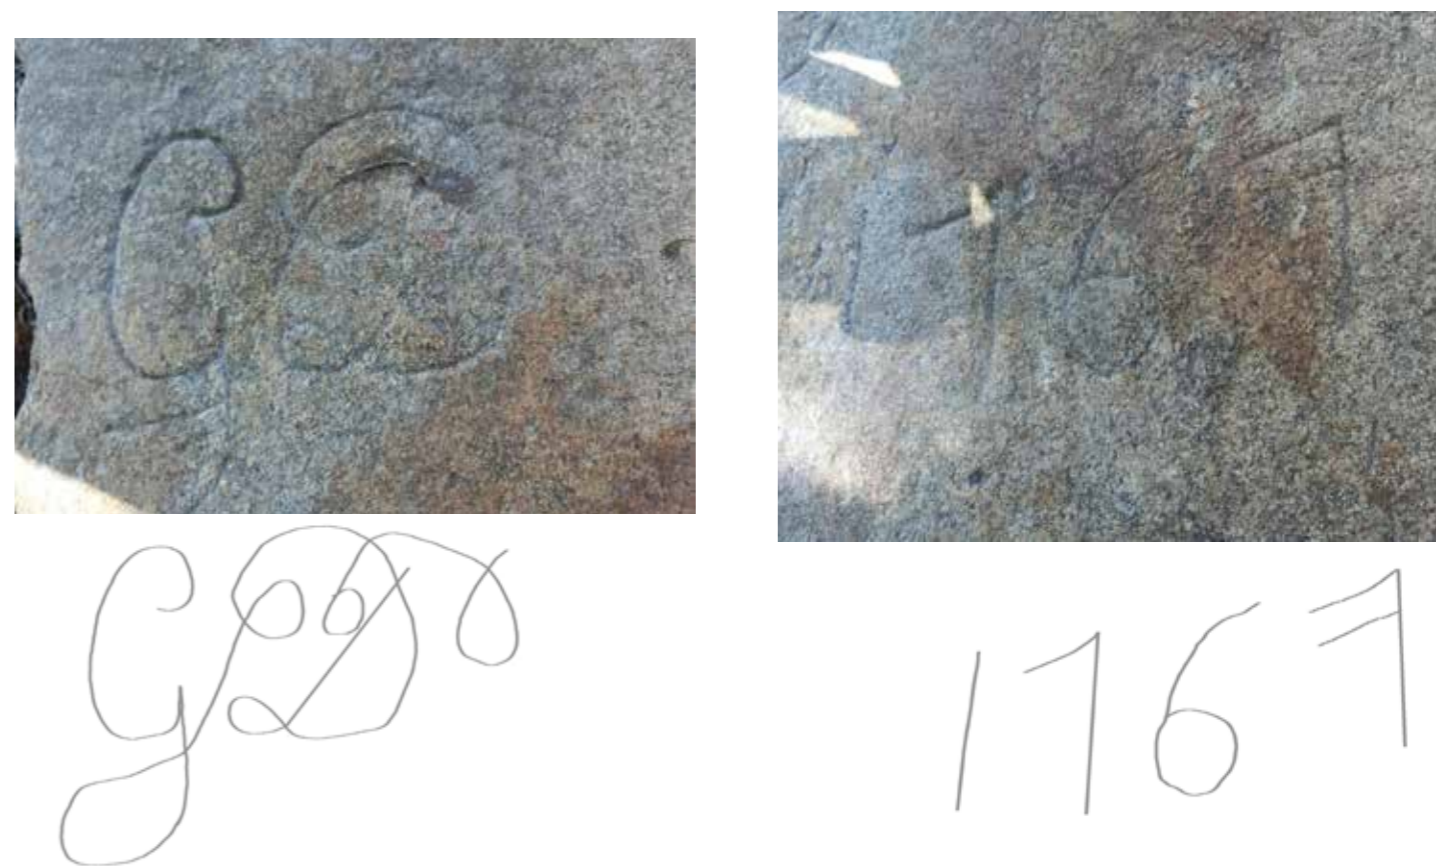
The immediate surrounds of the Gedenkschool are paved, but, like Du Toit House, the area to the east is not. No cultural material or structural remains were noted in this vicinity, although a slab of inscribed, dressed stone was located here. This stone is purportedly linked to the Hen House. Vos (2001: 203) reports “[t]here is evidence that in front of the cottage was a stone with engraved initials “GDT” (?) and the date “1767” below it (Magriet Louw, pers. com.). This has unfortunately disappeared. Dr Fagan (1994: 487) related that this stone was to be found at Druk-My-Niet but it could not be traced”.

The inscription appears to read “GD” followed by a stylised “T” or possibly a symbol, with the date ‘1767’ below. The correlation between the inscribed

stone and the Hen House is not known, however, and it cannot be assumed that the date on the stone is linked to the construction of the Hen House.

Figure 21. Detail of inscribed stone (above) and transcription (below) (RSA, 2021)

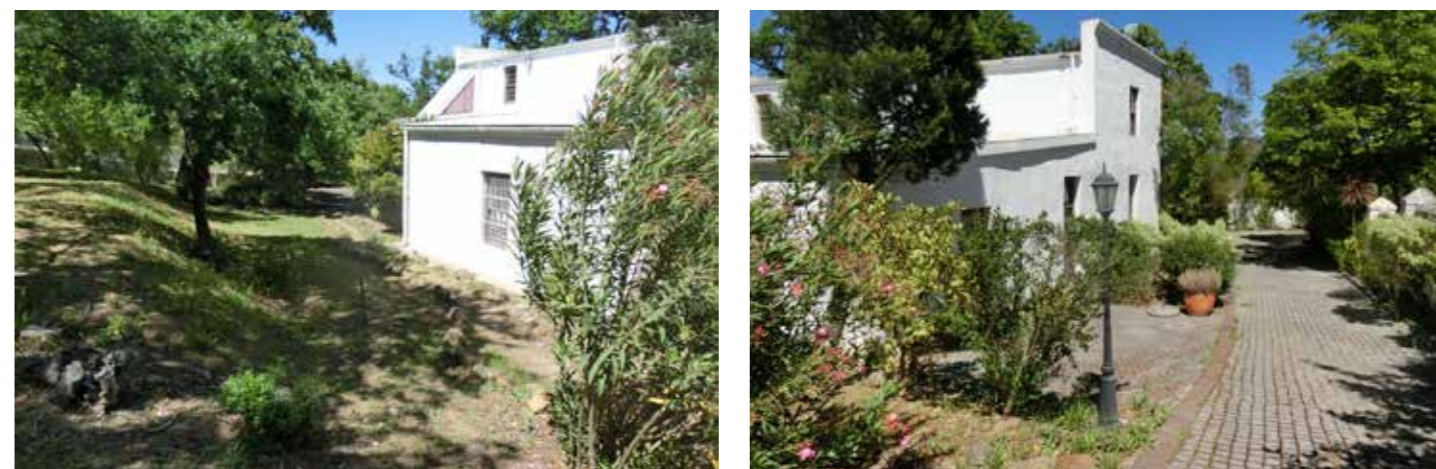
Figure 22. Transformed state of landscape around Gedenkschool (RSA, 2021)

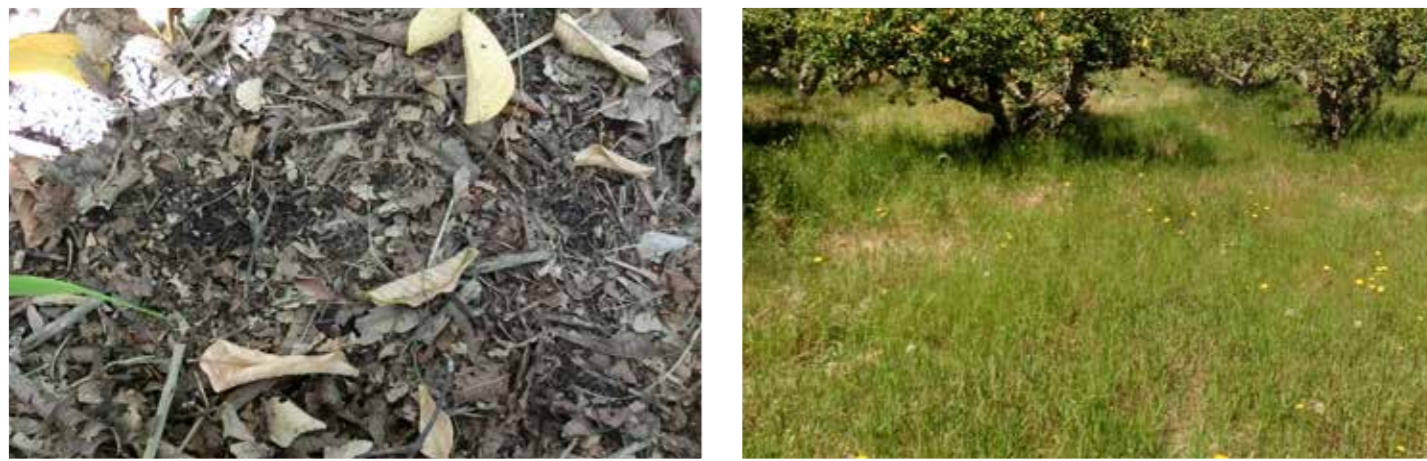
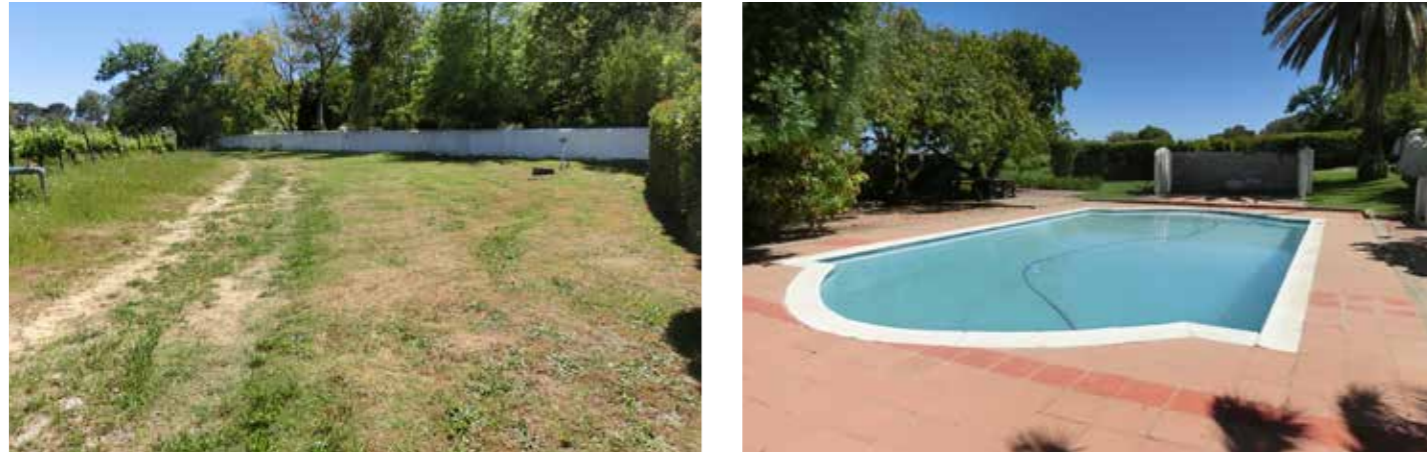
The guava orchard, pool and lawn are located across the wapaad from the Gedenkschool and Du Toit House, beyond a portion of historic ringmuur. Visibility was good within the orchard between the trees, where turned earth was inspected, but the grass of the lawn area occluded visibility there, and the pool surrounds are paved. There was no evidence of archaeological remains either artefactual or structural identified in this wider area.

Figure 23. Variable site conditions in areas adjacent to historic werfs (RSA, 2021)

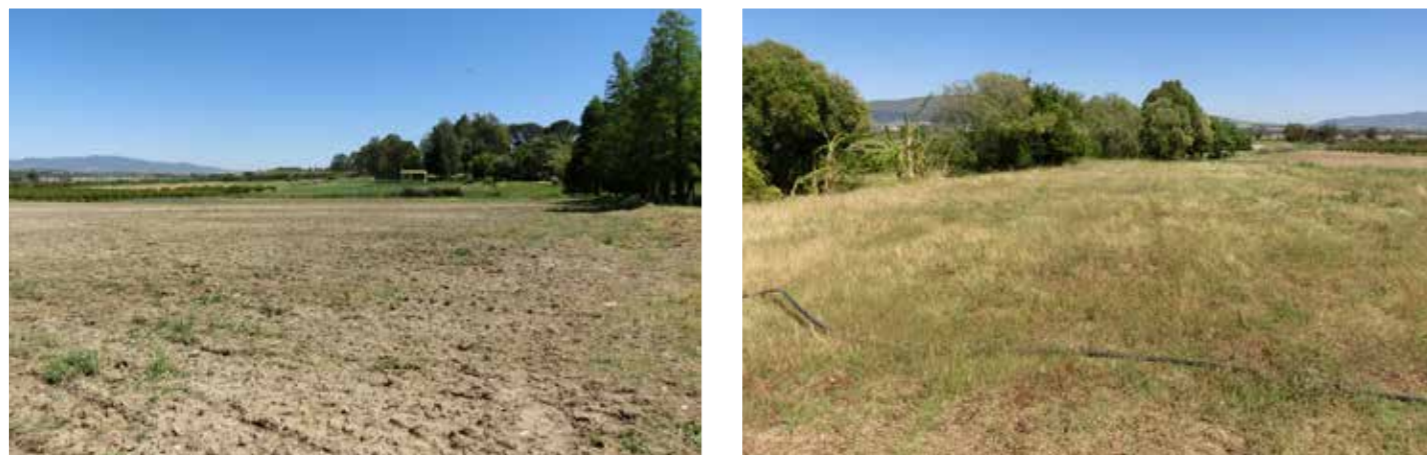
The location of the stone cottage is attested to in various oral accounts of the farm collected during previous assessments, and related in Vos (2001). The purported site of the cottage is currently at the very edge of a ploughed field beyond the end of the current driveway. A single modern service building is located to the south west of the area where the stone cottage is thought to have been located. Archaeological visibility here was good, but no structural remains or cultural material were identified.

Figure 24. Variable site conditions in areas adjacent to historic werfs (RSA, 2021)

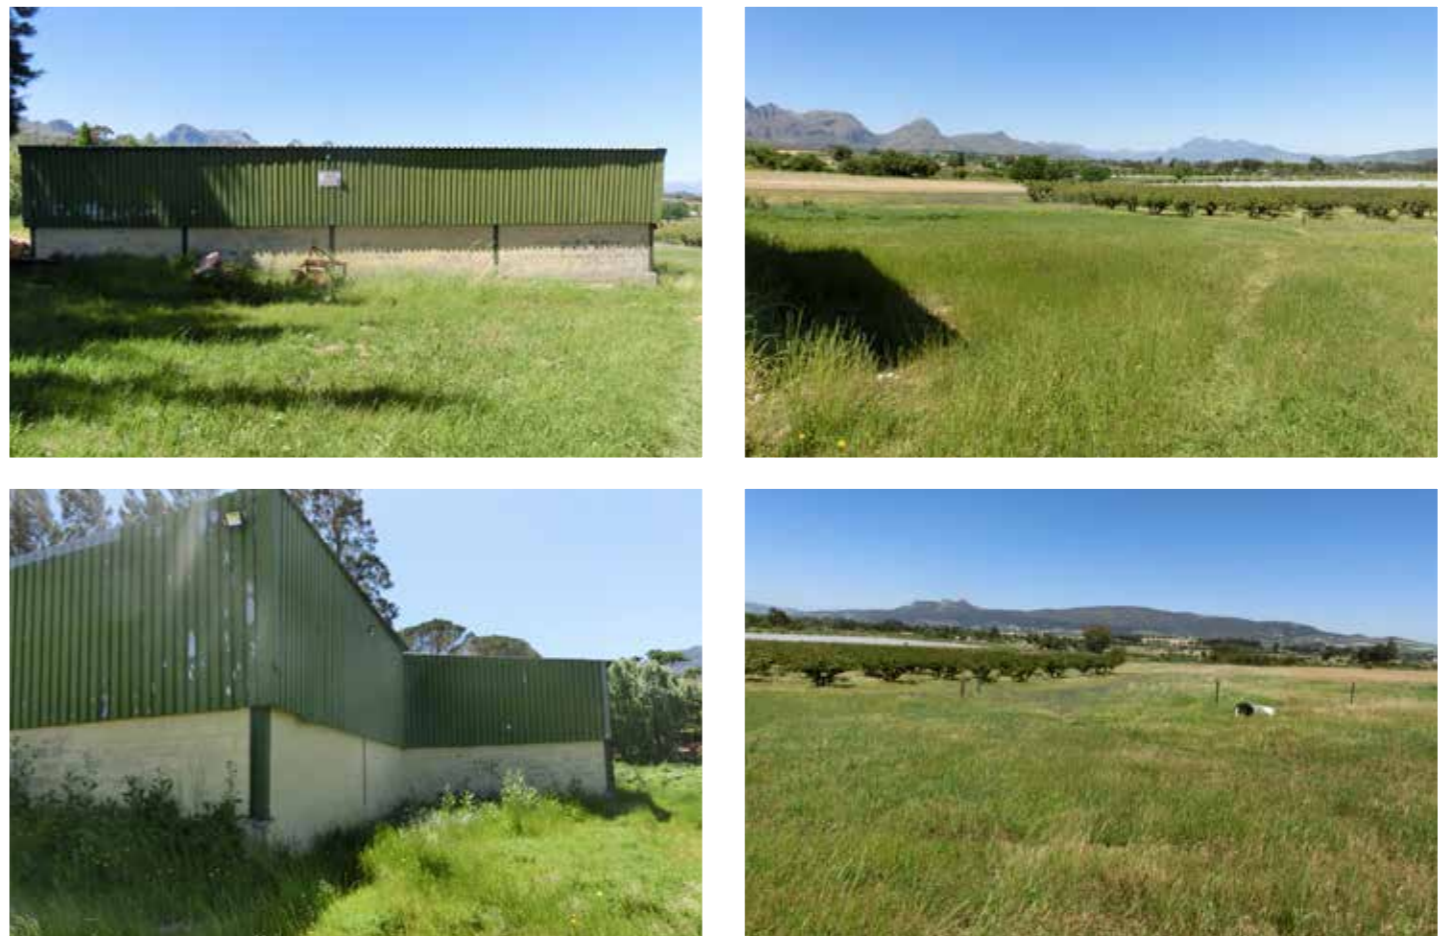
The final area investigated is across the wapad from the current workers' accommodation. The area proposed for development is open ground that is partly ploughed towards the west. This ground occupies the site of a large dam that was built in this area in the mid-C20th and later filled in when the current dam was built to the south west. The extent of this dam is still faintly visible in aerial images.

A large shed is located south east of the development footprint. This shed was built in mid to late C20th, and built of breeze block, corrugated sheeting and iron windows.

Figure 25. Modern shed and site conditions in area of proposed new development (RSA, 2021)

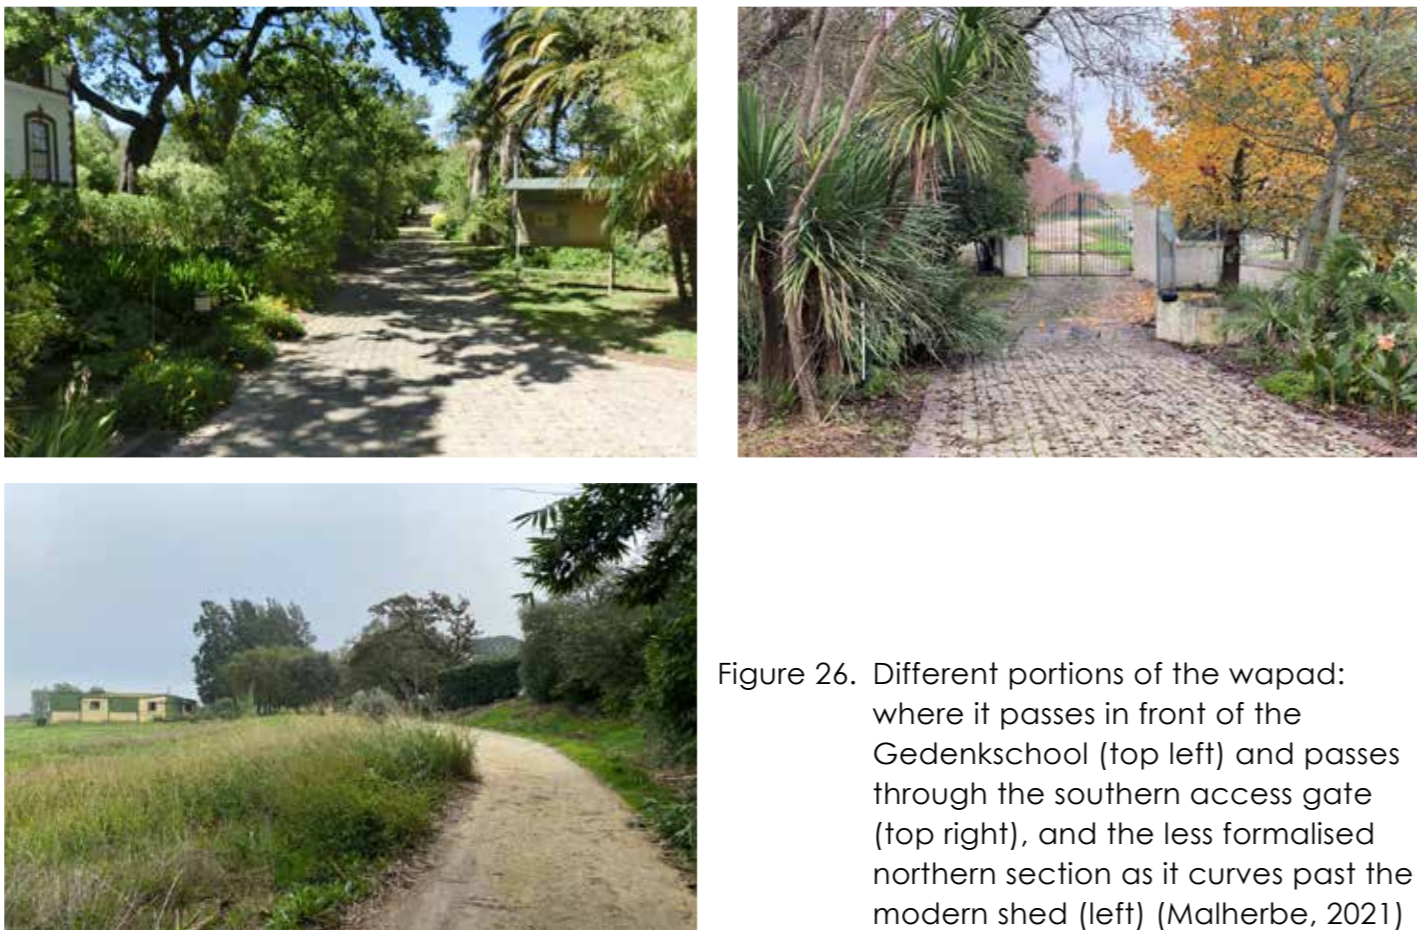
The disused access road between Malherbe House and the current driveway, and the old wapad both hold potential archaeological significance as elements of the archaeological landscape and routes of frequent traffic; no archaeological material has yet been recorded along them.

Figure 26. Different portions of the wapad: where it passes in front of the Gedenkschool (top left) and passes through the southern access gate (top right), and the less formalised northern section as it curves past the modern shed (left) (Malherbe, 2021)

Reinstatement of old road alignments has a **low-moderate** risk of impacts resources of moderate significance where material associated with long-term, intensive use of these routes could be damaged, displaced or destroyed. Without mitigation, impacts would be high and negative, while mitigation could ensure **neutral** to **positive** outcomes.

Focused periodic monitoring is recommended for interventions along old road alignments to test for possible associated cultural material

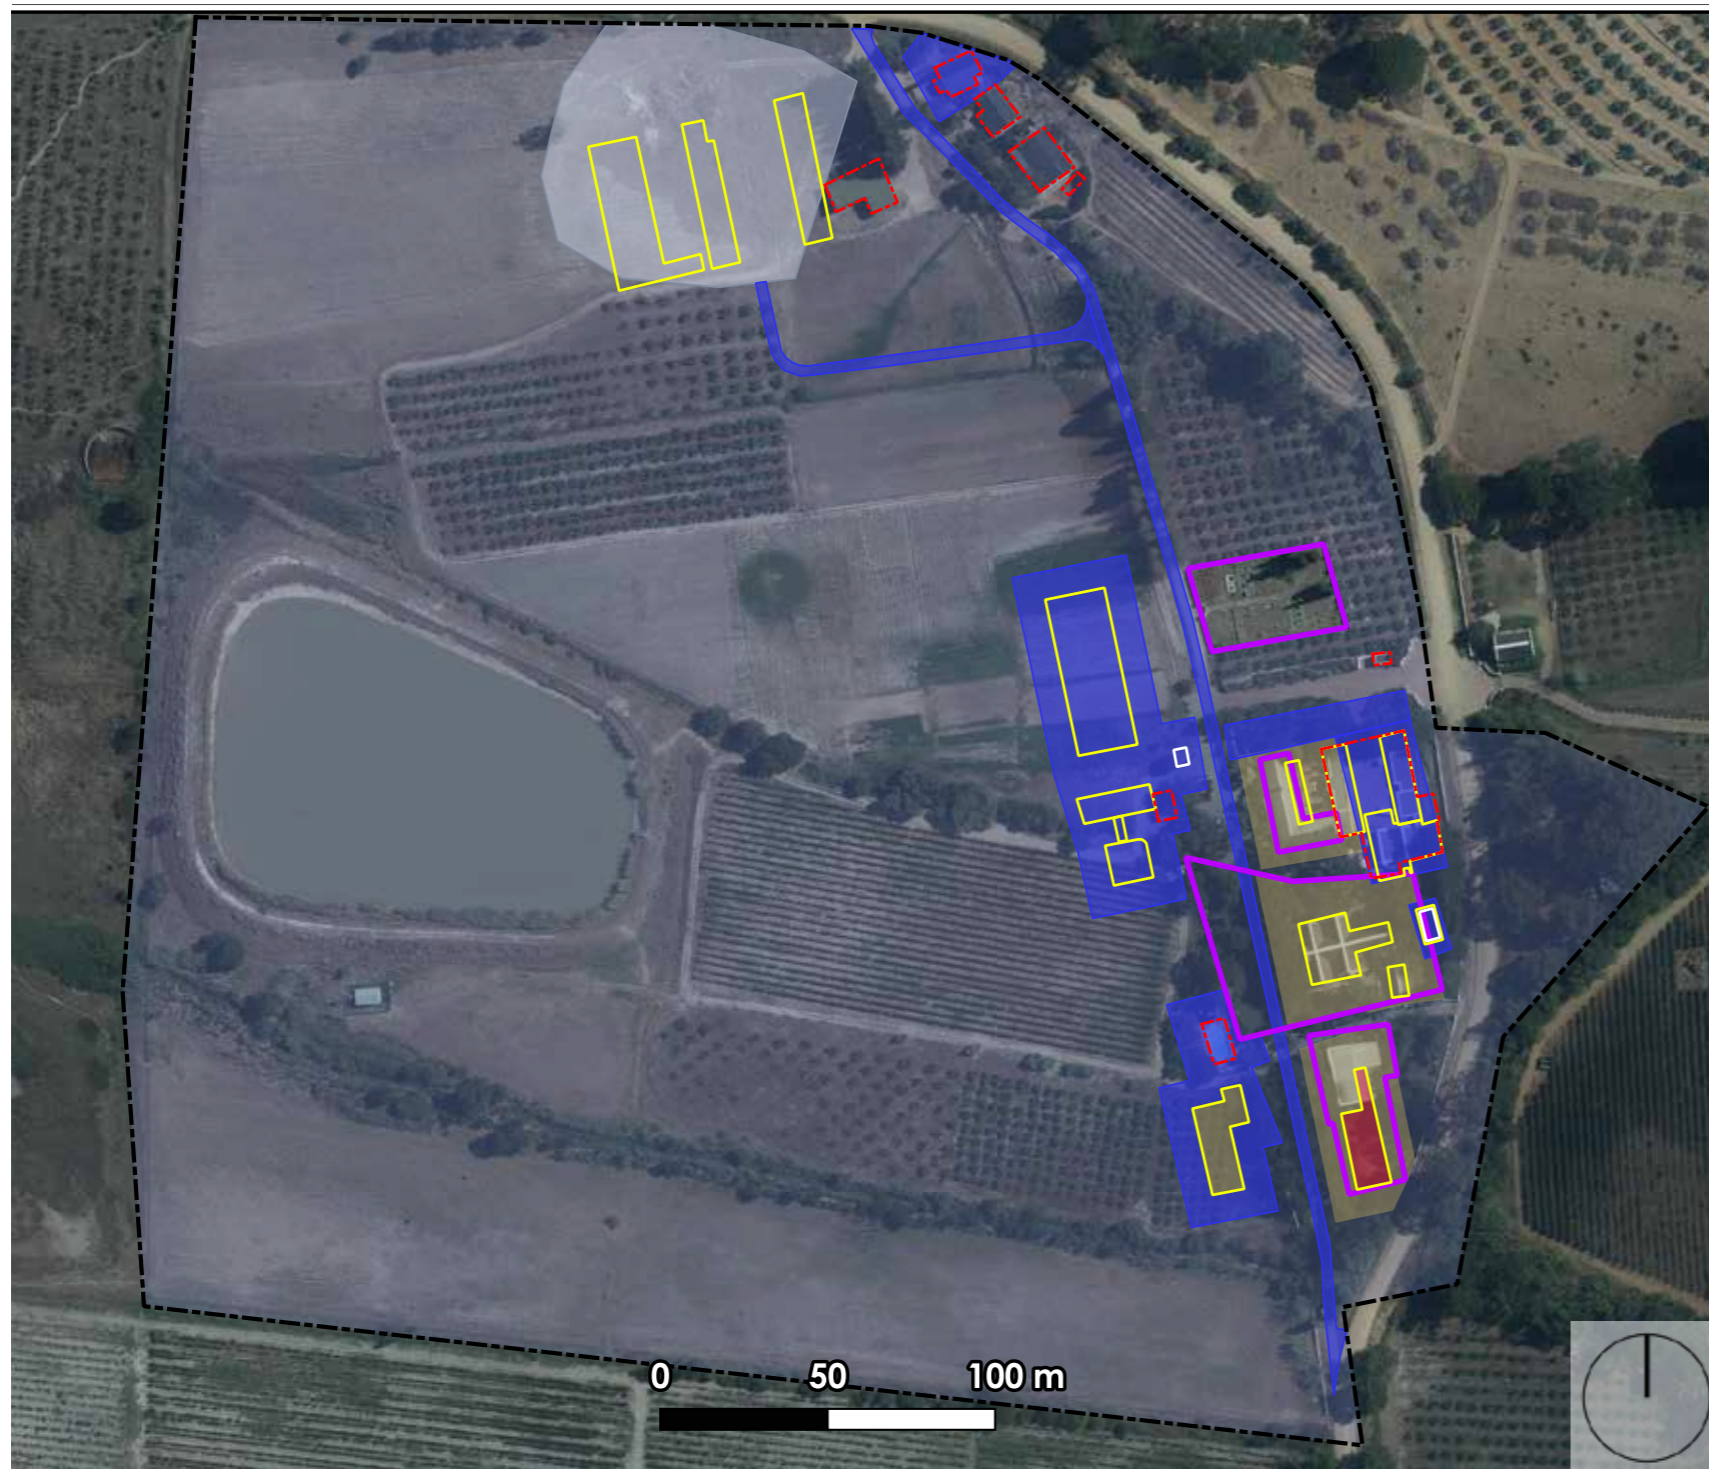
**Mitigatory Strategies**

This should take place periodically across the entire property when earthmoving, excavation or landscaping activities are undertaken; such monitoring can be infrequent and irregular. It is not anticipated that this monitoring will yield significant, in situ archaeological material, but is recommended in light of the possibility of human remains occurring on the property, the opportunity presented by redevelopment to expand the archaeological characterisation of historic farms such as these, and the generally high significance of the landscape and site history.

Intensive monitoring should take place within close proximity to extant historic structures where the possibility exists that in situ archaeological deposits such as middens will be encountered, or where stratified deposits might occur in relation to built fabric, such as historic foundation trenches, backfills, floor deposits etc.
