HERITAGE IMPACT ASSESSMENT: PROPOSED KENHARDT PHOTO-VOLTAIC SOLAR POWER PLANT ON REMAINDER OF THE FARM KLEIN ZWART BAST 188, NORTHERN CAPE PROVINCE

(Assessment conducted under Section 38 (8) of the
National Heritage Resources Act 25 of 1999)

April 2012

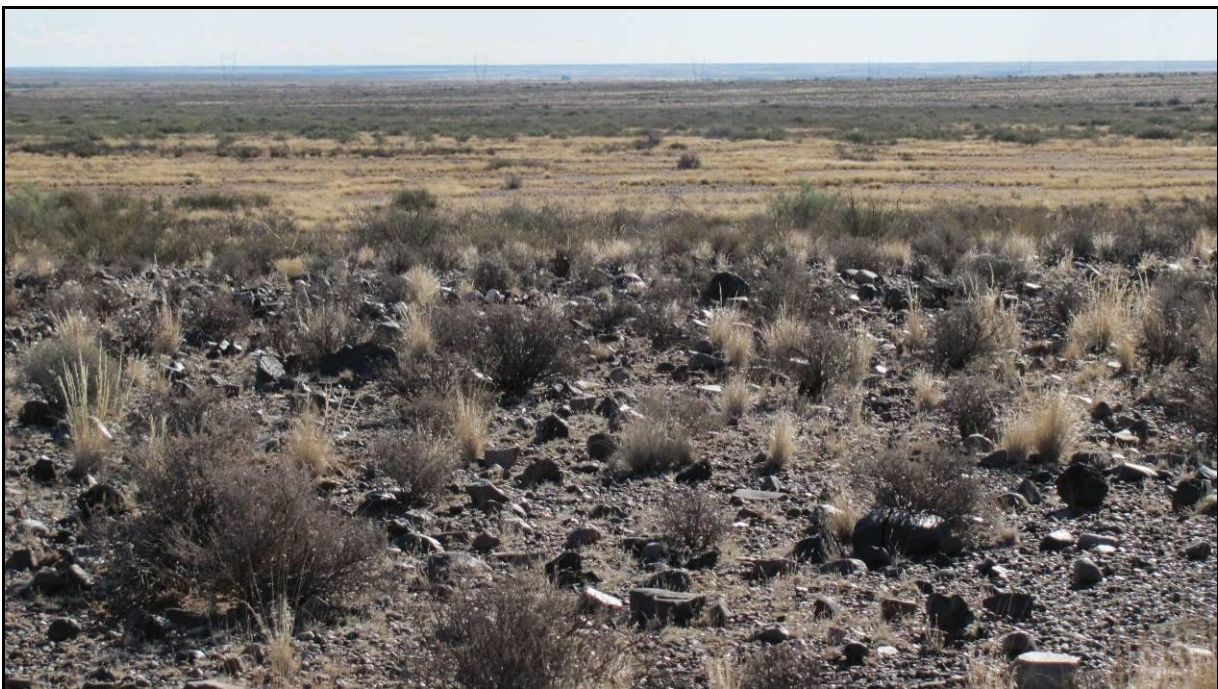
Plate 2: View of the shallow drainage channel which crosses the site from west to east. The drainage channel has been excluded from the proposed facility (see Figure 3). The transmission lines which cross the property are visible in the distance.

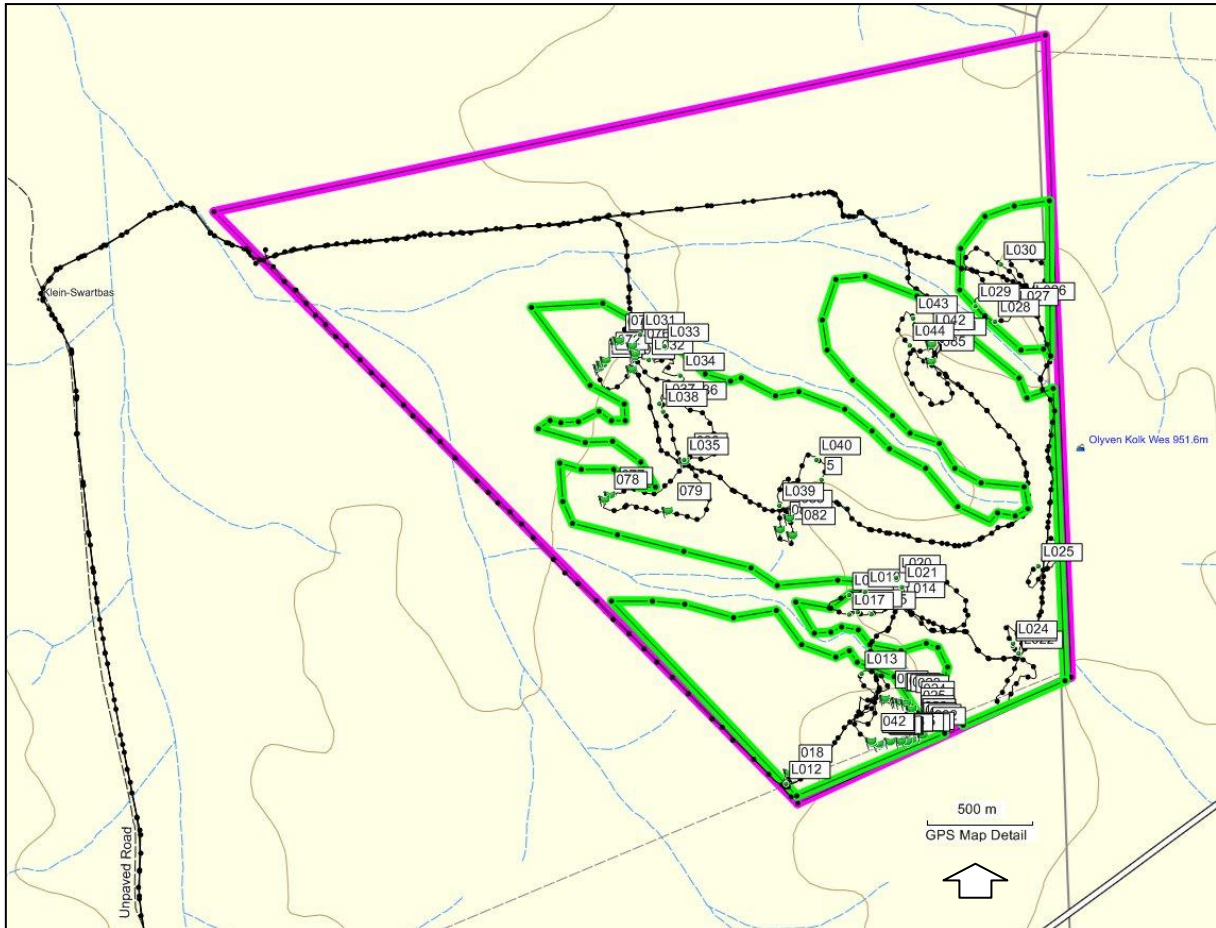
Figure 4: Map of tracks and sites recorded during field survey. The green lines indicate the boundaries of the proposed facility. Note the position of the farm house of Klein Swartbas to the west of the area.

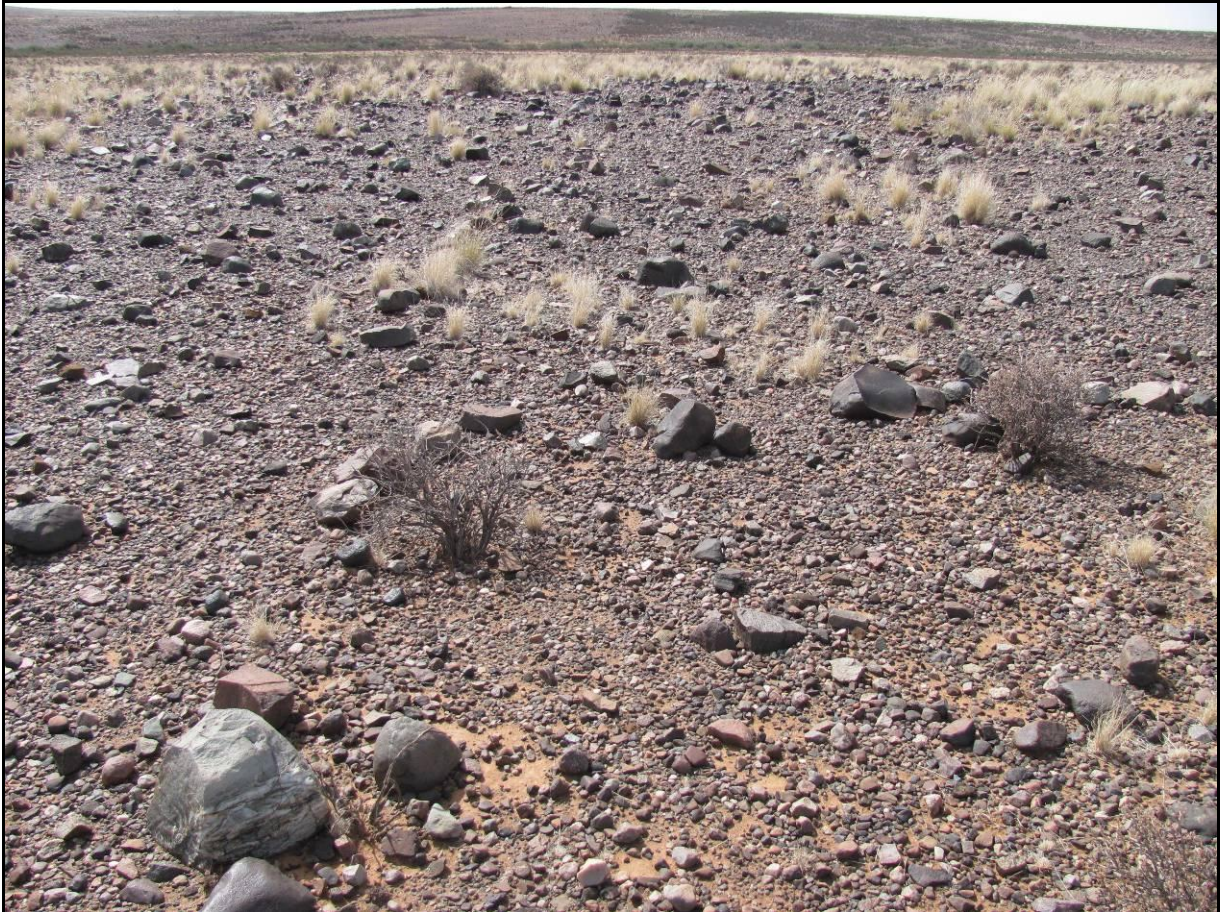
Plate 3: View of the gravel pavements where ESA and MSA artefacts occur in abundance. Many of the large cobbles have signs of being knapped.

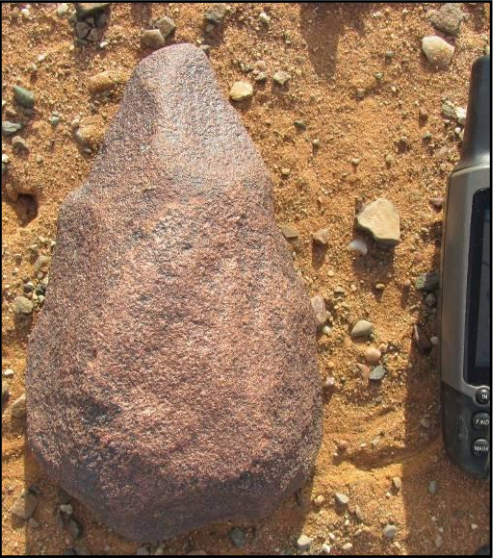
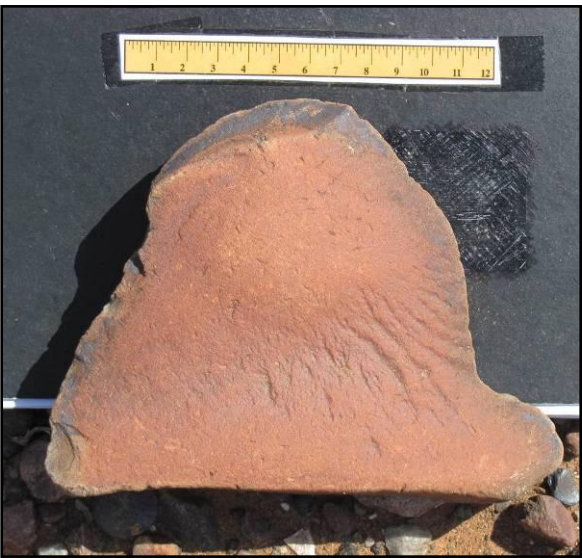
A number of large implements were recovered which resembled classic bifaces (ESA). They are very weathered and occur in isolation (Plate 4). They are made on very weathered hornfels and while occasional flakes and cores may occur, there is no evidence of ESA knapping sites.

Plate 4: Large weathered handaxe; **Plate 5:** Large weathered flake (scale in centimetres).

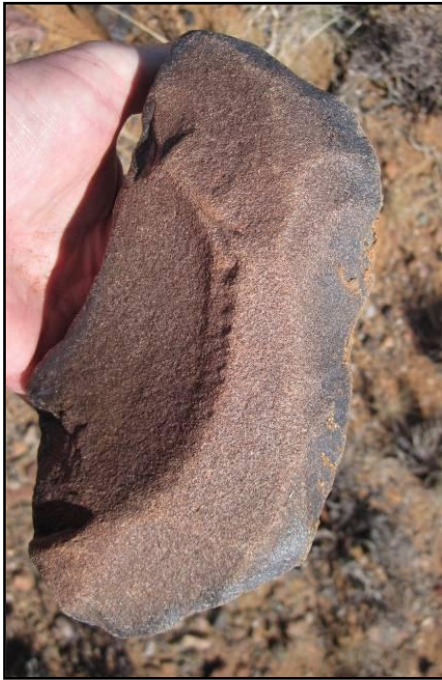
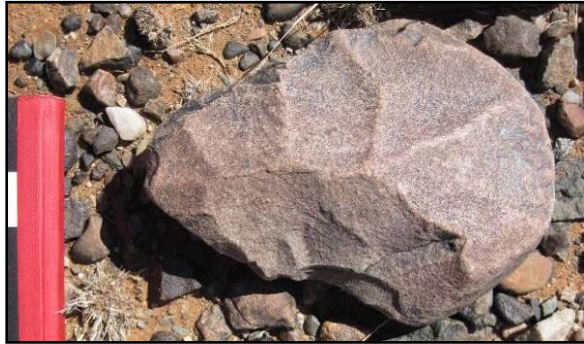
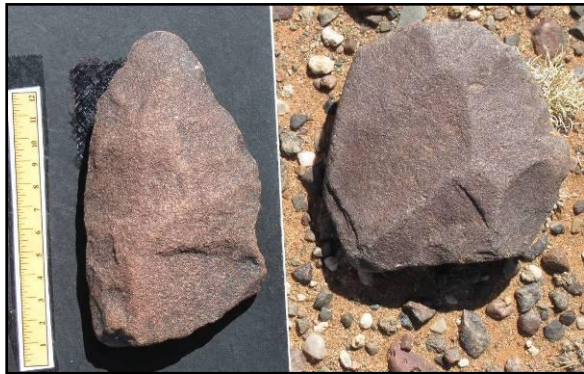
Plate 6: Weathered flake; **Plate 7:** Handaxe on quartzite; **Plate 8:** Weathered flake and core.

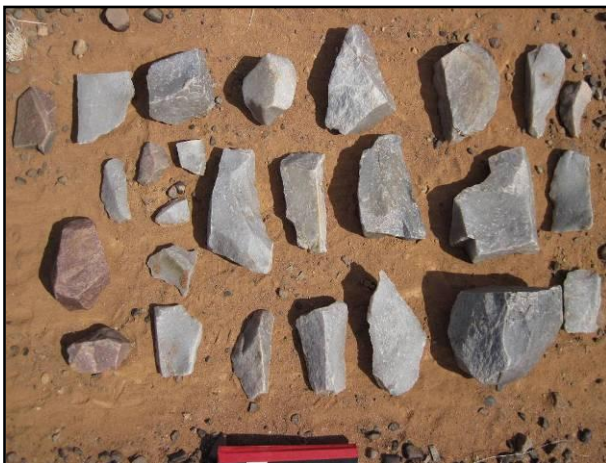
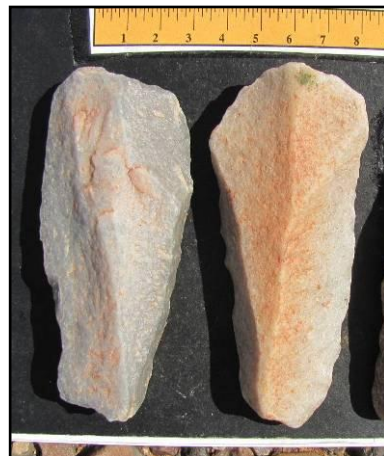
Most of the material we observed can probably be ascribed to the Middle Stone Age (MSA) (Plates 10, 11). Flakes, blades, chunks and cores make up the majority of the scatters, and retouch was present on some items. The most predominant raw material was pale grey/white quartzite, although red quartzite, banded ironstone, quartz and agate lumps were also recorded.

Plate 9: Characteristic collection of grey quartzite cores, chunks and flakes with few diagnostic elements. **Plate 10:** Typical triangular MSA flakes with convergent flake scars on the dorsal surface.

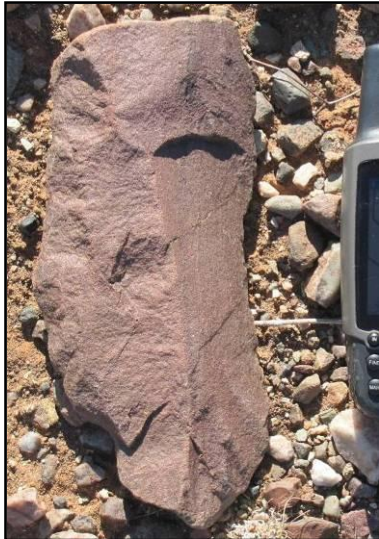
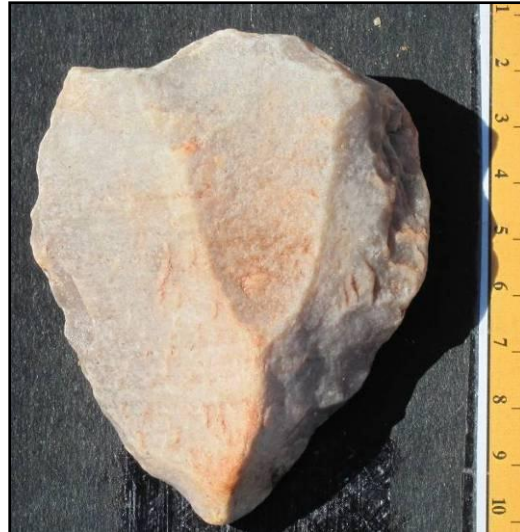
Plate 11: Blade on red quartzite; **Plate 12:** Triangular grey quartzite flake.

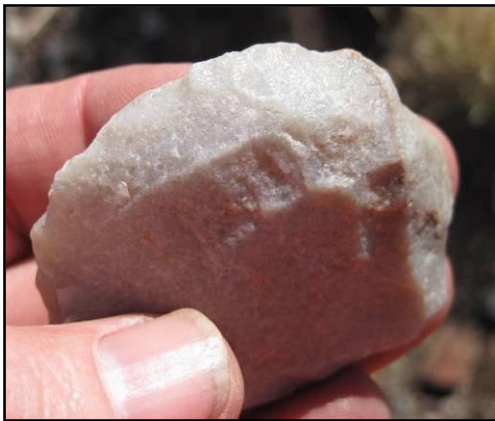
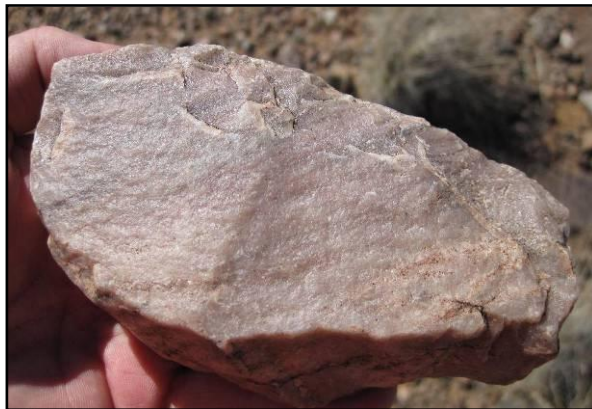
Plates 13 & 14: Retouched pieces. The flake on the left has a more classic scraper retouch, while the artefact on the right has steep step flaking.

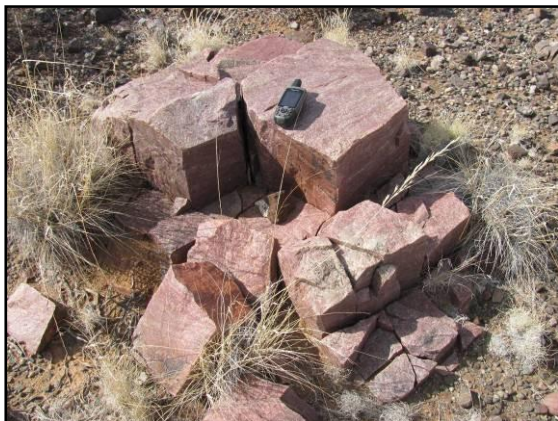
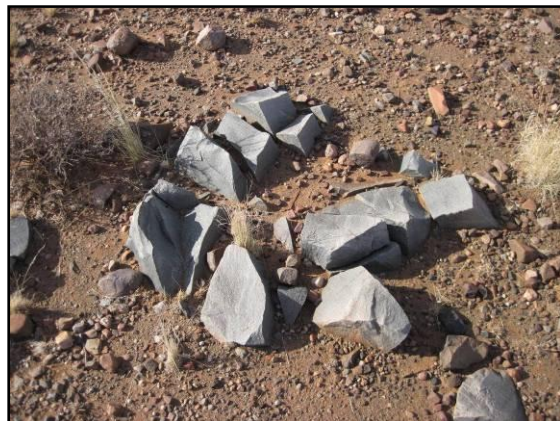
There is also some evidence of the knapping (flaking) of stone artefacts on site, from local sources of raw material. It was observed that some quartzite chunks, cores and flakes made on a particular shade of quartzite, occurred in close proximity. For example, there is a dense scatter of pink quartzite flakes within a 5m radius of the block of quartzite (Plate 15).

Plates 15 & 16: Block of pink quartzite (left) and grey quartzite (right), both with evidence of knapping of stone artefacts in the immediate vicinity.

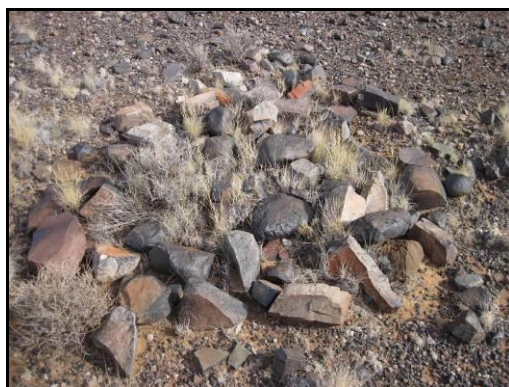
Plate 17: A few stone cairns were recorded in the study area.

While there is considerable evidence for stone age use of the area, formal burials have never been found in South Africa that date to the MSA, and while graves from the LSA are found from time to time, these tend to be found in softer soils, as would also have been the case in the colonial period. Although a few stone cairns were recorded, no typical surface grave markers were observed and we consider it highly unlikely that any graves are present on the site.

In the event that human remains are uncovered beneath the soil surface during the construction of the facility, work in that location should stop, and the heritage authorities (SAHRA) should be notified. They may recommend exhumation.
