Archaeological Impact Assessment

Title: Keurkloof (Prima Klipbrekers) Quarry, Robertson.

Proposal to convert from old order to new order mining rights at an existing quarry, **Breede River/Winelands Local Municipality, Western Cape**.

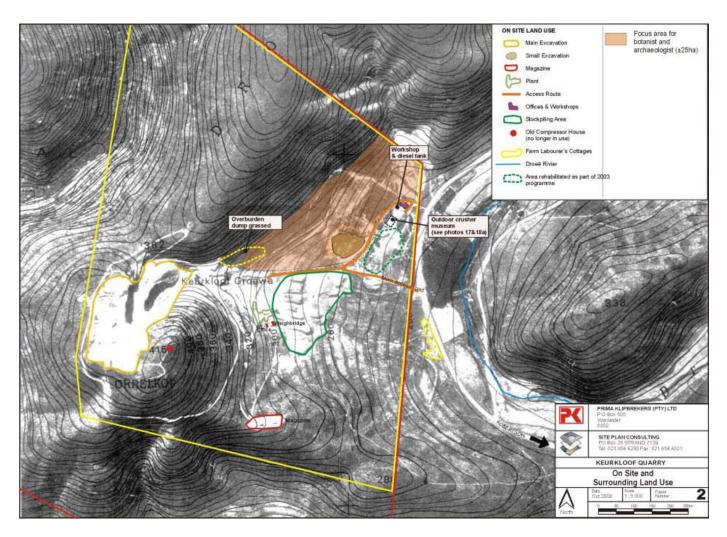
Figure 2. Plan of the property showing the focus area for future development

The property (Figure 2 & 3) is dominated by the hill Orrelkop and the ridge of the Droeberg running north from it with concordant summits of 460 m. The slopes are steep but flatten on the eastern side. The ongoing quarrying operations are on the west side of Orrelkop making a deep cleft in this hill. The intention is to extend future operations along the lower flanks (below 320 m) of the Droeberg towards the northeastern corner of the property. It is at or below this elevation on the flatter ground that most of the plant and stockpiling areas are situated and where SitePlan Consulting (Figure 2) have identified a focus area for botanical and archaeological survey. The focus area has a maximum length of 500 m and maximum width of 250 m. This is about 12 ha rather less than the 25 ha indicated by SitePlan on their plan in Figure 2.

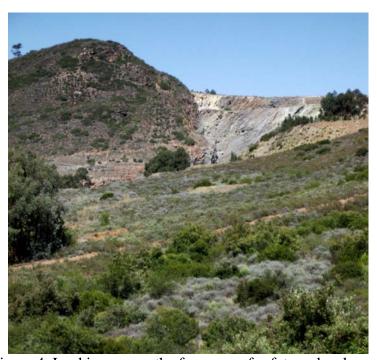
The quarry operations have a visual impact on the landscape. The high clef (>400 m) in Orrelkop (Figure 4) is visible from a distance in the town and from the valley to the north and this is a negative impact. Operation at a lower elevation (below 320 m) in the focus area of the proposed extension will be less visible. The smaller excavation in the focus area below 300 m has low visibility and without being prescriptive it suggests that this elevation or lower is optimal to minimise the visual impact.

Figure 4. Looking across the focus area for future development towards the quarry face.

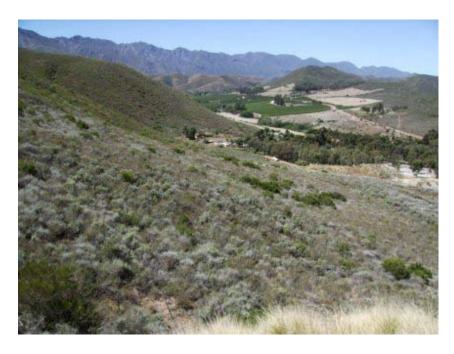
The quarry is on the urban edge in a narrow neck leading to scenic rural cultural landscape of farmlands to the north (Figure 5). This cultural landscape is significant. Minimising the visual impacts of the quarry operations has to be a management priority. This does not gainsay the value of the efforts at rehabilitation already undertaken in this well run quarry.

Figure 5. Looking northeast across the focus area towards farmlands in the valley from which future developments will be visible.

Future operations will have a visual impact and it has been noted that the setting, the rural landscape of valleys and dissected hills to the north, is of significance.

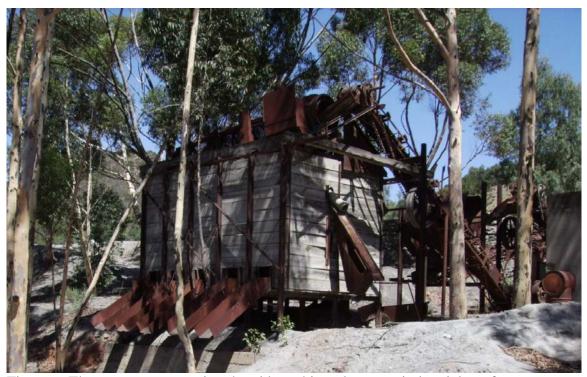
There is a museum on the site (Figure 6). This is an old plant with conveyors and a hopper. It is commendable that this example of industrial archaeology has been conserved in the context where it was used.

Figure 6. The museum preserving the old crushing plant – an industrial artefact.
