**ARCHAEOLOGICAL IMPACT ASSESSMENT
THE PROPOSED KUBOES OXIDATION PONDS
AND SEWER PIPELINE
NORTHERN CAPE**

**AUGUST
2011**

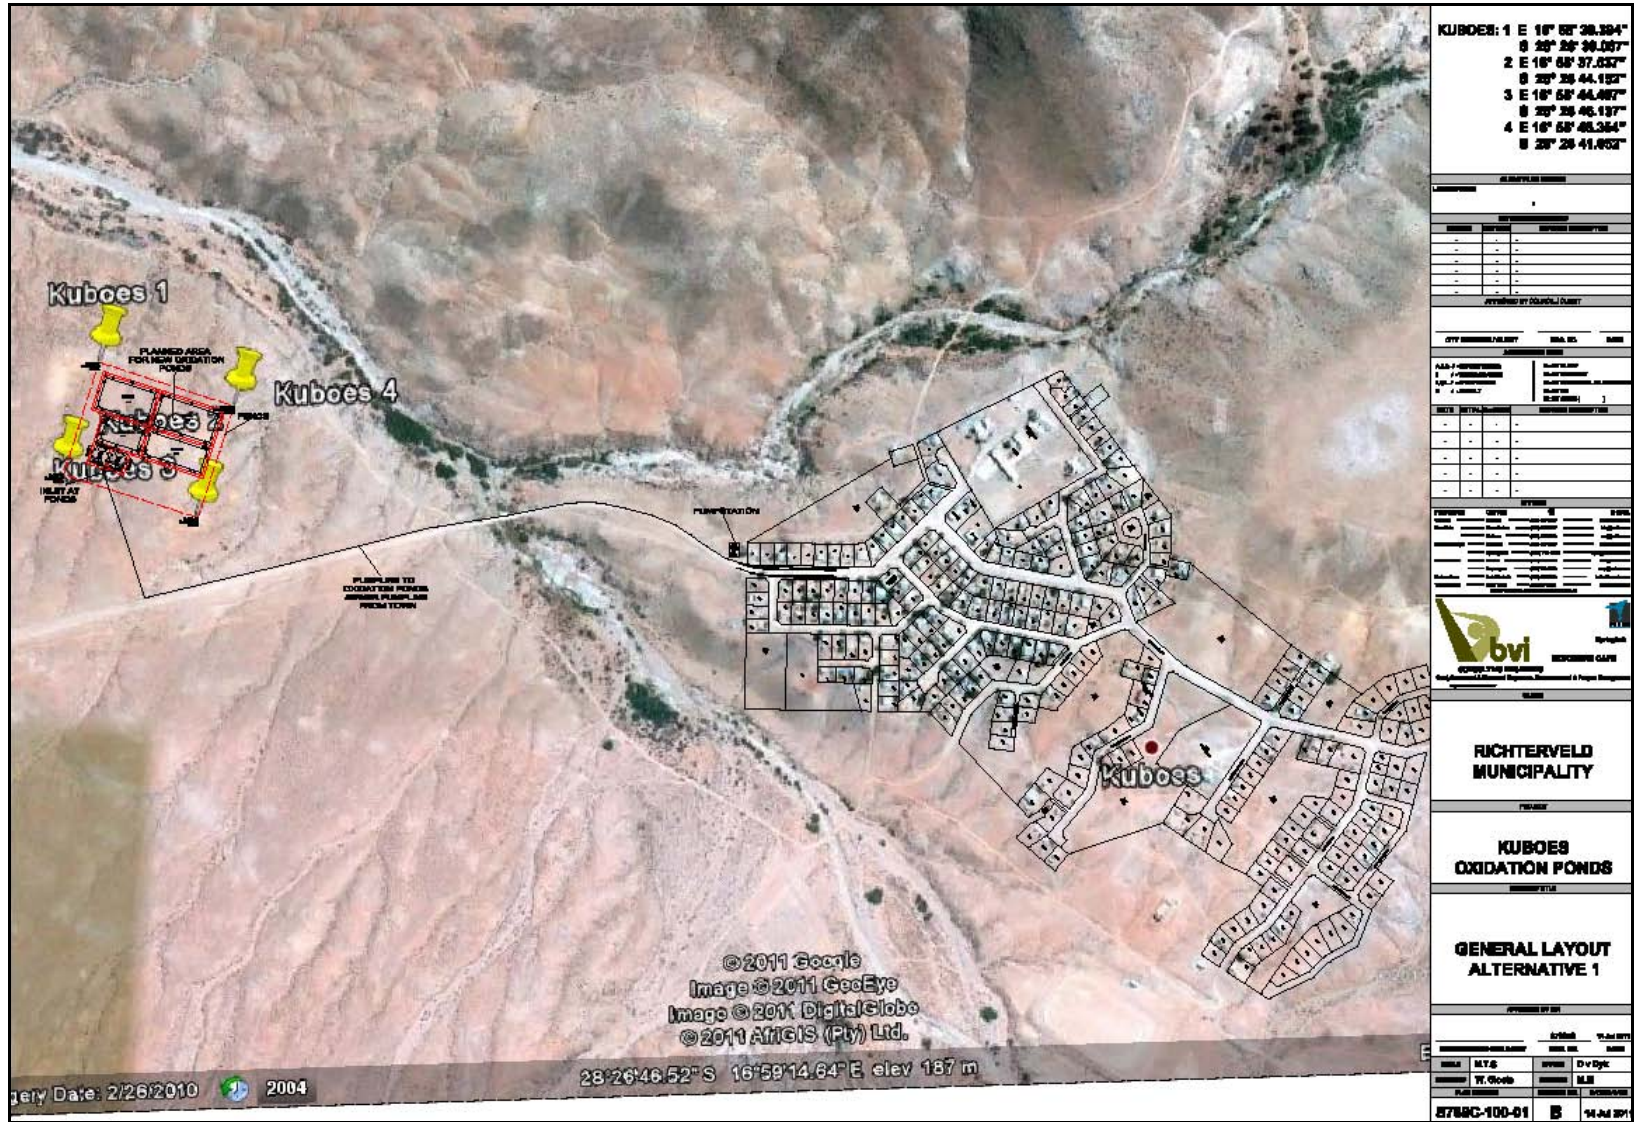
Figure 3. Proposed layout of the Kuboes Oxidation Ponds

An aerial photograph indicating the site layout for the proposed Kuboes oxidation ponds is illustrated in Figure 3.

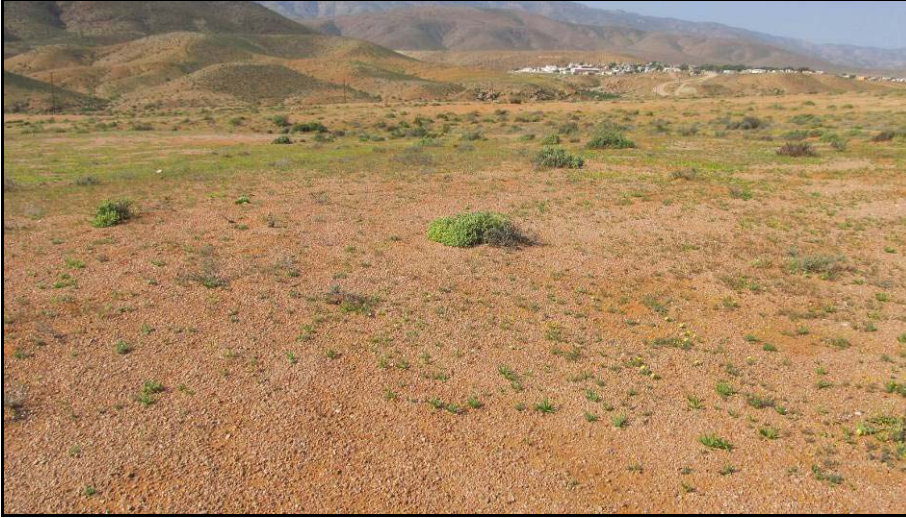
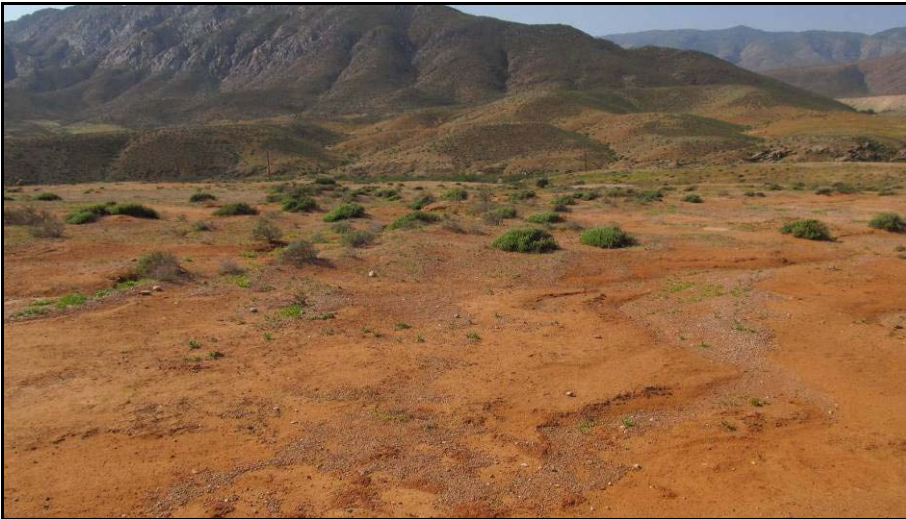
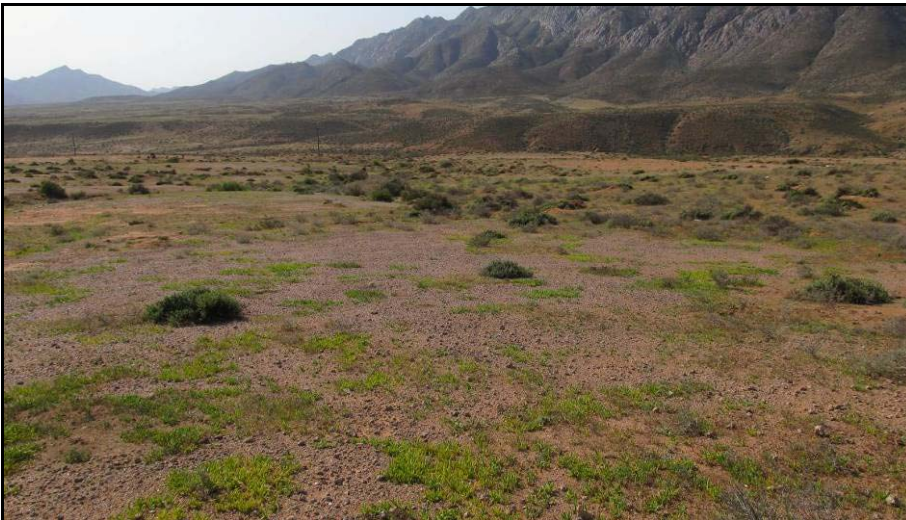
The proposed site comprises a series of heavily eroded and sheet washed terraces cut through by several small streams and deeper drainage channels, which flow into the Annis River (Figures 4-6). Most of the top soils have been washed away, exposing hard compact eroded surfaces where loose stone has collected in small channels. There is some sporadic vegetation and succulent ground covers that occurs over the site. There are no significant landscape features on the proposed site, which is very degraded. Surrounding land use is mainly marginal stock grazing.

Figure 4. View of the site facing southeast. Kuboes is in the background.

Figure 5. View of the site facing east. Note the small stream channels

Figure 6. View of the proposed site facing north east

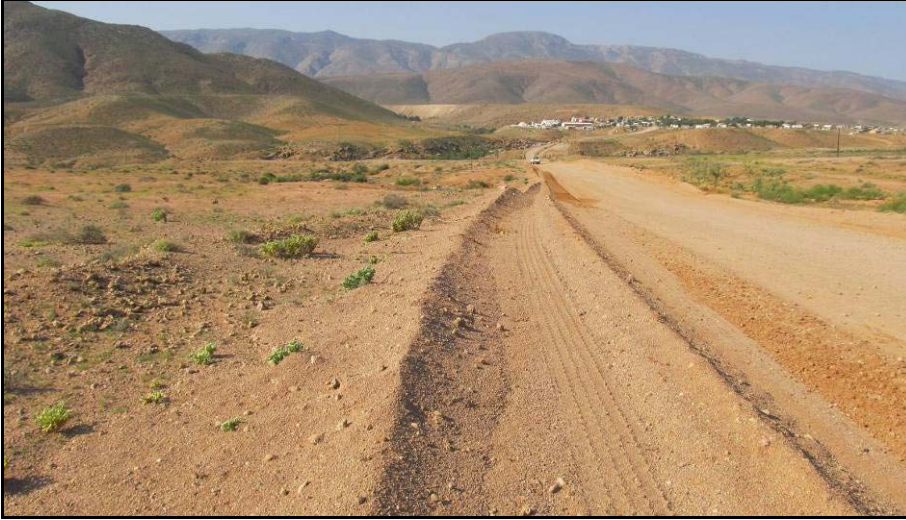
The proposed 1.1 km long underground sewer pipeline will mostly run alongside the main gravel road and connect to a proposed sewer pump station near the entrance to the town (Figure 7).

Figure 7. The proposed sewer pipeline will be located alongside the gravel road

The proposed 1.1 km long sewer pipeline falls within an area that has been identified for the proposed Kuboes waste refuse site and will be dealt with in a separate report (Kaplan 2011 c in prep). Suffice to say only a few tools were counted in the proposed pipeline route. Most of the route will be aligned alongside the main road where it will connect with a proposed pump station at the entrance to the town (refer to Figures 3 and 7).

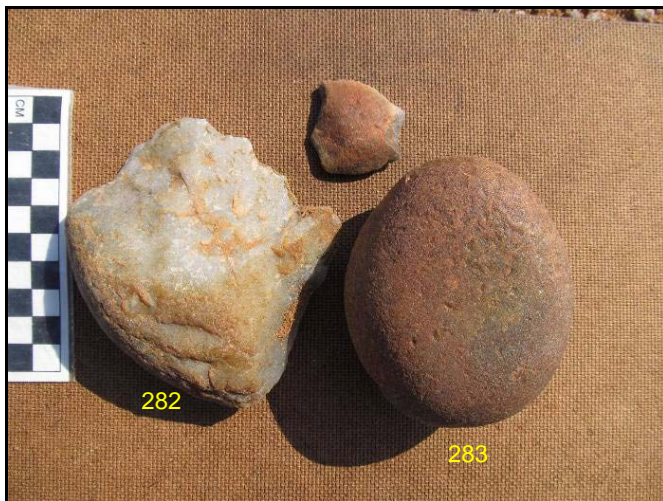
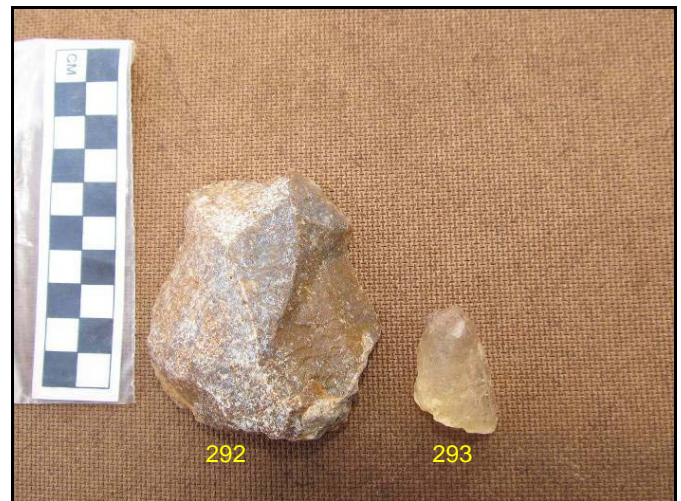
The tools are dominated by Later Stone Age elements and only one silcrete Middle Stone Age flake (292) was recorded. No Early Stone Age finds were made. Most of the tools comprise unmodified flakes, chunks, a blade (280) and flaked/broken cobbles. No cores were found. While no formal retouched tools, such as scrapers, adzes or backed artefacts were found, one pecked anvil (283) and one round pitted hammerstone (293) were counted. In addition, one quartz crystal (279) and one flaked quartz crystal chunk (290) were also found.

A collection of some of the tools documented during the study is illustrated in Figures 8 & 9.

Figure 8. Tools from the proposed oxidation ponds.
Scale is in cm

Figure 9. Tools from the proposed oxidation ponds.
Scale is in cm

The small numbers and the isolated and disturbed context in which they were found mean that the remains have been rated as having low archaeological significance.

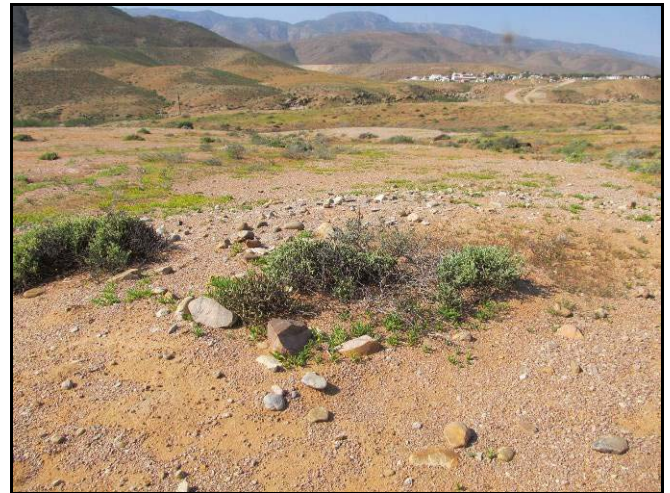
Figure 10. Possible grave

The remains of a possible 'traditional' or Christian grave were located during the study. At, S28 26.743 E16 58.749, the grave (270) is located near the north western edge of the proposed oxidation ponds (Figure 10). Typically, traditional forms of graves appear in the landscape as circular stone cairns and probably predate the colonial era. These types of graves are common in the Richtersveld landscape (Halkett 1999), and are often encountered alongside the road. However, no cairn is present on the proposed site, or it may have collapsed as a result of the extensive sheet wash and erosion in the surrounding area. The grave does not show any Christian influences either, such as rectangular mounds of stone, head or footstones, but large pieces of stone are still visible on the ground. No grave goods such as glass bottles, jars, or marine shellfish were noticed.

As a precaution, the location site has been 'Red Flagged'.

1. The project is deemed to be viable.
2. No archaeological mitigation is required.
3. The possible grave in the footprint area must be fenced off prior to any construction work commencing.
4. Should any unmarked human remains, or features such as buried ostrich eggshell caches be exposed or uncovered during excavations and bulk earthworks these must immediately be reported to the South African Heritage Resources Agency (Ms Mariagrazia Galimberti 021 4624502). Burials must not be removed until inspected by the archaeologist and will have to be removed by an archaeologist under a permit issued by SAHRA.

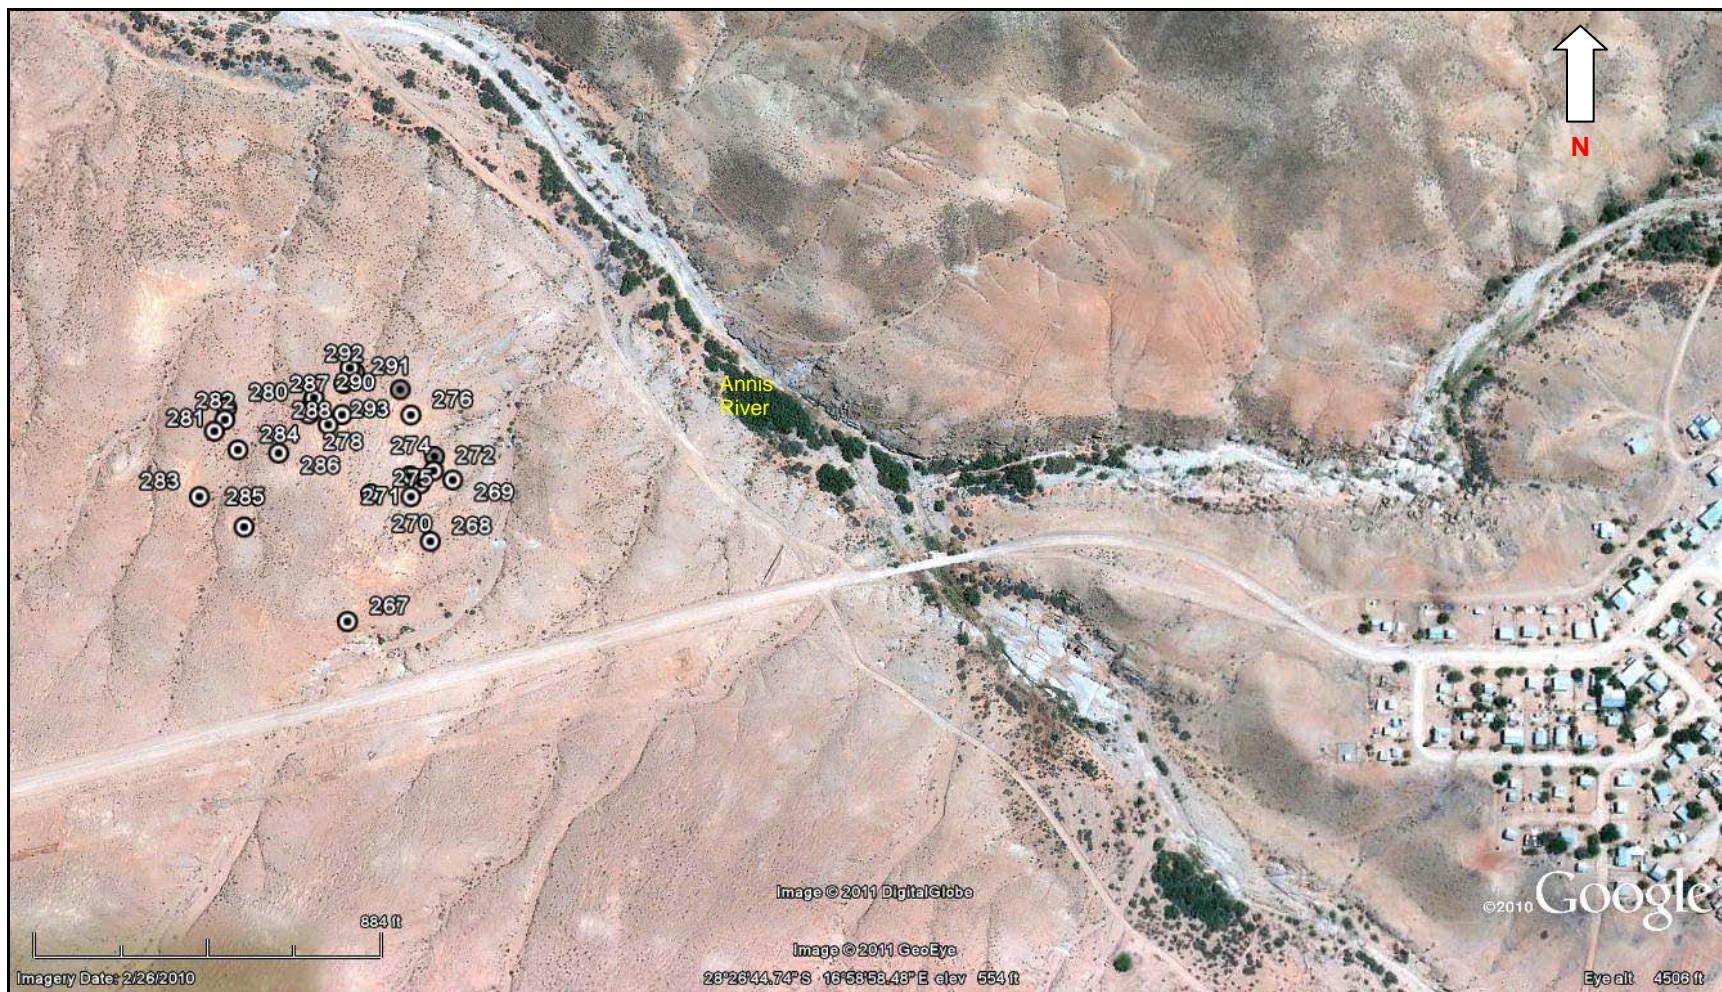
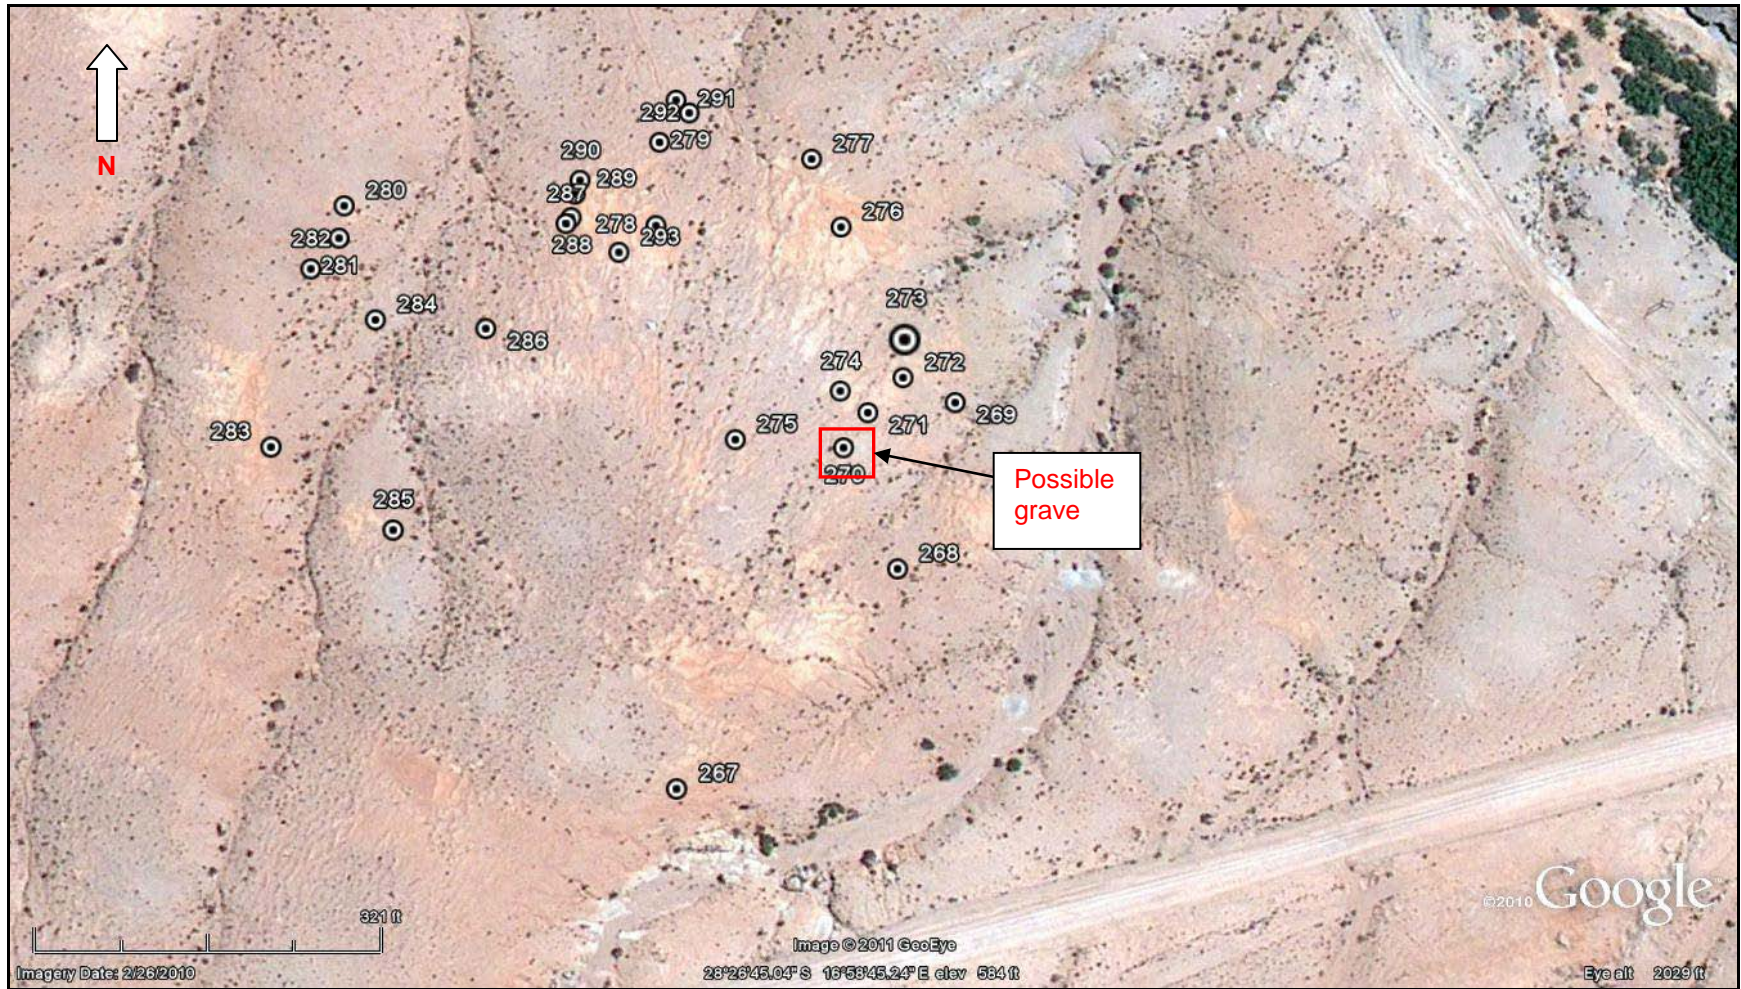
A Google aerial photograph indicating the waypoints of archaeological occurrences documented during the study is illustrated in Figures 11 and 12 in the Appendix.

Figure 11. Waypoints of archaeological finds

Figure 12. Waypoints of archaeological finds
