THE LOTUS RIVER CANAL BETWEEN THE N2 AND NEW DUINEFONTEIN ROAD

PHASE 1 ARCHAEOLOGICAL STUDY

August 2001

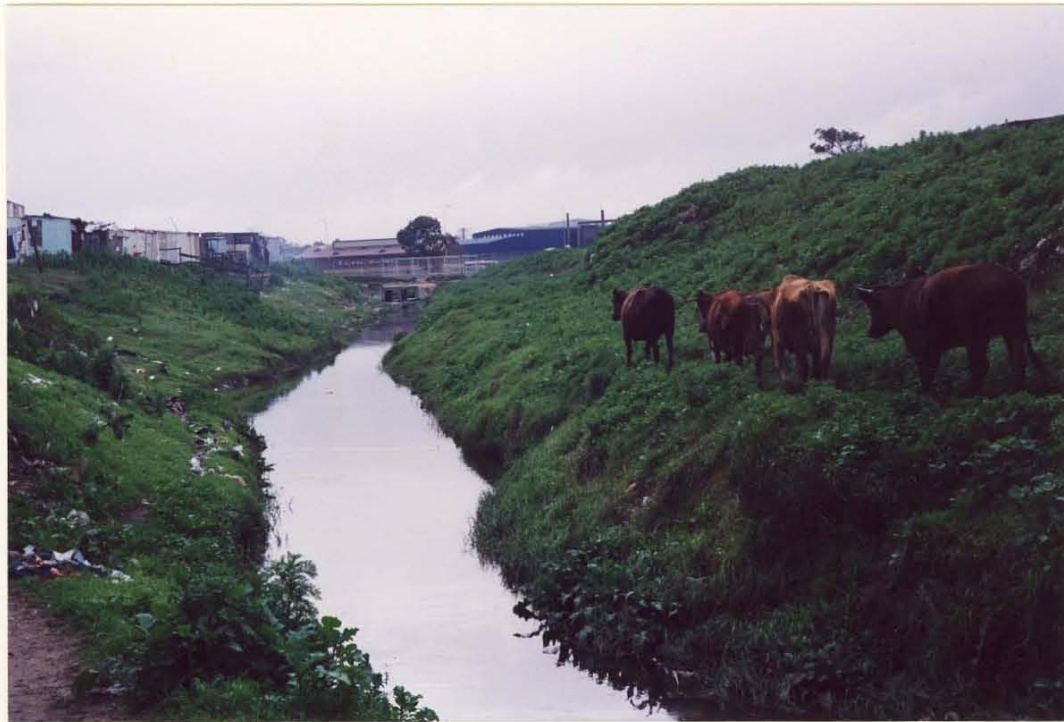
There was no need to undertake test excavations as the steep banks of dump material are loose and eroding, giving good visibility of the matrix. Both sides of the upper stretch of the canal show evidence of dump waste (black plastic bags, polystyrene, etc.), eroding out of the banks right down into the water level. There are some calcrete rocks in the base of the canal, which presumably indicate the original land surface. Only the east side of the lower stretch of the canal shows similar evidence of the dump, continuing right up to the Klipfontein Road.

1. Lotus River Canal, looking north towards N2.
2. East bank, showing height of dump material from canal level to top (for scale, see woman standing on top of the bank).
3. West bank, showing exposed in situ material down to water line.
4. Lotus River Canal, south end, at intersection with Klipfontein Road.
5. West bank, at point where the canal kinks in the middle reaches.

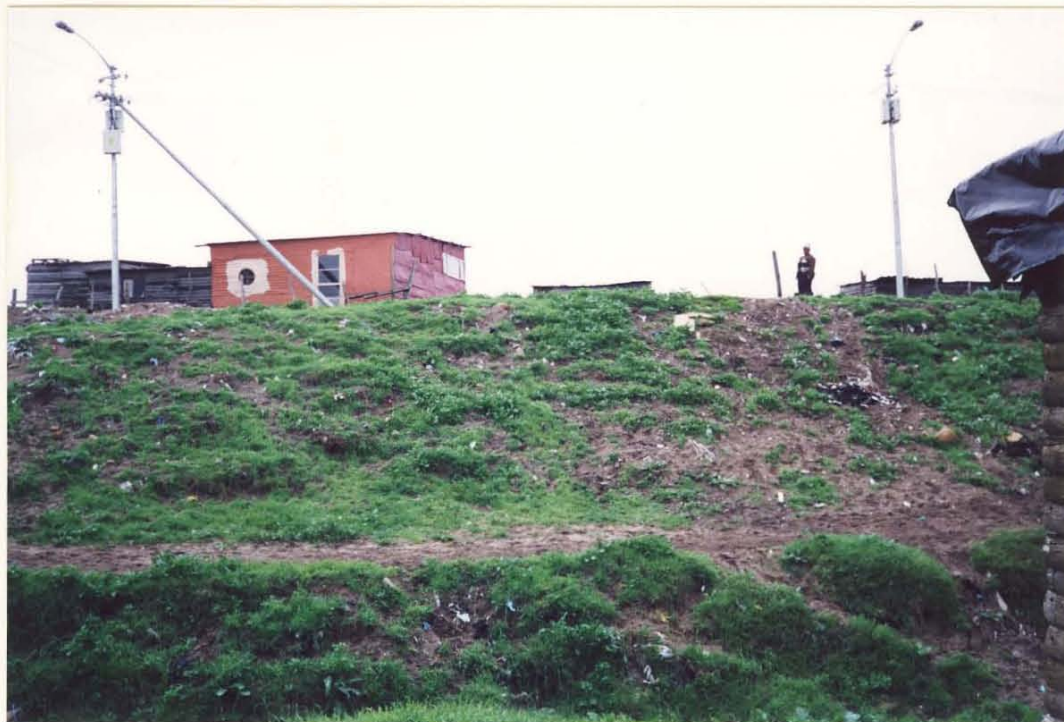
2.

A foot survey was undertaken along both sides of the canal, between the N2 and Klipfontein Road. The canal extends along two stretches of land: the N2 end passes through the dump and has high banks on both sides (about 6 or 7 metres); the Klipfontein Road stretch passes between a high bank on the east and lower sandy soils along the west. Both banks have houses built on them, but there is a wider corridor on the east side. The house lots on the low-lying west side of the lower stretch extend right up to the canal.

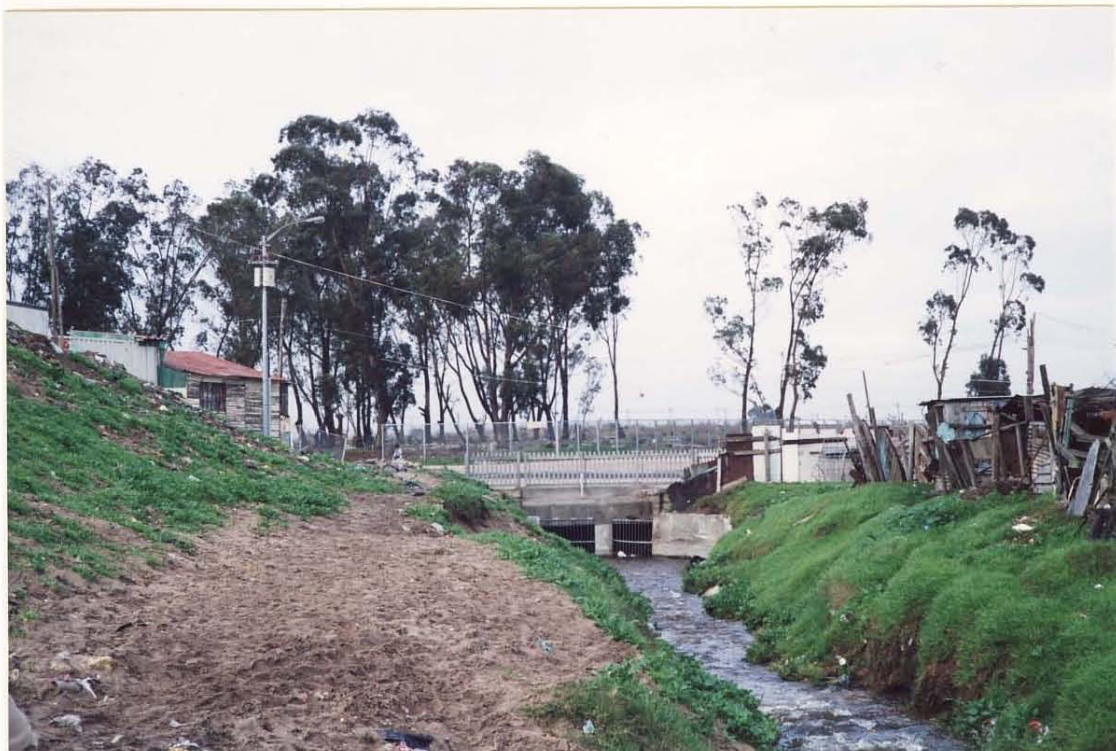
4

The west side has scatters and occasional pits of recent rubbish. There are quite substantial rocks in the base of the canal at the Klipfontein Road end.

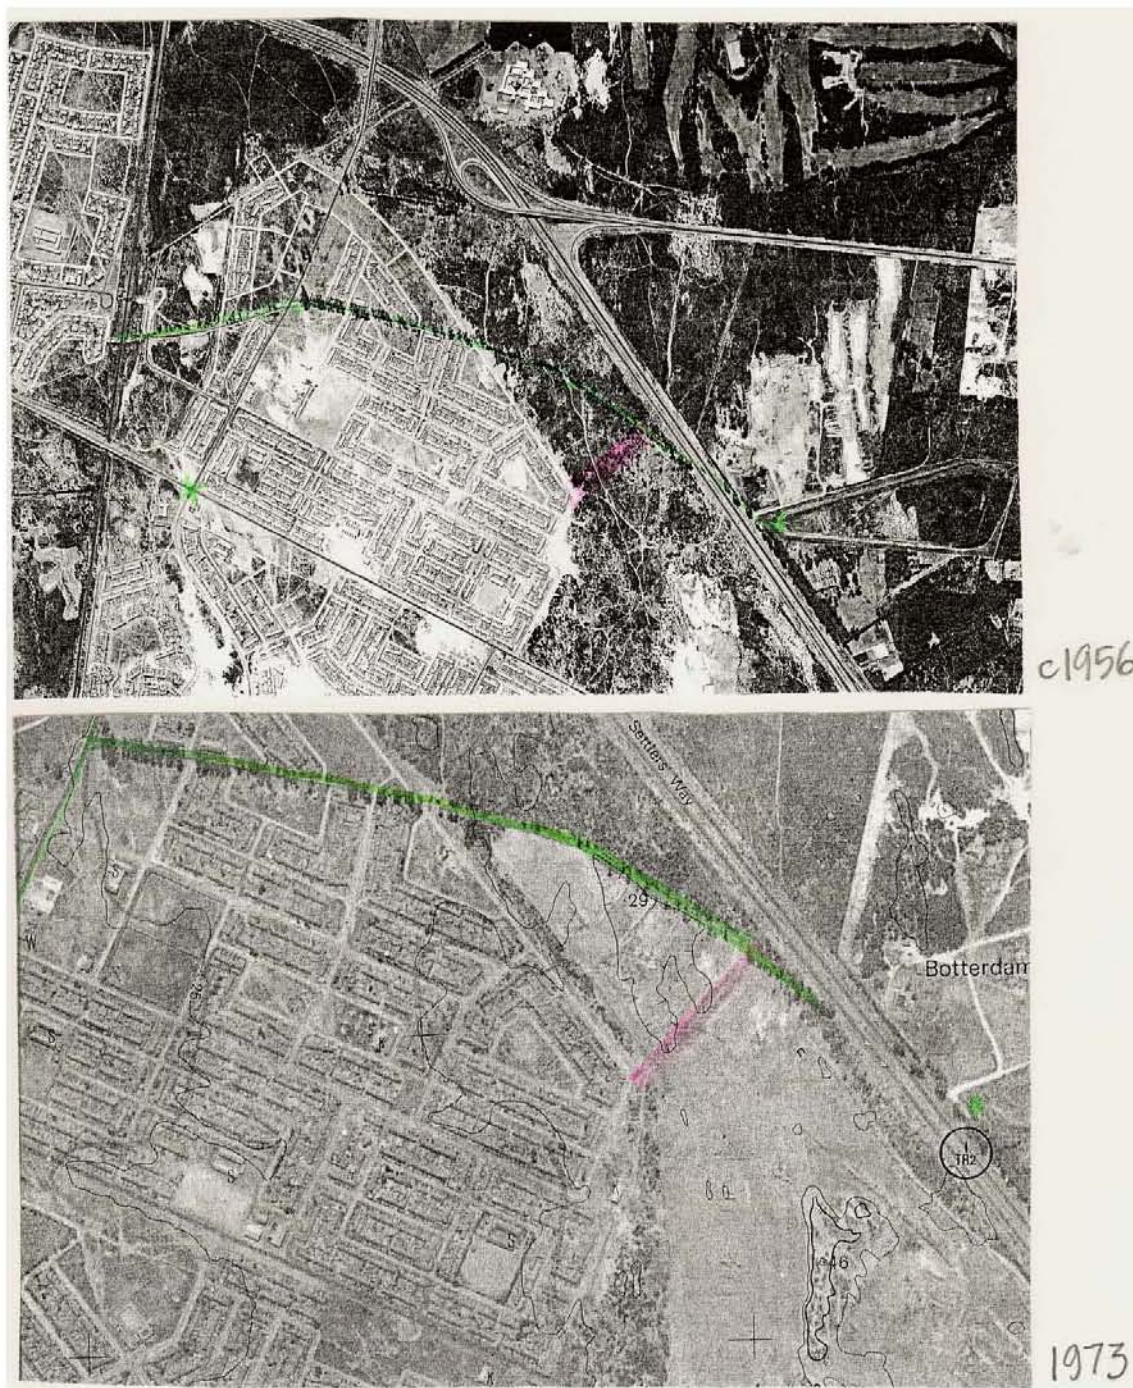
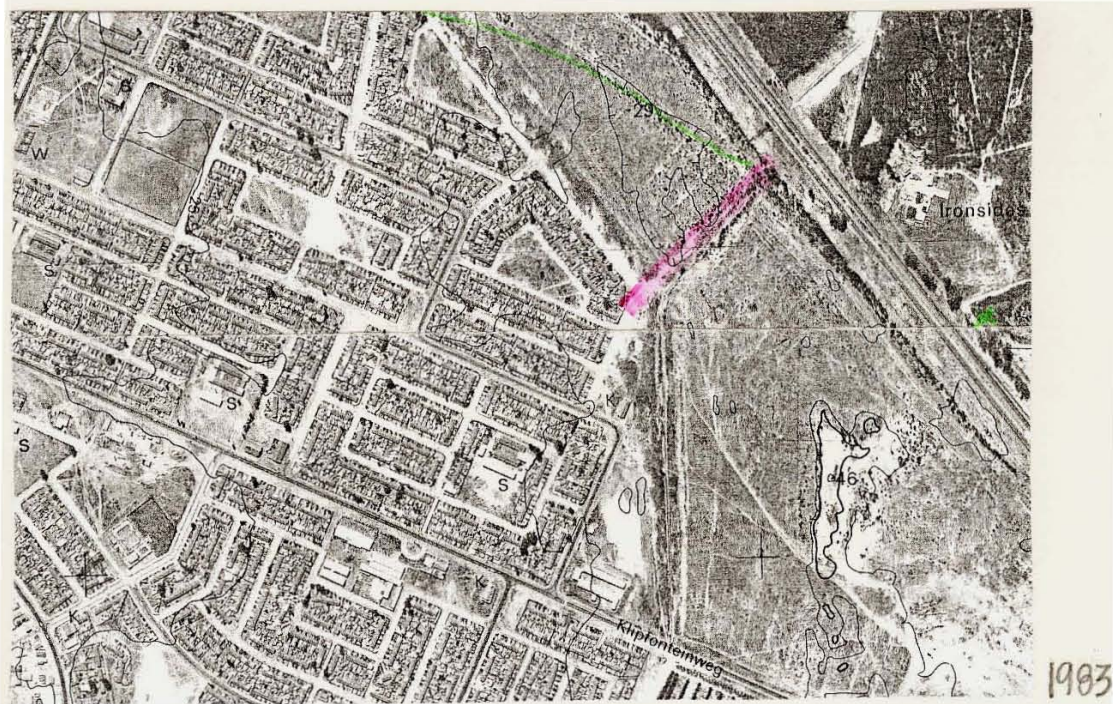
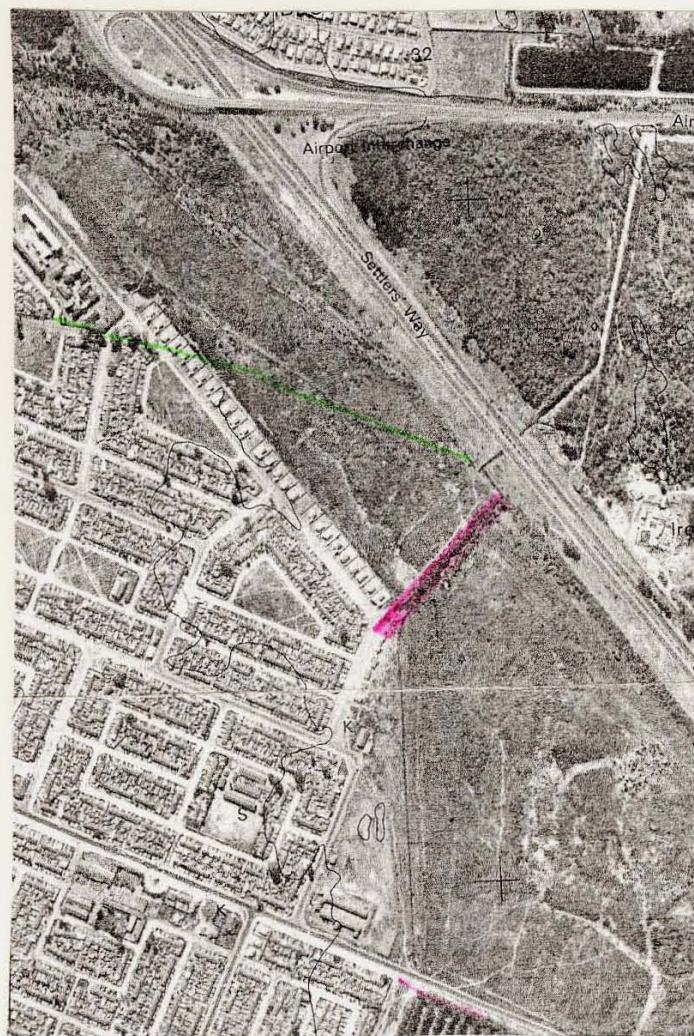
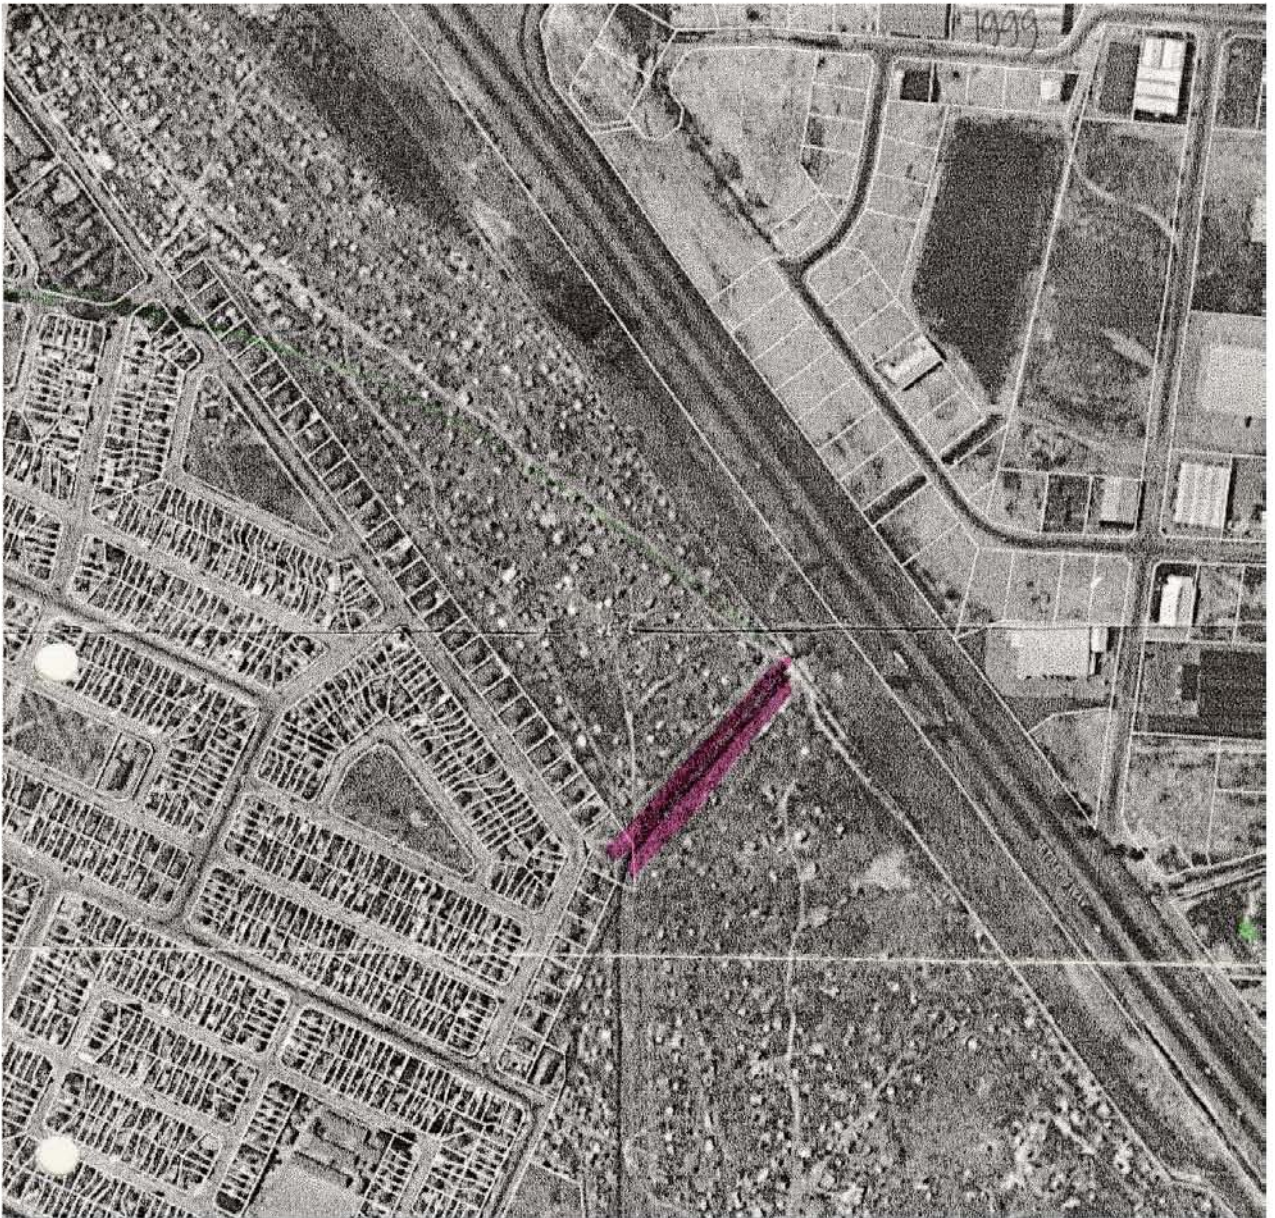
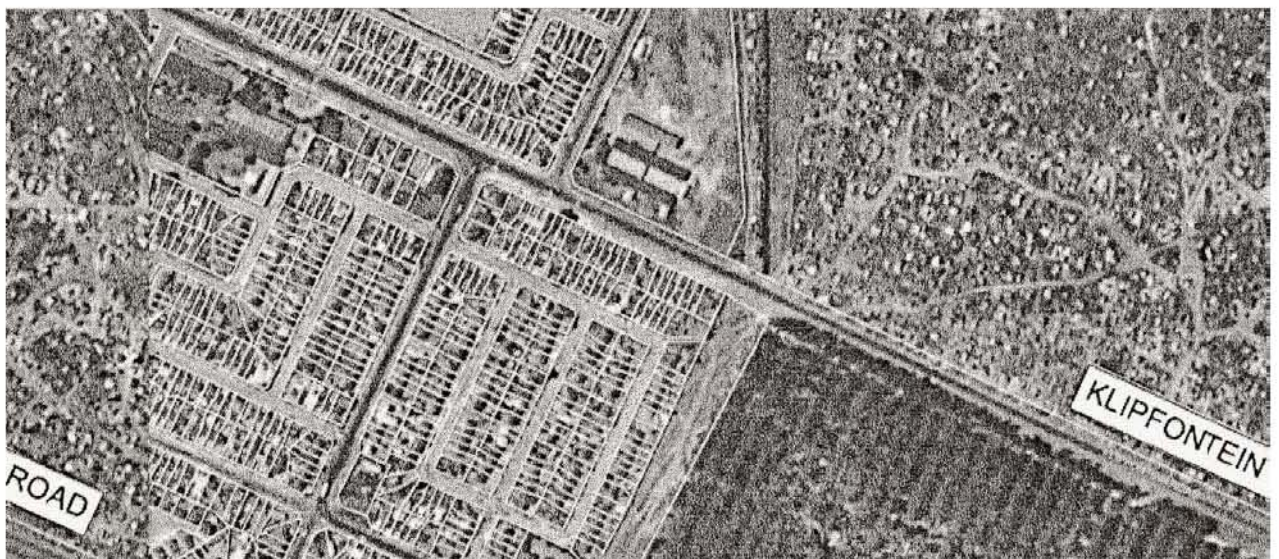
Aerial photographs

- The original Duinefontein Road is clearly marked by a row of trees on an aerial photograph of c1956 and they can still be seen on the orthophoto of 1973. By 1973 the rest of the landfill site is in use, except for a ridge of sand hills running north-south, from the old Duinefontein Road south eastwards to the corner where Klipfontein Road and the N2 intersect. Ten years later (1983) the site has been further cleared northwards across the old road, and the trees have been felled. The orthophoto of 1999 shows a few specimens still remaining in the built-up area.
- The 1989 orthophoto (reproduced in CIA 2000, p.3) shows the area covered in grass.
- Shacks have been built on the dump by 1999, most densely settled at the northeast end and sparsely scattered beside the canal.

[pink = canal; green = trees along old Duinefontein Road]

1. c 1956. 2. 1973. 3. 1983. 4. 1989. 5. 1999.
