**SUBJECT: PHASE 1 ARCHAEOLOGICAL / HERITAGE IMPACT ASSESSMENT:
PORTION 39 OF LYDENBURG TOWNLANDS 31 JT, MASHISHING/LYDENBURG,
MPUMALANGA PROVINCE**

**PHASE 1 ARCHAEOLOGICAL / HERITAGE IMPACT
ASSESSMENT: PORTION 39 OF LYDENBURG TOWNLANDS
31JT, MASHISHING/LYDENBURG,**

MPUMALANGA PROVINCE

30 JULY 2009

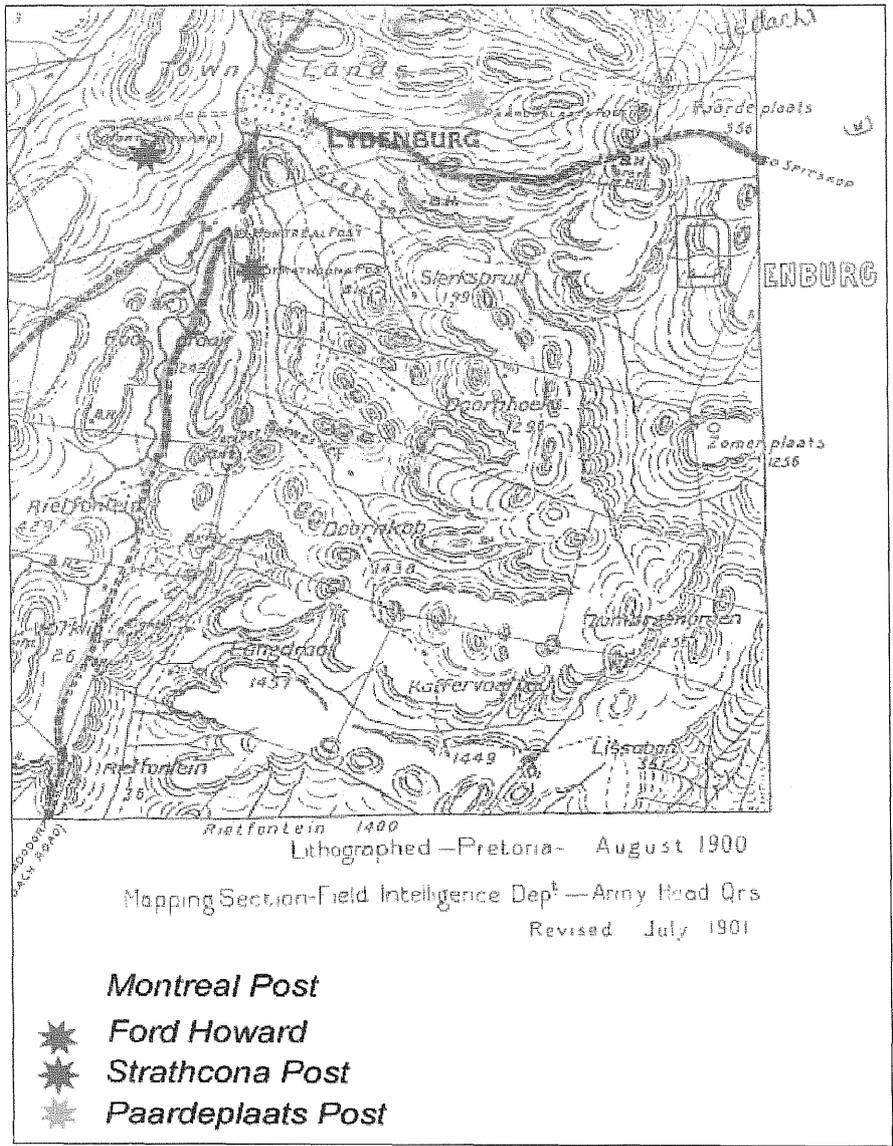
A map dated to 1900 (Major H.M. Jackson Series) indicated the military posts around Lydenburg, which include Fort Howard, Montreal Post, Strathcona post and Paardeplaats Post. Fort Howard and Paardeplaats Post were erected by the British Forces occupying the town.²² The map below indicates the location of Fort Howard (Fig 1), where the current Vodacom Cell mast is situated.

Fig 1: Location of Fort Howard and other military posts, 1900.²³

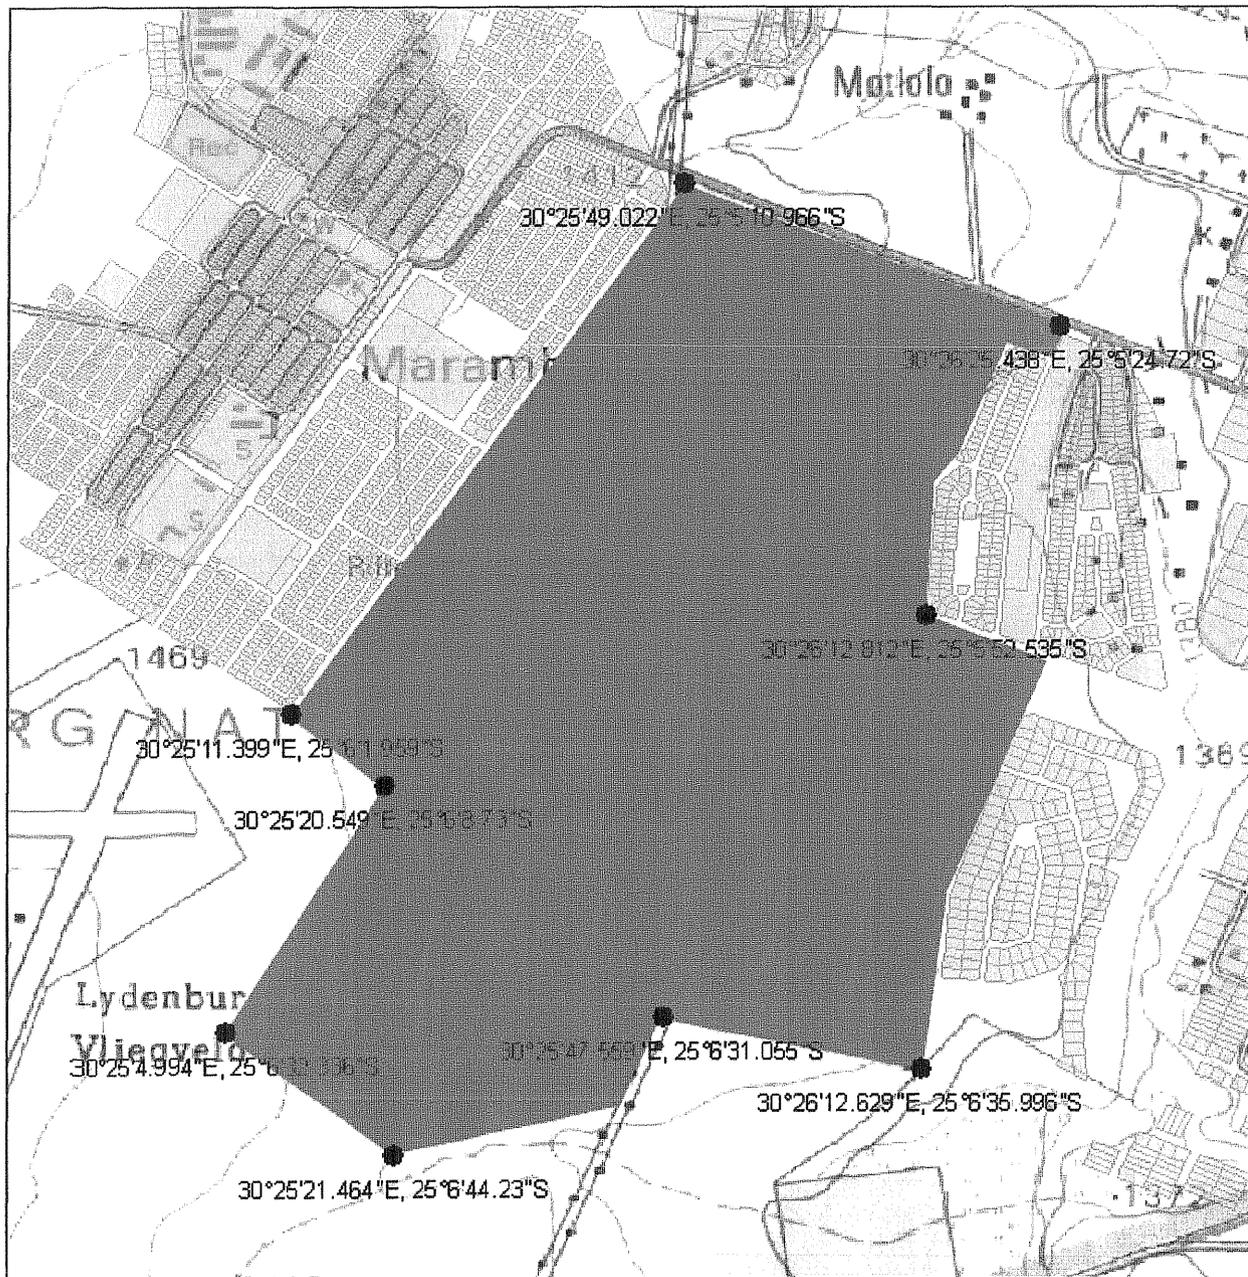
APPENDIX 1: Location & Proposed area of Development (Topographical map provided by Wandima Environmental Consultants).

Proposed Township development on the remainder of portion 39 of Lydenburg Townlands 31-JT, Mpumalanga

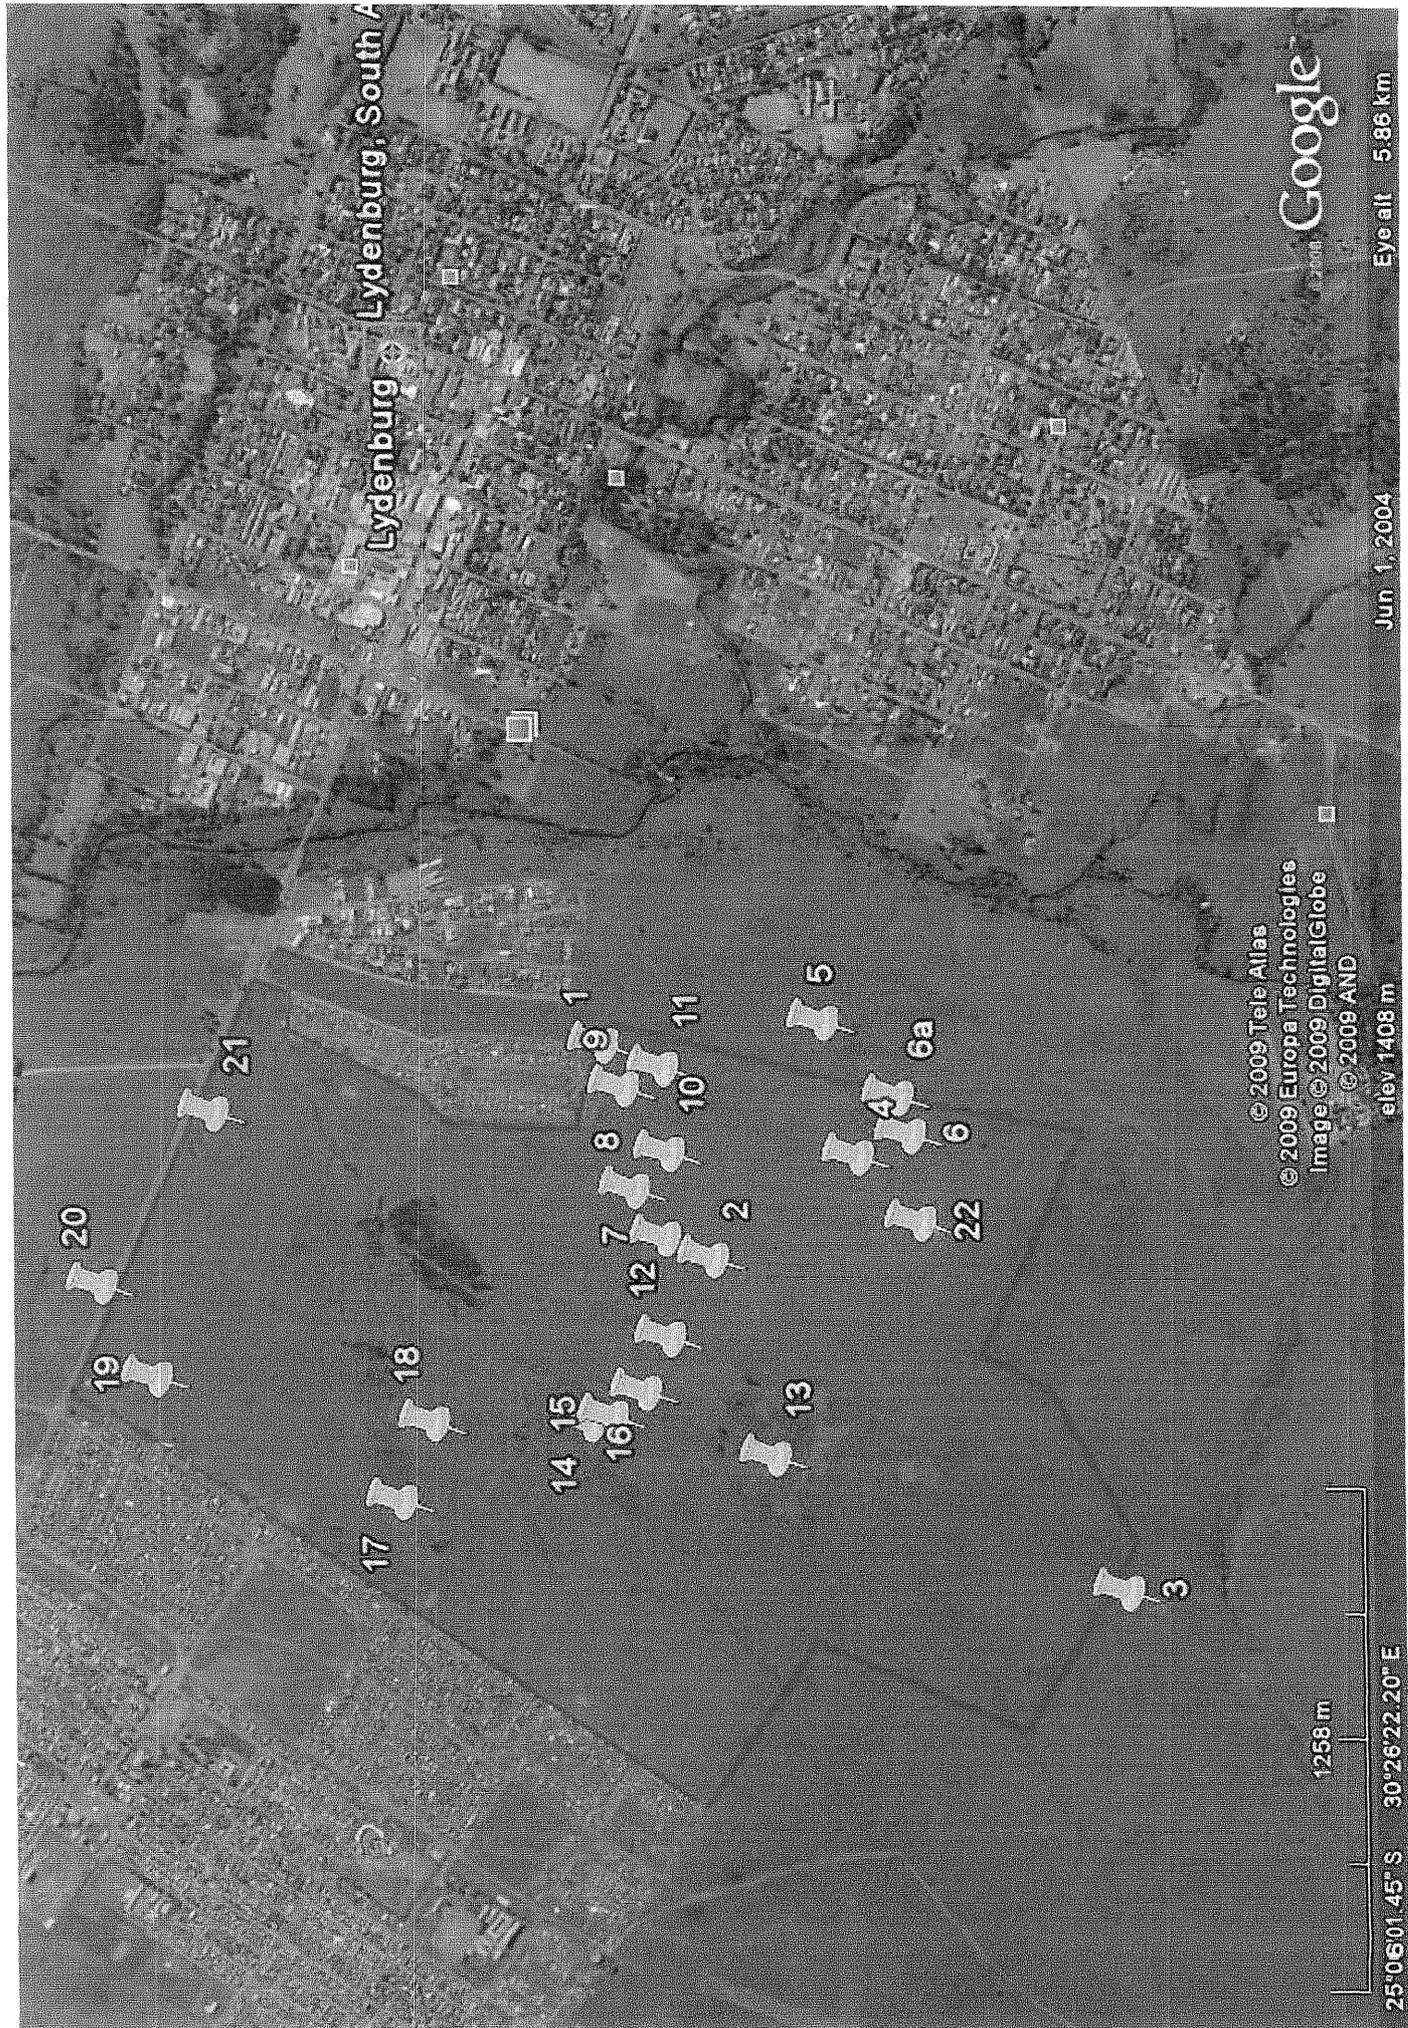
APPENDIX 3: Location of archaeological /
historical sites (Google Earth).

A total of twenty-two features were marked which comprised of one large Late Iron Age stone walling settlement (11 features: LT1, LT2, LT4, LT5, LT6, LT7, LT8, LT9, LT10, LT11, LT12). Feature LT20, consists also of a poorly defined stone walled site, but it is possibly not connected to the settlement in the east and could be more recent. The area used as a recent rifle range (feature LT13), concrete foundations associated with recent settlement (features LT3, LT16, LT17), recent loose stone foundations without concrete, (features LT14, LT15 & LT18); two areas which might be associated with early pioneer or European settlements (features LT19 & LT21), and LT22, which is the military site of Fort Howard, erected during 1900, (South African War).

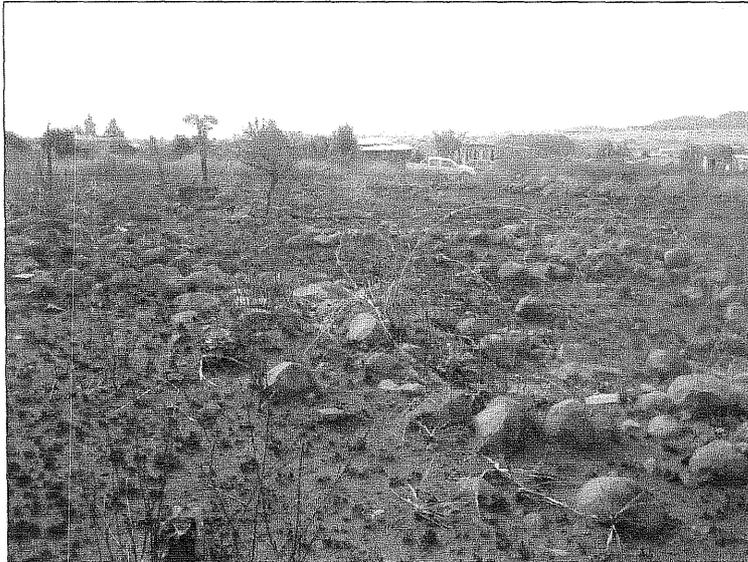
Photo 1: Site LT1: The LIA stone walls have already been disturbed by current township development

Mitigation: It is recommended that the LIA stone walls indicated as, LT1, TL2, TL7, TL8, TL9, TL10, TL11 & TL12, be documented and small sections excavated during a phase 2 study, and that the developer applies for a destruction permit from SAHRA, before construction activities commences.

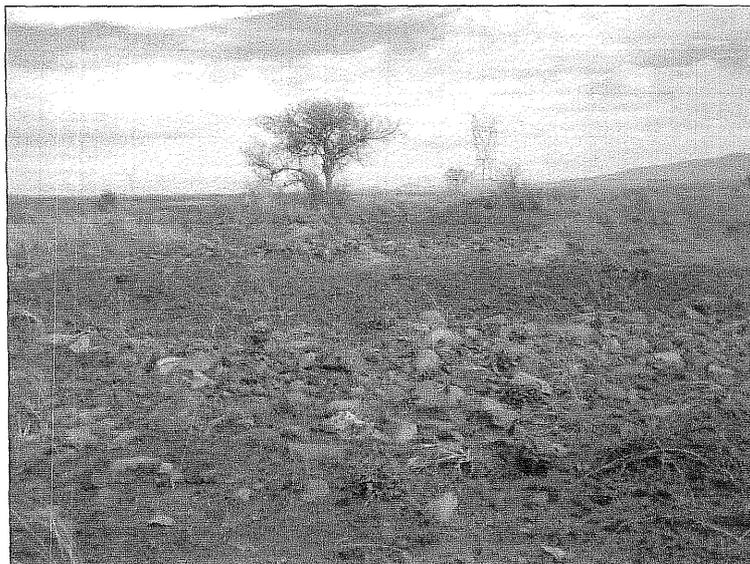
Photo 2: Site LT2: The LIA stone walls are extensive in this area but have been damaged by secondary road infrastructure.

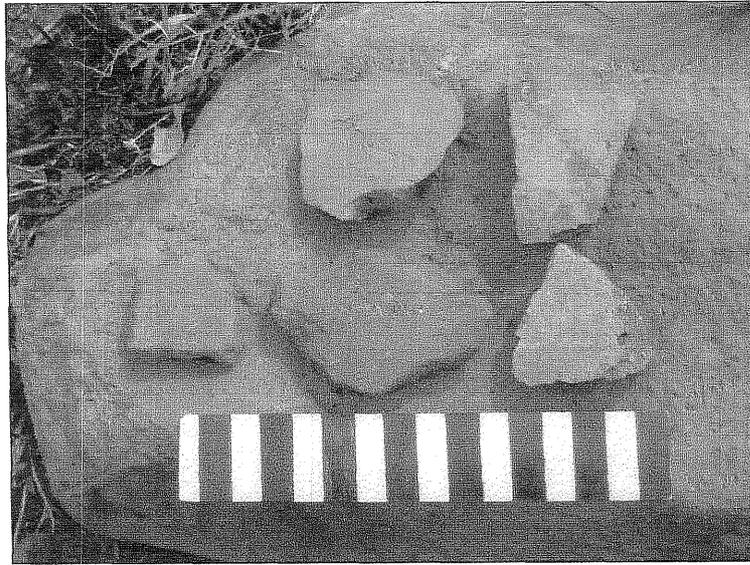
Photo 3: Site LT2: Surface collection - undecorated potsherds.

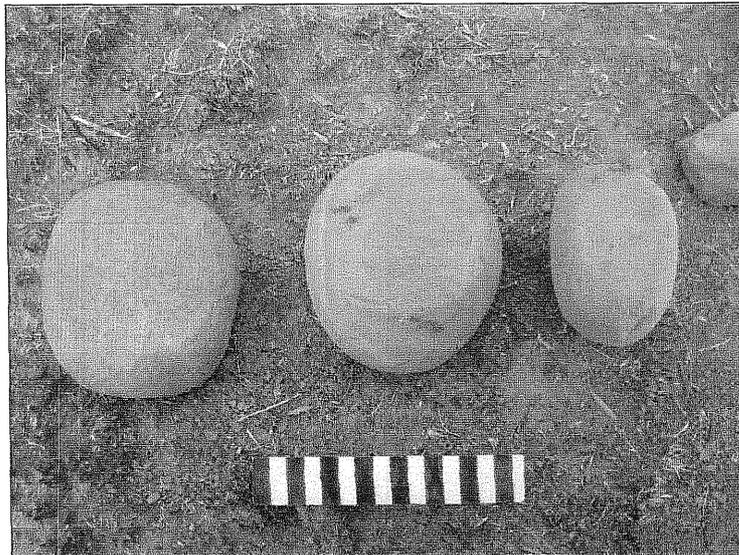
Photo 4: Site LT2: Upper grinders are to be found throughout the study area.

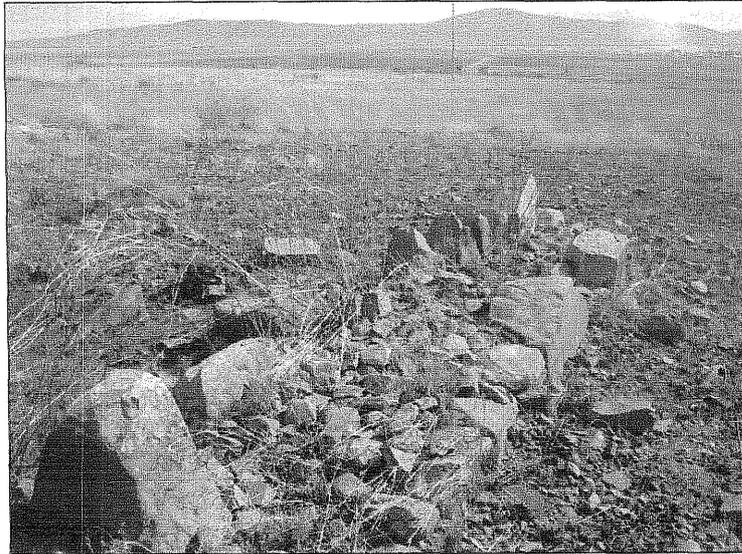
No. LT4 in Appendix 3.	<p>Elev: 1388m S25°06'13.0" E30°26'01.4"</p>	<p>LIA stone walling which are clearly defined, with a prominent upright stone visible. See photo 5 (Appendix 4).</p>
No. LT5 in Appendix 3.	<p>Elev: 1374m S25°06'08.4" E30°26'13.8"</p>	<p>LIA stone walling down the slope of a hill bordering the area that is currently being developed. In some areas the foundation/base of the walls are clearly defined. Exceptionally large stones were used in the base of the walls. Surface material includes an upper grinder. See photo 6 (Appendix 4).</p>

Photo 5: Site LT4: Sections of LIA stone walling are well defined with prominent upright stones.

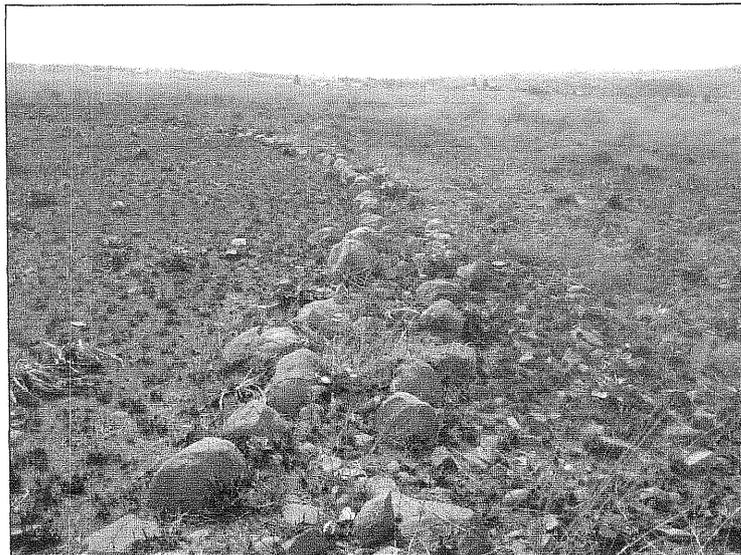
Photo 6: Site LT5: LIA stone wall, well defined.

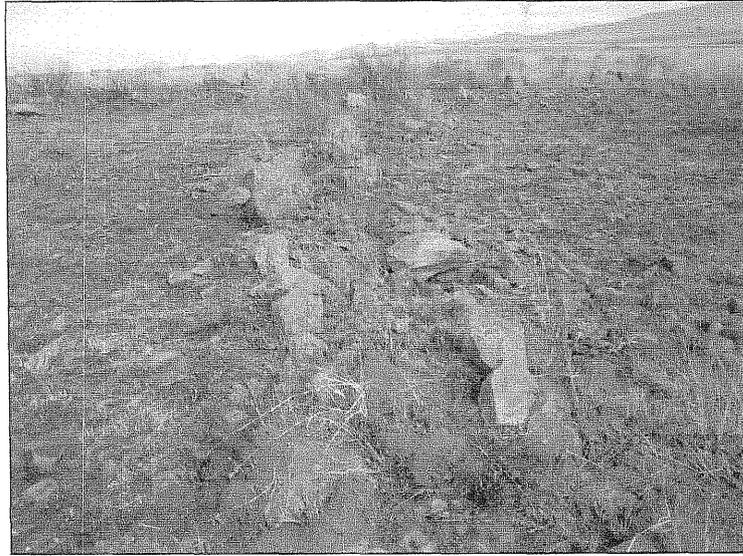
<i>Site location indicated in Appendix 3.</i>	<i>GPS Coordinates</i>	<i>Description, type and category of archaeological / cultural heritage features</i>
No. LT10 in Appendix 3.	Elev: 1418m S25°05'58.1" E30°26'14.2"	LIA stone walling with large stones links up with site no. 5. The settlement continues although some areas are poorly defined.
No. LT11 in Appendix 3.	Elev: 1419m S25°06'00.6" E30°26'16.0"	No 11: LIA stone walling links up with sites no. 5 and 10. The stones are quite large and continues towards the east where the new development is currently taking place. Sections have been damaged by the road infrastructure towards the south.
No. LT6 in Appendix 3.	Elev: 1442m S25°06'16.0" E30°26'07.4"	LIA stone walling which are clearly defined. Mr J.P. Celliers excavated sections on this site as mitigation measures for the adjacent current development.
No. LT6a in Appendix 3.	Elev: 1438m S25°06'11.6" E30°26'07.0" Elev: 1432m S25°06'09.7" E30°26'09.0"	Continuation of LIA stone walling as described in site no. 6, although the walls are poorly defined. See photo 7 (Appendix 4). Surface collection: Small upper grinder.

Photo 7: Site LT6a: Some LIA stone walls are not well defined.

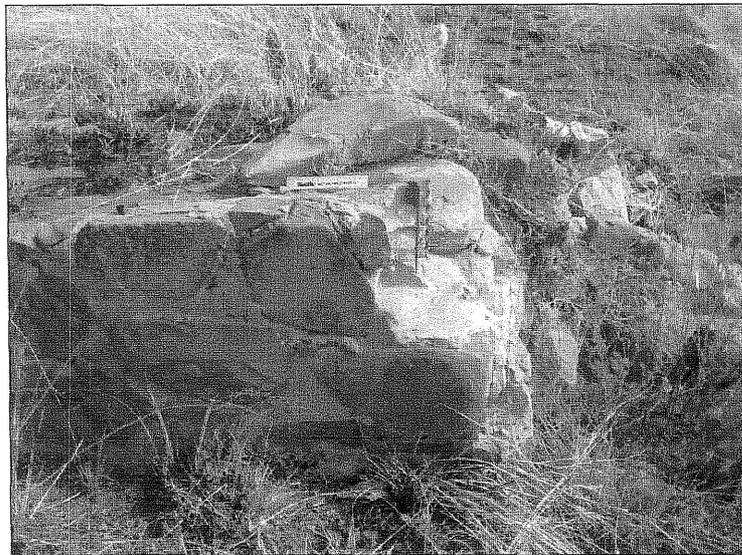
LT3: Remains of a recent structure associated with European settlement. Surface material consisted of modern baked bricks, concrete floors, other building rubble and metal fragments in Kikuyu grass. A small cobble stone floor is also set in concrete and the entrance to the property, which has collapsed, revealed a stone and concrete wall reinforced with modern metal droppers. A broken lower grinder is out of context and was probably used as a garden feature.

Photo 8: Site LT3: Remains of a recent structure associated with European settlement.

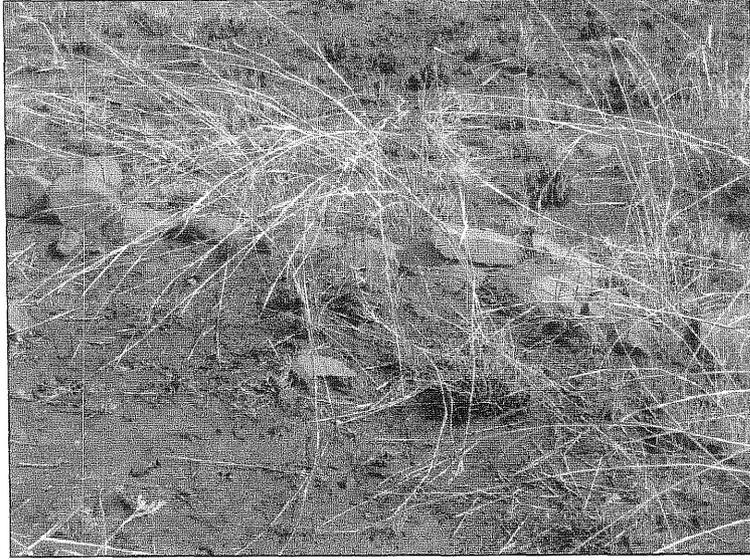
Site location indicated in Appendix 3.	GPS Co-ordinates	Comments on field survey: Archaeological / cultural heritage features
No. LT3 in Appendix 3.	Elev: 1375m S25°06'17.6" E30°25'41.8"	Remains of a recent structure associated with European settlement. Modern baked bricks, concrete floor and other building rubble and metal fragments in Kikuyu grass were observed. This might also be part of the previous Rifle Range (site no 13). -Cobble stone floor set in concrete; -Collapsed stone wall entrance with metal droppers used as re-enforcement. -Broken lower grinder near remains of structure (out of context). See photo 8 (Appendix 4).
No. LT13 in Appendix 3.	Elev: 1432m S25°06'07.1" E30°25'47.0"	Area of recent Rifle Range as indicated on the Topographical map 1:50 000, 2530 AB Lydenburg. Several trenches are still to be seen and used R1 bullet shells were observed;
No. LT14 in Appendix 3.	Elev: 1436m S25°06'00.2" E30°25'32.1"	Remains of a recent stone wall in a straight line, poorly defined. See photo 9 (Appendix 4).

Photo 9: Site LT14: Remains of a recent stone wall in a straight line, poorly defined.

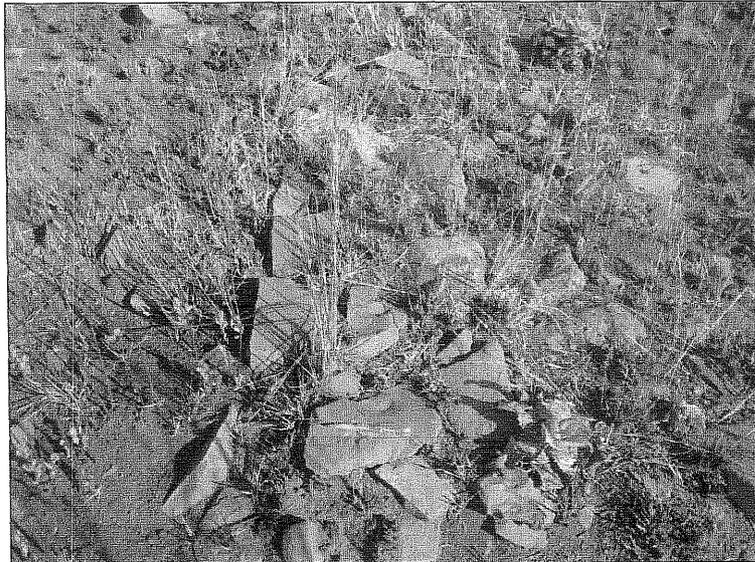
LT18: Recent stone foundations of rectangular shape. No surface material was identified.

Photo 10: Site LT18: Recent stone foundation of rectangular shape.

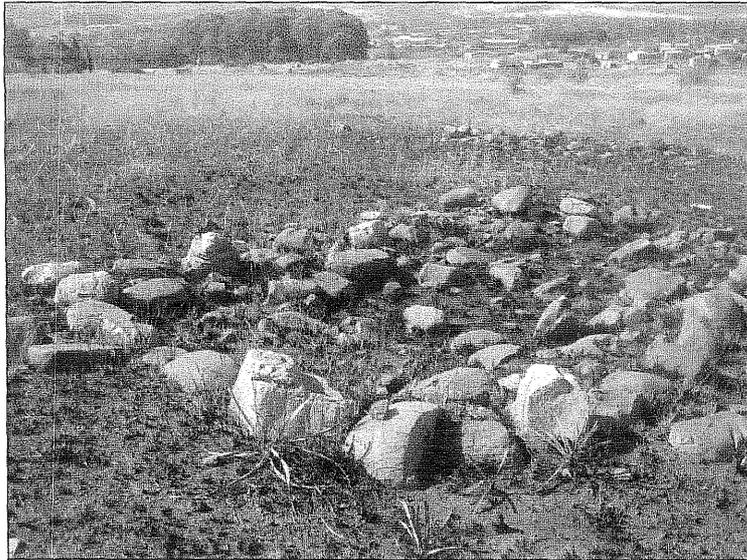
LT21: Several well defined stone foundations of rectangular structures (with divisions), not more than 15 meters apart, together with one circular unit, and one square unit without divisions. Surface material consisted of metal fragments. Another large rectangular stone foundation with divisions is also in close vicinity of the above units.

Photo 12: Site LT21: Rectangular stone foundations associated with early pioneer settlement.

Mitigation: It is recommended that this area be documented and a section excavated during a phase 2 study as it is believed to be older than 60 years and belonging to pioneer farmers. The developer should then apply for a destruction permit before construction activities commences.

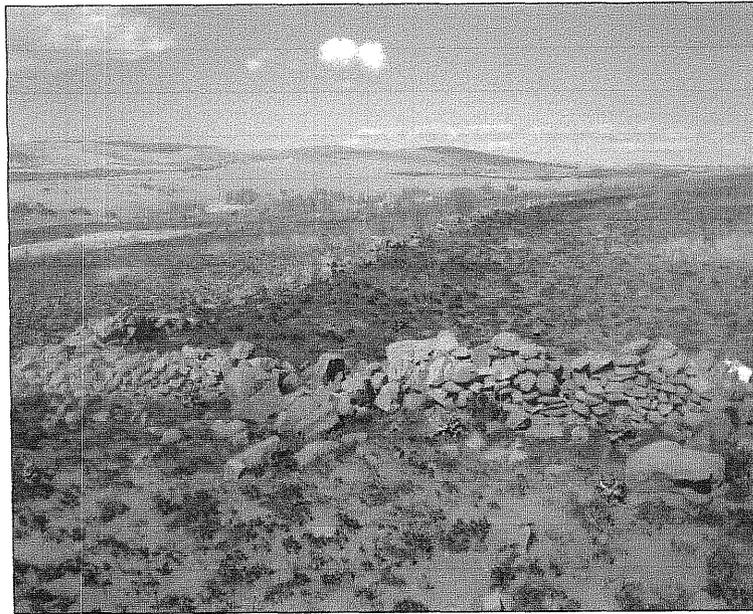
Photo 13: Site LT22: Site of Fort Howard. Sections of this site have been impacted upon by the construction of the Vodacom Cell Mast.

Mitigation: It is recommended that a management plan be developed for this section as this area will be vulnerable once the surrounding area is developed. Please note that JP Cilliers already recommended that this area be investigated, excavated and further researched, in his report on Extention 6, which borders the current development.²⁹

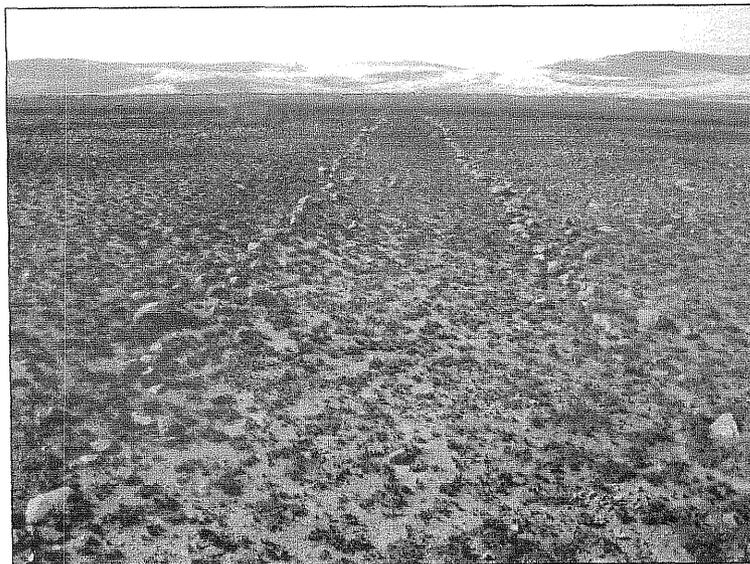
<i>Site location indicated in Appendix 3.</i>	<i>GPS Co-ordinates</i>	<i>Comments on field survey: Archaeological / cultural heritage features</i>
No. LT21 in Appendix 3.	Elev: 1385m S25°05'24.2" E30°26'10.8" Elev: 1384m S25°05'24.2" E30°26'13.0"	Several stone foundations of rectangular structures (with divisions), not more than 15 meters apart, together with one circular unit, and one square unit without divisions. Surface material consisted of metal fragments. See photo 12 (Appendix 4). Large rectangular stone foundations with divisions, in close vicinity of the above.
No. LT22 in Appendix 3.	Elev: 1344m S25°06'21.2" E30°26'02.8" Elev: 1294m S25°06'22.3" E30°25'56.0"	Location of Fort Howard as indicated in Fig. 1. Much of the remains have been disturbed or destroyed by the existing Vodacom Cell Tower and infrastructure. But there are many square and circular stone foundations left, as well as the clear outline of roads towards the fort. This area had been discussed in JP Celliers' report on Extension 6. It is currently fenced off with signs "No unauthorized entry" Surface material consisted of fragments of eroded metal. See photo 13 (Appendix 4). Outline of road associated with Fort, outside the fenced off area. See photo 14 (Appendix 4).

Photo 14: Site LT22: Outline of the historic road associated with Fort Howard.
