Archaeological and Heritage Impact Assessment

Title: Diep and Platteklip River Clearing Project.

Proposal to manage the clearing of the courses of the Diep and Platteklip rivers running through the town of Malmesbury to prevent flooding. .

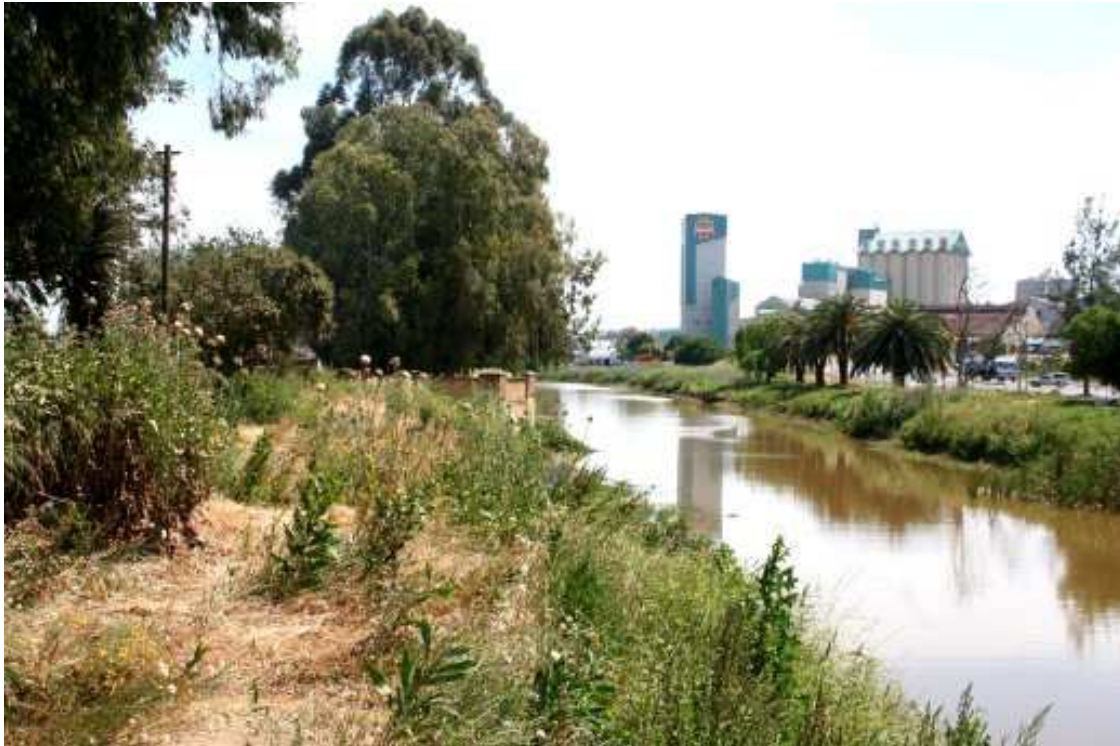
Figure 3. The Diep River dammed up with silt where it passes the Bokomo grain storage facilities. Sports fields on the left bank here are seasonally flooded.

The rivers are entrenched on the borders of the town and within the town they are partly channelled in culverts under road and rail bridges. There is significant siltation at a number of locations (Figs. 3 & 4).

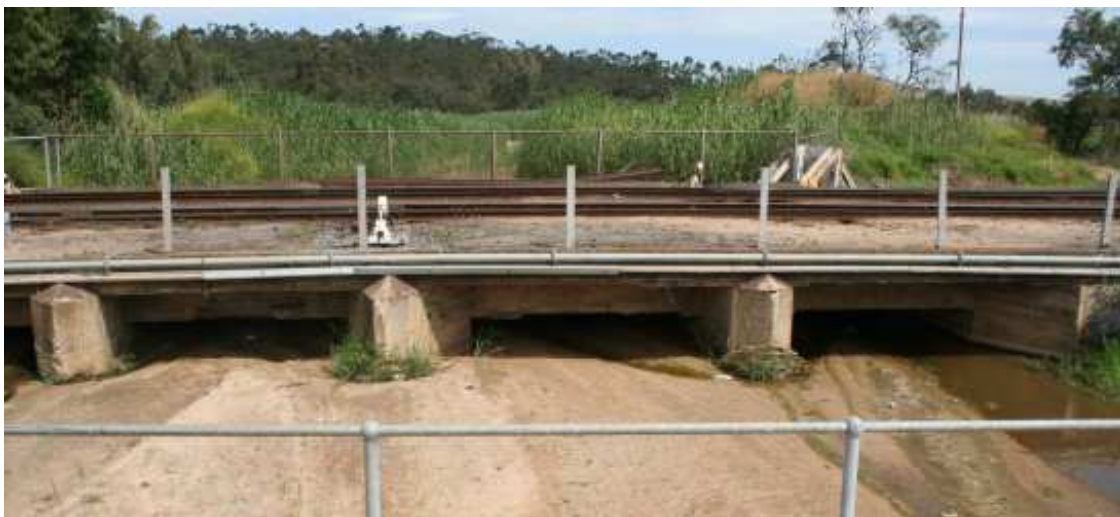
Figure 4. Silt accumulation under rail bridge on the Platteklip River near the confluence with the Diep River.
