Heritage Walkthrough

FOR THE 132 KM MEDUPI - SPITSKOP TRANSMISSION POWERLINE PROJECT, NORTHAM, LIMPOPO PROVINCE

VERSION 1.0
14 DECEMBER 2009

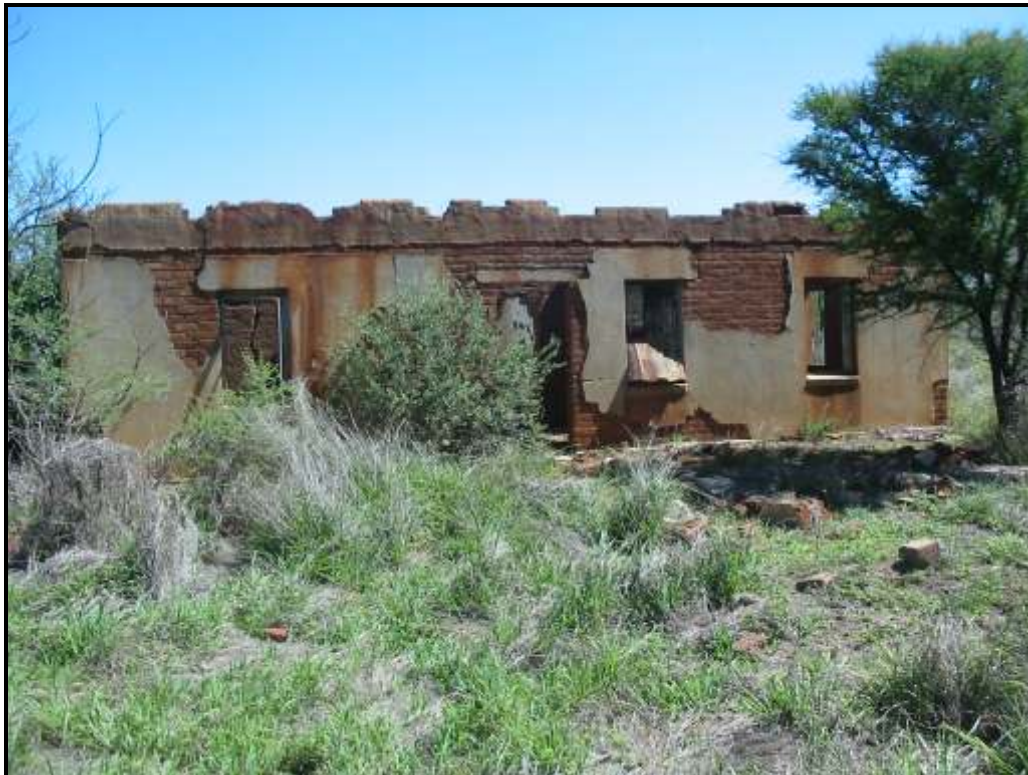
This is the location of a historical dwelling consisting of 8 rooms. The farm house is most probably one of the original farm houses on the farm Gospord 294 KQ. The house is constructed of sun dried bricks with two additional rooms added on to the original structure by later inhabitants. The house is facing north with a small veranda in front. A small ash midden is located about 10 meters in front of the veranda and according to the artefacts found, associated with a more recent period of habitation possibly by farm workers. The house got wooden window frames and cement lintels above the doors. To the south of the dwelling recent foundations of demolished structures are visible in the grass. The site is located to the east of the proposed alignment, approximately 188 meters from pylon MS 148.

FIELD RATING	GRADE	SIGNIFICANCE	RECOMMENDED MITIGATION
Generally Protected B (GP.B)	-	Medium Significance	Recording before destruction

Figure 1: Ruin viewed from the south

The site is located outside of the proposed power line alignment and almost no impact is foreseen for this site. However the site is older than 60 years as indicated by archival maps and is protected by legislation. It is recommended that as part of the EMP contractors must be made aware of the site and that the site is avoided during the pre construction and construction phase. Sites like these are also associated with graves and contractors must take cognisance of the fact that they might encounter graves during the pre construction phase.

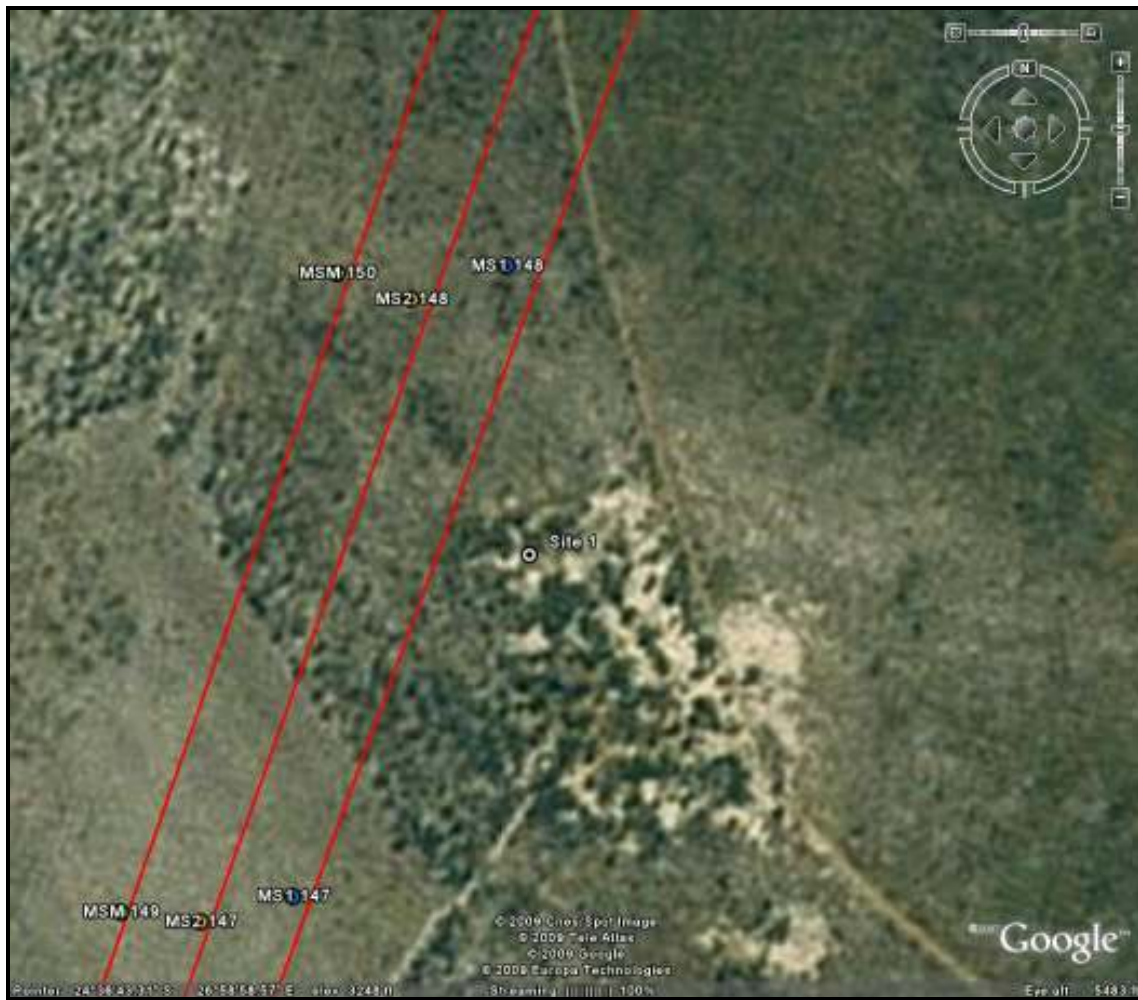
Figure 2: Aerial view of site 1 in relation to the proposed power line

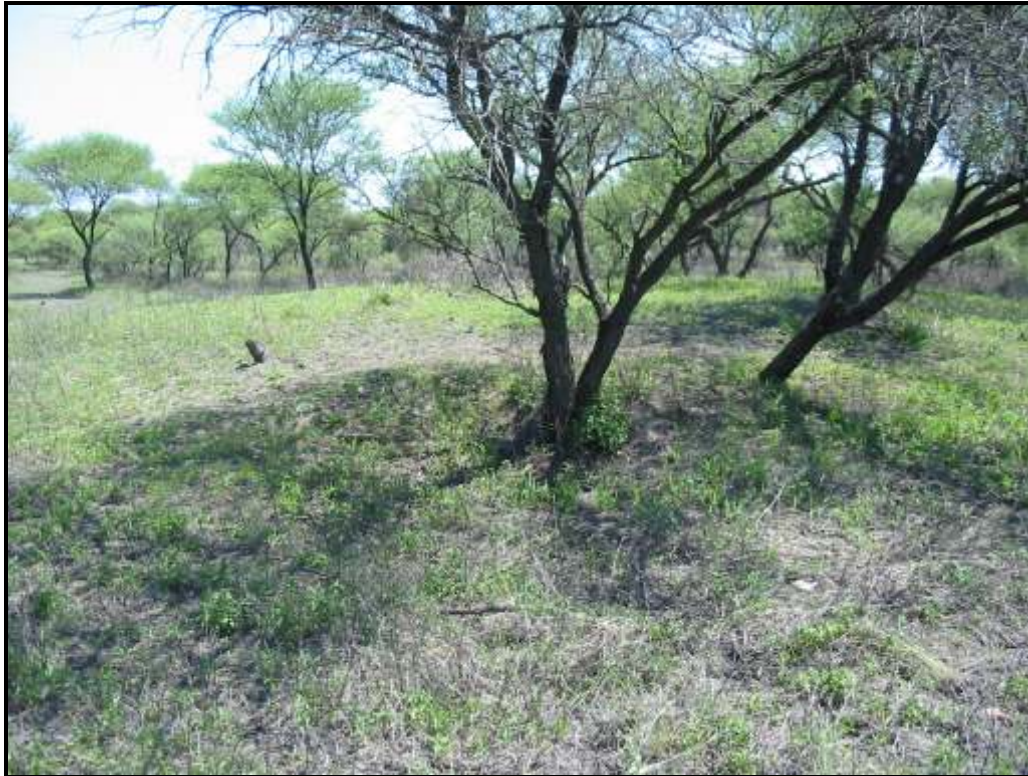
This is the location of a demolished mud dwelling. The site is marked by a slight rise in the topography with wire and iron scattered around the area. The site is located underneath the proposed power line, 89 meters to the north west from pylon MSM1 213.

FIELD RATING	GRADE	SIGNIFICANCE	RECOMMENDED MITIGATION
Generally Protected C (GP.C)	-	Low Significance	Destruction

Figure 3: Slight rise indicate remains of mud dwelling

Due to the fact that the site has been demolished and the lack of structures and features on site, the site was given a low heritage significance. The exact age of the site is unknown but based on the industrial material scattered over the site most probably not older than 60 years. The site is located directly under the proposed power line and a high impact is foreseen on the site during the pre construction phase in the form of bush clearing. No pylons are placed on the site and therefore no earthworks will occur on or close to these sites, that could expose unmarked graves that can some times be expected to be found in association with sites like these. No further action is recommended for the site.

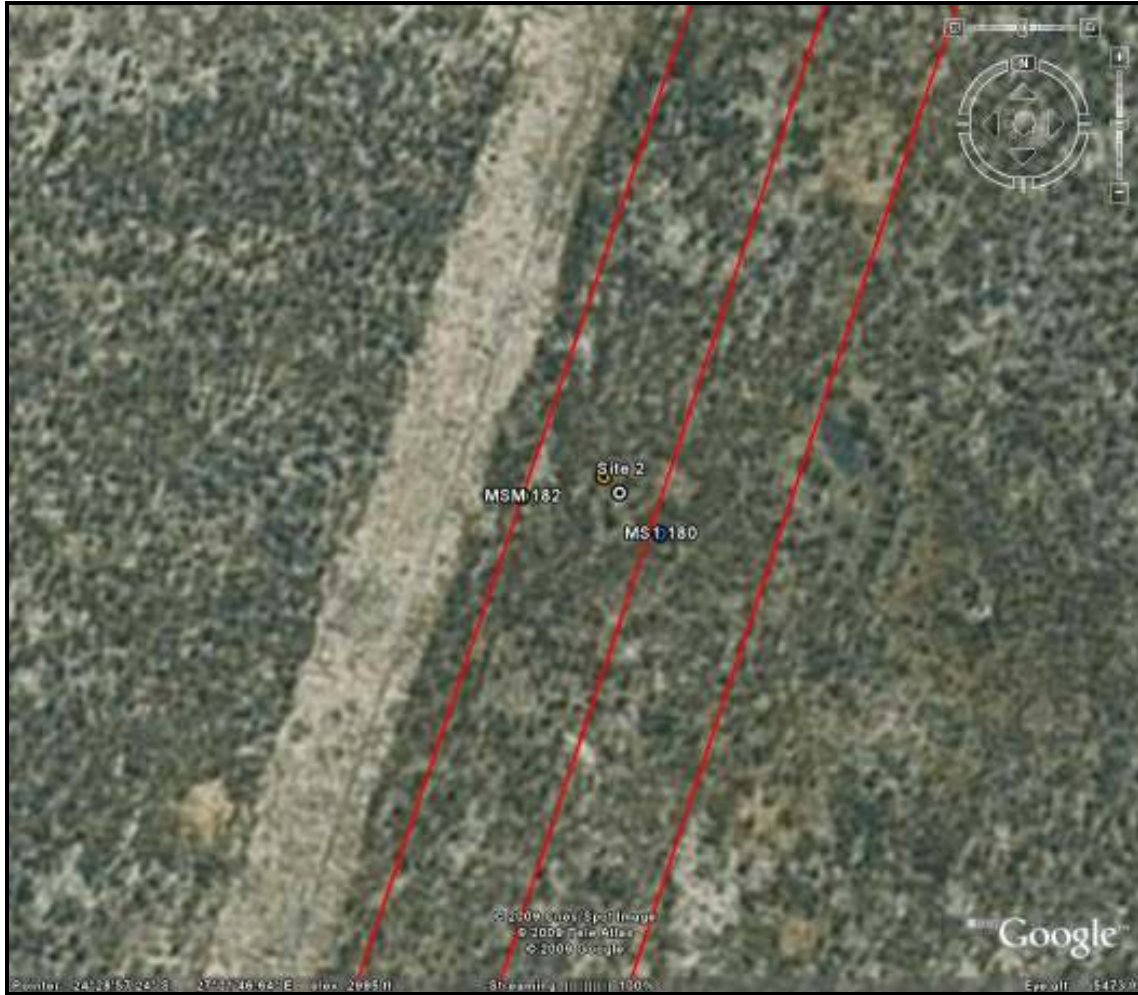
Figure 4: Aerial view of site 2 in relation to the proposed power line

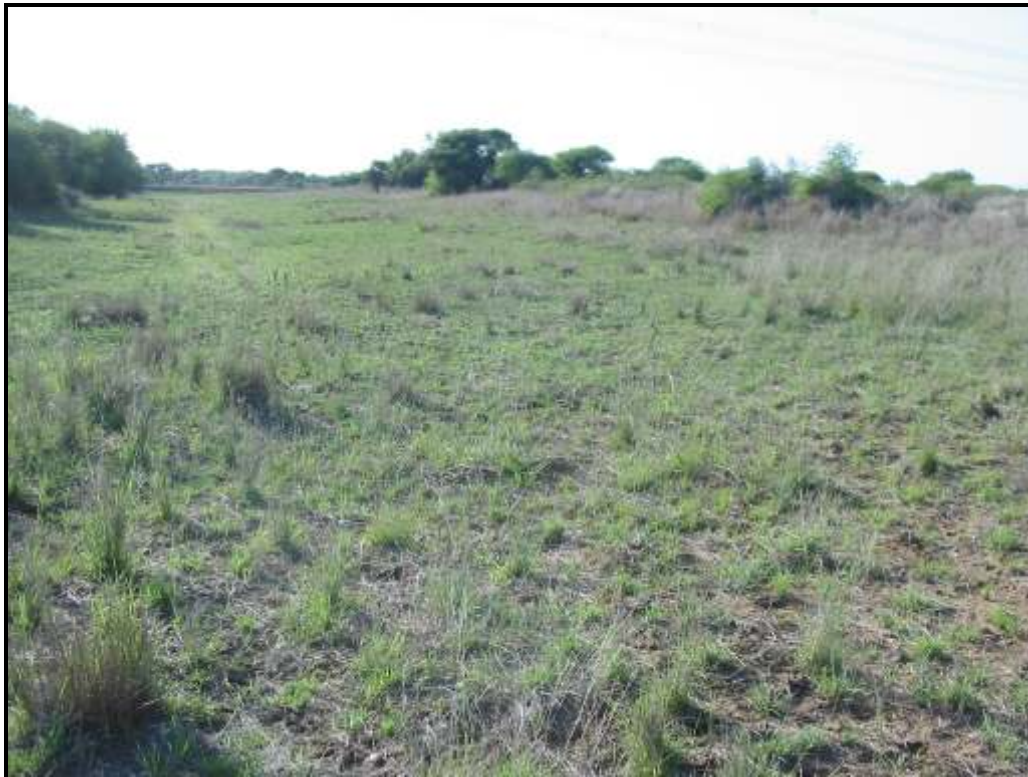
During the construction of a drainage line for a small dam a gravel layer containing widely scattered MSA artefacts were exposed. At this quarry site artefacts consist mostly of cores and flakes. This gravel layer is covered by a sandy loam, semi alluvial soil layer. The site is not located directly under the power line and the closest pylon is MS1 2113 that is 89 meters away.

FIELD RATING	GRADE	SIGNIFICANCE	RECOMMENDED MITIGATION
Generally Protected B (GP.B)	-	Medium Significance	Recording before destruction

Figure 5: Drainage line exposing gravel layer with MSA cores and flakes

A Negative impact is foreseen on the sites by the proposed power line. Since these quarry sites are open air sites and very little archaeological deposit is present due to sheet erosion the sites were given a medium heritage significance rating. The footprint of the towers is so small that the sites are not in danger of being totally destroyed. It is therefore recommended that an archaeologist map and collect surface samples of the sites. After which a destruction permit will be required from SAHRA before construction of the tower positions can start.

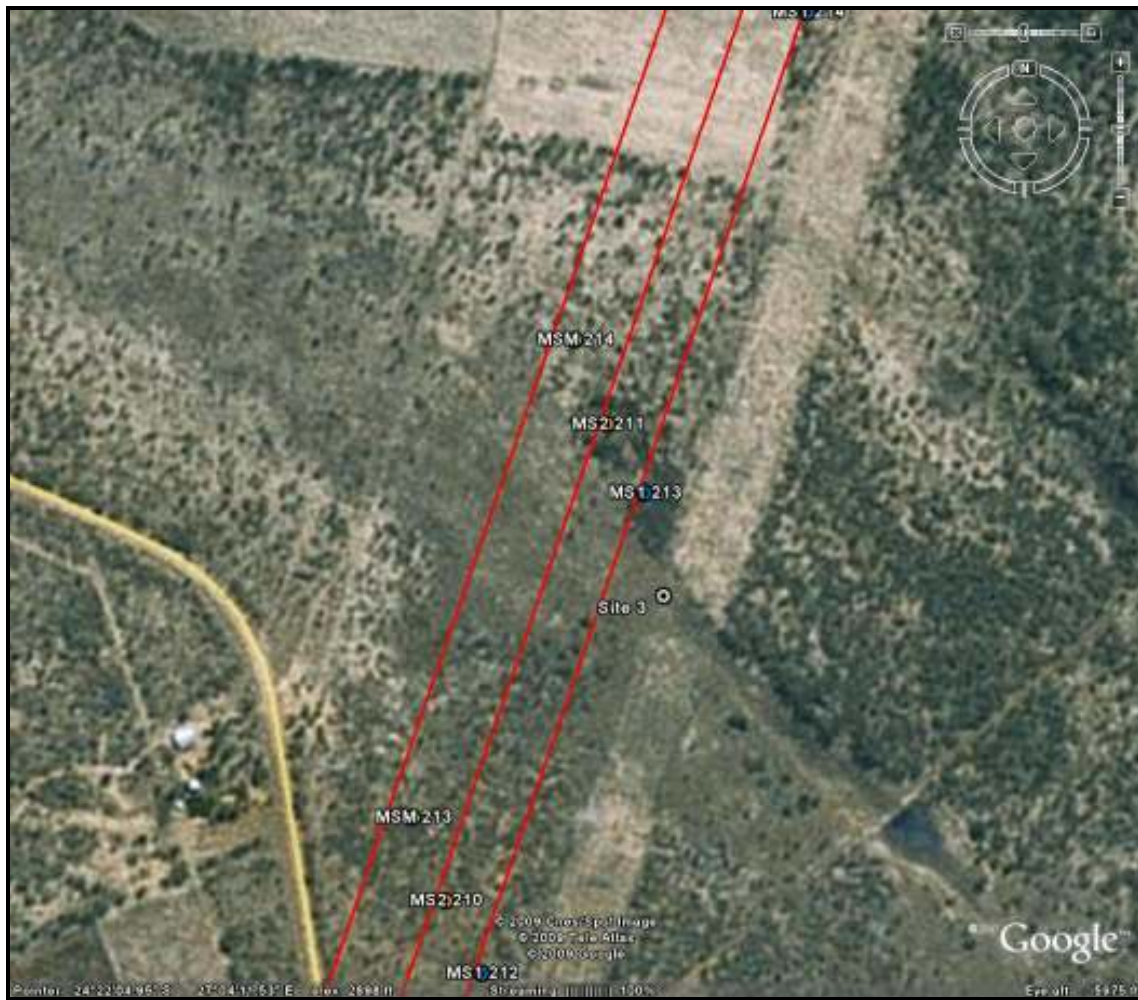
Figure 6: Aerial view of site 3 in relation to the proposed power line

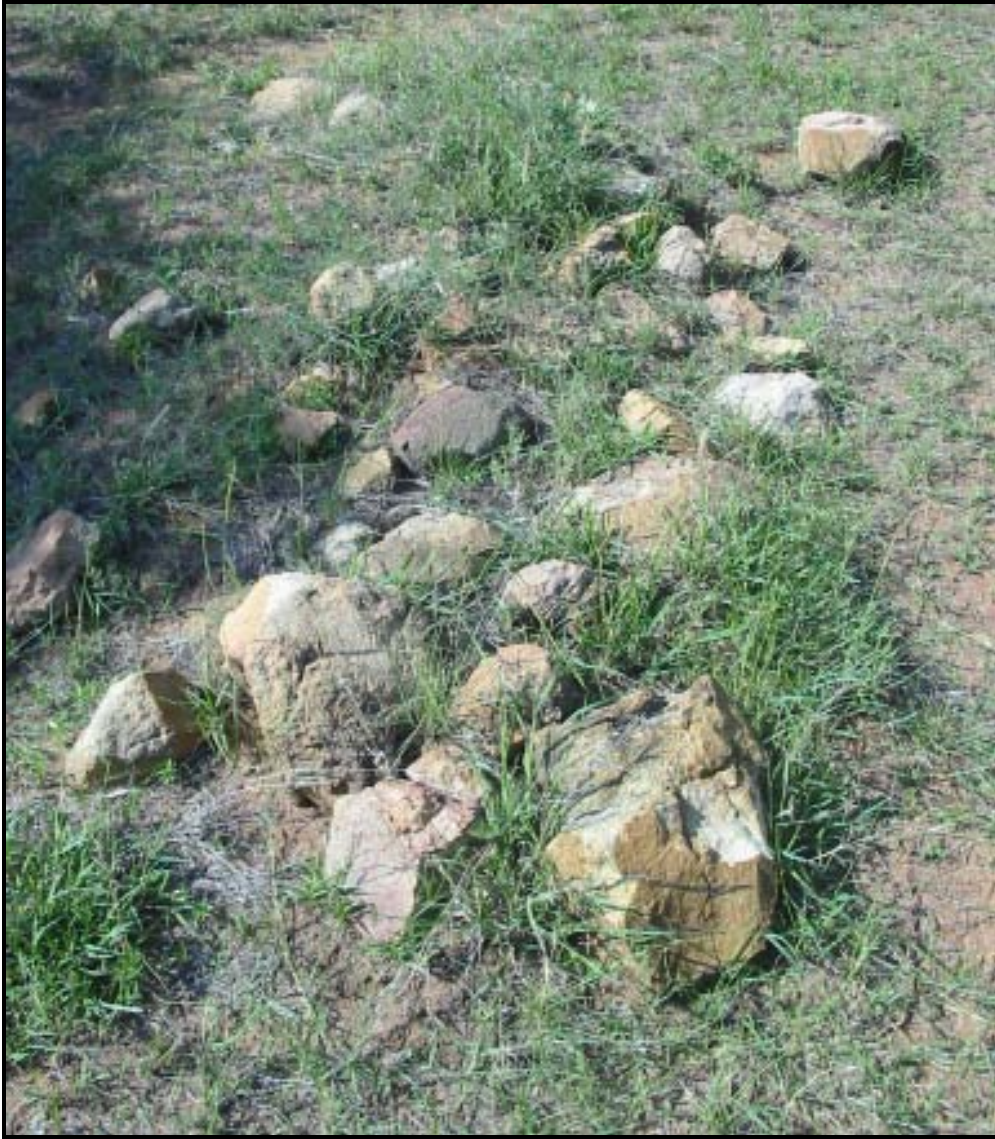
This site consists of an elongated stone cairn orientated east to west measuring 1.5 x 1.50 meters close to a feeding lot. At this point it is not clear if this feature is associated with the activities in constructing the cattle water point and feeding lot or if might be a single grave. The site is located approximately 31.93 meters from pylon MS2 215 and located directly under the proposed power line.

<i>FIELD RATING</i>	<i>GRADE</i>	<i>SIGNIFICANCE</i>	<i>RECOMMENDED MITIGATION</i>
Generally Protected A (GP.A)	-	High Significance	Mitigation before destruction

Figure 7: Elongated stone cairn

foreseen by the placement of the tower positions. It is therefore recommended that the site is demarcated with danger tape to protect the site during the pre construction and construction phase.

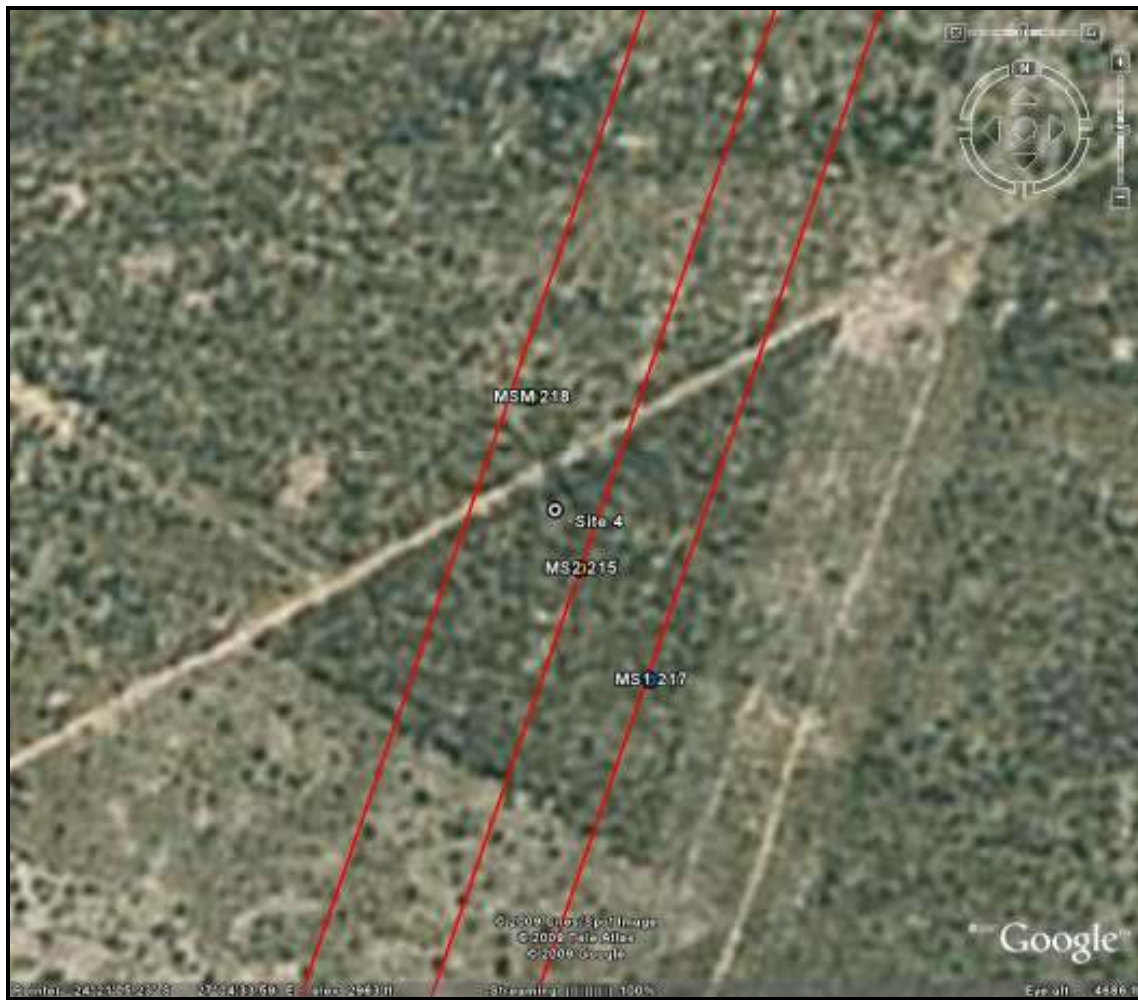
Figure 8: Aerial view of site 4 in relation to the proposed power line

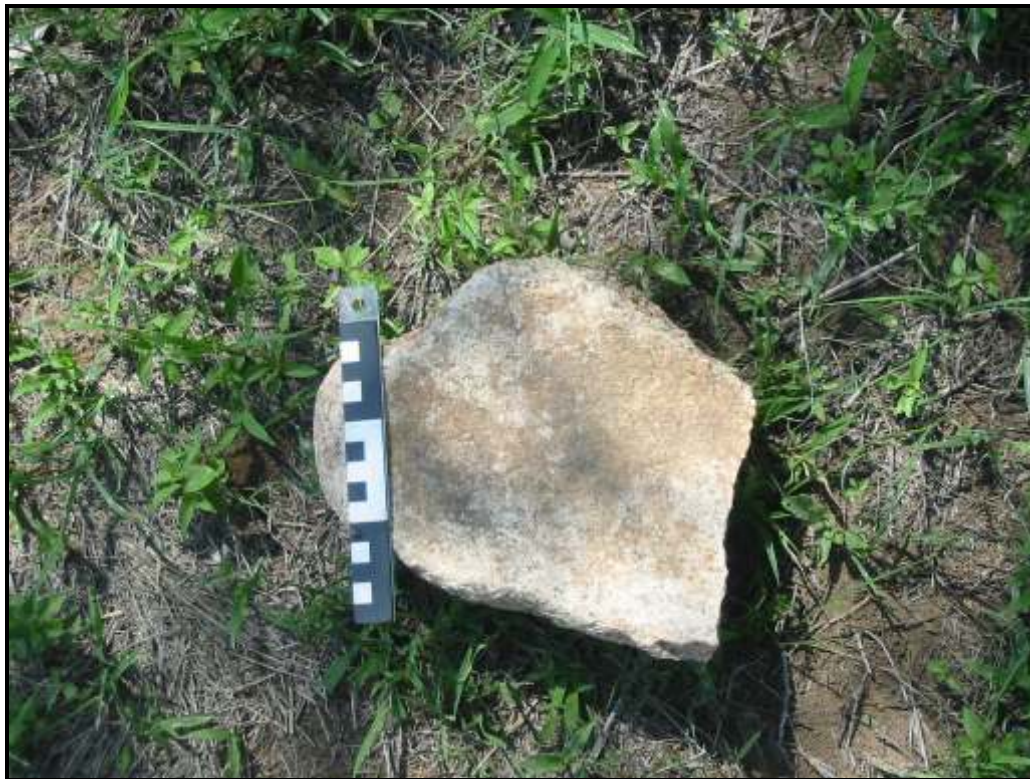
This is the location of a single broken lower grind stone found in a service road next to a game fence. Since no other features or artefacts occur in close proximity to the site, the site is classified as a find spot. It might be that the broken grind stone was used with other rocks to block ditches made by burrowing animals underneath the game fence. The closest pylon to the site is MS1 222 and is 207 meters away.

FIELD RATING	GRADE	SIGNIFICANCE	RECOMMENDED MITIGATION
Generally Protected C (GP.C)	-	Low Significance	Destruction

Figure 9: Broken Lower Grinder

The find spot is of low significance since the artefact was carried in with other rocks from another area and used to block holes under the game fence caused by burrowing animals. No further action is necessary for this site.

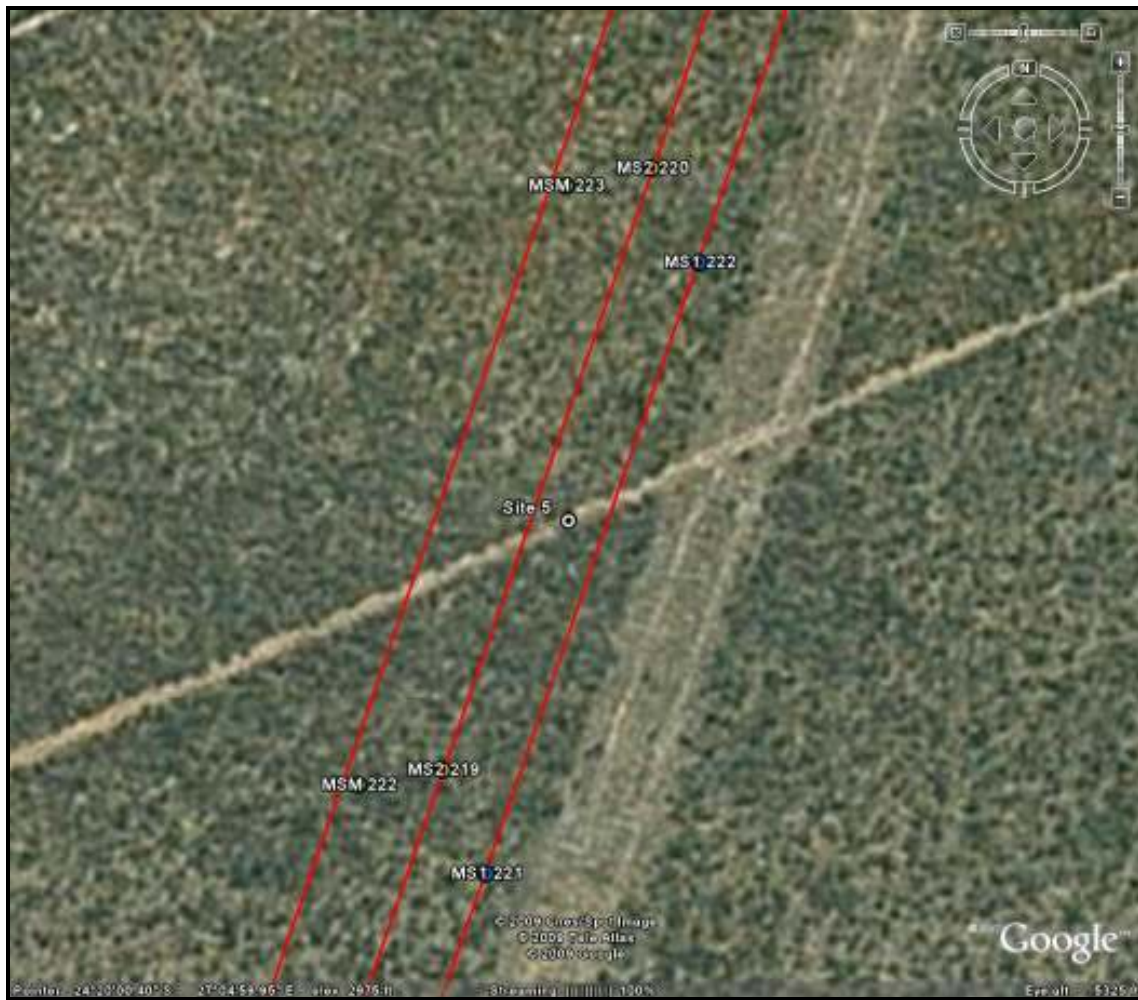
Figure 10: Aerial view of site 5 in relation to the proposed power line

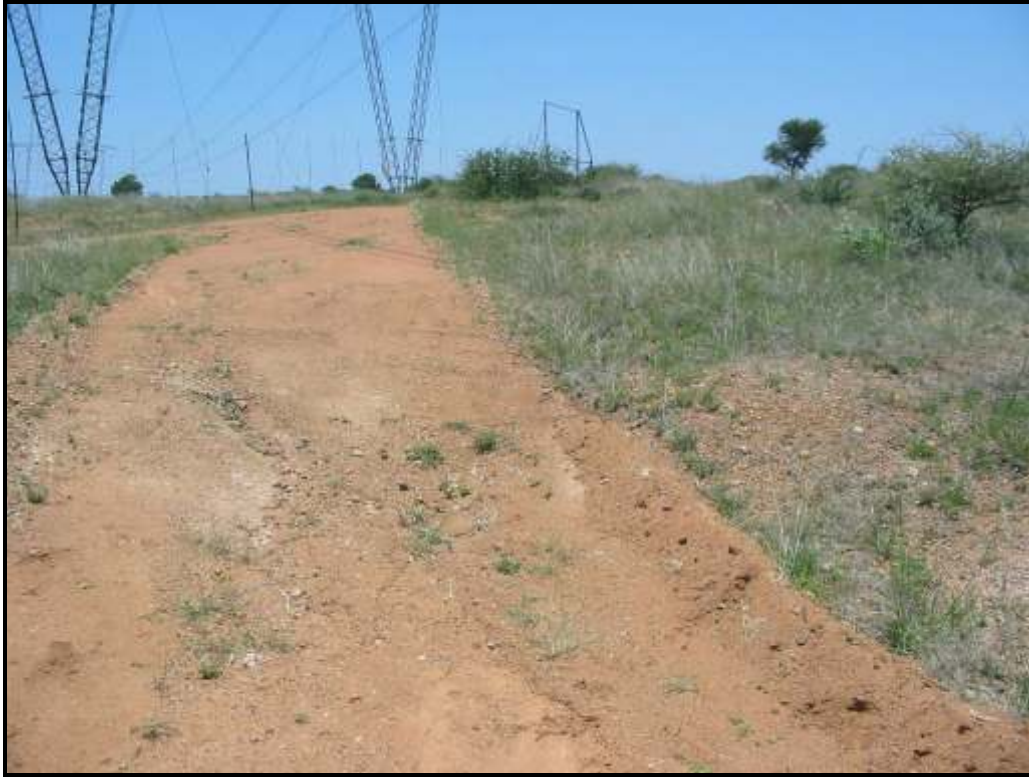
Figure 12: General Site conditions

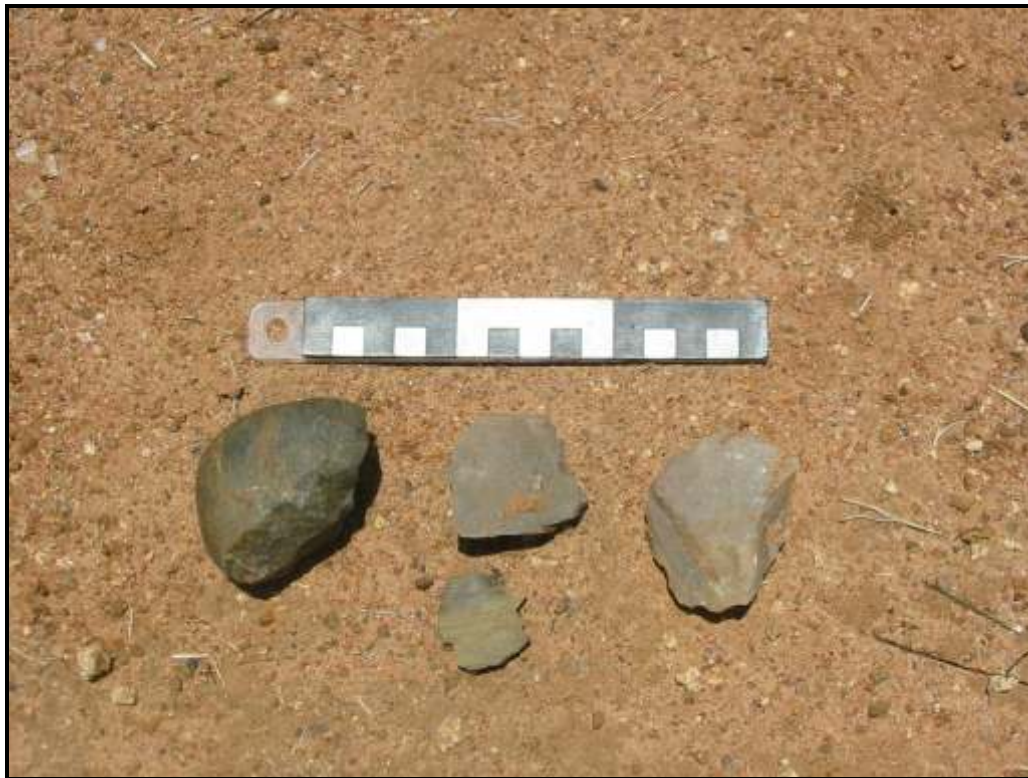
This is the location of another MSA quarry on the banks of the Mathlabas river. Raw material is found in abundance in the gravel layers that are exposed by sheet erosion. Tools consist of cores, choppers and flakes with prepared striking platforms. Artefacts are found scattered over an extensive area found in lower frequencies as one move further away from the river bank. The highest concentration of artefacts is found approximately 13.87 meters from tower MS2 269 and located directly under the power line.

FIELD RATING	GRADE	SIGNIFICANCE	RECOMMENDED MITIGATION
Generally Protected B (GP.B)	-	Medium Significance	Recording before destruction

Figure 13: Stone artefacts found at Site 7

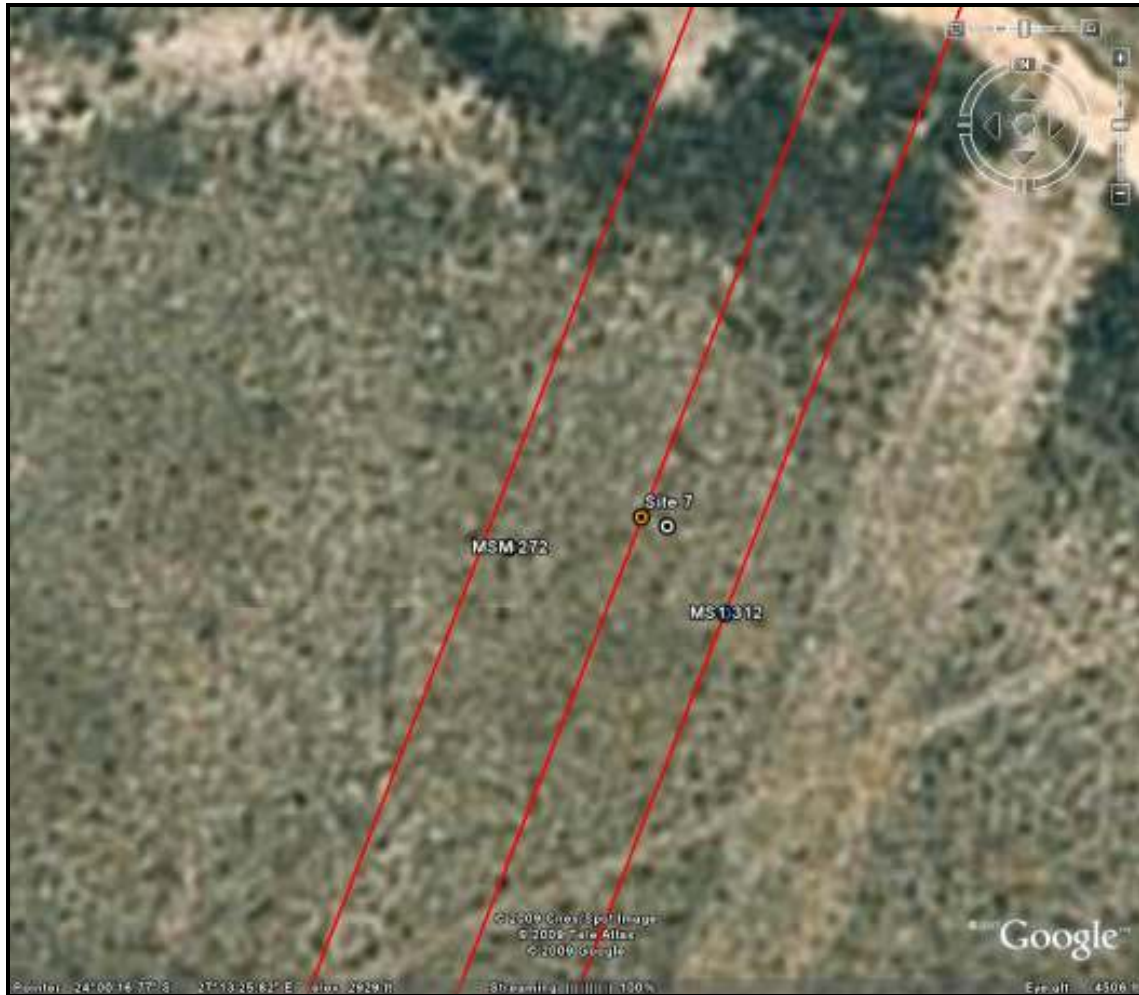
Figure 14: Areal view of extend of site 7

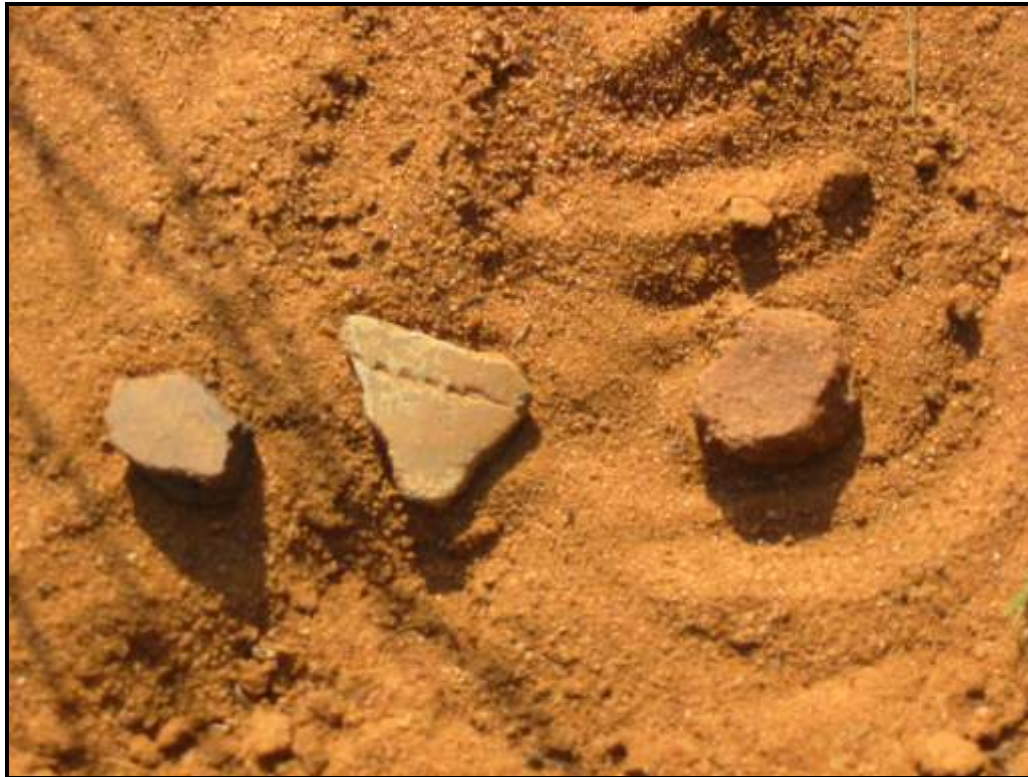
Several aardvark burrows exposed some decorated and undecorated ceramics buried underneath red Kalahari windblown sand. The extend of the site is unknown but the area is marked by grewia flava shrubs. At least 5 different vessels was identified, one being a small lip fragment with punctuates underneath the rim. Although more decorated ceramics are needed to positively identify the site, punctuates under the rim are characteristic of the Letsibogo ceramic facies. More sites can be expected in the area since a major water source is close by (Mathlabas River) and the low visibility of the sites. The site is located directly under the proposed power line with the closest tower to the site being pylon MS2 273 that is 273 meters away from the site.

FIELD RATING	GRADE	SIGNIFICANCE	RECOMMENDED MITIGATION
Generally Protected B (GP.B)	-	Medium Significance	Recording before destruction

Figure 15: Ceramics found at site 8

The lack of a large sample of decorated ceramics from the sites hampers the positive identification of the sites but the one decorated piece found at site 8 have characteristic decoration attributed to the Letsibogo ceramic facies dating to AD 1500 – 1700. This facies belongs to the Moloko branch of the Urewe tradition and was first described in Botswana with only a few known sites south of the Limpopo giving the recorded sites a medium heritage significance.

The sites are buried underneath the red Kalahari windblown sand that hampers archaeological visibility. Although no towers are placed on where sites are found (marked by scatters of pottery) the possibility exist of founding sites closer to the tower positions covered by soil. It is therefore recommended that the wider areas around the recorded sites are visited by an archaeologist after bush clearing during the pre-construction phase. The tower positions must also be monitored by an archaeologist during construction to document and mitigate accidental finds.

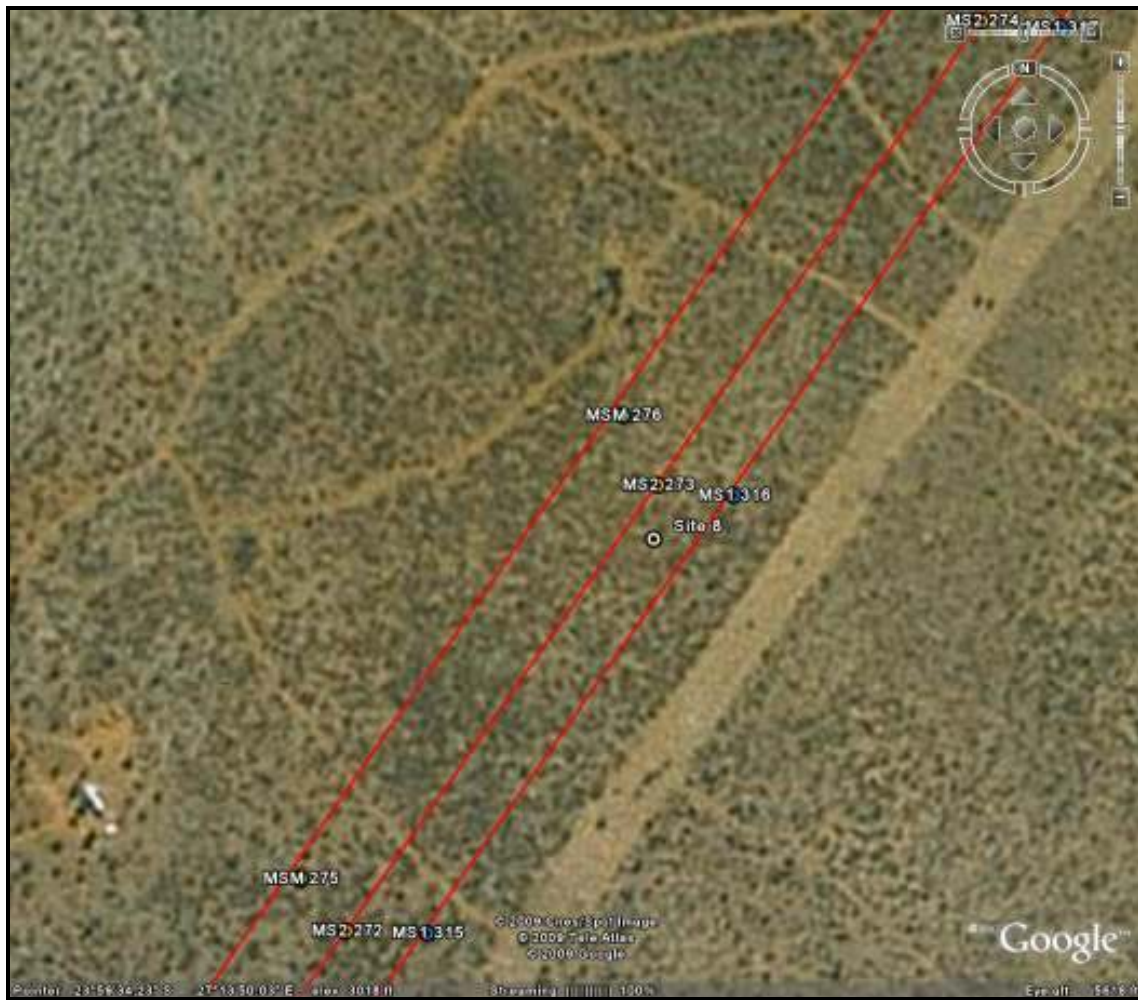
Figure 16: Areal view of site 8 in relation to the power line

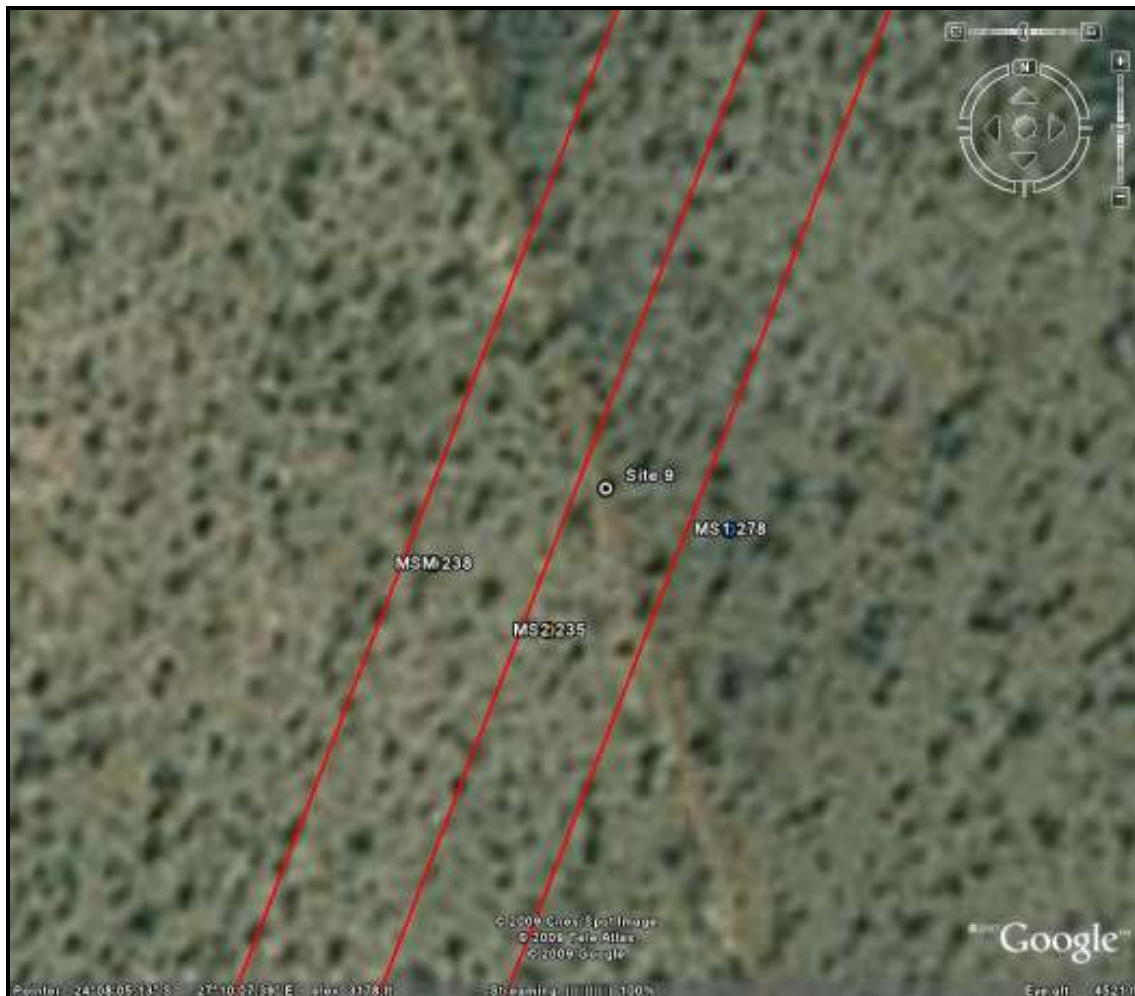
A small gravel road exposed a few undecorated ceramics scattered over a wide area. The site might be buried under the sand. A Large calcrete pan is close by and Stone Age and Iron Age sites can be expected in this area. The closest tower to the site is MS1 278 that is 48 meters from the site.

FIELD RATING	GRADE	SIGNIFICANCE	RECOMMENDED MITIGATION
Generally Protected B (GP.B)	-	Medium Significance	Recording before destruction

Figure 17: Areal view of site 9 in relation to the proposed power line.

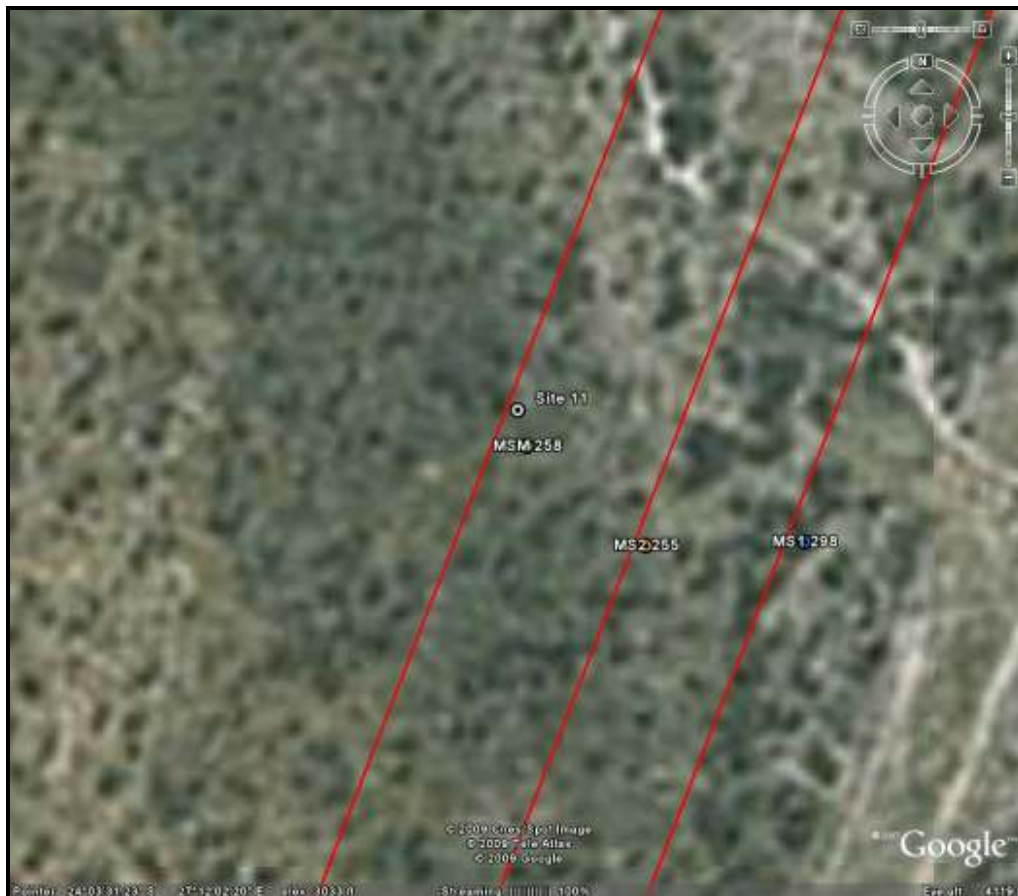
This is the location of a large calcrete pan and MSA tools with prepared striking platforms are found scattered in high frequencies over the area. Tools consist of cores and flakes. The site is located directly under the proposed power line and highest concentration of artefacts found is approximately 14 meters from tower MSM 258. During the survey it was raining heavily and it was not possible to take photographs.

FIELD RATING	GRADE	SIGNIFICANCE	RECOMMENDED MITIGATION
Generally Protected B (GP.B)	-	Medium Significance	Recording before destruction

Figure 18: Aerial view of site 11 in relation to the power line
