PHASE 1 HERITAGE IMPACT ASSESSMENT

**FOR THE PROPOSED CONSTRUCTION OF A NEW WASTE WATER TREATMENT
AND SEWAGE PIPELINE ON PORTION 32 OF THE FARM MORGENZON 466-IS,
LEKWA LOCAL MUNICIPALITY, MPUMALANGA PROVINCE.**

Compiled by: P.D. Birkholtz
Date: 8 October 2008

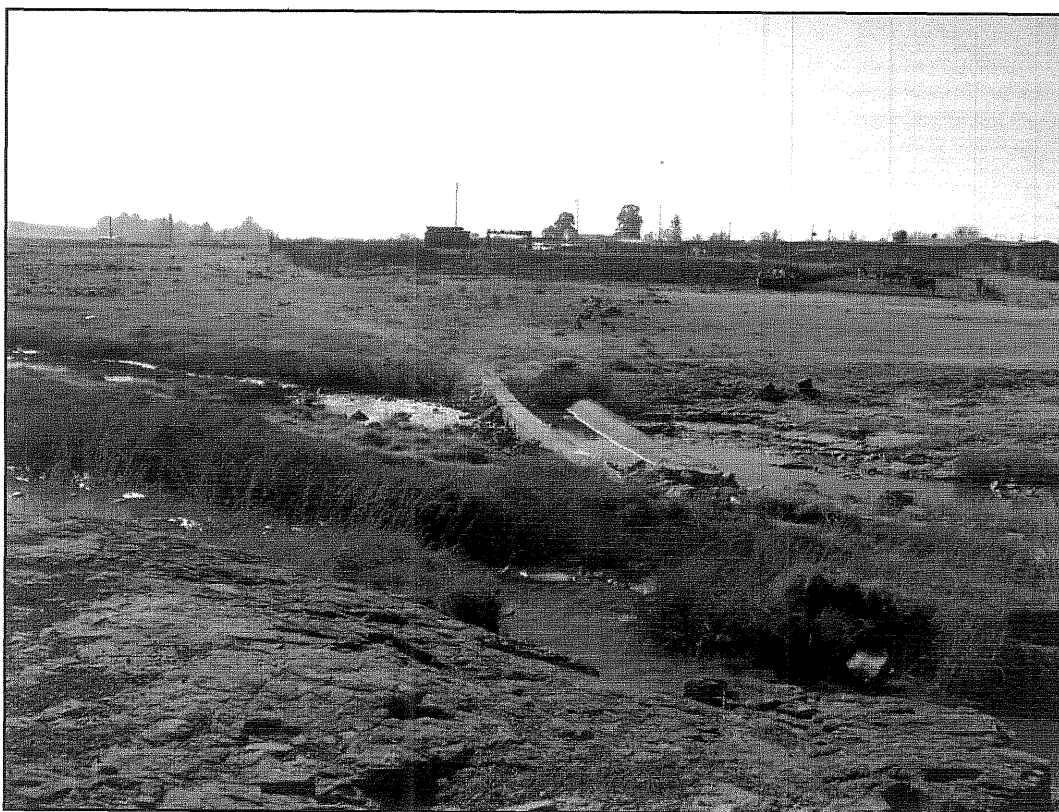
Plate 1 View across the Osspruit of the existing pump station at Sivukile.

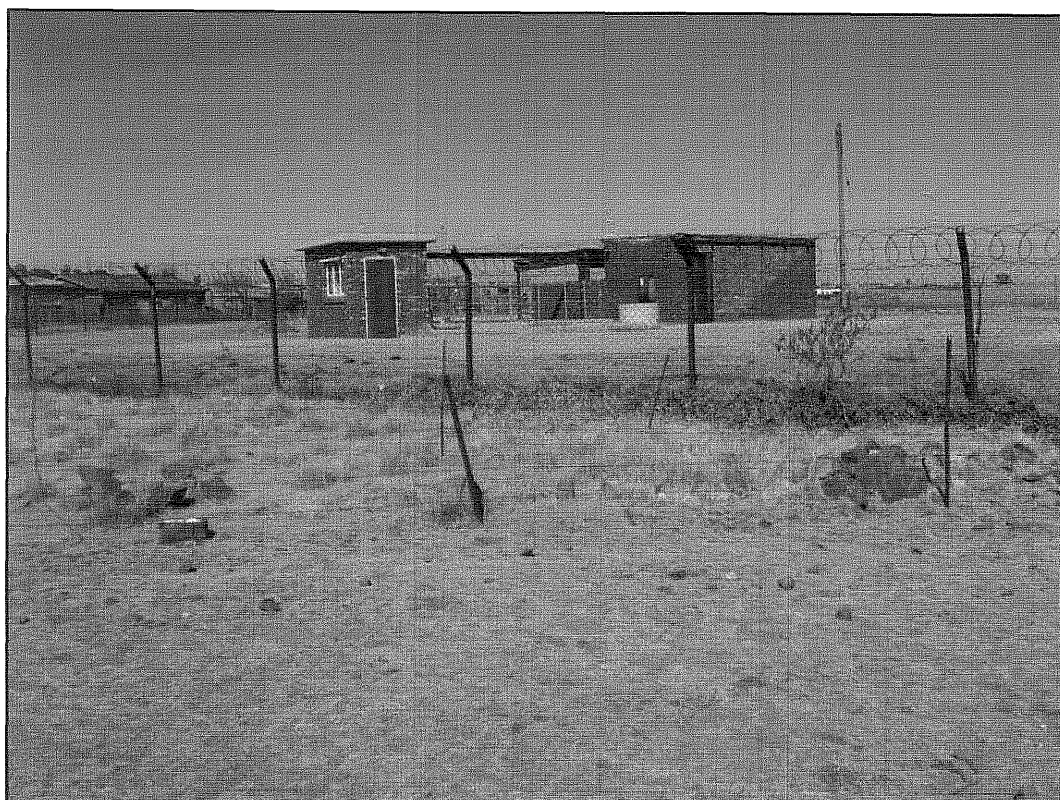
Plate 2 Closer view of the pump station at Sivukile.

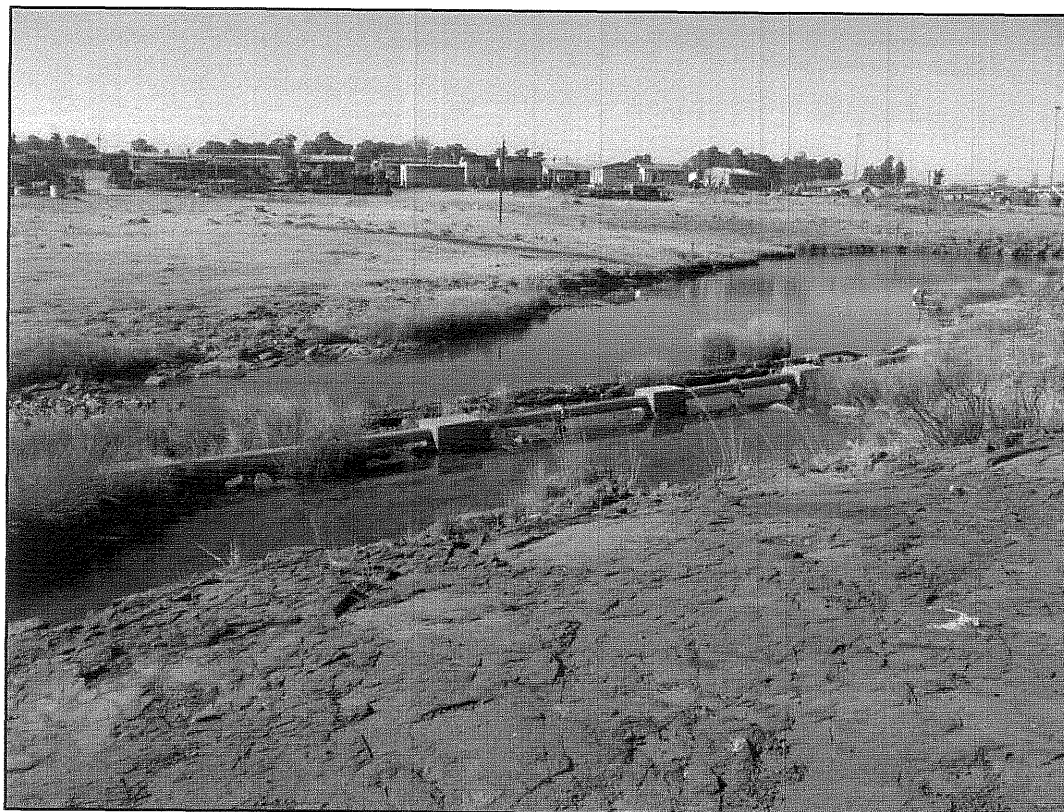
Plate 3 An existing pipeline and the Osspruit are visible in the foreground with Sivukile in the back.

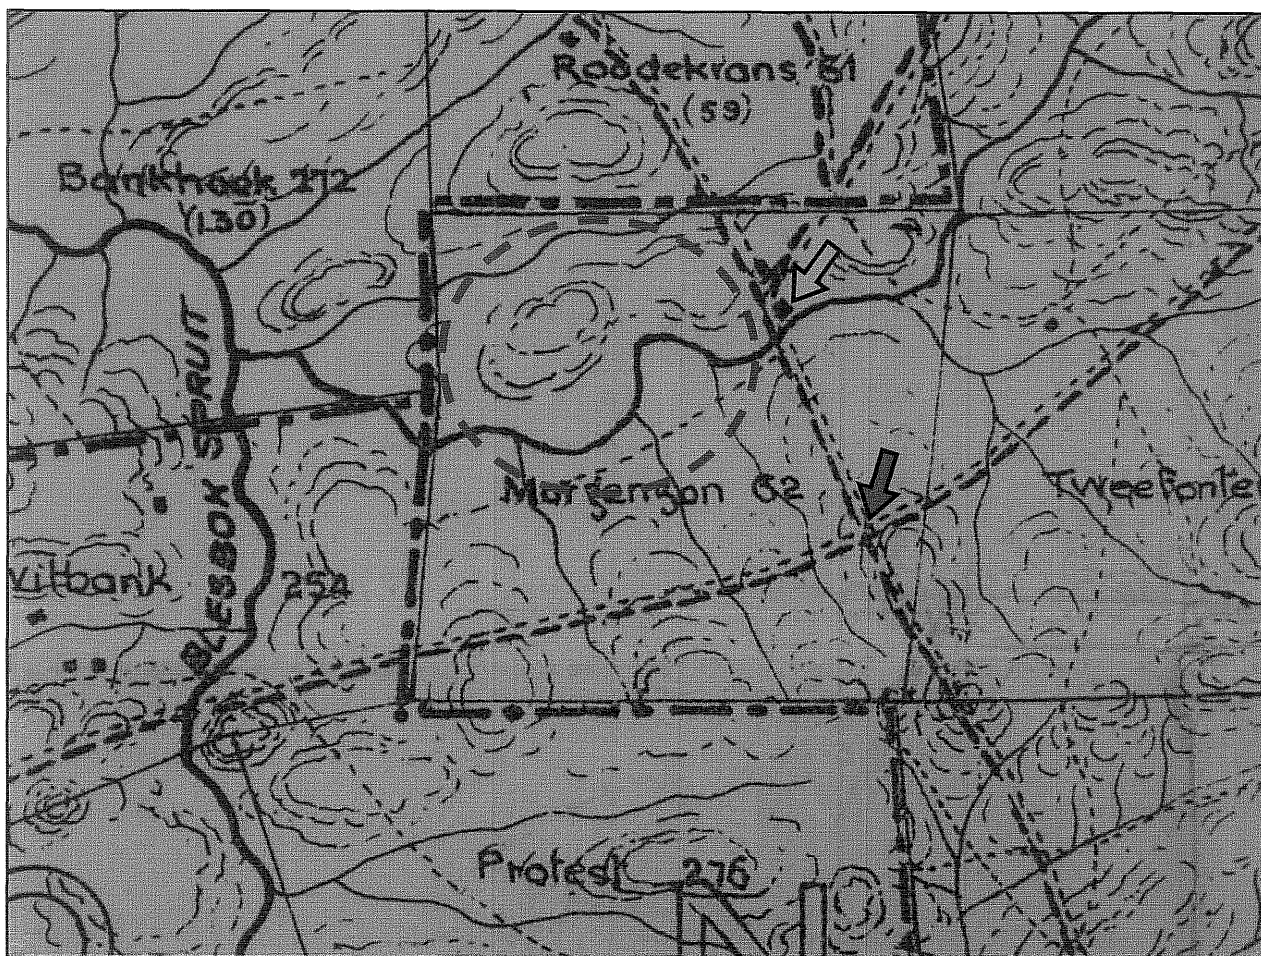
Figure 1 below depicts an enlarged section of the Amersfort sheet of the Major Jackson Series (National Archives, Maps, 3/610). This series was produced during the South African War (1899-1902) by the Mapping Section of the Field Intelligence Department under the supervision of Major R.M. Jackson. The sheet is dated to December 1900.

No sites are indicated within the proposed development area and direct surroundings (see red dotted line). The only features depicted on the farm as a whole are a homestead (marked in green) and a number of roads. At the time the roads from Standerton (west), Bethal (north), Ermelo (east) and Amersfoort (south) met at a point situated near the south-eastern corner of the farm (see pink arrow).

Figure 1 Enlarged section of the Amersfort sheet of the Major Jackson Series. The approximate position of the study area and direct surroundings is marked in red dotted line.

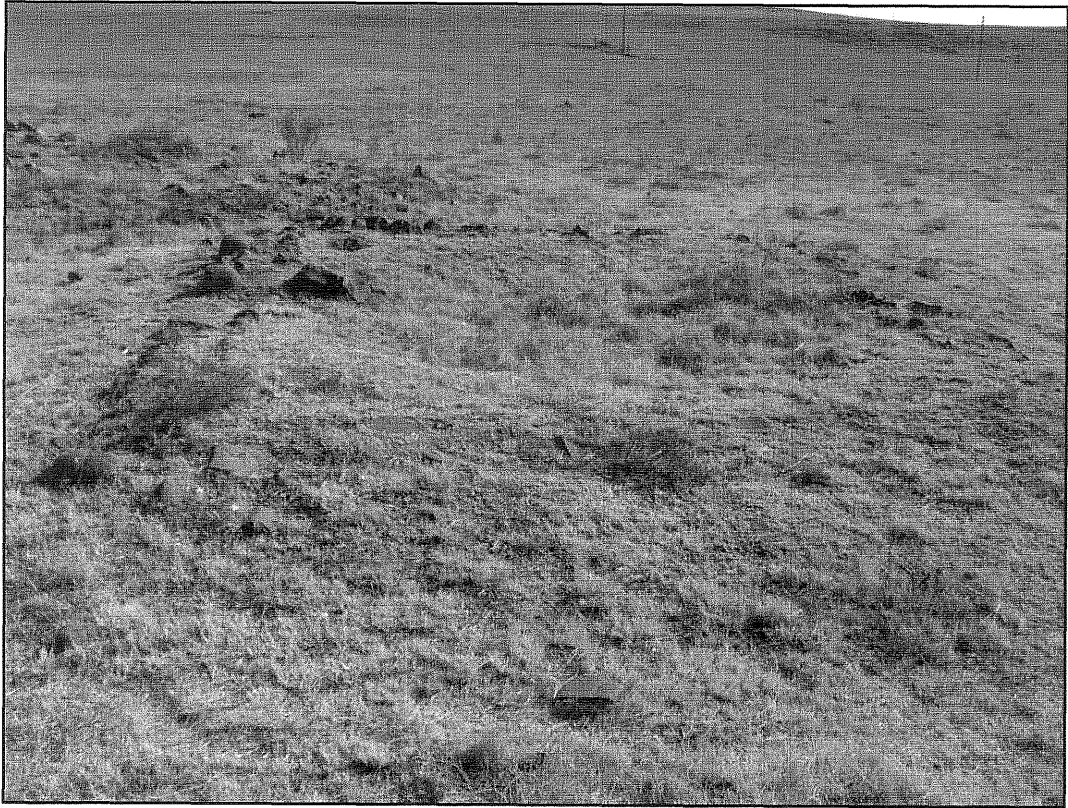
Site 1 comprises the remains of an abandoned homestead and associated cattle enclosure. The homestead consists of a rectangular main building (15m x 5m) which is divided into three rooms of roughly equal size. A small, square structure flanks the main building to the west and is approximately 5m x 5m in extent. A second small square structure is located on the eastern side of the main building and measures approximately 7m x 7m. The cattle enclosure is located approximately 25m south of the main building and is square shaped measuring approximately 20m x 20m.

The dilapidated remains of the structures consist of thick but collapsed stone walls which vary between 0.7m and 1m in thickness. Most of the walls are quite low though some sections of walling approximately 1m in height were observed.

The site can be interpreted as an abandoned black homestead and may likely have been the accommodation of farm workers. Past experience has shown that in some cases stillborn babies were buried close to the homes of their parents and especially along the sides of the dwellings. These graves were seldom marked with surface dressings. As the site appear to have been abandoned some time ago, no direct information with regards to the presence (or not) of graves here has been found.

Without the presence of a grave(s) the site is of **Low Significance**.

Plate 7 View of one of the structures from the homestead.

As it is presently uncertain what the exact impact of the proposed pipeline on the site would be, the first step in the mitigation comprises a visit to the site in the company of the project land surveyor to establish whether it is located within the development footprint of the proposed pipeline. If the site is located more than 10m away from the pipeline footprint, the following mitigation would be required:

- Compilation of a site management plan with which the preservation of the site during the construction and operational phases can be ensured.

Should it be established that the site (or components thereof) is located within the pipeline development, two options exist. The first of these is for the layout of the pipeline to be altered slightly to allow the pipeline to pass the site without having any direct impact on it. If such a measure would be too costly or impractical, the following mitigation measures will have to be followed.

The National Heritage Resources Act 25 of 1999 states that no structures older than 60 years may be altered or demolished without a permit from the relevant heritage authority. The following mitigation measures are recommended for the structures:

- Measured drawing of a site layout plan.
- Photographic recording.
- Compiling the drawings, photographic recordings and descriptions into a report.
- Submit report to the relevant heritage authority to acquire a destruction permit.

Once the destruction permit is acquired, the following mitigation measures must be undertaken to address the possible presence of graves:

- All located structures must be investigated by way of test excavations. These excavations will result in one of two outcomes, namely that evidence (i.e. skeletal material, coffin remains etc.) for the existence of a grave (or graves) is found, or alternatively that no such evidence is found. If no evidence for graves is found, the site can be destroyed. However, should evidence for a grave be found, the excavation pit must be backfilled upon which a standard grave relocation process must take place. Such a process must always be undertaken in full cognisance of the relevant legislation, and must include a detailed social consultation component to try and identify the family of the deceased.

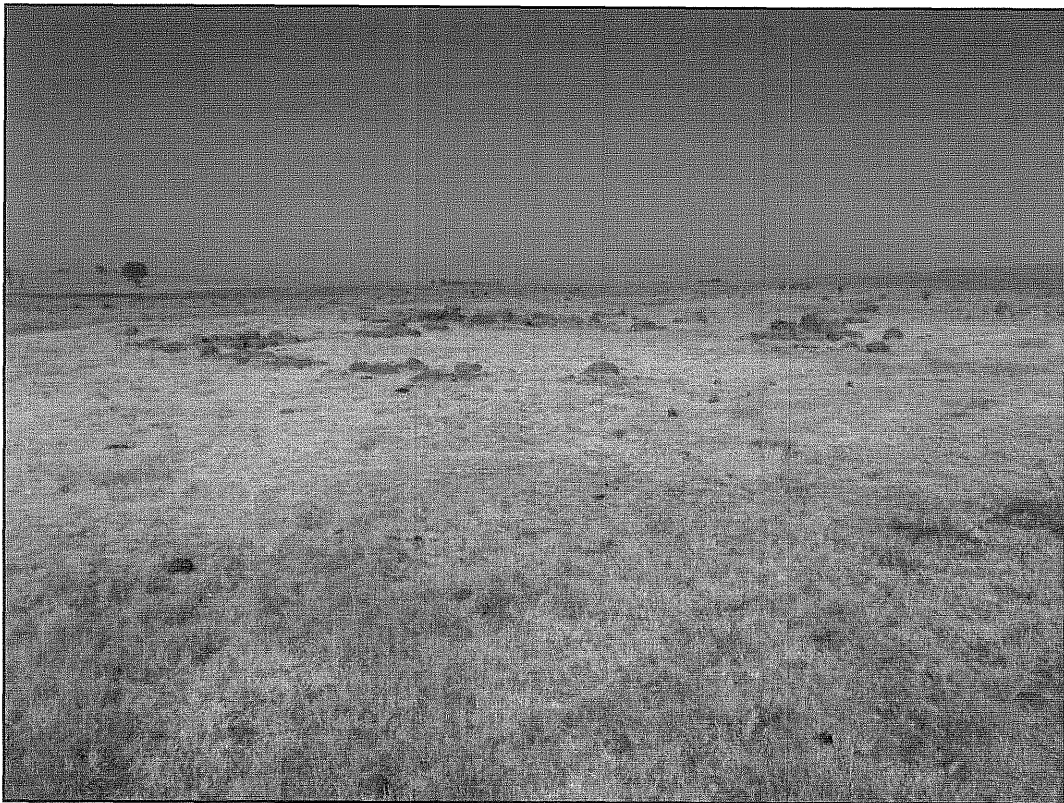
Plate 8 The cattle enclosure from Site 1.

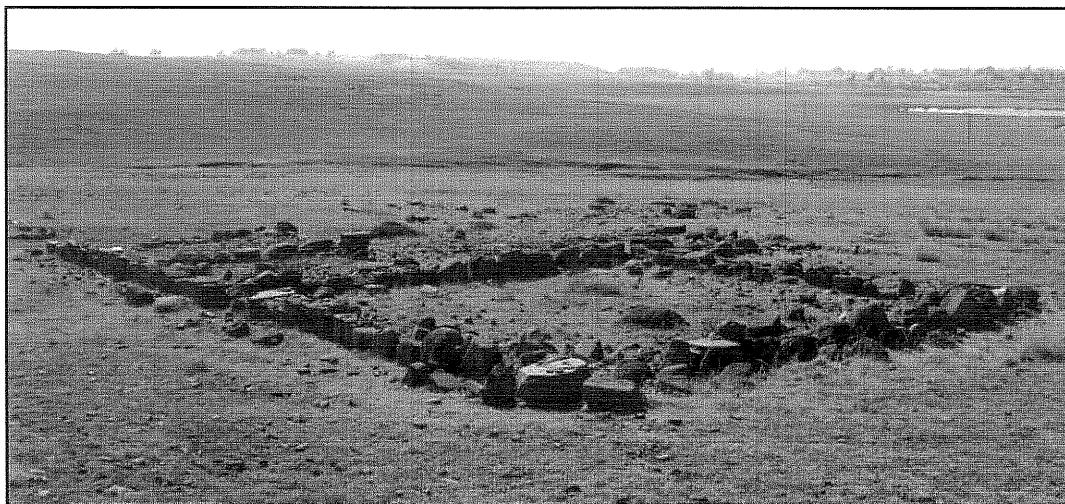
Site 2 comprises the remains of an abandoned homestead and its associated cattle enclosure. The homestead is comprised of five separate structures namely three square structures (two of which are 5m x 5m in extent and the third 7m x 7m in extent) and two rectangular structures (both 10m x 5m in extent). The livestock enclosure is situated approximately 10m to the west of the homestead. It is square shaped and measures approximately 20m x 20m.

The dilapidated remains of the structures consist of thick but collapsed stone walls which vary between 0.7m and 1m in thickness. Most of the walls are quite low though some sections of walling approximately 1m in height still remain.

The site can be interpreted as an abandoned black homestead and may likely have been the accommodation of farm workers. Past experience has shown that in some cases stillborn babies were buried close to the homes of their parents and especially along the sides of the dwellings. These graves were seldom marked with surface dressings. As the site appear to have been abandoned some time ago, no direct information with regards to the presence (or not) of graves here has been found.

Without the presence of a grave(s) the site is of **Low Significance**.

Plate 9 General view of a section of Site 2.

The first step in the mitigation comprises a visit to the site in the company of the project land surveyor to confirm whether it is located within the development footprint of the proposed pipeline. If the site is located more than 10m away from the pipeline footprint, the following mitigation would be required:

- Compilation of a site management plan with which the preservation of the site during the construction and operational phases can be ensured.

Should it be established that the site (or components thereof) is located within the pipeline development, two options exist. The first of these is for the layout of the pipeline to be altered slightly to allow the pipeline to pass the site without having any direct

impact on it. If such a measure would be too costly or impractical, the following mitigation measures will have to be followed.

The National Heritage Resources Act 25 of 1999 states that no structures older than 60 years may be altered or demolished without a permit from the relevant heritage authority. The following mitigation measures are recommended for the structures:

- Measured drawing of a site layout plan.
- Photographic recording.
- Compiling the drawings, photographic recordings and descriptions into a report.
- Submit report to the relevant heritage authority to acquire a destruction permit.

Once the destruction permit is acquired, the following mitigation measures must be undertaken to address the possible presence of graves:

- All located structures must be investigated by way of test excavations. These excavations will result in one of two outcomes, namely that evidence (i.e. skeletal material, coffin remains etc.) for the existence of a grave (or graves) is found, or alternatively that no such evidence is found. If no evidence for graves is found, the site can be destroyed. However, should evidence for a grave be found, the excavation pit must be backfilled upon which a standard grave relocation process must take place. Such a process must always be undertaken in full cognisance of the relevant legislation, and must include a detailed social consultation component to try and identify the family of the deceased.
