**HERITAGE SURVEY OF THE PROPOSED NKANYA
LODGE, WILD COAST, EASTERN CAPE
FOR COASTAL & ENVIRONMENTAL SERVICES**

DATE: 5 March 2009

**By Gavin Anderson
Umlando: Archaeological Tourism and Resource
Management
PO Box 102532, Meerensee, 3901
Phone/fax: 035-7531785 Fax: 0865445631cell:
0836585362**

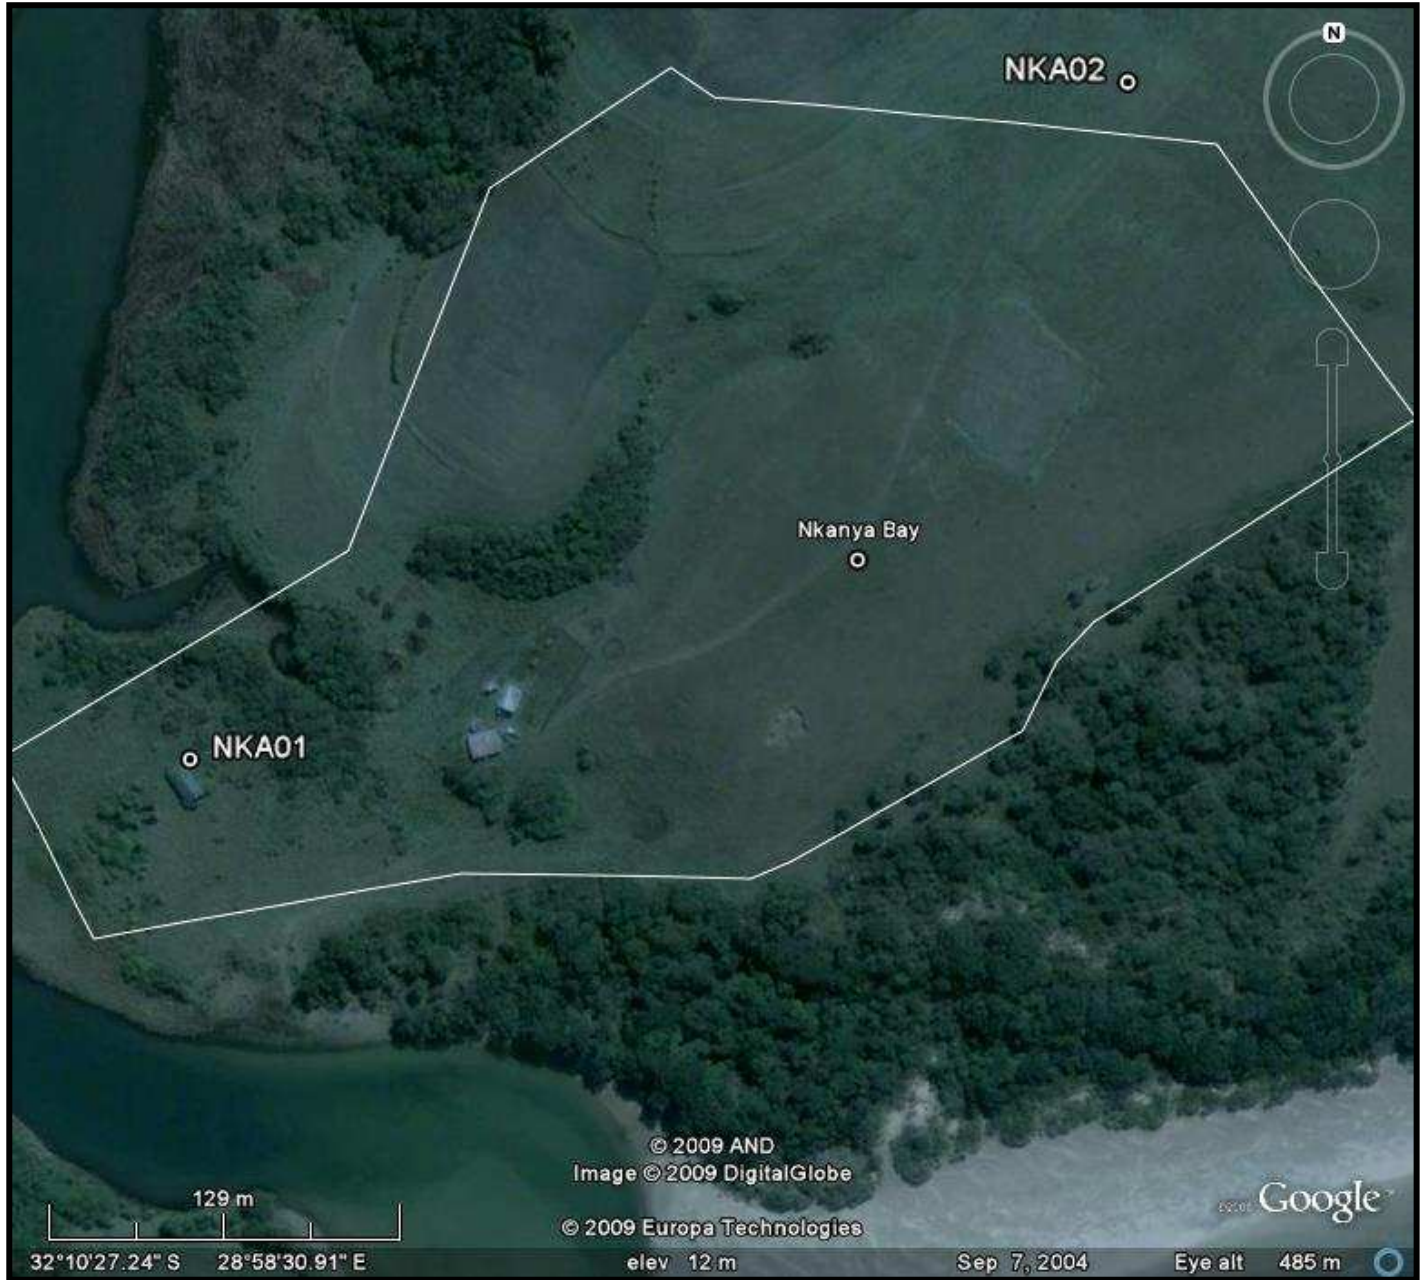
FIG. 2: LOCATION OF RECORDED SITES IN THE STUDY AREA

Two sites were recorded during the survey. The location of these sites is illustrated in Figure 2.

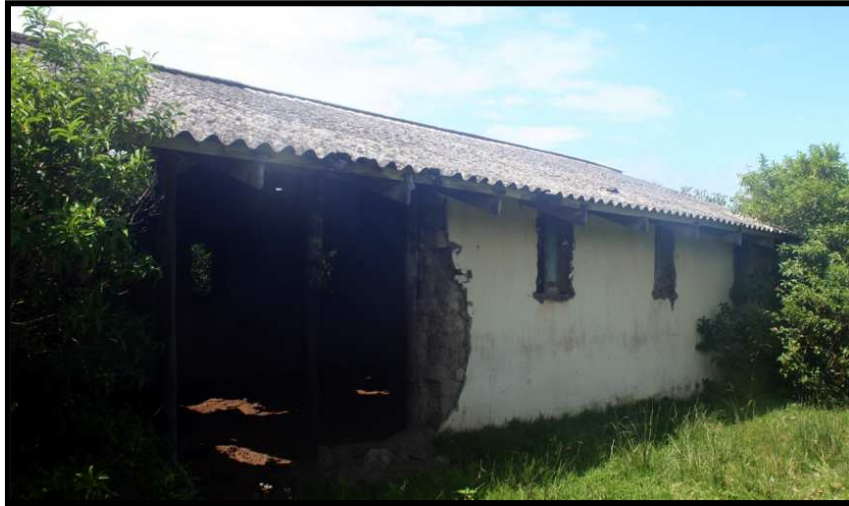
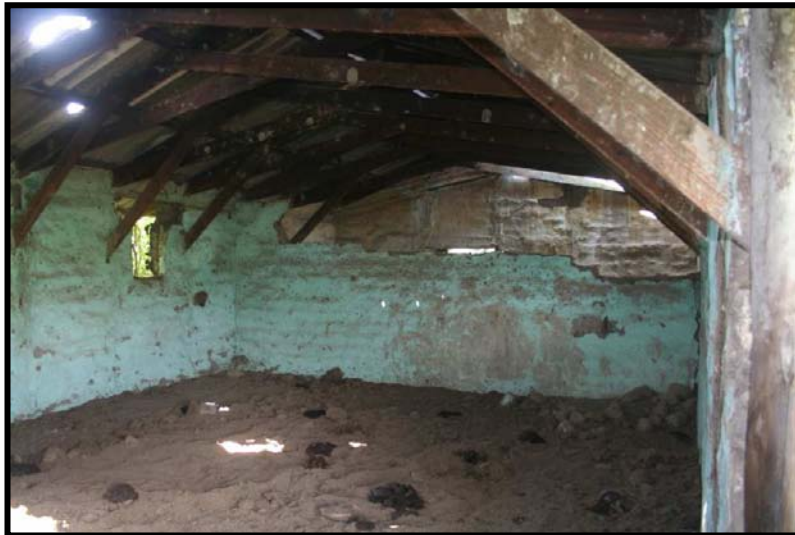
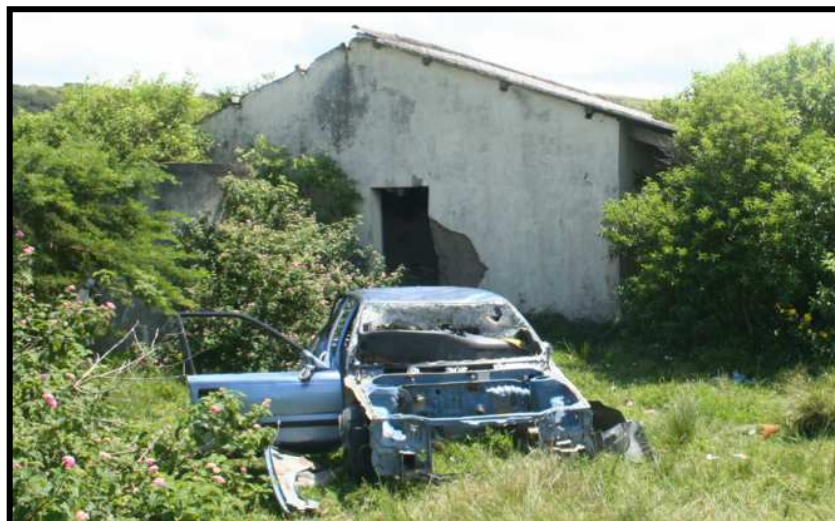
FIG. 3: VIEWS OF HISTORICAL BUILDING AT NKA01

NKA01 is an apparently old building that is supposed to be an NGK Mission¹ (fig. 3). The building is of the 'wattle and daub' style and has two sections: a main area 4/5th of the building, and a separate room with its own entrance. There is no evidence that this building was used as a mission or a church. That is, there are no crosses, steeples, and other accrements to indicate a religious structure.

Significance: The building is of low significance.

This is a roughly built rectangular structure under asbestos sheeting on raw timber purlins on scissor trusses. It appears constructed out of mud brick which has been bag-washed internally and painted with a distemper. There are gum-pole columns which support the roof.

The structure is in a derelict state, with large plaster spalls to the one end next to the door, and it would appear as though the opposite wall has fallen out at gable level in the past and has been reconstructed. There are large holes in the asbestos sheeting. There is no stabilized floor to speak of and any doors and windows have been removed.

It has been recently used as an animal shed. It is doubtful whether the structure is over 60 years of age which would automatically protect it in terms of the South African Heritage Resources Act no 25 of 1999. It has no architectural merit, has no architectural context (does not contribute to a group or a streetscape) and at this point is not known to be associated with any famous person or historic event or contain items of scientific or technological in nature. It is however, rumoured to be connected with a mission of the Dutch Reformed Church, and this should be explored a little more fully.

Mitigation: No further mitigation is required.

The Nkanya Lodge did not yield any significant sites. The historical building appears to be of low significance. The building should be fully photographed and mapped as part of a general plan to record vernacular architecture.

This structure does not markedly contribute to the environment, and is a reasonable though damaged example of a timber and earth farm vernacular building of which many exist. Attempting to repair this building, which appears to have had major structural damage in the past, is neither practical nor economic unless it has association with a major personage or event.

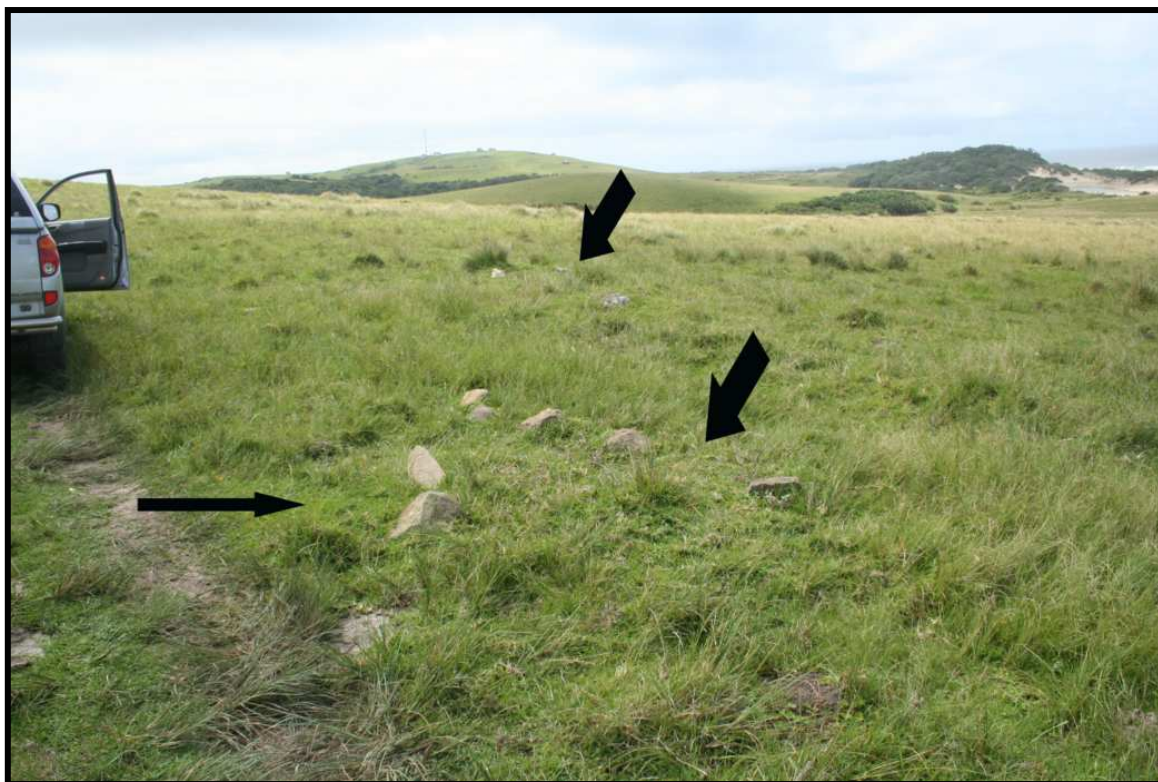
FIG. 4: STONE FEATURE AT NKA02

NKA02 is located just outside of the study area. It consists of a semi-circle of stones, and another stone feature uphill (fig. 4). These appear to be old dwellings. I did not observe any graves in the immediate area.

Significance: The site is of low significance

The development proposal did not include the route for the access road to the Nkanya Lodge. If the current track is used it will affect NKA02. The positioning of the access road will need to account for other ruined dwellings. I did not observe others along the existing track.

Mitigation: no further mitigation is required, as the site is probably not older than 60 years.
