**HERITAGE SURVEY OF THE PROPOSED WASTE
WATER TREATMENT WORKS, NTABANKULU

FOR COASTAL ENVIRONMENTAL SERVICES**

DATE: 28 August 2011

**Umlando: Archaeological Tourism and Resource
Management**

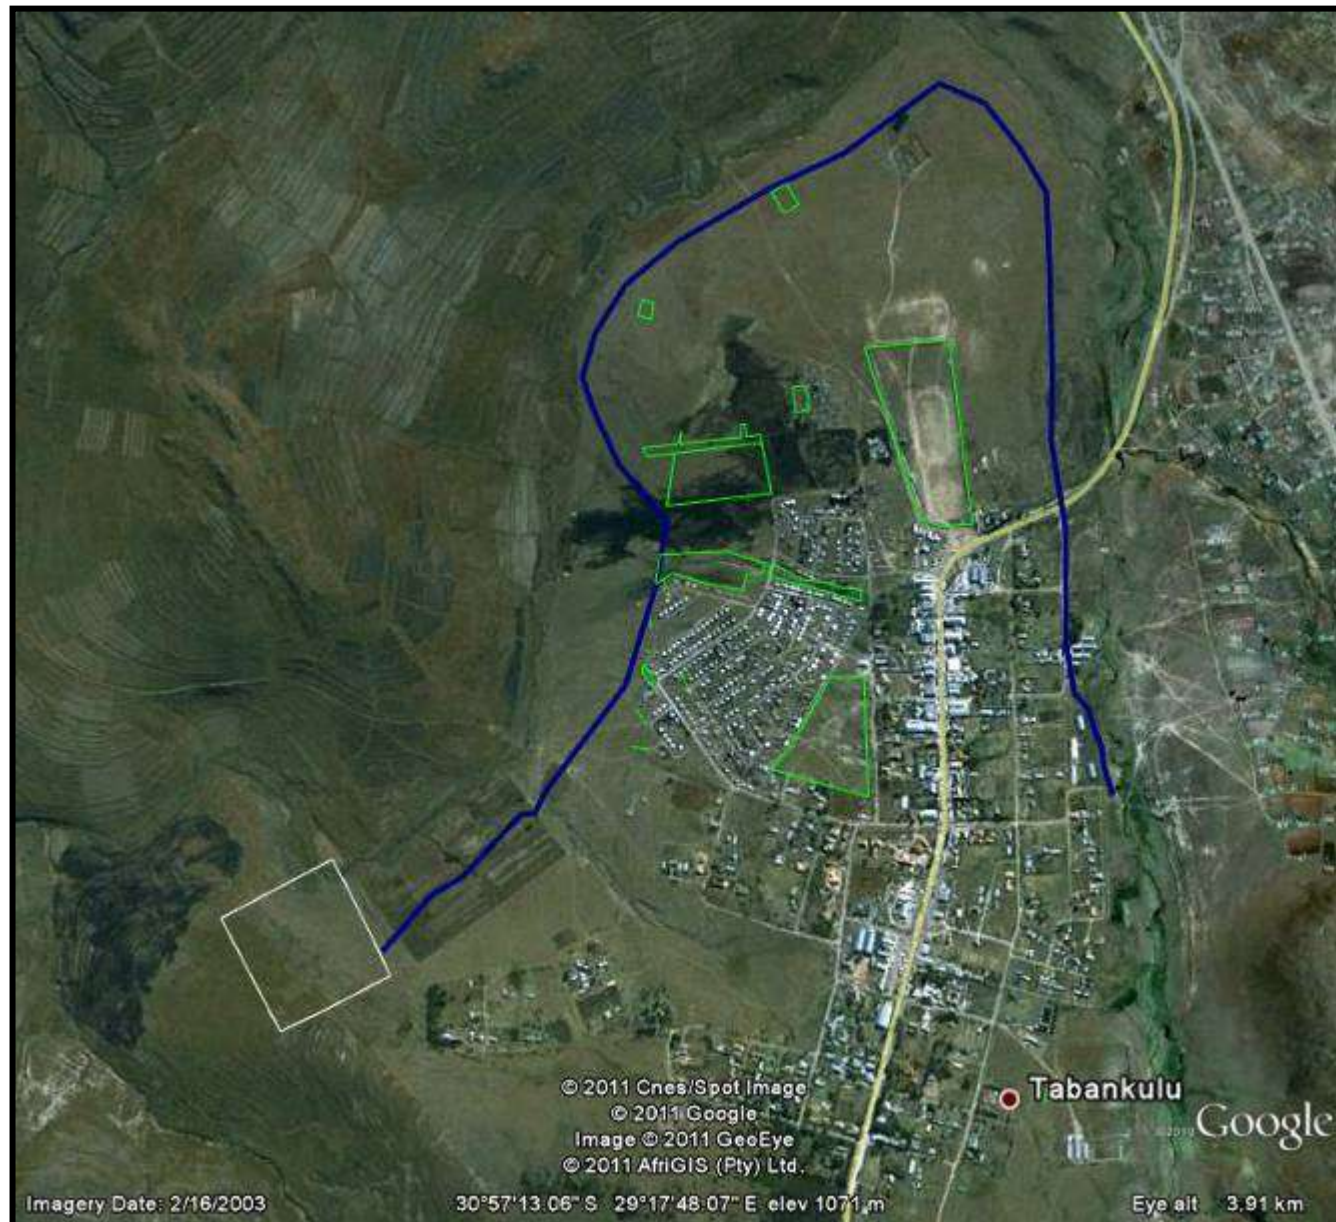
FIG. 2: AERIAL OVERVIEW OF THE PROPOSED TWWTW¹

¹ Blue line = pipeline,; white square = treatment works

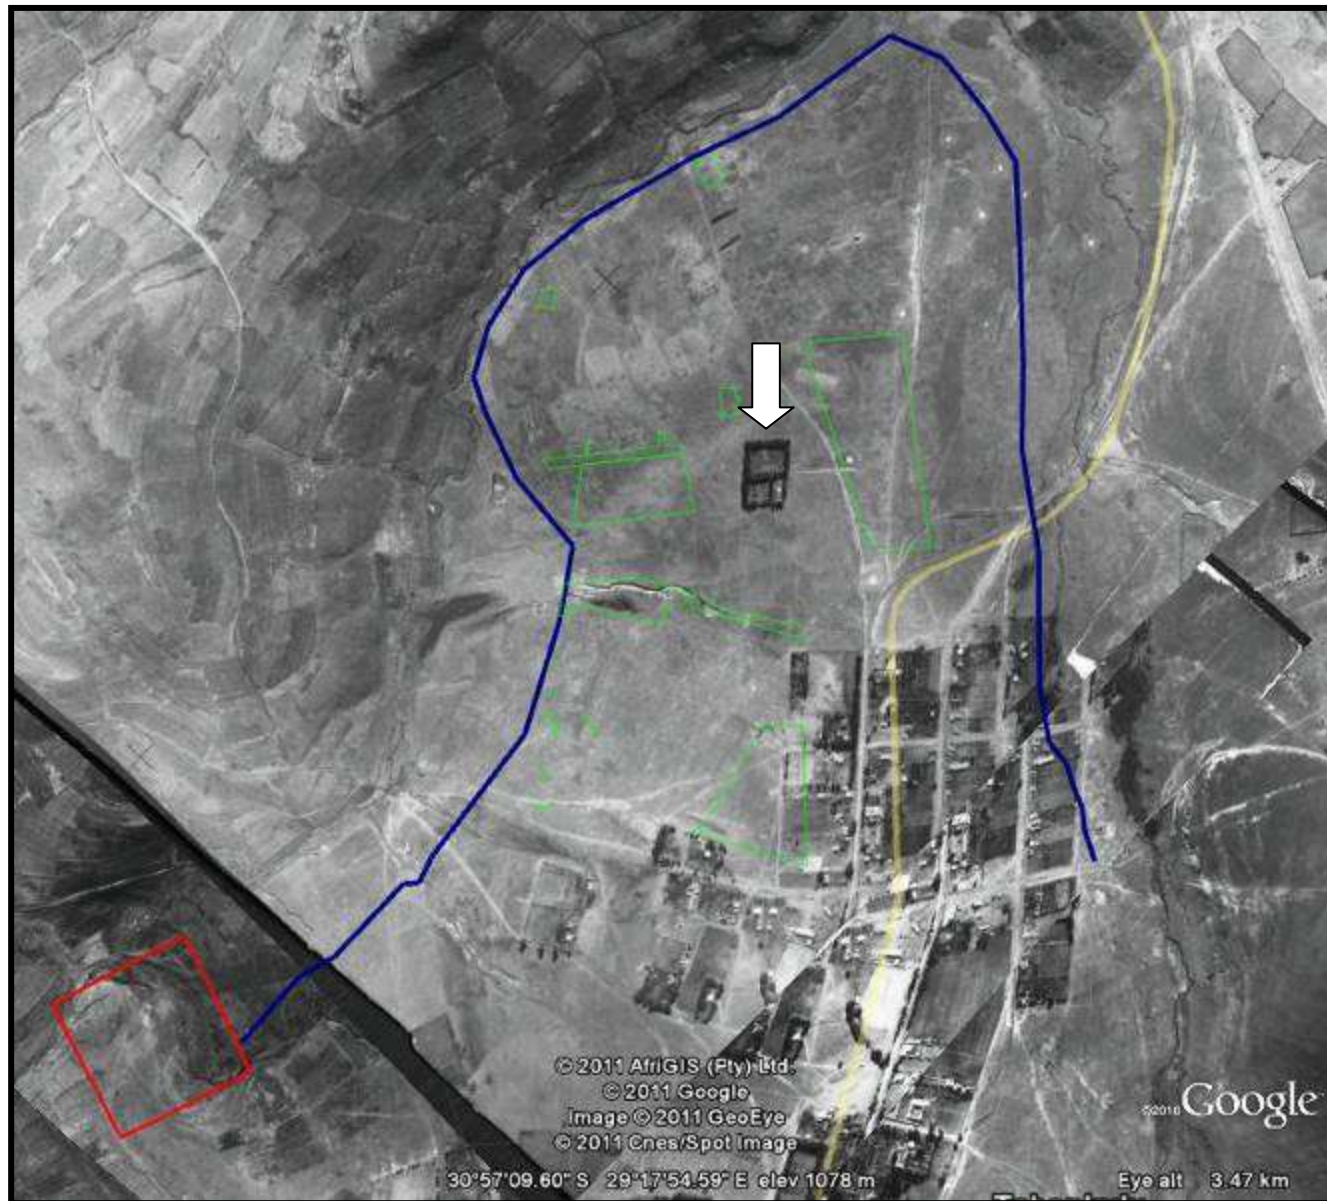
FIG. 4: LOCATION OF TWWTW AND LINE IN 1937²

Fig. 4 shows the study area in 1937. The map indicates that the study area has been extensively ploughed. There are no houses in the direct path of the pipeline or the treatment plant area. The cemetery is clearly visible, but some distance from the proposed development.

² Arrow = cemetery

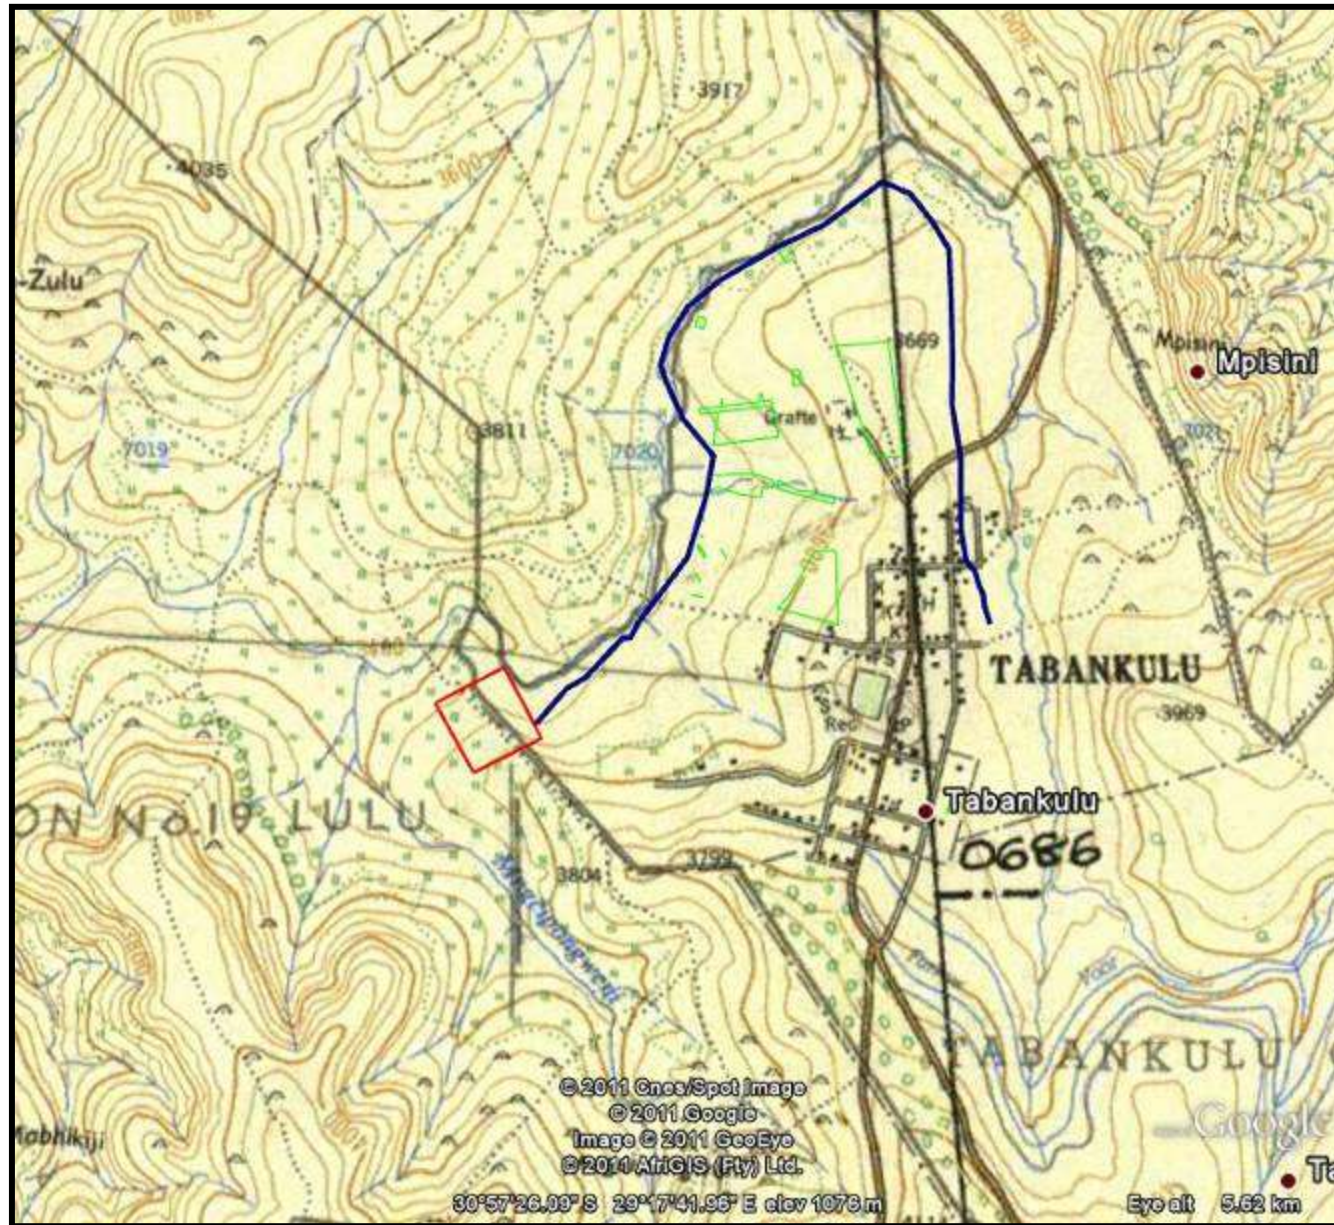
FIG.5: LOCATION OF TWWTW AND LINE IN 1963³

Fig. 5 shows the study area in 1963. The only difference is that the ploughed fields are not as much in use and have reverted to grassland. The land has then been converted to agricultural fields and/or gone fallow in 1982 (fig. 3) and 2002 (fig. 2)

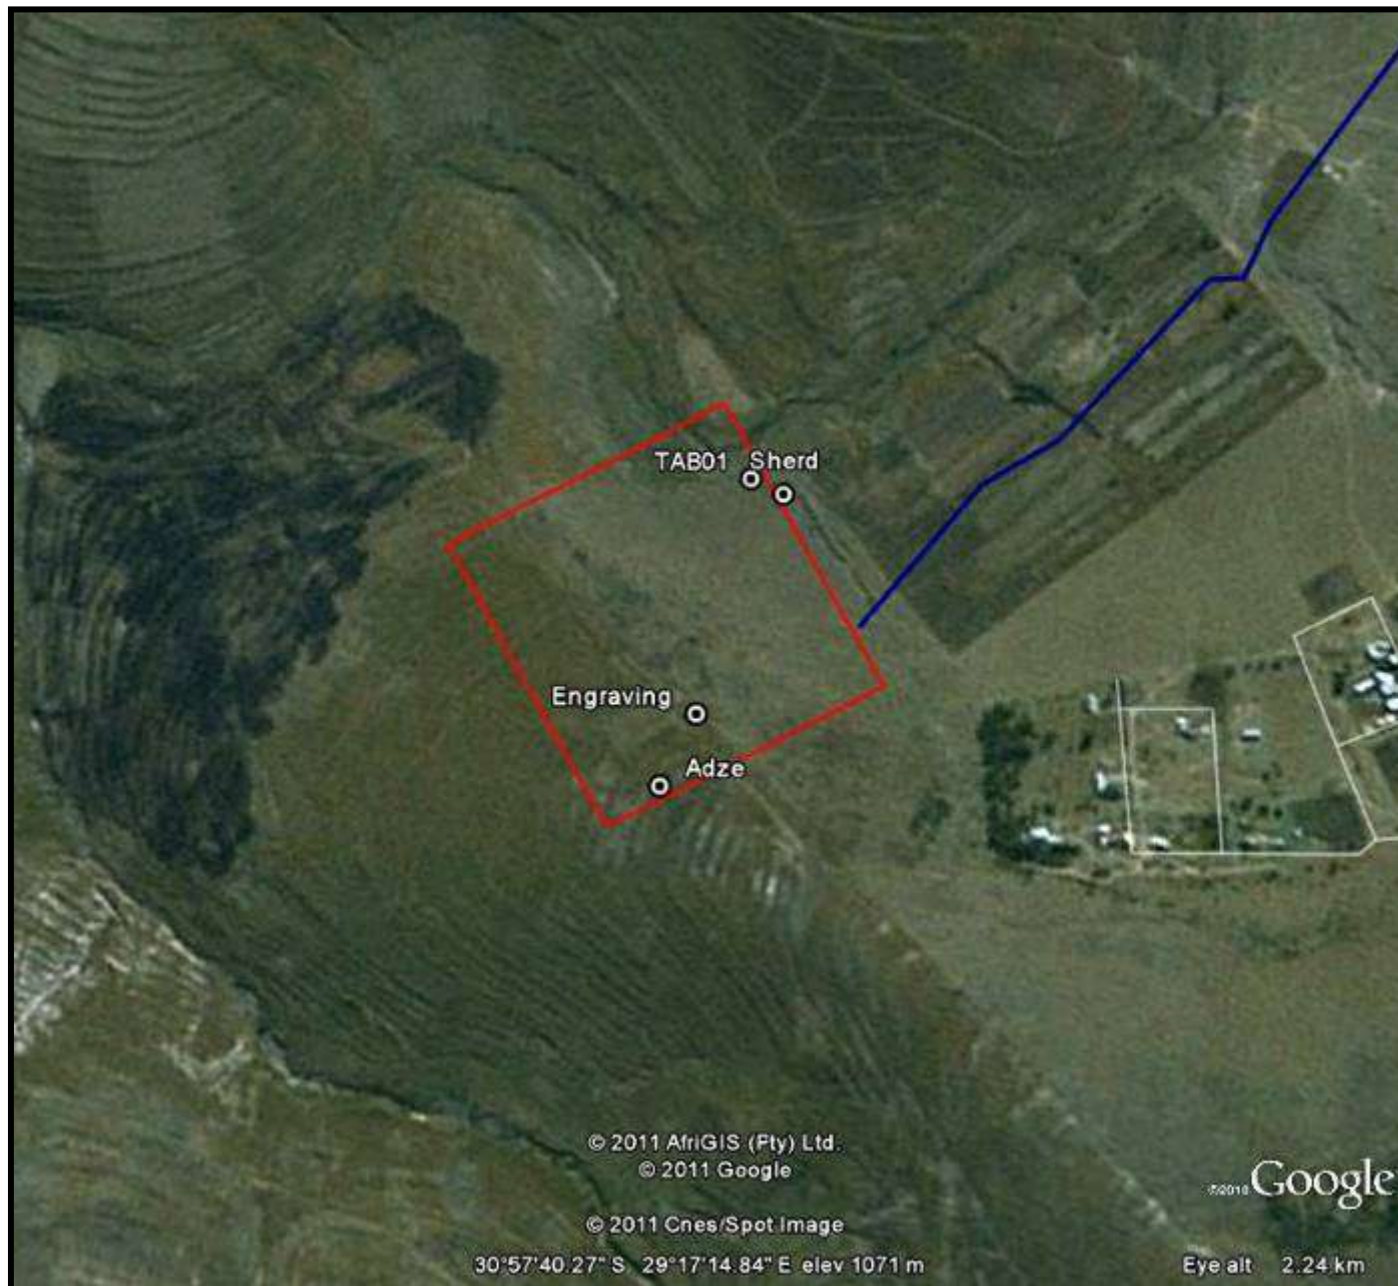
FIG. 6: LOCATIONS OF RECORDED SITES

The field survey was undertaken over a single day. The proposed pipeline was walked, as was the area for the treatment facility. The list of sites recorded during the survey are summarised in Table 1. Figure 6 shows the locations of the finds.

Name	Description	South	East	Requires Mitigation
TAB01	LSA scatter	S30 57 34.8	E29 17 16.2	No
Adze	Single stone tool	S30 57 44.4	E29 17 12.9	No
Pot	Single pot sherd	S30 57 35.3	E29 17 17.4	No
Engraving	Recent Engraving	S30 57 42.2	E29 17 14.2	No

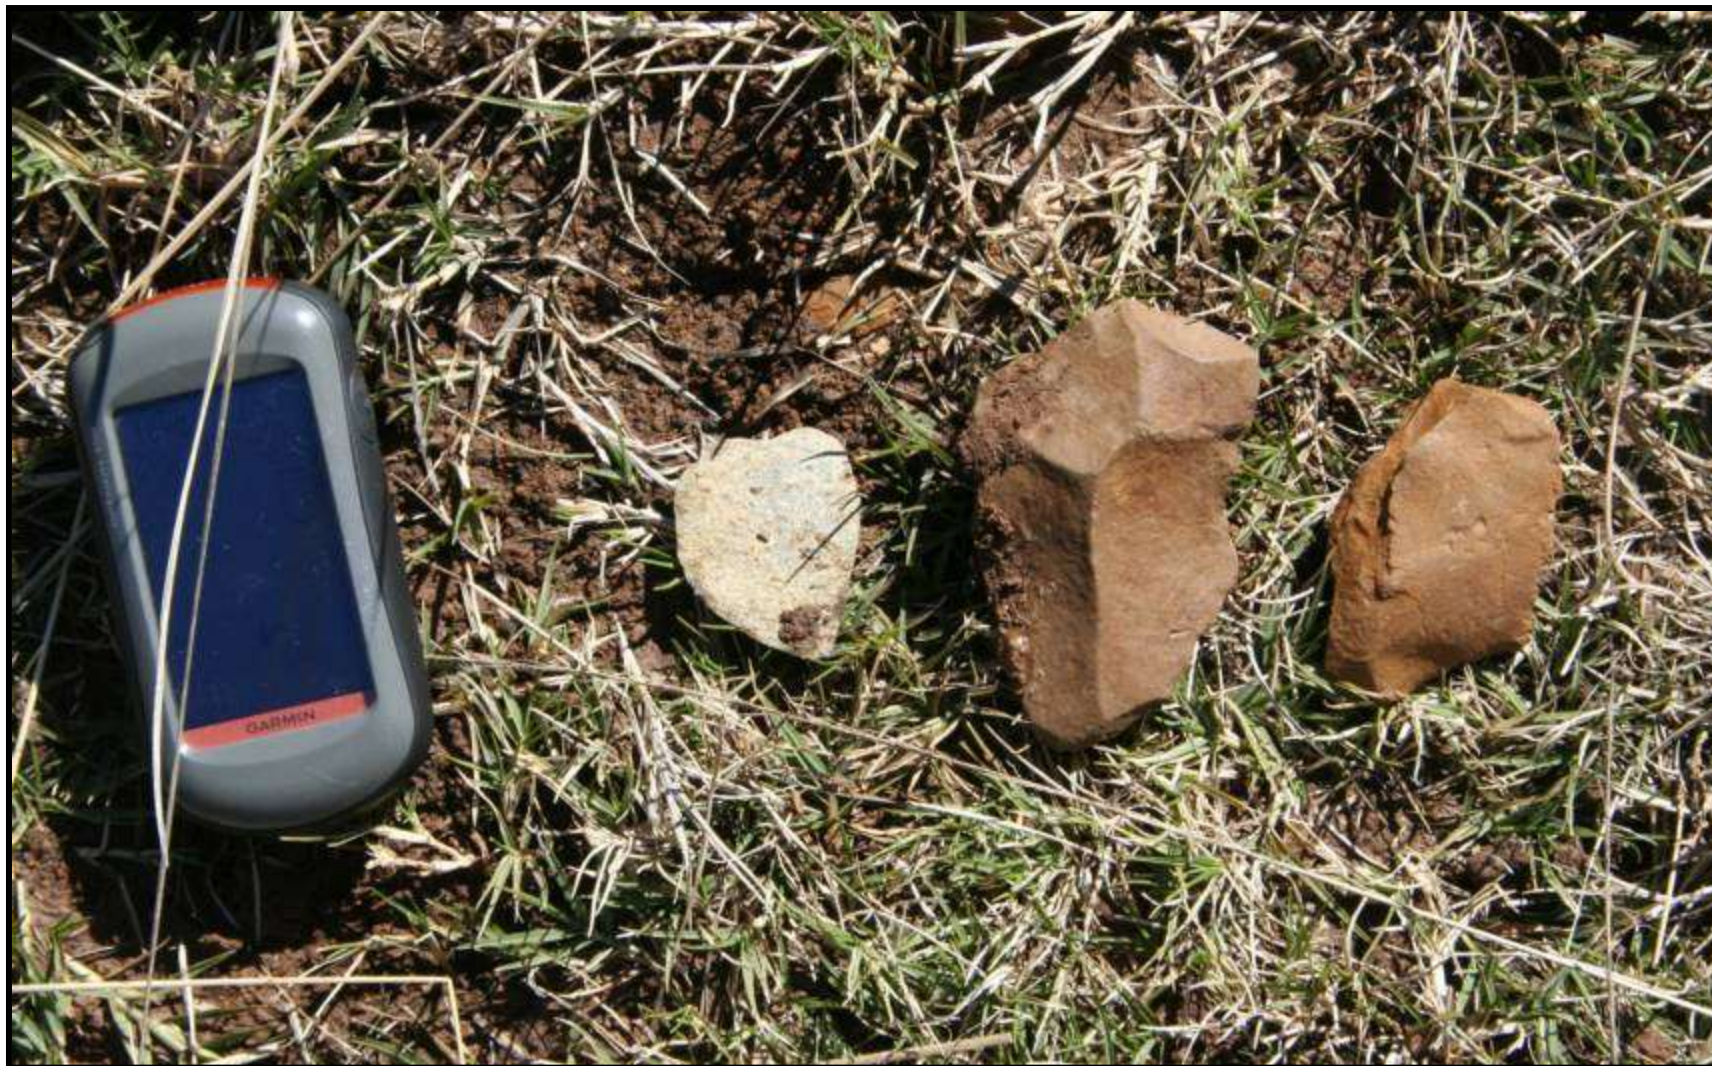
FIG. 7: STONE TOOLS AT TAB01

TAB01 is located near the edge of the planned treatment facility. The site consists of a small scatter of Middle/Late Stone Age tools (fig. 7) that have washed down the hill and erosion gully (fig. 8).

The tools are mostly flakes and show evidence of utilisation. The one MSA tool has been reworked in the LSA.

Significance: the site is of low significance as the tools are few in number and a secondary context.

Mitigation: No further mitigation is required.

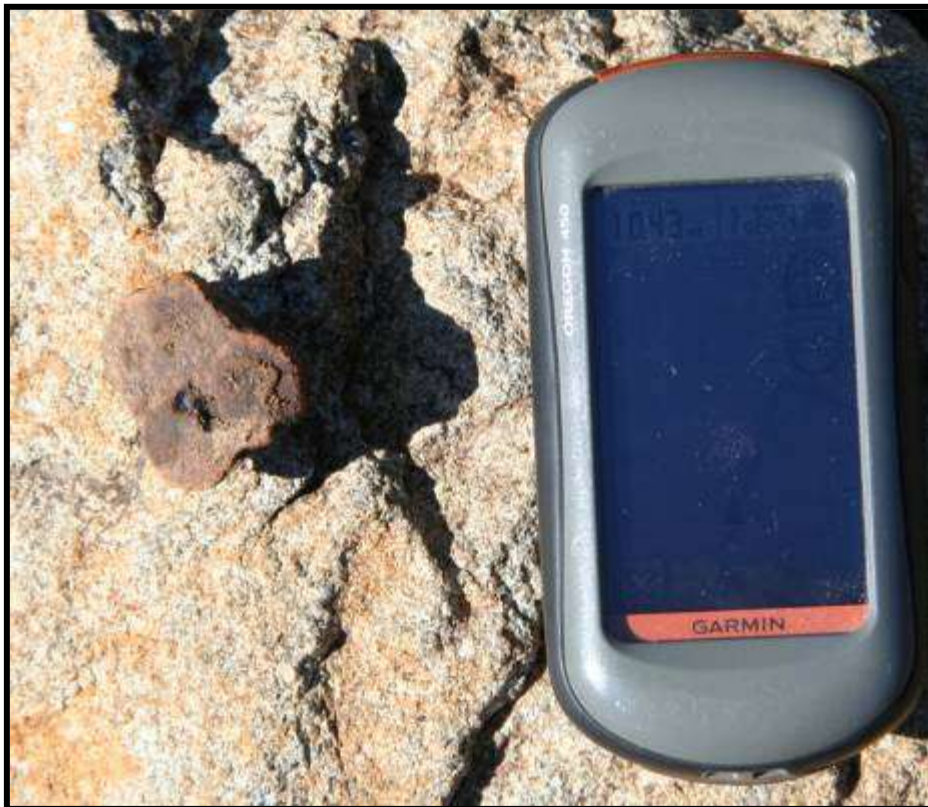
FIG. 9: POTTERY SHERD

A single pottery sherd was observed in the erosion gully (fig. 9). It probably originates from further up the hill, and more sherds are likely to occur in the general area. It is not possible to date the sherd.

Significance: The artefact is of low significance.

Mitigation: No further mitigation is required.

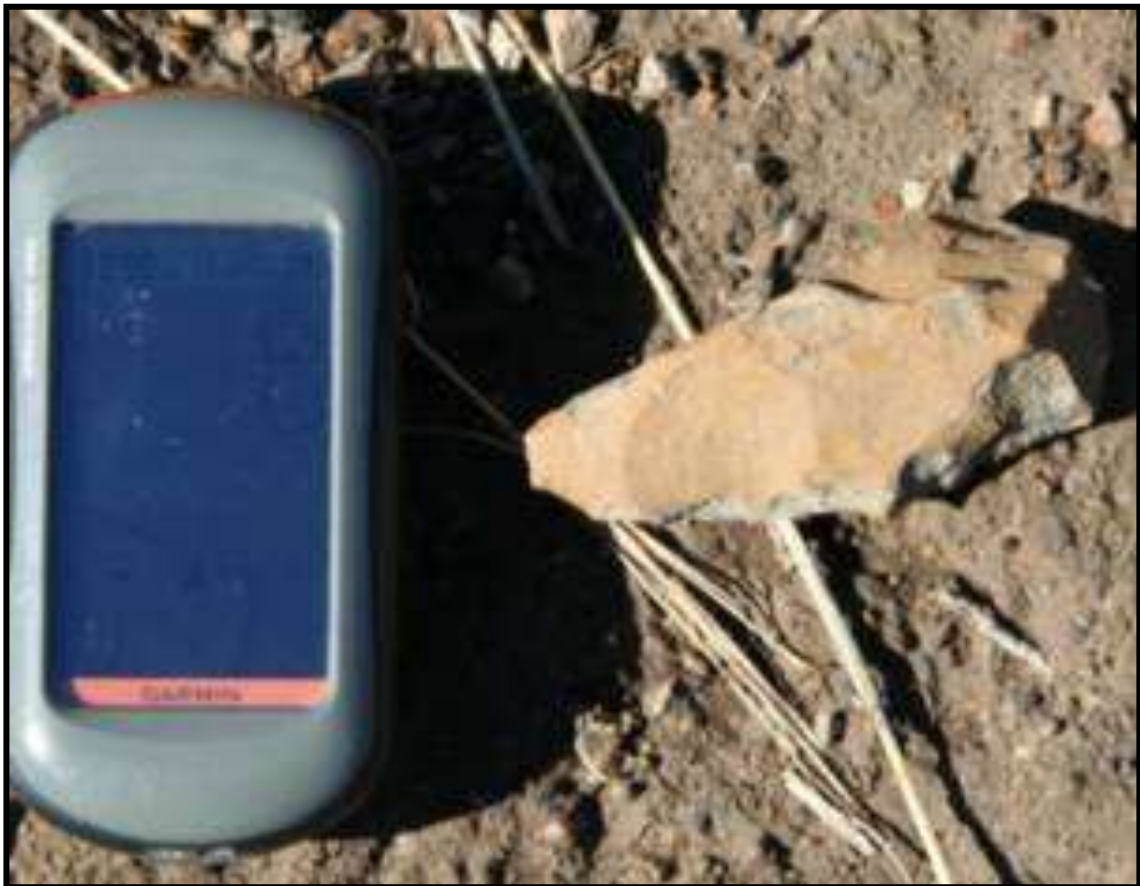
FIG. 10: LATE STONE AGE ADZE

A single flake with Heavy Edge Damage was located on the top of the hill (fig. 10). The tool does have some step flaking and it could be a reworked as an adze. The LSA flake has also been reworked on a MSA tool.

Significance: The tool is of low significance as the tools are few in number and a secondary context.

Mitigation: No further mitigation is required.

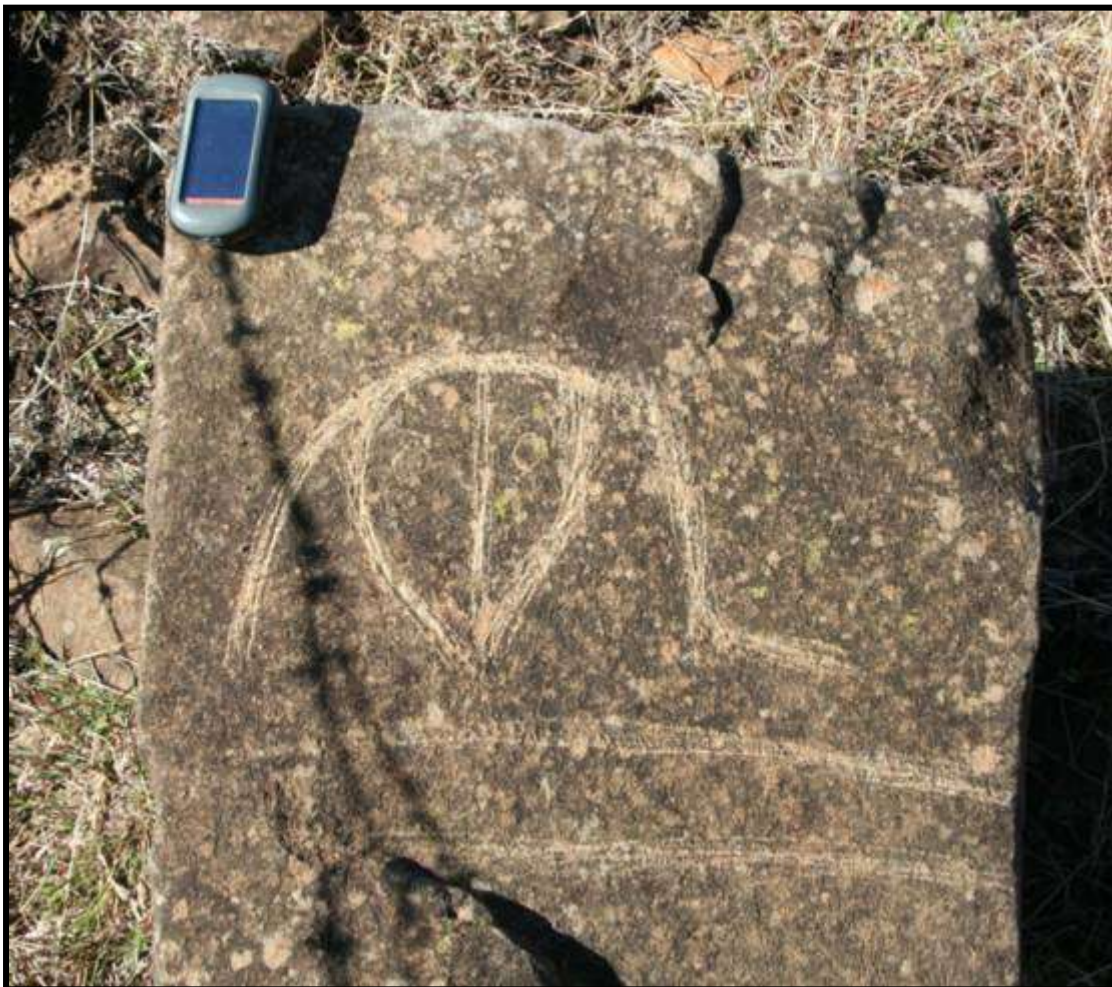
FIG. 11: ENGRAVING

A single modern engraving was observed on the top of the hill besides the fence. The engraving is that of a human face with two horizontal lines below.

Significance: The engraving is of low significance and appears to be recent.

Mitigation: No further mitigation is required.
