**ARCHAEOLOGICAL AND HERITAGE
ASSESSMENT REPORT VERSION 3:OPTIMUM
MINE EMP AMENDMENT, NORTH OF
HENDRINA, MPUMALANGA**

**ANNEXURE 1: ASSESSMENT OF ROUTES OF
PROPOSED PIPELINE, CONVEYOR AND
ASSOCIATED INFRASTRUCTURE**

**ANNEXURE 1: ROUTES OF CONVEYOR BELTS, PIPELINES AND
ASSOCIATED INFRASTRUCTURE**

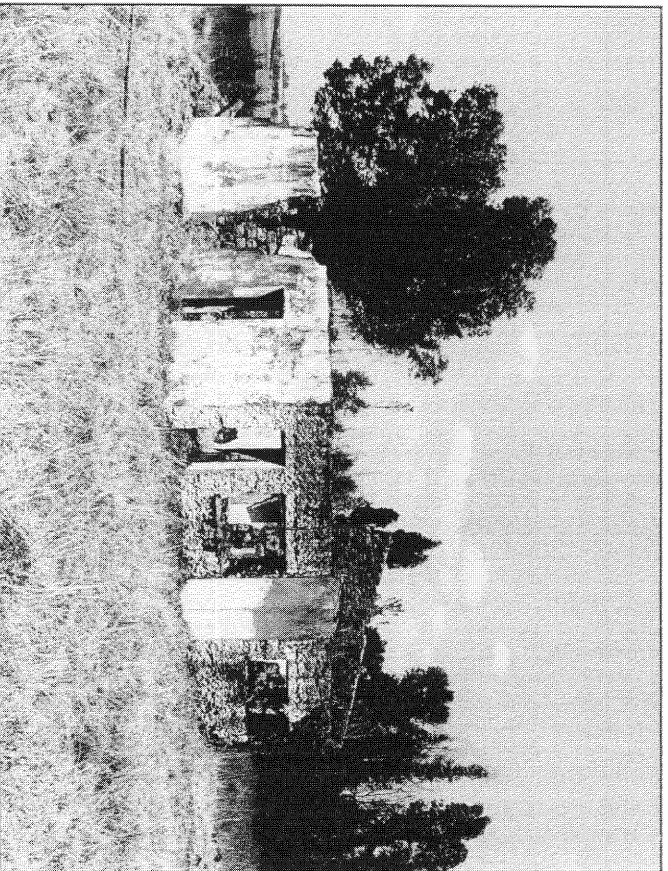
Site 56: Ruins of farmstead

Location: Boschmanspoort 159 IS, -26.02852 S, 29.72181 E

This site is located about 100 m south of the fence. It is understood that the pipeline will run along the southern side of the fence. It is unlikely that the pipeline will have a direct impact.

Description: Ruins of farmstead, including main house, barns, kraals, outbuildings etc

Significance: Low local

Management: Document buildings older than 60 years if affected, otherwise avoid site. Protect during construction with barrier tape and monitor situation.

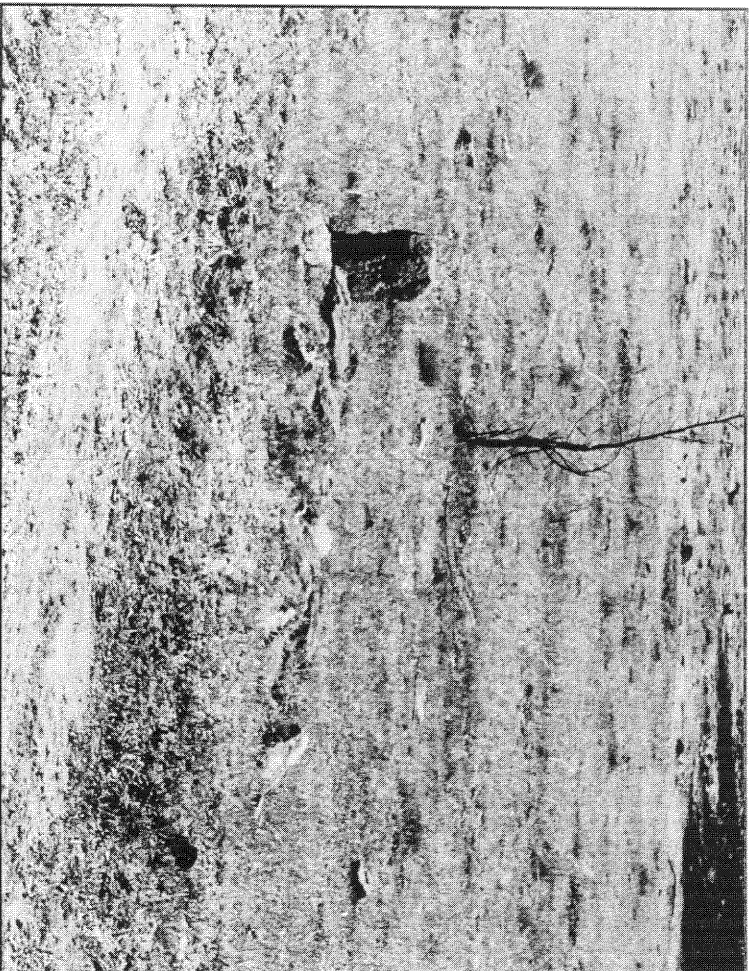
Site 1: Grave

Location: Bankvalel 190 IS or Boschmanspoort 159 IS, -26.02905 S 29.70858 E

The grave is located about 3 m north of the fence. It is understood that the pipeline will run south of the fence. It is therefore unlikely that the pipeline will have a direct impact.

Description: The site is represented by a single grave located directly north of an existing farm fence. The grave dressing is oval shaped and consists of flat stones. An unmarked rectangular stone represents the headstone, which is located on the grave's western side. The grave is aligned along the East-West axis.

Site 1 is located close to the stone-built structures from **Site 2**, and it appears highly likely that these two sites are associated.

Significance: High local

Management: Avoid or alternatively relocate grave. Protect during construction work with barrier tape and monitor situation.

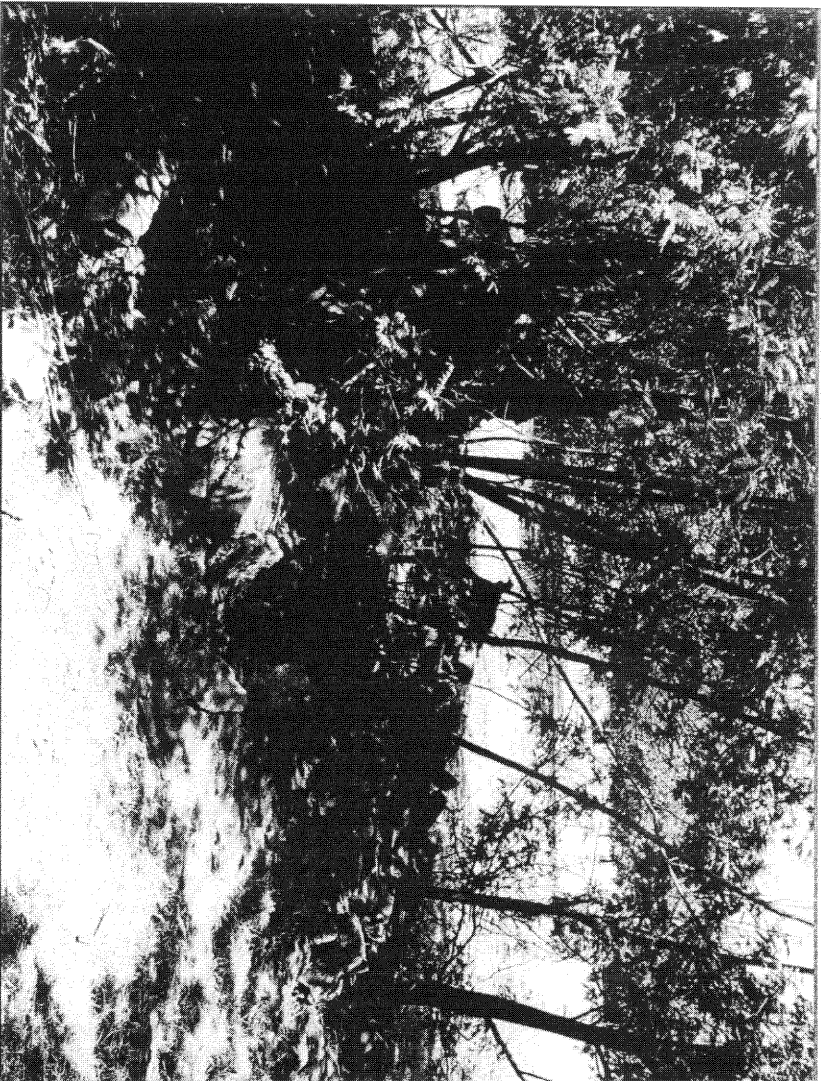
Site 2: Ruins of homestead and kraals

Location: Boschmanspoort 159 IS, -26.02833 S 29.70855 E

The site is located about 50 m north of the fence. It is understood that the pipeline will run south of the fence. It is unlikely that there will be a direct impact.

Description: **Site 2** is represented by a number of rectangular stone structures. The building technique used in the construction of these structures is dry stonewalling.

Although the age of the structures is unknown, their rectangular shape suggests a historic or recent association. Cultural material in the form of old glass fragments was observed here as well.

Site 2 is situated north of the grave at **Site 1**, and it appears to be highly likely that these two sites are associated.

Significance: Low local

Management: Document/map if affected. Protect during construction with barrier tape and monitor situation.

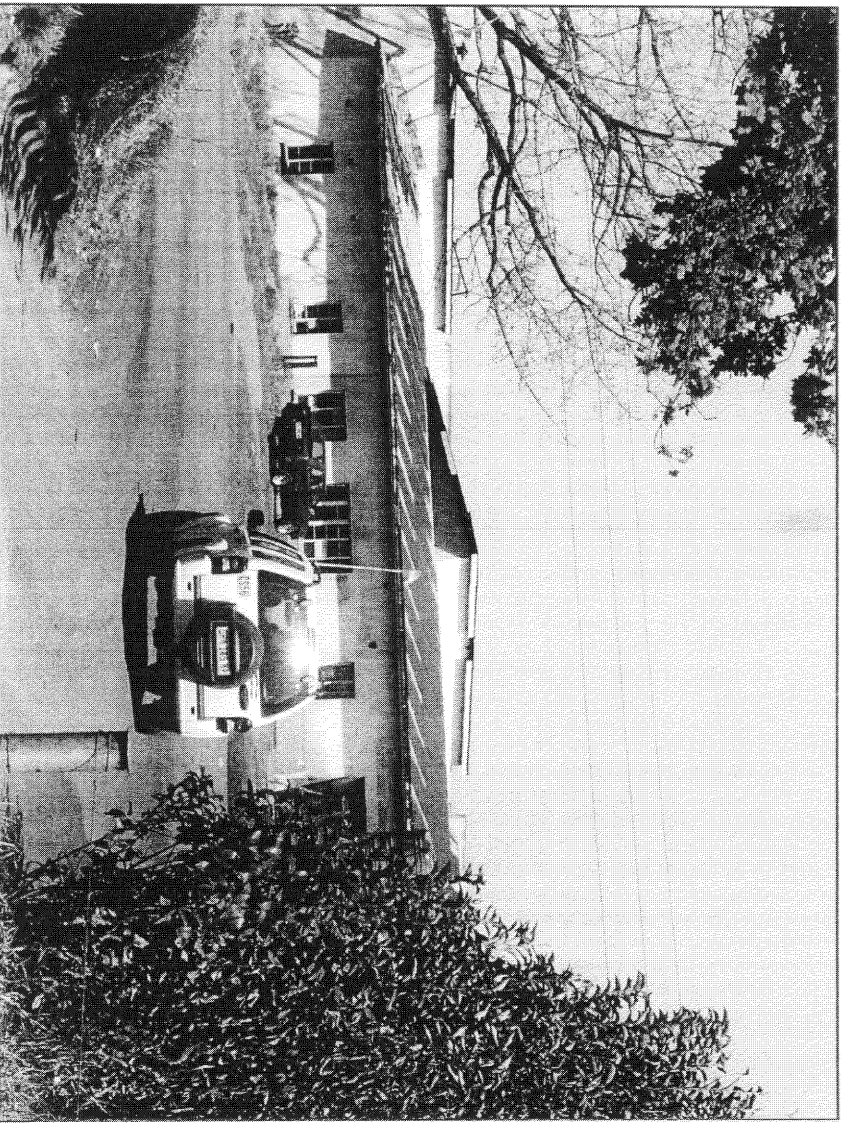
Site 57: Former Woestalleen Prison

Location: Pullen's Hope 155 IS, -26.01110 S 29.65219 E

From the location map it appears as if construction work will bypass this site to the north and west.

Description: The site consists of the buildings of the former *Woestalleen Geyangeris Buitepos* (ca 1930s) with a cluster of shacks, prefabricated buildings and houses of prison wardens. The site is currently inhabited.

Significance: High local. The history of the former prison facility still must be researched but the site has been assessed as one of high local (political) significance during the 2003-2004 survey of heritage sites in the Nkangala District Municipality.

Management: Avoid the site at all costs (no-go area).

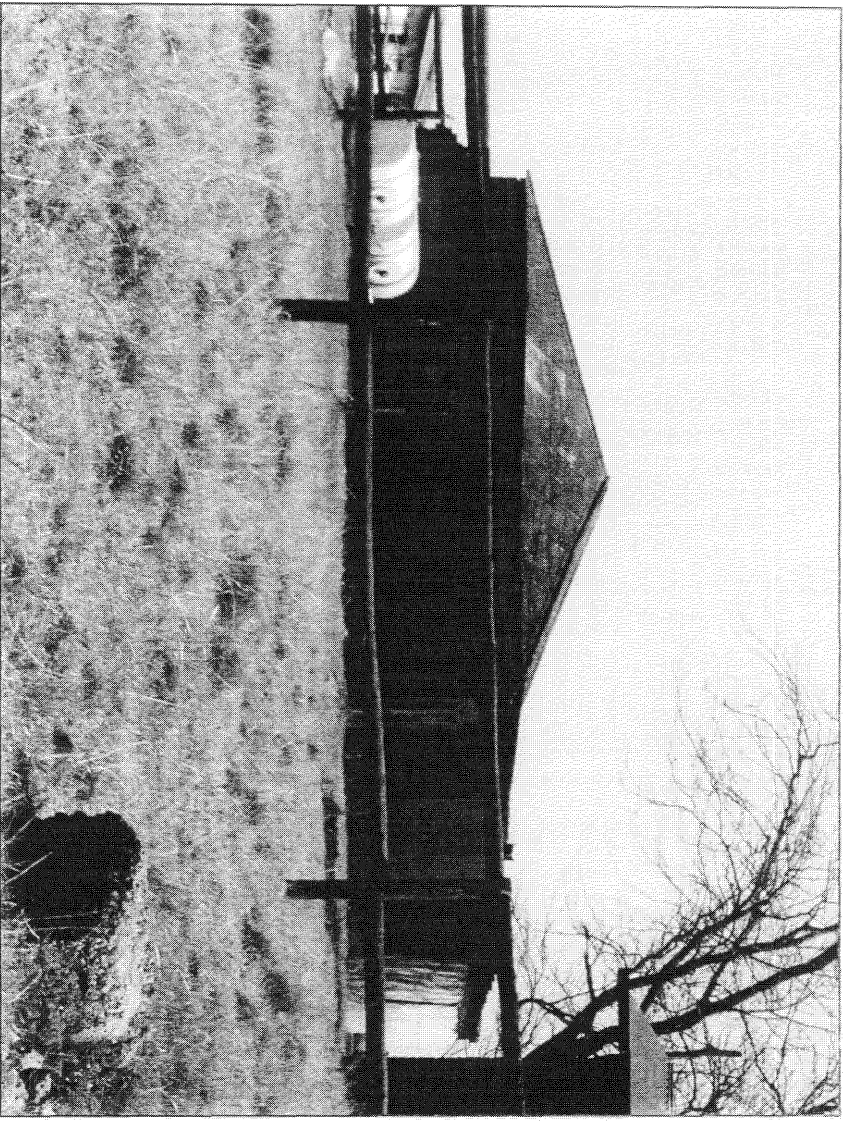
Site 58: Pullen's Hope farmstead

Location: Pullen's Hope 155 IS, -26.02452 S 29.65334 E

From the location map it appears as if construction work will bypass this site to the east.

Description: The site consists of the buildings of the historic Pullen's Hope farmstead, including an old sandstone dwelling, stone kraals, stone barns, enclosures and various modern buildings.

Significance: Low local.

Management: Avoid the site. If this is not possible all buildings older than 60 years must be documented before any demolition.
