## Archaeological Heritage Impact Assessment

**Title: Residential development of Erf 8724 Paarl.**

Proposal to develop a new residential area on agricultural land, on the urban edge of Paarl, Western Cape. The property is on Main Road (R45) and Retief Street, North Paarl.

**Date: 25 August 2008**

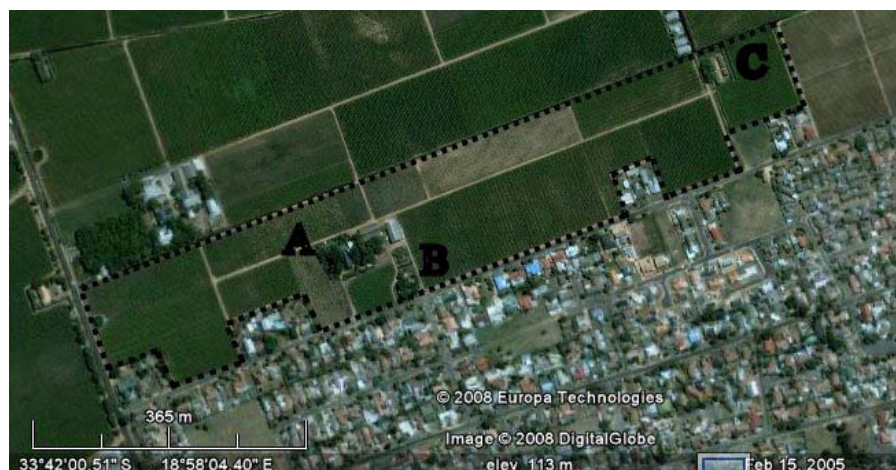
There is a homestead (A in Fig.2) with three outbuildings (circa AD 1900). Adjacent to homestead are two large industrial buildings (modern – less than 60 years old) that currently serve as a motor vehicle repair shop but will be vacated and put to other use. The owner intends retaining these buildings and says the only alteration necessary will be the replacement of the corro-iron of the roof of the homestead with new corro-iron sheets in the same style.

There is a single residence on Retief Street (B in Fig.2) in the same block as the homestead. This is a modern structure and the intention is to demolish it. Also for demolition when alternative accommodation has been provided are four modern workers cottages (C in Fig.2) on the northeast corner of the property.

**Figure 2. The long axis of the property Erf 8724 borders Retief Street. A=homestead, B=house to be demolished, C=cottages to be demolished.**

In as far as it is in the competence of the APM committee it is recommended that the consideration be given to the approval of the demolition of the single house on Retief Street and the workers cottages or these matters be referred to BELcom.

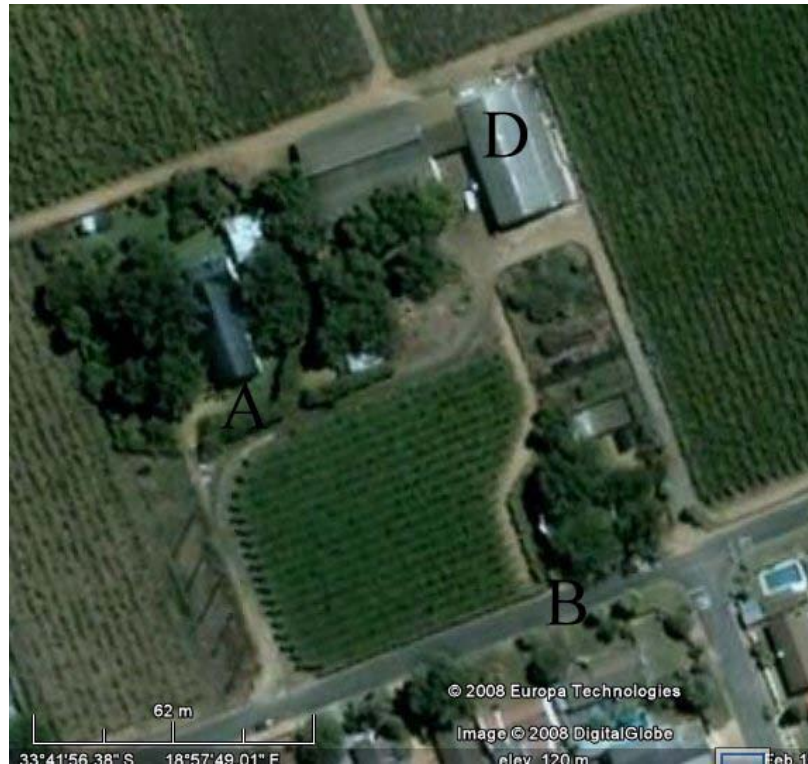
**Figure 4. Aerial view of the homestead (A), the industrial buildings (D), the single house to be demolished (B).**

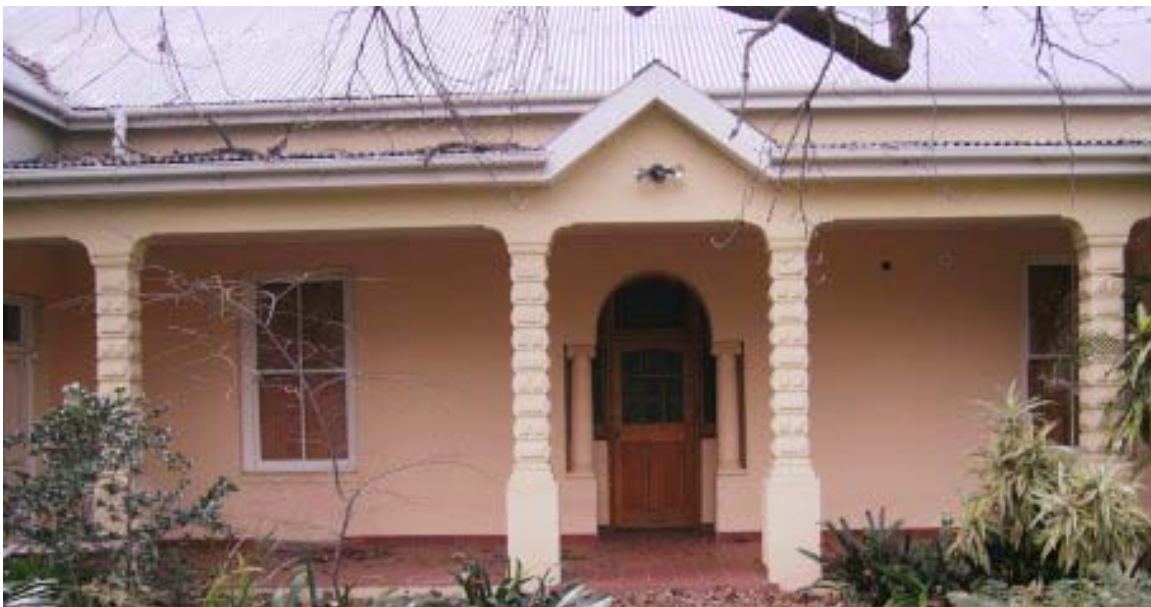
**Homestead (Figs. 3-6):** conservation worthy, more than 100 years old, altered with original features and fabric, condition sound.

The homestead and associated out buildings although altered are significant because of their age and condition and must be conserved.

**Fig. 5. Entrance to homestead (A in Figs. 3&4), note windows have interior shutters, stoep is a later addition, roof is corro-iron that needs replacing. The building has been structurally altered (see Fig. 8) and this reduces its heritage status.**

Although none are planned, it is recommended no structural alterations be made to the homestead or the three out buildings, all older than 60 years, without submission of detailed plans for consideration by HWC.

In as far as it is in the competence of the APM committee it is recommended that the necessary maintenance re-roofing of the homestead building in the original style be approved or the matter referred to BELcom for approval.

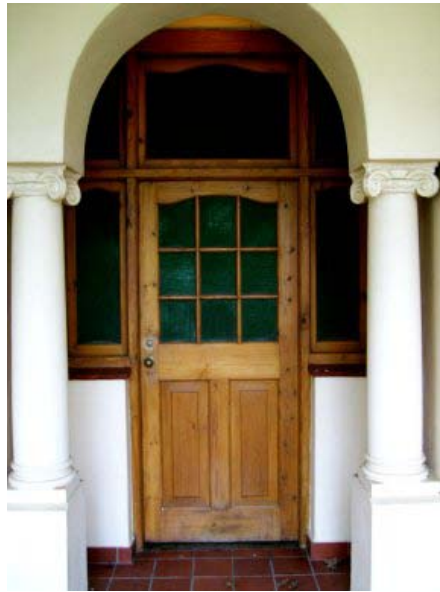
**Fig. 6. Front door detail, Oregon pine (circa 1900 AD).**

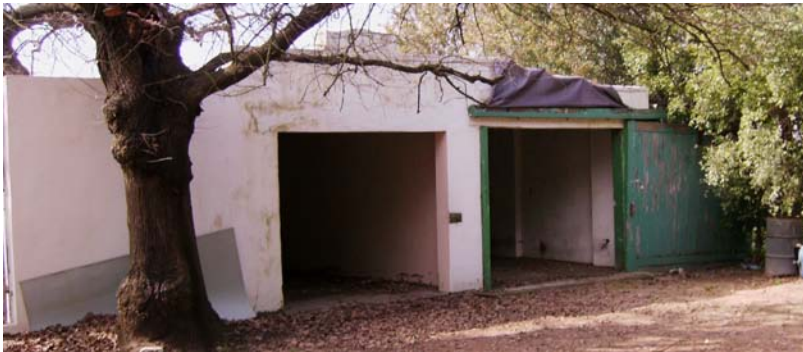
**Three associated outbuildings (Figs. 7-8):** merit same conservation status as homestead, poplar beams, original ironwork, altered with additions, condition medium to poor.

**Fig. 7. One of three outbuildings of similar age to the homestead that have old ironwork and poplar beams. These are conservation worthy but condition is poor.**

Although not planned, any conservation/restoration of the out buildings would require an architectural assessment to determine what is older fabric and what are recent additions.

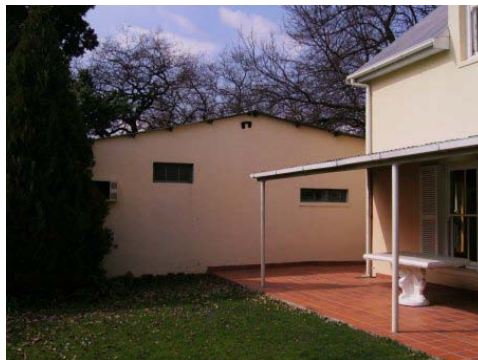
**Fig. 8. Modern double storey addition on the north face of the homestead with one of the outbuildings in the background.**

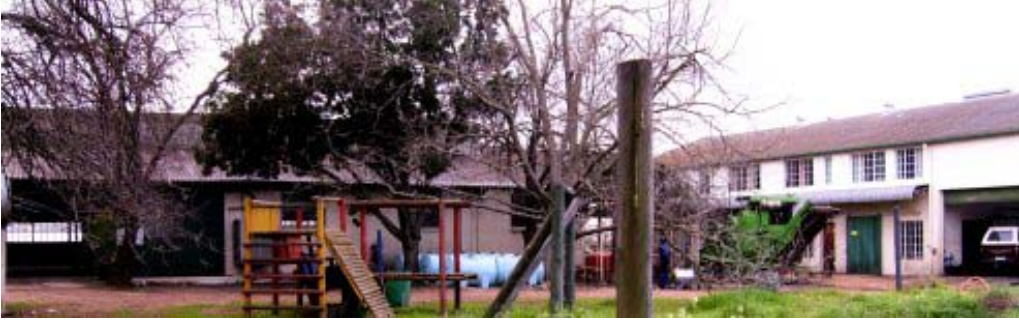
**Industrial buildings (Figs. 4 & 9):** modern, will be retained.

**Fig. 9. Two modern industrial buildings adjacent to the homestead (D in Fig. 4)**

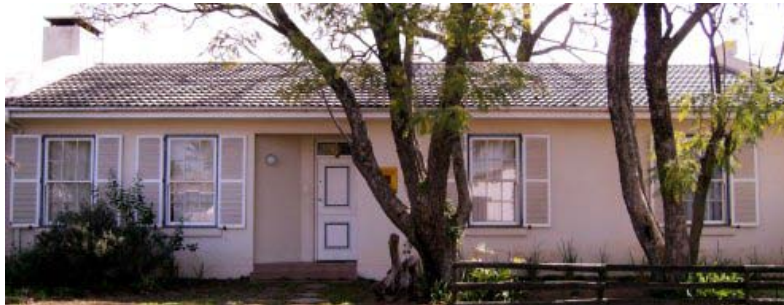
**Single house (Figs. 3, 4 & 10):** modern structure intended for demolition.

**Fig. 10. House on Retief Street in the same block as the homestead (B in Figs. 3& 4) intended for demolition.**

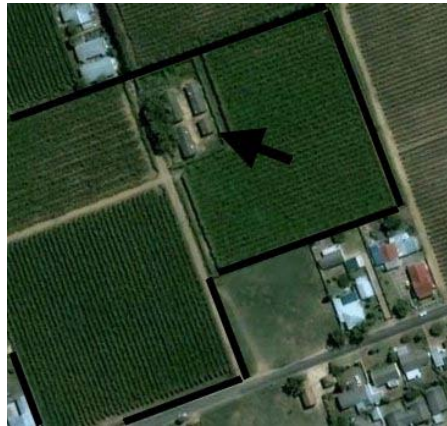
**Workers cottages (Figs. 2, 3, 11 & 12):** modern structures intended for demolition.

**Fig. 11. Position of workers cottages (C in Fig. 3) intended for demolition**

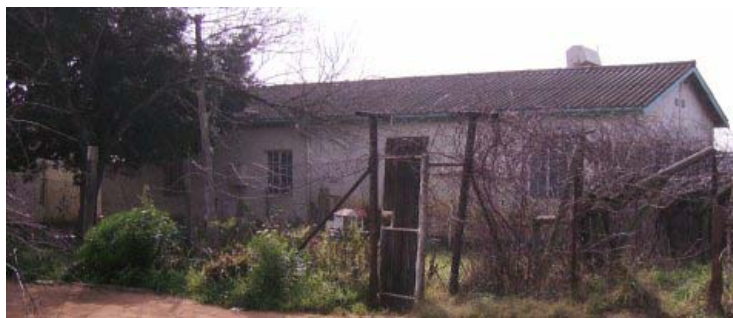
**Fig. 12. Cottage, modern structure, intended for demolition**
