PHASE 1 ARCHAEOLOGICAL IMPACT ASSESSMENT

**QUTUBENI VILLAGES WATER RETICULATION SCHEME:  
BULK WATER SUPPLY BACKLOG – NGCOBO CLUSTER 6,  
(LUQOLWENI, MARELENI, SIDINDI, EMPINDWENI,  
ENGXANGXASI, SILIDINI AND HALA VILLAGES)  
QUTUBENI, EASTERN CAPE, SOUTH AFRICA**

DATE: 2010-08-16

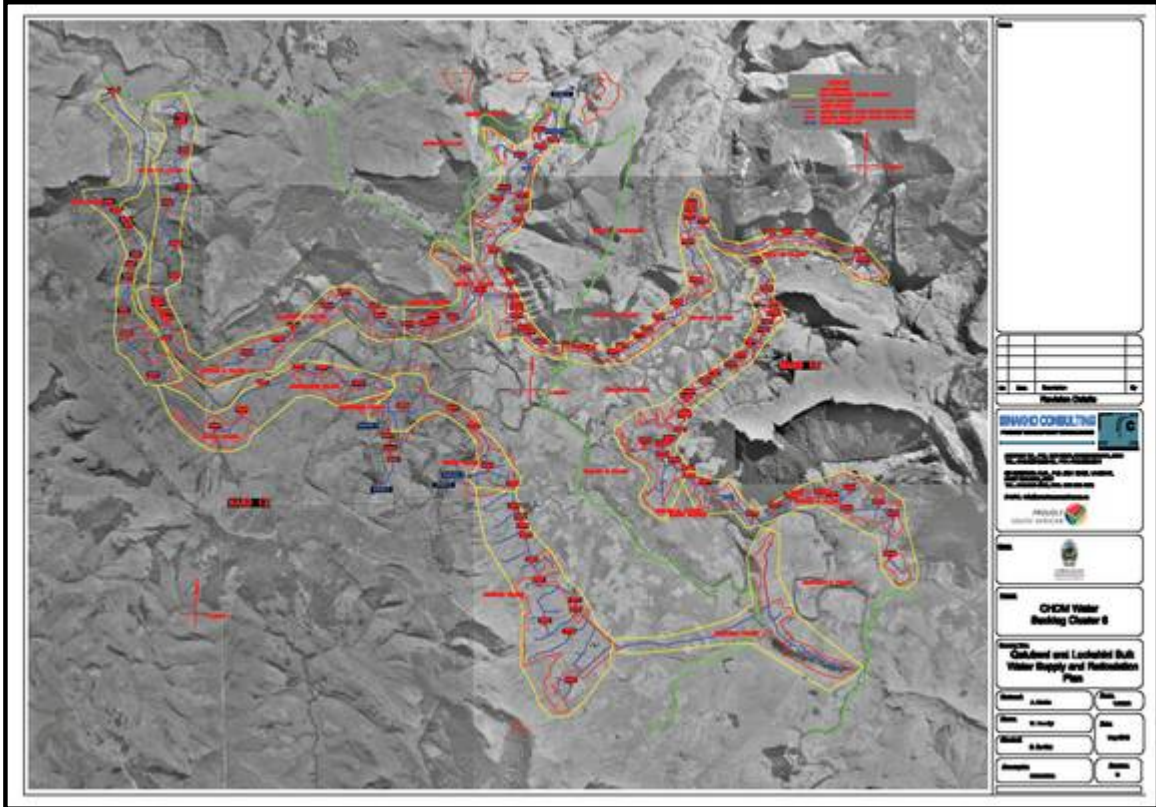
**Figure 5:** Greater design plan of the Qutubeni Water Supply Scheme, with the current proposed development area situated along the western and southern parts of the map (courtesy AGES)

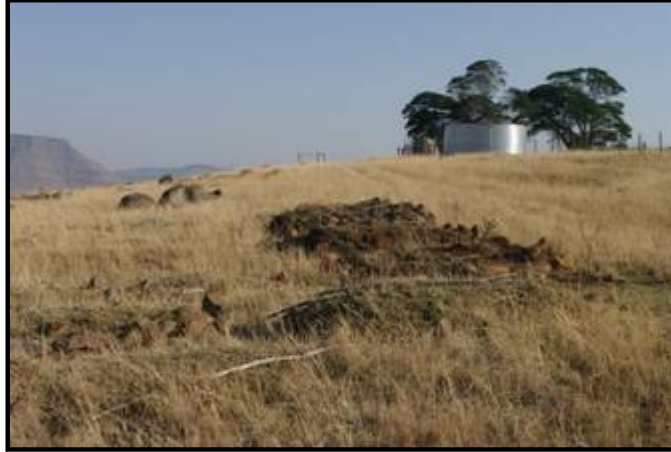
**Figure 32:** View of the Site C1 cemetery – 1

- **RECOMMENDATIONS:** *Site C1 comprises of a heritage site as defined and protected under the NHRA 1999. The site is ascribed a SAHRA MEDIUM SIGNIFICANCE and a GENERALLY PROTECTED B FIELD RATING. Development will not directly impact on the formal cemetery however proximity of the site to the line route does necessitate conservation measures.*

- 1) *It is recommended that the line route development in the vicinity of Site C1 be located south of the access road to Luqolweni Village, providing for a minimum conservation barrier of 5-7m between the cemetery and the line route (despite the fact that the existing road is located immediately adjacent to the cemetery / within the conservation barrier).*

- 2) *Alternatively, in the event that the line route cannot be moved to the south of the access road, it is recommended that the cemetery be formally fenced with an access gate (minimum SAHRA conservation standards) prior to commencement of construction. Formal conservation should be preceded by community consultation.*

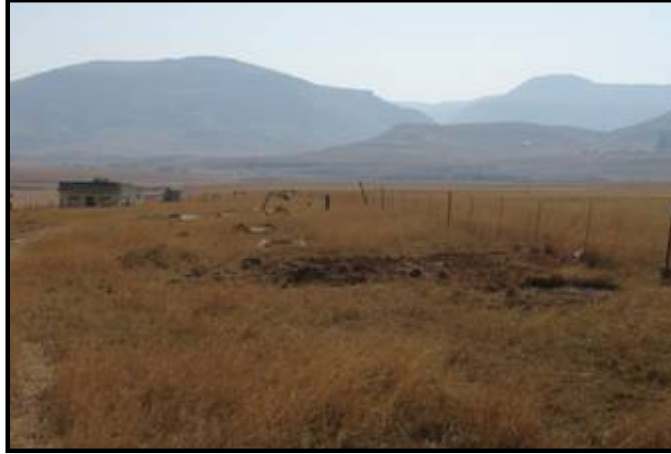
**Figure 40:** General view of Site C6

- **RECOMMENDATIONS:** *Site C6 comprises of a heritage site as defined and protected under the NHRA 1999. The site is ascribed a SAHRA MEDIUM SIGNIFICANCE and a GENERALLY PROTECTED B FIELD RATING. The site is situated more or less 30m north of the main access road and will not be impacted on by development.*

*It is recommended that development in the vicinity of the site proceeds as applied for without the developer having to comply with further heritage compliance requirements regarding Site I1. The site should be conserved in situ; formal conservation (permanent fencing) is not recommended. The developer may consider temporary fencing (pole and plastic danger tape) during the construction period. Temporary fencing should be negotiated with the community and all temporary conservation measures removed after development.*

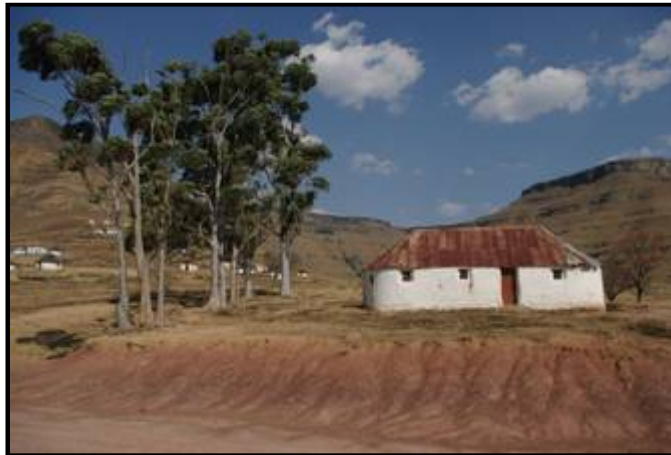
**Figure 52:** General view of Site H9 with the characteristic section exposure between the road level and the site surface level in the foreground

- RECOMMENDATIONS:** *Site H9 comprises an archaeological site and historic period structure as defined and protected by the NHRA 1999. The site is ascribed a SAHRA MEDIUM SIGNIFICANCE and a GENERALLY PROTECTED B FIELD RATING. Despite the fact that the site is no longer in use, it is at present well kept and maintained. Formal site conservation complying to the SAHRA minimum standards of a fence and access gate is not recommended, based on proximity of the structure and related features (Eucalyptus trees) to the access road and surface levels between the access road and site that may in time result in increased erosion encroaching on the site property.*

*For purposes of site conservation it is recommended that development in the vicinity of the site be restricted to the already demarcated road surface area or alternatively that it be placed north and west of the gravel road in the general area of site H9.*

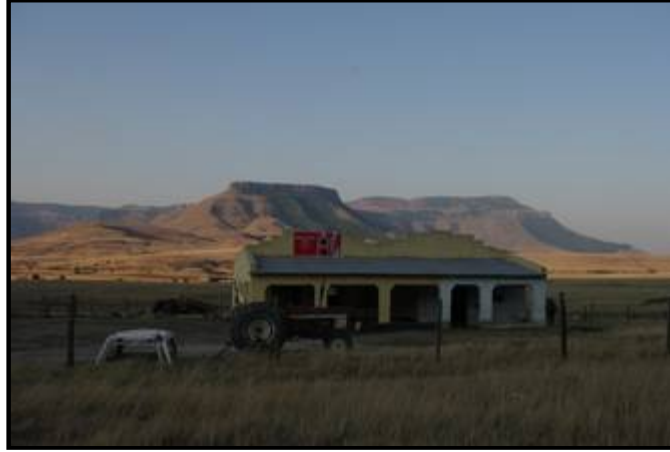
**Figure 56:** General view of Site H11

- **RECOMMENDATIONS:** *Site H11 comprises an archaeological site and historic period structure as defined and protected by the NHRA 1999. The site is ascribed a SAHRA MEDIUM SIGNIFICANCE and a GENERALLY PROTECTED B FIELD RATING. The site is at present formally fenced complying with SAHRA minimum site conservation standards; the structure is at present still in use and fairly well conserved.*

*It is recommended that development in the vicinity of site H11 proceeds as applied for without the developer having to comply with further heritage compliance requirements. The site is formally fenced complying with SAHRA minimum site conservation standards and will not be impacted on by development.*

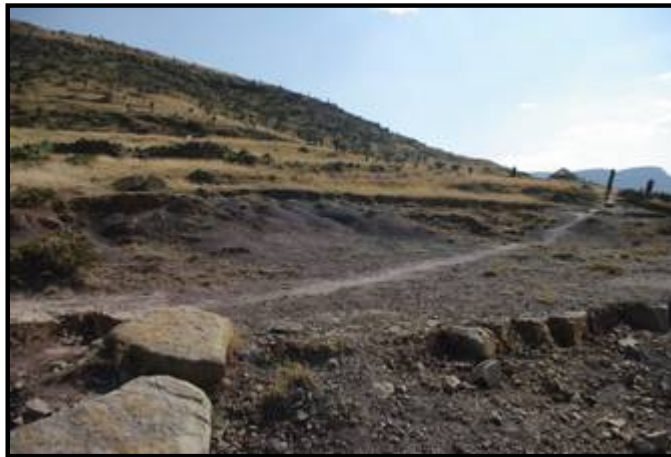
**Figure 63:** View of the H7 fence post feature with a contemporary rectangular stone stock enclosure and anthropic sterile exposed sub-surface sections in the middle and foreground

- **RECOMMENDATIONS:** *Sites H1, H2, H3, H4, H5, H6, H7, H8 and H10 constitutes archaeological site components or features as defined and protected by the NHRA 1999. All the sites are ascribed a SAHRA LOW SIGNIFICANCE and a GENERALLY PROTECTED C FIELD RATING. Recorded site features are at most evidence of former Historic Period landscape use without the potential to yield significant new data relating thereto in the case of formal conservation or Phase 2 archaeological mitigation. All of the fence post features are located adjacent to the proposed development line route – development thus need not impact thereon, implying that the features will be largely conserved.*

*Should development in particular cases require destruction or partial impact on any of these recorded features it is recommended that development proceeds without the developer having to apply for SAHRA Site Destruction Permits.*

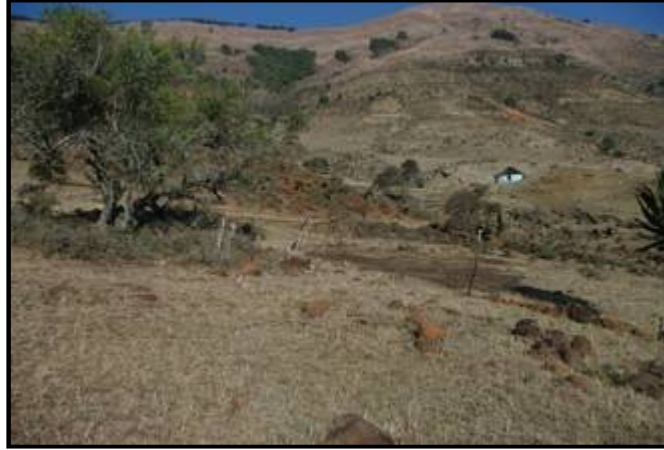
Site I1 (S31°35'27.2"; E27°57'02.1") demarcates the locality of what is believed to have been a 2<sup>nd</sup> generation Iron Age homestead of the Tyane family, constructed by one of the 3 sons of the first settler of Silidini Village. The site is characterized by the stone wall remains of a large circular 'kraal' or stock enclosure, approximating 15-17m in diameter. The remains of at least one hut associated with the 'kraal' is faintly identifiable by means of a rough sand / very fine grained gravel smear indicative of a decayed *daga* floor on a relatively horizontal surface level. No associated artefacts, with particular reference to decorated ceramic or midden material, were identified at the site. Graves are believed to be situated in close proximity to the site, but early grave demarcations have totally disappeared from the landscape (stone outlines and earth fill).

**Figure 66:** General view of the 'kraal' remains at Site I1

- **RECOMMENDATIONS:** *Site I1 represents a later Iron Age archaeological site, as defined and protected under the NHRA 1999. An approximate date of 100-150 BP may be ascribed to the site. The site is assigned a SAHRA MEDIUM SIGNIFICANCE and a GENERALLY PROTECTED B FIELD RATING: The site is situated approximately 180m south-east of the proposed line route and will not be impacted on by development; the site will thus be conserved.*

*It is recommended that development in the vicinity of the site proceeds as applied for without the developer having to comply with further heritage compliance requirements regarding Site I1. The site should be conserved in situ; formal conservation (permanent fencing) is not recommended. The developer may consider temporary fencing (pole and plastic danger tape) during the construction period. Temporary fencing should be negotiated with the community and all temporary conservation measures removed after development.*

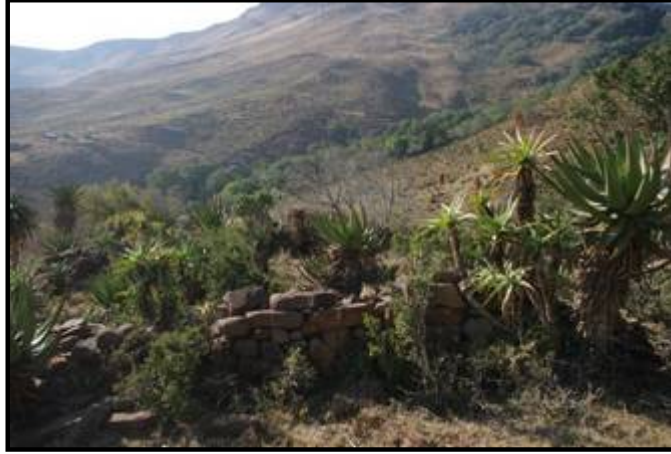
Site 12 (S31°35'34.5"; E27°56'57.8") comprises of the remains of a relatively small, approximate 10m in diameter circular stone walled stock enclosure. The site is associated with the 'sunken' remains of a hut. In order to accommodate steep slopes of the landscape an area was leveled prior to construction of the residential unit / hut, resulting in a neatly cut section on the one side of the hut with the door facing the opposite floor level. The wall portion next to the cut section is particularly well preserved while the remaining circular foundation remains can be clearly identified. The site is relatively overgrown, having largely hampered identification of possible associated related structures, artefacts, middens and graves that can reasonably be inferred to be present in the area. The site is believed to demarcate the locality of the 1<sup>st</sup> Iron Age settler in the area, the direct ancestor of the contemporary Tyane family, with a recorded family history in the area that may go back to 5-6 generations. (The site is at present formally fenced, much to the dismay of the local community and the Tyane family in particular.)

**Figure 70:** View of a portion of the stock enclosure / 'kraal' remains

- **RECOMMENDATIONS:** *Site 12 represents a later Iron Age archaeological site, as defined and protected under the NHRA 1999, inferred to date to 100-150BP. The site is ascribed a SAHRA MEDIUM SIGNIFICANCE and a GENERALLY PROTECTED B FIELD RATING: The site is situated more or less 350m south of the proposed line route and will not be impacted on by development.*

*It is recommended that development in the vicinity of the site proceeds as applied for without the developer having to comply with further heritage compliance requirements regarding Site 12. Formal conservation measures (permanent fencing), complying to minimum standards set by SAHRA are in place.*

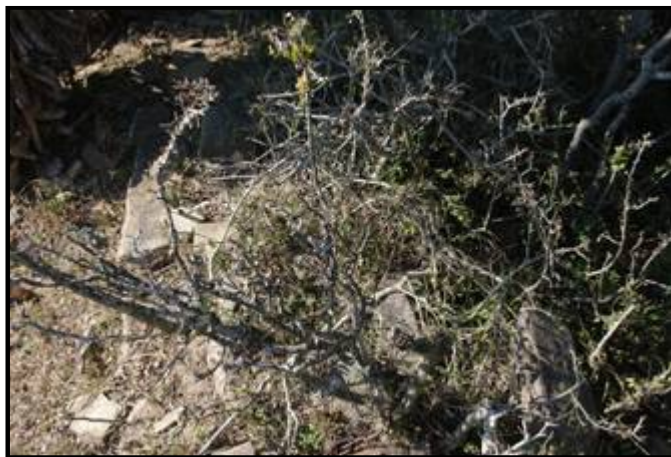
**Figure 72:** Stone foundation remains of the circular hut structure

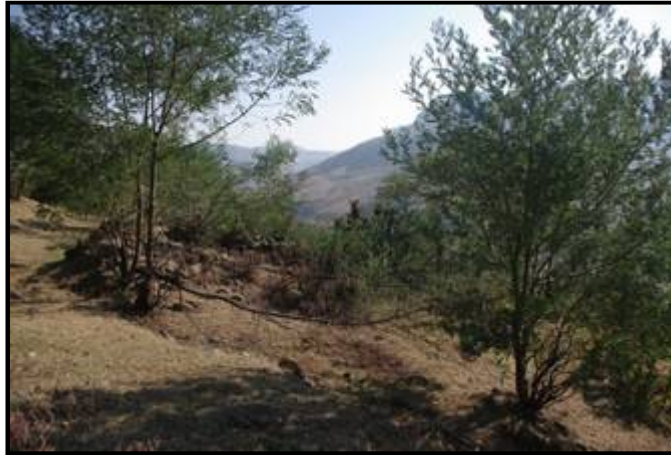
**Figure 77:** Remains of the Site I5 stock enclosure

- RECOMMENDATIONS:** *Site 15 comprises a later Iron Age archaeological site, as defined and protected under the NHRA 1999. An approximate date of 80-100 BP may be ascribed to the site. The site is assigned a SAHRA MEDIUM-LOW SIGNIFICANCE and a GENERALLY PROTECTED B FIELD RATING: The site is situated approximately 170m south-west of the proposed line route and will not be impacted on by development.*

*It is recommended that development in the vicinity of the site proceeds as applied for without the developer having to comply with further heritage compliance requirements regarding Site 15. The site should be conserved in situ; formal conservation (permanent fencing) is not recommended. The developer may consider temporary fencing (pole and plastic danger tape) during the construction period. Temporary fencing should be negotiated with the community and all temporary conservation measures removed after development.*

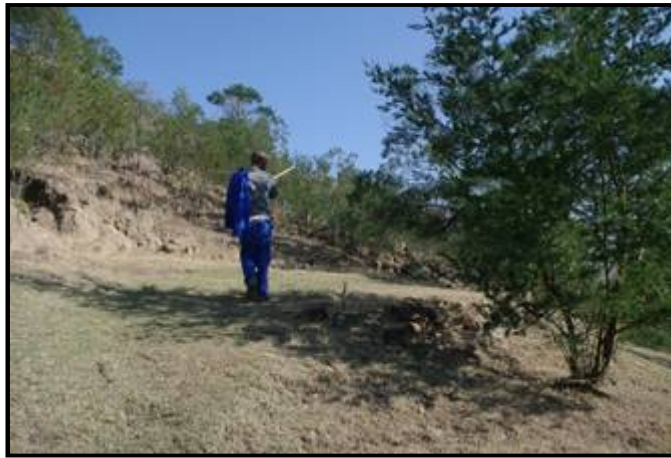
**Figure 78:** General view of the Site I5 residential platform

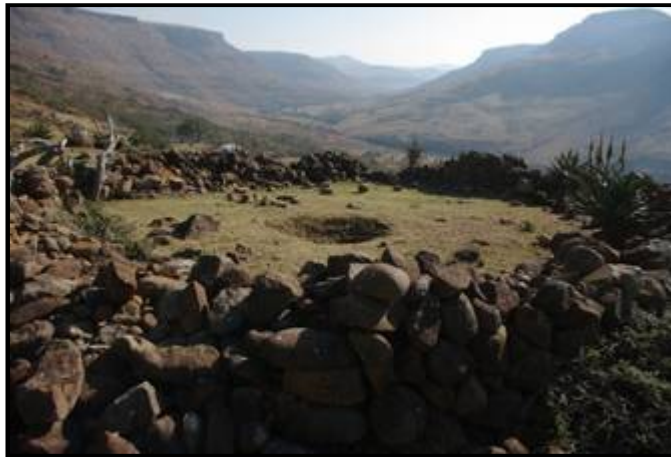
**Figure 81:** Close-up of the 'kraal' with the centrally located hole representing early corn storage practices

- **RECOMMENDATIONS:** *Site 18 comprises a later Iron Age archaeological site, as defined and protected under the NHRA 1999. An approximate date of 100-150 BP may be ascribed to the site. The site is assigned a SAHRA MEDIUM SIGNIFICANCE and a GENERALLY PROTECTED B FIELD RATING: The site is situated approximately 180m south, south-west of the proposed line route and will not be impacted on by development; the site will by implication be conserved.*

*It is recommended that development in the vicinity of the site proceeds as applied for without the developer having to comply with further heritage compliance requirements regarding Site 18. The*

*site should be conserved in situ; formal conservation (permanent fencing) is not recommended. The developer may consider temporary fencing (pole and plastic danger tape) during the construction period. Temporary fencing should be negotiated with the community and all temporary conservation measures removed after development.*

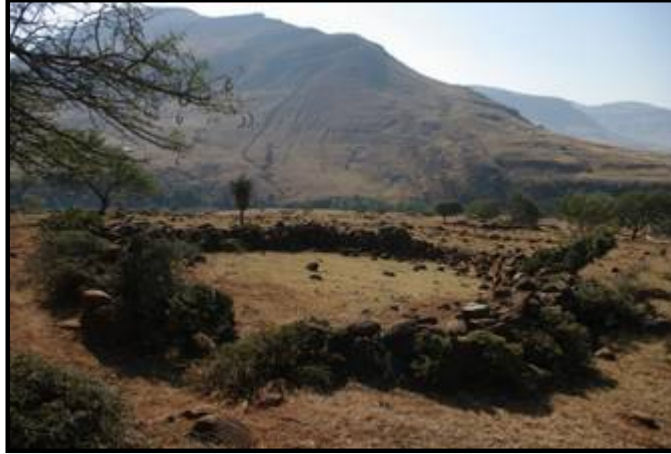
The Site I10 (S31°34'50.0"; E27°56'25.7") is situated between 60 and 130m from the proposed line route. The site is characterized by the remains of a circular stone 'kraal' structure, with estimated dimensions of 10x10m and 2 relatively well preserved hut structures. In addition foundation remains of at least 1 additional hut was clearly discernable. The site may well represent a 3<sup>rd</sup>-4<sup>th</sup> generation settlement of the Silidini area, with a relative approximate date of 80-100 BP. The site is inferred to be directly related to the nearby contemporary homestead.

**Figure 84:** View of the I10 stock enclosure structure

- RECOMMENDATIONS:** Site I10 constitutes a later Iron Age archaeological site, as defined and protected under the NHRA 1999. An approximate date of 80-100 BP is assigned to the site. The site is assigned a SAHRA MEDIUM-LOW SIGNIFICANCE and a GENERALLY PROTECTED B FIELD RATING: The site is located between 60-130m north-east of the proposed line route and will not be impacted on by development.

*It is recommended that development in the vicinity of the site proceeds as applied for without the developer having to comply with further heritage compliance requirements regarding Site I10. The site should be conserved in situ; formal conservation (permanent fencing) is not recommended. The developer may consider temporary fencing (pole and plastic danger tape) during the construction period. Temporary fencing should be negotiated with the community and all temporary conservation measures removed after development.*

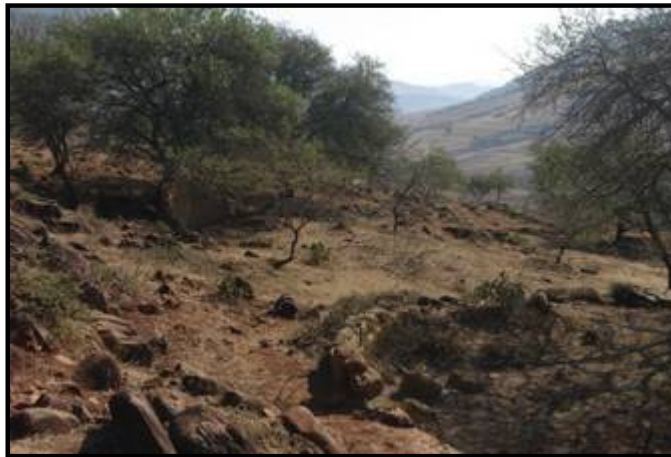
**Figure 85:** Remains of hut structures with a relatively well preserved hut wall in the middle ground

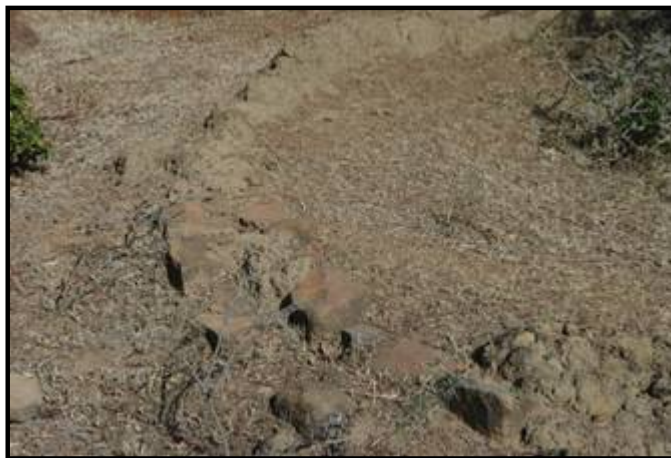
**Figure 86:** Remains of hut foundations at Site I10

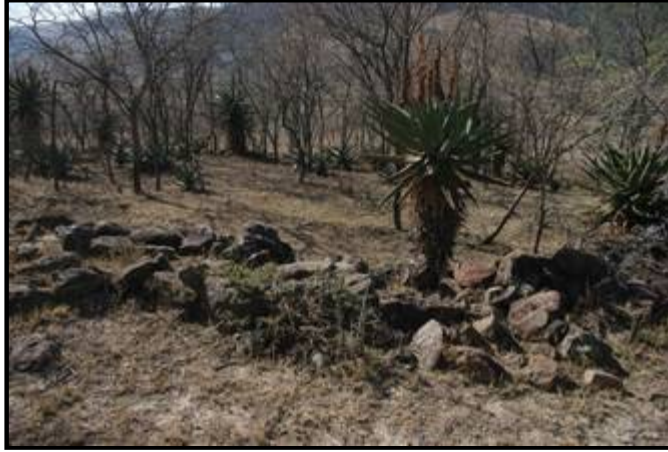
**Figure 98:** The rectangular 'kraal' structure characterizing Site I14

*It is recommended that development in the vicinity of the site proceeds as applied for without the developer having to comply with further heritage compliance requirements regarding Site I14. The site should be conserved in situ; formal conservation (permanent fencing) is not recommended. The developer may consider temporary fencing (pole and plastic danger tape) during the construction period. Temporary fencing should be negotiated with the community and all temporary conservation measures removed after development.*

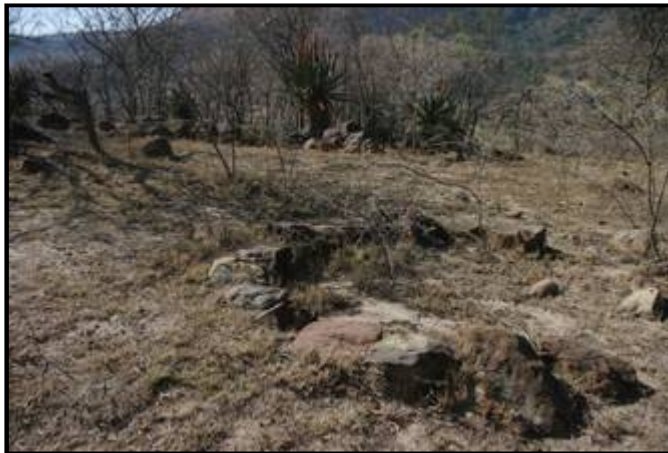
**Figure 99:** Circular foundations, in diameter too small for a hut, may well represent the foundations of relatively elaborate grain storage facilities

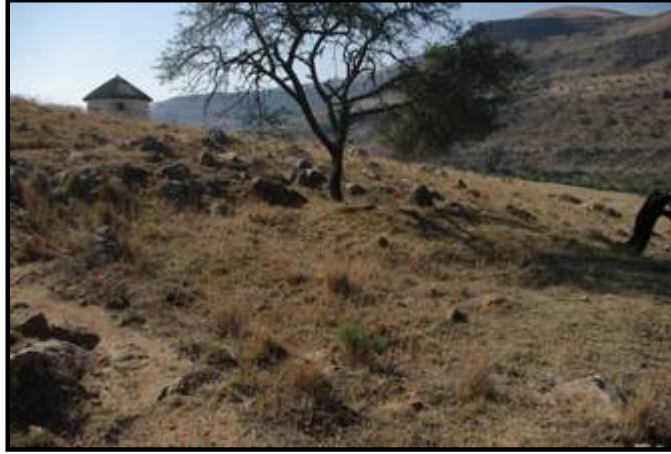
**Figure 101:** Remains of the original circular stock enclosure at Site I18

*It is recommended that development in the vicinity of the site proceeds as applied for without the developer having to comply with further heritage compliance requirements regarding Site I18. The site should be conserved in situ; formal conservation (permanent fencing) is not recommended. The developer may consider temporary fencing (pole and plastic danger tape) during the construction period. Temporary fencing should be negotiated with the community and all temporary conservation measures removed after development.*

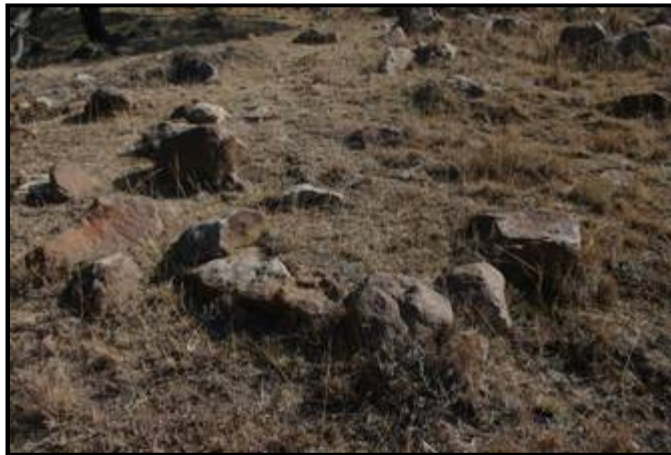
**Figure 102:** Stone foundation remains of a small feature interpreted as a grain storage bin foundation

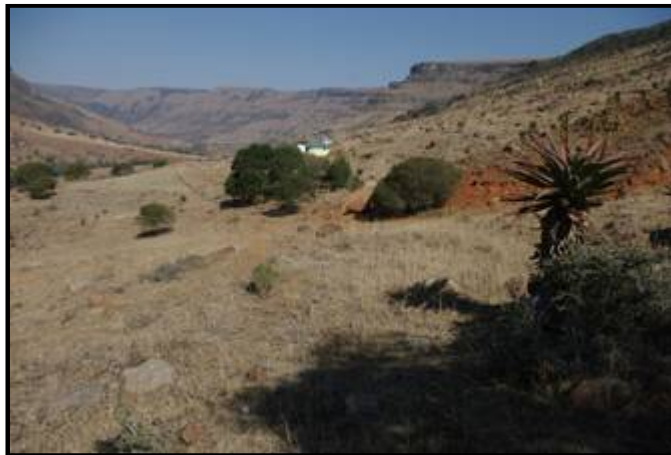
**Figure 103:** One of the leveled surfaces at Site I18 on which the eroded remnants of a *daga* floor were identified
