**CULTURAL HERITAGE IMPACT ASSESSMENT
OF A SECTION OF THE NATIONAL ROUTE R61
BETWEEN UMTATHA AND QUEENSTOWN AND
ASSOCIATED QUARRY AND BORROW PITS,
EASTERN CAPE**

ACTIVE HERITAGE cc.

April 2011

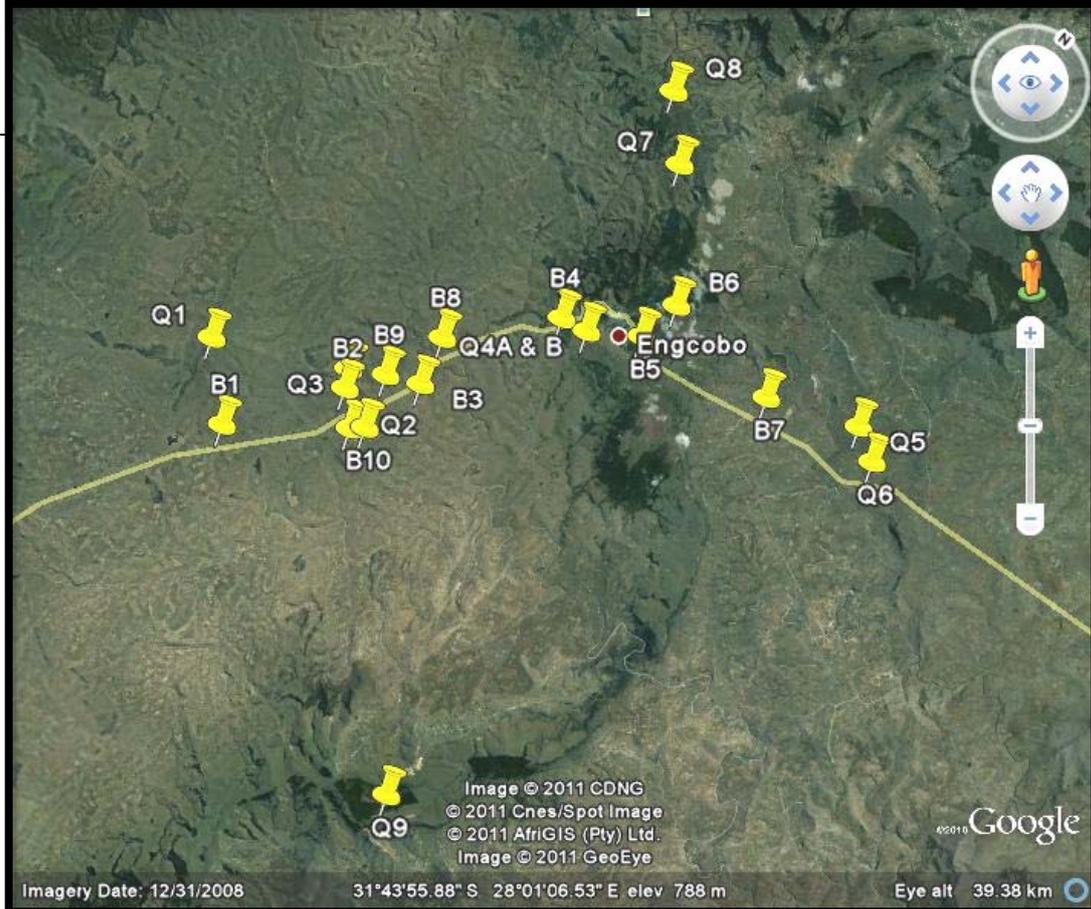
Figure 2. Google aerial photograph showing the distribution of the quarry and borrow pits in the study-area

being Quarry pits 1 and 5 and 7 that are located more than 10km from the R61 (Fig 2). Given the potential impact the construction of a quarry and borrow pit may have on heritage resources in its environs a description of each and every potential pit feature is given below.

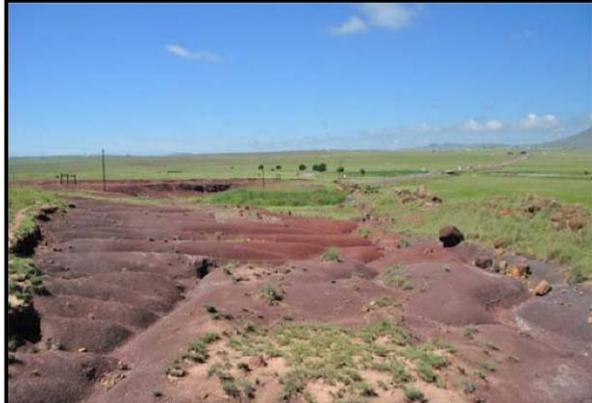
BORROW PIT: 1

Borrow Pit 1 is an existing shallow, highly to moderately weathered, disused mudstone borrow pit located alongside the road, on the north side, at Km 44.2, approximately 900m east of the Qumanco River Bridge. A small shallow reed filled pond occupies the borrow pit floor in the south west corner and a 2m wide, steeply dipping dolerite dyke, extends along the east side of the borrow pit. The borrow pit has a base 80m long by 30m wide. Material comprises maroon, highly to moderately weathered, medium hard rock mudstone which is overlain by 0.3m of light brown silt. The site is bounded by a fence and a road to the south. It can be expanded to the east, however, the depth of overburden increases to >2.5m within 30m of the eastern edge of the existing borrow pit. Trial Hole TH4 excavated 60m east of the borrow pit intersected sandstone at 2.70m.

No heritage sites and features occur on or near this borrow pit.

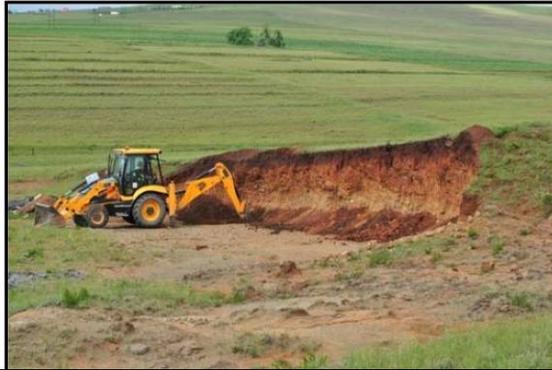
BORROW PIT 2**POSITION: Km 49.8km: 500m North****DESCRIPTION:**

Borrow Pit 2 is an existing, small, shallow borrow pit located 500m north of the road at Km 49.8. Access is via a narrow gravel track. Material comprises olive brown, highly to completely weathered dolerite which is overlain by red brown, completely weathered dolerite, in turn overlain by colluvial dark brown silty clay. The borrow pit dimensions are 50m x 50m x 2.5m. The completely weathered dolerite has not been sampled as it is likely to have a high Plasticity Index and would therefore be unsuitable as road subgrade material. This material must be removed to spoil prior to excavation of better quality material. The highly weathered dolerite in the borrow pit floor has, in comparison, potential as selected subgrade G6/G7 material. Deeper excavations may require blasting.

No heritage sites or features occur on or near this borrow pit.

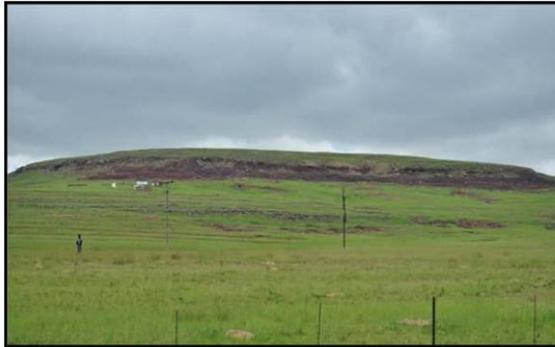
BORROW PIT 3**POSITION : Km 52.6: 1000m South****DESCRIPTION:**

Borrow Pit 3 is a weathered maroon mudstone material source located 1 Km south of the R61 road. It consists of a clearly visible large excavation near the summit of a long hill. The face length is approximately 600m with a height of approximately 12m. The mudstone is capped by sandstone which varies between 2m and 3m in thickness. Several dolerite dykes varying in thickness from 0.5m to 1.0m have intruded the mudstone at dips which vary from near-vertical to horizontal. Occasional sandstone lenses up to 10m long and 0.4m wide are present within the mudstone. Samples were removed from the face at ground level for laboratory testing. No trial holes were excavated south of the face because of the impenetrable nature of the sandstone capping.

No heritage sites or features are associated with this borrow pit.

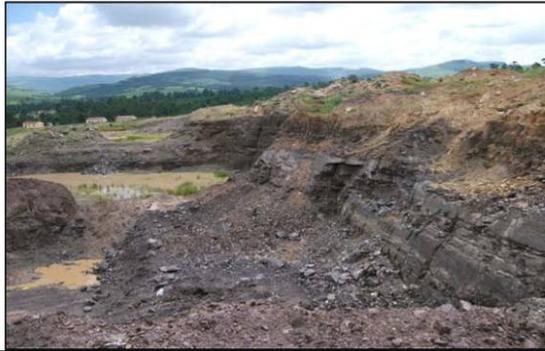
BORROW PIT 4**POSITION: Km 59.6: 300m South****DESCRIPTION**

Borrow Pit 4 is an existing mudstone borrow pit located alongside 300m south of the R61. Material comprises maroon, highly to moderately weathered mudstone, with hardness of mudstone that increases with depth. A sandstone capping overlies the sites western and south western extent. This is a large borrow pit that has been extensively mined as confirmed by the size and extent of the cut as well as the large area of spoiled rock to the north. Ponding occurs at the base of the borrow pit and will need to be managed if further excavation occurs.

No heritage sites or features are associated with this borrow pit

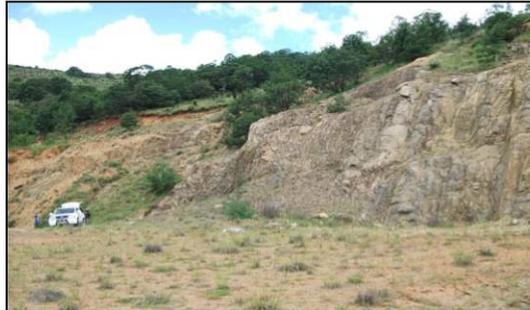
BORROW PIT 5**POSITION: Km 65,0: 800m South****DESCRIPTION**

Borrow Pit 5 is an existing weathered dolerite borrow pit located 800m south of the R61 and slightly beyond the south-east boundary corner of Ngcobo Town. Material comprises highly weathered to moderately/ slightly weathered dolerite. A central less-weathered zone is flanked by highly weathered zones that extend to the north west and south east. A bench within the borrow pit consists of moderately weathered dolerite and most probably remained due to an inability to rip this medium hard rock. The borrow pit is located on the side of a relatively steep slope through which the weathered dolerite is assumed to extend. A large amount of dolerite core stones are found to the north of the site where they occur within the upper residual and completely weathered dolerite horizons in this north section.

No heritage sites or features are associated with this borrow pit.

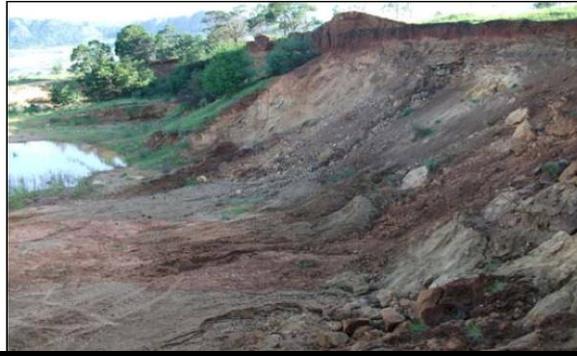
BORROW PIT 6**POSITION: Km 65,1: 600m North****DESCRIPTION**

Borrow Pit 6 is an existing weathered dolerite borrowpit located 600m up a side road north of the R61. Its southern end comprises of a weathered mudstone previously used to construct nearby gravel roads. Material comprises of a light olive, completely weathered dolerite overlying olive, highly weathered soft to medium hard rock dolerite. On the western side of the borrow pit the dolerite is overlain by a mudstone horizon and in the north west capped by sandstone as intersected in Trial Holes 5 and 6. Sedimentary rock will require removal to spoil where encountered during borrowing. Deep weathering means there is a relatively deep ($\pm 3.0\text{m}$) volume of overburden consisting of residual and completely weathered dolerite. This material is expected to have relatively high plasticity and may require spoiling. The site is bounded by a gravel road to the south. Any new development should be extended vertically into the footwall to the north east.

No heritage sites or features occur in association with this borrow pit.

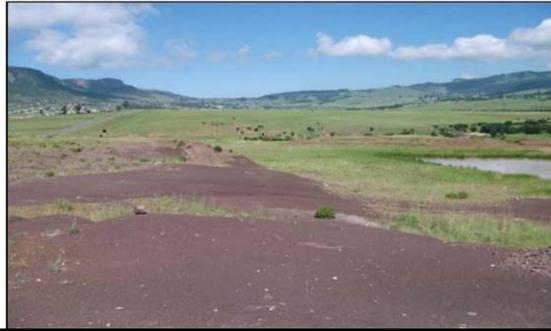
BORROW PIT 7**POSITION: Km 71,0: 200m North****DESCRIPTION**

Borrow Pit 7 is an existing highly to slightly weathered sedimentary mudstone borrow pit located 200m north of the road. Material consists of maroon, highly weathered mudstone overlying a band ($\pm 400\text{mm}$) of grey blue, slightly weathered, siltstone/sandstone which in turn overlies additional maroon, highly weathered mudstone. Mudstone hardness increases rapidly with depth. The site has most likely been used as a source of gravel wearing course for surrounding gravel roads and possibly as Selected Subgrade for the R61.

No heritage sites or features occur in association with this borrow pit.

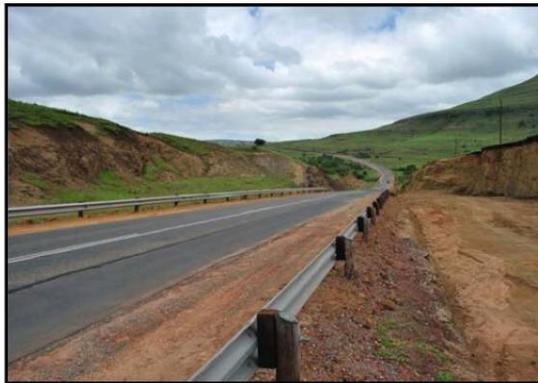
BORROW PIT 8

Borrow Pit 8 is an existing, highly to completely weathered dolerite borrow pit that is currently in use for minor road maintenance. It has two 5m to 8m high cutfaces north and south of the R61 respectively, which road bisects the borrow pit. The weathered dolerite is capped by 0.5m to 1.0m of red brown clayey silt. It can be extended north and south in a direction perpendicular to the road.

No heritage sites or features were observed in association with this borrow pit.

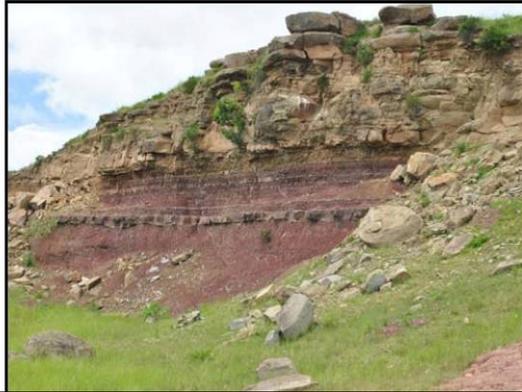
BORROW PIT 9

Borrow Pit 9 is an existing borrow pit with a relatively small 80m long X 30m wide base and hill cut extension on the western side within which is a cutface 6m high. This borrow pit has a 3m capping of moderately weathered sandstone. The borrow pit could possibly be expanded towards the east by excavating the footwall. This would eliminate the costly removal and spoiling of the thick sandstone capping.

No heritage sites or features occur on or near this borrow pit.

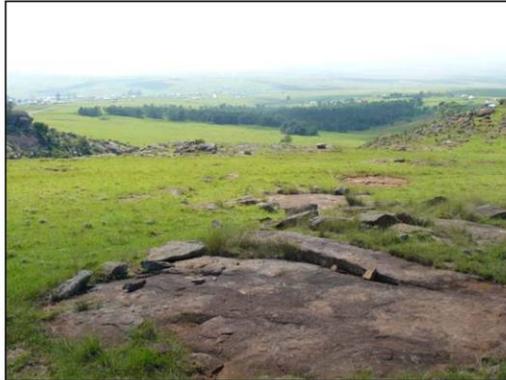
QUARRY OPTION Q1**POSITION: 45+400; 3,5 Km N****DESCRIPTION:**

Proposed Quarry Option 1 is located near the start of the project and a direct distance of 3,5 kilometres north of the R61 (4,9 kilometres via a gravel access road). It is situated at the top end of a small natural valley along an elevated ridge. The proposed site has extensive outcrops of very hard, massive, unweathered, 'domed' dolerite. A minor flow line drains the area southwards which will be the conduit to drain stormwater from the quarry during construction. Shallow soils and short grasses cover interstitial areas between outcrops. Investigation will require rotary core drilling.

No heritage sites or features occur in association with this potential quarry.

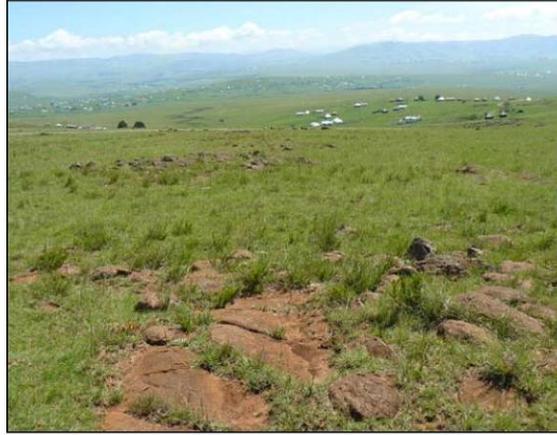
QUARRY OPTION Q2**POSITION: 49+200; 1,7 Km S****DESCRIPTION:**

Quarry site Q2 is located 1,1 kilometres directly south of Km 49,1 of the R61 and 1,7 kilometres away by road. Here the topography forms a long south trending ridge comprising a dolerite sill of variable extent and weathering. The proposed quarry site is located on the gentle east facing side of the ridge. It has reasonably good access via a minor rural gravel road. The site has occasional flat to slightly domed outcrops of very hard, massive, slightly weathered to unweathered dolerite with grass covered soils and in places masses of hard angular dolerite corestones. The latter remnants of earlier weathering and erosion along the ridge. There are several homesteads downslope of the access road as located along the eastern end of the proposed site.

No heritage sites or features occur in association with this potential quarry.

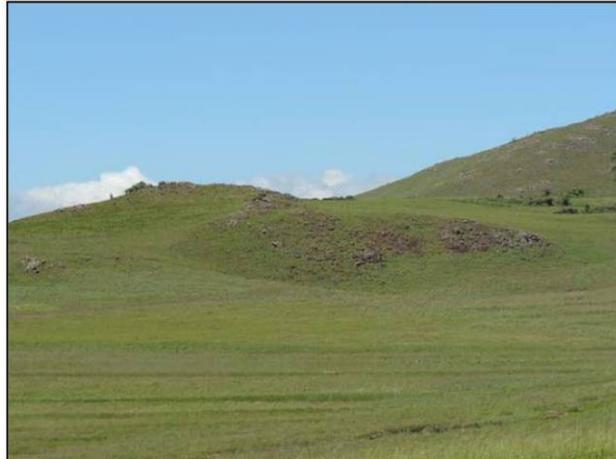
QUARRY OPTION Q3**POSITION: 50+000; 1,1Km N****DESCRIPTION:**

Quarry site Q3 is located 1,1 kilometres north of Km 50,1. It is accessible within 0,5 Km on its eastern side by a local gravel road. Thereafter access is difficult with the site separated by a marsh wetland. A new access would have to be constructed from the R61 via a low ridge leading up to the site. The site is located on an east/ west trending elevated ridge. The ridge top consists of large angular dolerite corestones piled on top of occasional domed outcrops of slightly weathered to unweathered hard rock dolerite. The eastern extremity of the ridge has large exposures of massive domed rock. There are no houses on the site and nearest habitation is about 0,5 Kms to the north and east.

No heritage sites or features occur in association with this potential quarry.

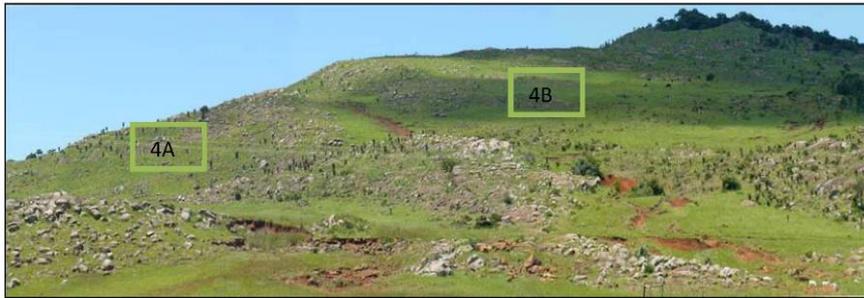
QUARRY OPTION Q4 A & B**POSITION: 60+500; 1,5 Km S****DESCRIPTION:**

Quarry Option 4 is located immediately south of Ngcobo Town – 1,5 kilometres south of the R61 - alongside the Ngcobo Dutywa Road on a west facing hillslope 500m east of the road. Two sites – 4A and 4B - about 200m apart are possible. Both contain excellent exposures of massive dolerite, the main difference being that A has a higher and steeper slope than B. A pathway intersects the 2 sites in what appears to be a zone of deeper weathering along a fault or feeder dyke. Springs emanating from the ridge are common with plastic reservoir tanks over-flowing below 4A.

Although the terrain appeared promising for Later Iron Age site occurrence no heritage features were observed.

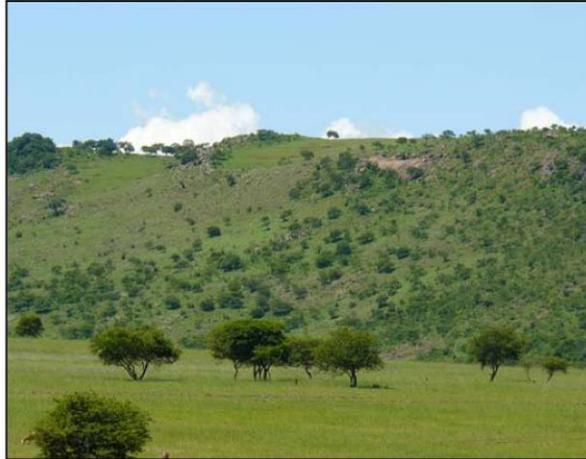
QUARRY OPTION Q5**POSITION: 74+200; 1,2 Km N****DESCRIPTION:**

The proposed quarry is located 6 kilometres beyond the eastern end of the project. It is 1,2 kilometres due north of the R61 and 1,4 kilometres via a local gravel access road. It is located in a small horseshoe shaped plateau area between two ridge highpoints. The proposed quarry overlooks the Xuka River valley to the west. The site is grass-covered but there are extensive nearby outcrops of massive dolerite which presumably extend to beneath the plateau proposed as the quarry site. Drilling will be required for confirmation. There are several houses immediately north of the quarry area.

No heritage sites or features occur on the quarry site.

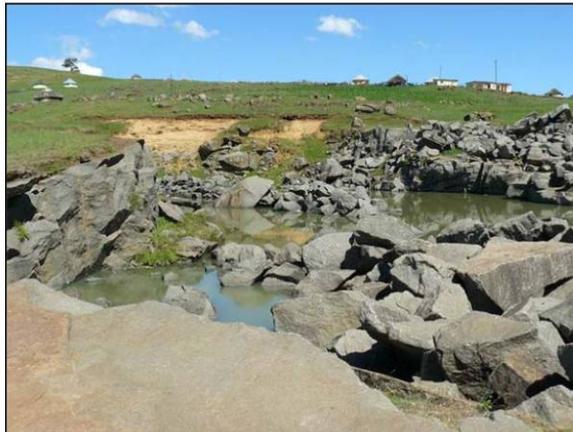
QUARRY OPTION Q6**POSITION: 76+200; 0,1 Km S****DESCRIPTION:**

Quarry Option Q6 is an existing disused quarry located nearly 10 kilometres beyond the eastern end of the project. It is situated not more than 100m south of the R61 where it occupies a domed rock outcrop highpoint. The existing excavation is relatively small at 30m X 30m X 4m with the quarry presumably used for construction of the original R61. There are masses of angular dolerite overbreak boulders lying about suggesting poor earlier blasting techniques. A stagnant pond masks the quarry floor. There is an abundance of domed hard rock dolerite in the area as attested to by exposures alongside the quarry excavation. Especially the large hard rock plateau on its western side.

No heritage sites occur in association with this quarry.

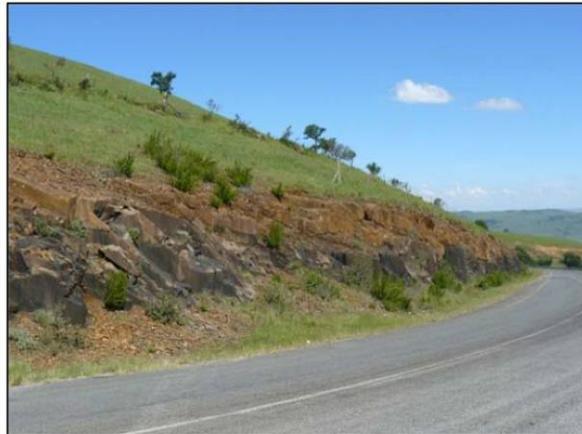
QUARRY OPTION Q7**POSITION: 63+000; 5,5 Km N****DESCRIPTION:**

Quarry 7 would entail widening of an approximately 250m long cutting at a point 6 kilometres north of Ngcobo town (Km 63,0) alongside the road linking Ngcobo to Cala and Elliot. Here the road has been widened into hard unweathered dolerite. There is scope for extensive widening of the cut towards the east cutting across a natural curve in the road and in so doing providing a safer road plus extensive volumes of hard rock aggregate. There are though a number of problems that need to be overcome should this source prove popular. These include a hillslope which is steep and high with problems in development; very little flat ground on which to establish a crusher and aggregate stockpiles; closure of the road during blasting; and hauling of material through the northern part of Ngcobo. Problems are envisaged in persuading the road authorities to allow regular road closure.

No heritage sites occur on or near this quarry.

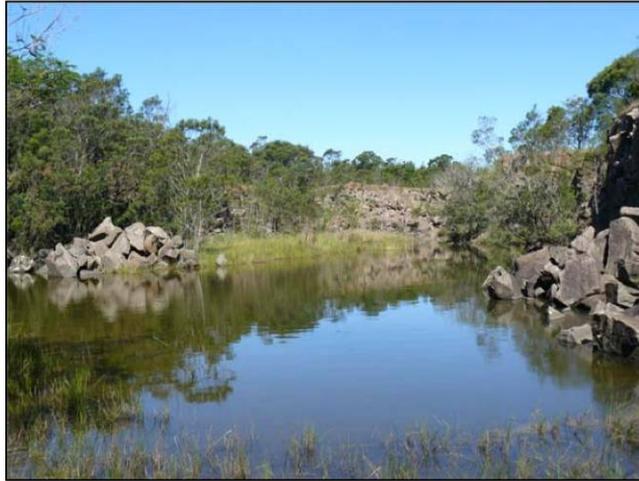
QUARRY OPTION Q8**POSITION: 45+400; 3,5 Km N****DESCRIPTION:**

No heritage sites or features are associated with this quarry.

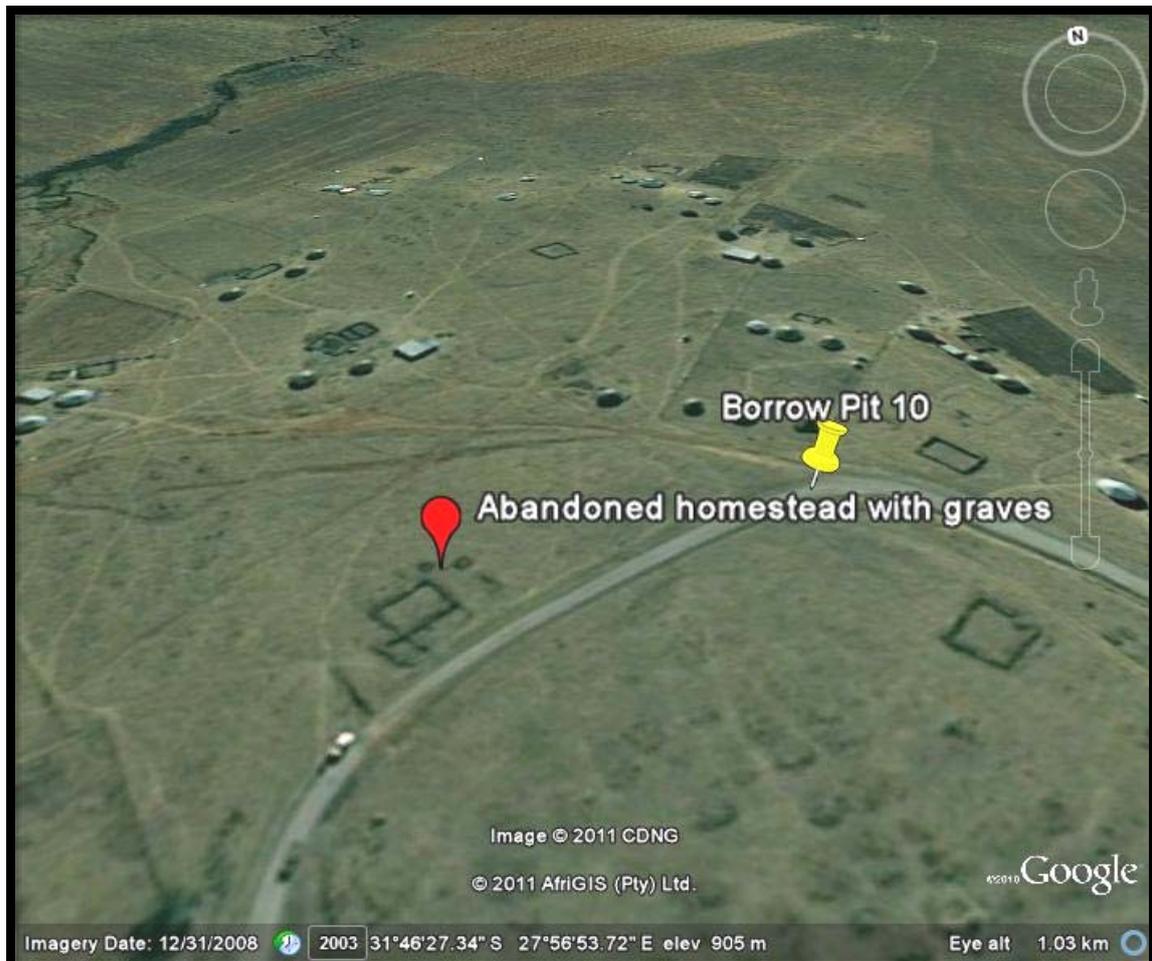
Figure 5. Google aerial photograph showing the location of the graves relative to Borrow Pit 10.

Borrow pit 10 is situated in field adjacent to a small village. It is not an existing borrow pit but consists of a borrow pit opportunity with highly weathered dolerite exposed in the road side drain on the west side of the road. The access road to this point is 4.5 km from the R61. The potential borrow pit is, however, surrounded by abandoned and occupied homesteads. These consists of huts and square cattle byres constructed of stone. Two contemporary graves occur approximately 25m to the west of the proposed borrow pit (Fig 5). These are indicated by small heaps of stone measuring

Maintain a 20m buffer zone around the identified heritage sites. No dumping of construction material is allowed within this buffer zone and no alteration or damage of these sites may occur.

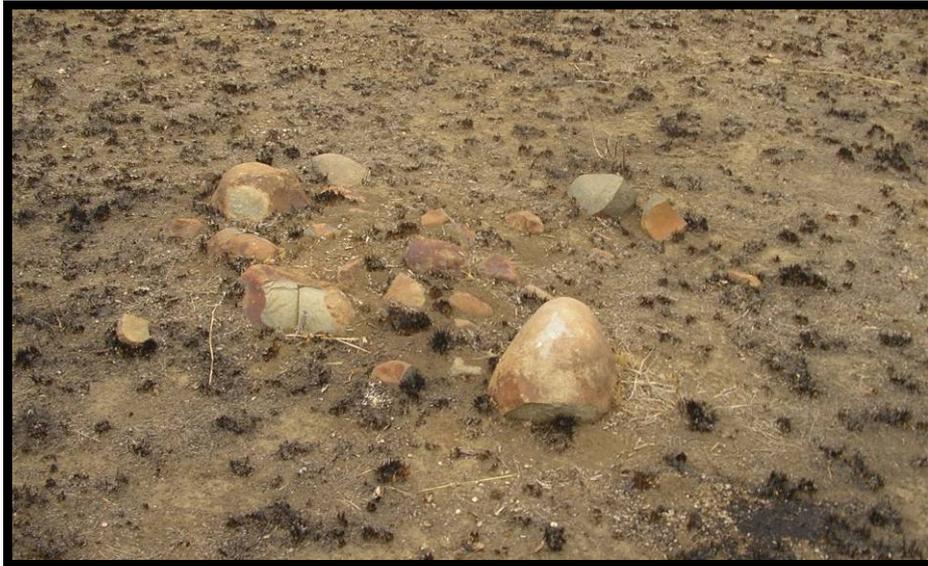
Figure 6. Grave site one, some stone robbing occurred here in the past.

approximately 1x2m (Fig 6) and 2x3m (Fig 7) in extent. It appears that some stone robbing of the smaller grave did occur in the recent past. Preliminary interviews with inhabitants of the local village suggests that these graves are approximately 80 years old and that the descendant family of the deceased still live in the area. The main attributes of this grave site is summarised in Table 2.
